CRESCO MUNICIPAL AIRPORT PAVEMENT MANAGEMENT REPORT

Prepared For:
Iowa Department of Transportation
Office of Aviation

Prepared By:
Applied Pavement Technology, Inc.

November 2003

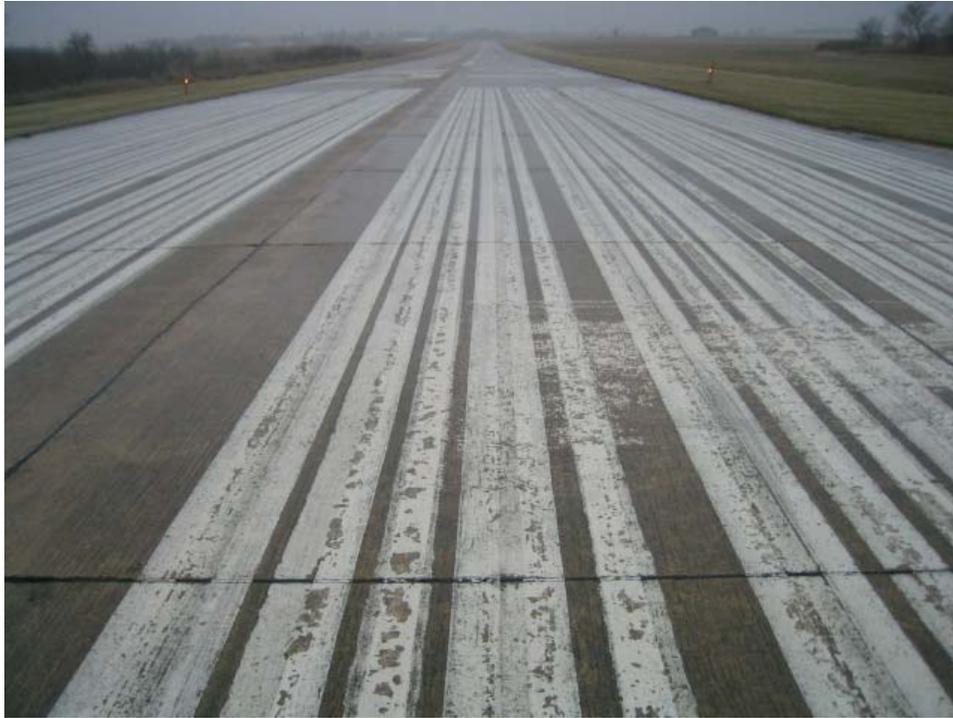
R15CR-01. Overview.

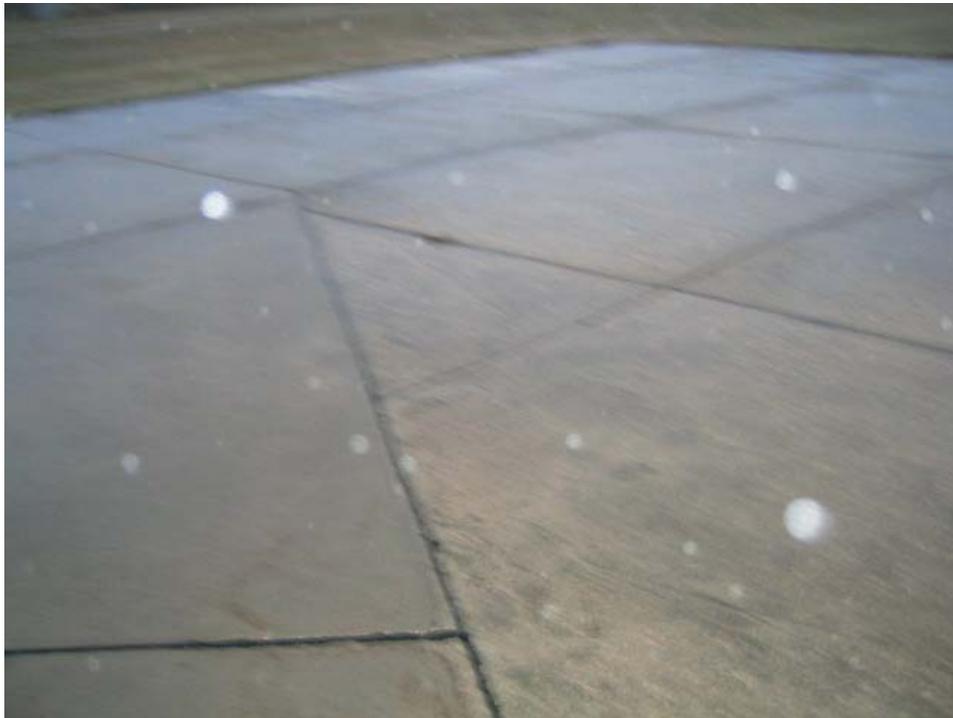
R15CR-02. Overview.

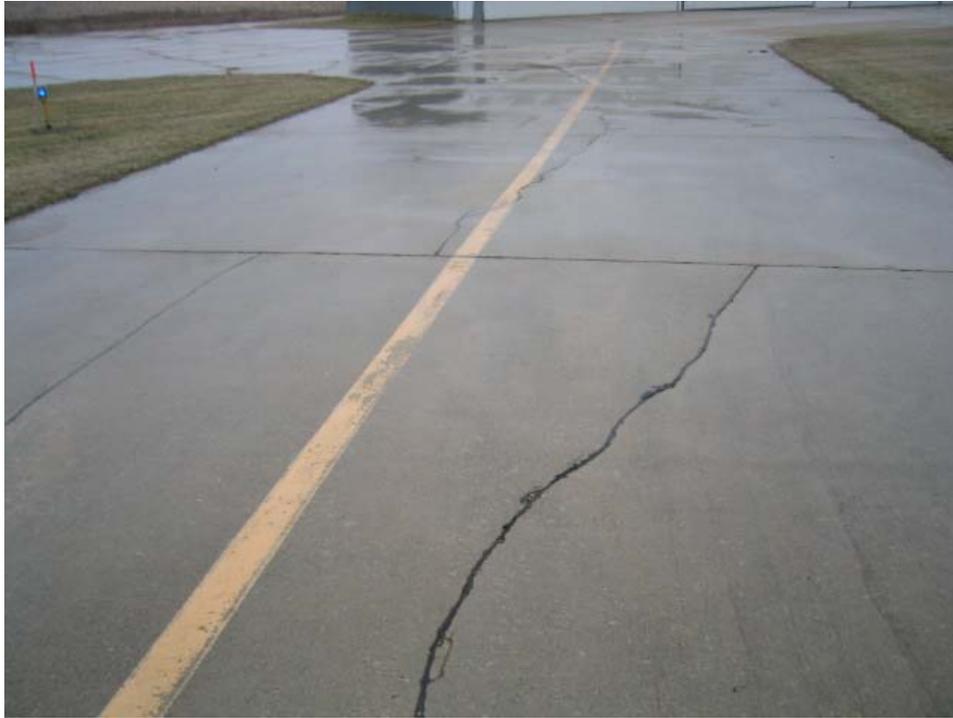
T01CR-01. Overview.

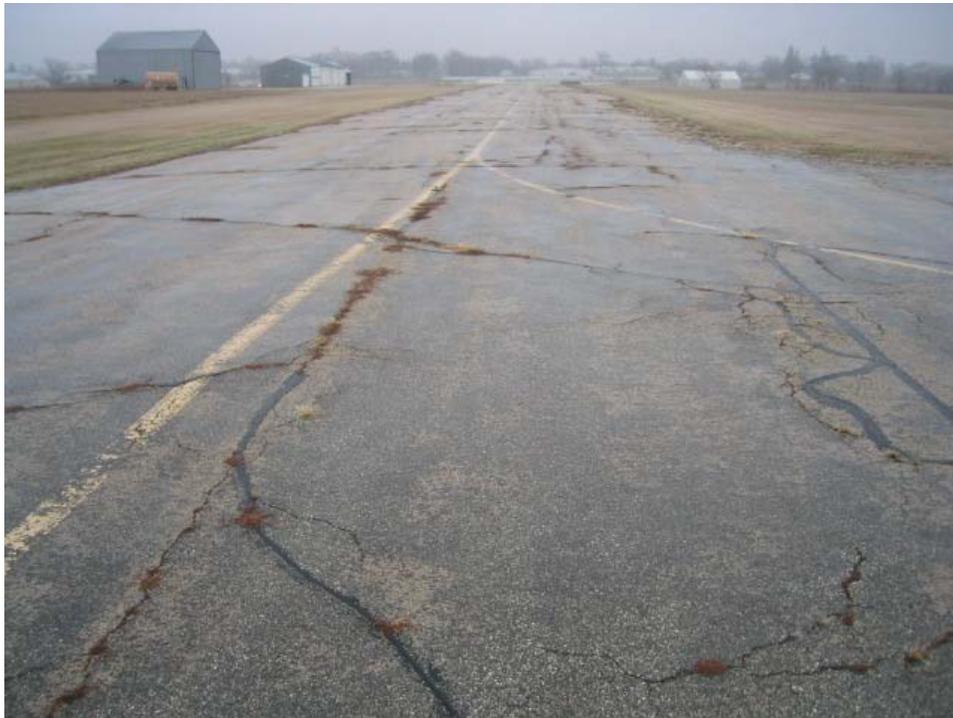
T03CR	01	AC	52,269	6/1/1973	37	63	37	Rutting, Alligator cracking, Block cracking, Longitudinal and transverse cracking

T03CR-01. Overview.

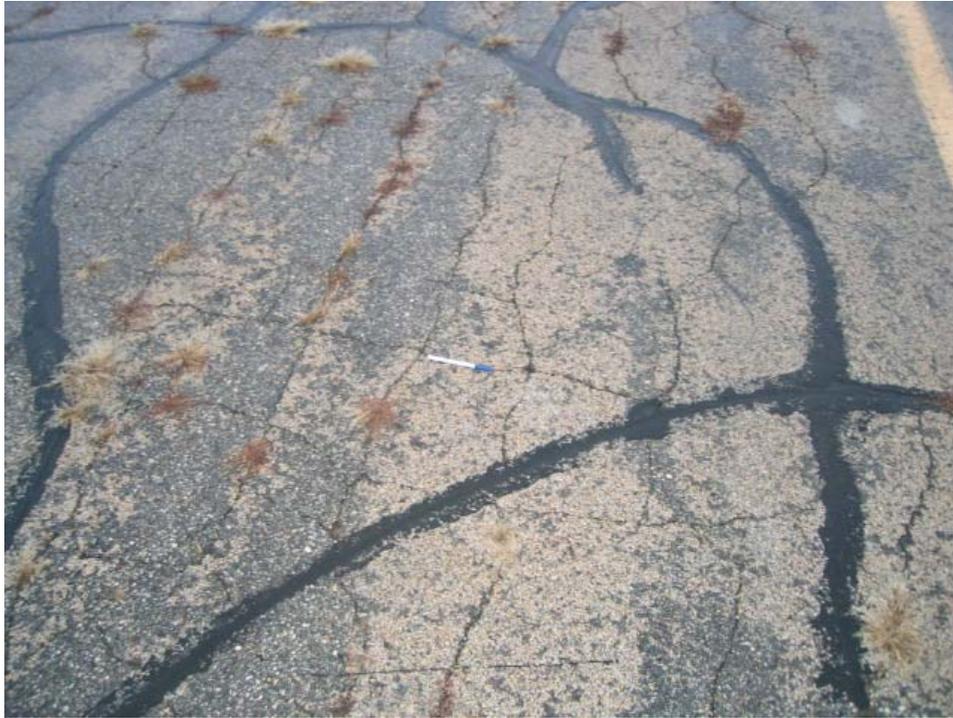
T03CR-01. Alligator cracking.

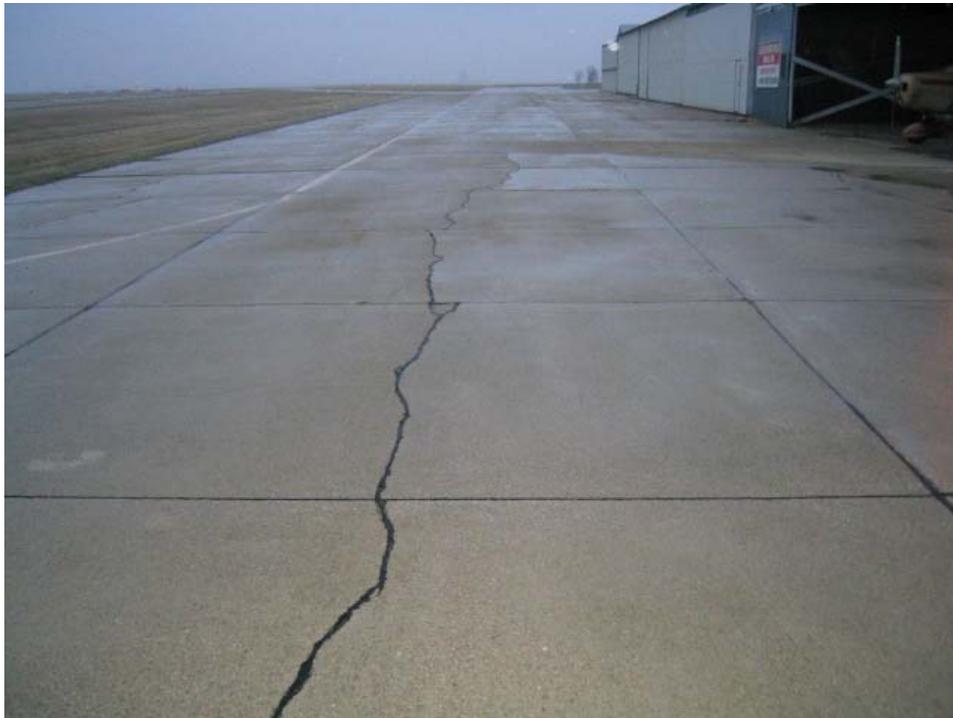
A01CR-01, A01CR-02, and A01CR-03. Overview.

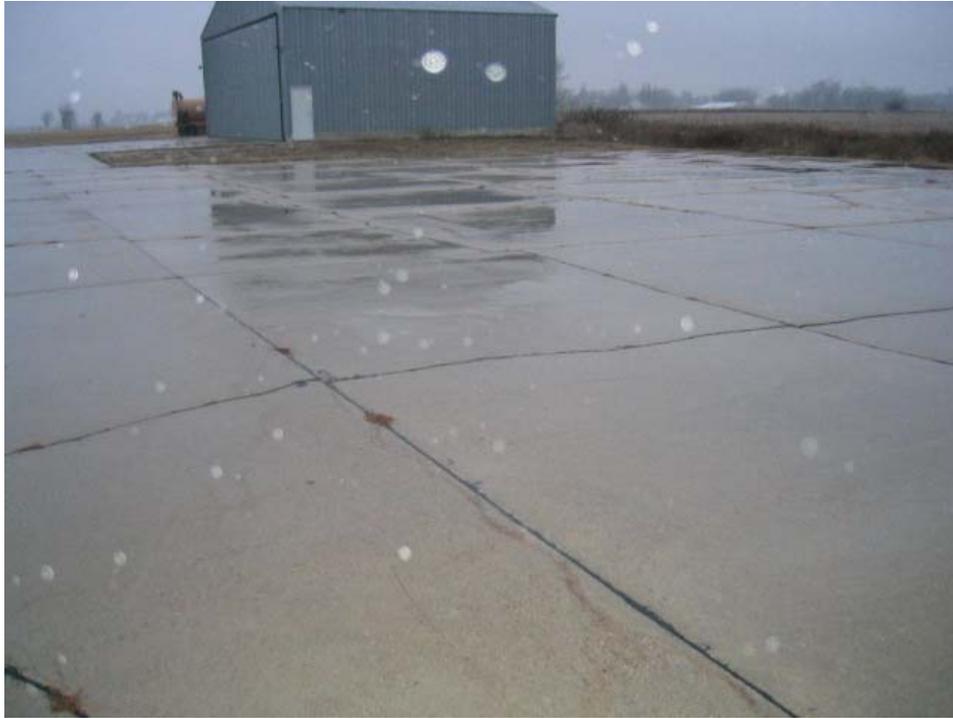
A02CR-01. Overview.
