# CORNING MUNICIPAL AIRPORT PAVEMENT MANAGEMENT REPORT

**Prepared For:**  
Iowa Department of Transportation  
Office of Aviation

**Prepared By:**  
Applied Pavement Technology, Inc.

November 2003

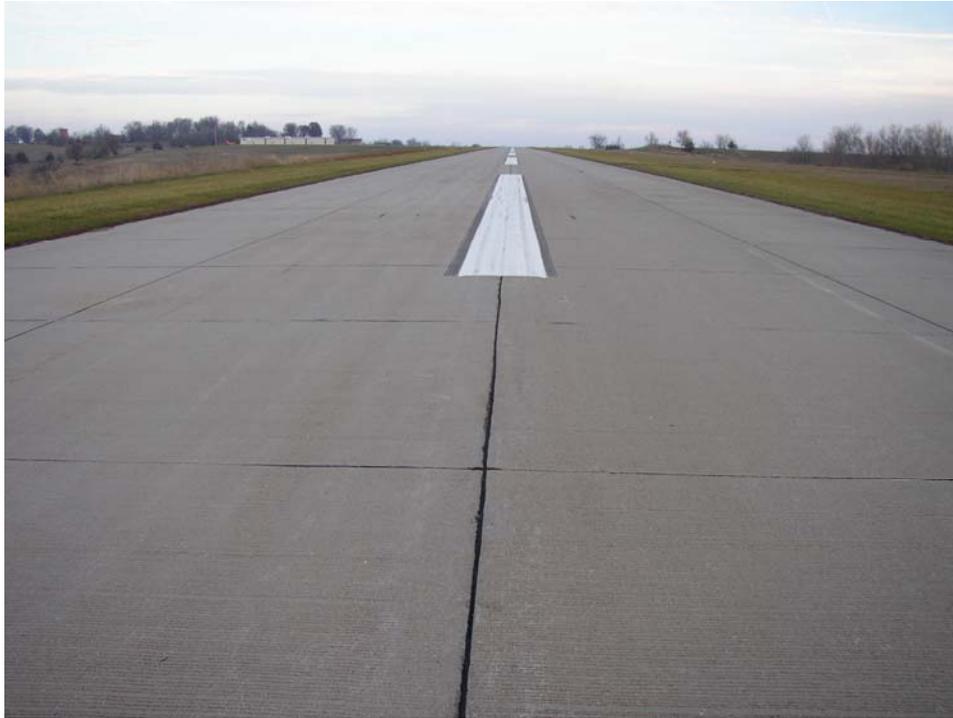
R17CO-01. Overview.

Corning Municipal Airport								
Branch <sup>1</sup>	Section	Surface Type <sup>2</sup>	Section Area, sf	LCD <sup>3</sup>	2003 PCI	% Distress Due To:		Distress Types
						Load <sup>4</sup>	Climate or Durability <sup>5</sup>	
A01CO	01	PCC	16,200	6/1/1987	91	29	71	Linear Cracking, Joint seal damage
R17CO	01	PCC	134,150	6/1/1987	93	14	47	Small patch, Linear Cracking, Joint seal damage, Joint spalling, Corner spalling
T01CO	01	PCC	6,860	6/1/1987	89	0	66	Joint seal damage, Corner spalling

Branch	Section	Distress Type <sup>1</sup>	Severity	Distress Quantity	Unit	Maintenance Action	Estimated Cost
A01CO	01	Joint Seal Damage	M	104	Slabs	Joint Seal (Localized)	\$3,506
R17CO	01	Joint Spall	H	1	Slabs	Patching - PCC Partial Depth	\$61
		Joint Spall	M	32	Slabs	Patching - PCC Partial Depth	\$1,524
		Joint Seal Damage	M	20	Slabs	Joint Seal (Localized)	\$655
T01CO	01	Corner Spall	M	2	Slabs	Patching - PCC Partial Depth	\$41
		Joint Seal Damage	M	41	Slabs	Joint Seal (Localized)	\$938
