SIBLEY MUNICIPAL AIRPORT PAVEMENT MANAGEMENT REPORT

Prepared For:
Iowa Department of Transportation
Office of Aviation

Prepared By:
Applied Pavement Technology, Inc.

November 2003

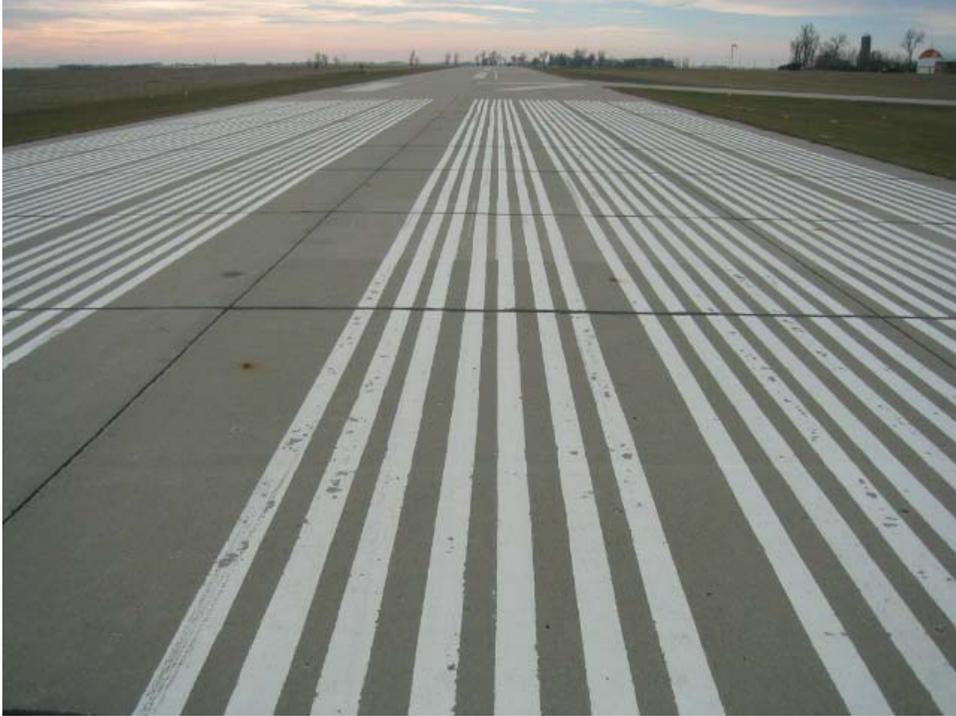
| Sibley Municipal Airport | | | | | | | | |
|---|---|---|---|---|---|---|---|---|
| R17IS | 01 | PCC | 150,000 | 6/1/1994 | 93 | 84 | 0 | Corner break, Joint spalling, Linear Cracking, Shattered slab |

R17IS-01. Overview.

| Year | Branch ¹ | Section | Type of Repair ² | Estimated Cost ³ |
|---|---|---|---|---|
| | R17IS | 01 | Localized Maintenance | \$428 |

| Branch | Section | Distress Type ¹ | Severity | Distress Quantity | Unit | Maintenance Action | Estimated Cost |
|---|---|---|---|---|---|---|---|
| R17IS | 01 | Corner Break | L | 15 | Slabs | Crack Sealing - PCC | \$185 |
| | | Shattered Slab | L | 5 | Slabs | Crack Sealing - PCC | \$244 |

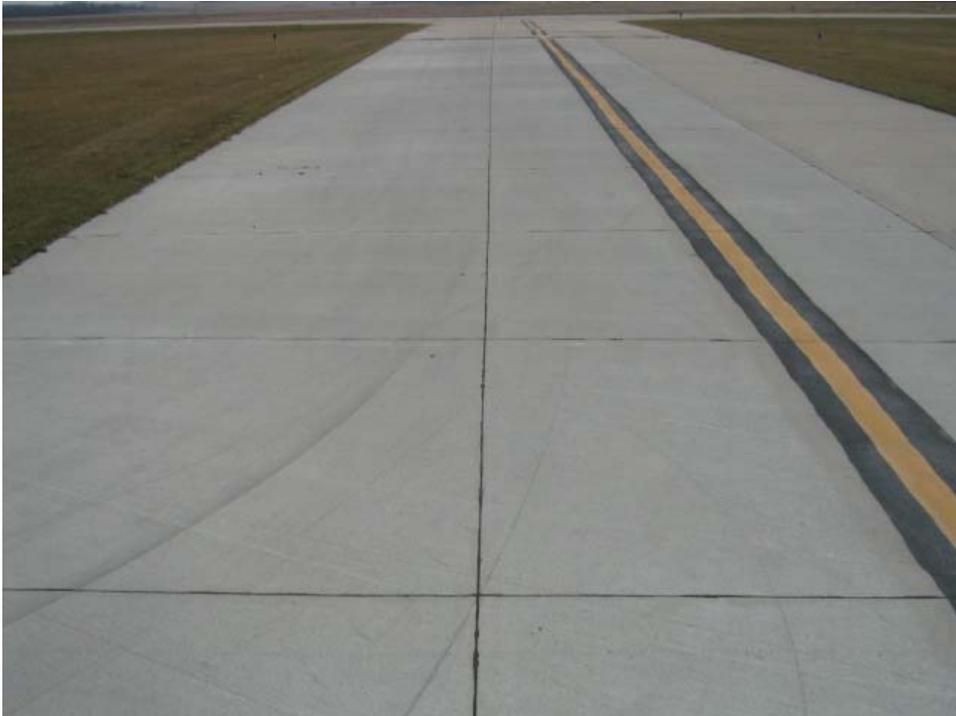
| Sibley Municipal Airport | | | | | | | | |
|---|---|---|---|---|---|---|---|---|
| T01IS | 01 | PCC | 2,470 | 6/1/2001 | 81 | 49 | 51 | Linear Cracking, Joint seal damage |

T01IS-01. Overview.

| Year | Branch ¹ | Section | Type of Repair ² | Estimated Cost ³ |
|---|---|---|---|---|
| | T01IS | 01 | Localized Maintenance | \$568 |

| Branch | Section | Distress Type ¹ | Severity | Distress Quantity | Unit | Maintenance Action | Estimated Cost |
|---|---|---|---|---|---|---|---|
| T01IS | 01 | Joint Seal Damage | H | 20 | Slabs | Joint Seal (Localized) | \$546 |
| | | Linear Cracking | M | 1 | Slabs | Crack Sealing - PCC | \$23 |

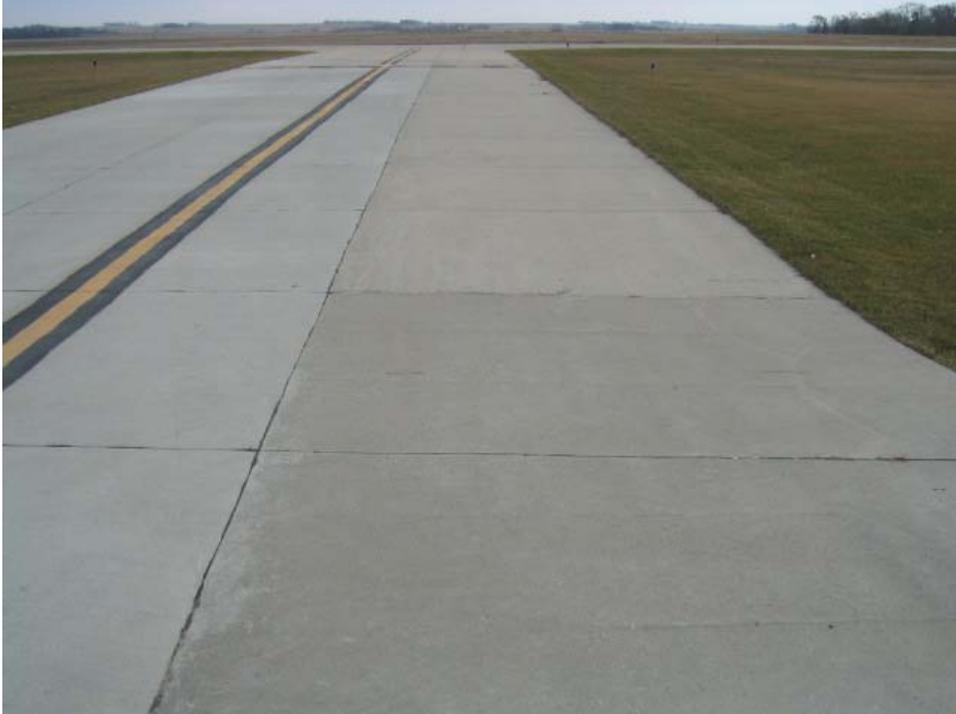
| Sibley Municipal Airport | | | | | | | | |
|---|---|---|---|---|---|---|---|---|
| T01IS | 02 | PCC | 1,208 | 6/1/2001 | 100 | 0 | 0 | |

T01IS-02. Overview.

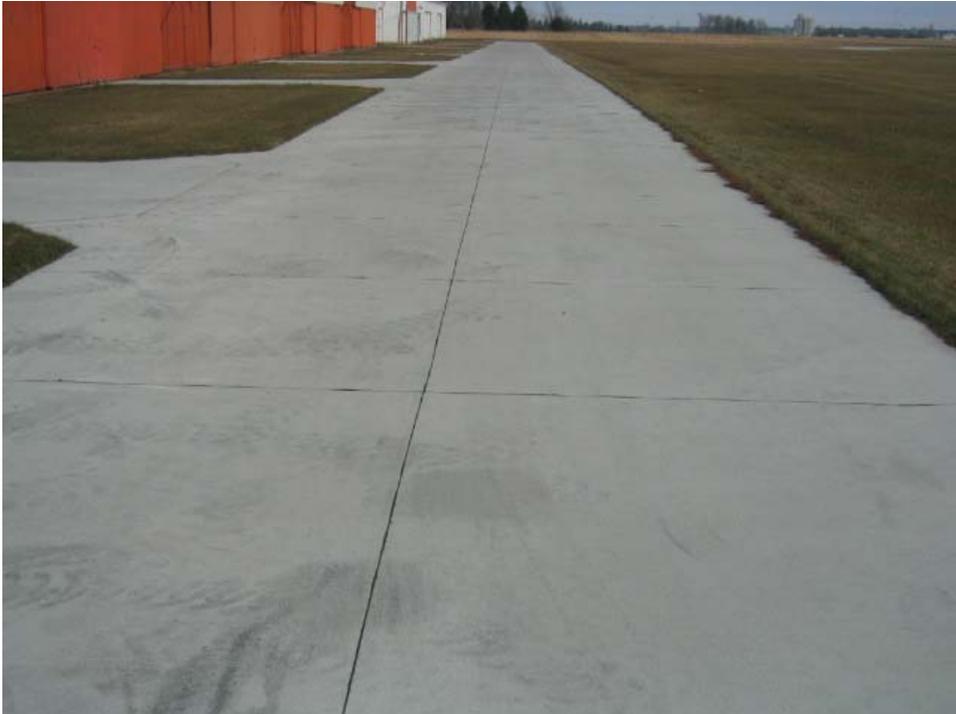
| Sibley Municipal Airport | | | | | | | | |
|---|---|---|---|---|---|---|---|---|
| T02IS | 01 | PCC | 11,250 | 6/1/2001 | 100 | 0 | 0 | |

T02IS-01. Overview.

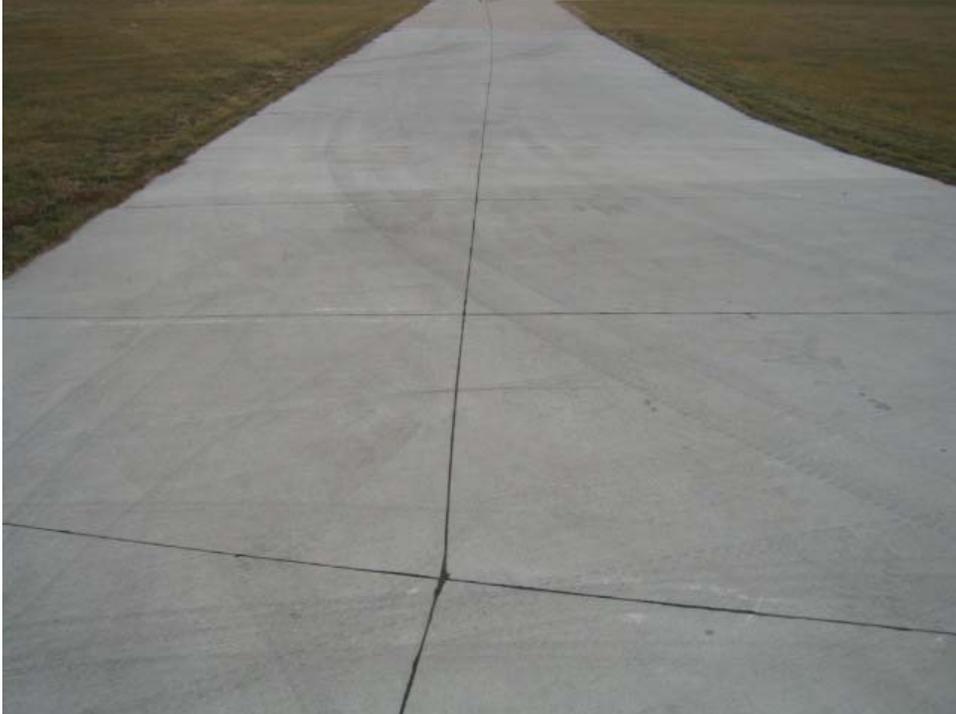
| Sibley Municipal Airport | | | | | | | | |
|---|---|---|---|---|---|---|---|---|
| T03IS | 01 | PCC | 1,667 | 6/1/2001 | 100 | 0 | 0 | |

T03IS-01. Overview.

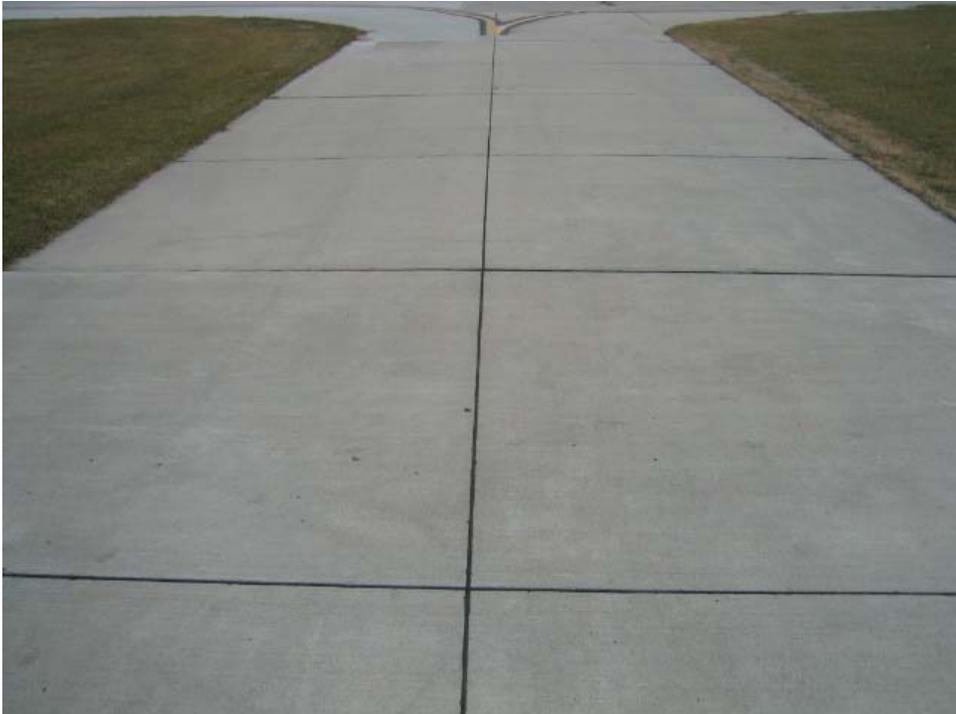
| Sibley Municipal Airport | | | | | | | | |
|---|---|---|---|---|---|---|---|---|
| T03IS | 02 | PCC | 1,350 | 6/1/2001 | 82 | 44 | 38 | Small patch, Linear Cracking, Joint seal damage, Corner break, Large patch |

T03IS-02. Overview.

| Year | Branch ¹ | Section | Type of Repair ² | Estimated Cost ³ |
|---|---|---|---|---|
| | T03IS | 02 | Localized Maintenance | \$438 |

| Branch | Section | Distress Type ¹ | Severity | Distress Quantity | Unit | Maintenance Action | Estimated Cost |
|---|---|---|---|---|---|---|---|
| T03IS | 02 | Corner Break | L | 1 | Slabs | Crack Sealing - PCC | \$8 |
| | | Joint Seal Damage | M | 15 | Slabs | Joint Seal (Localized) | \$429 |

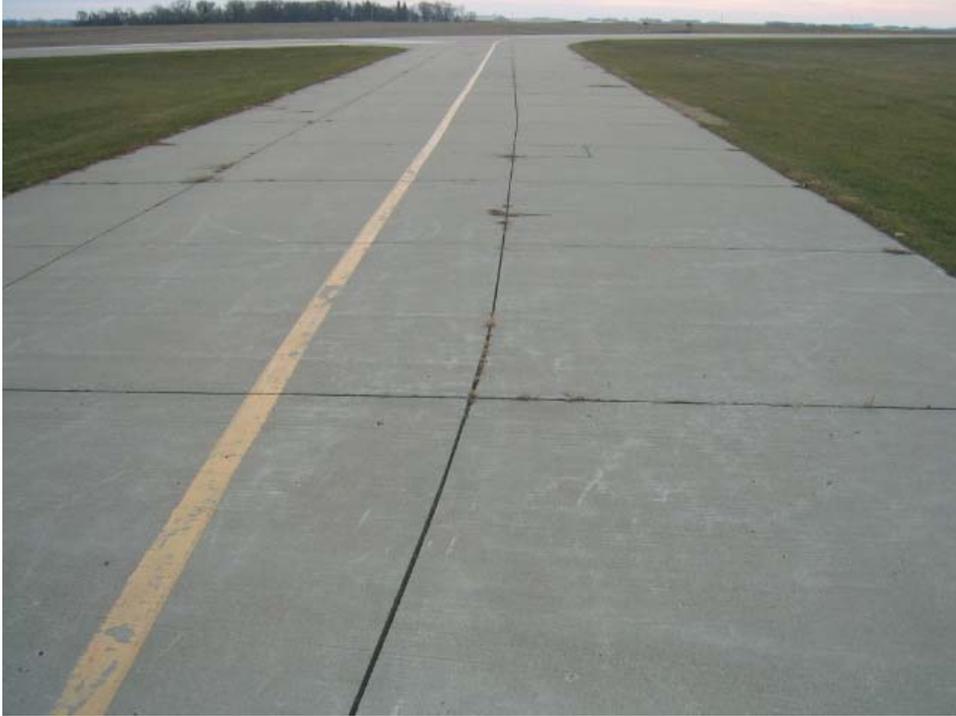
| Sibley Municipal Airport | | | | | | | | |
|---|---|---|---|---|---|---|---|---|
| T03IS | 03 | PCC | 4,950 | 6/1/1994 | 88 | 0 | 74 | Large patch, Durability cracking, Joint seal damage |

T03IS-03. Overview.

| Year | Branch ¹ | Section | Type of Repair ² | Estimated Cost ³ |
|---|---|---|---|---|
| | | 03 | Localized Maintenance | \$1,479 |

| Branch | Section | Distress Type ¹ | Severity | Distress Quantity | Unit | Maintenance Action | Estimated Cost |
|---|---|---|---|---|---|---|---|
| | 03 | Joint Seal Damage | M | 77 | Slabs | Joint Seal (Localized) | \$1,479 |

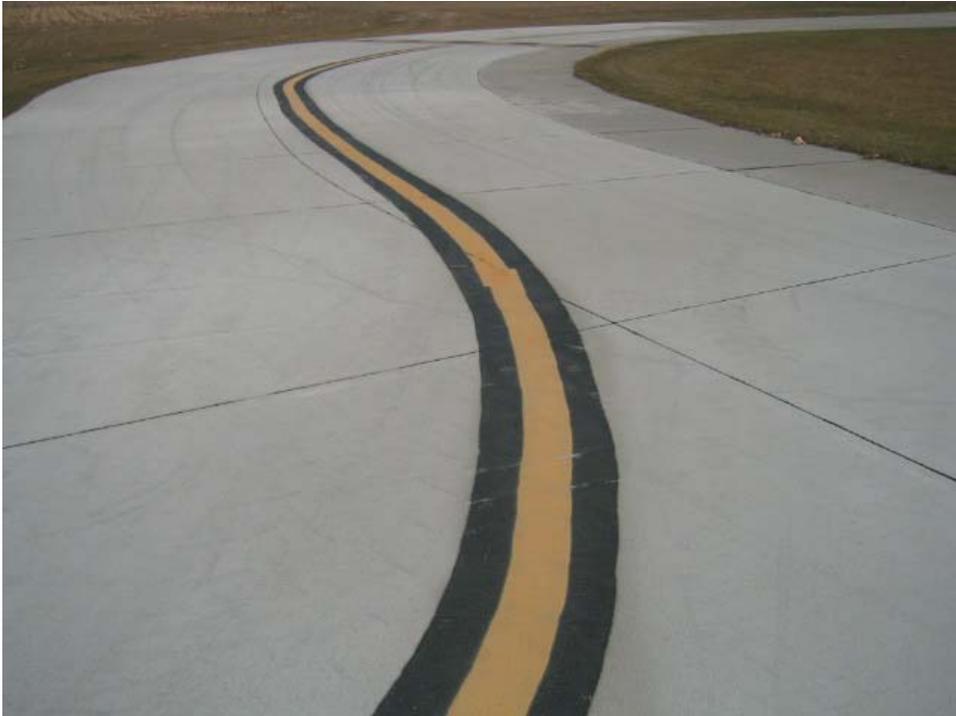
| Sibley Municipal Airport | | | | | | | | |
|---|---|---|---|---|---|---|---|---|
| T04IS | 01 | PCC | 9,966 | 6/1/1994 | 98 | 0 | 100 | Joint seal damage |

T04IS-01. Overview.

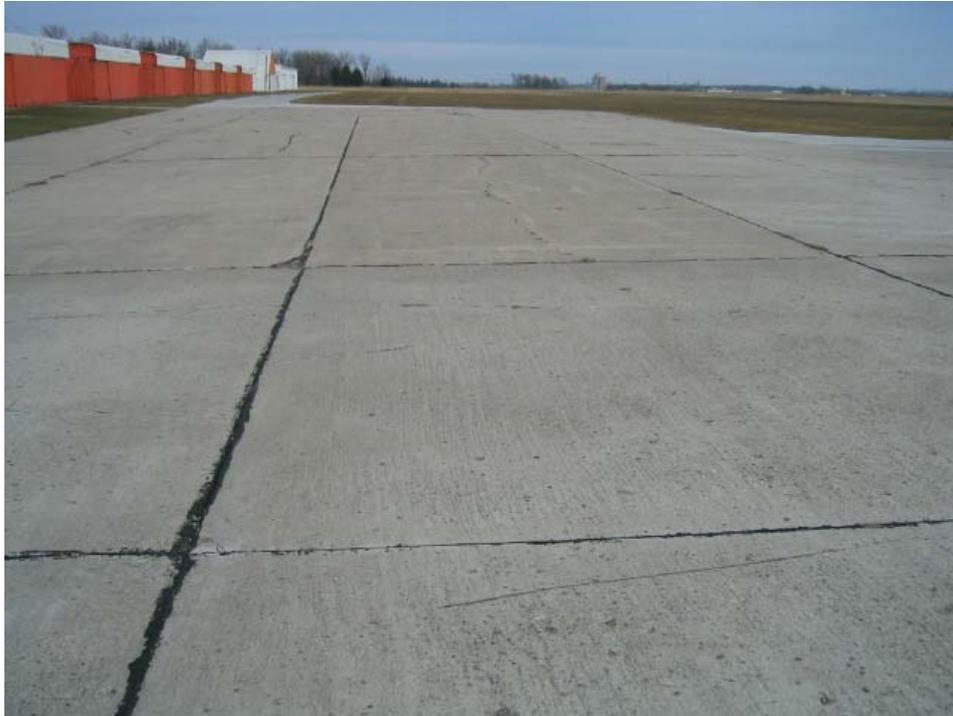
| Sibley Municipal Airport | | | | | | | | |
|---|---|---|---|---|---|---|---|---|
| A01IS | 01 | PCC | 21,250 | 6/30/1966 | 14 | 59 | 15 | Linear Cracking, Large patch, Joint spalling, Faulting, Corner break, Durability cracking, Shattered slab |

A01IS-01. Overview.

| Year | Branch ¹ | Section | Type of Repair ² | Estimated Cost ³ |
|---|---|---|---|---|
| 2004 | A01IS | 01 | Major Rehabilitation | \$176,375 |

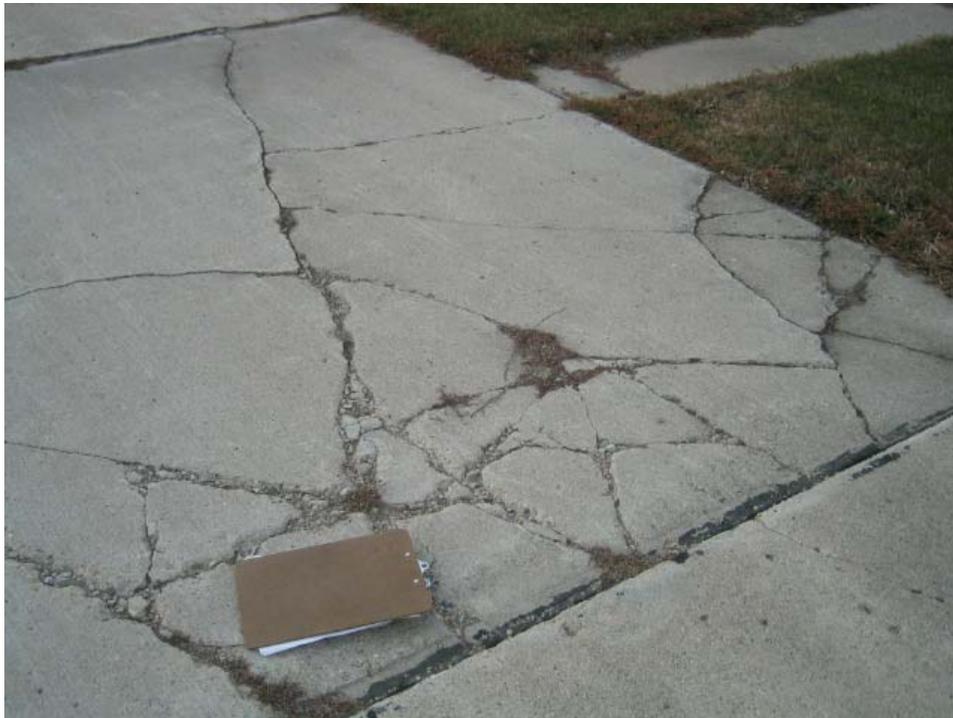
| Distress Type | Probable Cause of Distress |
|---|--|
| Shattered Slab | Load repetition |

A01IS-01. Shattered slab.

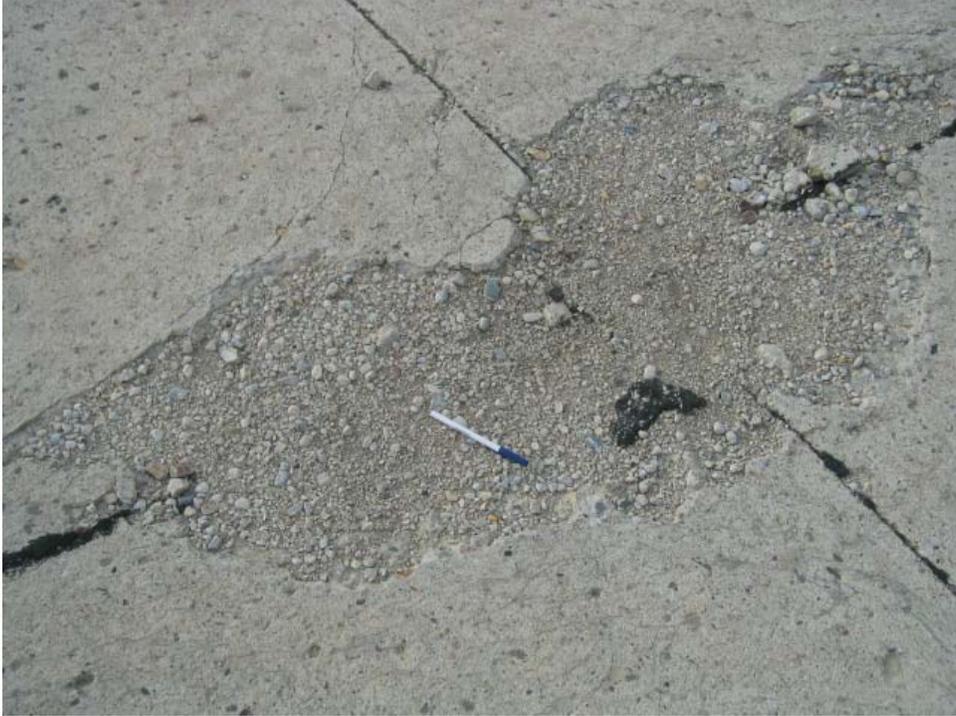
| Distress Type | Probable Cause of Distress |
|---|--|
| Durability Cracking | Concrete's inability to withstand environmental factors such as freeze-thaw cycles |

A01IS-01. Durability cracking.
