IOWA STATE HIGHWAY 92 OVER DRAINAGE DITCH #25

Performance Evaluation Galvanized Reinforcing Bars

Louisa County, Iowa

Final Report
June 15, 2015
WJE No. 2012.5759

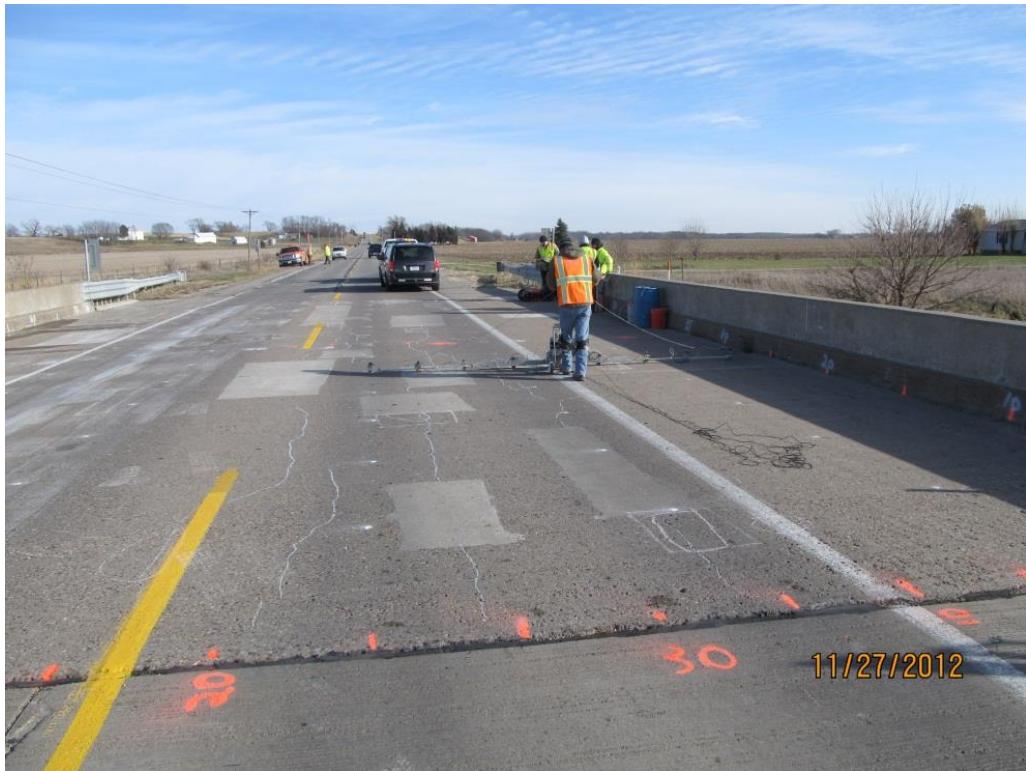
Overall photos of the deck top surface are shown in Figures 3.1 and 3.2. The deterioration noted during the visual and delamination surveys is presented on the plan drawings in Appendix A.

Figure 3.1. Overall view of eastbound lane of bridge, looking east. Chalk lines indicate cracks and delaminations identified by survey.

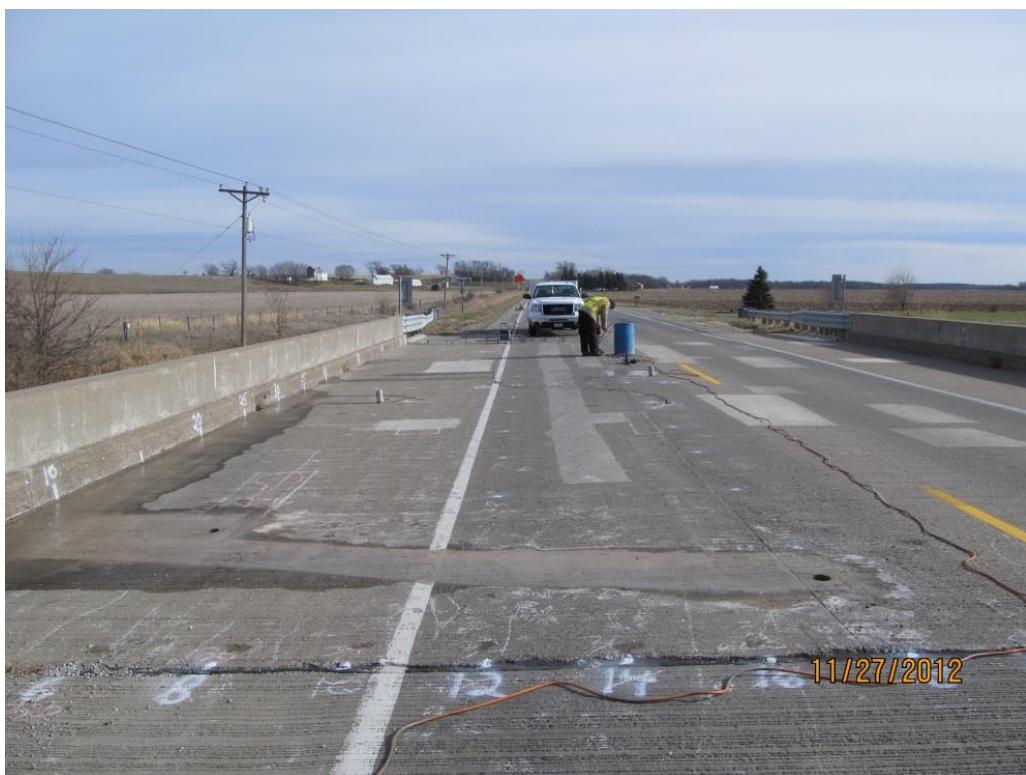
Figure 3.2. Overall view of westbound lane of bridge, looking east. Chalk lines indicate cracks and delaminations identified by survey.

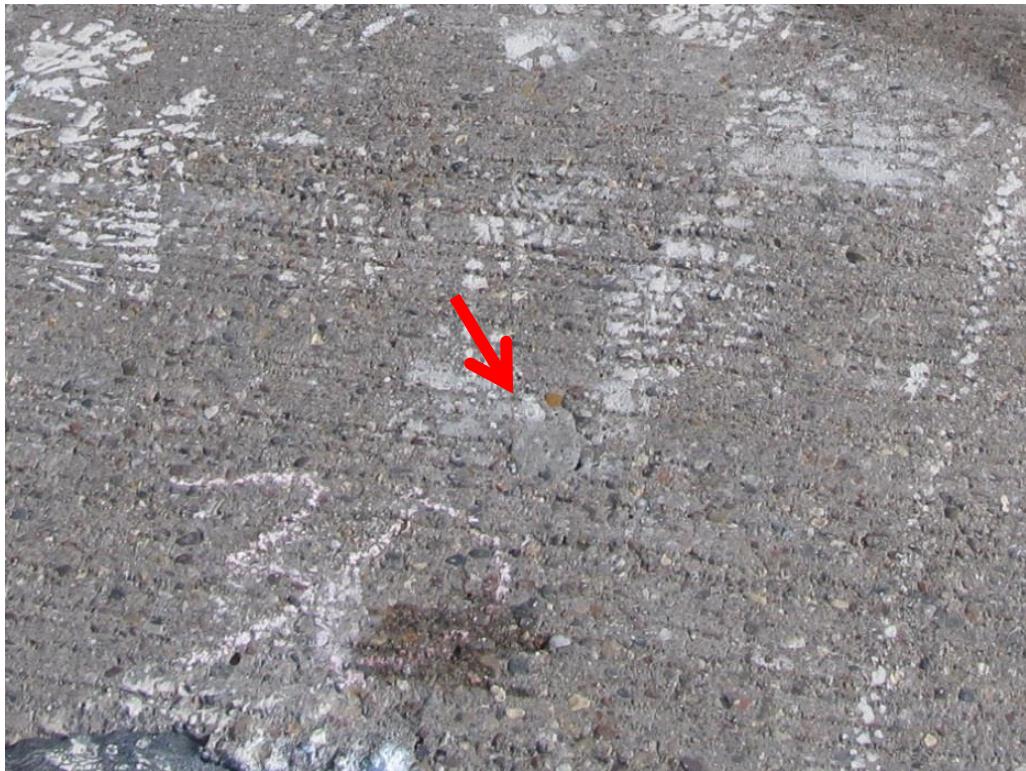
The patch repairs were generally distributed uniformly across the deck surface. One long, relatively narrow (approximately 24-inch wide) repair was present at the location where the temporary barrier rail had been installed during the original construction. It is unclear whether this repair was performed to address corrosion-related distress, but it is likely that the repair was prompted at least in part by the anchor holes for the barrier rail. These holes were partially filled with grout where they remained (see Figure 3.3).

Figure 3.3. Patched rail anchor hole at west end of westbound lanes.

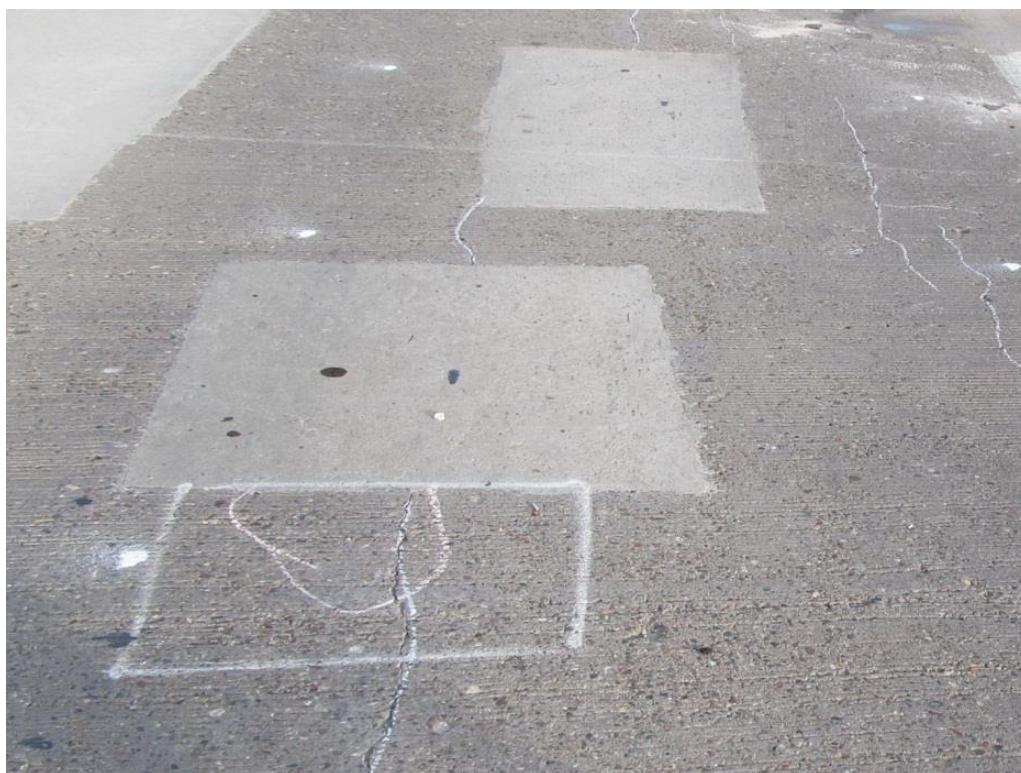
With one exception, the patch repairs were generally sound. Many of the new delaminations were located immediately adjacent to these repairs, and likely resulted from the “halo” or “ring anode” effect, a process by which corrosion of embedded reinforcing immediately adjacent to concrete repairs is accelerated by locally large differences in the internal concrete environment at the perimeter of the patch repairs. An example of a new delamination along a crack and adjacent to an existing repair is pictured in Figure 3.4.

Figure 3.4. Delamination marked in pink chalk and proposed repair location marked in white paint adjacent to previous patch repair.

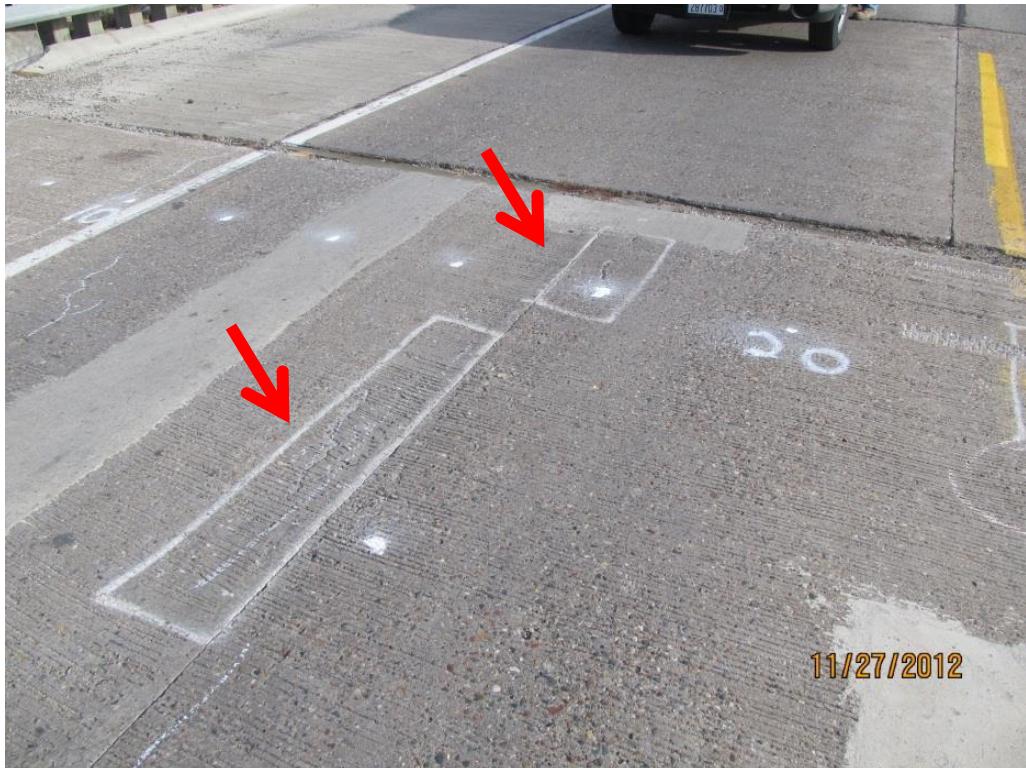
Three of the areas located adjacent to the construction joint marked by IaDOT for repair as part of the 2013 rehabilitation showed cracking distress (see Figure 3.5), but were not identified as delaminated during WJE’s survey. The cause of this distress is uncertain, but may be related to differential movement between the north and south portions of the deck, or freezing of water trapped in the construction joint.

Figure 3.5. Repair areas marked by IaDOT associated with cracking adjacent to construction joint, but not identified as delaminated.

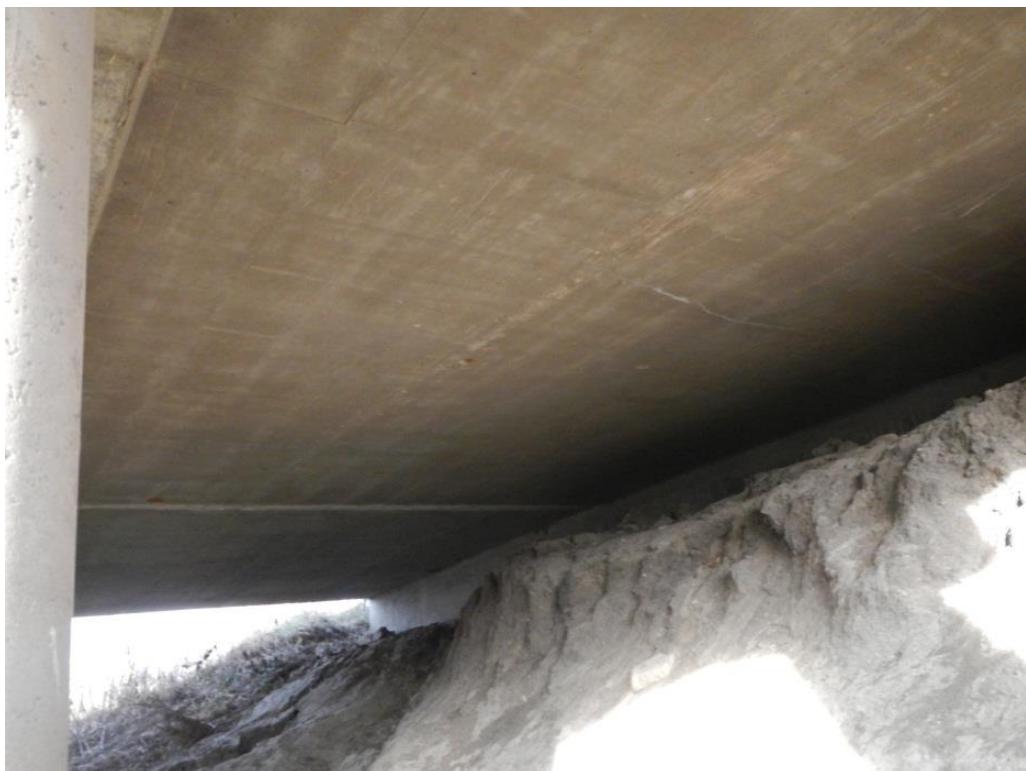
The underside of the deck is generally in very good condition, as can be seen in Figures 3.6 and 3.7. While some signs of efflorescence were present at the construction joint and at some other cracks, indicating moisture passing through the thickness of the deck, only a few through-deck cracks were observed. No underside spalls were identified, and the only moisture staining noted at the drain penetrations was limited to localized areas (see Figure 3.8).

Figure 3.6. Deck underside east span.

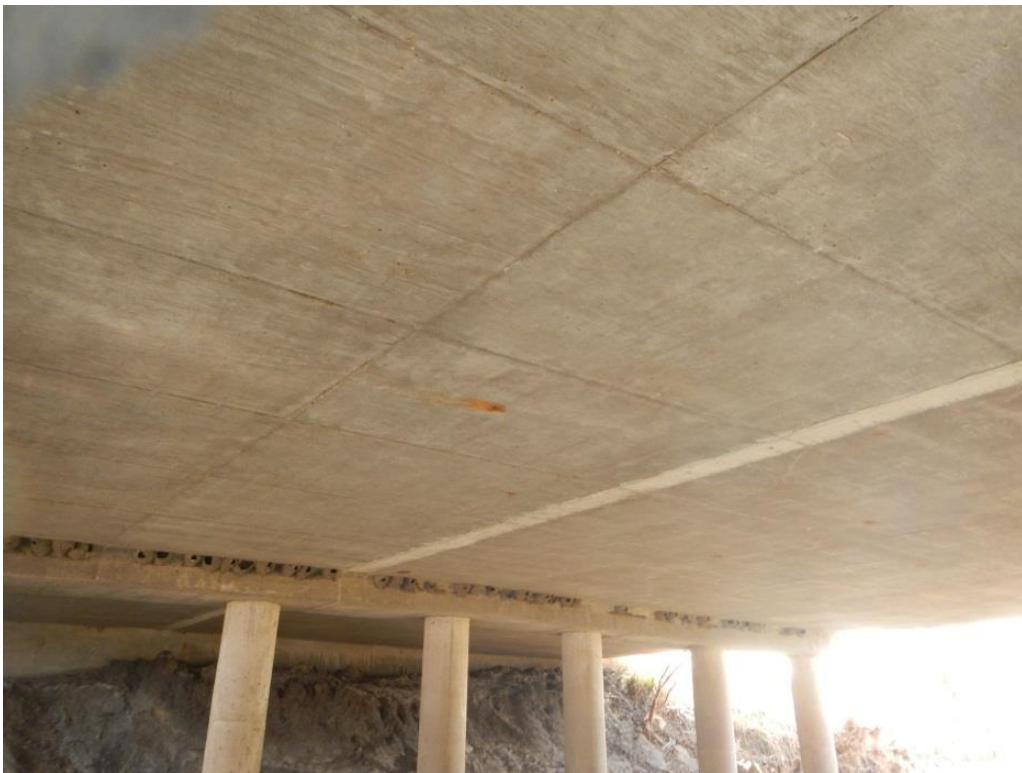
Figure 3.7. Deck underside center span.

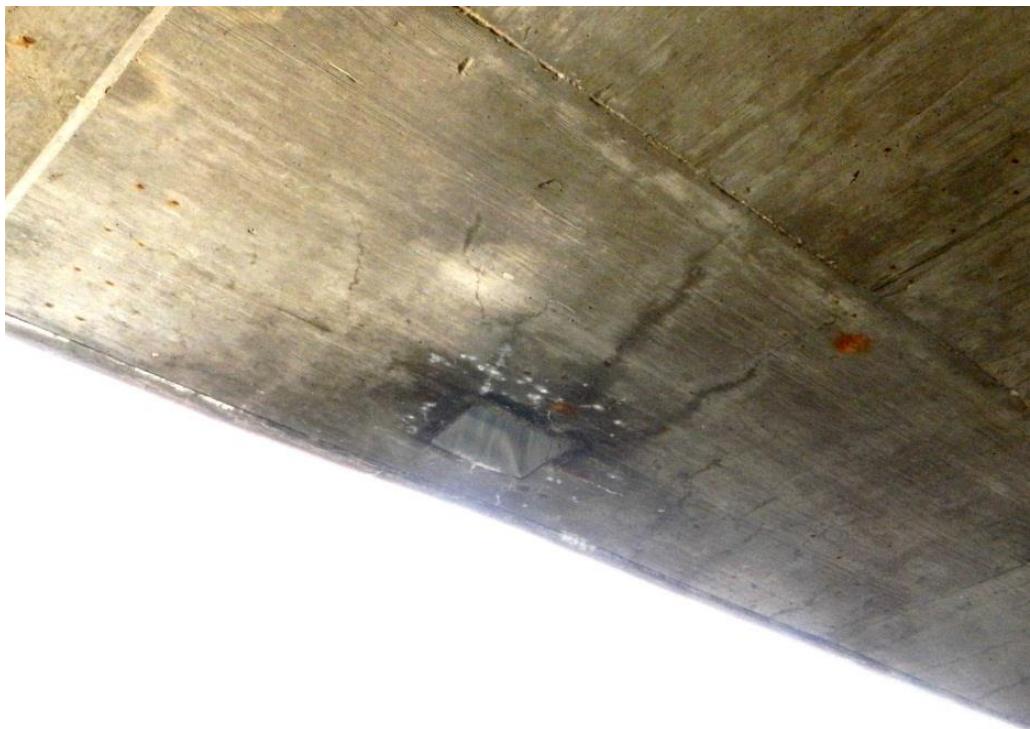
Figure 3.8. Moisture staining on deck underside surrounding drain penetration.

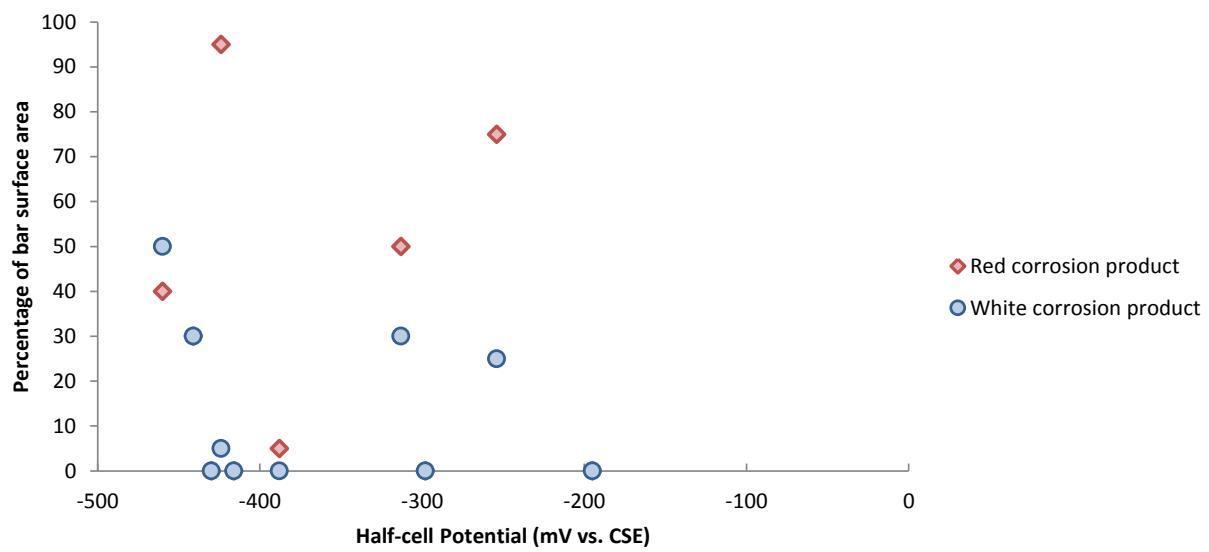
To determine if the half-cell potentials could be used to identify the condition of the galvanizing for the embedded reinforcing, the corrosion state for each core was plotted versus the measured potential at that location (see Figure 3.9), as determined by the rolling wheel contour map. The corrosion state was considered as the percentage of corrosion product on the bar for both white corrosion product (zinc corrosion) and red corrosion product (steel corrosion). The plot shows that no clear relationship was evident between the corrosion product on the bar and the measured half-cell potential.

Figure 3.9. Relationship of half-cell potential to corrosion product observed on extracted bar sample.

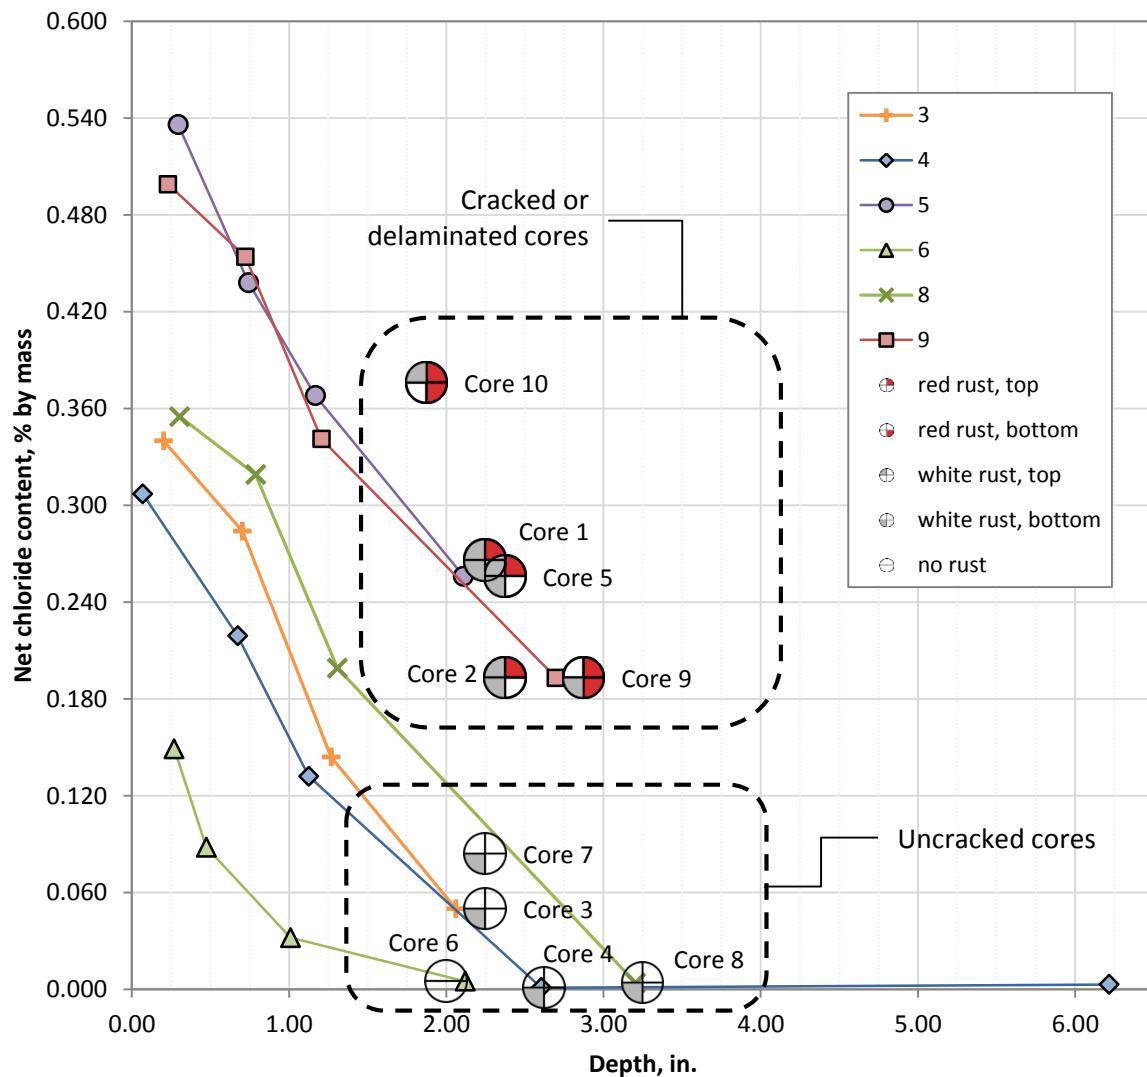
Acid-soluble chloride content test results are provided for each core in Table 3.5. Chloride content profiles versus depth are plotted in Figure 3.10; chloride contents at the bar depth are also indicated for all 10 cores. For comparison purposes, the corrosion state of the extracted bars, as described in Section 3.2.3 below, is indicated by the symbol shown for each core. Cores at cracked or delaminated locations are also identified.

- Chloride profiles for cracked cores are represented by Cores 5 and 9, which had partial depth vertical cracks. The cores taken at cracked or delaminated locations had the highest chloride content at the bar depth, in excess of 0.180 percent by weight of concrete. These bar samples had red rust (steel corrosion) at least on the top surface of the bar and white rust (zinc corrosion) on the top and bottom surfaces of the bar.

- Chloride profiles for uncracked cores are represented by Cores 3, 4, and 8. These cores had chloride contents less than 0.060 percent by weight of concrete at the bar depth. The bars from these cores did not have any red rust (steel corrosion), but did have some white rust (zinc corrosion) evident on the bar underside.

- The sheltered core profile is represented by Core 6. This profile had the lowest surface concentration of chloride of all the cores. This core came from the shoulder of the north half of the deck near the barrier. Documentation from the 2006 inspection indicated that this area had a build-up of 2 inches of “gravel”. It is unclear whether the gravel build-up had a direct effect on the chloride exposure, or whether localized drainage patterns had resulted in lower chloride exposure than on other areas of the deck. The bar extracted from Core 6 did not have active zinc or steel corrosion.

Figure 3.10. Chloride content profiles with depth for 6 cores. Chloride content at bar depth is also shown for all 10 cores. The corrosion state of extracted bars is indicated by the symbol shown for each core, where a colored indication (grey or red) denotes that 10 percent or more of the bar exhibited white or red rust. Lines for the chloride profiles do not pass exactly through the bar designation for each core, because the actual position of the slice varied slightly relative to the top of the bar.
