Report on  
Evaluation of Interstate 80 Sign Truss

**Office of Bridges and Structures  
The Iowa Department of Transportation**

Terry J. Wipf  
Brent M. Phares

September 25, 2002

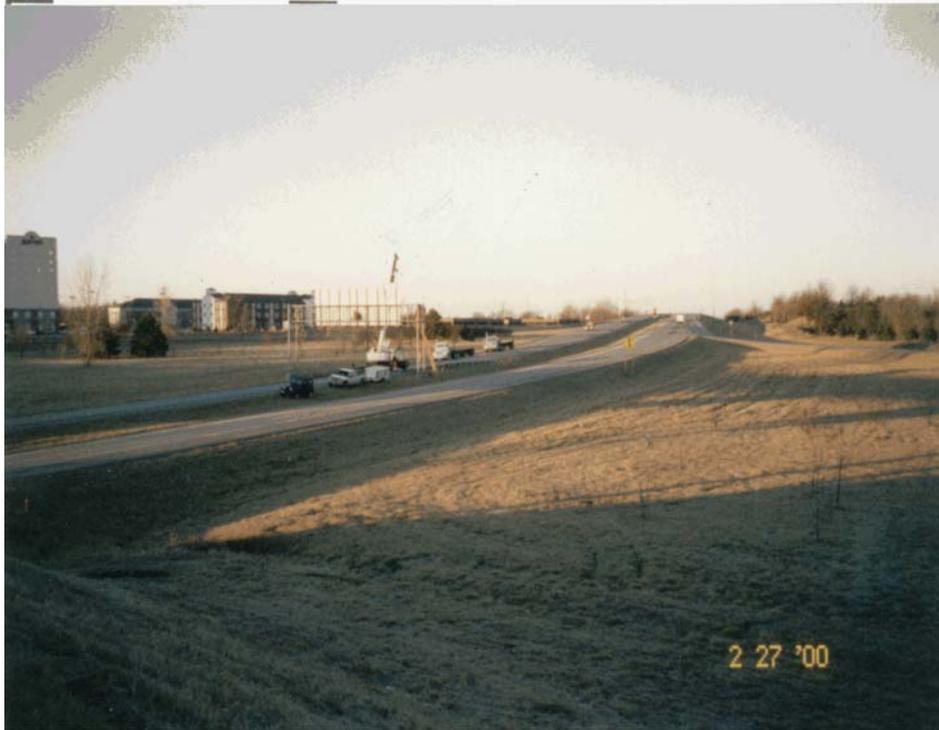
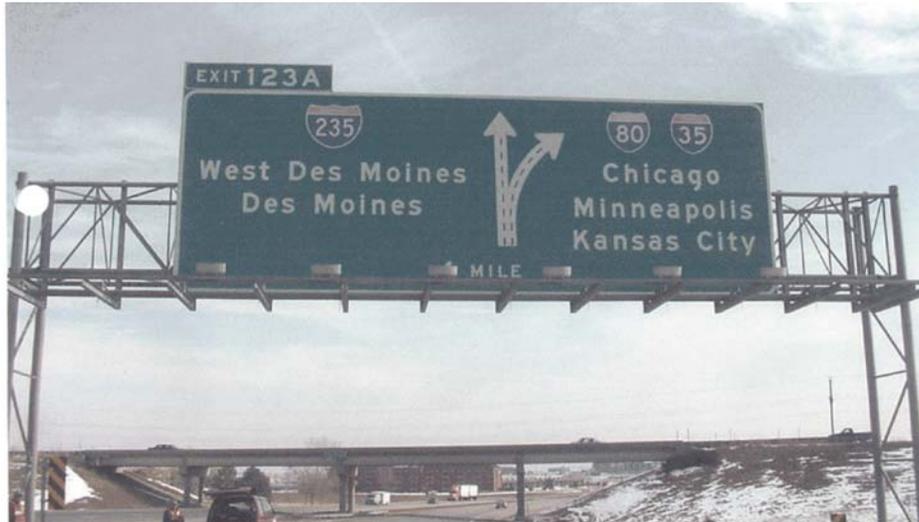
Figure 1. Photographs of Sign Truss before Removal.

The truss is a galvanized steel, four chord truss with a span of approximately 60 ft and carries a single 14 ft x 40 ft sign and associated lighting as shown in Fig. 1. Figure 2 shows a photograph of the deterioration of one of the bottom chord members near mid span.

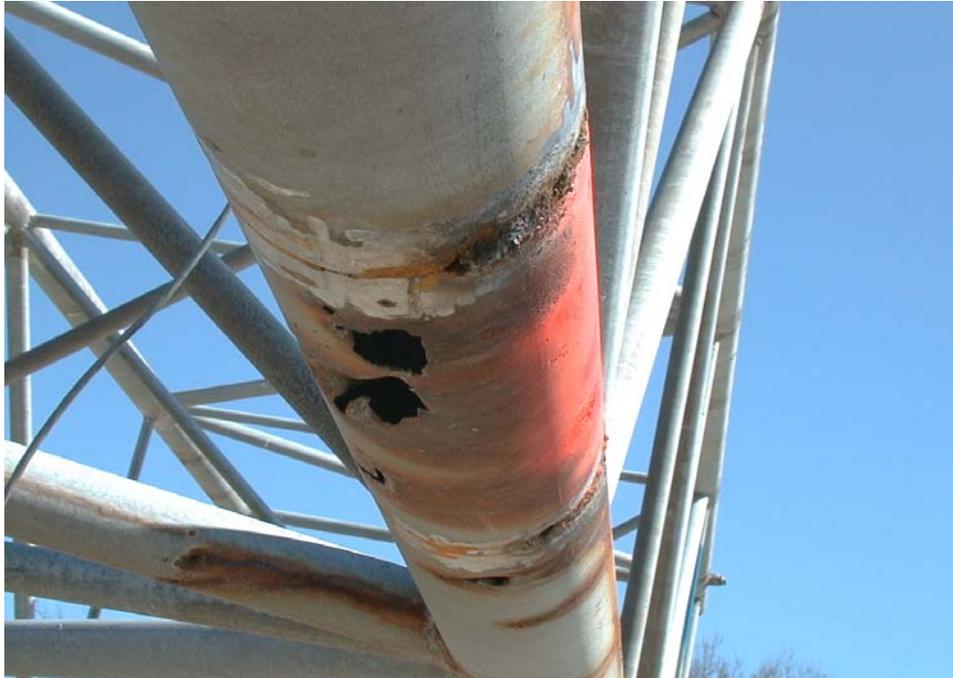
Figure 2. Deterioration of Bottom Chord Member of the Truss

A sign support truss over eastbound I-80 about 2 miles west of the west I-35/I-80/I-235 interchange near Des Moines, IA was removed in the spring of 2000. A routine inspection of the truss found that one of the bottom chord members was severely deteriorated. Corrosion of the bottom chord has caused significant thickness loss of cross section area of many members. This deterioration led to a concern about the structural adequacy of the truss.

The investigated truss had a badly corroded bottom chord member located at mid span. Many other members were also corroded. This damage likely affects the performance of the truss. However, the experimental tests and an analytical investigation indicated that the truss did not need to be removed due to potential structural inadequacy. It was found that the truss has redundant load paths that allow redistribution of the loads. Due to this load path redundancy, if one or more members were to fail due to corrosion or other means (e.g., over height vehicle impact, etc.), the load will likely be redistributed to other members. From these tests, it was found that after load redistribution, the strain levels in other members were still below the yield strain of steel. It appears that for the subject truss, it may have been sufficient to simply repair the corroded member. However, in general, the extent of corrosion damage must to be accurately assessed. The structural performance of the damaged structure can then be evaluated using an analytical model similar to the one discussed herein.

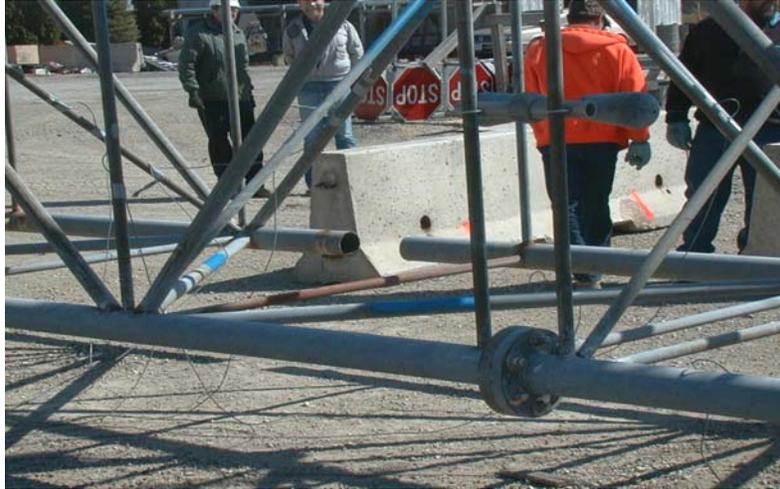
Figure 4. Sign Truss after Cutting the Bottom Chord Member.

The first tests conducted were intended to assess the structural behavior of the undamaged and damaged truss with a specific interest in structural redundancy. These tests were conducted in March 2000. Figure 4 shows a photograph of the truss after cutting the bottom chord member. The second set of tests were conducted in April 2000. These test were intended to assess the impact of removing other critical members from the truss. The second set of tests covered several cases. Each case involved removing additional truss members at critical locations. The results of this series of tests are not presented herein but further reified the conclusions developed from the tests conducted in March, 2000.

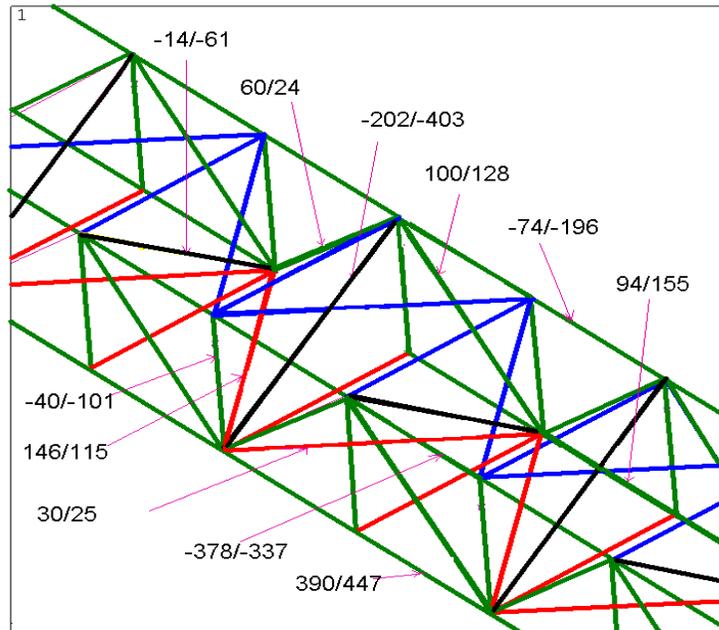
Figure 10. Experimental and Analytical Results for Damaged Truss

After the deteriorated member was cut (damaged condition), part of the load carried by the south truss near the removed member was transferred to the north truss by axial forces in the out of plane diagonals. This redistribution of load was evident from both the experimental and the analytical results. These results indicate a significant load redistribution property of the truss due to the highly redundant load paths in the structure.

The difference between the field and analytical results may be attributed to several factors. First, many members of the truss were corroded. This means that the theoretical values of section properties used in the analysis (which are taken from the design plans) are likely less than their actual values. Variations in elements properties would result in a load distribution different from that predicted from the analysis. More accurate analysis results may be obtained by modifying the properties of the corroded members in the
