SUBJECT: Potential for Fracture to Occur in Iowa Steel Girder Bridges due to Triaxial Constraint

DATE: January 24, 2011

Potential For Fracture To Occur In Iowa DOT Steel Girder Bridges Due to Triaxial Constraint

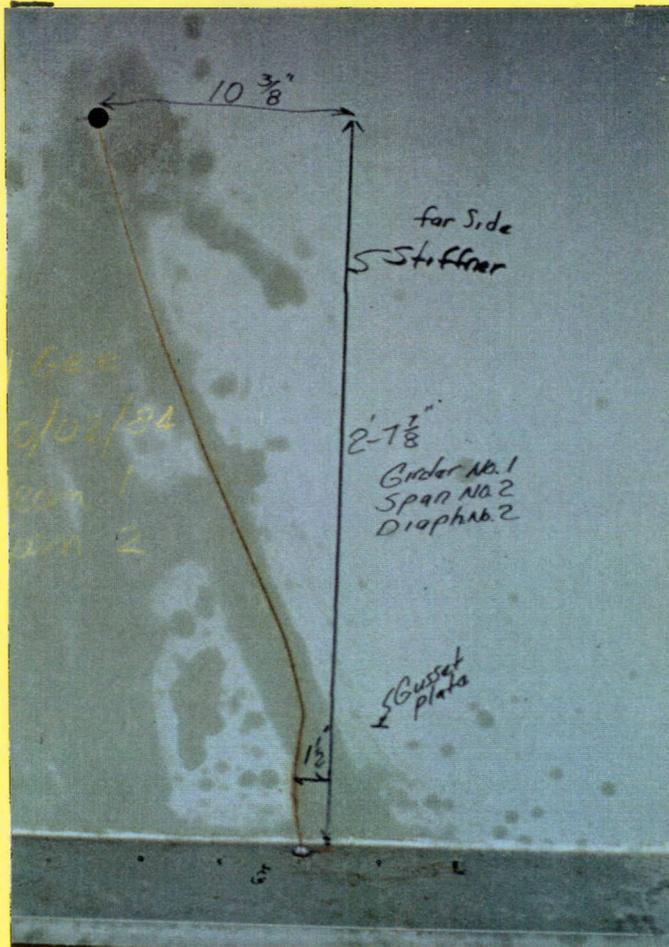
SLIDE NO. 17

Span #2, Girder
#1, Diaphragm
#2, (LEFT Side

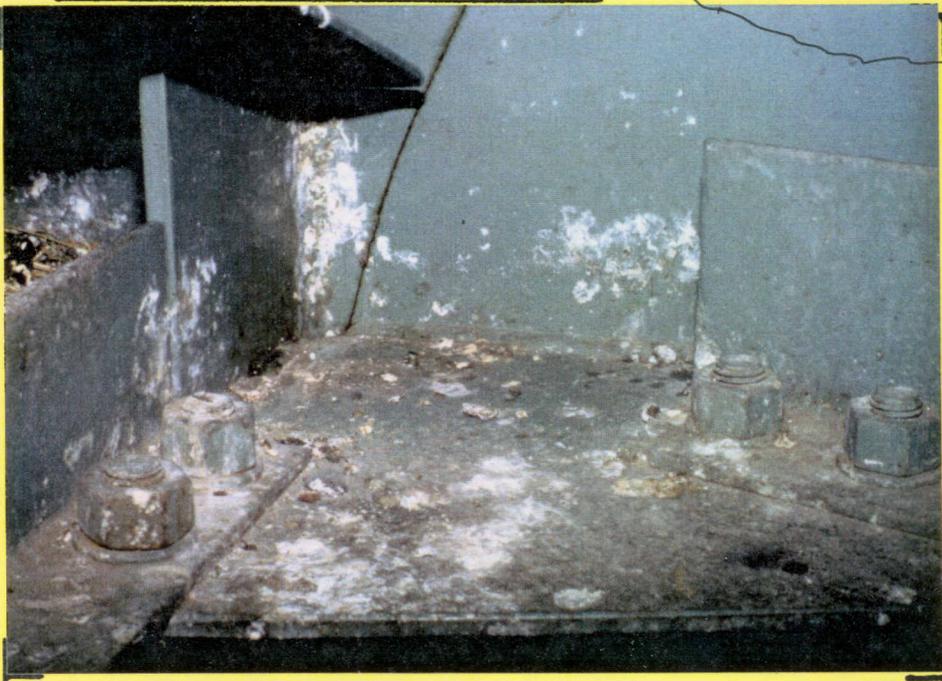
SLIDE NO. 20

Span #2, Girder
#1, Diaphragm #2,
Bottom Flange,
Bottom View

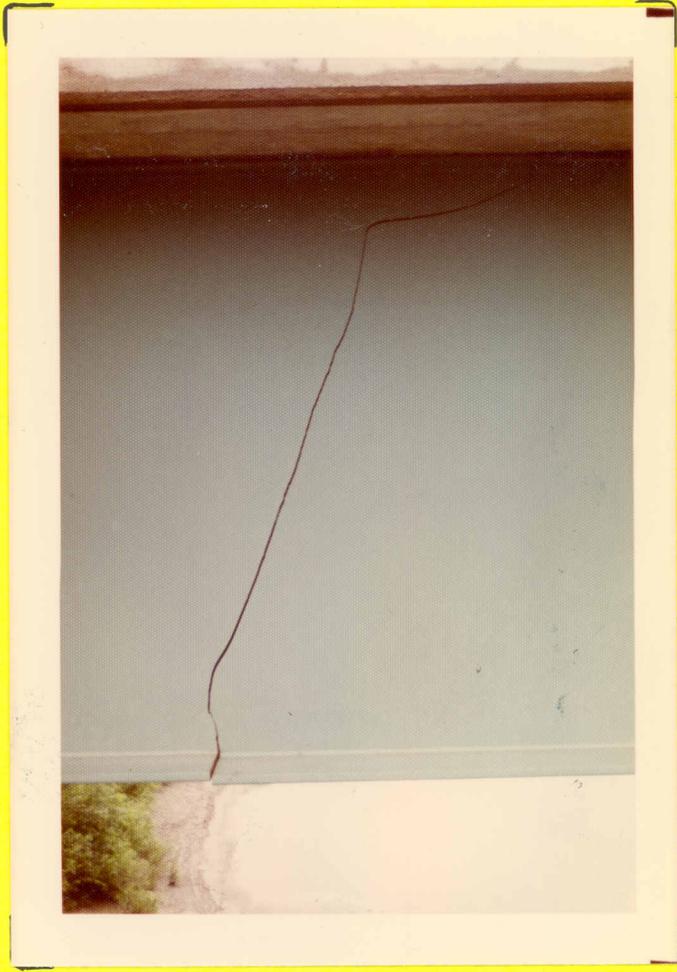
SLIDE NO. 251

Exterior Face

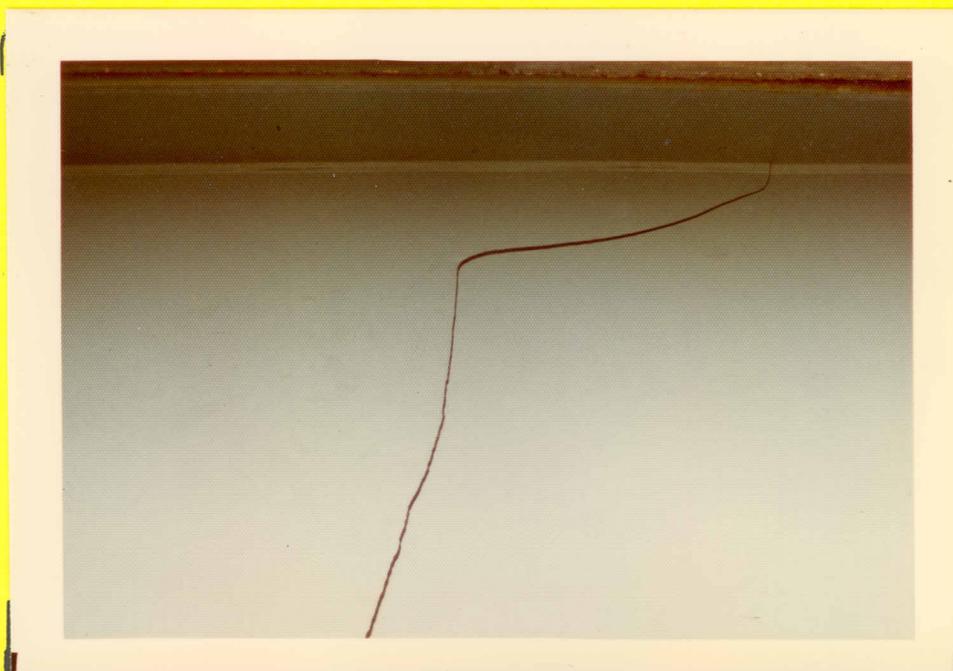
SLIDE NO. 252

Exterior Face

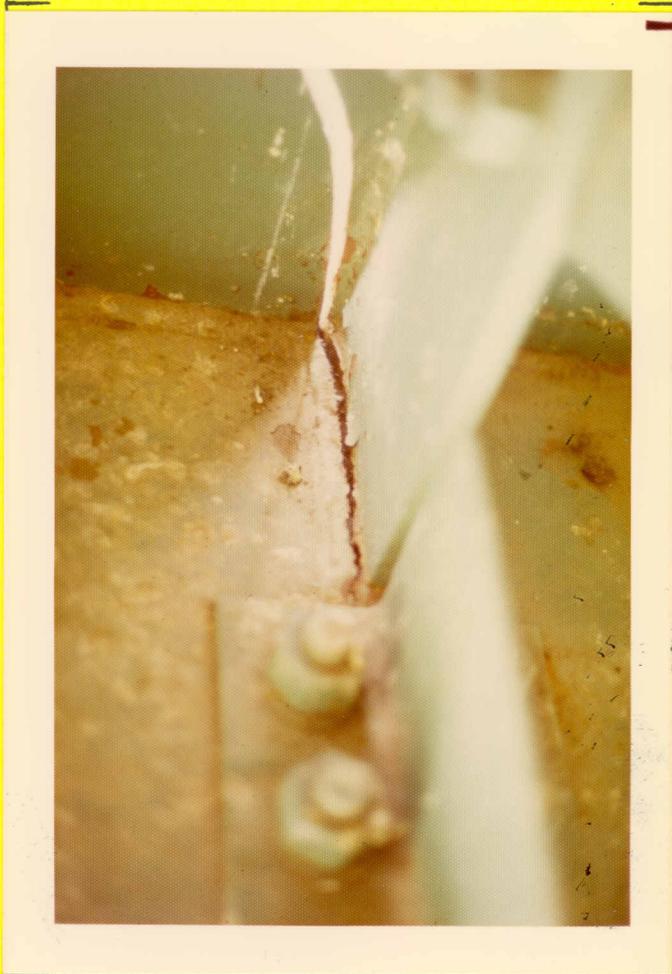
SLIDE NO. 261

Weld-gusset
to web stiffener

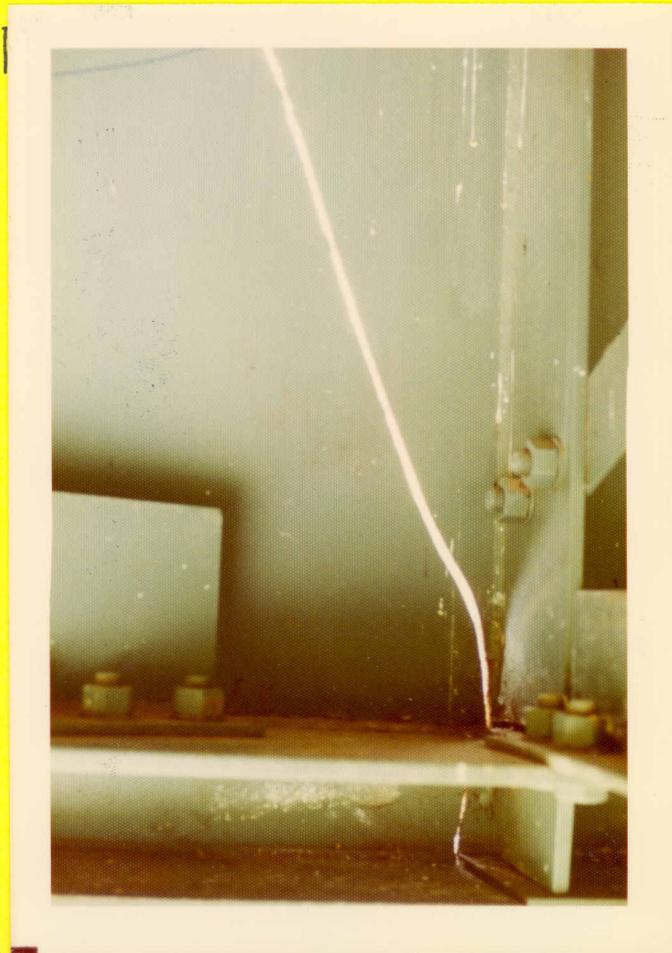
SLIDE NO. 262

Top of gusset
Plate

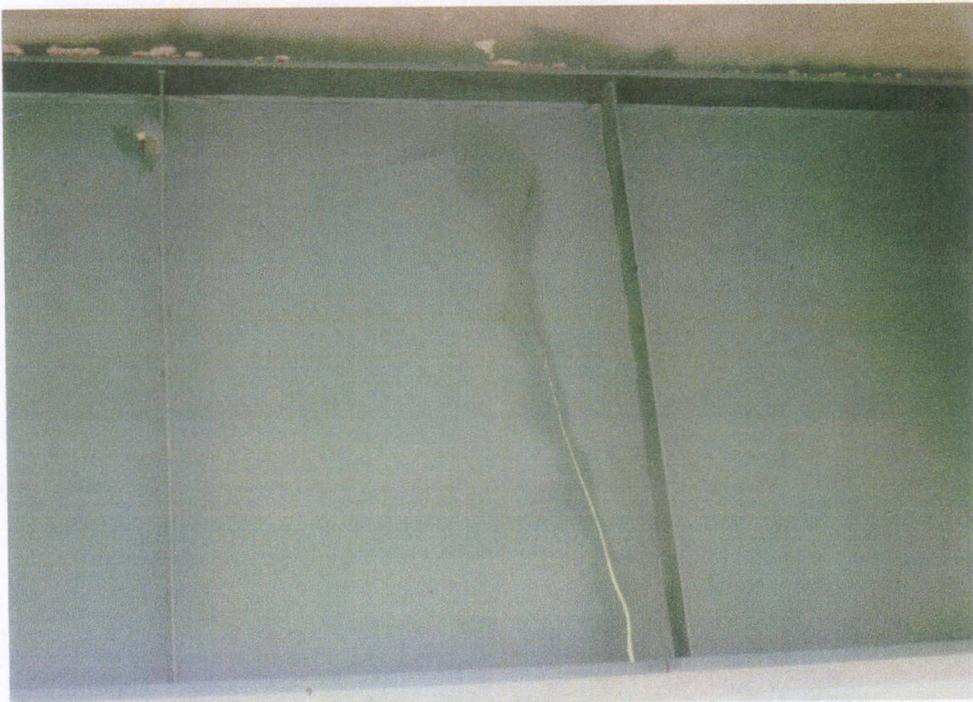
Figure 1

Full depth crack in the exterior girder of the Cherokee County Bridge.

Investigation determined fracture initiated at web to flange weld. No evidence of fatigue crack initiation or growth prior to fracture.
