# **LOW COST TECHNIQUES OF BASE STABILIZATION**

**FINAL REPORT  
IOWA HIGHWAY RESEARCH BOARD  
PROJECT HR-312**

**JANUARY 1994**

LOW COST TECHNIQUES  
OF BASE STABILIZATION  
DUBUQUE COUNTY

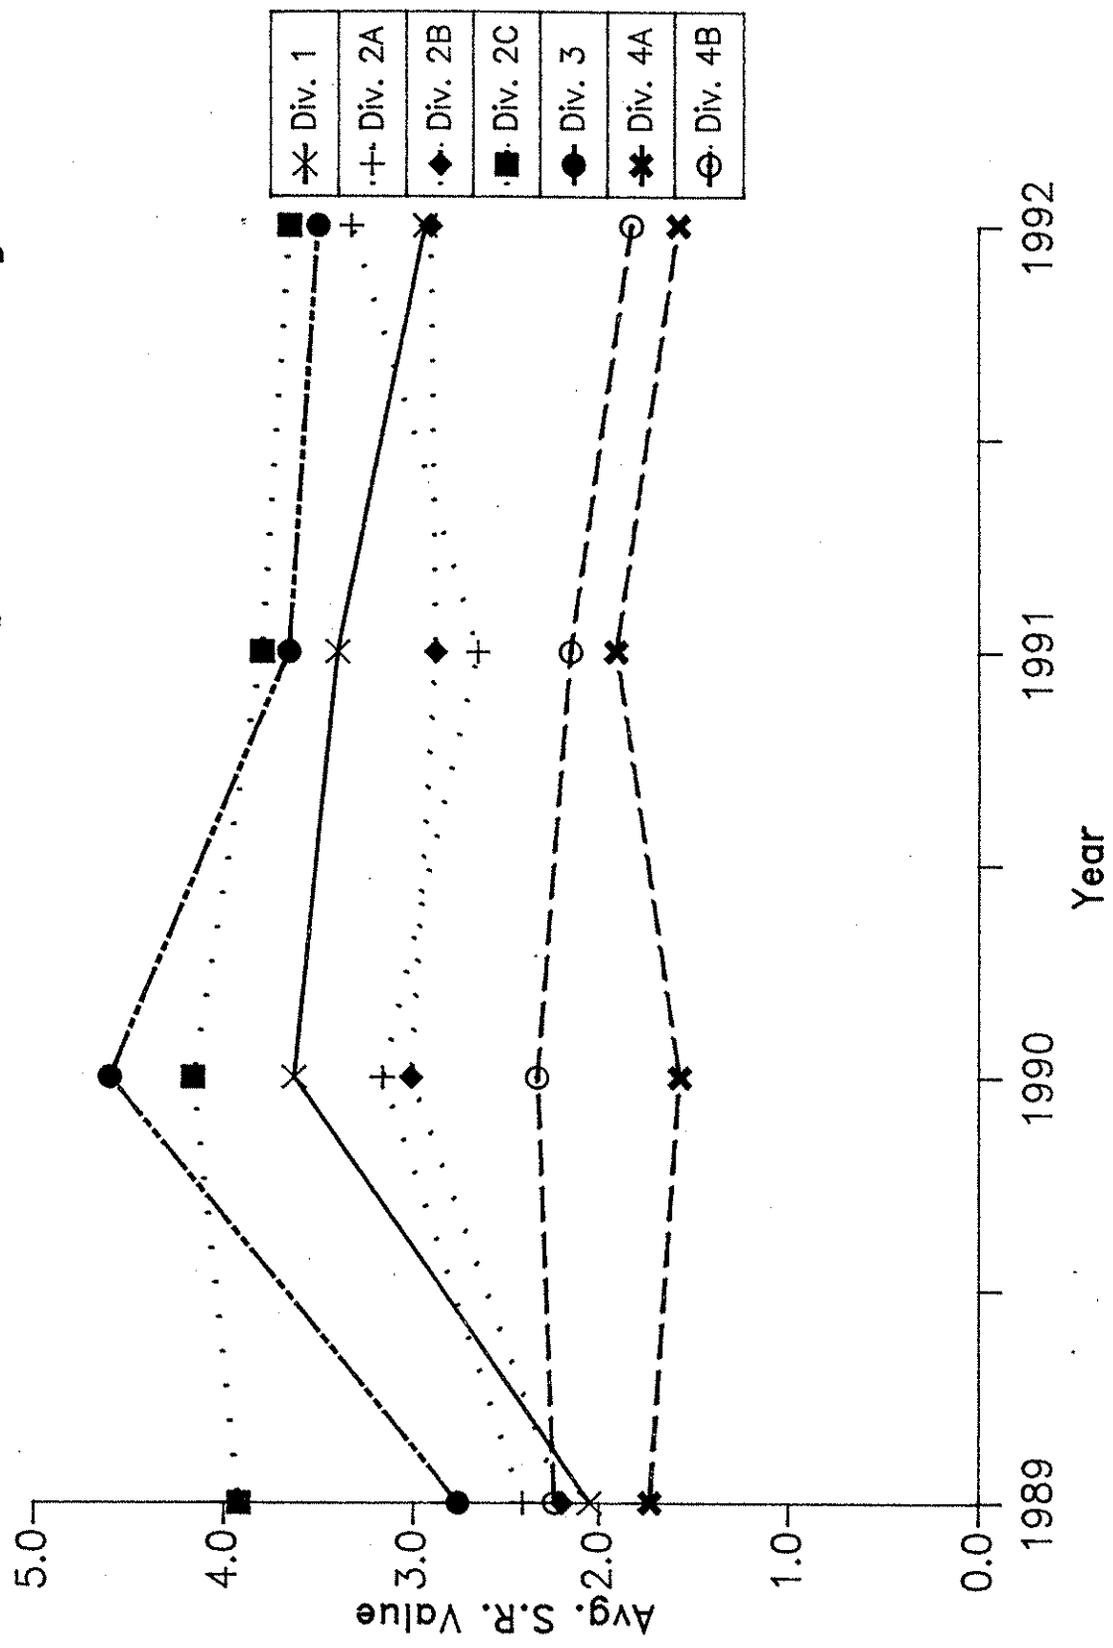
FIGURE 1

section may be caused by the fact that annual testing is performed on the outside wheel track during the months of April and May when the roadway exhibits the poorest structural support. The structural rating can vary from one year to the next depending upon the moisture content. Figure 1 and Figure 2 show the Structural Rating and Soil K values for the annual testing.

# Annual Structural Rating Values Horseshoe Road, Dubuque County

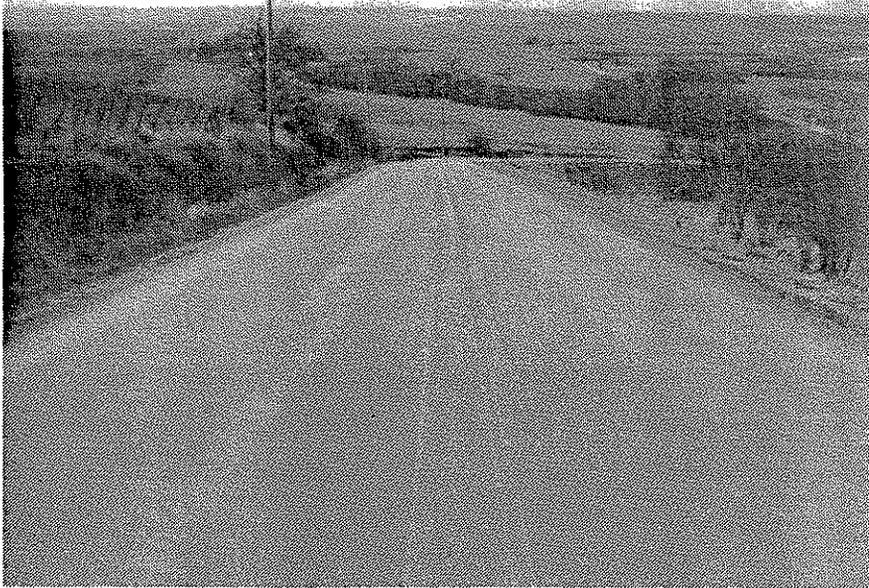
Section IV (Macadam) appeared to be in good condition for all the visual reviews. In 1991, a few places had been patched. By 1992 some minor rutting had occurred.

Photo 1 - Macadam Base Section

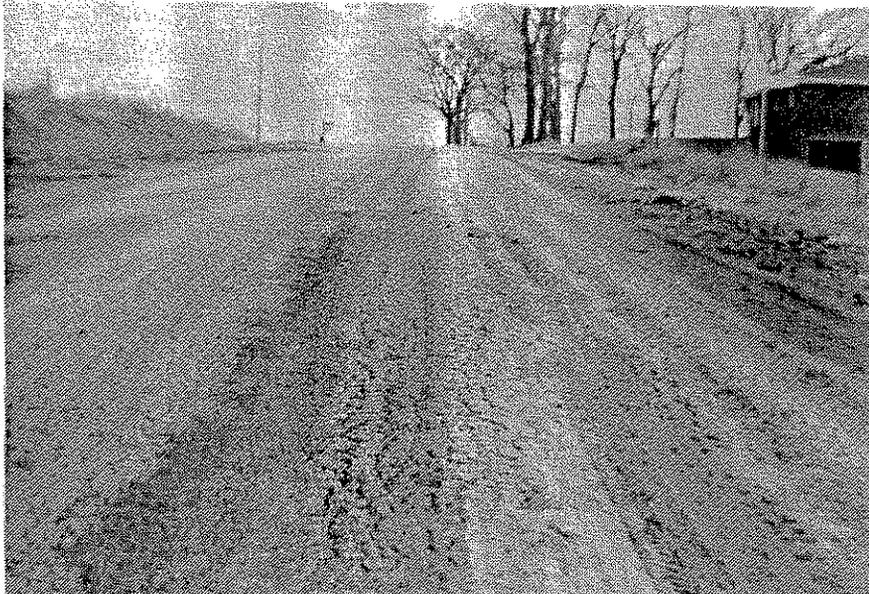
The failure of the soil stabilization techniques was primarily alligator cracking followed by rutting as the base completely

gave way to the forces of the traffic. This may have been due to freeze/thaw cycles damaging the base. The Iowa DOT evaluation MLR-87-10, "Evaluation of the Consolid System of Soil Stabilization" indicated that the method was susceptible to freeze/thaw cycles. The alligator cracking was another indicator that frost action may have caused the failure.

Photo 2 - Typical Alligator Cracking and Rutting  
of Soil Stabilized Base
