R.A. Lohnes, B.H. Kjartanson, and A. Barnes

Regional Approach to Landslide Interpretation and Repair

Iowa DOT Project TR 430

Final

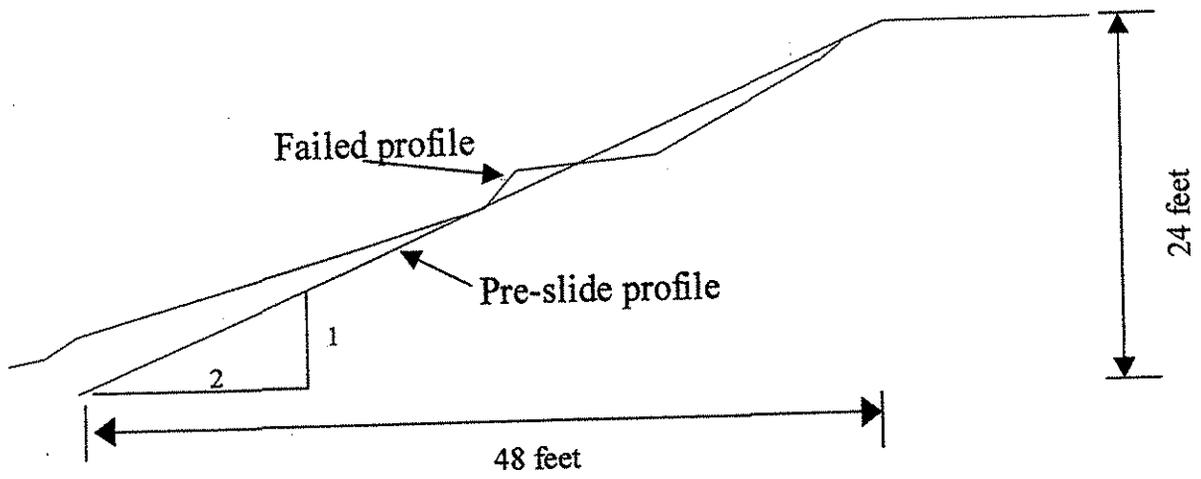
Figure 9.1 Profiles of original slope and landslide surface of Highway 34 slide.

The foreslope, shown in Figure 9.1, is 24 ft (8 m) high at a 2:1 slope. The slide is classified as a translational slide in which a few blocks of fine grained soil have failed along a shallow failure plane about 2.5 feet (0.75m) deep. The failure plane is approximately parallel to the slope of the existing embankment. During fieldwork in April 1999, it was observed that the soil in the failure zone appeared wetter and with an aggregated structure that differed from the soil samples collected from the borings and the soil on the surface adjacent to the slide.

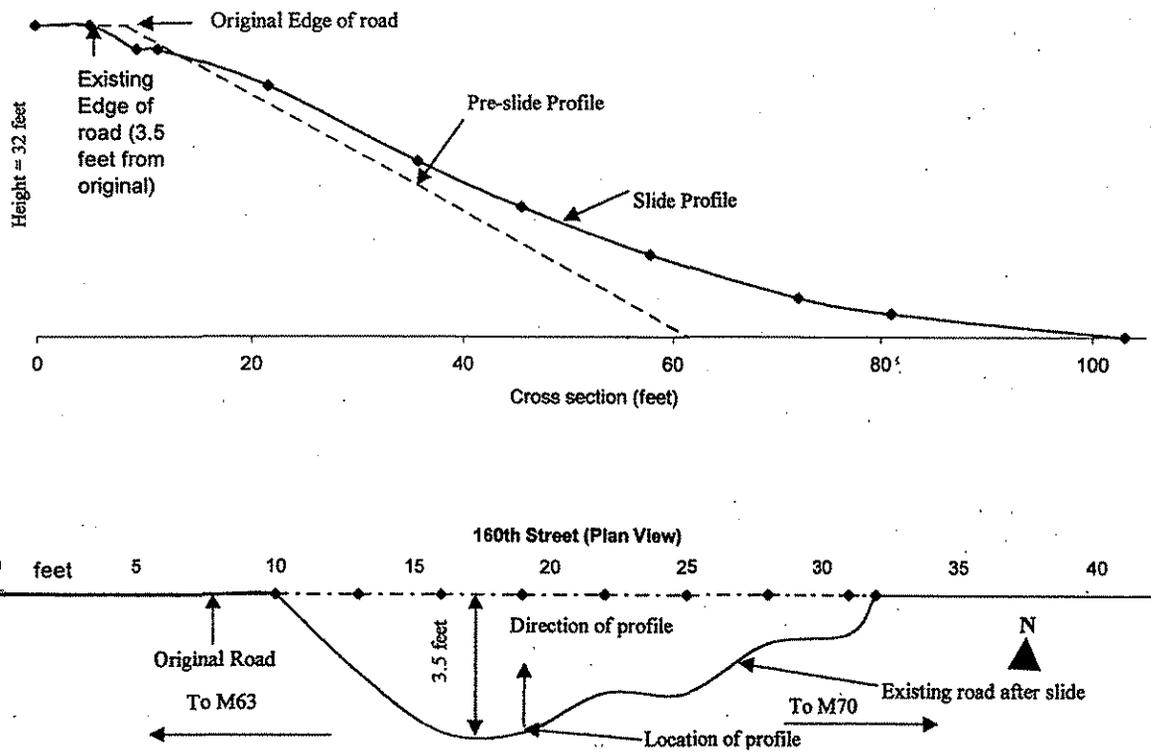
Figure 9.5 Profiles of original slope and post slide failure surface at 160th St. slide.

A wet area approximately 10 feet (3 m) wide parallel to the road and 21 feet (6.5 m) in length, perpendicular to the roadway, was observed over the failure zone about 56 feet (17 m) down the slope. This was anomalous because of the low amounts of precipitation in 1999 and 2000. The source of the moisture is not known.

A corrugated metal pipe about 12 inches (0.3 m) in diameter has its outlet at the toe of the slope. This pipe was observed to be dry during four site visits in the summers and falls of 1999 and 2000. The location of the inlet of the pipe is not known. According to Mr. Jim Christensen, County Engineer, Page County, the slope had failed previously, and the pipe was installed parallel to the slope to drain the slope. The time of the installation is not known as it was prior to Mr. Christensen's tenure as county engineer, but it can be safely assumed to be at least ten years old. The water in the embankment at the base of the slide and the dry pipe indicated that the drain is not functioning properly.

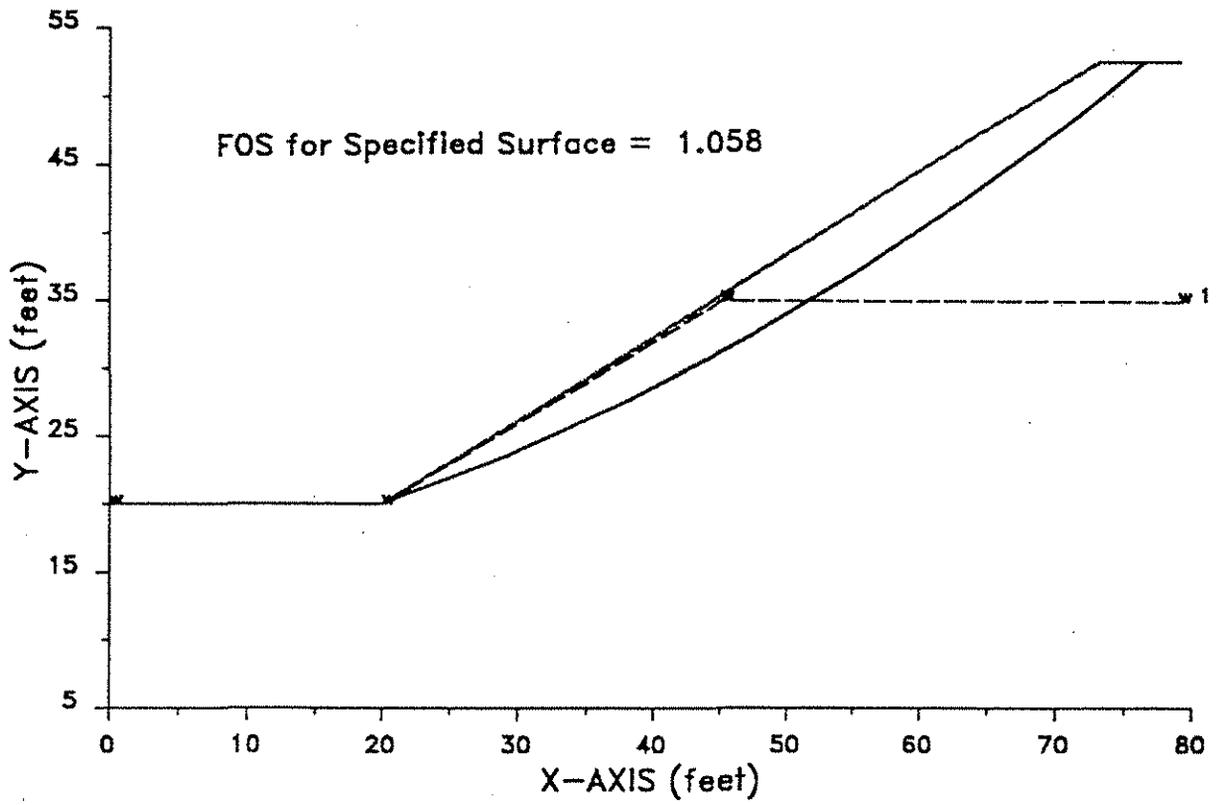
Figure 9.7 XSTABL results for 160th St. assuming watertable at midheight in the embankment

The slope was analyzed by XSTABL software using the Simplified Bishop Method which generates a circular failure surface. A shallow failure surface based on field observations was used in the analyses. The analyses were conducted for a moist slope and a slope with the elevation of the water table at mid-height of pre-slide slope. Total unit weight was used for the analysis of the moist slope, whereas saturated unit weight was used for the analysis with water table at mid-height. The minimum factors of safety from the XSTABL analysis are 1.3 and 1.1 for the natural moisture and water table at mid-height condition, respectively. The entire results of the analysis are in Karnik (2001). Figure 9.7 shows the analysis result for water table at mid-height.

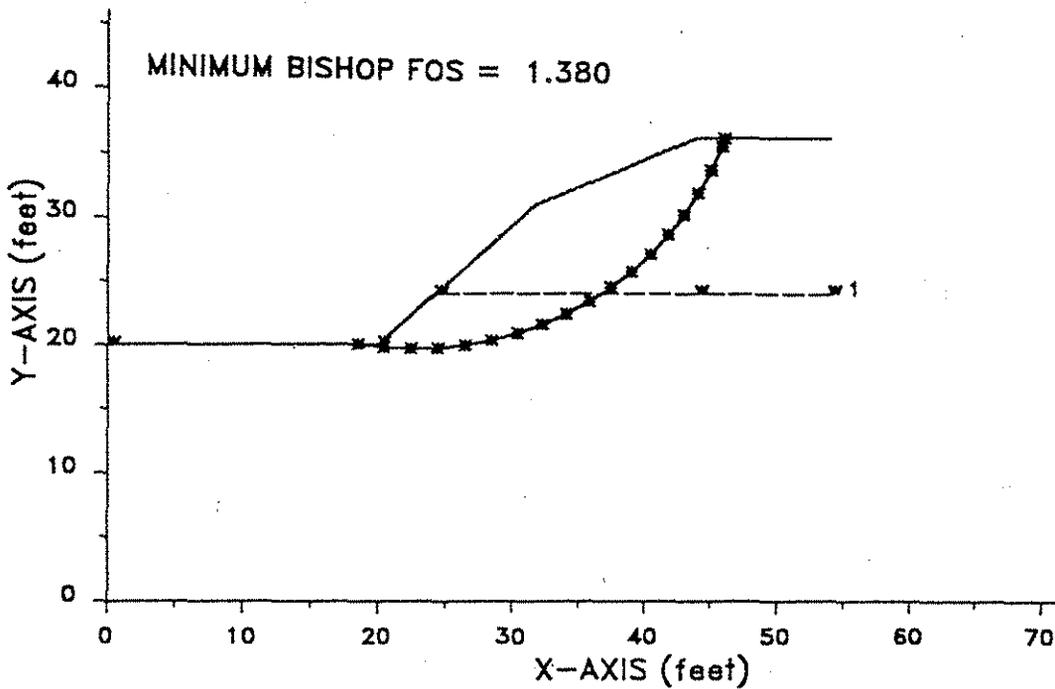
Figure 9.9 XSTABL results for K Street slide with watertable at 25% slope height.

Table 9.3 shows the various minimum factors of safety obtained for different profiles. A typical analysis is shown in Figure 9.9.

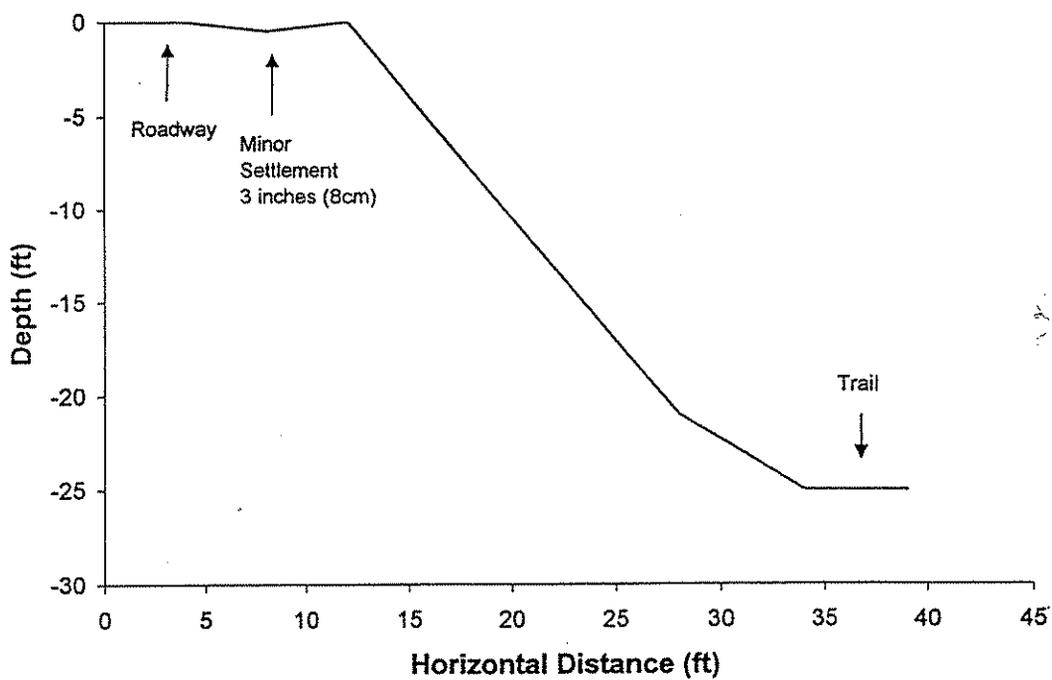
9.12 Post failure slope profile at Murray Hill

The site is 170 feet (52 m) above the Missouri River floodplain, near the upper part of the upland bluffs. The slopes adjacent to the roadway are vegetated with grasses and trees. During the site investigation carried out by ISU in June 1999, a longitudinal crack was observed along the edge of the existing asphalt pavement, and a minor settlement of 3 inches (8cm) was observed. A horizontal ledge interpreted as an old trail was observed at the bottom of the slope failure, about 25 feet (7.5 m) below the roadway. Slope profiles were measured along the slide and adjacent to it. The original slope profile is 33 feet (10 m) high with angles of 41° in the upper portion and 51° in the lower portion (Figure 9.11). The slope profile in the failed region is shown in Figure 9.12.

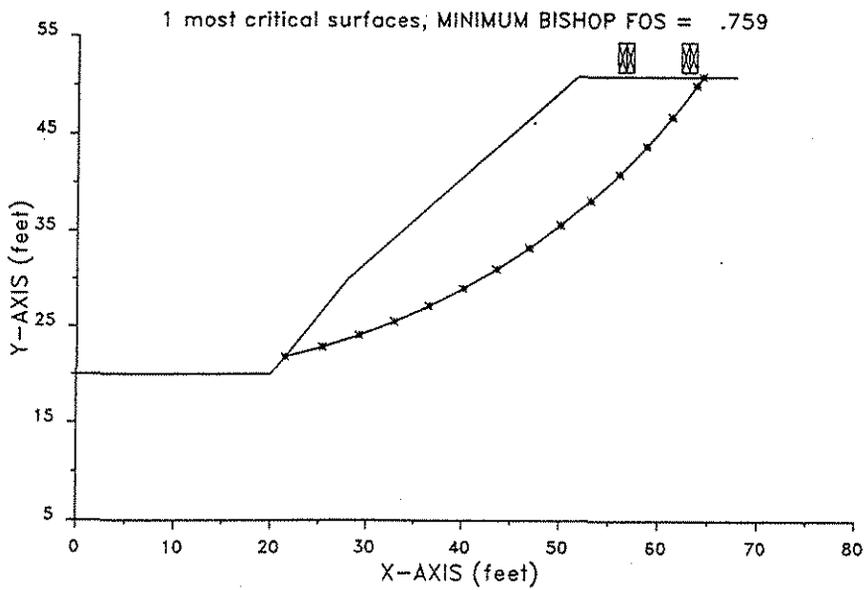
Figure 9.15 XSTABL results for Murray Hill slide with truck surcharge.

During fieldwork, trucks were observed to pass close to the edge of the road with their tires tracking through the depression in the pavement. Therefore, XSTABL analyses with a surcharge load from the trucks were performed. The vehicle surcharge loading represented a tandem truck; a stress of 17000 psf (814 kPa) was applied on each tire in the location shown in Figure 9.15. The minimum factor of safety decreases to 0.8 when the surcharge is included with the load at the shoulder; the failure surface shown by the analysis, however, extends further back below the roadway than suggested by the cracks observed on the pavement. It is interpreted that the slope without surcharge is at a metastable condition; and instability results from the surcharge load of passing trucks.
