# LOW PROFILE MARKER FOR WET/NIGHT VISIBILITY

HR - 1005 Final Report

HIGHWAY DIVISION

April 1977

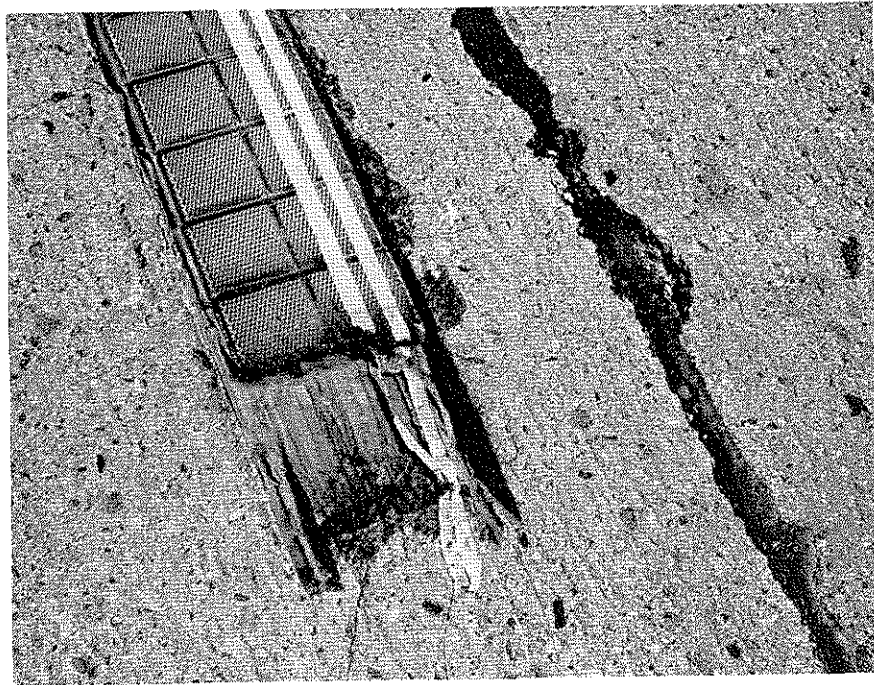
Figure 2A. Illustrates reflector unit installed using Polymeric Systems - Adhesive Sealant

The experiments referred to above showed that the Polymeric Systems adhesive compound produced a shadowing effect upon the reflectivity of the reflector elements with aluminized backing, but it appeared not to

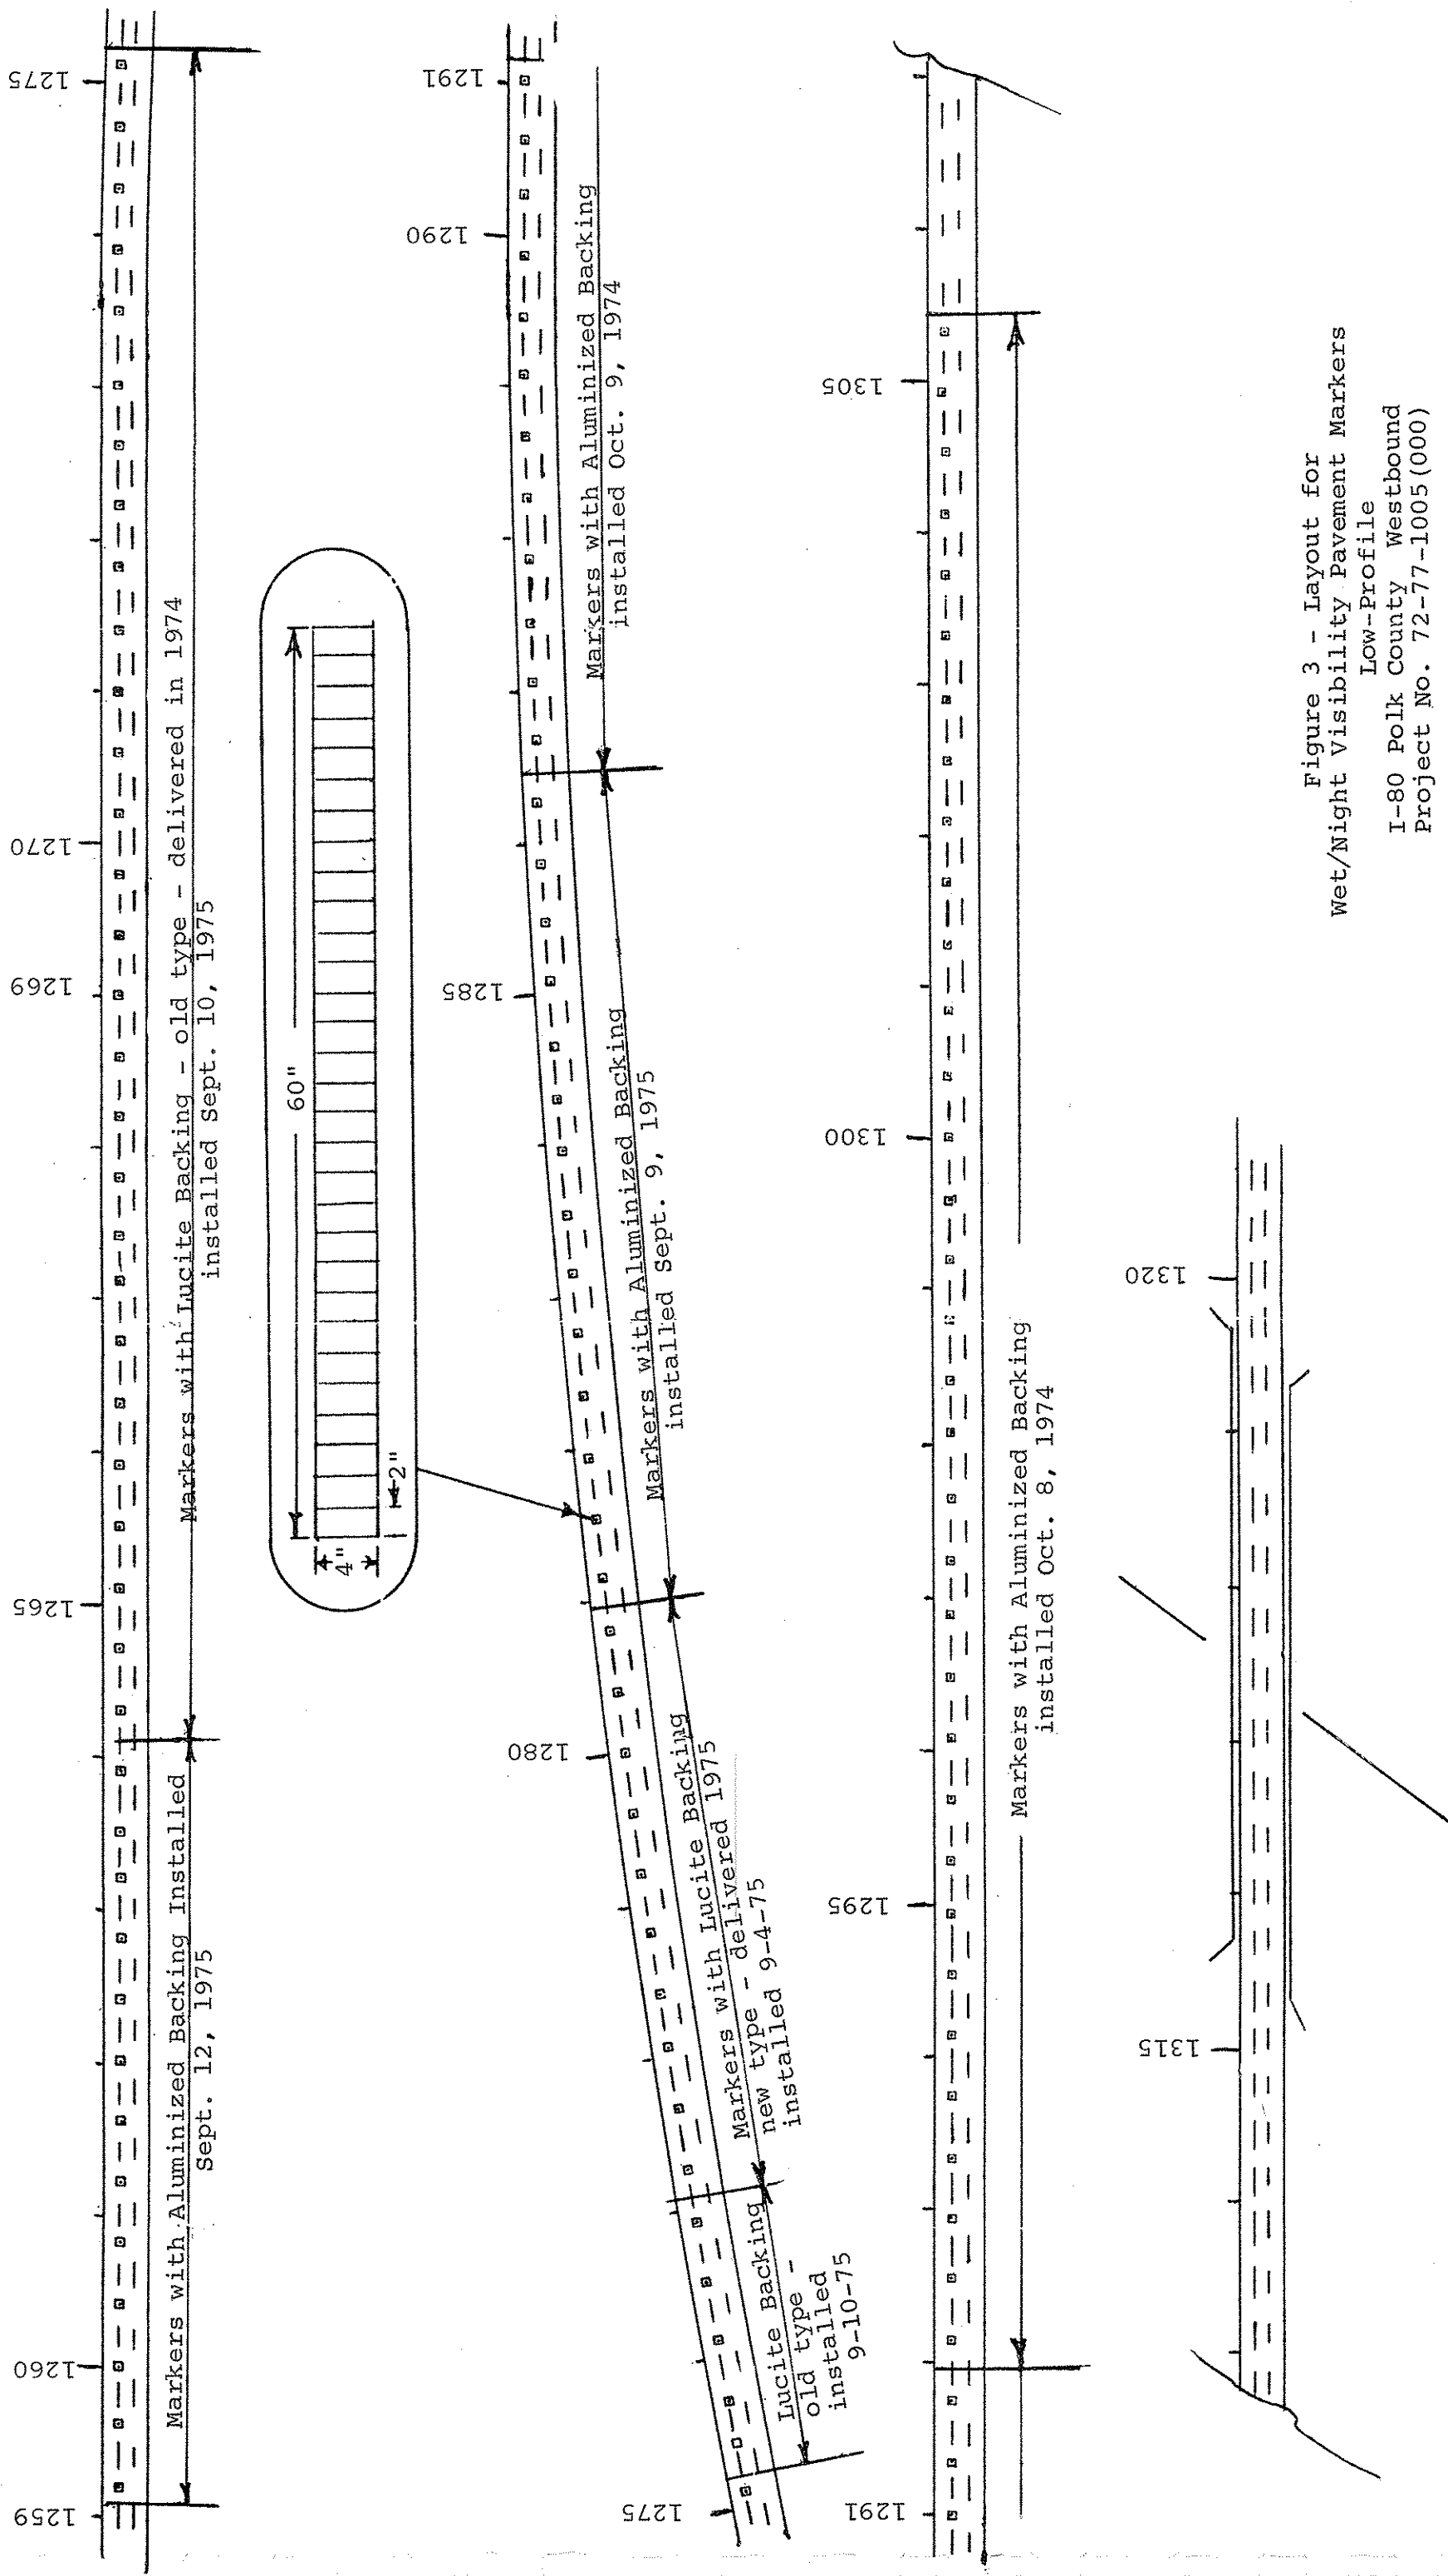
Figure 3 - Layout for  
Wet/Night Visibility Pavement Markers  
Low-Profile  
I-80 Polk County Westbound  
Project No. 72-77-1005(000)

Information on the locations, types of reflectors and dates of installation has been illustrated in Figure 3. Calbar epoxy was used in the installation of all reflectors except those from Station 1277+25+ to Station 1280+80+ (10 reflector units).

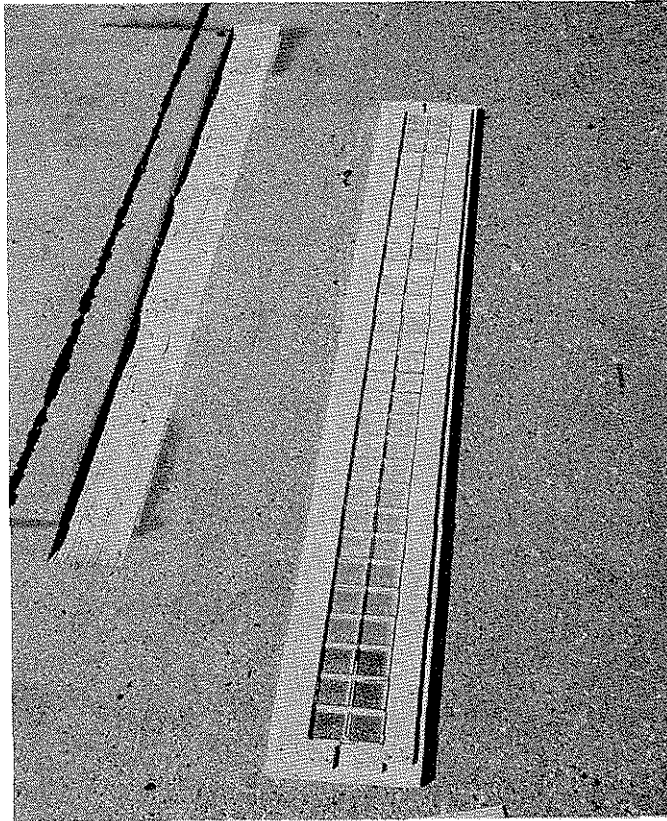
Figure 4. Inverted reflector unit in alignment board

A build-up of epoxy on the board resulted in the problem of not being able to remove the reflector elements from the recess in the board when it was inverted over the groove in the pavement. This resulted in a decision to try installing a few reflector units using the procedure of placing more epoxy in the pavement groove and not filling the recesses in the back or bottom of the reflectors.

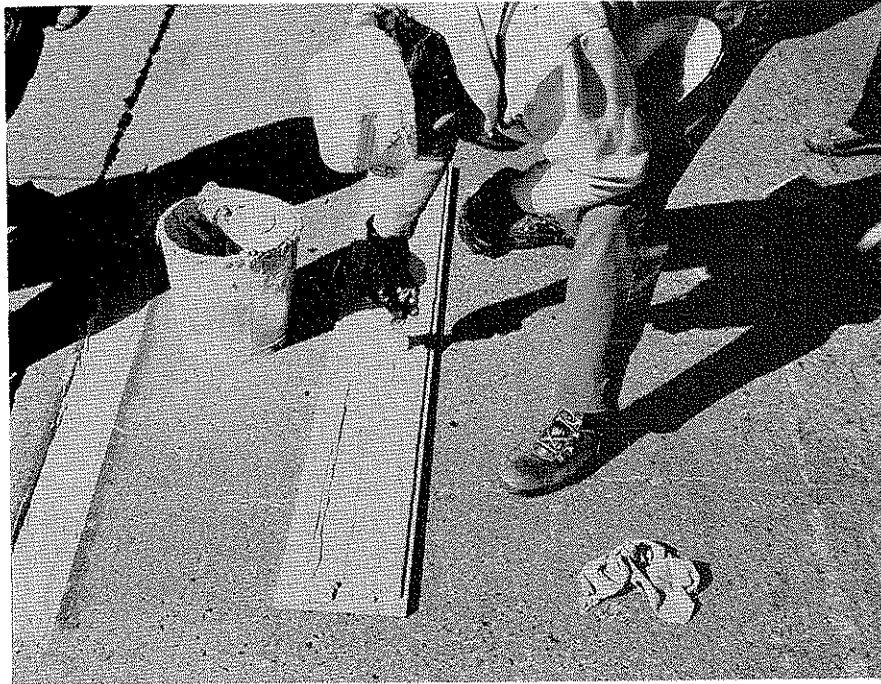
Figure 5. Application of epoxy to reflector unit and to groove in pavement

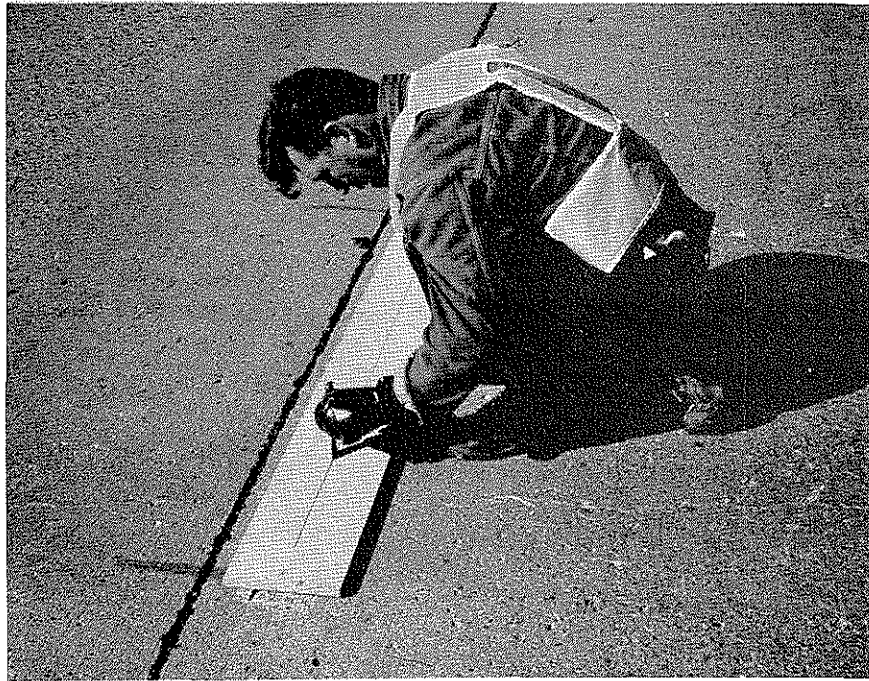
Figure 6. Using a putty knife to eject reflector elements from the alignment board

In order to overcome the problem of not being able to remove the reflector elements from the recess in the alignment board, a saw-cut was made in the board down the center of the recessed area. (See Figure 6). The saw-cut made possible the ejection of the reflector elements with the use of a putty knife while the board was in an inverted position over the groove in the pavement.

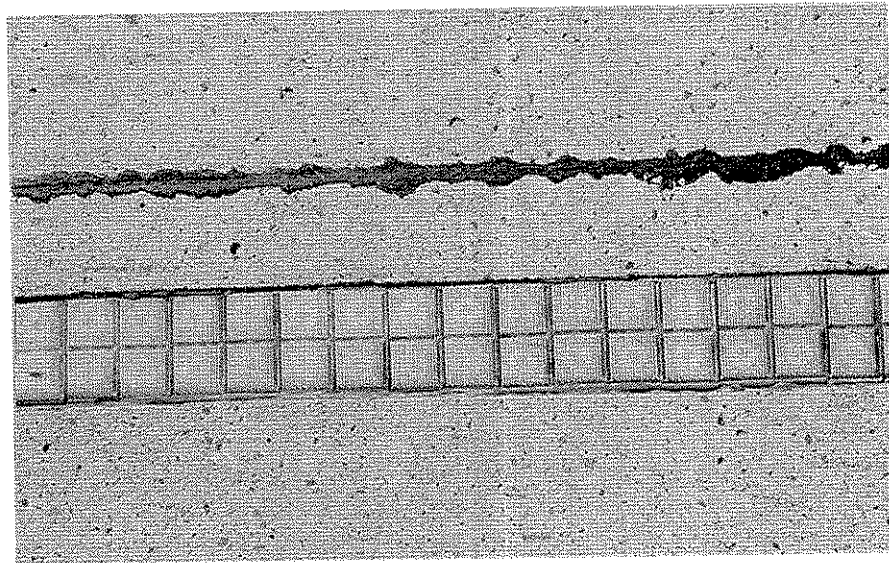
Four descriptive terms were selected in an attempt to rate the condition of reflector units. The terms chosen were: 1. "Excellent" - No apparent breaking, cracking or loosening of reflector elements. Figure 7 is an example.

Figure 7. A reflector unit in "excellent" condition

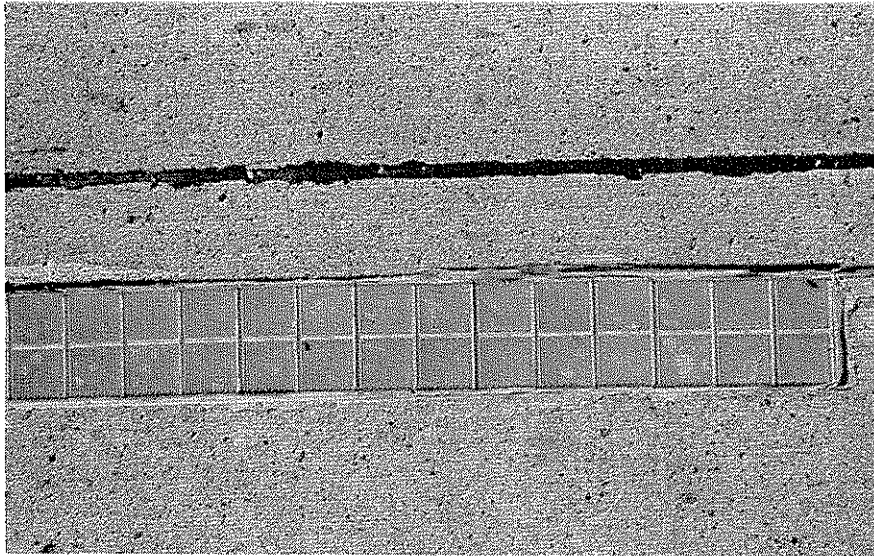
2. "Good" - Up to four (4) cracked elements or some apparent shadowing in up to six (6) of the elements in a unit. See Figure 8.
3. "Fair" - More than four (4) but not more than eight (8) broken or loosened elements; may include shadowing (signs of leaking ) in 50% of the elements in a unit. Figure 9 is an illustration.
4. "Poor" - More than eight (8) broken, loosened or missing elements or shadowing (signs of leaking) in more than 50% of the elements in a unit. Figure 10 indicates a reflector unit judged for this condition.

Figure 8. A reflector unit in "good" condition

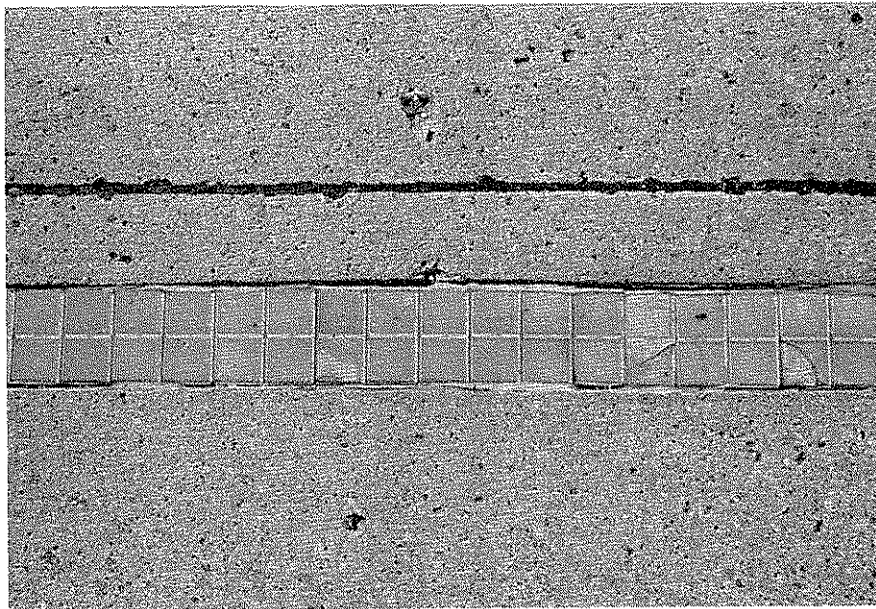
Figure 9. A reflector unit in "fair" condition

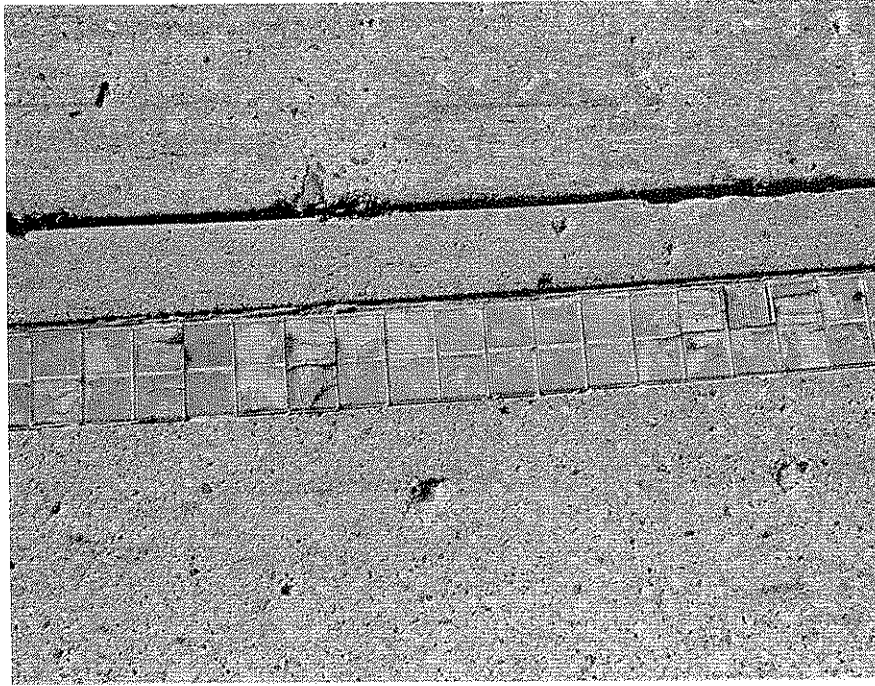
Figure 10. A reflector unit in "poor" condition

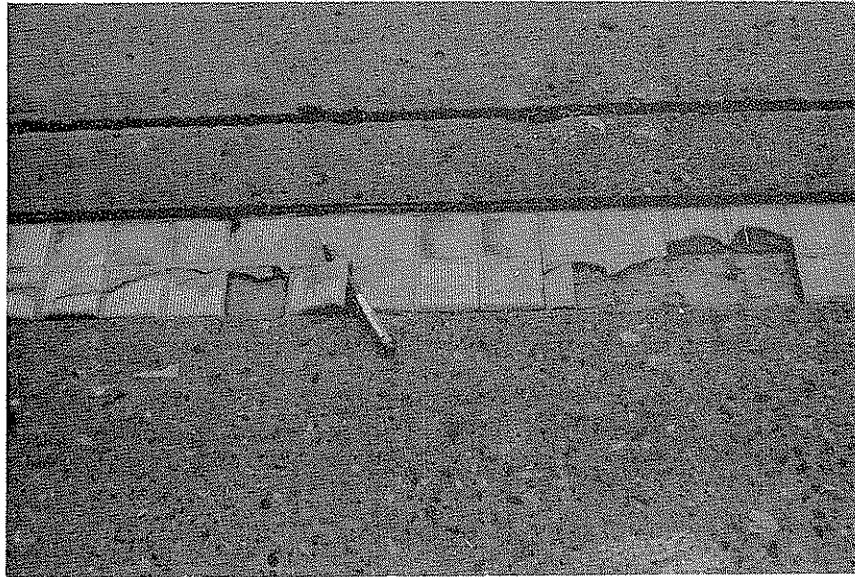
It appears that the aluminum-backed reflector units are less durable than those with lucite backing. There is more breakage among the aluminum-backed units and some units showed a separation of the aluminum coating from the acrylic material.

Some reflectors appeared to have been punctured by a small stone or piece of aggregate forced through the surface by a vehicle tire. Some of this damage may have been caused by studded tires. Again, breakage due to traffic appeared to be greater among the aluminum-backed units.

Some of the loosening of reflector elements may have been a result of epoxy failure. However, with the exception of the first day's installation, where workmanship may have been a factor, it is believed that most failures were due to a separation of the aluminum coating from the acrylic material. Although the type of epoxy used may have caused the loosening, only one (1) epoxy was applied to the aluminized markers and therefore any conclusions would be only speculative. If some of the breakage experience was due to shock, the use of a more resilient material such as the Polymeric Systems Adhesive - Sealant may well be an improvement. For the most part, it appears that the epoxy used was quite effective, however.

To the date of the final inspection (9-8-76) there were no complete physical losses of markers. However, the condition of some markers was extensively deteriorated as illustrated by Figure 11.

Figure 11. Badly deteriorated units
