Bridge Deck Rehabilitation Rebonding a Delaminated PCC Overlay By Epoxy Injection

**Final Report for
Iowa DOT Project HR-1036
FHWA Project DTFH 71-83-51-1A-06**

FINAL REPORT
BRIDGE DECK REHABILITATION
REBONDING A DELAMINATED
P.C.C. OVERLAY BY EPOXY INJECTION

IOWA RESEARCH PROJECT
HR 1036

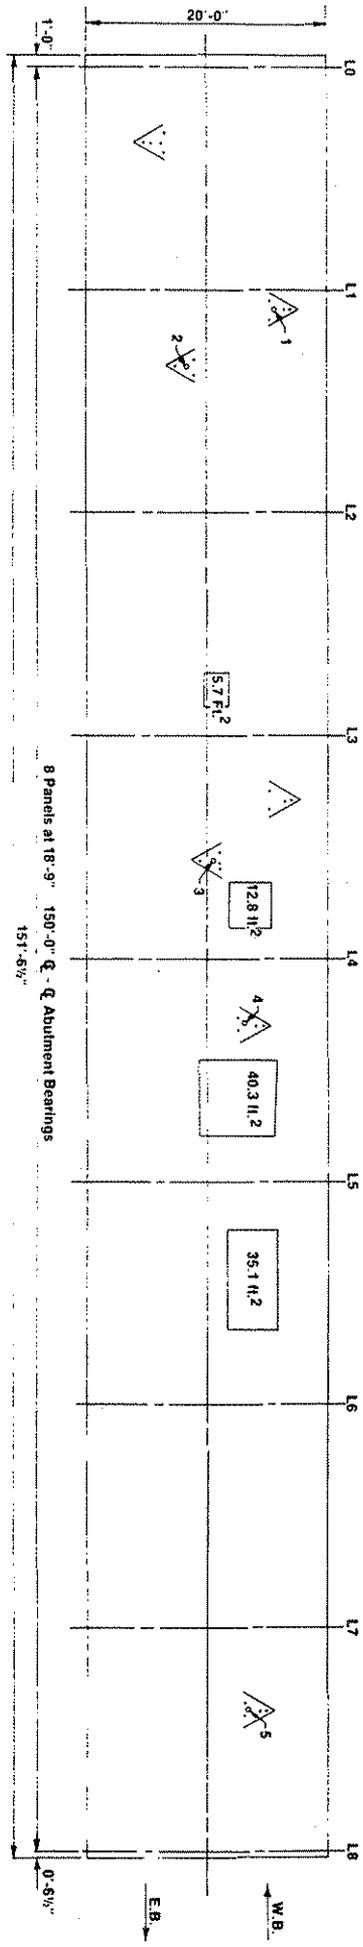
FIGURE 1
PRE-PROJECT LAYOUT

The four breakout areas were repaired with low slump dense concrete using Iowa's standard procedures with the one exception that during removal, no attempt was made to extend the repair area to sound concrete at all edge boundaries. Figure 1 is a layout of the work completed prior to beginning the demonstration project.

Five four inch diameter cores were cut from injection test sites May 10, 1983. These are shown in Figure 1. Visual-examination indicated good rebonding of the fracture plane in cores 1, 2 and 5. Core number 4 was partially rebonded; the remainder of the interface appeared to be coated but not filled with epoxy.

The overlay was not bonded to the substrate in Core 3. The layer of epoxy was bonded to the overlay. The face of the substrate exhibited a layer of powdery contaminant. Part of the contaminant adhered to the epoxy and the remainder, a thin layer, prevented bond of the epoxy to the solid substrate. This core was obtained from a test site near an overlay repair area (L3-L4).

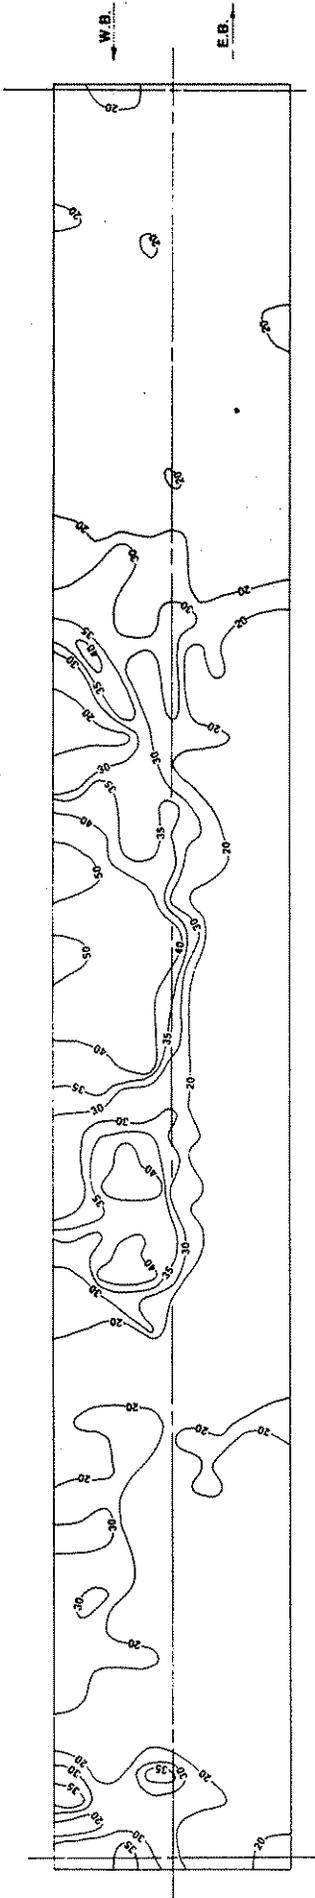
FIGURE 2
BEFORE CONDITION SURVEY
HALF CELL ELECTRICAL POTENTIAL

Field data were collected on June 13, 1983. A delametect survey of the deck and electrical potentials were obtained. Copper-copper sulfate half cell readings were taken on a two foot by two foot grid. Figure 2 shows the contour plot from the electrical potential survey. Figure 3 shows the results of the delametect survey.

The delametect survey indicated that 693 sq. ft. were delaminated in the westbound lane and 192 sq. ft. in the eastbound lane. Half cell tests indicated that almost all of the eastbound lane was in the range of 0 to -0.20 volts as was about thirty five percent of the westbound lane. Nearly one-half of the westbound lane showed potentials at or higher than -0.35 volts, the generally accepted corrosion threshold level.

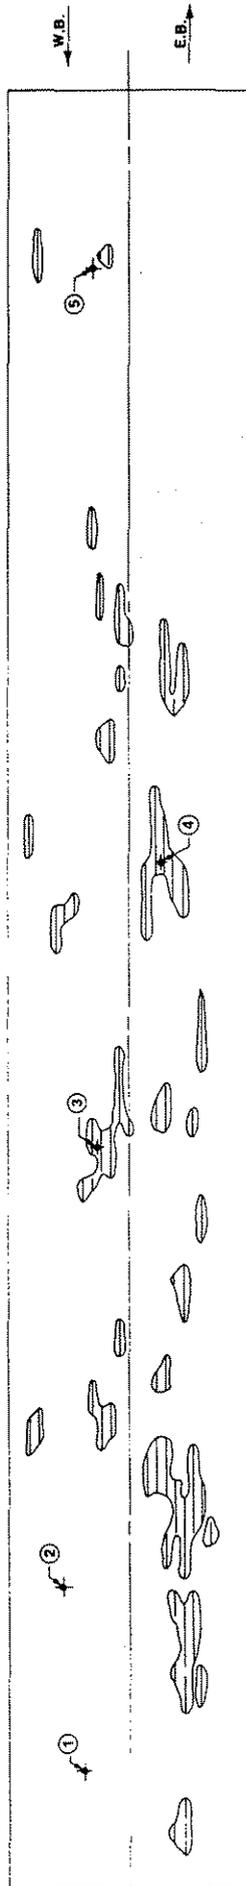
FIGURE 4
AFTER CONDITION SURVEY
DELAMTEC CORES

A post-treatment delamect survey was conducted August 22, 1983. This survey indicated that 77 sq. ft. of delaminated PC overlay remained in the westbound lane and 143 sq. ft. remained in the eastbound lane. The original total delaminated area of 885 sq. ft. had been reduced to 220 sq. ft. This is a reduction from 29.2% to 7.2% or 22% of the total deck area. Delamination in the westbound lane where epoxy injection was preformed was reduced from 45.7% to 5.1% of the gross area of the lane. In the eastbound lane, a reduction from 12.7% to 9.4% occurred as carry over from treating the westbound lane.

The remaining areas of delamination in the eastbound lane are readily understood. The areas remaining in the westbound lane warrant additional analysis. A review of the post treatment delamect plot, Figure 4, superimposed over the plot of pre-treatment test sites and overlay repair areas, Figure 1, shows a relationship between the pre-treatment activities and the remaining delamination (see Figure 5). The delamination near L2 is at the boundary between the end of first day treatment and the beginning of second day activity. With these factors taken into account it is estimated that, without pre-treatment interference, over half of the remaining delamination in the westbound lane would have been rebonded. It is presumed, also, that technique can be improved to reduce the failure to rebond at boundaries between days work areas such as at L2.

Five four inch diameter cores were cut from selected locations on August 31, 1983. The locations from which these cores were obtained is shown in Figure 4. Cores were located to avoid top reinforcing, cut to a partial depth to contact bottom layer reinforcing, then broken out by wedging. Cores 3 and 4 were deliberately selected where delamination was indicated in an attempt to evaluate failure to rebond. In both cases, the top portion of the core had rotated to destroy conditions at the delamination interface. No evidence of epoxy indicates failure to inject at these points. No evaluation could be made to confirm the presence of a contaminant such as observed in pretest core Number 3, see Appendix A.

Cores 1, 2 and 5, by visual examination, indicated successful rebonding. Core 1 broke too close to the bond plane to be shear tested. Cores 2 and 5 were tested in shear at the bond plane and in substrate. Core 5 contained a sufficient depth of overlay concrete to permit a test in this zone also.

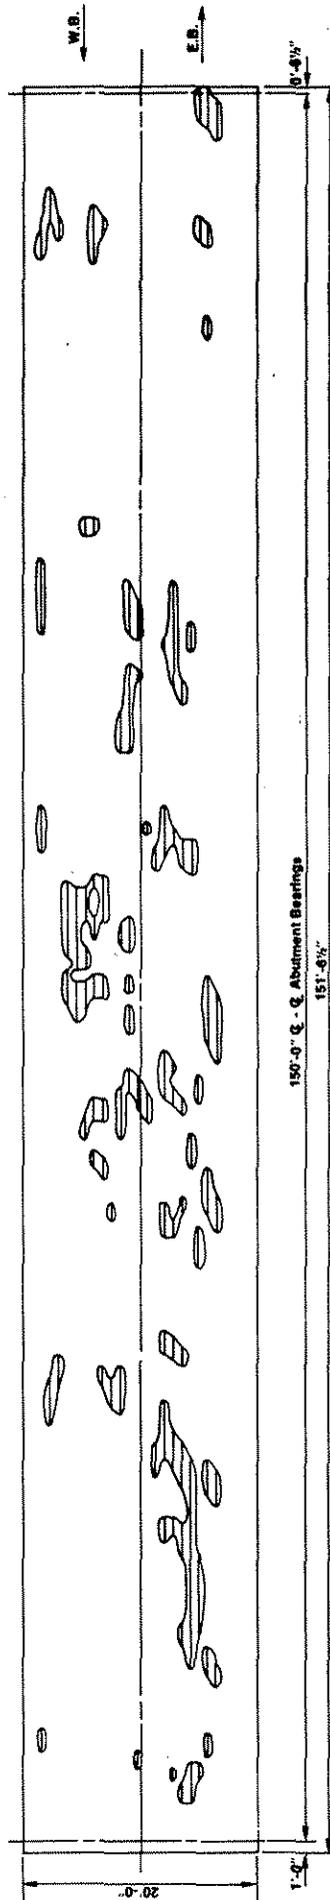
FIGURE 6
1984 DELAMINATION SURVEY

The survey rerun was performed on September 19, 1984. Results of the strip chart interpretation indicated total delamination of 222 sq. ft., only 2 sq. ft. different from that indicated in August 1983. This time, however, the westbound lane indicated 98 sq. ft. of delamination and the eastbound lane indicated 124 sq. ft. Each of these indications varies from the August 1983 results by about 20 sq. ft. but in opposite directions to result in a total that represents virtually no change.

Figure 6, attached, is a deck plot of the September 19, 1984 delamination survey.

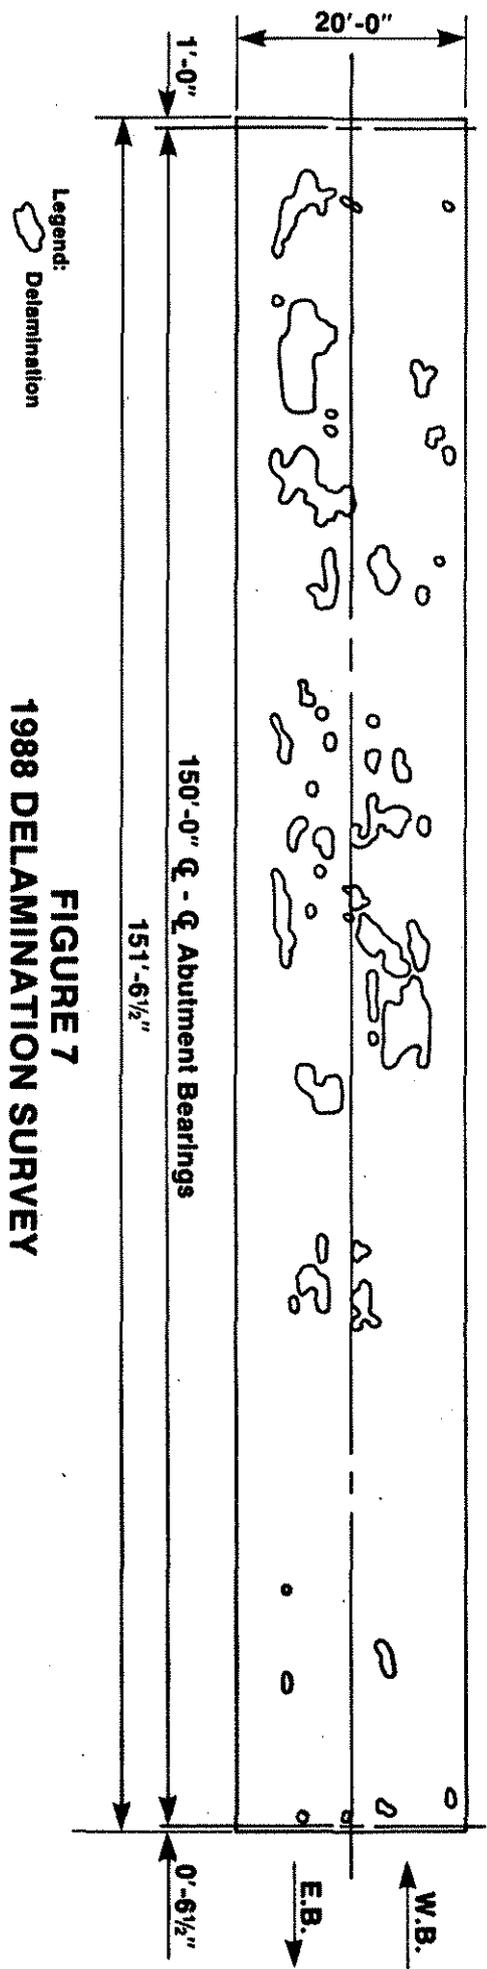
FIGURE 7
1988 DELAMINATION SURVEY

A final survey of the bridge deck was performed on May 23, 1988. Visual observations indicated no change in the appearance of the deck surface from previous post-treatment observations. The delamtect survey provided results very similar to previous observations, nearly identical to the results obtained in April 1984. Figure 7 is a deck plot of the delamination survey conducted May 23, 1988.
