EVALUATION OF BOND RETAINAGE
IN
PORTLAND CEMENT CONCRETE OVERLAYS
BY
INFRARED THERMOGRAPHY
AND
GROUND PENETRATING RADAR

IOWA DEPARTMENT OF TRANSPORTATION

DONOHUE & ASSOCIATES, INC.
ENGINEERS & ARCHITECTS

DONOHUE PROJECT NO. 50389
COPYRIGHT, DONOHUE 1988

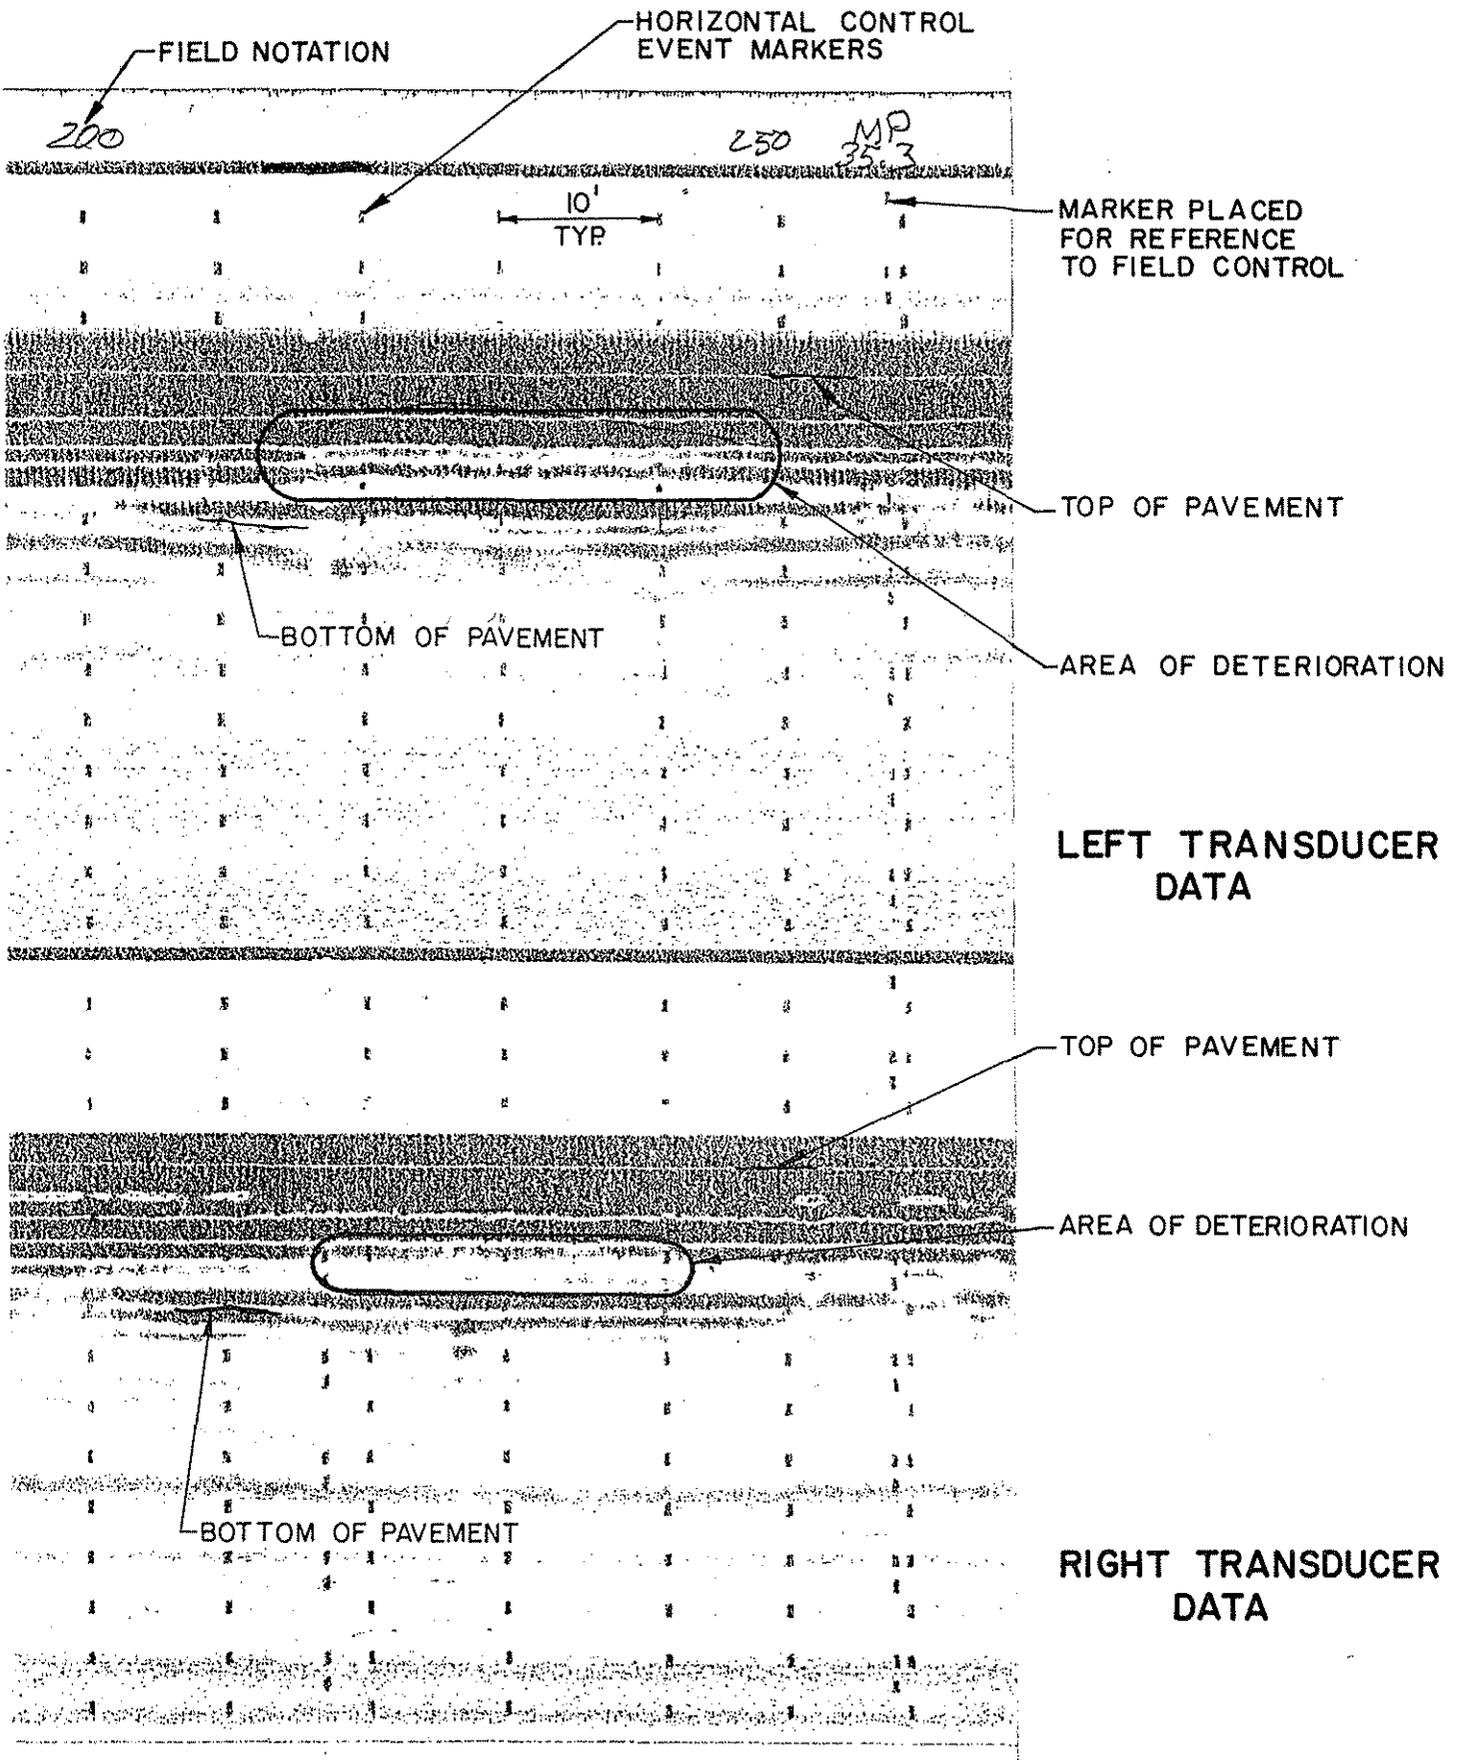
**FIGURE 3
SAMPLE OF GPR CHART SHOWING
DETERIORATION SIGNATURE
IOWA DEPT. OF TRANSPORTATION**

All three cores taken between mileposts 35.25 and 35.35 (Numbers 2, 3 and 4) and Core Number 2 between mileposts 36.00 and 36.10 on Interstate 80 were either broken during coring or broken when handled. While no debond condition was present, the cores broke easily, with light finger pressure, just below the interface between the original pavement and PCC overlay. We feel that these cores are representative of a weak concrete which is a preface to an early stage of deterioration where small fractures begin to occur. This is a condition that can be related to the degradation of the interface signature seen at various locations in these same sections (Figure 3). At two locations between mileposts 35.25 and 35.35 on Interstate 80, the degradation of the interface signature occurred in several of the data passes simultaneously.

At each site 6,336 feet of GPR data was collected and analyzed. This analysis identified 258 lineal feet of scan that showed this deteriorated condition between mileposts 35.25 and 35.35 (4.1%), and 116 lineal feet between mileposts 36.00 and 36.10 (1.8%). The location of this deterioration is shown in Appendix B. No GPR data representing any debonding that we can identify or deterioration was found at any of the other sites.

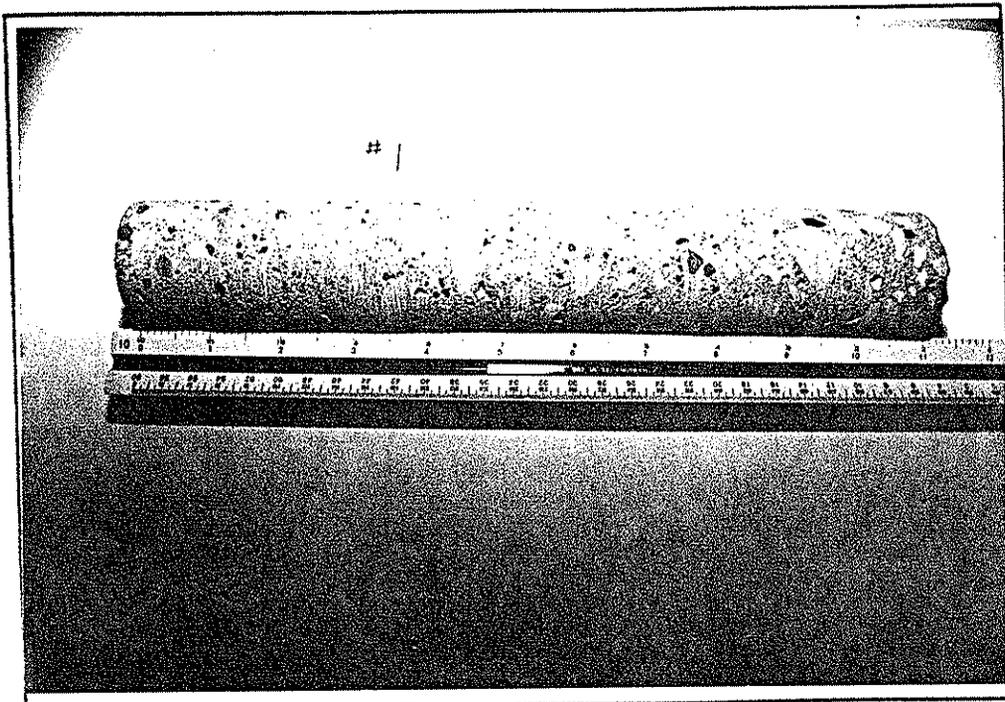
CORE: # 1

OVERLAY THICKNESS: 3.25 inches

DEFECTS IN CORE: None

REMARKS: Good Bond - no defects

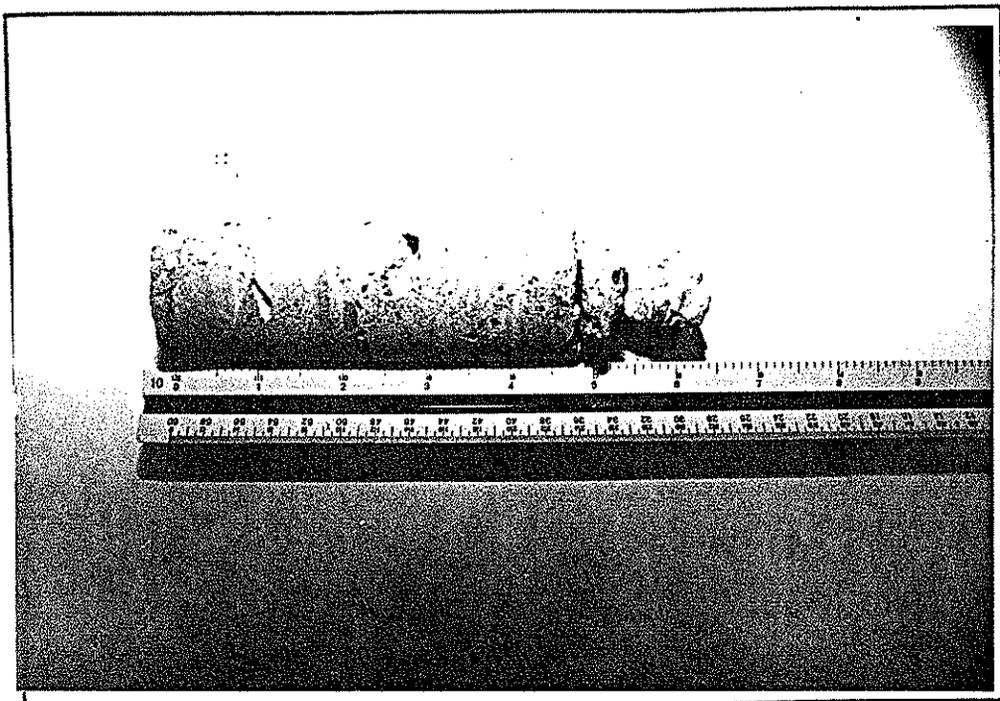
CORE: # 2

DEFECTS IN CORE: Poor original pavement

QUALITY OF CONCRETE: Poor

REMARKS: Original Pavement broke easily

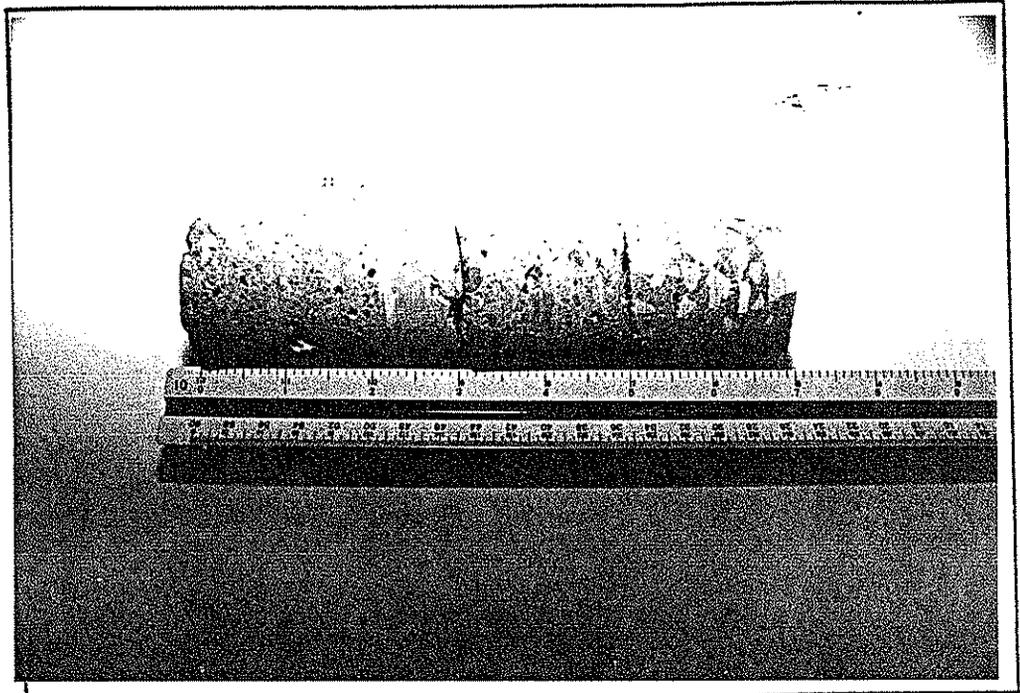
DEFECTS IN CORE: Broke just beneath Bond

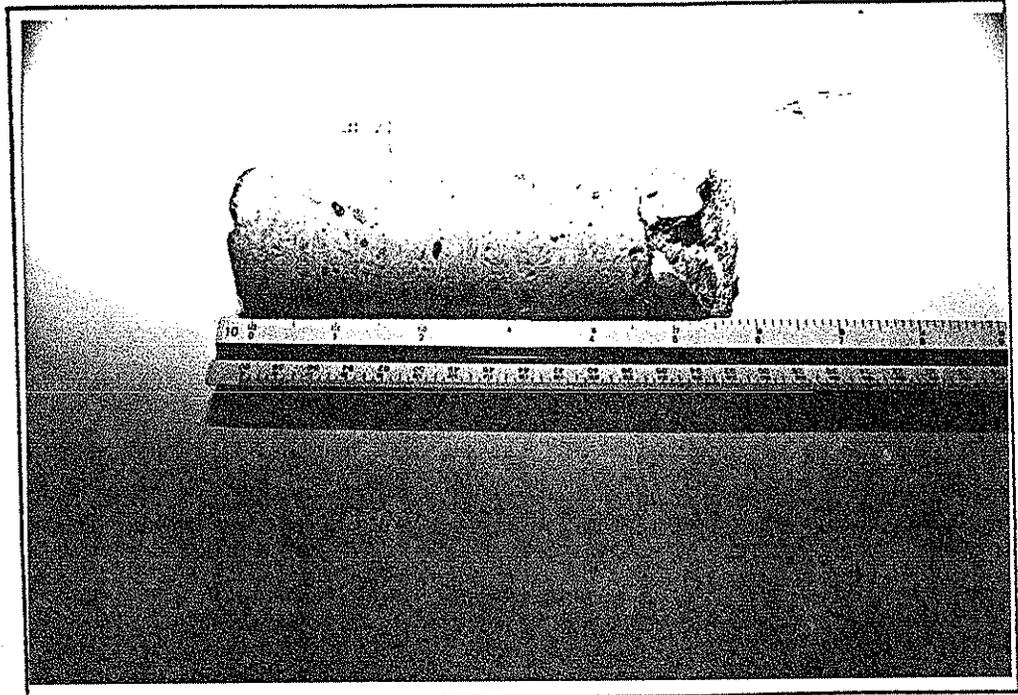
DEFECTS IN CORE: Poor original pavement

QUALITY OF CONCRETE: Poor

REMARKS: Original pavement broke easily

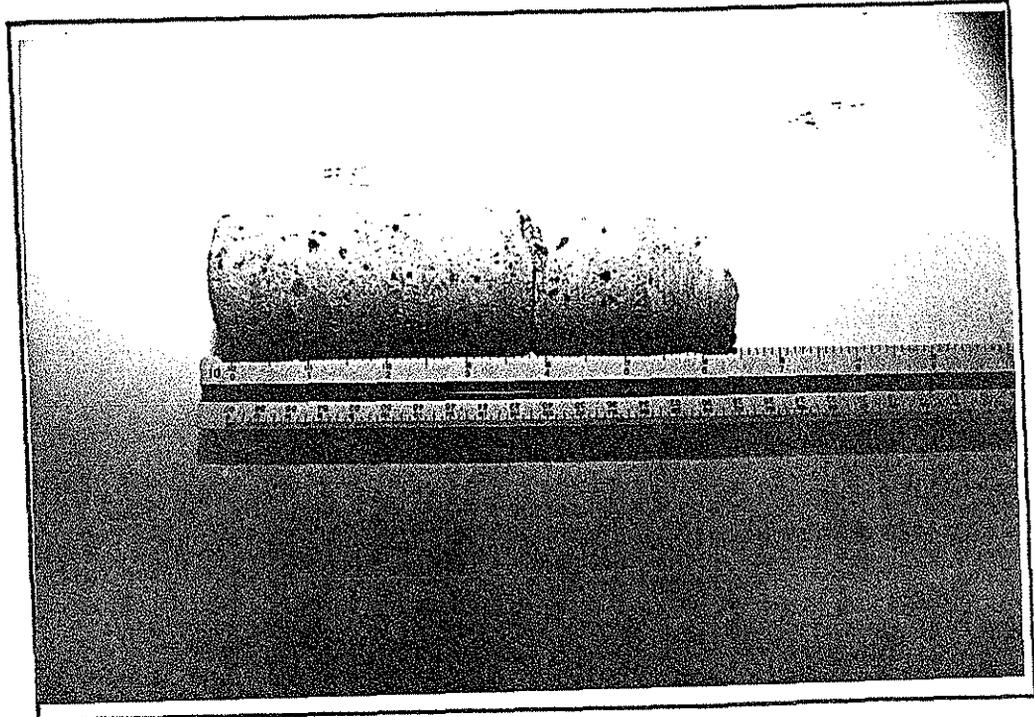
DEFECTS IN CORE: Poor original pavement

QUALITY OF CONCRETE: Poor

REMARKS: Original pavement broke easily

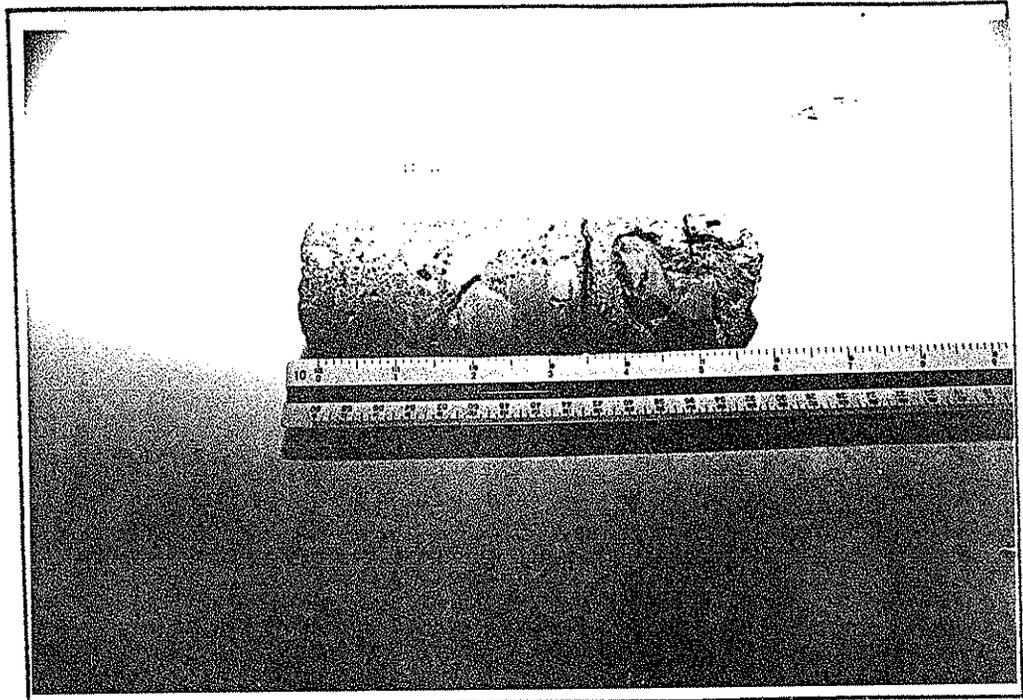
DEFECTS IN CORE: Poor Original Pavement

QUALITY OF CONCRETE: Poor

REMARKS: Original Pavement Broke Easily

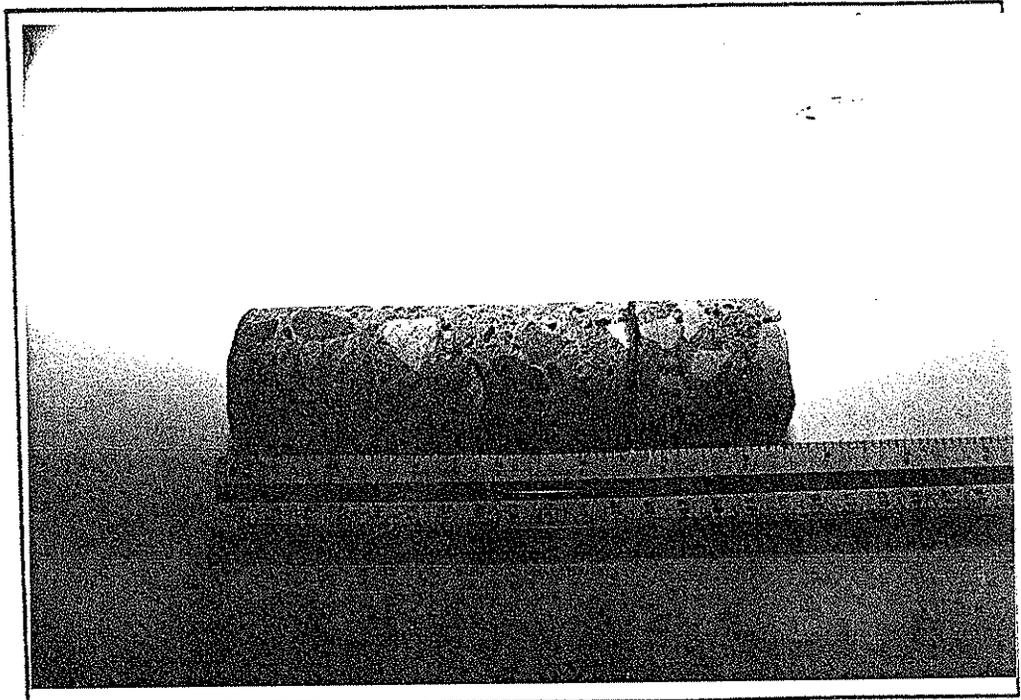
DEFECTS IN CORE: Debanded Overlay

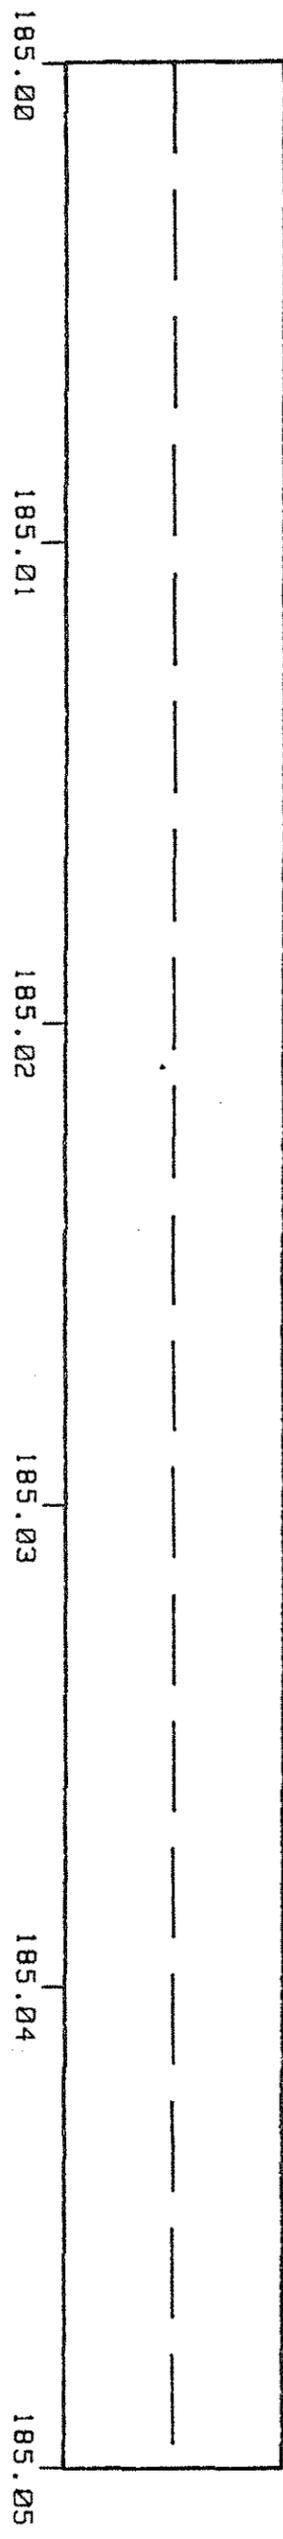
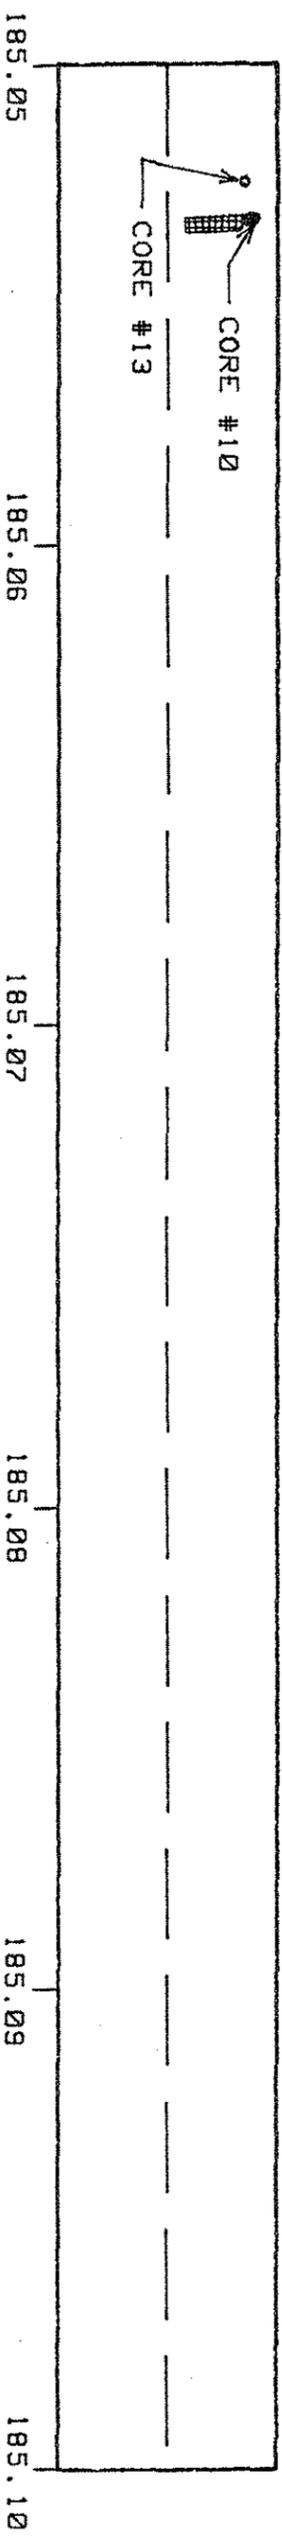
IR AND GPR EVALUATION OF BOND RETRAINAGE
IN PORTLAND CEMENT CONCRETE OVERLAYS
I-80 (WESTBOUND) STR 185.00 TO STR 185.10
IOWA DEPARTMENT OF TRANSPORTATION

AREAS		WESTBOUND LANES	
Total Area	12,672 (sq.ft.)		
Debond (IR)	1 (sq.ft.)		
Concrete Patch	11 (sq.ft.)		
Deterioration (GPR)	None (11n.ft.)

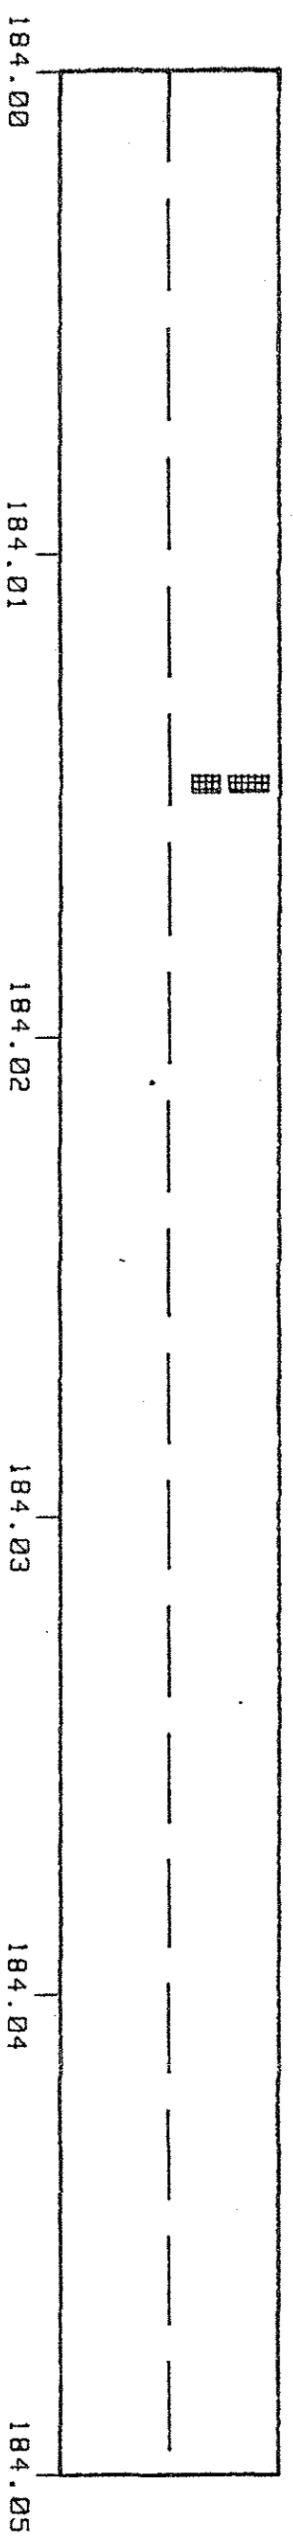
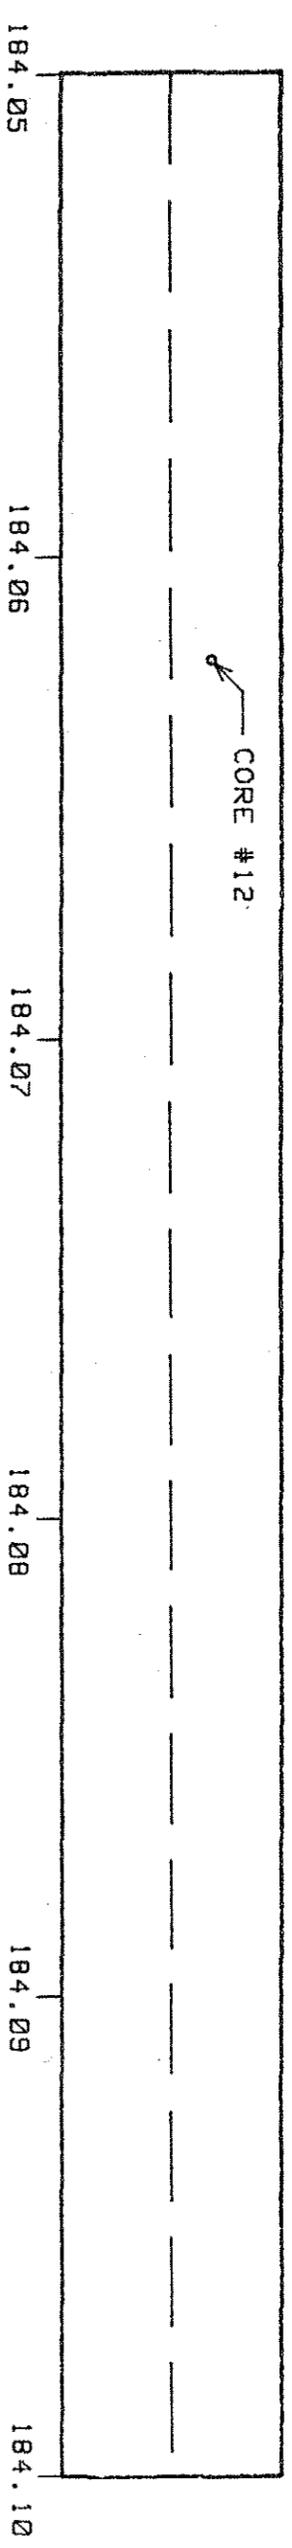
IR AND GPR EVALUATION OF BOND RETRAINAGE
IN PORTLAND CEMENT CONCRETE OVERLAYS
I-80 (WESTBOUND) STA 184.00 TO STA 184.10
IOWA DEPARTMENT OF TRANSPORTATION

AREAS		WESTBOUND LANES	
Total Area	12,672 (sq. ft.)		
Debond (IR)	None (sq. ft.)		
Concrete Patch	13 (sq. ft.)		
Deterioration (GPR)	None (lin. ft.)

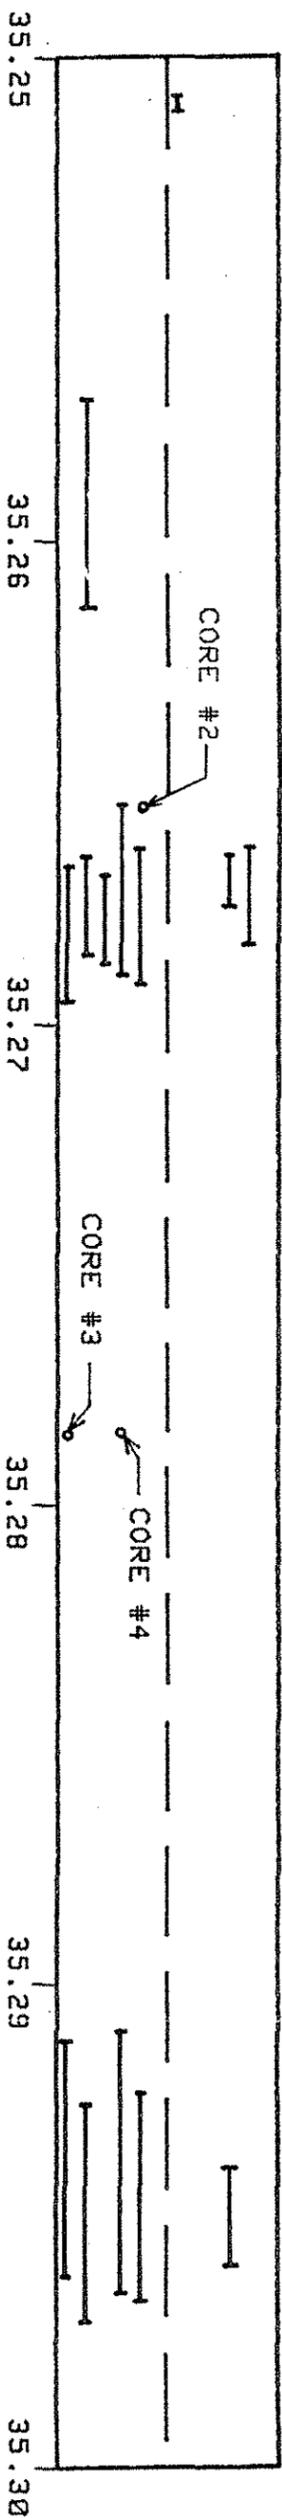
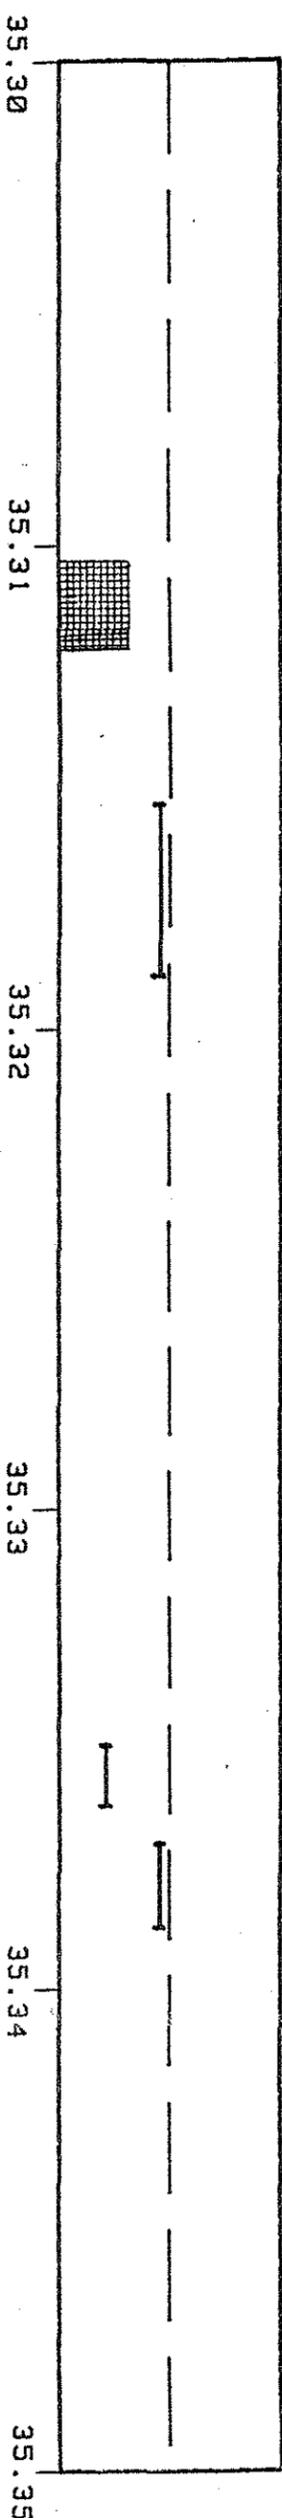
IR AND GPR EVALUATION OF BOND RETAINAGE
IN PORTLAND CEMENT CONCRETE OVERLAYS
I-80 (WESTBOUND) STR 35.25 TO STR 35.35
IOWA DEPARTMENT OF TRANSPORTATION

Total Area	12,672 (sq.ft.)
Debond (IR)	None (sq.ft.)
Concrete Patch	65 (sq.ft.)
Deterioration (GPR)	258 (1 in.ft.)

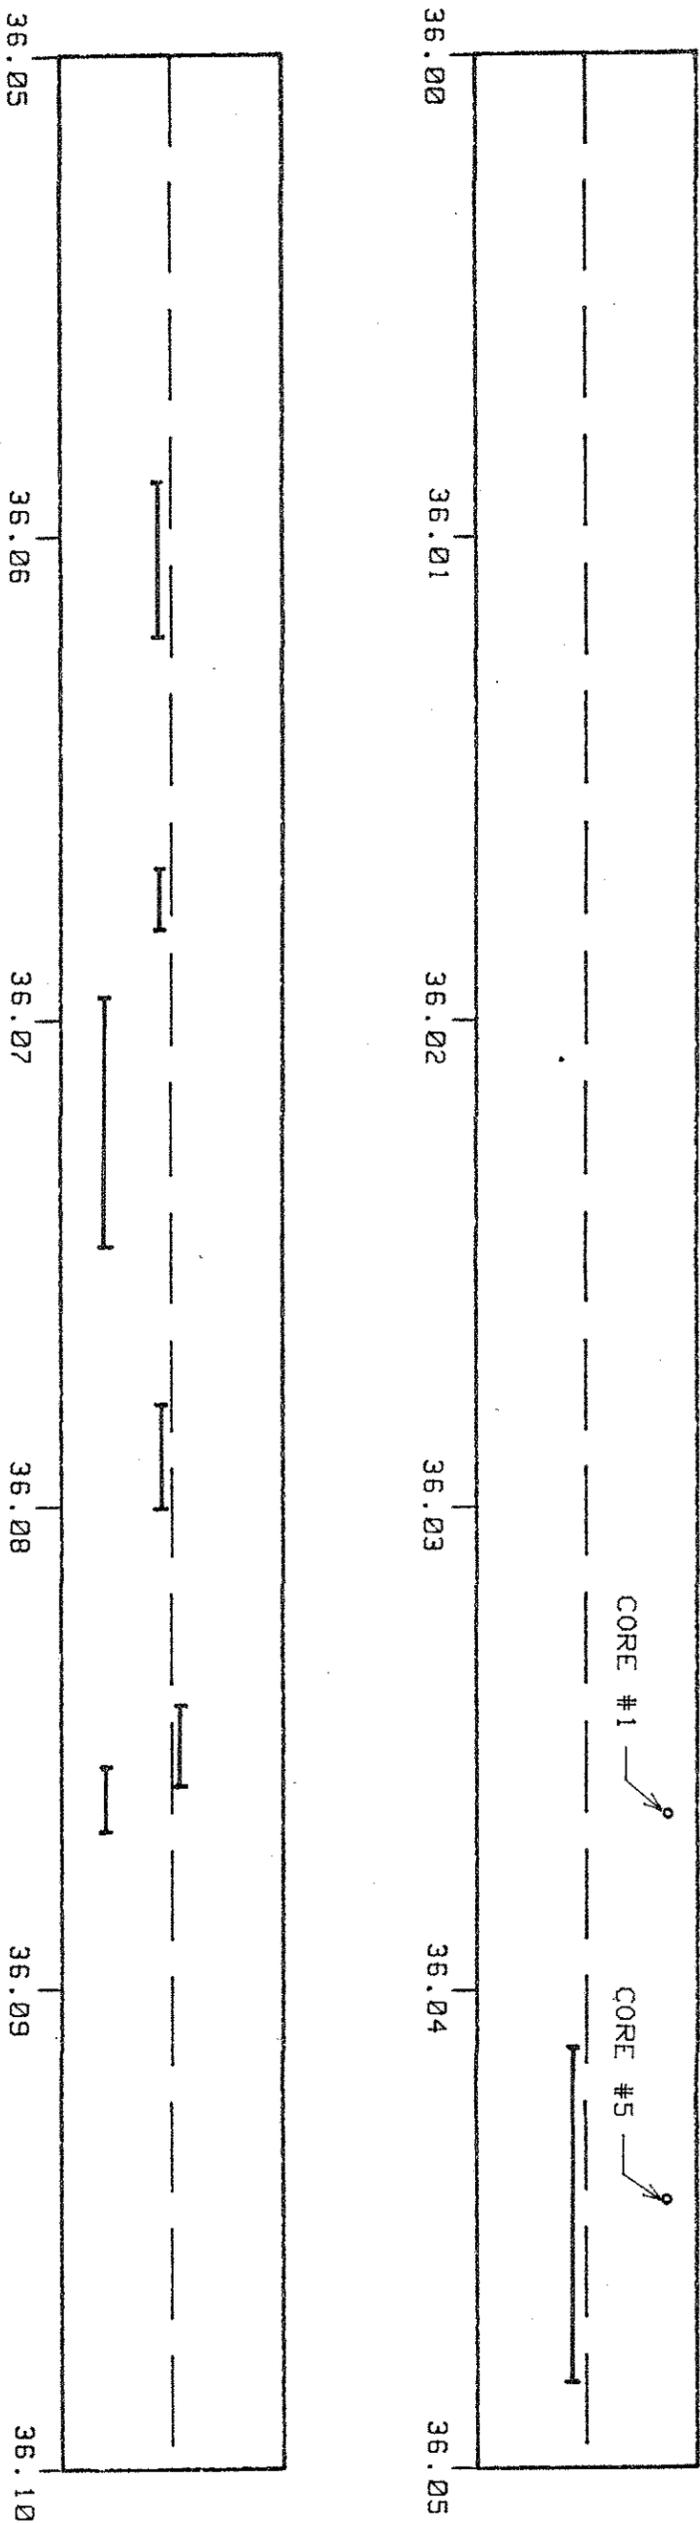
AREAS	
Total Area	12,672 (sq.ft.)
Debond (IR)	None (sq.ft.)
Concrete Patch	None (sq.ft.)
Deterioration (GPR)	116 (lin.ft.)
