Final Report
Iowa Highway Research Board
Project HR-250

**A NONDESTRUCTIVE METHOD
FOR DETERMINING THE THICKNESS
OF SOUND CONCRETE
ON OLDER PAVEMENTS**

Donohue & Associates, Inc.

December 1983

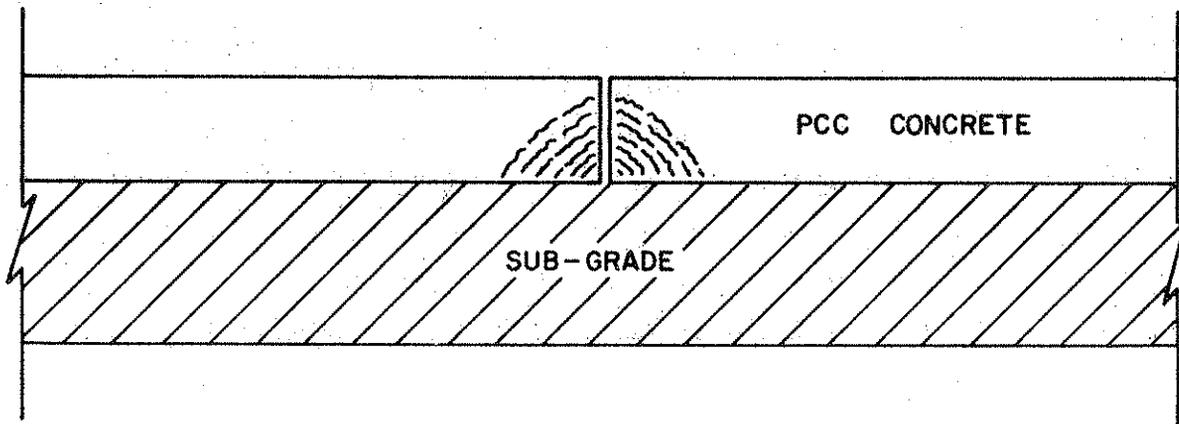
D-cracking appears to begin at the bottom of the slab. As deterioration increases the cracking expands both outward from the joint and upward from the bottom of the slab. A schematic diagram of D-cracking is shown on Figure 1. Identification of D-cracking at the joints is currently done by core drilling each joint. Visual observation of D-cracking from the surface is not possible until complete joint failure occurs. Core drilling is a time consuming and expensive process. Therefore, it would be advantageous if a rapid, non-destructive technique could be found to locate and assess the subsurface pavement deterioration.

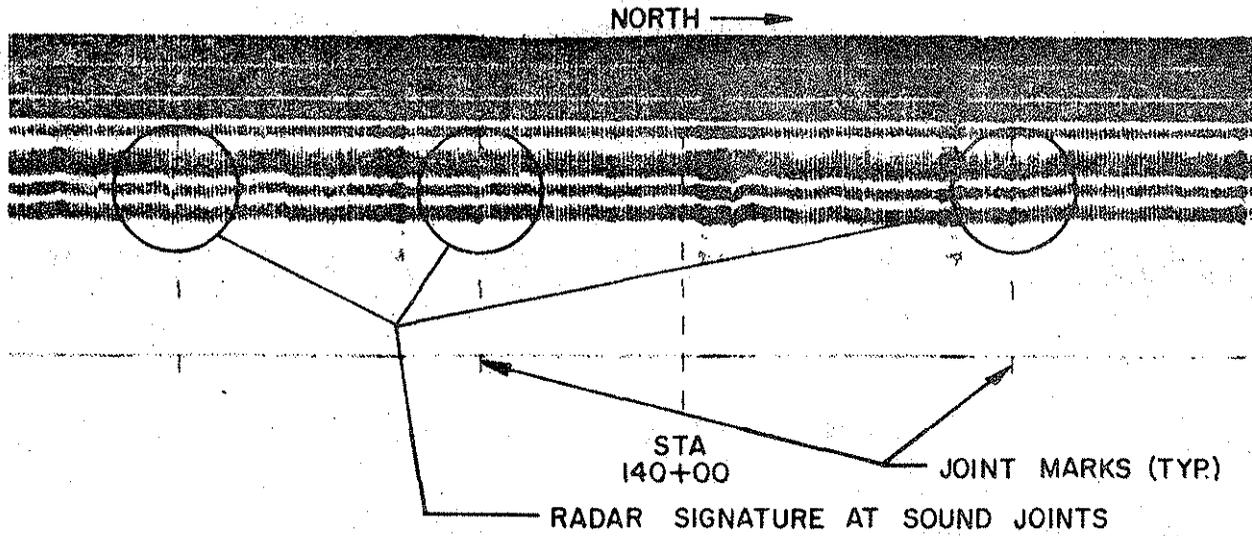
MADISON CO. RD. P-53
 N. BOUND LANE
 9' W. OF E. PAVEMENT EDGE
 NON-REINFORCED CONCRETE

Joints appear sound. Possible minor distress at joints at stations 140+15± and 140+45± on scans taken 2 ft, 4 ft and 6 ft from pavement edge.

Donohue and Associates report noted possible minor distress at the joint at station 140+15. A core was drilled at this joint and some cracking was identified at the bottom of the core which corresponds to the results indicated by the ground penetrating radar.

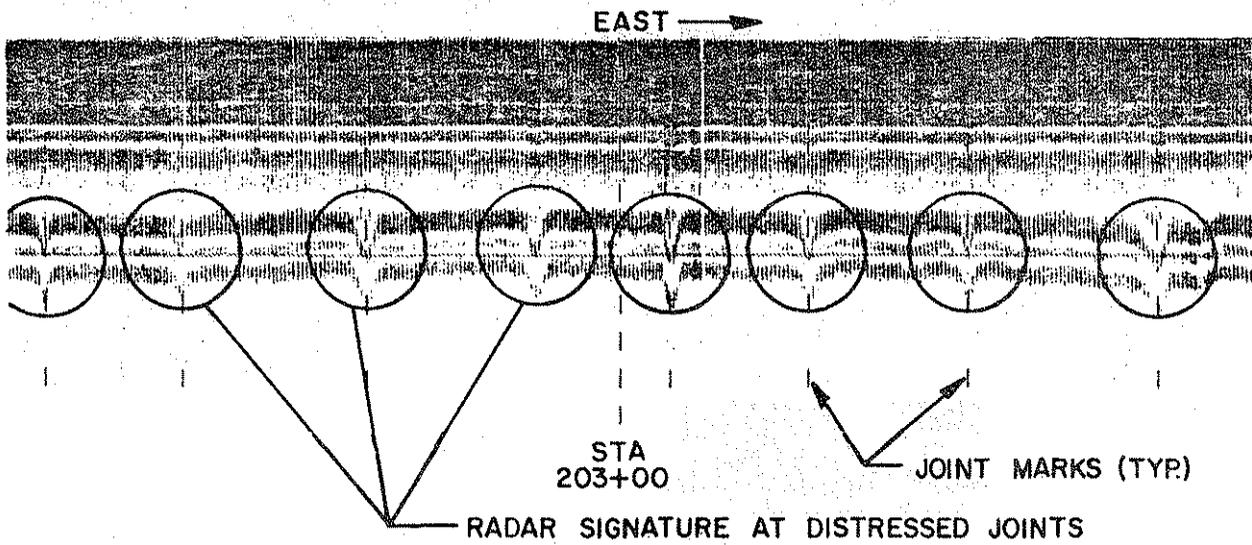
IOWA HIGHWAY 92
 E. BOUND LANE
 6' N. OF S. PAVEMENT EDGE
 NON-REINFORCED CONCRETE

All joints show evidence of pavement distress. Additionally,
scans 2 ft, 4 ft and 6 ft north of pavement edge show distress
from station 203+60 to 203+65 and from 203+76 to 203+85.
