# CONSTRUCTION AND EVALUATION OF SUBMERGED VANES FOR STREAM CONTROL

Research Project No. HR-274

Submitted to  
The Highway Division  
Iowa Department of Transportation  
Ames, Iowa

IIHR Report No. 321  
Iowa Institute of Hydraulic Research  
The University of Iowa  
Iowa City, Iowa 52242  
March 1988

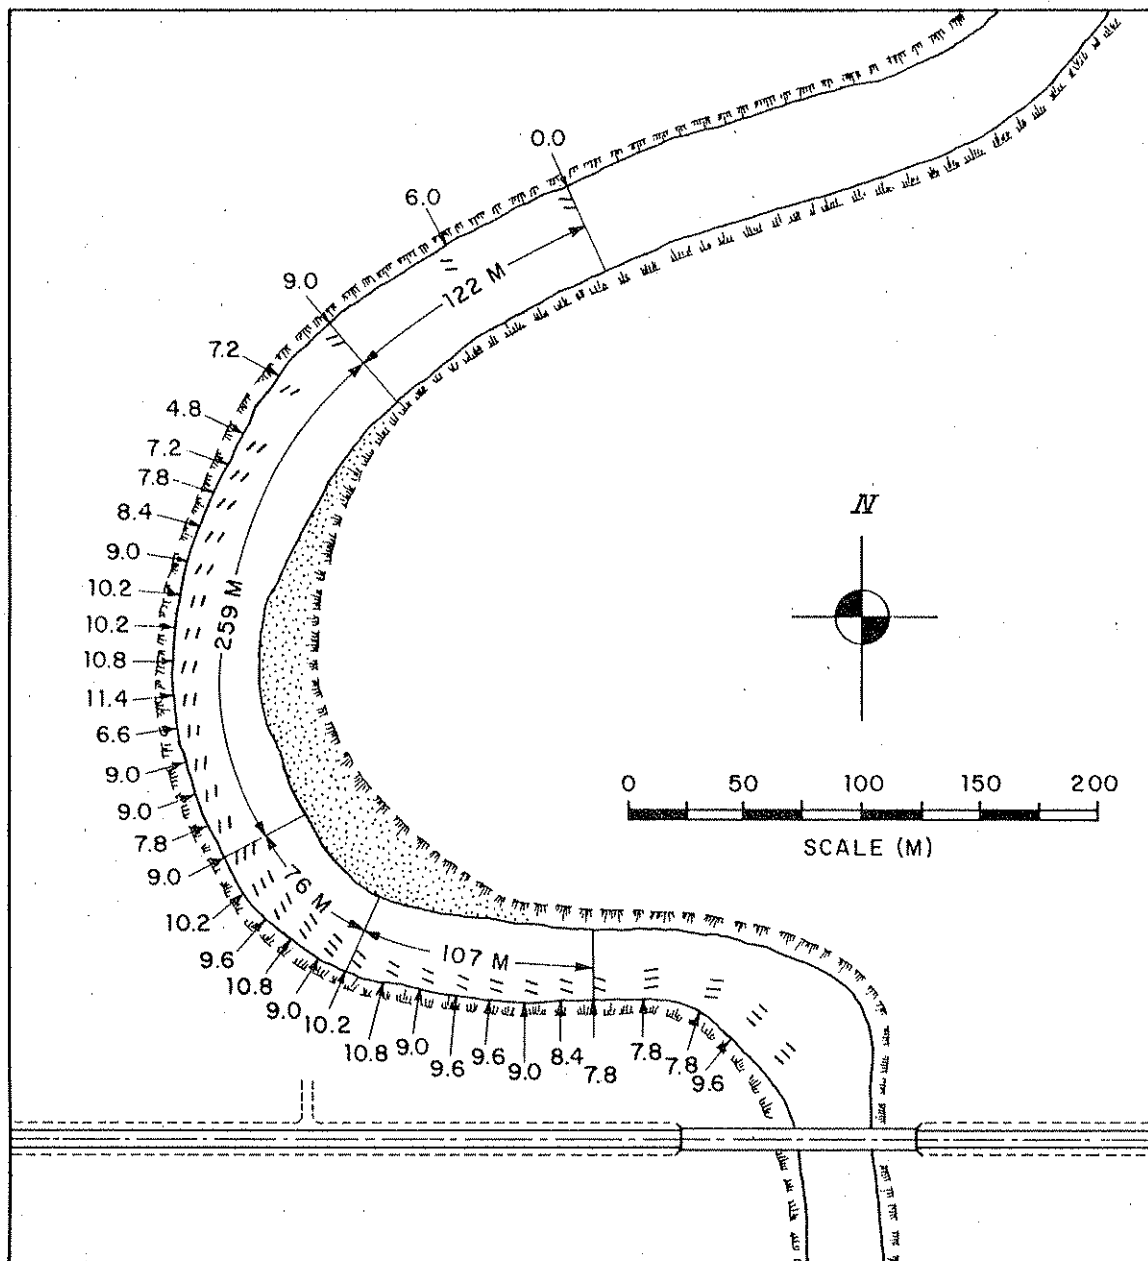
Figure 9. Vane-to-Bank Distances Measured on December 5, 1987 Aerial Photo.  
Discharge =  $7.5 \text{ m}^3/\text{s}$ .

Vane-to-bank distances were measured again on a December 5, 1987 aerial photo. The distances are shown in Figure 9. Discharge was  $7.5 \text{ m}^3/\text{s}$ . The average of the seven vane-to-bank distances along the rock protection is 8.7 m, while the overall average is 8.6 m, suggesting that overall the low-flow vane-to-bank distance is still about the same as in 1985 after construction. However, along a 60 m reach around the middle of the bend, a 1-2 m increase is noted.

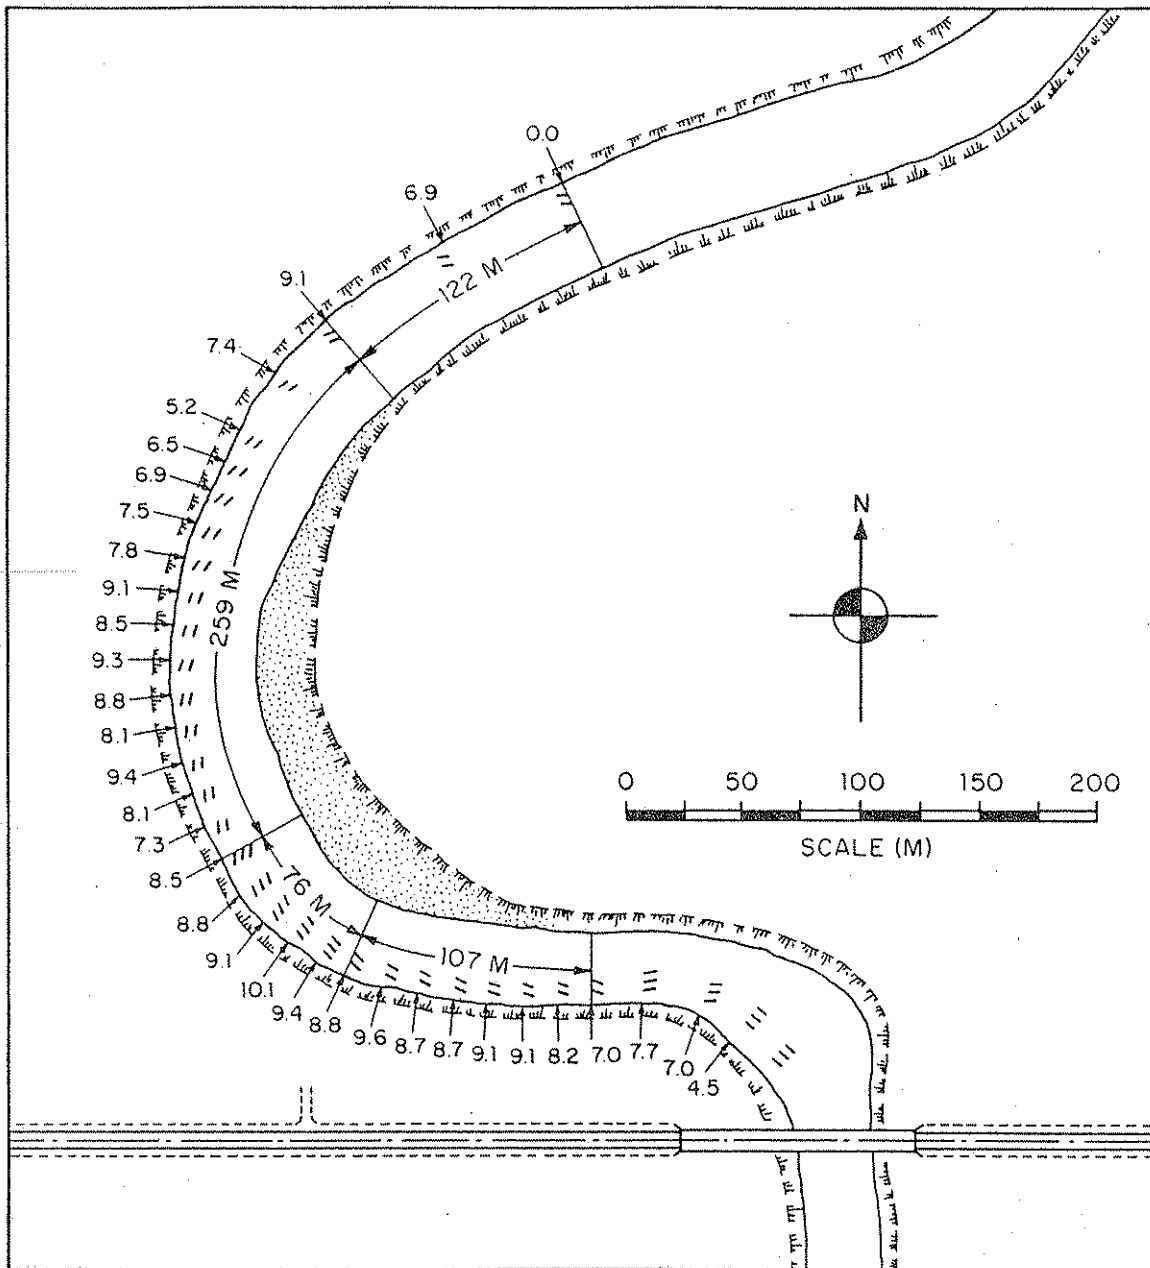
Figure 8. Vane-to-Bank Distances Measured by Iowa Department of Transportation Red Oak District Personnel on August 29, 1986. Discharge =  $10.6 \text{ m}^3/\text{s}$ .

On August 29, 1986, personnel from the Iowa Department of Transportation Red Oak District measured the distance from the outermost upstream pile in each vane array to the edge of the water at the bank. The distance is shown in Figure 8. The average distance was about 7.9 m, or about 1.8 m larger than the design-low flow distance. The difference between the 1986 distances and the design-low flow distance is due mainly to difference in stage. On August 29, 1986, the stage was about 0.5 m higher than the stage during the installation in August of 1985. A good reference is obtained from the data along the highway, where a rock protection is maintaining a stable bankline. The August 86 average of the seven vane-to-bank distances there is 8.4 m or 0.5 m larger than the overall average August 1986 vane-to-bank distance. This suggests that overall, the low-flow vane-to-bank distance did not increase during the one year period from August 1985 to August 1986.

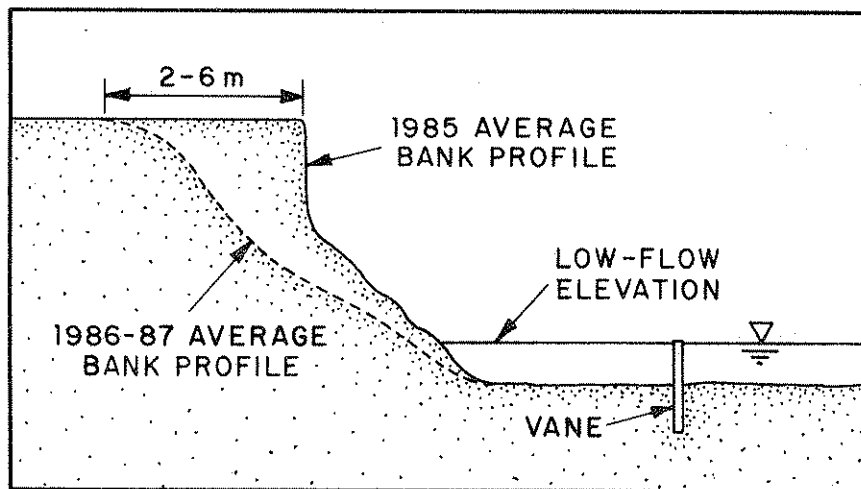
Figure 7. Schematic Comparison of Bank Profiles Before and After Installation of Vanes.

was slowed due to a group of mature trees along this part of the bank. The protrusion caused an acceleration of the near-bank flow at Section 3 resulting in an undesirable increase of near-bank depth and velocity at Section 3, as seen in Figure 5. There is some concern that this may eventually lead to the forming of a channel between the bank there and the vane system. At other sections, the slope of the bank is decreasing in a favorable manner as shown schematically in Figure 7.

No bank erosion occurred between the time of project completion and the time of the first survey. During the May 1986 high flow, the top edge of the bank receded on the average about one meter between Sections 2 and 4. Most of the erosion loss was at Section 3, where, prior to the vane installation, the bank protruded about 6 m into the channel over a length of about 30 m. These erosion losses were expected, as the pre-vane bank was too steep to be stable under undrained conditions. Because of the low percentage of sand and gravel in the bank material it may take several high flows and more erosion before the bank is cut back to a stable slope and a stable, natural toe protection is formed. The 6 m protrusion of the bank into the channel developed just prior to the vane installation when high flows caused the bank to recede about 6 m on either side of the protrusion. The erosion of the protruding bank section

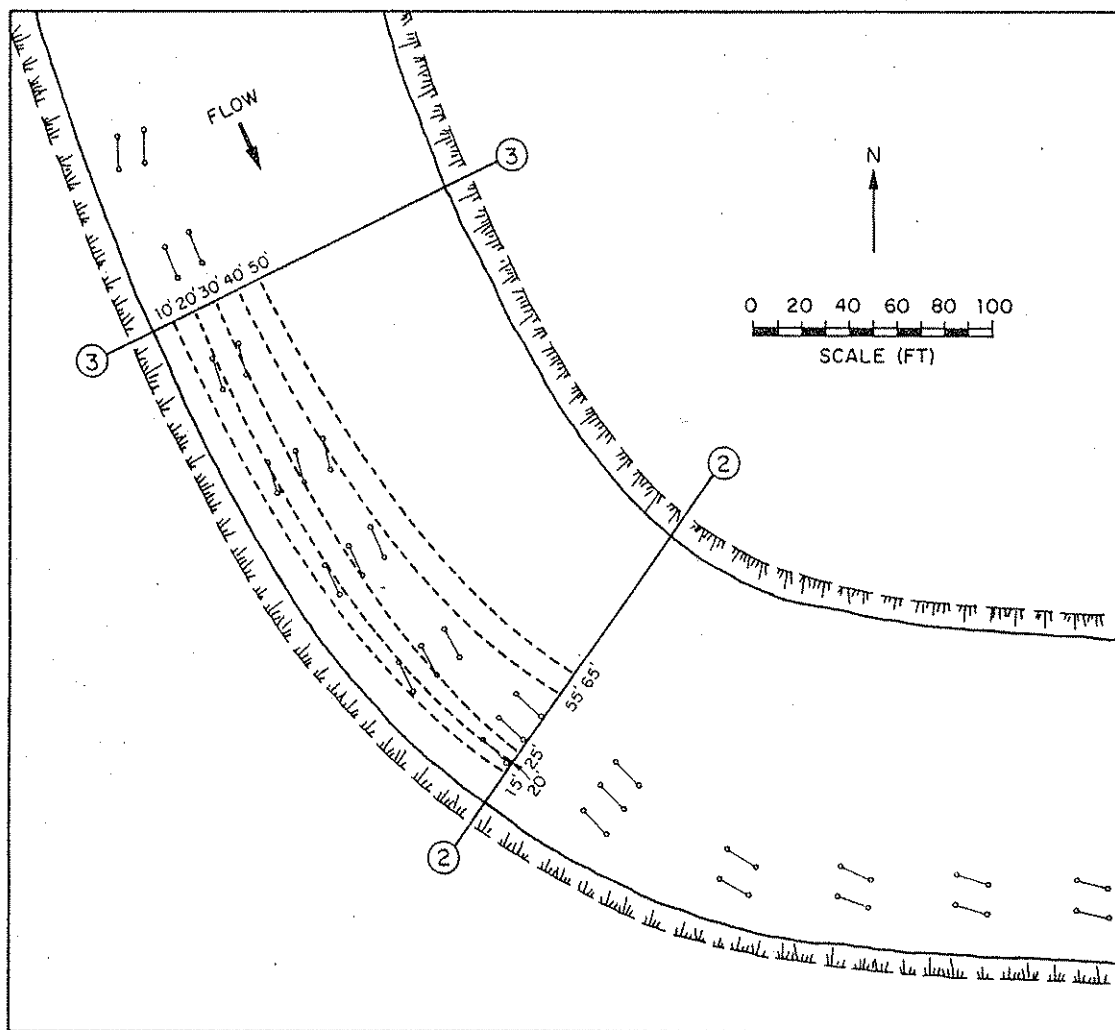
Figure 6. Average Paths of Surface Floats Measured in the May 12-13, 1986 Survey.

In order to directly test the vanes efficiency in eliminating the secondary-flow component, float studies were performed. Plastic balls were released at certain distances from the outer bank in Sections 3 and 4 and were followed photographically as they moved downstream through the bend. Their lateral position was recorded as they passed a downstream section. It was found that the floats generally moved away from the bank. Figure 6 shows results from the May 12-13 survey in which 500 floats were tracked between Sections 3 and 2. On the average, the floats followed the paths shown dotted in Figure 6, which indicates that the average deflection angle (toward the bank) was less than zero. In other words, there was no secondary-flow component. Without vanes, the deflection angle would have been greater than 10 degrees toward the bank.

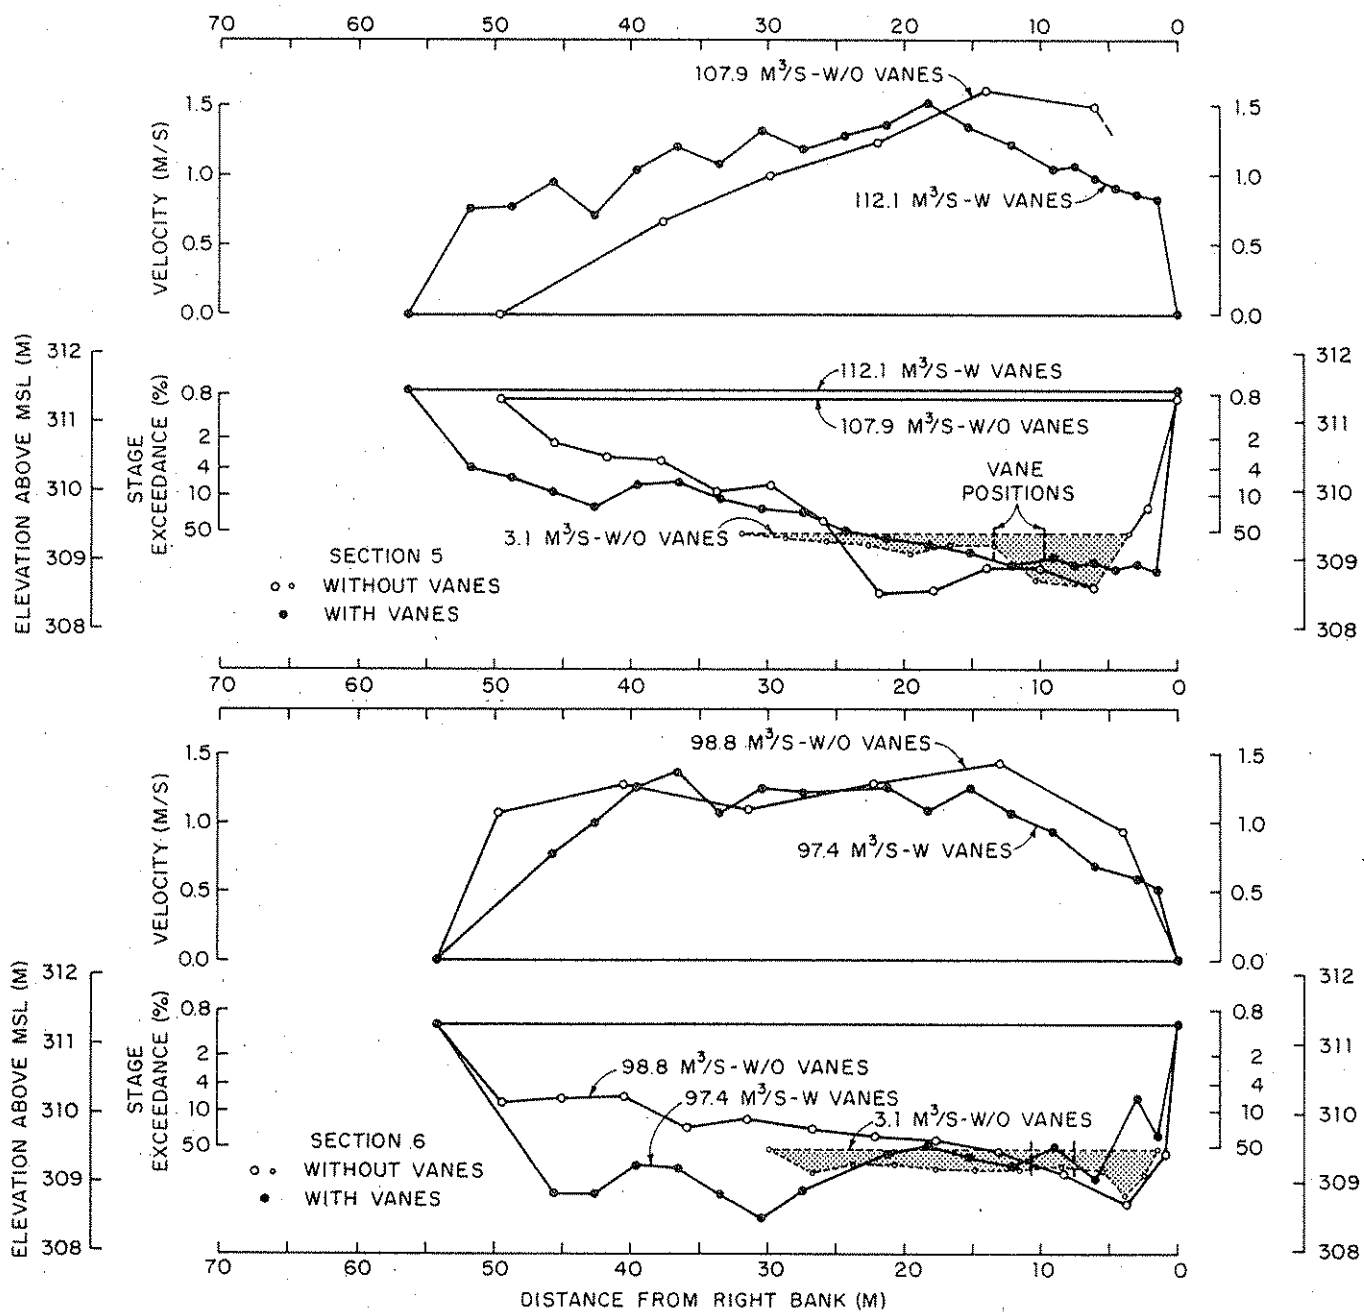
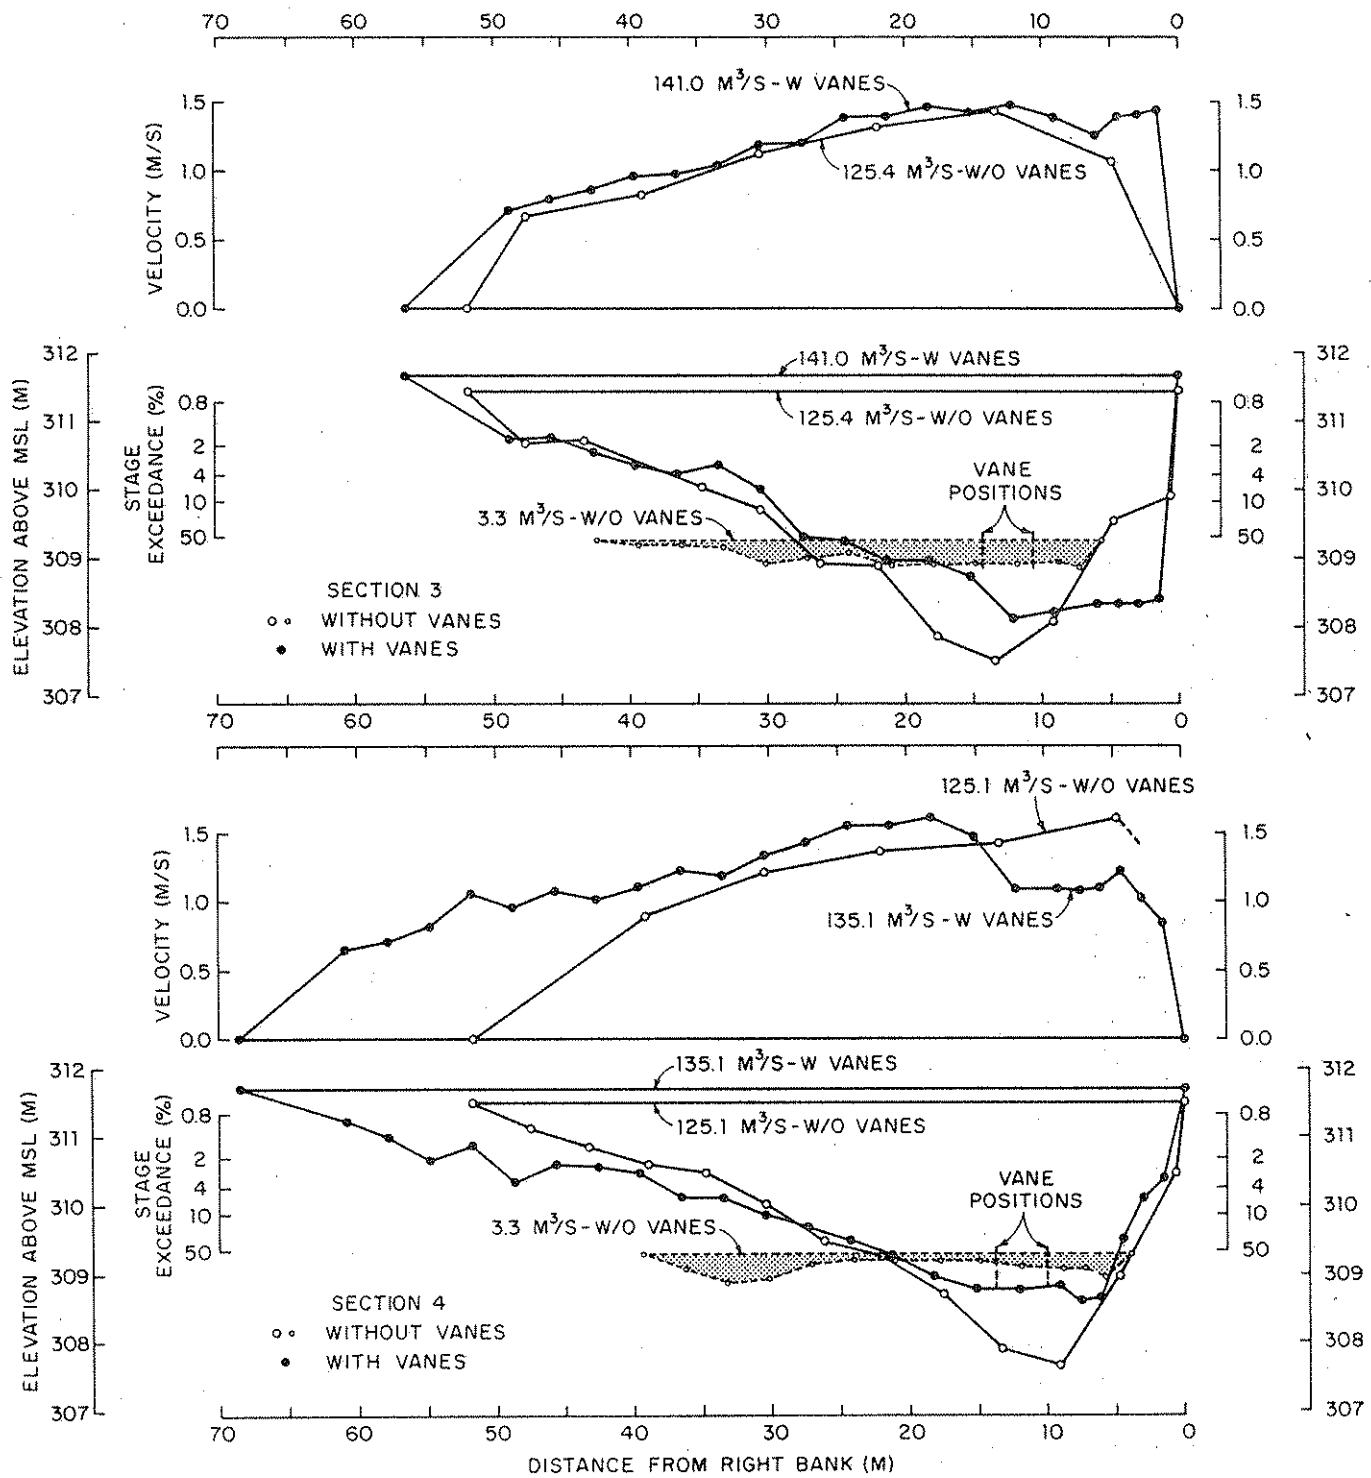
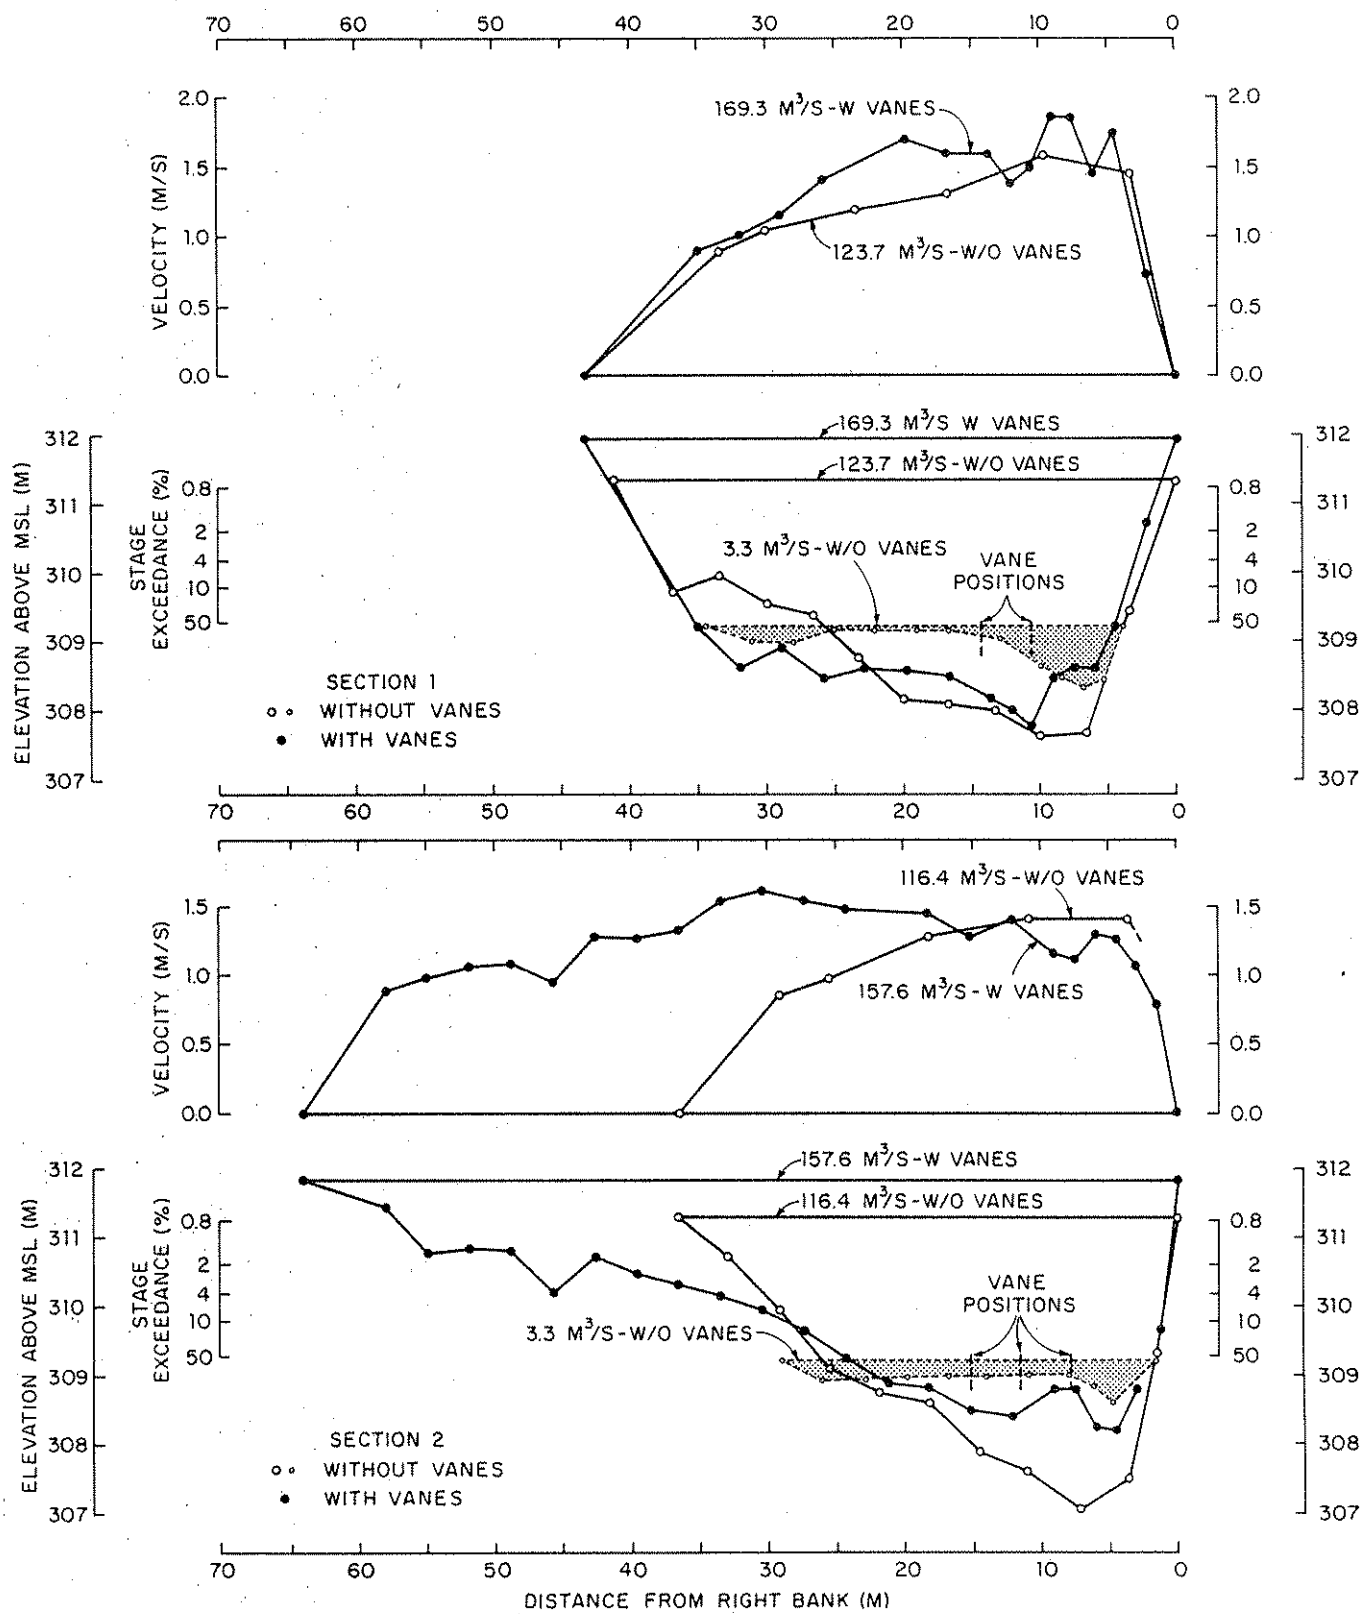
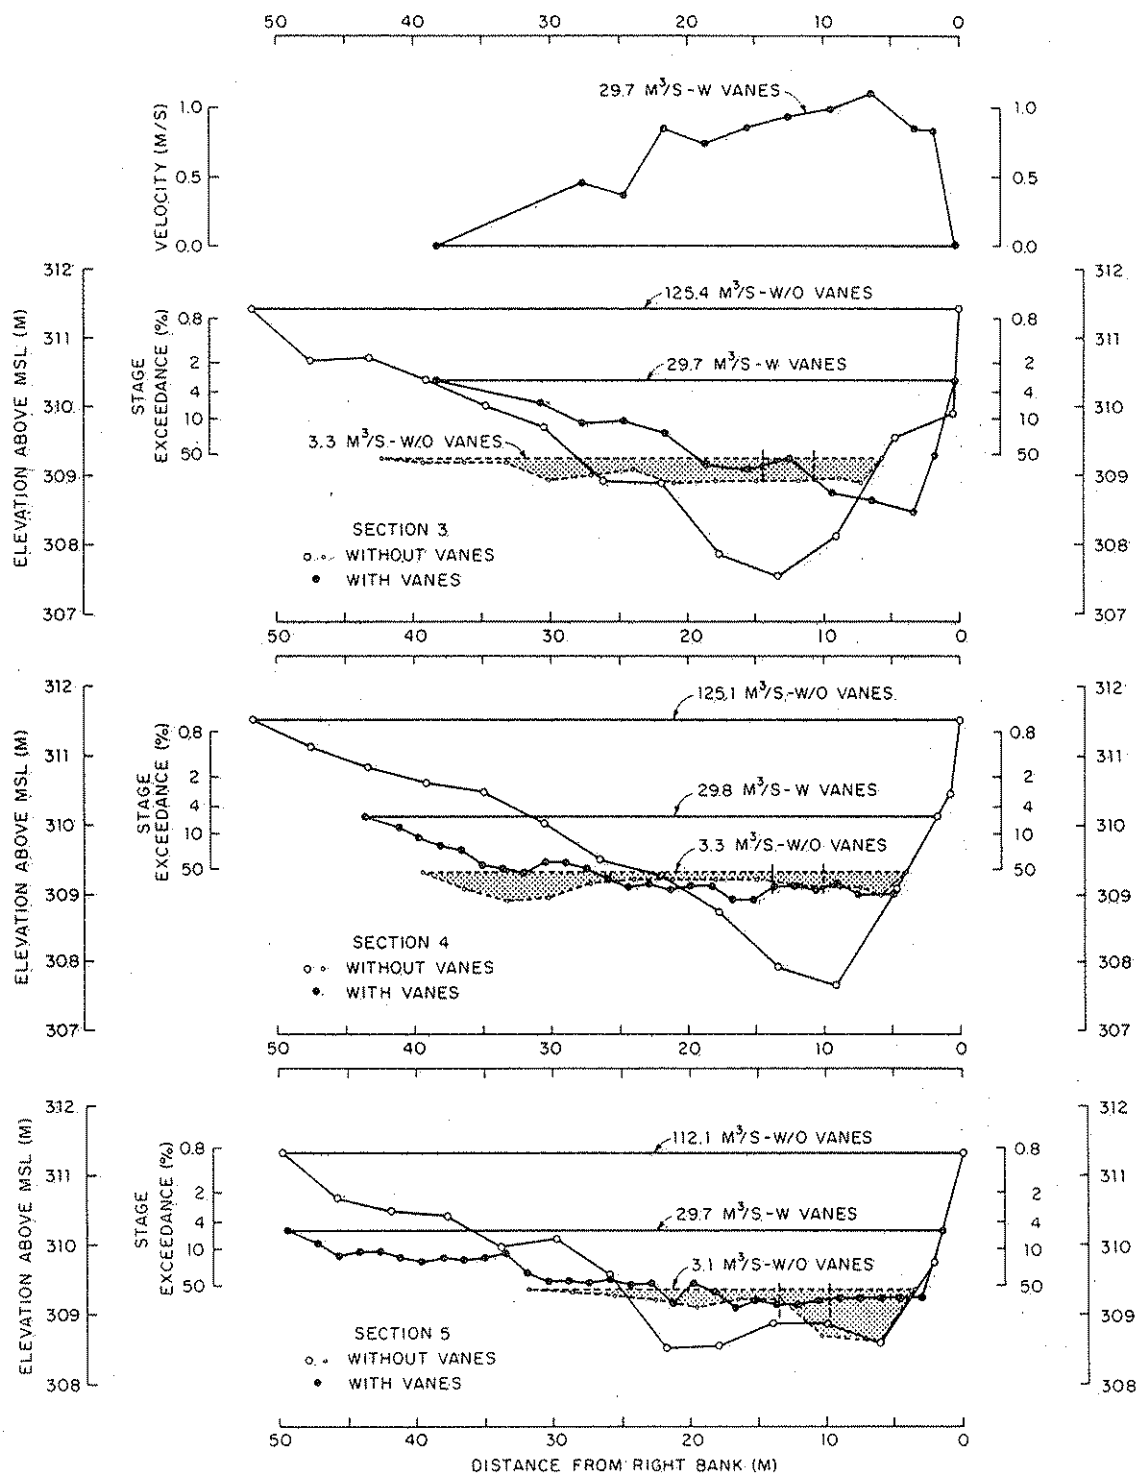
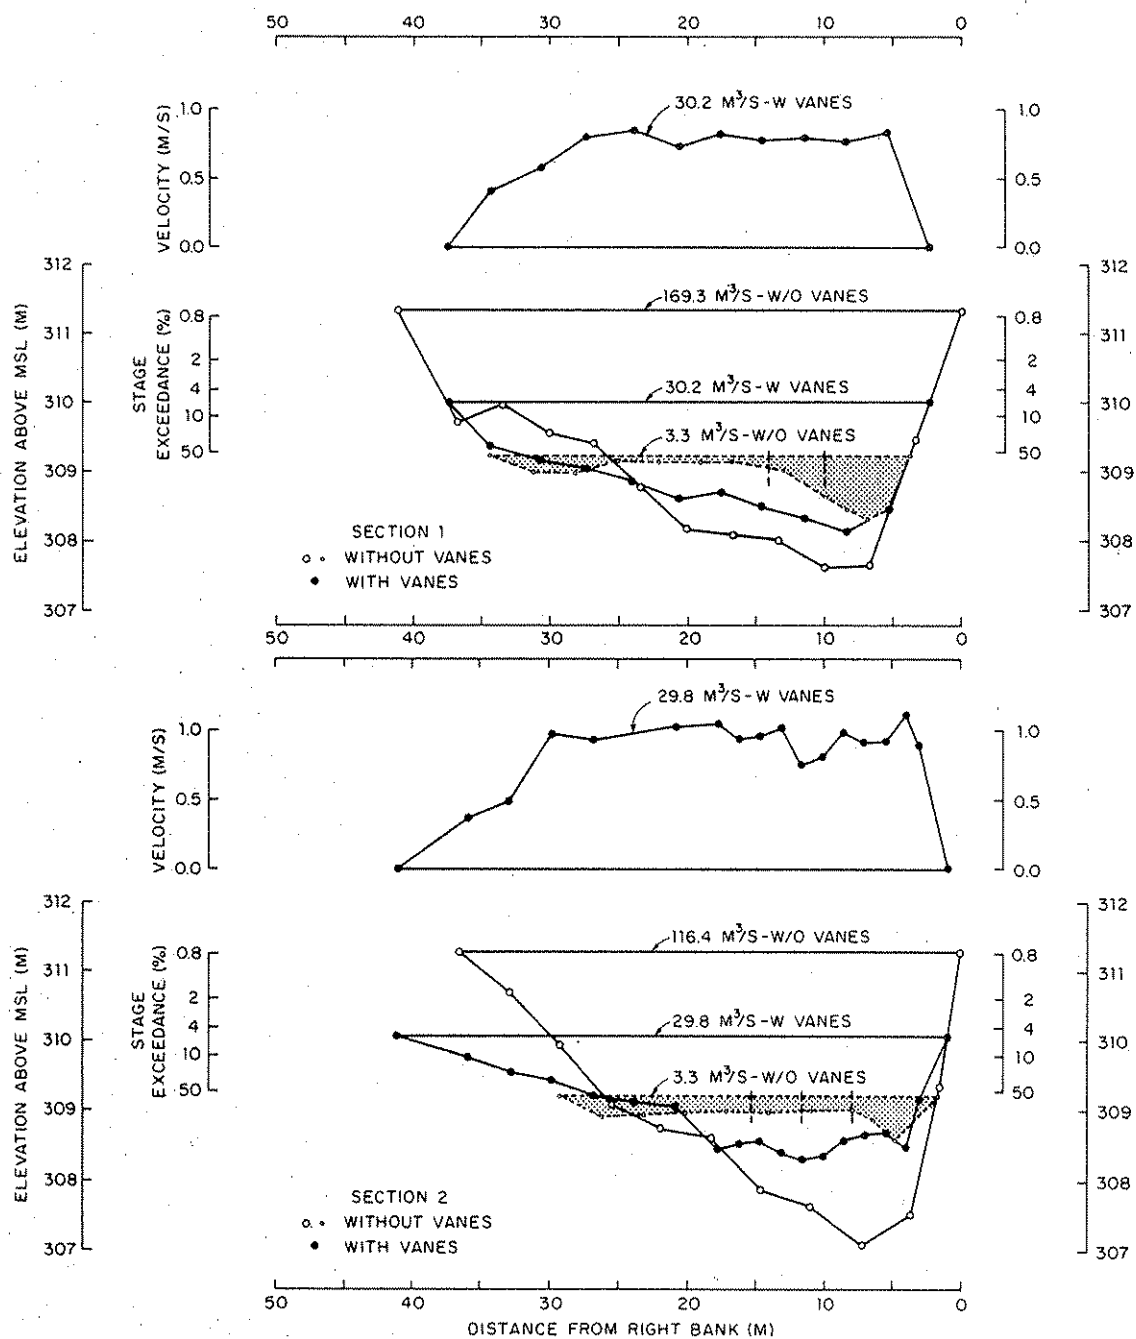
Figure 5. Sections Measured before and after Installation of Vanes.

Figure 5 shows the measured cross sections. The pre-vane cross sections are superimposed for comparison (the pre-vane low-flow cross section is shown dotted).

The vanes are seen to have produced a substantial reduction of the transverse slope of the bed. For example, at Section 2 the transverse slope of the bed with vanes was 0.062 at a near-bankfull discharge of  $157.6 \text{ m}^3/\text{s}$ , whereas the pre-vane transverse bed slope was more than twice as big (0.14) at a 26 percent lower discharge. Along the outer bank the vanes were generally able to maintain the bed at its low-flow elevation and prevent the near-bank scour typical of the pre-vane cross section. Instead of scouring along the outer bank, the flow at most sections widened its channel by removing sand from the inside point bar. For the same discharge there is seen to have been little difference in the average depth in the channel with and without vanes.

As seen in Figure 5, there was also a notable improvement in most of velocity distributions, which, of course, corresponds with the reduction of
