Pipe Rehabilitation with Polyethylene Pipe Liners

Final Report
Iowa Highway Research Board
Project HR-370

April 2003

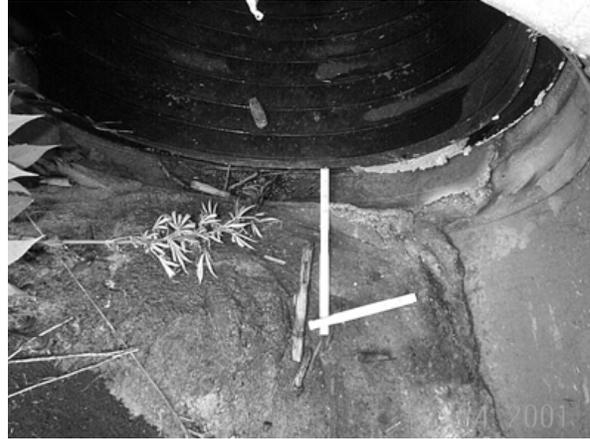
Figure 8
Close-up of north end showing liner movement.

After seven years of service the culvert is performing well. The liner has shifted about 60 mm to the south as shown in Figure 8, but neither that nor the higher elevation of the center seems to be causing any problems with performance. The joints appear tight and there is no sign of leakage.

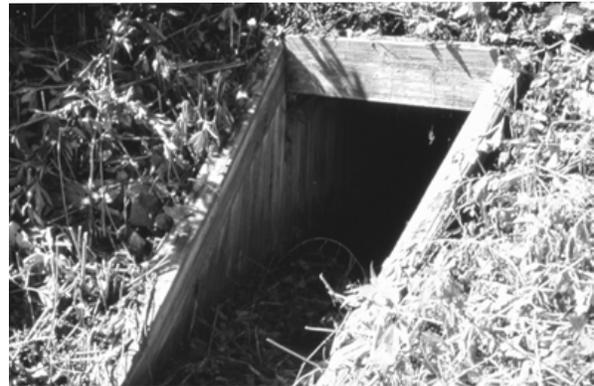
Figure 9
North end of original culvert.

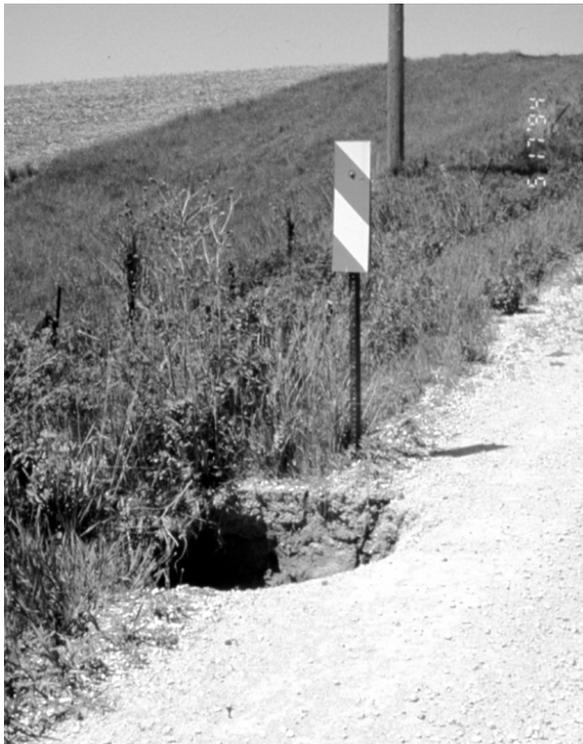
Figure 11
Section of roadway that was subsiding into the old culvert.

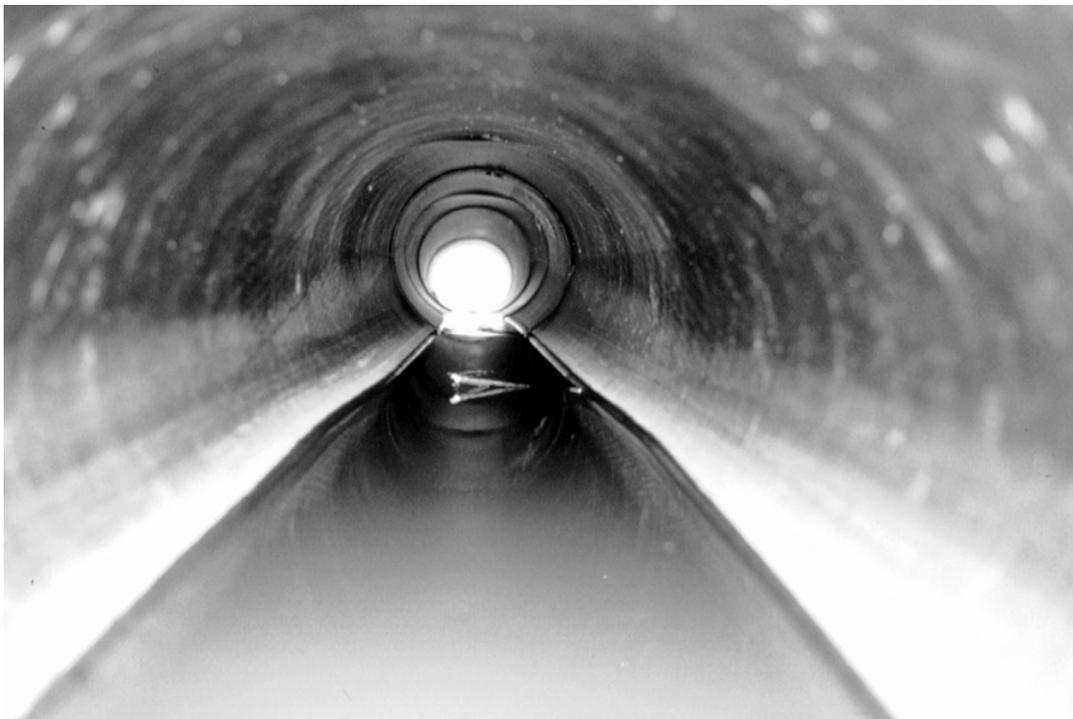
Figure 21
View of the inside of the lined culvert several years after construction. Note the indentations in the top of the liner from the grouting pressure.

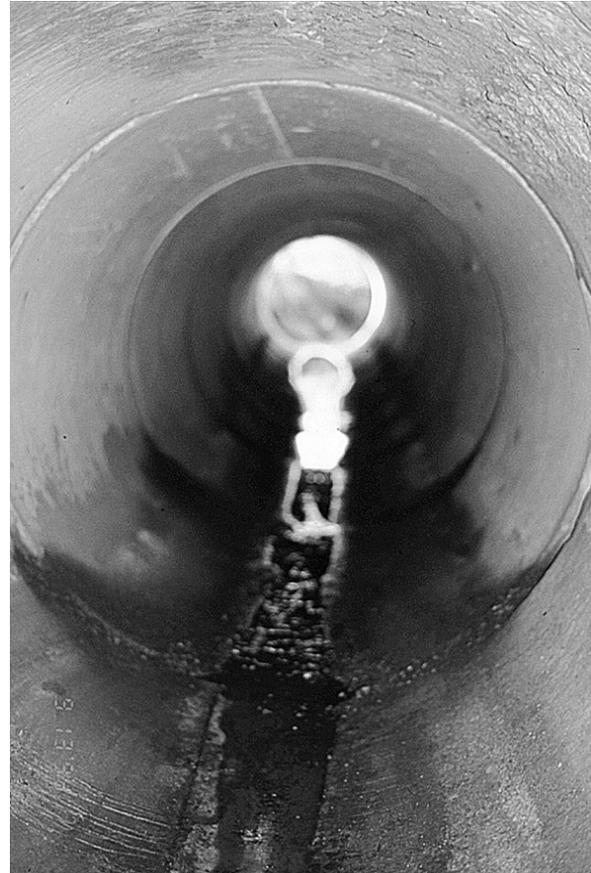
Figure 24

Photograph of original culvert showing deterioration and joint separation.

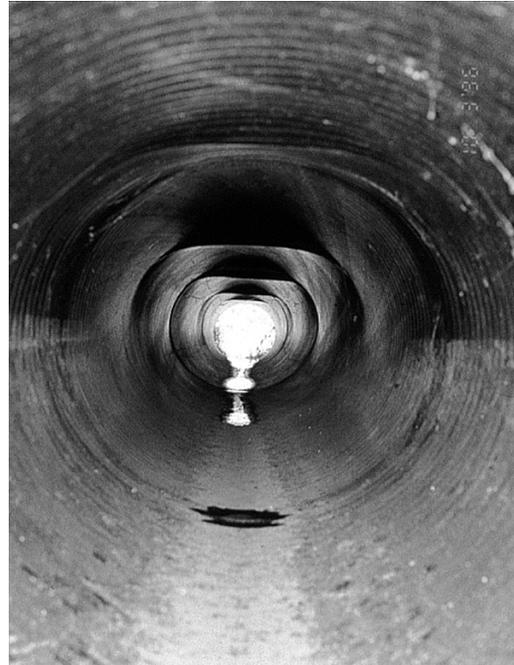
Grouting took place the following day. The Culvert Renew™ liner experienced deformation during the grouting procedure. This deformation was a maximum of 100 mm at the bracing points tapering off for 3 m to

Figure 32
Installed Culvert-Renew™ liner as it looked in 1996. Not deformations in the roof.

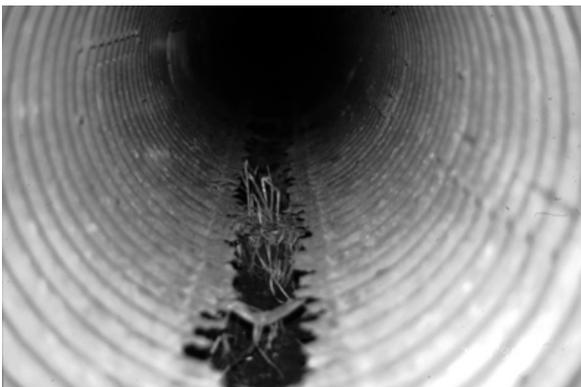
Figure 33
Bottom of original culvert.

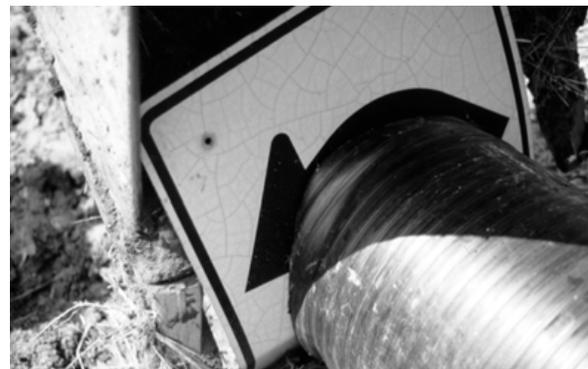
Figure 37
An old road sign was used to protect the end of the liner during insertion. Note that there is still some deformation.

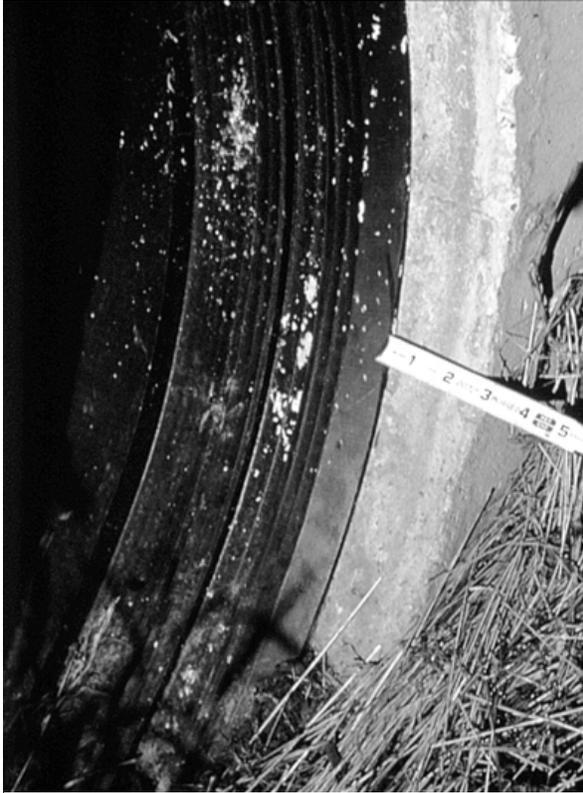
Figure 58
 Movement of the liner with respect to the headwall on the north side.

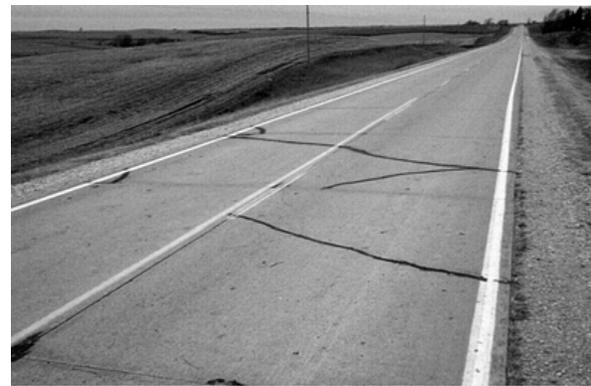
Figure 60
 Cracking that appeared above the culvert. These cracks were not observed in the previous inspection (2001).

Of greater concern is that the fill above the culvert appears to have settled in the intervening years causing cracks in the overlying road. This could indicate additional loss of material in the unlined portion of the culvert.

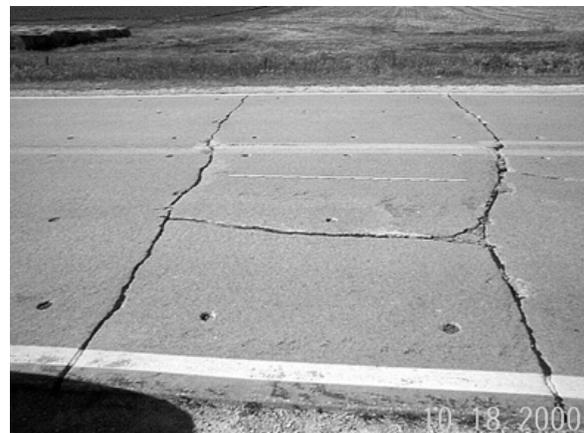
Figure 65
Pavement over culvert showing settlement cracking and mud-jacking holes.

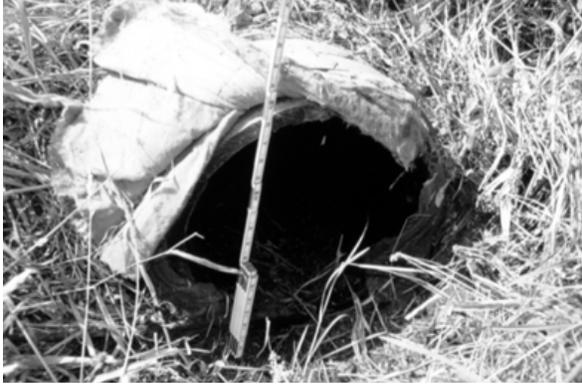
Figure 70

Inlet end of lined culvert after several years. The fabric has come loose and tends to interfere with water flow (it was moved out of the way for this photograph).

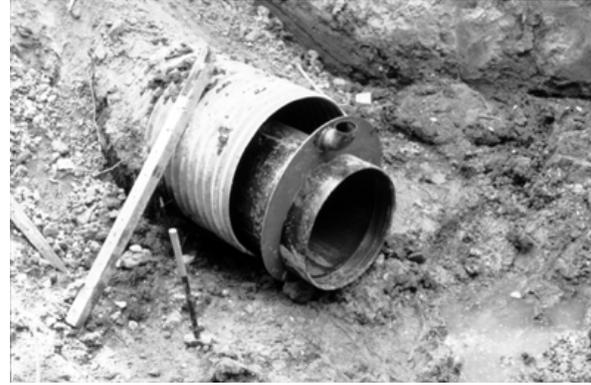
Figure 83
After the problem shown in the last photograph, it was impossible to pump more grout into the outlet end. The remaining mortar was pumped into the inlet end of the lined culvert.

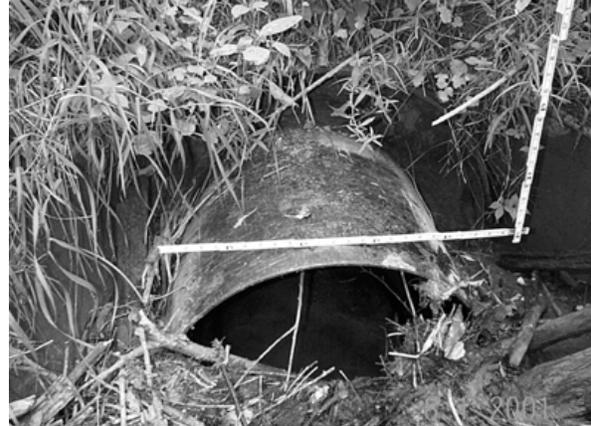
Figure 85
The inlet to the lined culvert, also at about six years. It was mostly covered and clogged with debris (some of which was removed for this photograph).
