USE OF LONGITUDINAL SUBDRAINS IN THE 3R PROGRAM

**FINAL REPORT
Project HR-509**

**Highway Division
December 1981**

BY
VERNON J. MARKS
RESEARCH ENGINEER
515/239-1447

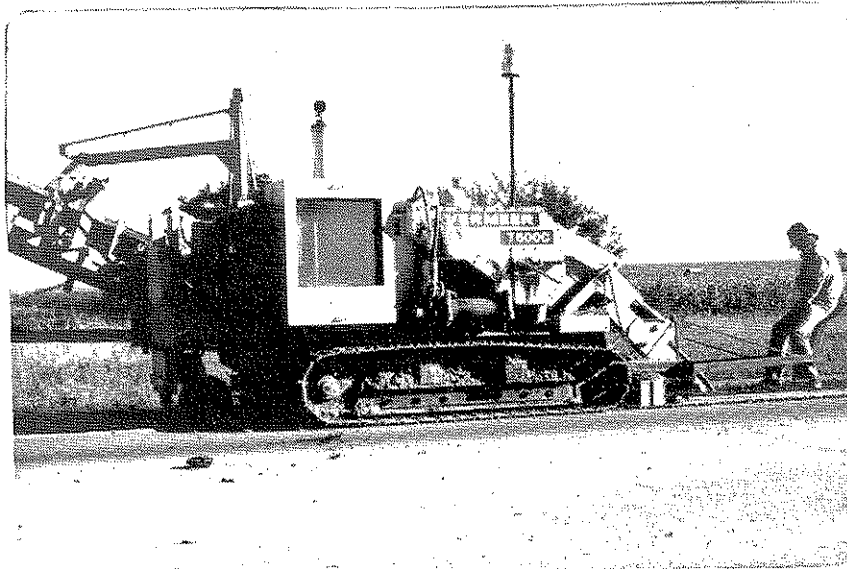
Figure 1: Vermeer T-600C Trencher

The first operation utilized a Vermeer T-600C (Figure 1) trencher to cut the one foot wide, 2 foot deep trench. Initially, this trencher was equipped with a disc cutter wheel (Figure 2) to aid in maintaining proper alignment. Later, this was of questionable benefit. The trencher cut very neat side walls and alleviated some initial concern that chunks might be torn from the asphalt concrete shoulder surfacing. It was, however, relatively severe to the trencher's cutting teeth.

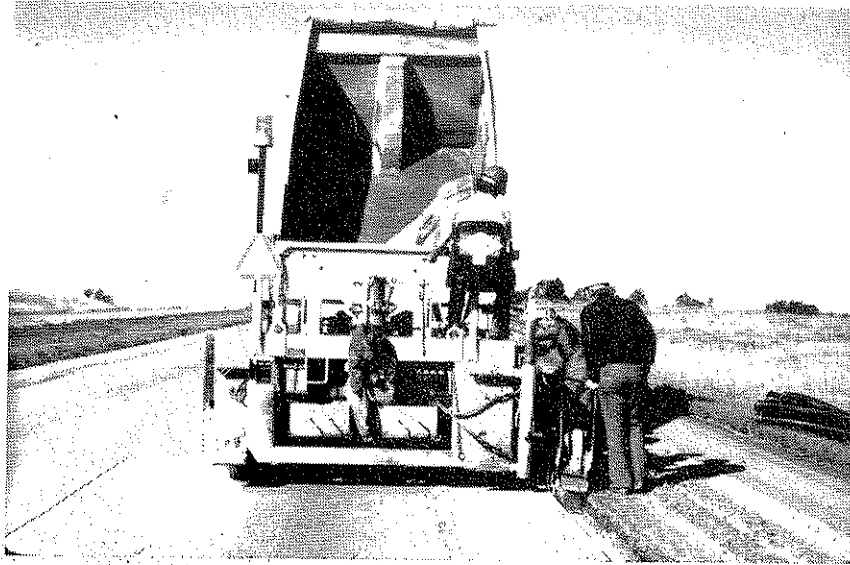
Figure 5: Blawnox RW-38 Placing Porous Backfill

The next operation in the train was the proper placement of the porous backfill material using a Blawknex RW-38 road widener (Figure 5) with a special box attachment. This operation caused the most problems and required special attention. With proper modifications, the tubing was threaded through a guide in the special attachment and the 3" bedding beneath the pipe was achieved. A vibrating pan unit (Figure 6) was attached to the special box for compaction of the porous backfill.

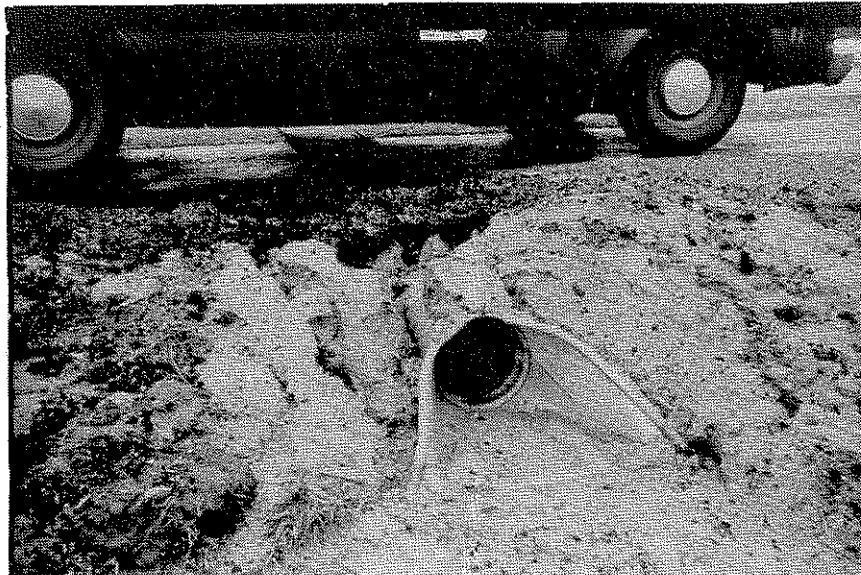
Figure 11: Erosion Around the RF-22 Outlet

Construction was not completed during 1978. Another problem was recognized in the early spring of 1979. The RF-22 outlets froze shut during the winter period. Early spring flow from the subdrains eroded the earth fill around the RF-22 outlet (Figure 11). This problem was solved by carrying the porous backfill the total length of the RF-22 outlet.

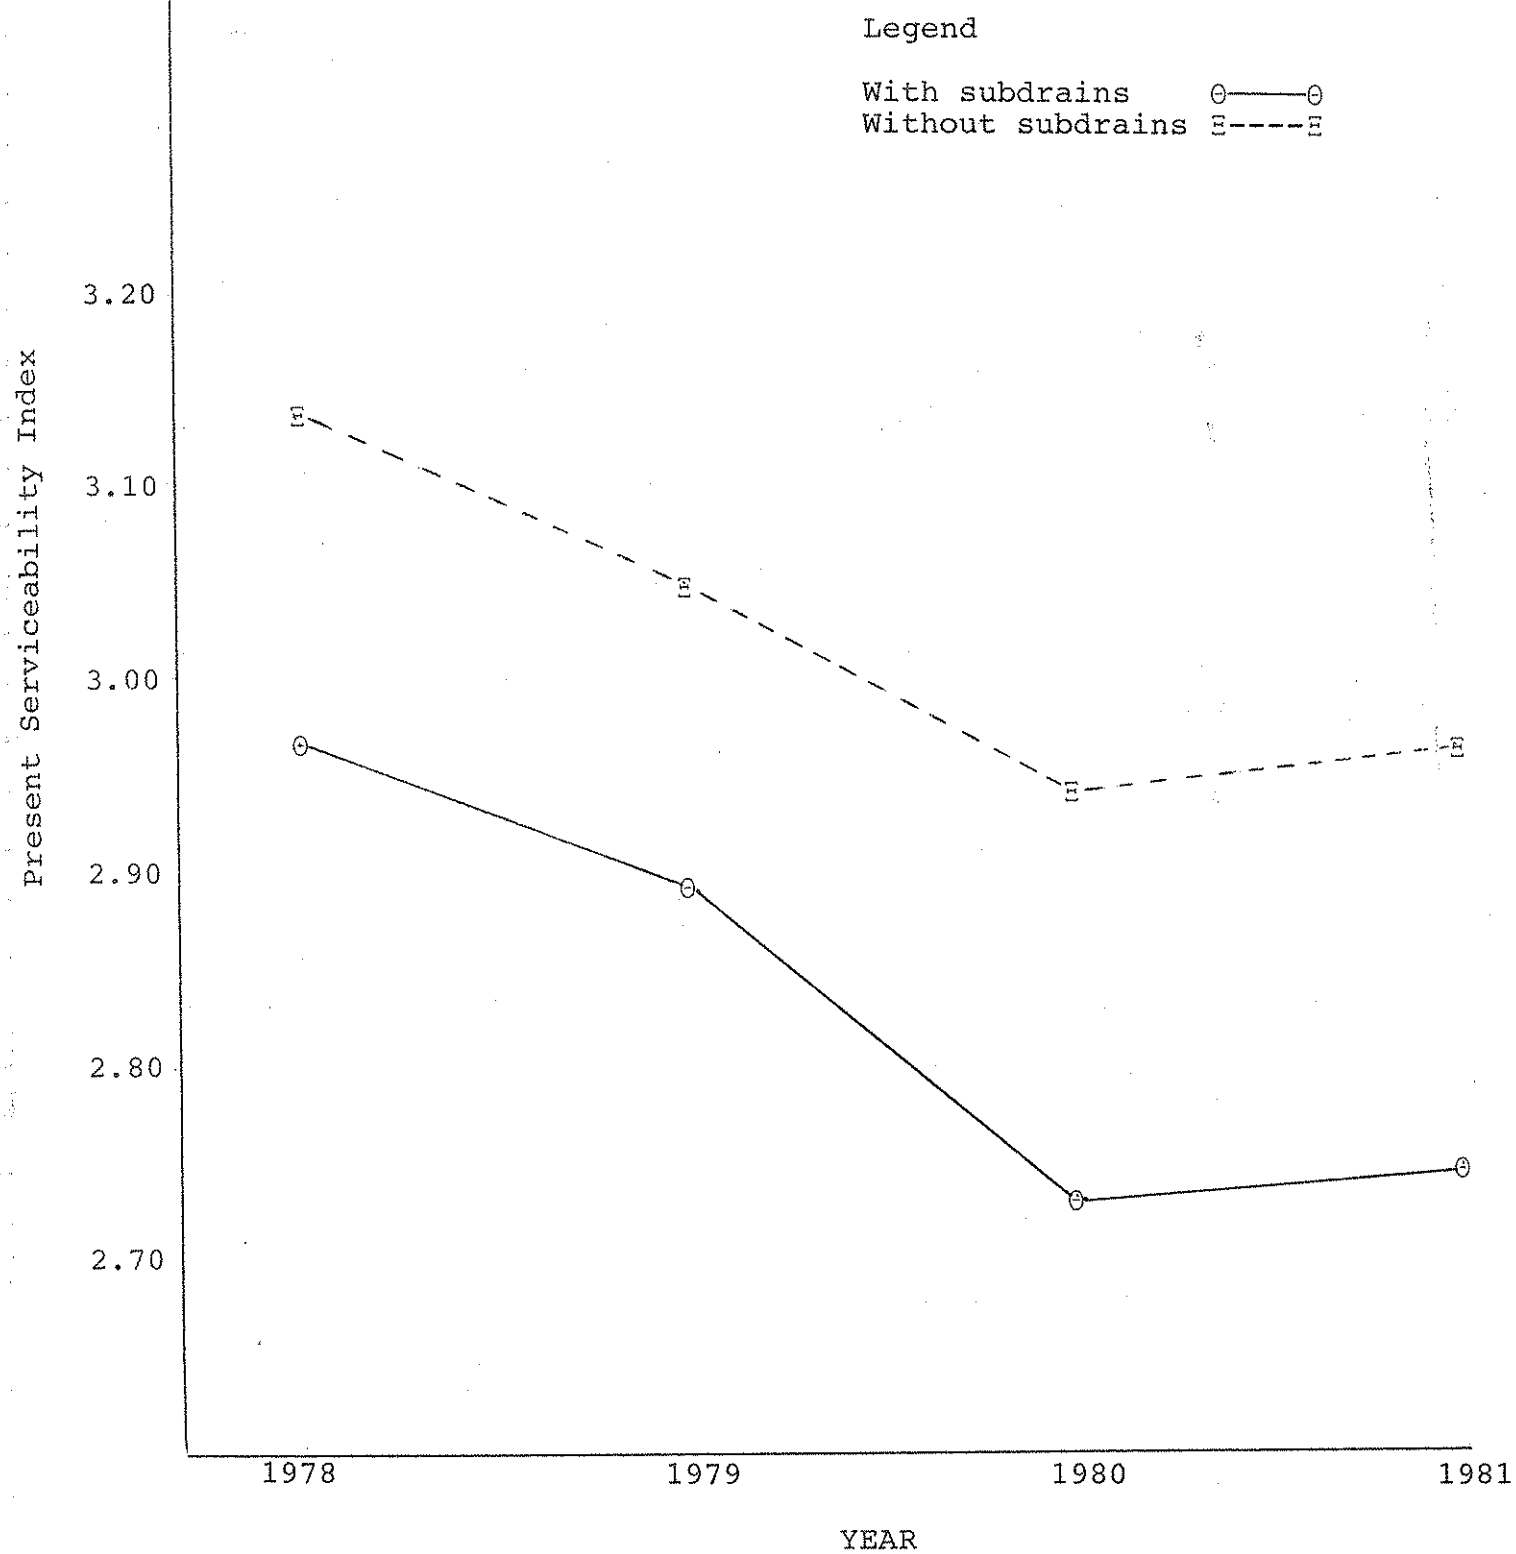
Figure 12 PAVEMENT DETERIORATION

The graphical plot of PSI in figure 12 indicates no significant change in the rate of pavement deterioration when compared to an adjacent section of pavement without longitudinal subdrain installation.

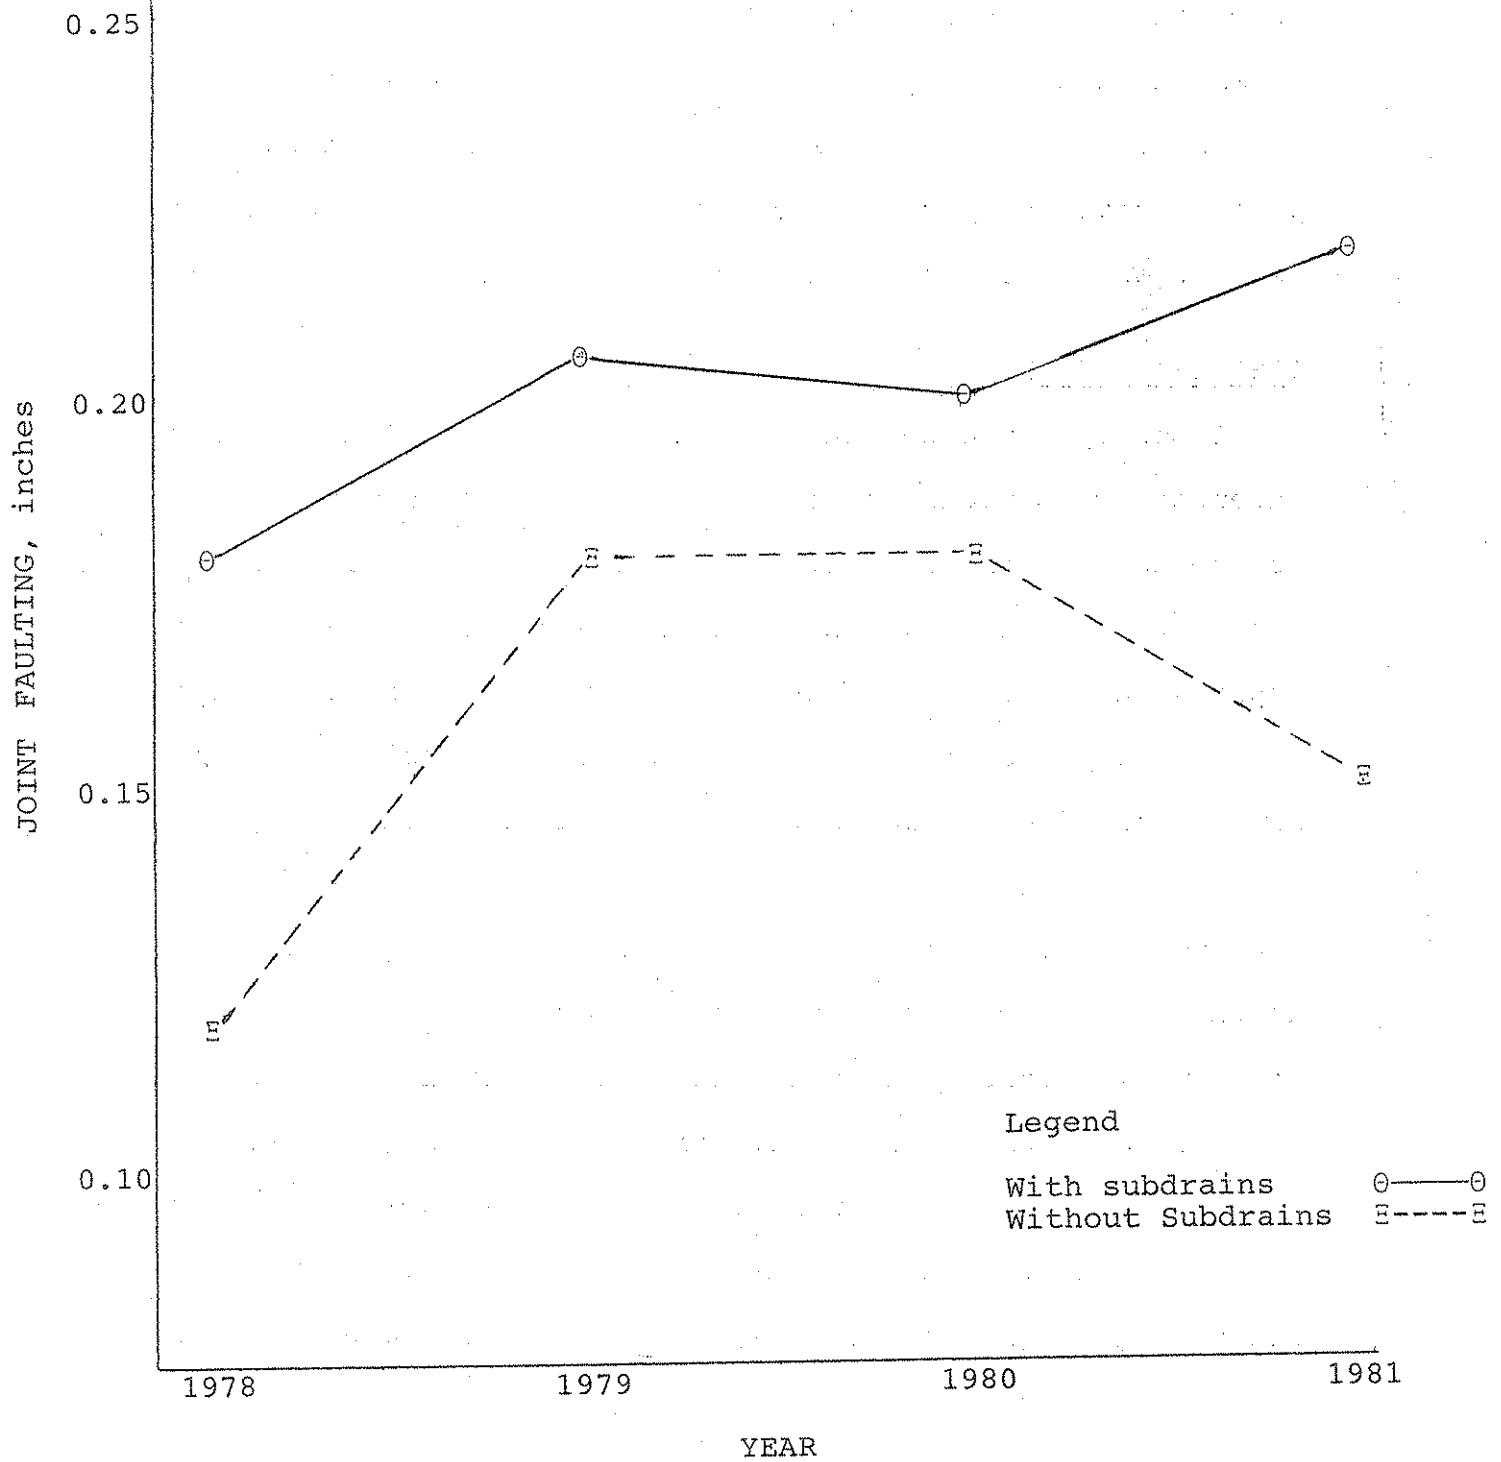
Figure 13 FAULTING SURVEY

Again, a graphical plot (Figure 13) does not indicate significant difference between the pavement within the subdrain project and the adjacent pavement without subdrains. The data seem to be quite variable which could be due to weather or temperature variations.
