HR-513

IOWA DEPARTMENT OF TRANSPORTATION

SUBJECT: I-80 EB Pottawattamie County Bonded Overlay Study

Work Plan to Evaluate 3" PCC Bonded Overlay
on I-80 EB in Pottawattamie County
From MP 35.15 to MP 39.23

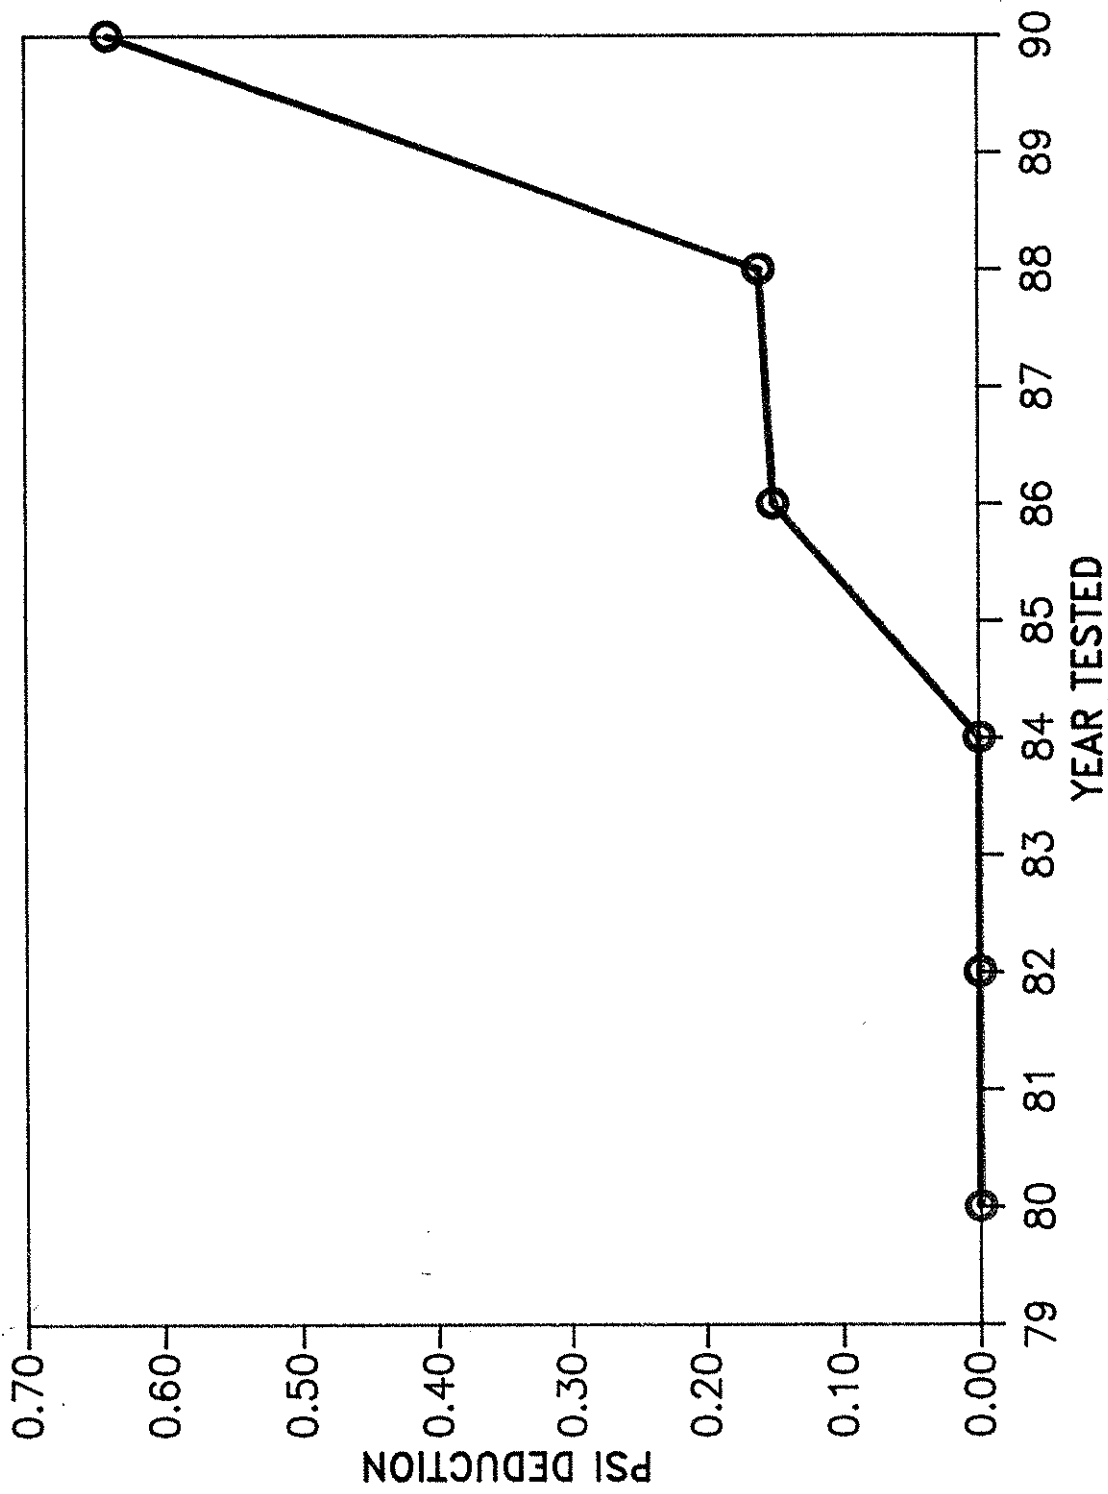
FIGURE 1
PSI DEDUCTION VS. YEAR TESTED

There was a dramatic increase in cracking, patching and PSI DED between 1987 and 1989 which led to pavement reconstruction.

Pavement distress trends are shown for PSI Deduction, Patched Area and Percent of Project Patched in Figures 1, 2 and 3, respectively.

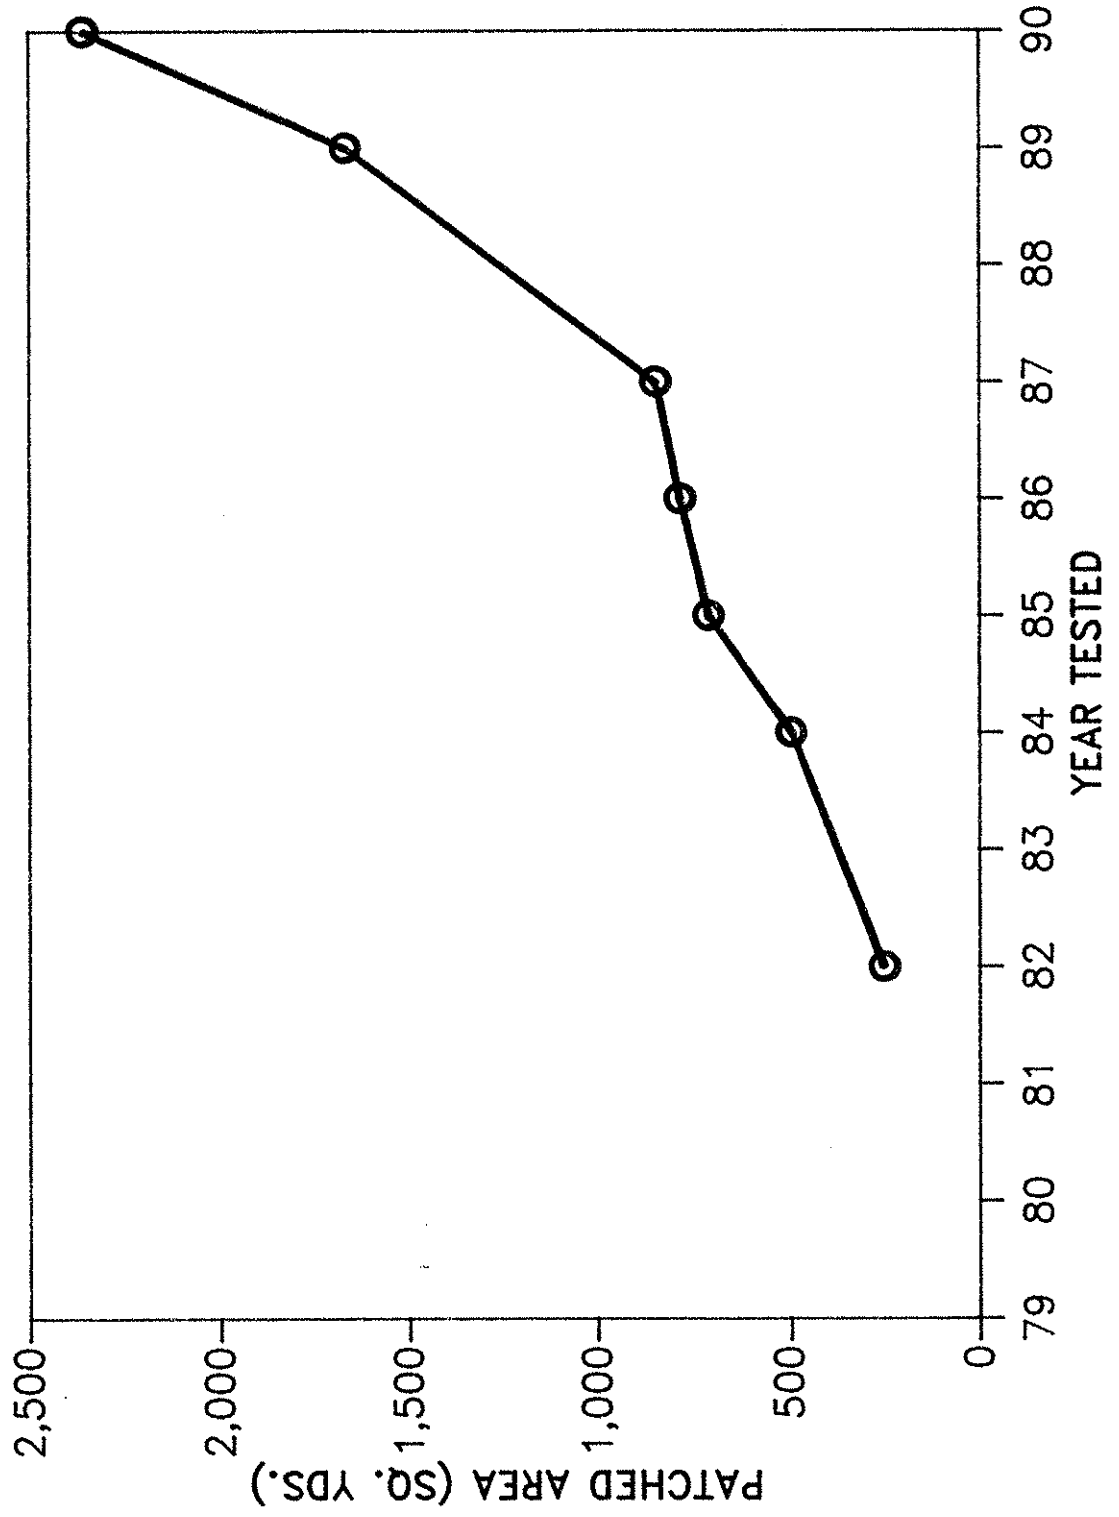
FIGURE 2
PATCHED AREA (SQ. YDS.) VS. YEAR TESTED

Dick Smith of the Materials Research Section also conducted patching surveys on the entire project length as shown in Table 4. Here again, there was a large increase in the amount and percent of patching between 1987 and 1989, and also between 1989 and 1990.
