FINAL REPORT
EVALUATION OF BOND RETAINAGE
IN
PORTLAND CEMENT
CONCRETE OVERLAYS
USING
INFRARED THERMOGRAPHY
AND
GROUND PENETRATING RADAR

PROJECT NO. 50389
COPYRIGHT, DONOHUE 1989

January 30, 1989

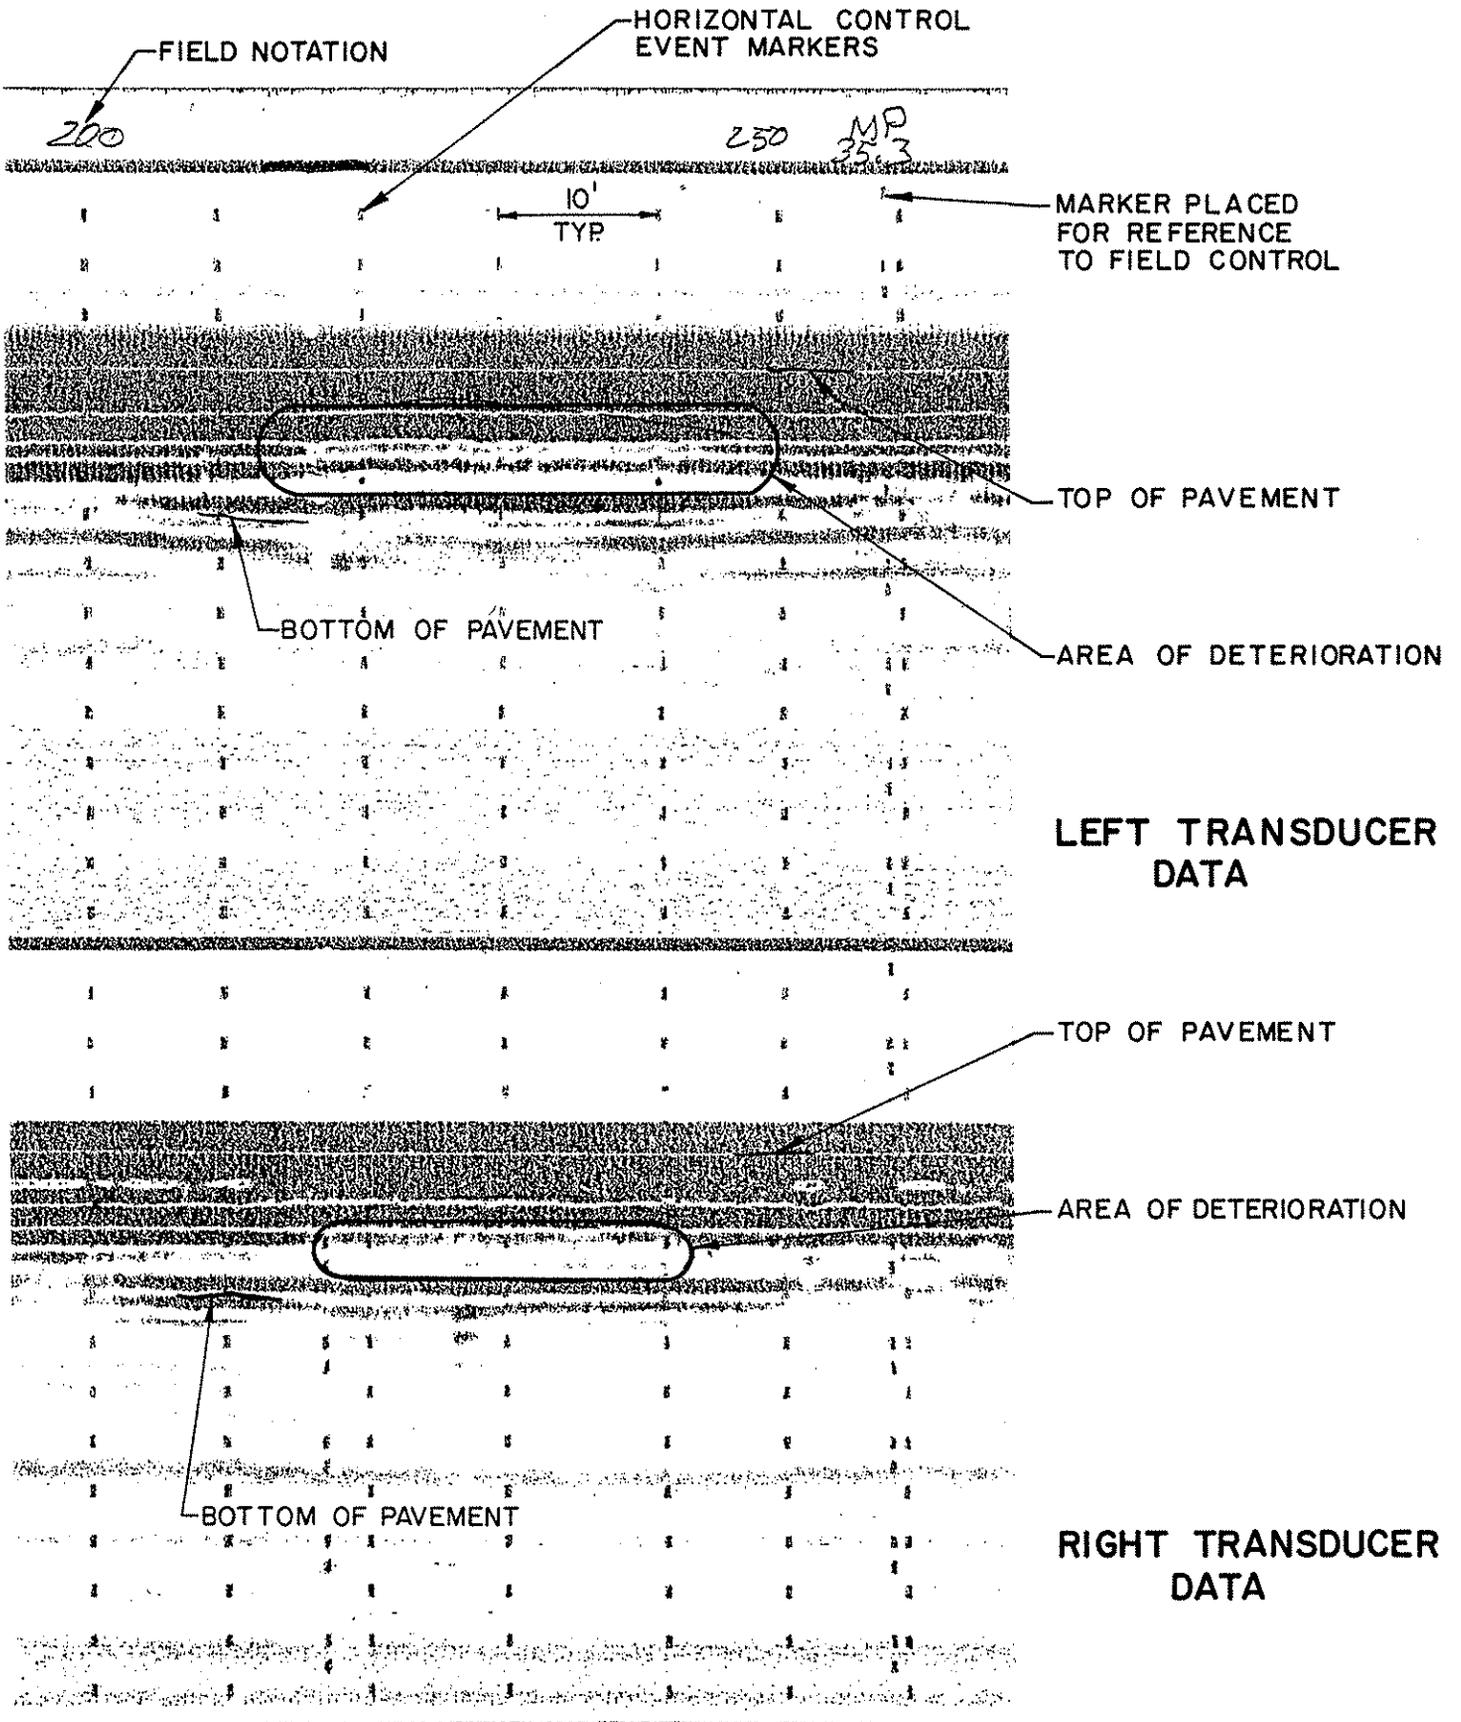
**FIGURE 3
 SAMPLE OF GPR CHART SHOWING
 DETERIORATION SIGNATURE
 IOWA DEPT. OF TRANSPORTATION**

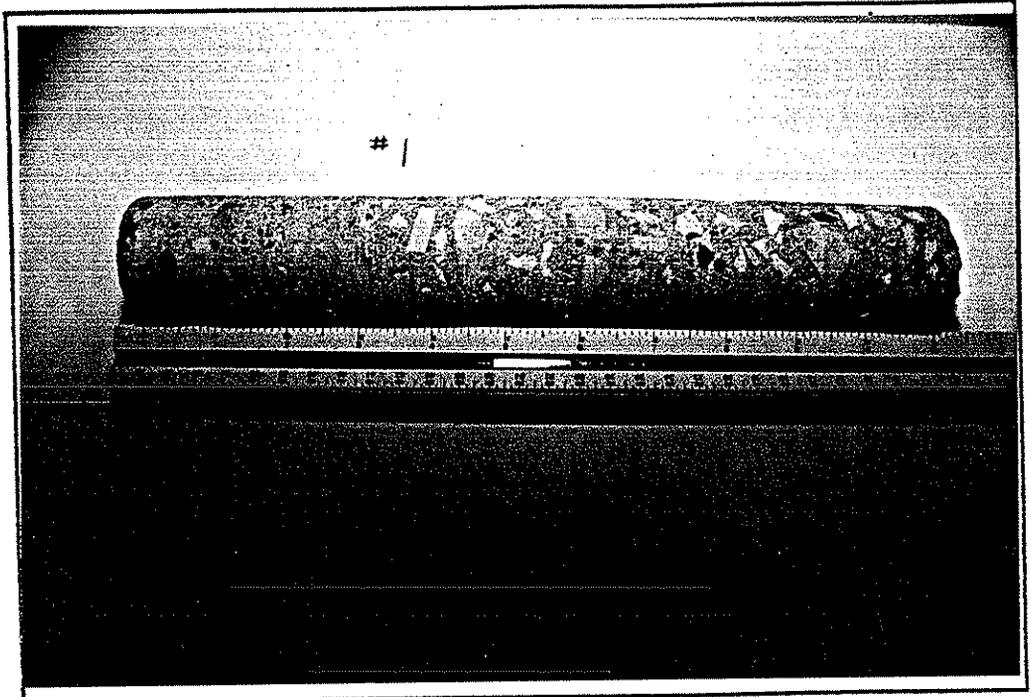
CONDITION OF ASPHALT: Good

DEFECTS IN CORE: None

QUALITY OF CONCRETE: Good

REMARKS: Good Bond - no defects

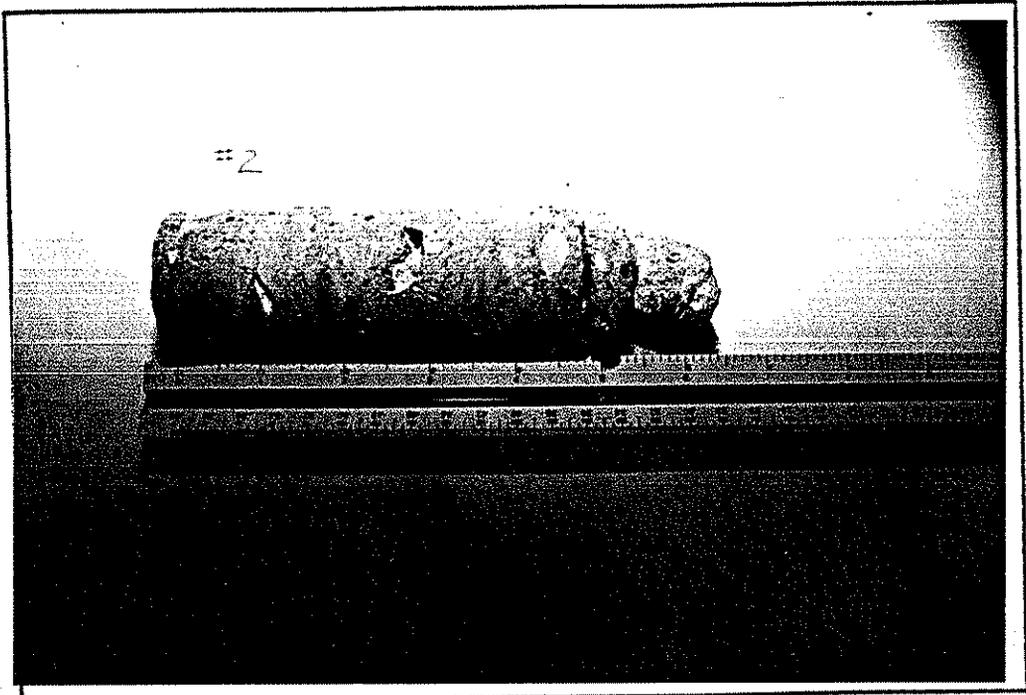
CONDITION OF OVERLAY: Good

DEFECTS IN CORE: Poor original pavement

QUALITY OF CONCRETE: Poor

REMARKS: Original Pavement broke easily

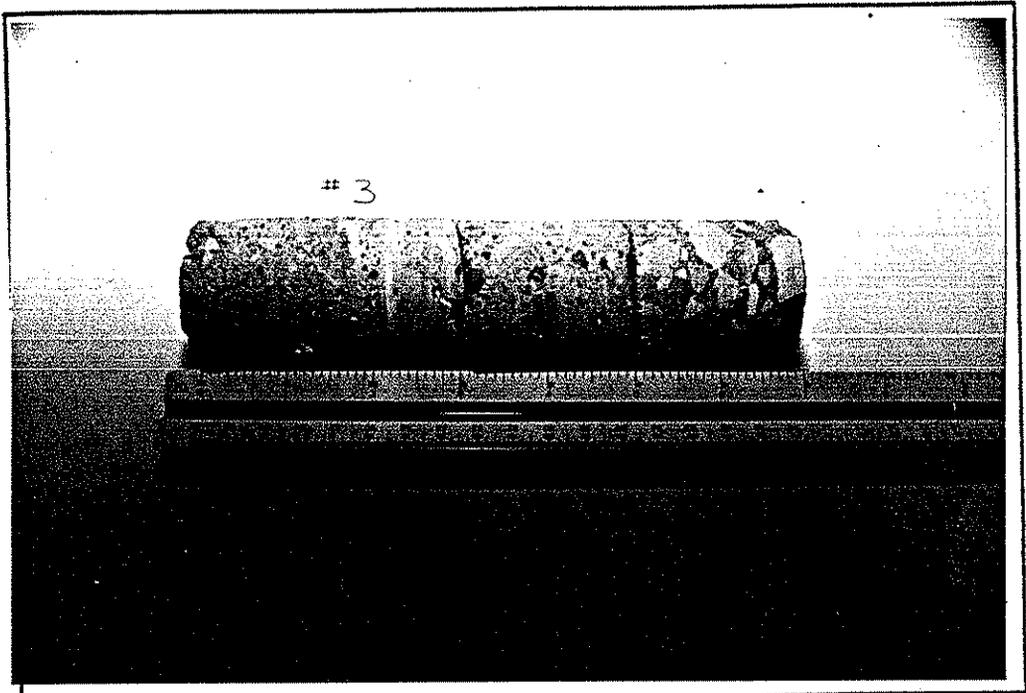
CONDITION OF OVERLAY: Good

DEFECTS IN CORE: Broke just beneath Bond

QUALITY OF CONCRETE: Good

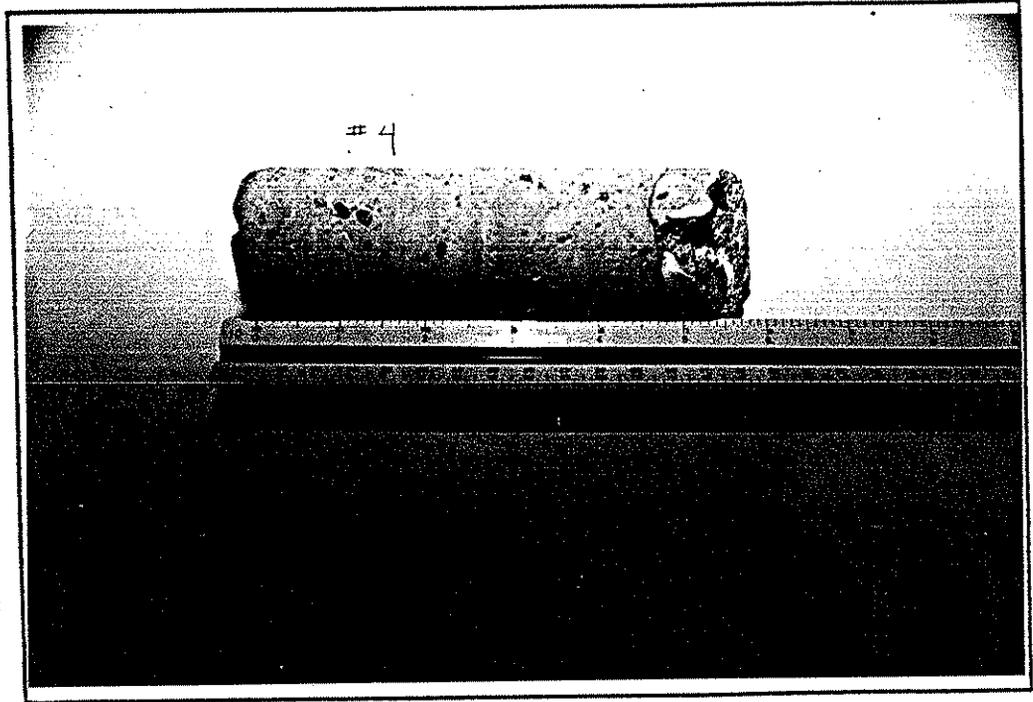
CONDITION OF OVERLAY: Good

DEFECTS IN CORE: Poor original pavement

REMARKS: Original pavement broke easily

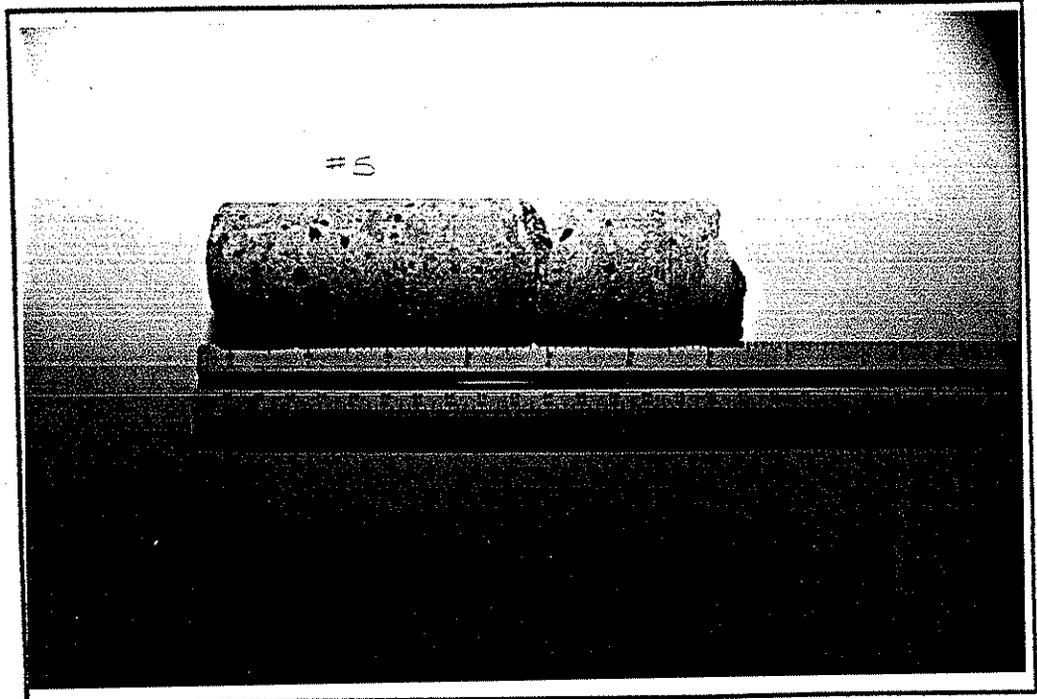
CONDITION OF OVERLAY: Good

DEFECTS IN CORE: Poor original pavement

REMARKS: Original pavement broke easily

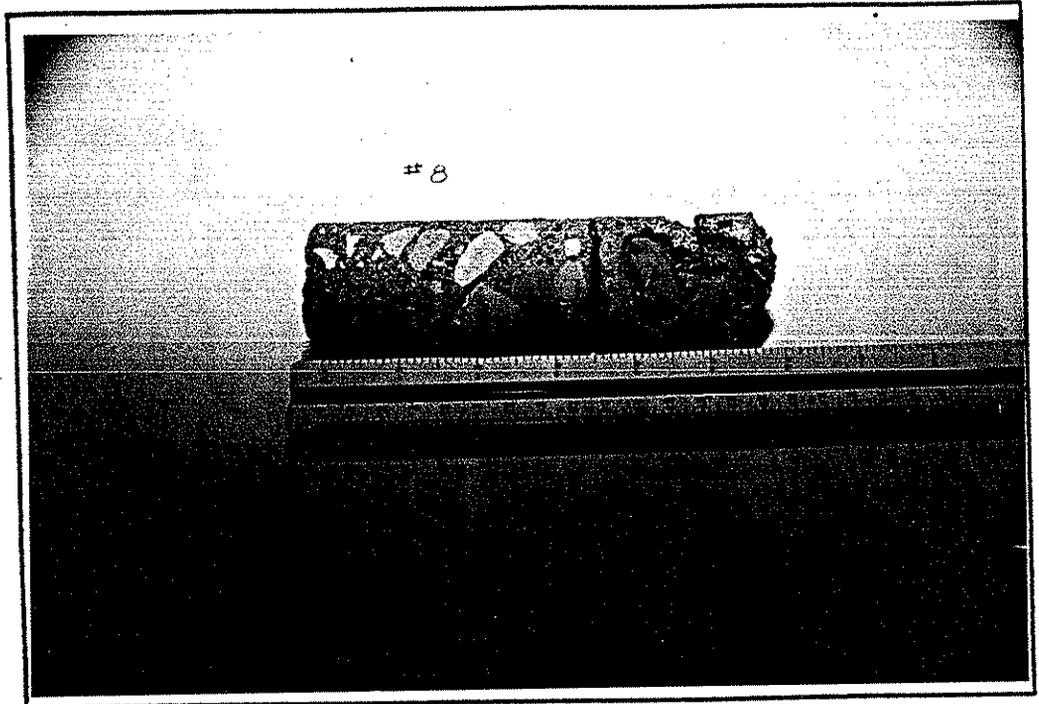
CONDITION OF OVERLAY: Good

DEFECTS IN CORE: Poor Original Pavement

REMARKS: Original Pavement Broke Easily

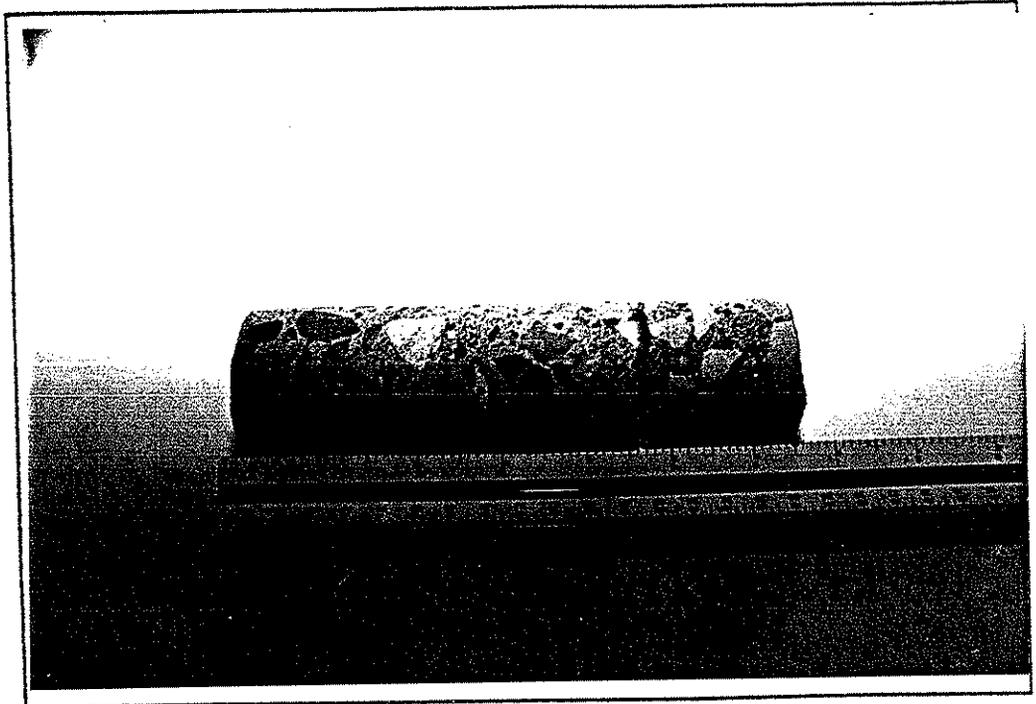
CONDITION OF OVERLAY: Good

DEFECTS IN CORE: Debonded Overlay

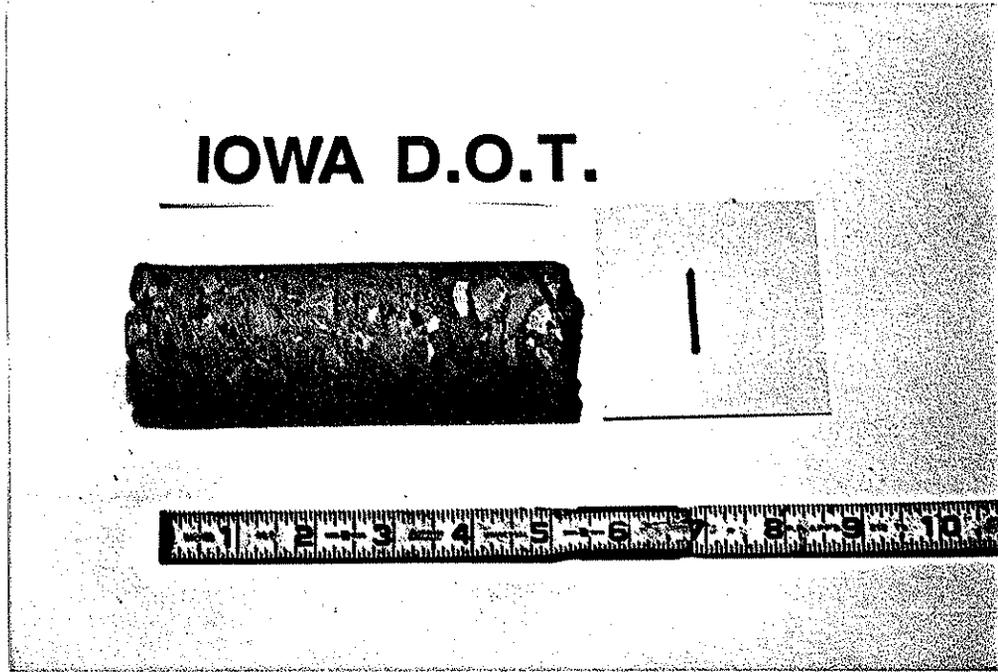
CONDITION OF OVERLAY: Good

DEFECTS IN CORE: Poor original pavement

REMARKS: Original pavement broke easily

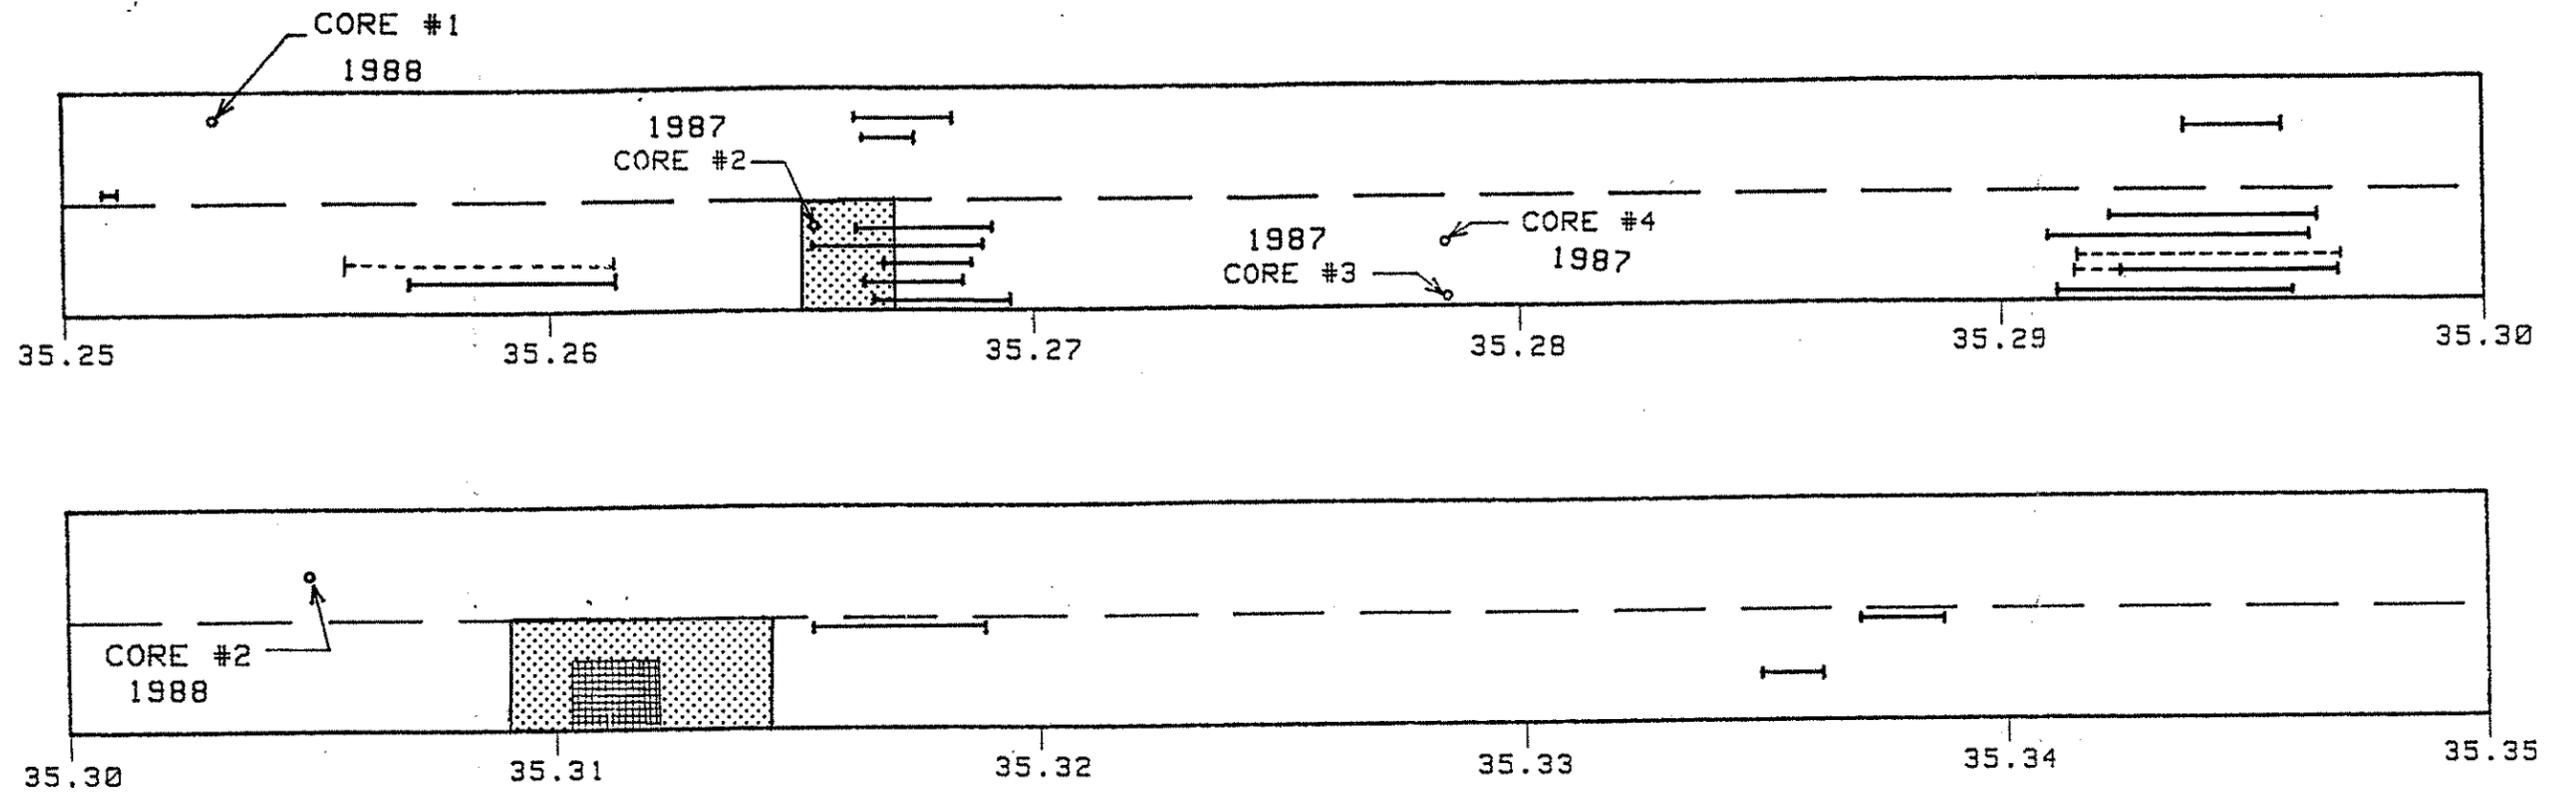
IR AND GPR EVALUATION OF BOND RETAINAGE
IN PORTLAND CEMENT CONCRETE OVERLAYS
I-80 (EASTBOUND) STA 35.25 TO STA 35.35
IOWA DEPARTMENT OF TRANSPORTATION

AREAS	EASTBOUND LANES
Total Area	12,672 (sq.ft.)
Debond (IR)	None (sq.ft.)
Concrete Patch	468 (sq.ft.)
Deterioration (GPR)	304 (1in.ft.)

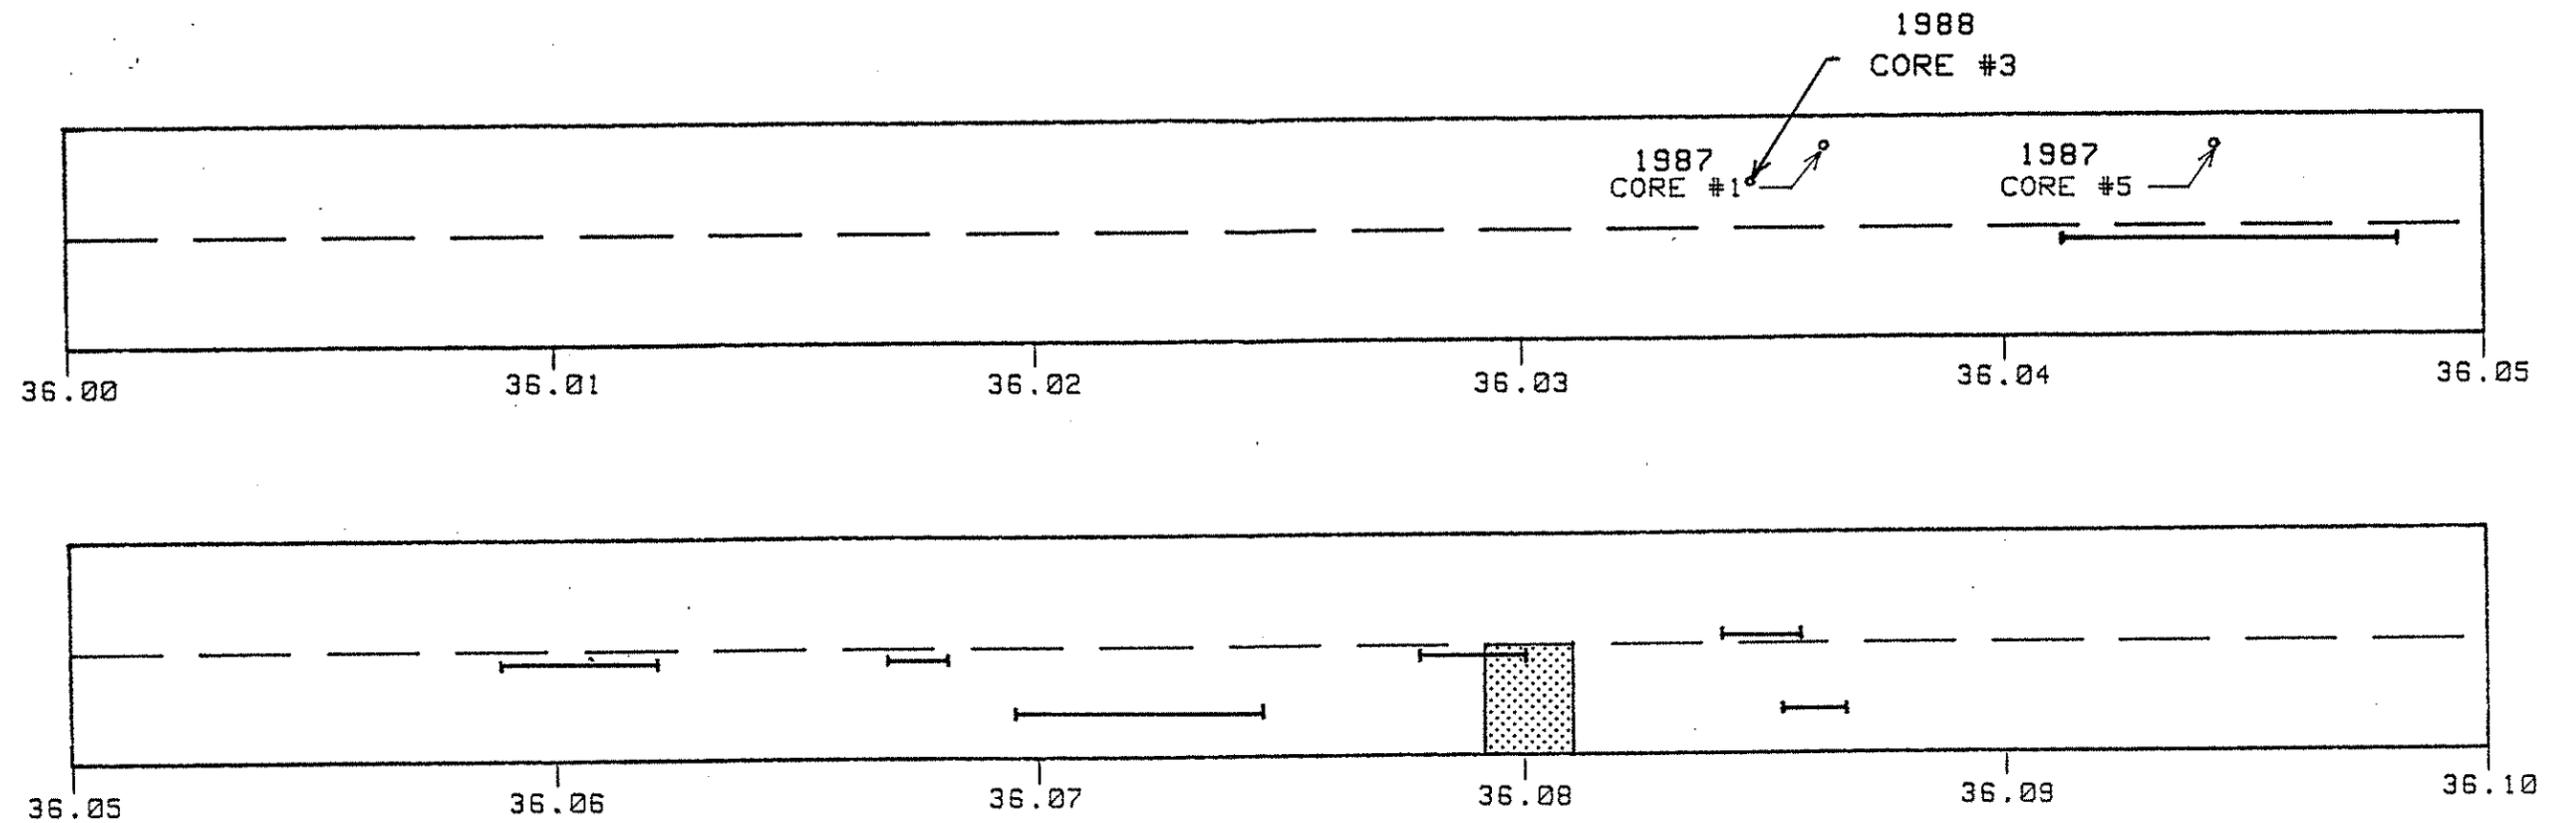
IR AND GPR EVALUATION OF BOND RETAINAGE
 IN PORTLAND CEMENT CONCRETE OVERLAYS
 I-80 (EASTBOUND) STA 36.00 TO STA 36.10
 IOWA DEPARTMENT OF TRANSPORTATION

AREAS	EASTBOUND LANES
Total Area	12,672 (sq.ft.)
Debond (IR)	None (sq.ft.)
Concrete Patch	120 (sq.ft.)
Deterioration (GPR)	112 (lin.ft.)

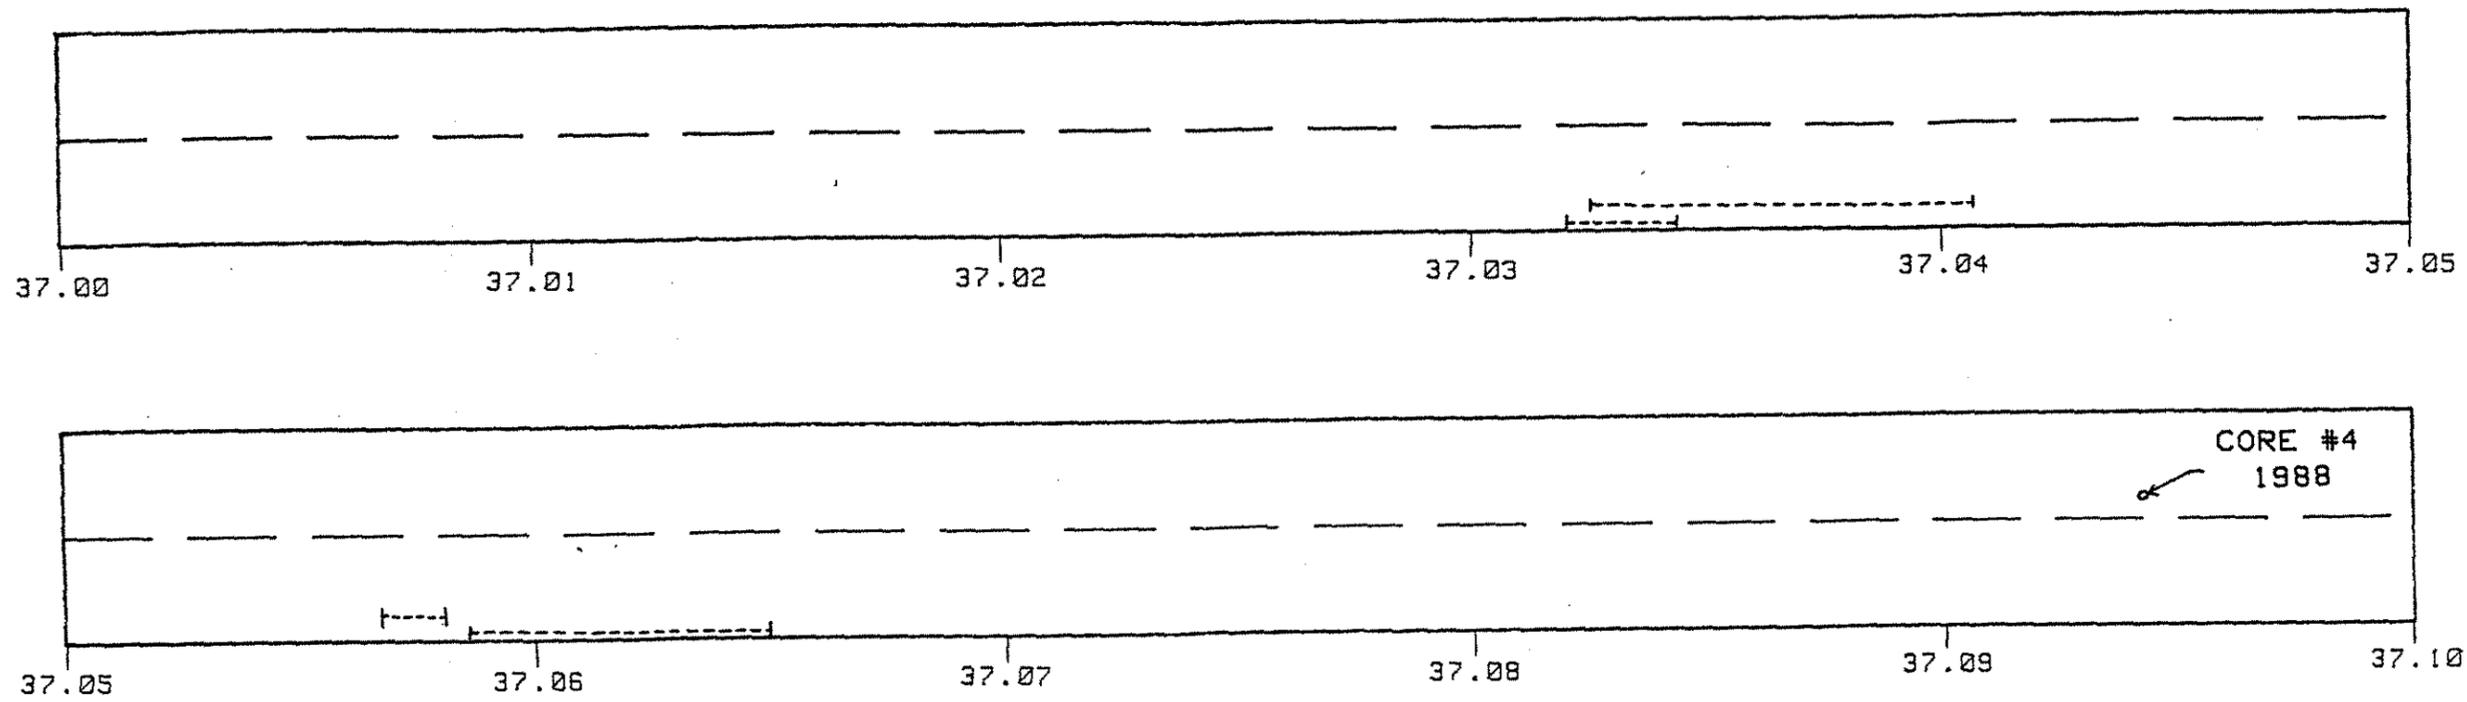
IR AND GPR EVALUATION OF BOND RETAINAGE
IN PORTLAND CEMENT CONCRETE OVERLAYS
I-80 (EASTBOUND) STA 37.00 TO STA 37.10
IOWA DEPARTMENT OF TRANSPORTATION

AREAS	EASTBOUND LANES
Total Area	12,672 (sq. ft.)
Debond (IR)	None (sq. ft.)
Concrete Patch	None (sq. ft.)
Deterioration (GPR)	96 (lin. ft.)

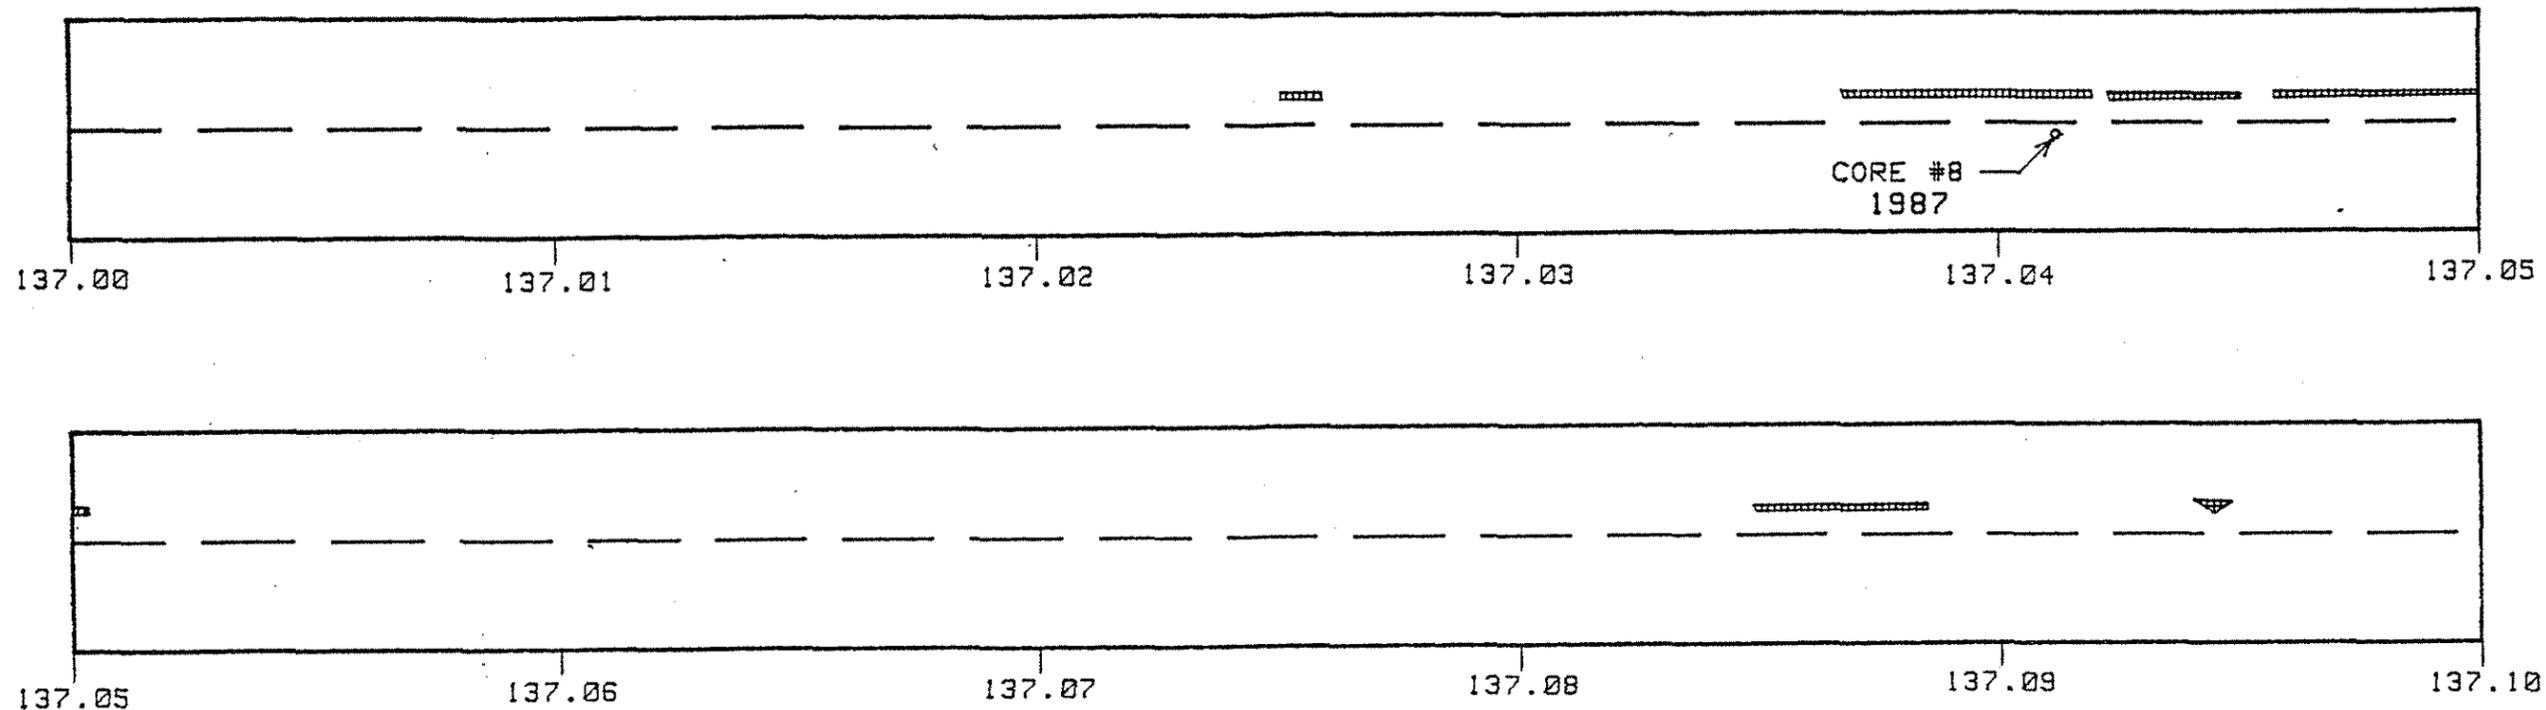
IR AND GPR EVALUATION OF BOND RETAINAGE
IN PORTLAND CEMENT CONCRETE OVERLAYS
SH141 (EB & WB) STA 137.00 TO STA 137.10
IOWA DEPARTMENT OF TRANSPORTATION

AREAS	EASTBOUND LANES	WESTBOUND LANES
Total Area	6,336 (sq.ft.)	6,336 (sq.ft.)
Debond (IR)	None (sq.ft.)	None (sq.ft.)
Concrete Patch	None (sq.ft.)	72 (sq.ft.)
Deterioration (GPR)	None (lin.ft.)	None (lin.ft.)

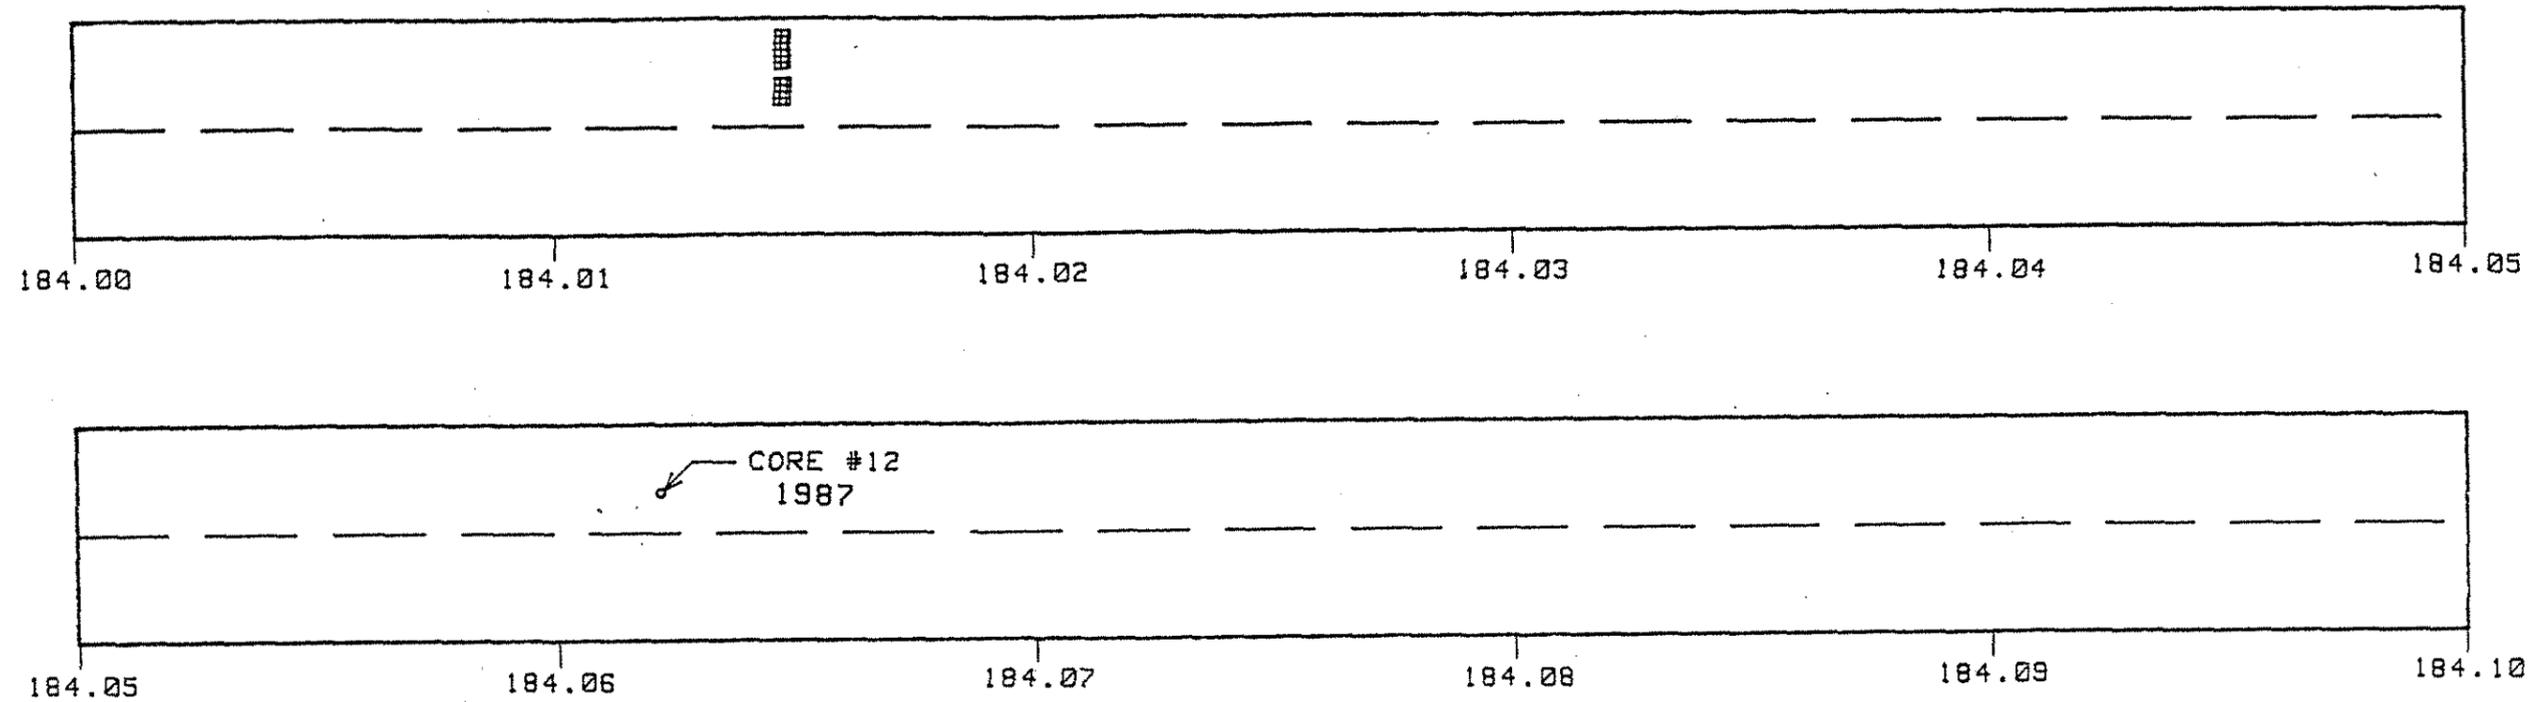
IR AND GPR EVALUATION OF BOND RETAINAGE
IN PORTLAND CEMENT CONCRETE OVERLAYS
I-80 (WESTBOUND) STA 184.00 TO STA 184.10
IOWA DEPARTMENT OF TRANSPORTATION

AREAS	WESTBOUND LANES
Total Area	12,672 (sq.ft.)
Debond (IR)	None (sq.ft.)
Concrete Patch	13 (sq.ft.)
Deterioration (GPR)	None (lin.ft.)

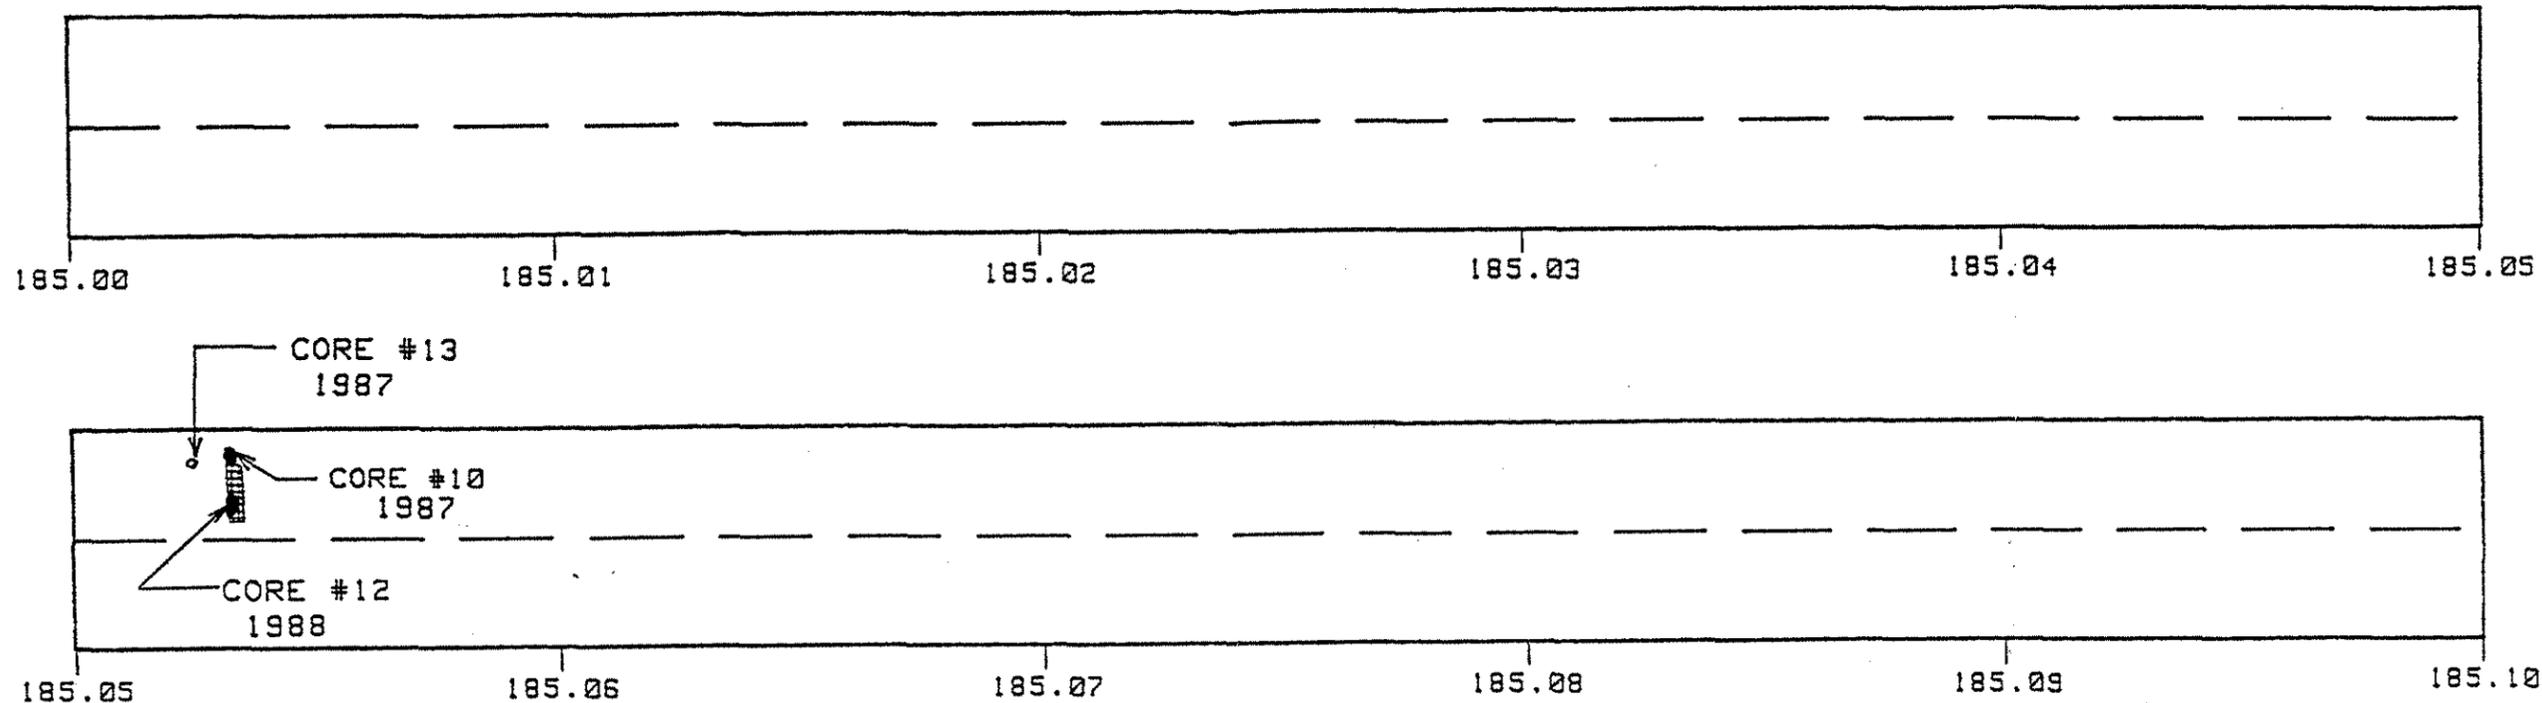
<p>Donohue Engineers & Architects</p>	IR AND GPR EVALUATION OF BOND RETAINAGE
	IN PORTLAND CEMENT CONCRETE OVERLAYS
	I-80 (WESTBOUND) STA 185.00 TO STA 185.10
	IOWA DEPARTMENT OF TRANSPORTATION

The results of the infrared scanning showed that no debonding of the overlay is present in the five test sections of pavement on Interstate 80 eastbound between mileposts 35.25 and 39.10. This is confirmed by the eleven cores (Nos. 1-5 in 1987 and Nos. 1-6 in 1988) which were taken in these sections. Also, no debonding was identified in the five test sections on S.H. 141 between mileposts 134.00 and 138.10. This is confirmed by the four cores (nos. 6, 7, 8 and 9) taken in 1987 and the three cores (Nos. 7, 8, and 9) taken in 1988. An area of patching was observed in both 1987 and 1988 between mileposts 137.00 and 137.10 with a total area of approximately 72 square feet. In the five test sections of pavement on Interstate 80 westbound between milepost 184.00 and 188.10, one square foot of debonding was located adjacent to an existing patch (11 square feet) between milepost 185.00 and 185.10 in 1987. The location of the debond was 247 feet west of milepost 185.10 and three and one-half feet south of the north edge of the pavement. Core 10 was taken at this location and showed a debond to be present. In 1988, an additional one square foot of debonding was identified at the

same location, within the existing patch. This debond was confirmed by Core #12. In addition, eleven square feet of patching was observed in both 1987 and 1988 in the section of pavement between mileposts 186.00 and 186.10. No other defects were observed in these test sections. This is confirmed by the five other cores (Nos. 11-13 in 1987 and 10-11 in 1988) taken in these areas. Detailed descriptions of the cores can be found in Appendix A. Also, a summary of the IR and GPR results can be found in Table 1 on page 2-10, as well as the planviews in Appendix B.

AREAS	WESTBOUND LANES
Total Area	12,672 (sq.ft.)
Debond (IR)	2 (sq.ft.)
Concrete Patch	11 (sq.ft.)
Deterioration (GPR)	None (lin.ft.)

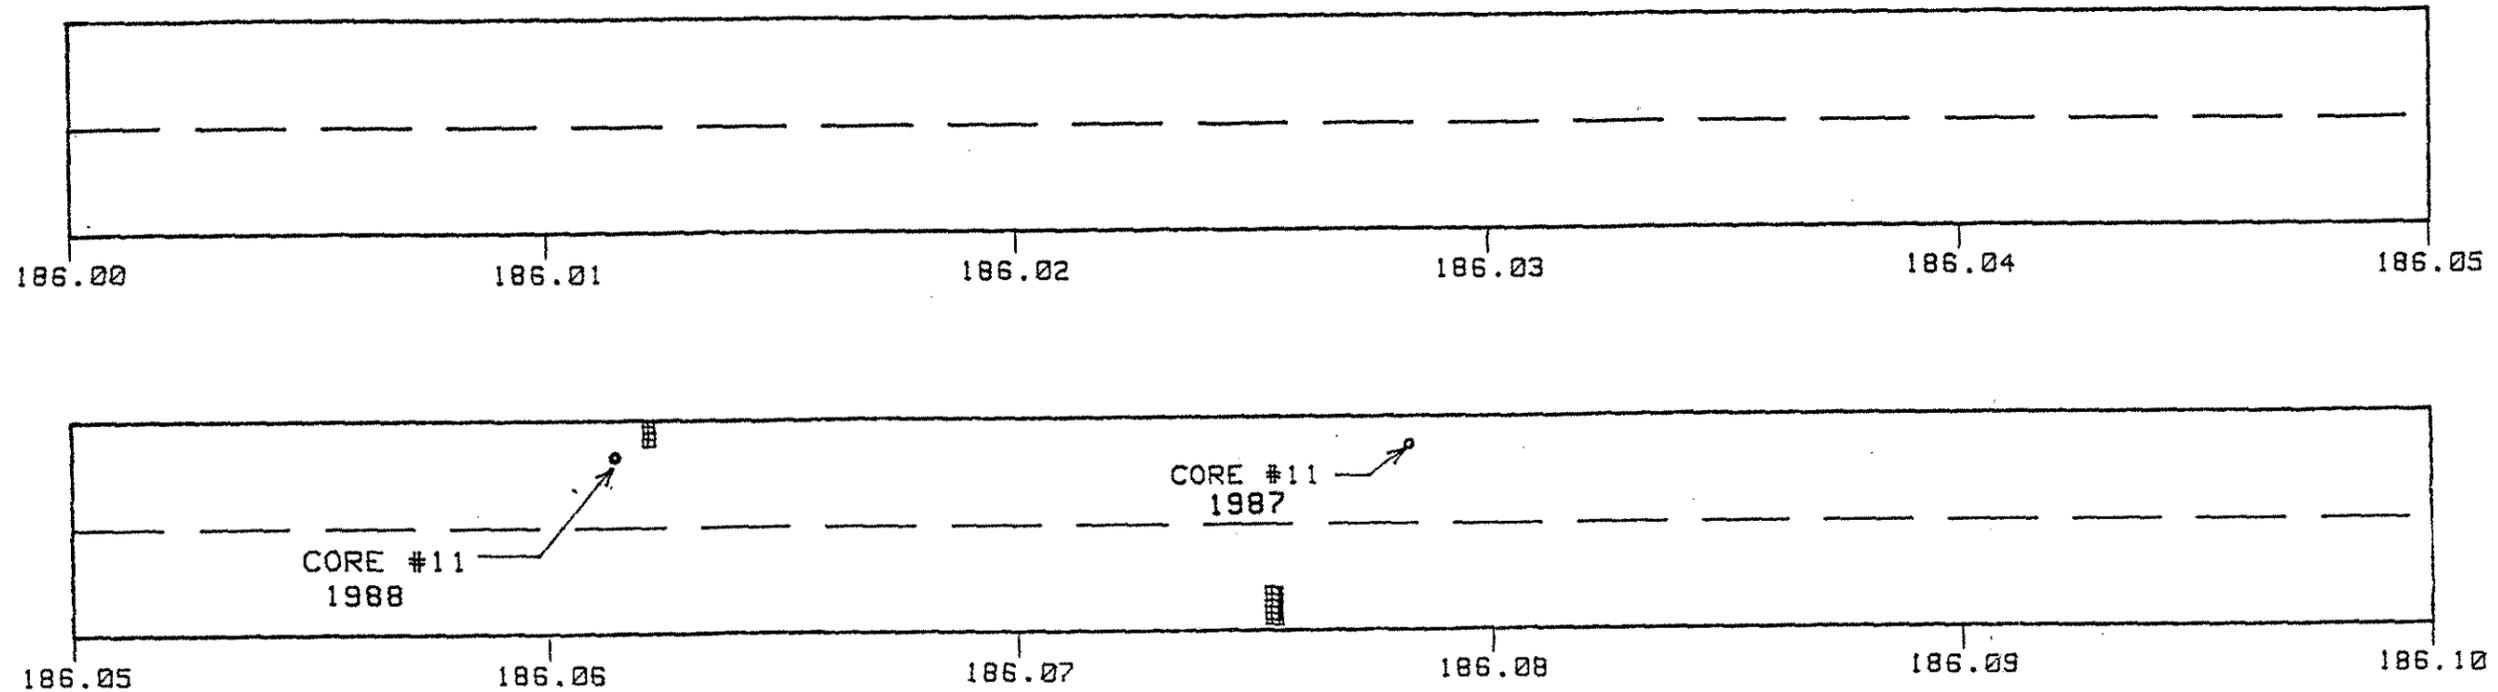
IR AND GPR EVALUATION OF BOND RETAINAGE
IN PORTLAND CEMENT CONCRETE OVERLAYS
I-80 (WESTBOUND) STA 186.00 TO STA 186.10
IOWA DEPARTMENT OF TRANSPORTATION

AREAS	WESTBOUND LANES
Total Area	12,672 (sq.ft.)
Debond (IR)	None (sq.ft.)
Concrete Patch	11 (sq.ft.)
Deterioration (GPR)	None (lin.ft.)
Inspection Date:	August, 1987 August, 1988
