FAST TRACK PORTLAND CEMENT CONCRETE PAVEMENT

**Final Report
Iowa Department of Transportation
Project HR-538**

April 1997

**Iowa Department
of Transportation**

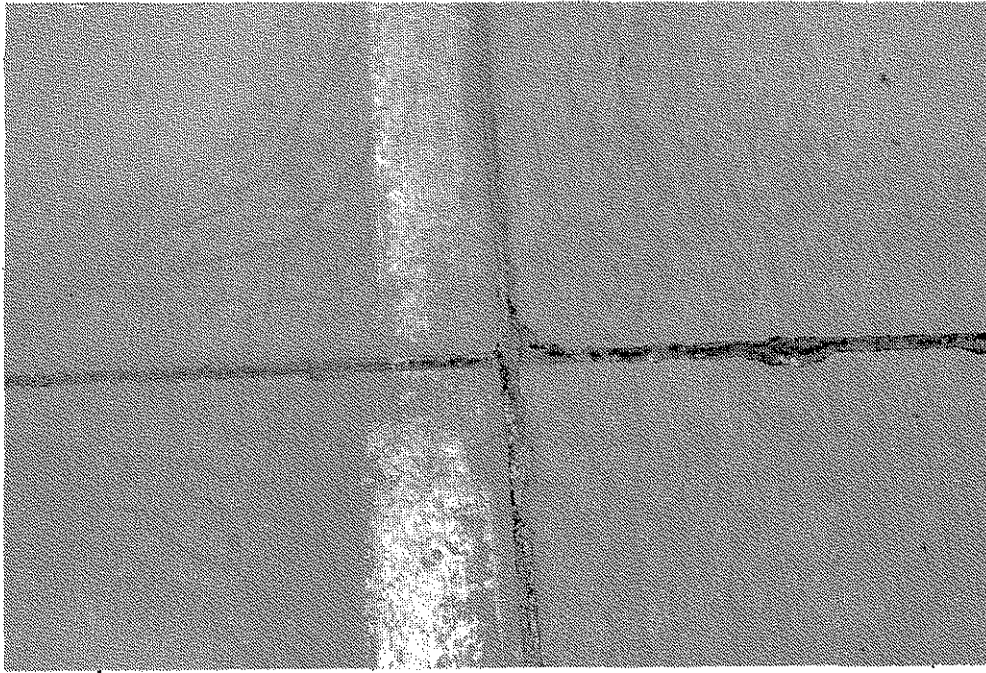
The condition of the fast track pavement had changed substantially by November 1991 when severe premature distress was identified (Figure 2). The worst deterioration was in the two full-width westbound lanes in the sag vertical curve. There was closely spaced cracking about 15 cm (6 in.) wide on both sides of the transverse joints (Figure 3) in this sag vertical. There was cracking along some of the westbound longitudinal joint. By October 1992 there was substantial spalling at many of the westbound lane transverse joints. Cold bituminous patching material had been used to fill the bigger deeper spalls (Figure 4). Many of these were at the intersection of the transverse and longitudinal joints. Some of these bituminous patches were 0.6 m (2 ft.) long and wide by November 1994. The condition has continued to deteriorate, requiring more and more maintenance. The most deteriorated section in the sag vertical curve, 152 m (500 ft.) of the westbound roadway (2 lanes), was replaced in 1996.

Figure 2 - Severe Premature Distress in November 1991

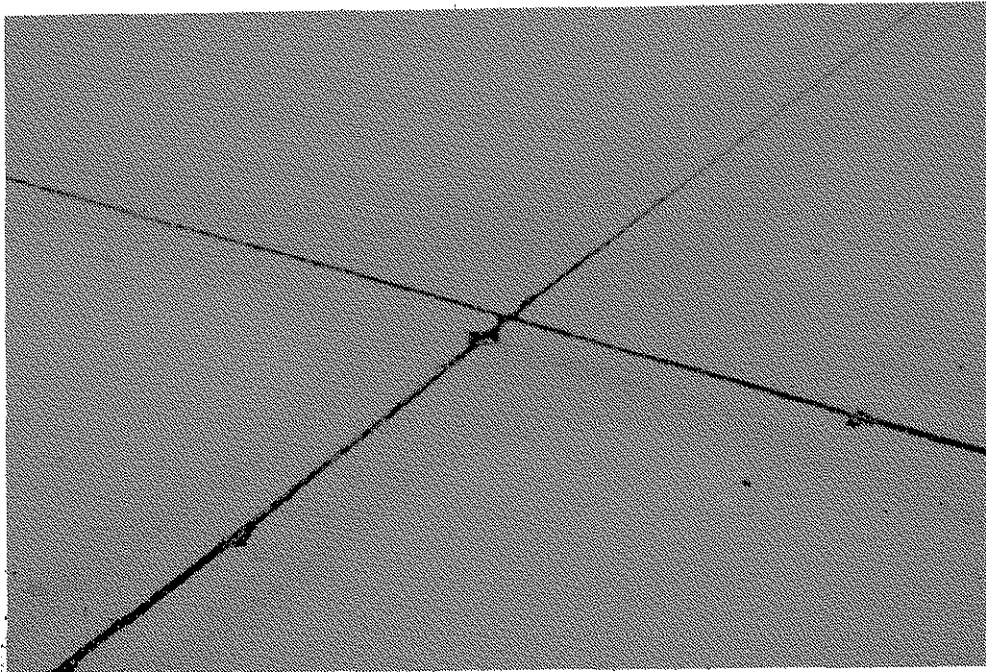
Figure 3 - Cracking Along Both Sides of a Transverse Joint

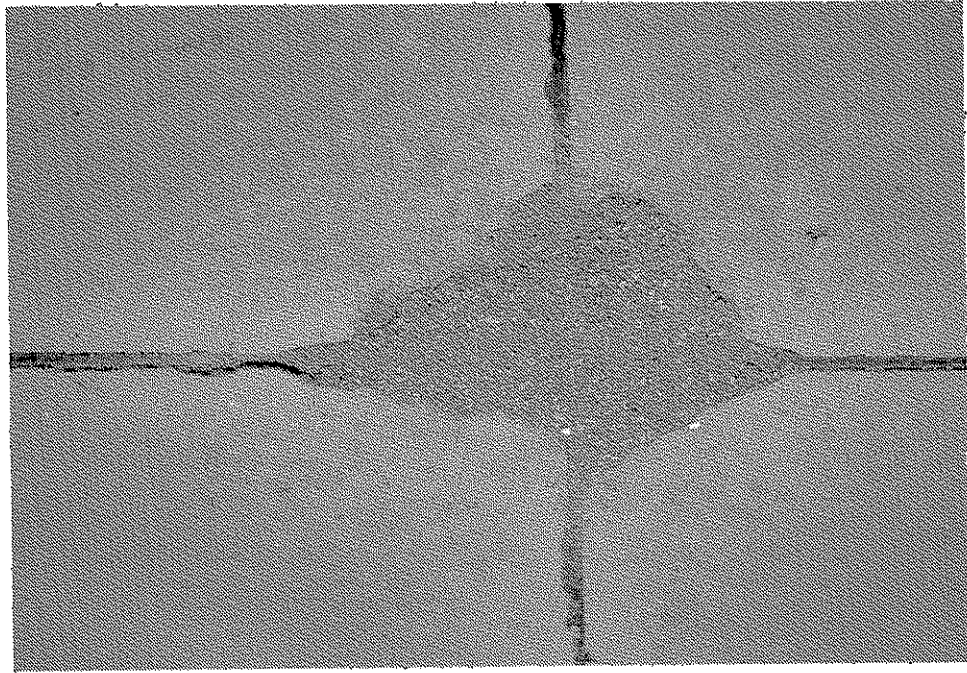
Figure 4 - Bituminous Patching of Spalling at the Joint Intersections
