DETERMINE INITIAL CAUSE FOR CURRENT PREMATURE PORTLAND CEMENT CONCRETE PAVEMENT DETERIORATION

FINAL REPORT

Sponsored by the Project Development Division
of the Iowa Department of Transportation
and the Iowa Highway Research Board
Iowa DOT Project TR-406
CTRE Management Project 97-13

OCTOBER 2000

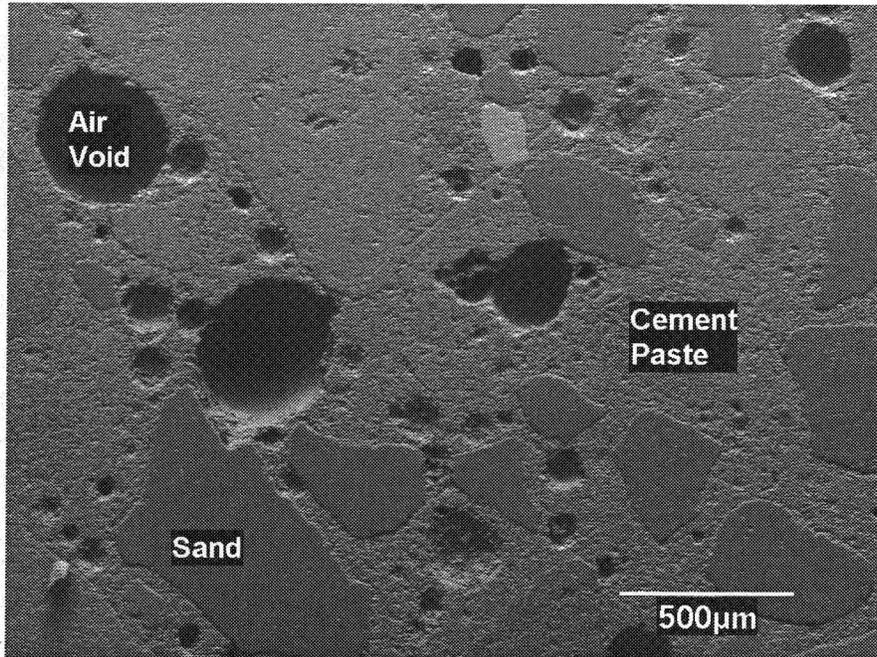
Site	Road	Description of Pavement Distress	Description of Distress Noted in Cores
1	US 20	No distress observed	No cracks evident; entrapped air voids common
2	US 20	Severe cracking at joints, similar to D-cracking, but some cracks extend the length of the panels on 450-mm (18 inch) to 600-mm (24 inch) spacing	Cracking noted in all cores, typically subparallel to top of core; many large, entrapped air voids; shale pop outs common on sides of core
3	US 169	Staining and faint to moderate cracking noted only at joint area	Poor core extraction, broke off at about 125 mm (5 inches); cracking noted, typically subparallel to top of core
4	Hwy 175	No distress observed	No cracks evident; some staining around shale particles; entrapped air voids common
5	Hwy 175	No distress observed	No cracks evident; some staining around shale particles; entrapped air voids common
6	Hwy 175	No distress observed	One fine crack at base of core, ran halfway around the core; some staining around shale particles; entrapped air voids common.

FIGURE 3 Good section of US 20.

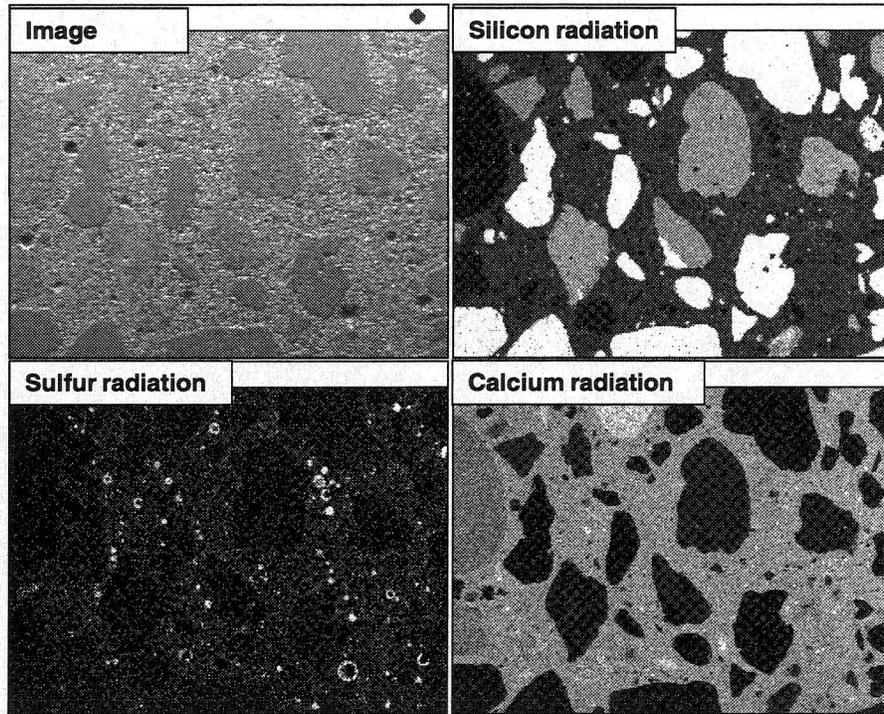
FIGURE 5 Illustration of the use of X-ray maps to highlight the ettringite-filled air voids.

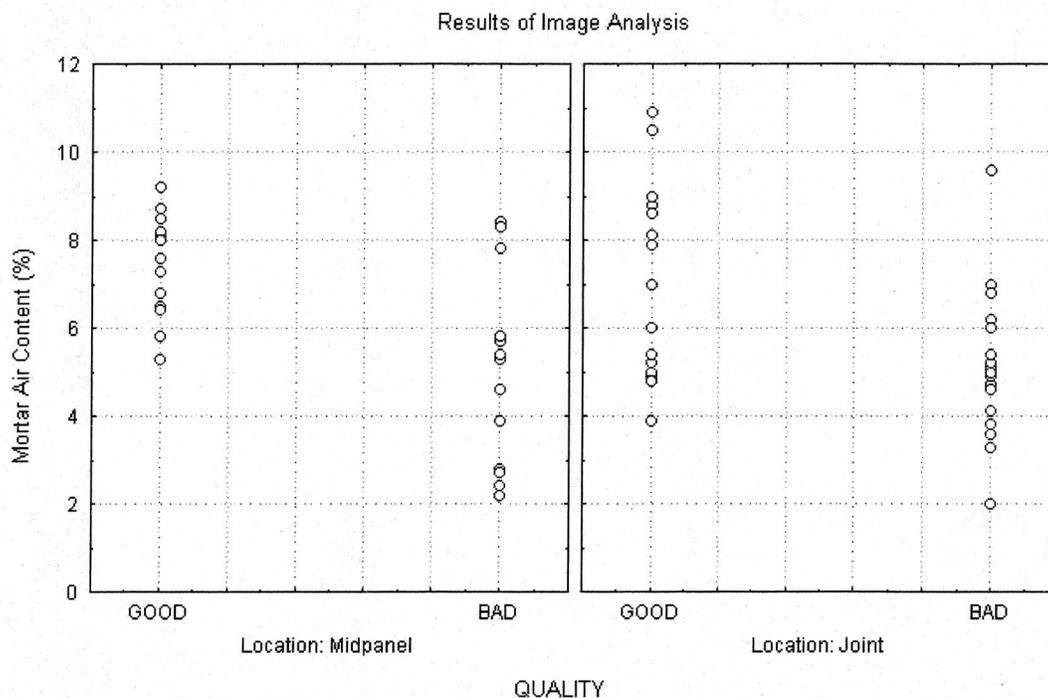
The results summarized in Table 3 and shown in Figure 7 indicate that the pavements that exhibited premature deterioration tended to have a wide range of mortar air contents (roughly from two to 10 percent). The average mortar air content for the pavements that exhibited premature distress was 5.1 percent, and only seven out of the 39 specimens that were tested had

air contents greater than 6 percent. In contrast, the pavements that exhibited good field performance had a slightly narrower range of air contents (range from four to 11 percent). The average mortar air content for the good pavements was 7.3 percent and only eight out of the 32 specimens that were tested had air contents less than 6 percent.

FIGURE 7 Results of the image analysis measurements for air content.

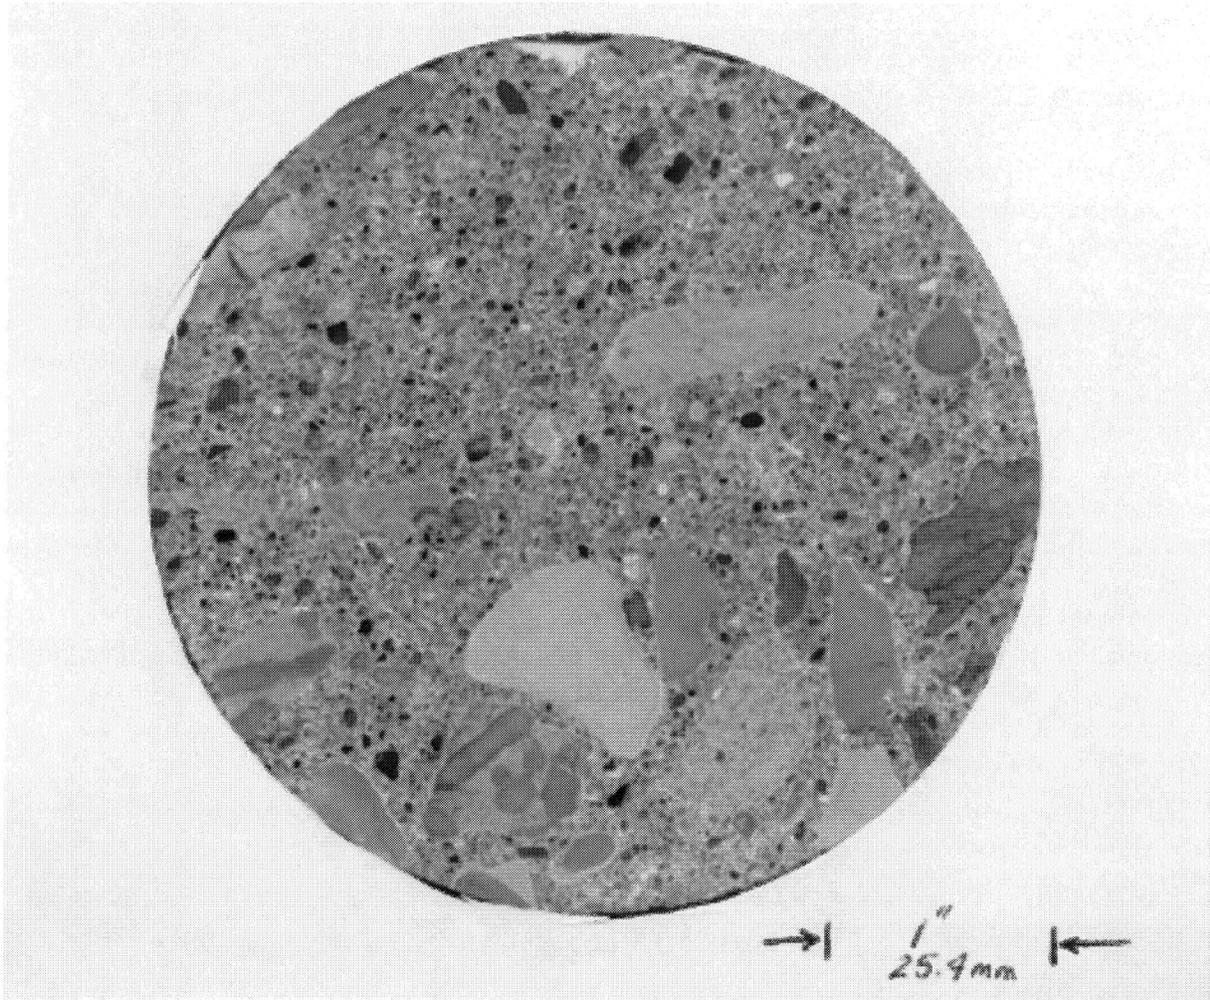
FIGURE 8 Illustration of segregation in a core extracted from I-80 in Iowa county.

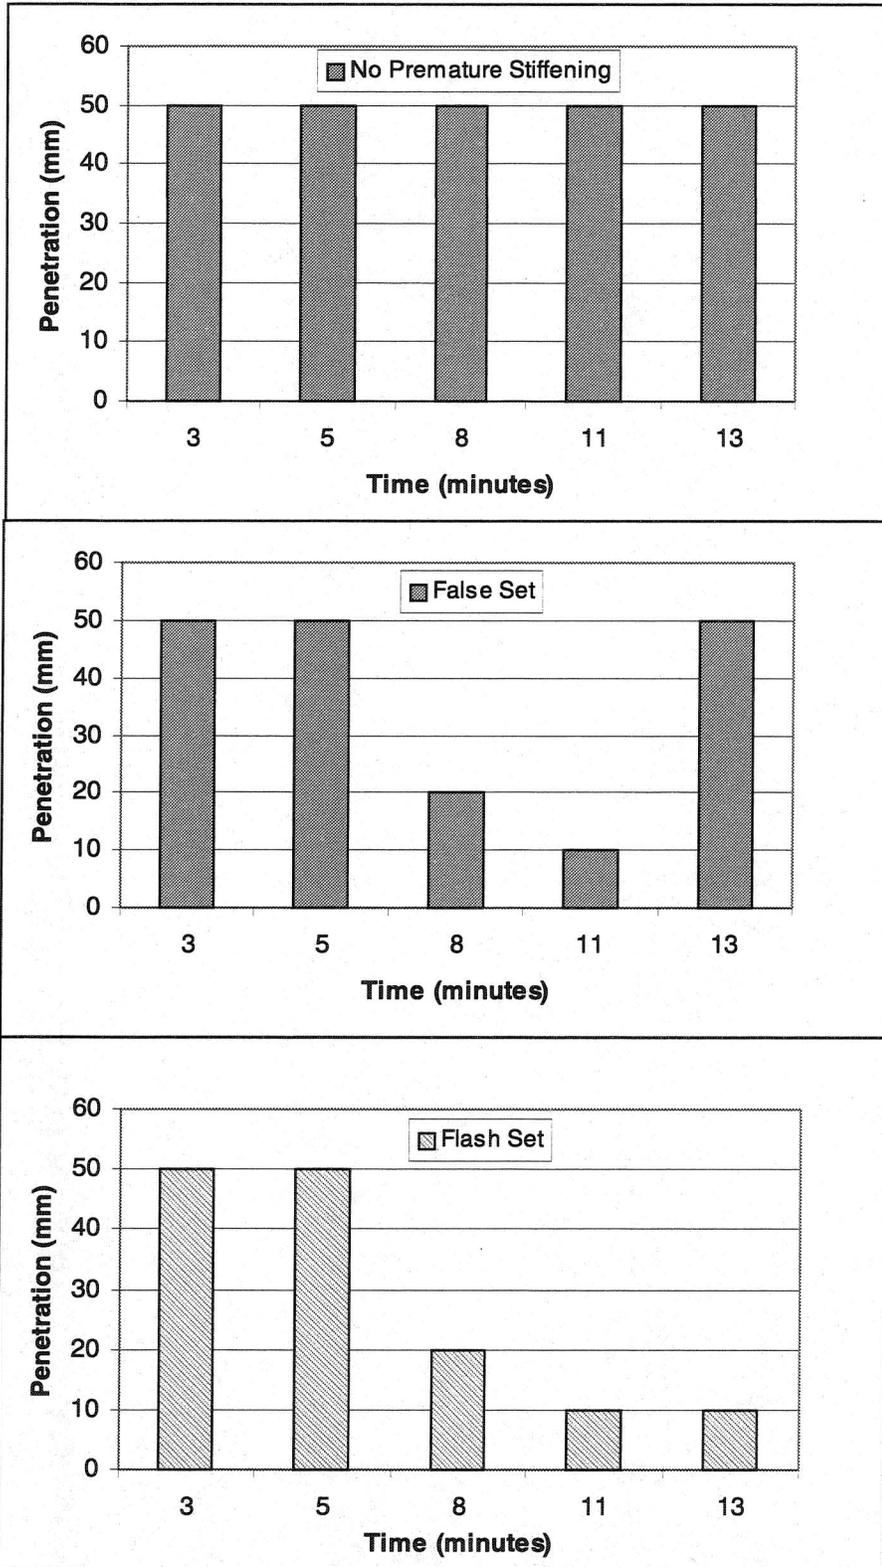
FIGURE 11 Illustration of mortars exhibiting false set and flash set.

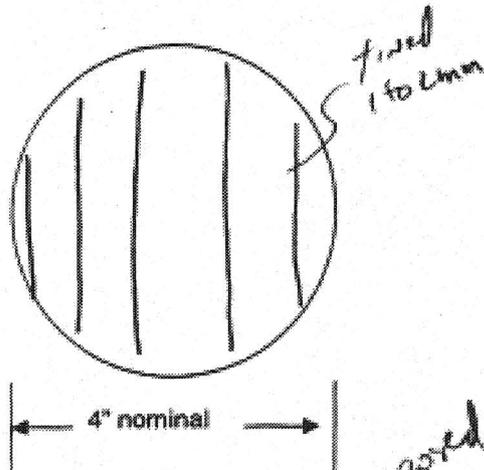
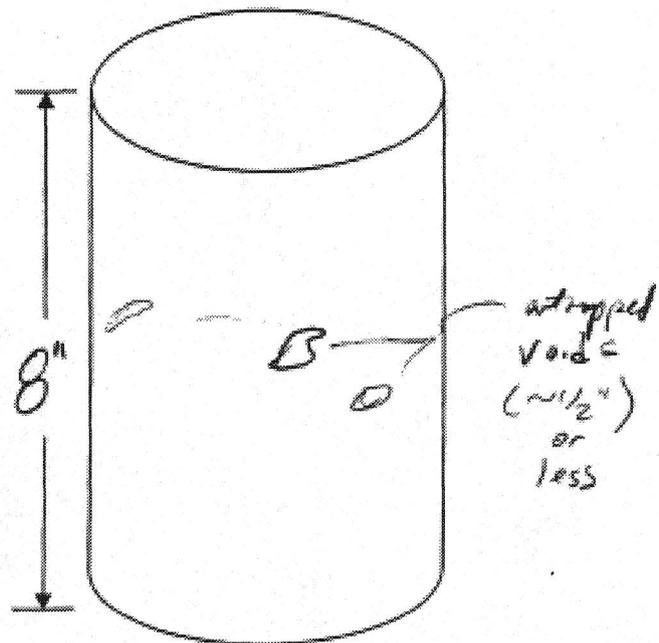
Sample Identification: HWY 175 WB G n.l.c Post 156.2
(9 Inside Joint)

Some agg. exposed on wear surface

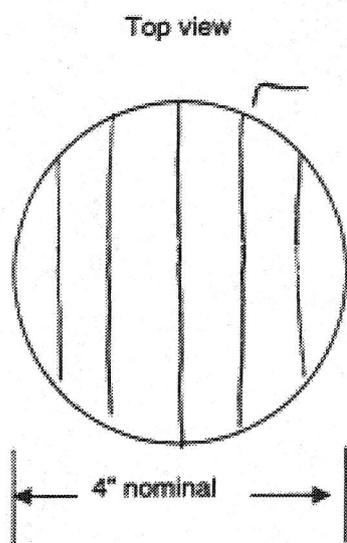
1 to 4"
very sloppy

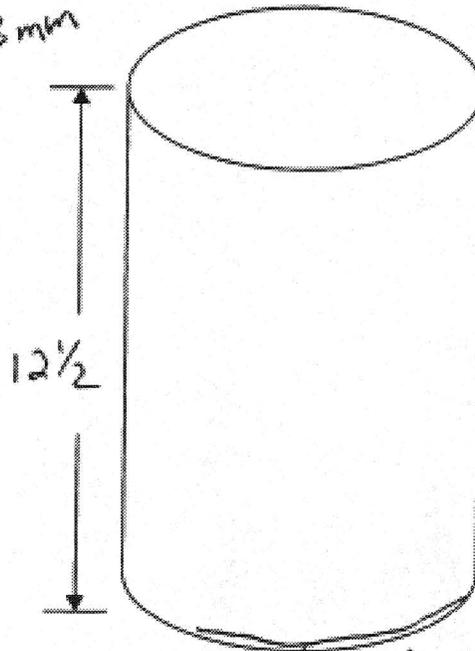
slight crack withing
1/4" of base

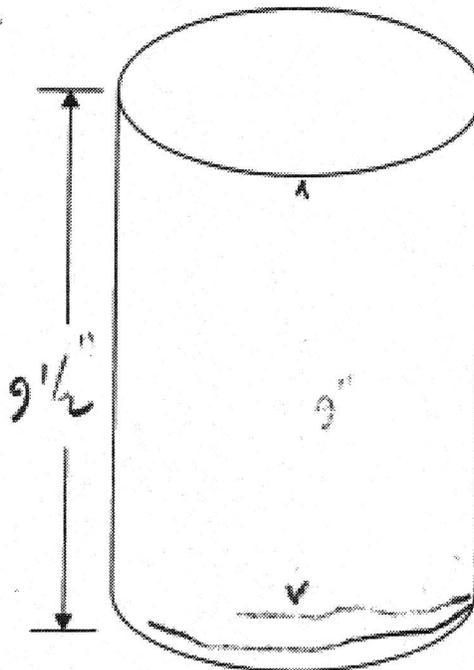
*fine cracks
some
thin
paste &
CA*
