# **Effective Structural Concrete Repair Volume 1 of 3**

## **Repair of Impact Damaged Prestressed Concrete Beams with CFRP**

March 2004

Iowa DOT Project TR - 428

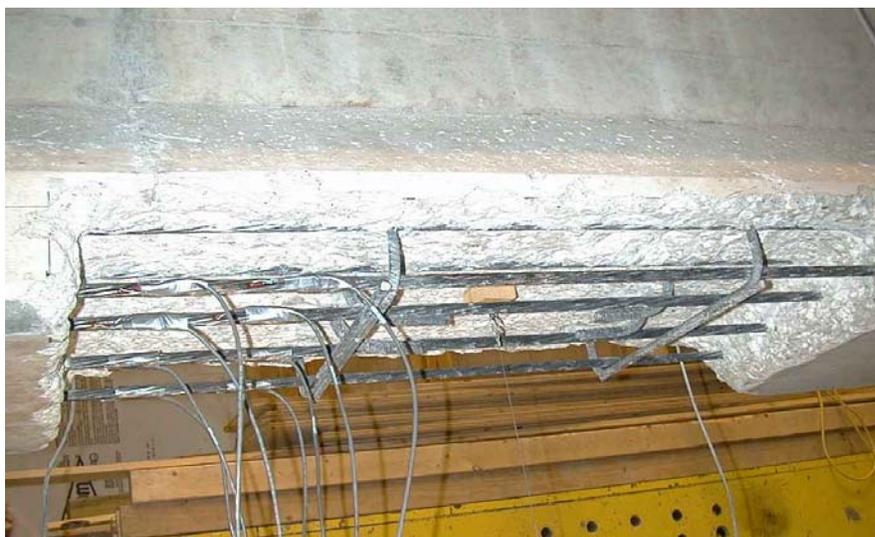
Concrete was removed from the bottom flange of the P/C beams using a handheld demolition hammer. The section of the bottom flange removed was 3 ft long and 4 in. deep across the entire width of the bottom flange. This was enough to expose two layers of prestressing strands (i.e. eight prestressing strands). Special care was taken to avoid damaging the exposed prestressing strands with the demolition hammer. To produce the maximum effect from the given loading, the damage was located at the beam centerline as shown in Figure 3.12. After the concrete was removed, a service load test with a maximum load  $P$  of 25 kips (i.e. 50 kips applied to the beam) was conducted to determine changes in the stiffness characteristics of the beam. The results of these tests are presented and discussed in Chapter 5. A photograph of the beam with 4 in. of concrete removed is shown in Figure 3.13. Two exposed stirrups are also clearly visible in this photograph.

Figure 3.13. Damaged beam with concrete removed.

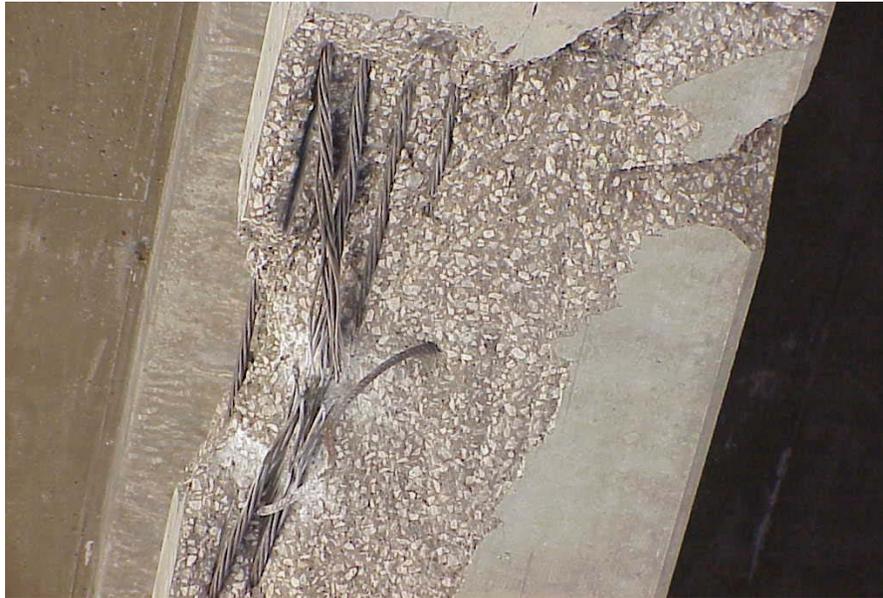
Figure 3.19. Photograph of the damage to Beam 2 in the Altoona Bridge.

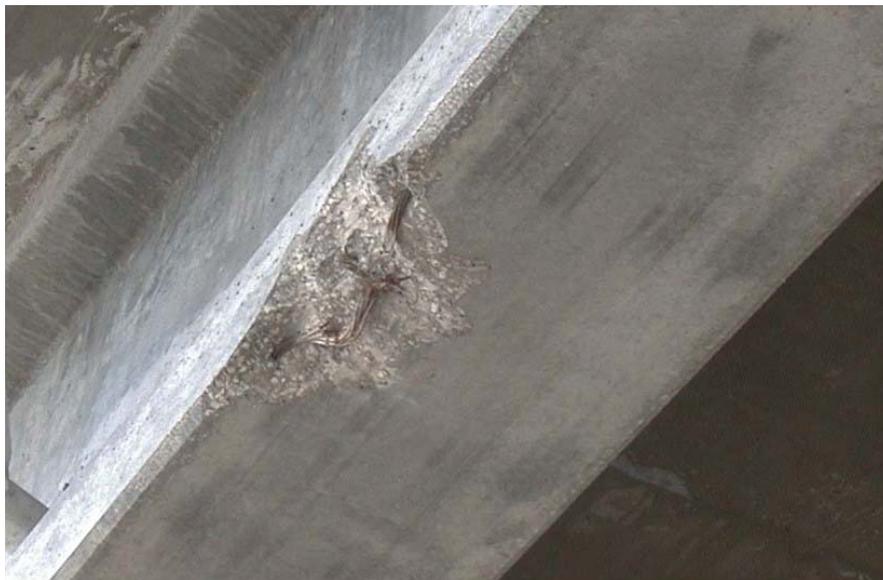
Figure 3.20. Photograph of the damage to Beam 1 in the Altoona Bridge.

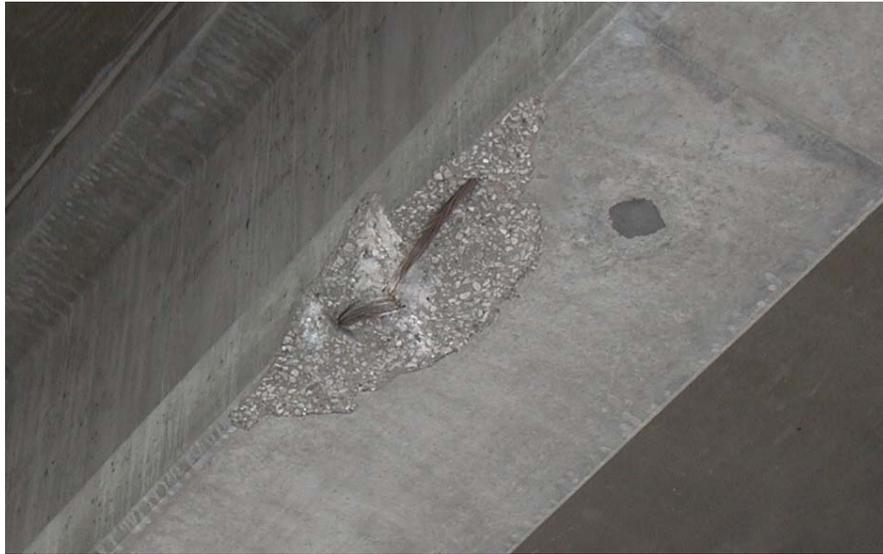
Figure 3.21. Photograph of the damage to Beam 5 in the Altoona Bridge.

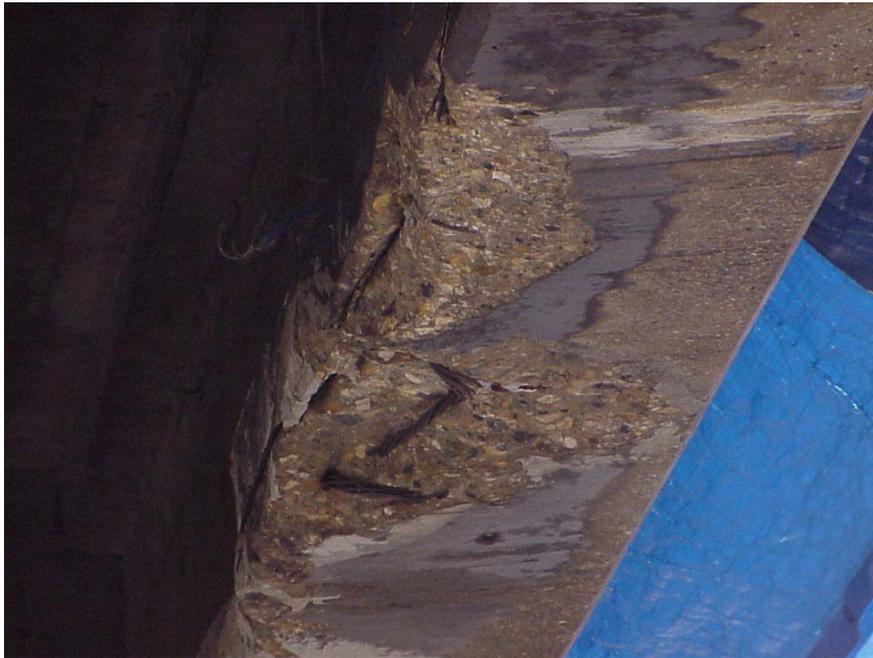
Figure 3.31. Photograph of the damage to Beam 1 in the Osceola bridge.

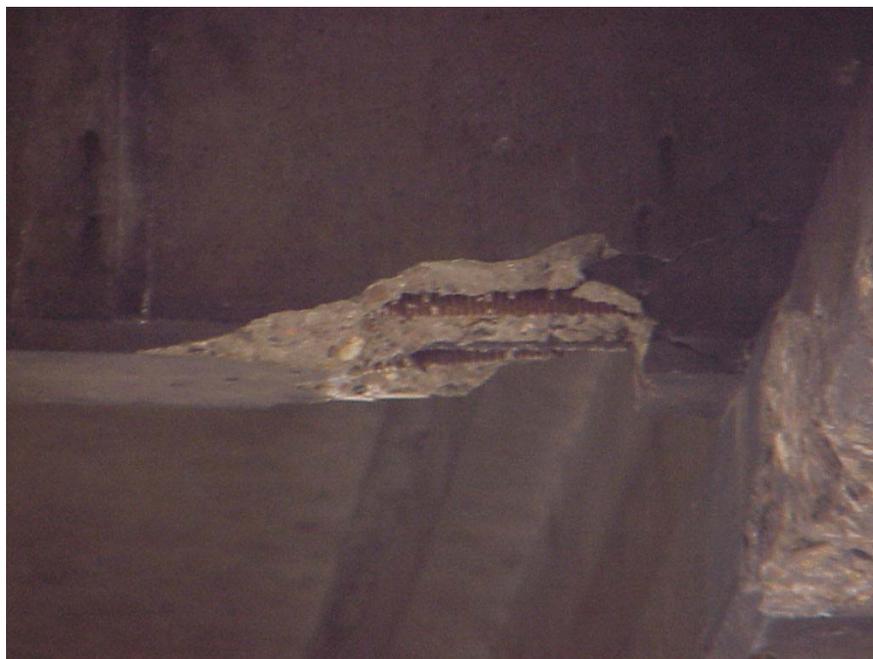
Figure 3.32. Photograph of the damage to the diaphragm in the Osceola bridge.

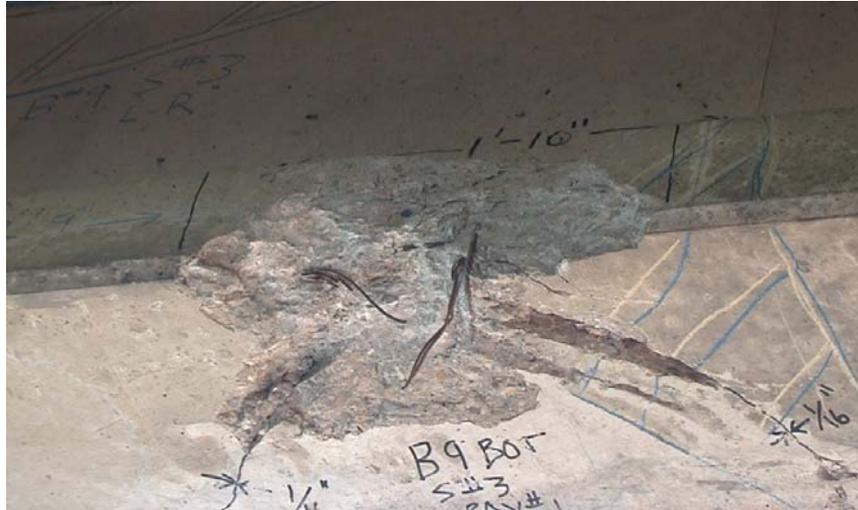
The bridge incurred some damage due to an overheight vehicle traveling south on Highway 169. The vehicle missed the seven northernmost beams and struck the final two, Beams 8 and 9. Beam 1 sustained significant concrete loss and also lost a prestressing tendon. Two of the damaged areas are shown in Figure 3.40 and 3.41. Appendix B contains a more thorough report of the damage.

Figure 3.41. Photograph of severed prestressing strand in the De Soto bridge.

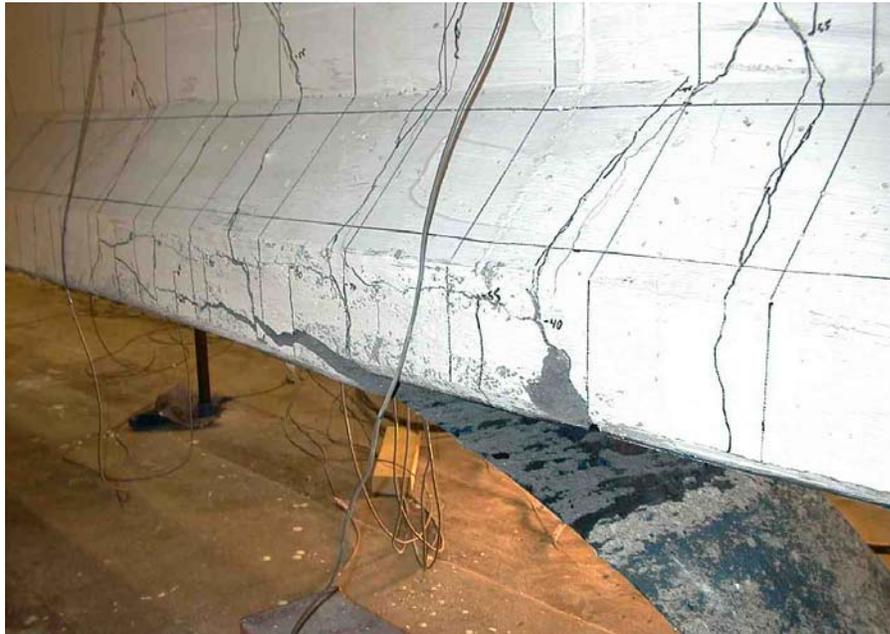
As previously mentioned, failure was initiated by the debonding of the CFRP sheets which occurred at the CFRP/concrete interface. The debonding action started near the center of the beam and then quickly propagated to one of the ends. The large flexural cracks were likely the source of the sheet debonding. This sheet debonding process is idealized in Figure 5.4; it should be noted that the crack width and the relative vertical displacements were exaggerated in this figure to illustrate the behavior. As these vertical cracks opened in the P/C beam near the ultimate load, they produced small vertical displacements at each end of the crack ( $\Delta_{tip}$ ). These crack tip displacements resulted in a normal force or stress being applied to the CFRP sheets which caused the CFRP sheets pull away or “unzip” from the P/C beam. It is also possible that the patch contributed to the debonding problem as well. At failure, the beam curvature may have resulted in the patch material also producing a normal force on the CFRP.

Figure 5.5. North side of Beam 1 after sheet debonding.

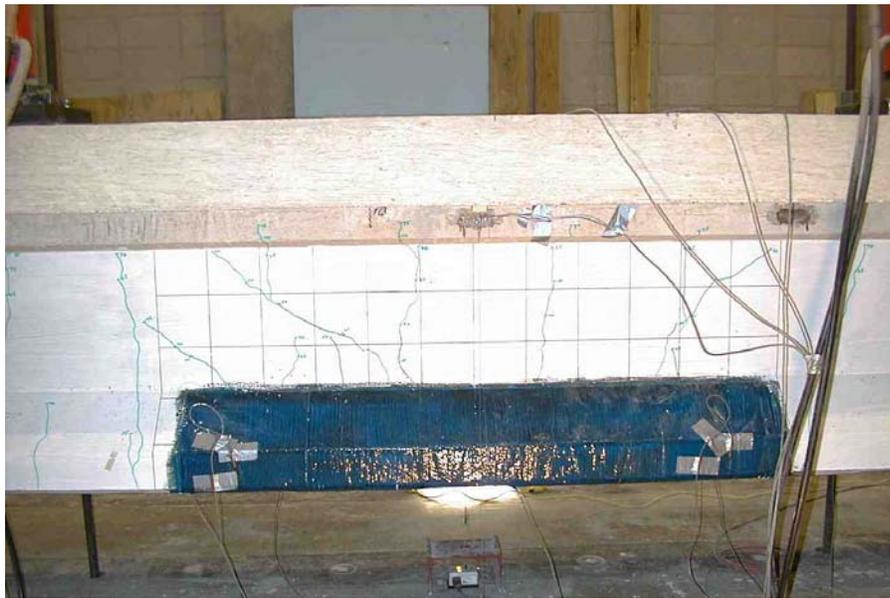
At this level of load, the cracks extended half way through the top flange of the P/C beam. When failure occurred, the cracks were 2 to 3 in. into the 8 in. thick concrete slab. A close-up of the CFRP jacket after debonding occurred is presented in Figure 5.15. The debonded longitudinal fibers are clearly visible in the left-hand side of the photograph. Vertical flexural cracks extended through the CFRP jacket into the concrete web. The jacket obviously provided no strength to the beam in the longitudinal directions since the fibers were oriented in the transverse direction.

Figure 5.14. Crack pattern on the side of Beam 2 at 75 kips.

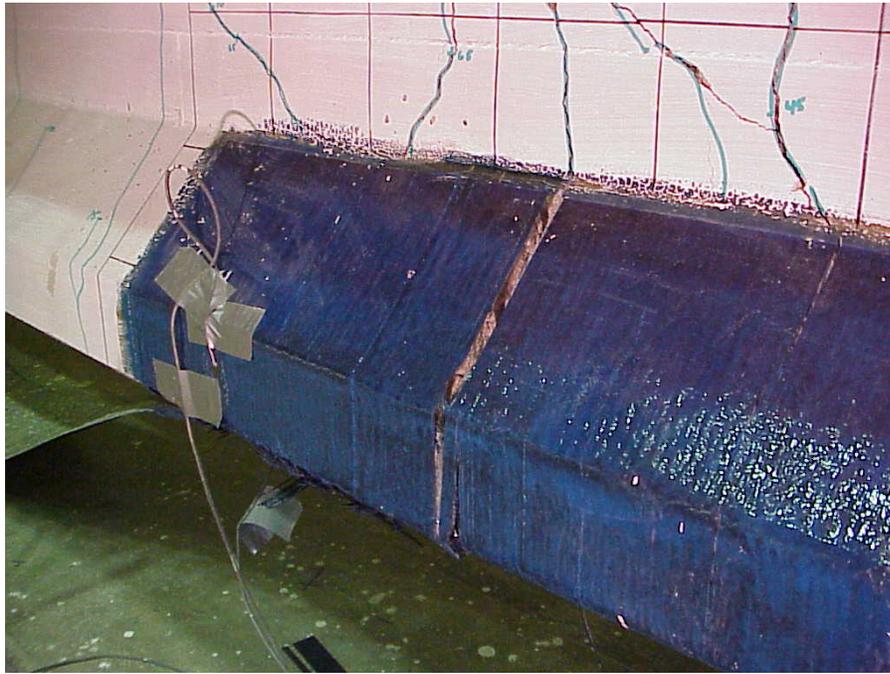
Figure 5.15. Close-up of cracks in CFRP jacket after failure of Beam 2.

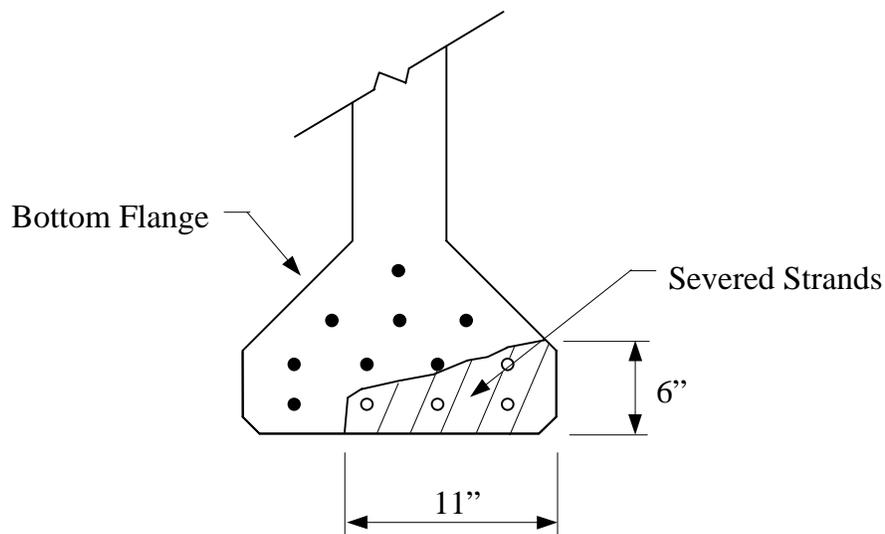
Figure 5.21. Beam 3 damage, four prestressing strands removed.

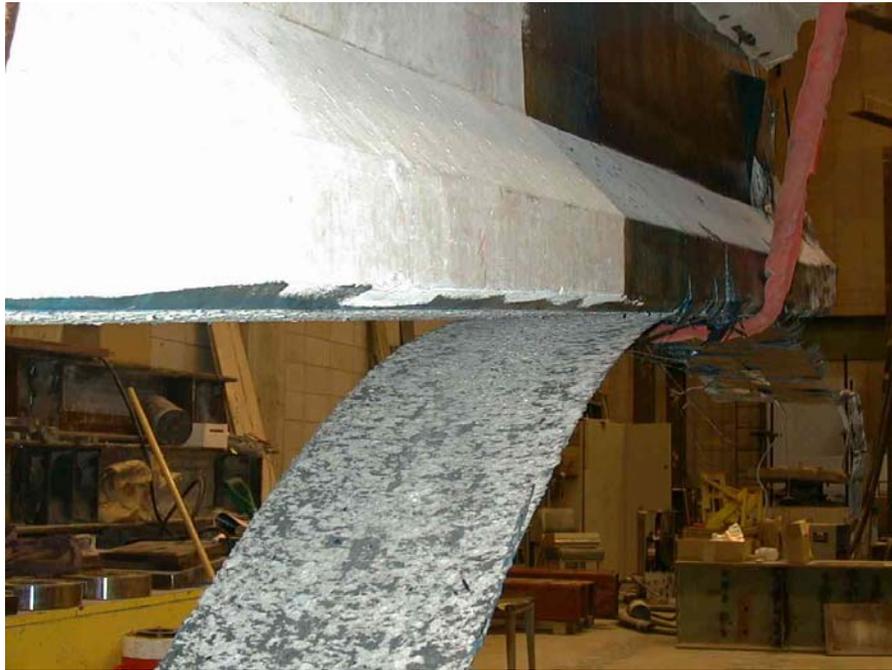
Figure 5.24. Debonded longitudinal sheets on Beam 3.

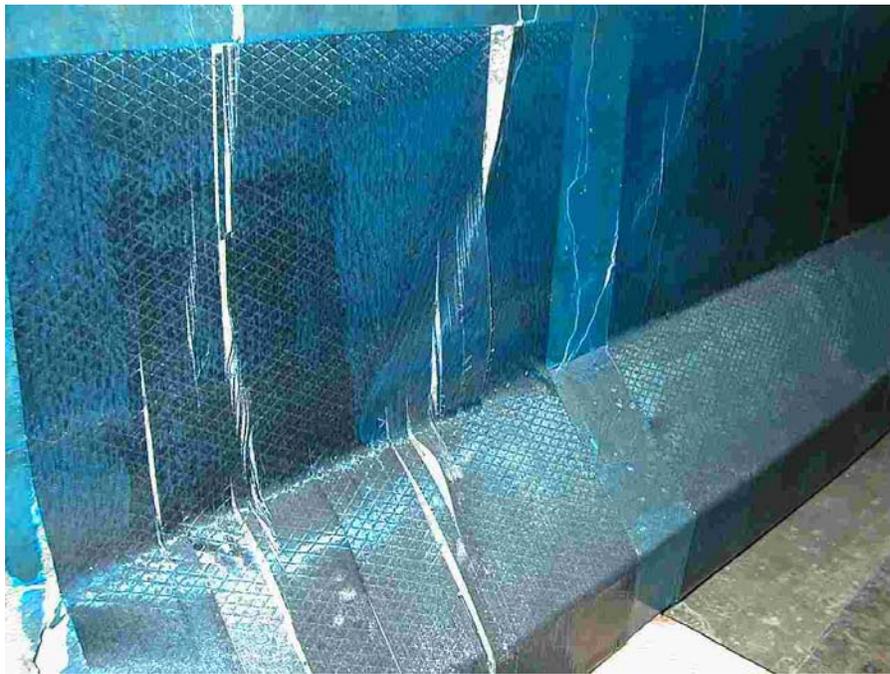
Figure 5.25. CFRP jacket cracks and local delaminations on the web in Beam 3.

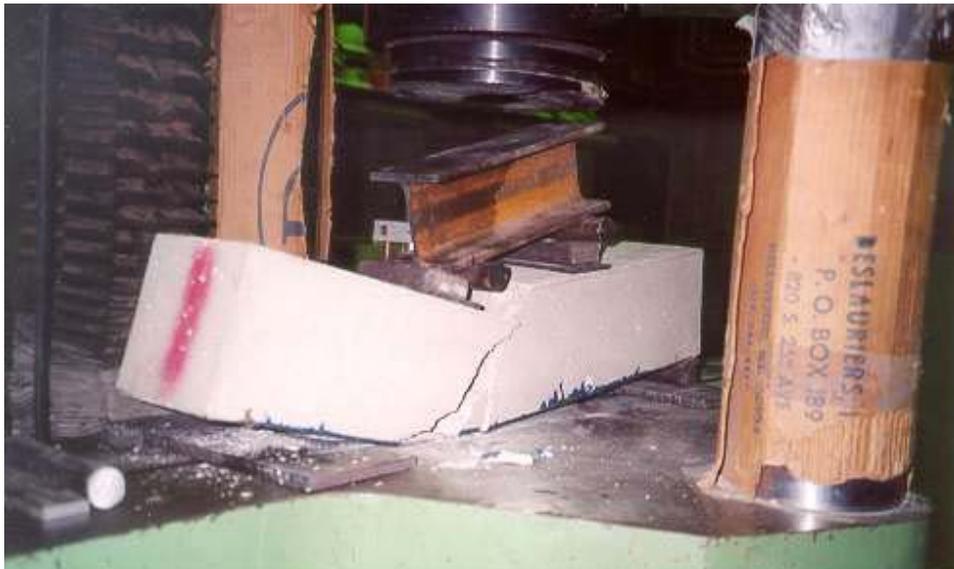
Figure 5.38. Strengthened modulus of rupture beam immediately after failure.

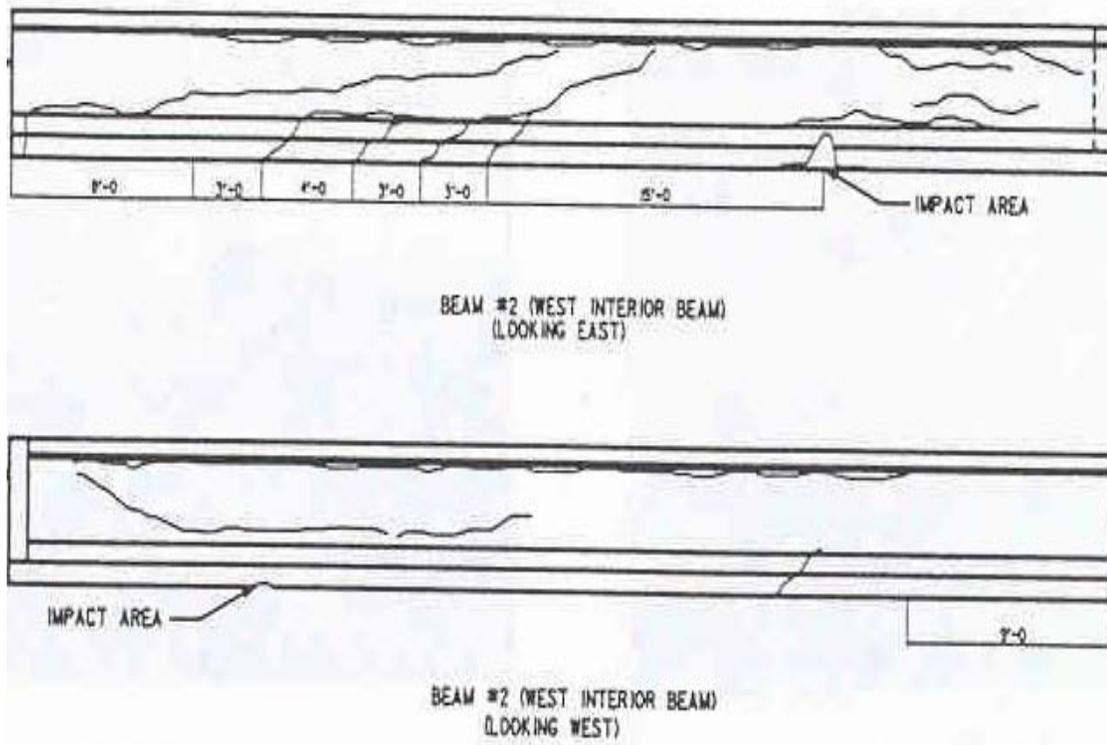
Figure B1. Altoona beam #2 damage drawings.

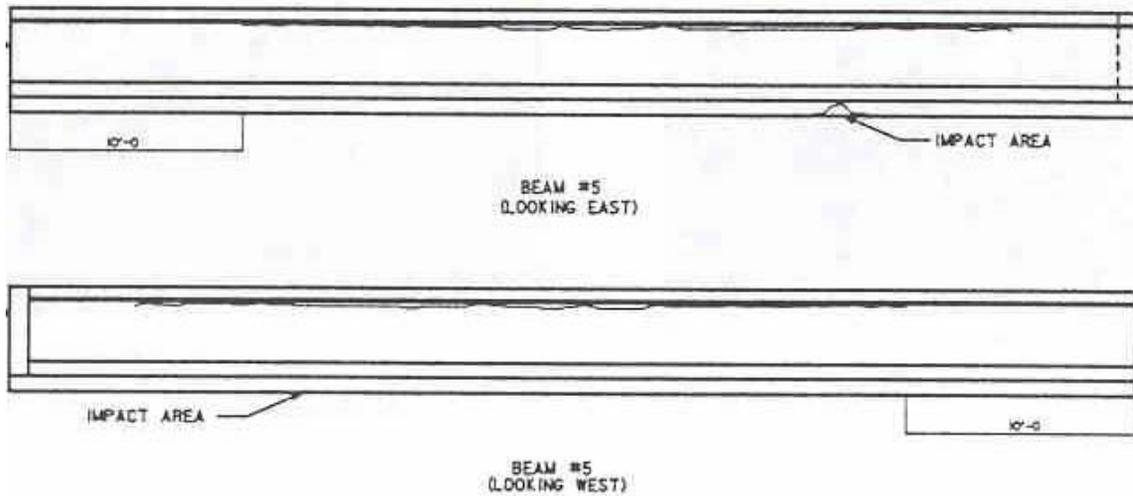
Figure B2. Altoona beam #5 damage drawing.

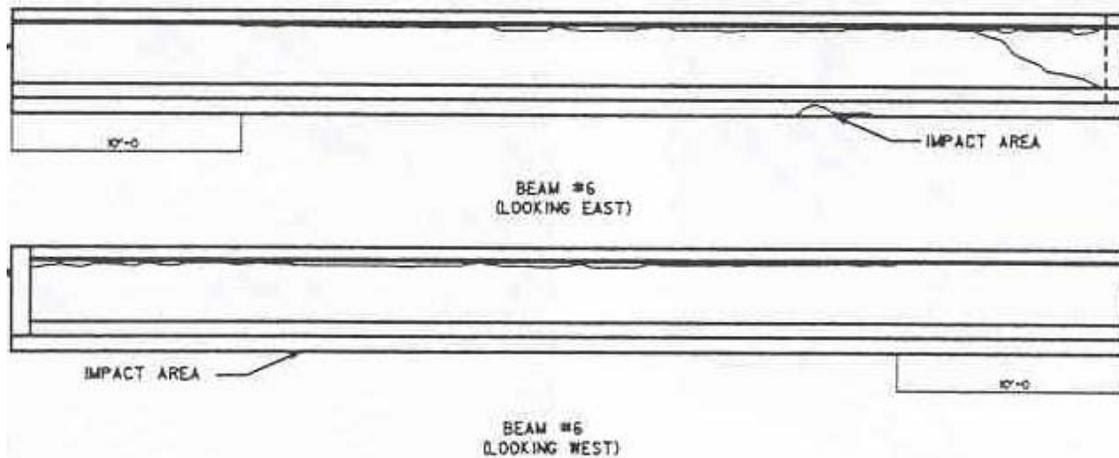
Figure B3. Altoona beam #6 damage drawing.

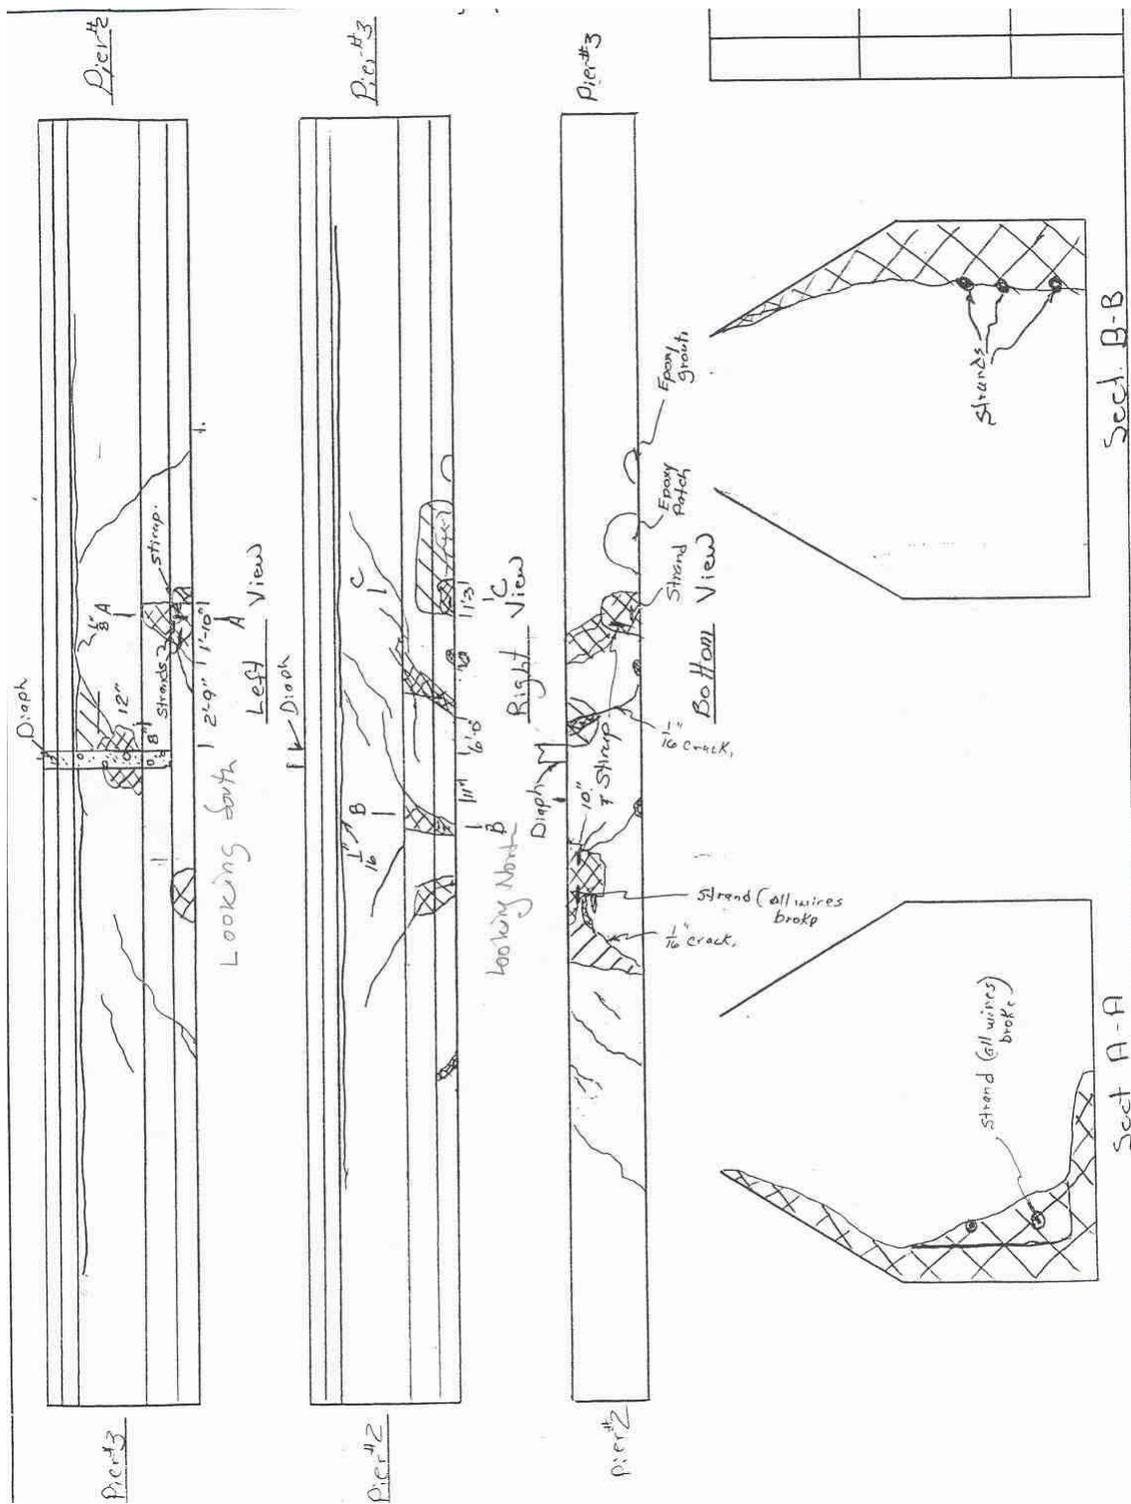
Figure B5. De Soto damaged beam drawing.
