Investigation of Steel-Stringer Bridges: Superstructures and Substructures, Volume II

Final Report
October 2007

Sponsored by
the Iowa Highway Research Board (Project TR-522)
and the Iowa Department of Transportation (CTRE Project 04-184).

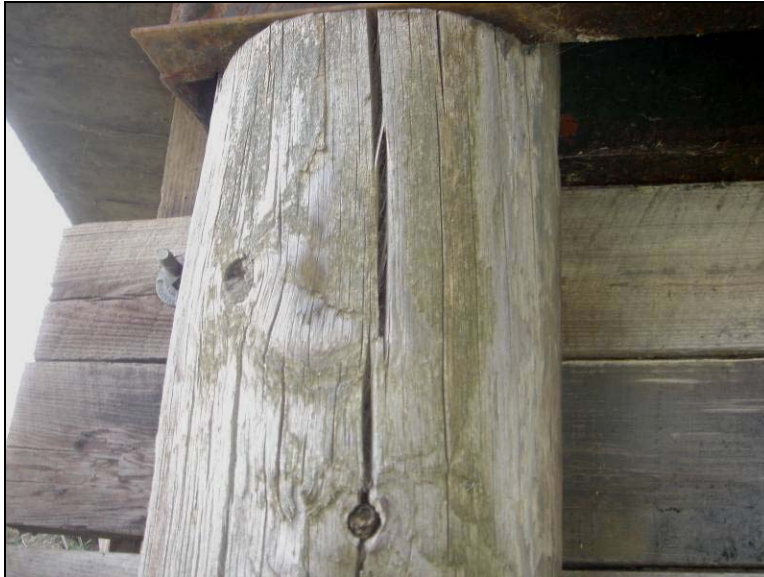
Figure 4.2. Pile cracking near the pile top (Bridge No. 1045 Black Hawk County – April 2 2005)

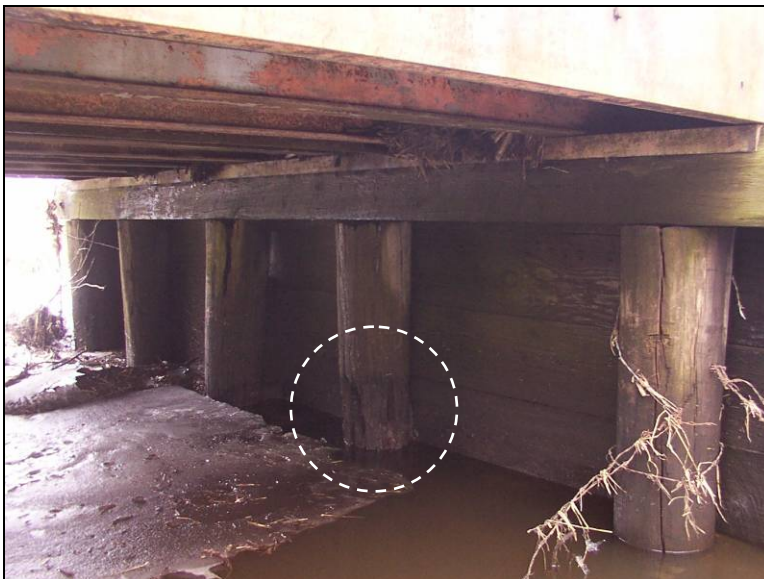
Figure 4.3. Reduction of pile cross section by abrasion from flowing debris and ice (Bridge No. 27-74-23 – February 15 2007)

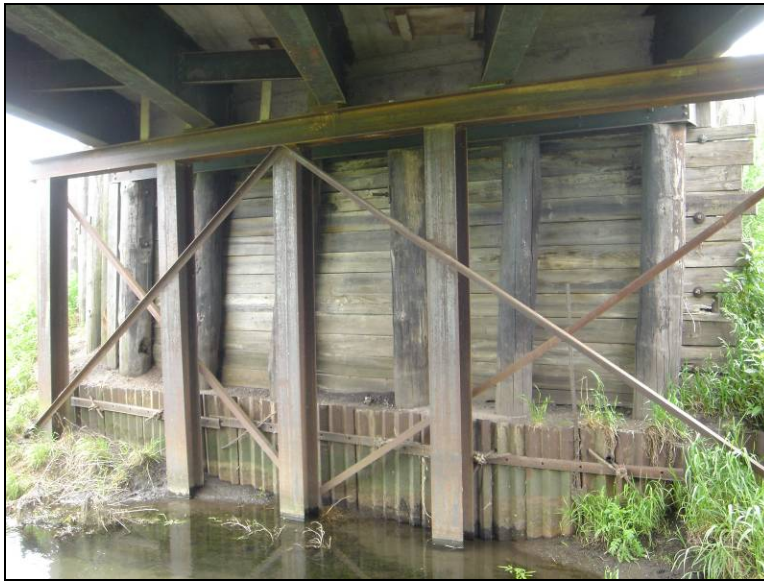
Figure 4.14. Steel piles used to replace deteriorated timber abutment (Bridge in Boone County – June 1 2005)

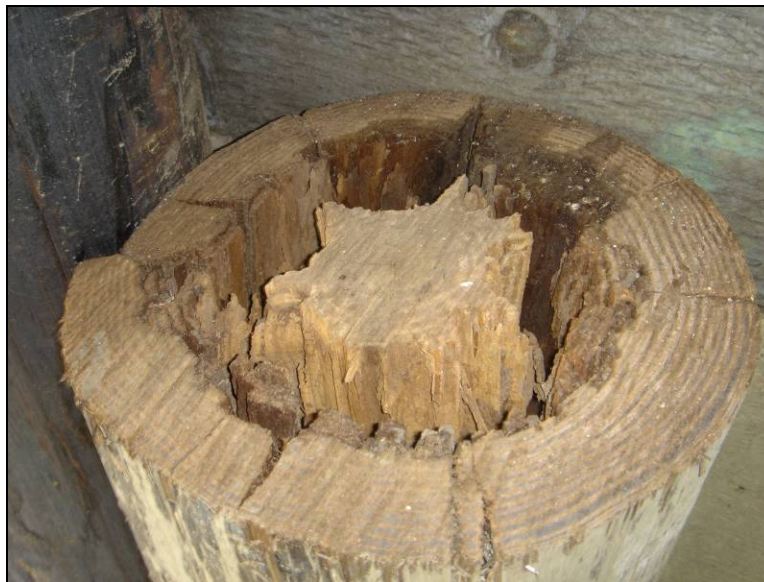
An example of a deteriorated pile is shown in Figure 5.1. The rapid attenuation of the wave in the hollow region hindered the detection of the intact area near the pile core and prevented the wave from reaching the receiving transducer.

Figure 5.1. Significant internal pile deterioration that is difficult to detected using the stress wave technique (Bridge No. 31-72-50 Tama County – June 10 2005)

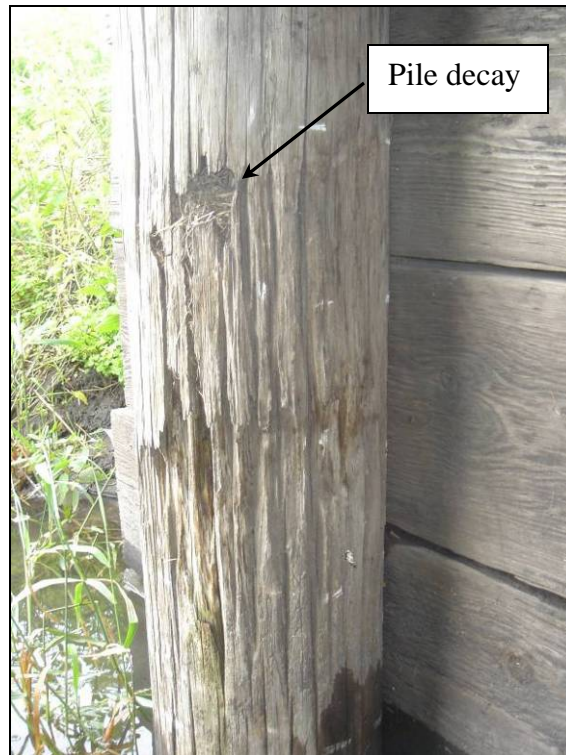
Figure 7.6. Deterioration at pile No. 1 (Bridge No. 7710 Boone County – July 1 2005)

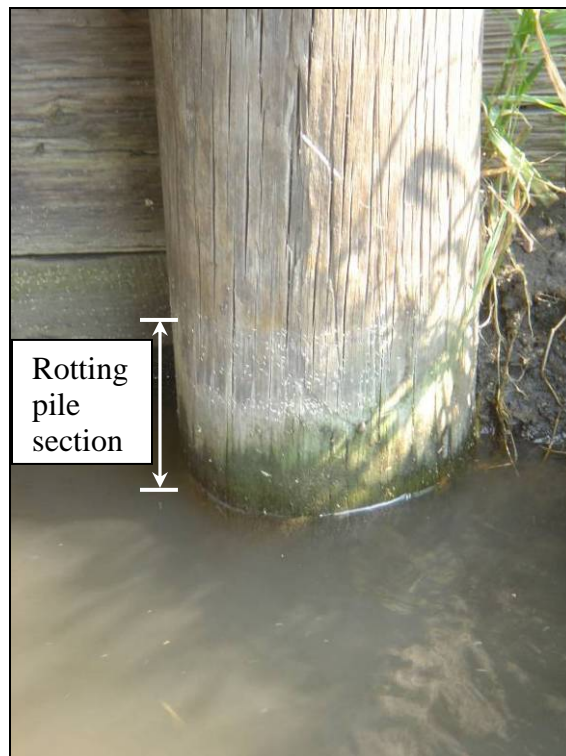
Figure 7.7. Soft section at pile No. 7 above the water level (Bridge No. 7710 Boone County – July 1 2005)

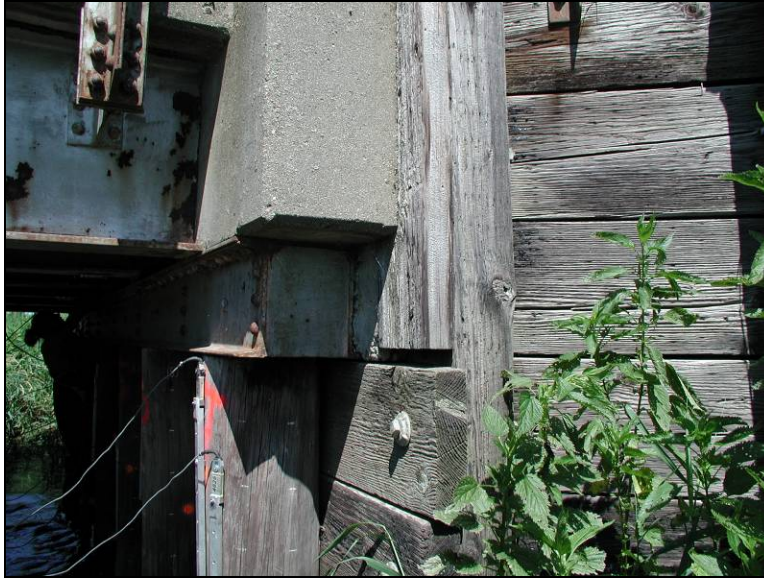
**Figure 7.13. Possible eccentric loading caused by misalignment of pile cap (Bridge No. 7710
– Boone County)**

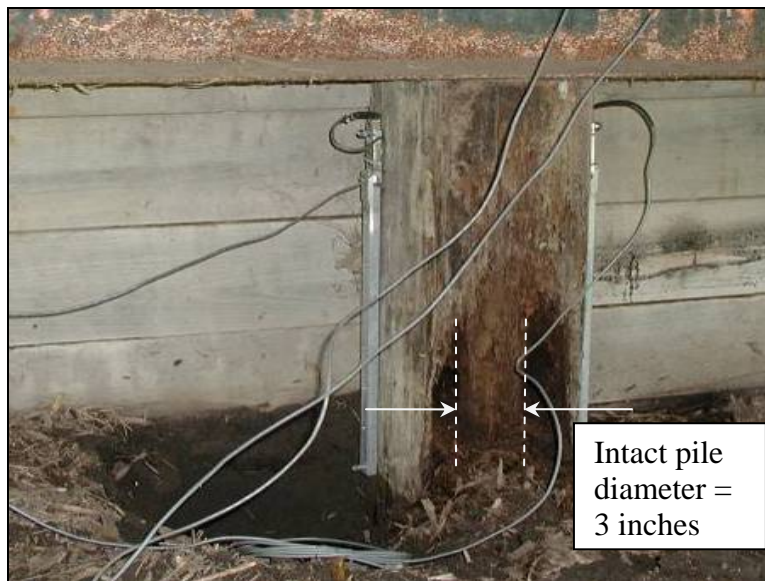
Figure 8.7. Pile no. 4 at the north abutment undergoing biological deterioration (Bridge No. 243470 Marshall County – July 27 2005)

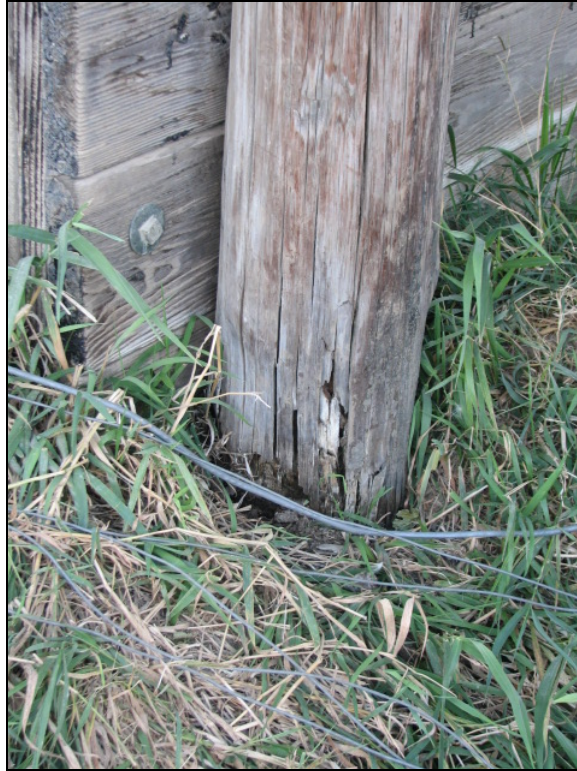
Figure 9.4. Biological deterioration of pile No. 1 at the ground level (Bridge No. 237350 Mahaska County – October 25 2005)

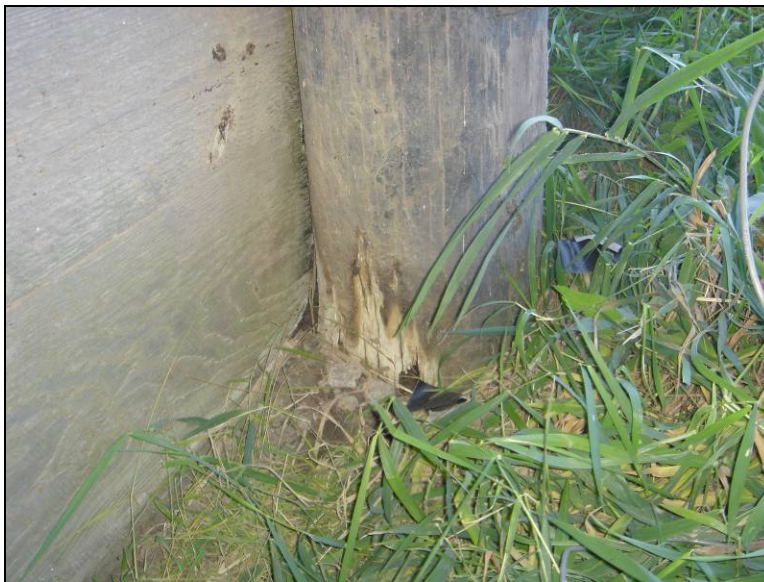
Figure 9.9. Rotting observed at pile No. 5 (Bridge No. 237350 Mahaska County – October 25 2005)

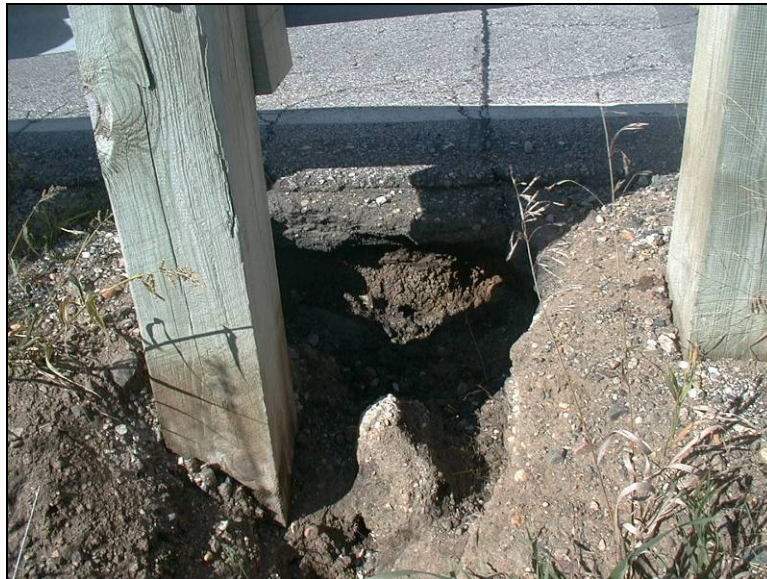
Figure 10.3. Soil erosion near the north abutment (Bridge No. 094680 Carroll County – April 15 2006)

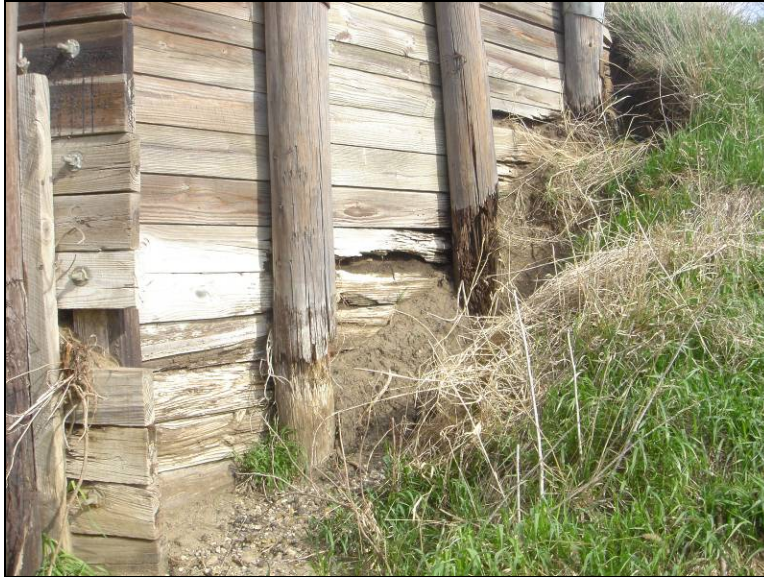
Figure 10.4. Severe deterioration observed at the northeast wingwall piles (Bridge No. 094680 Carroll County – April 15 2006)

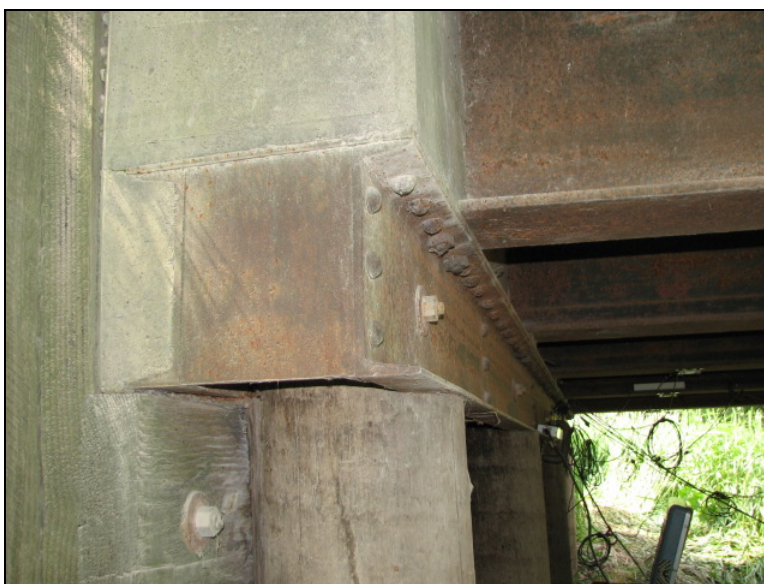
Figure 11.15. Partial bearing of the pile cap on the southeast abutment backwall (Bridge No. 237380 Mahaska County – May 27 2006)
