Field Testing and Evaluation of a Demonstration Timber Bridge

Final Report
February 2012

Sponsored by
Iowa Highway Research Board
(IHRB Project TR-604)
Iowa Department of Transportation
(InTrans Project 08-343)

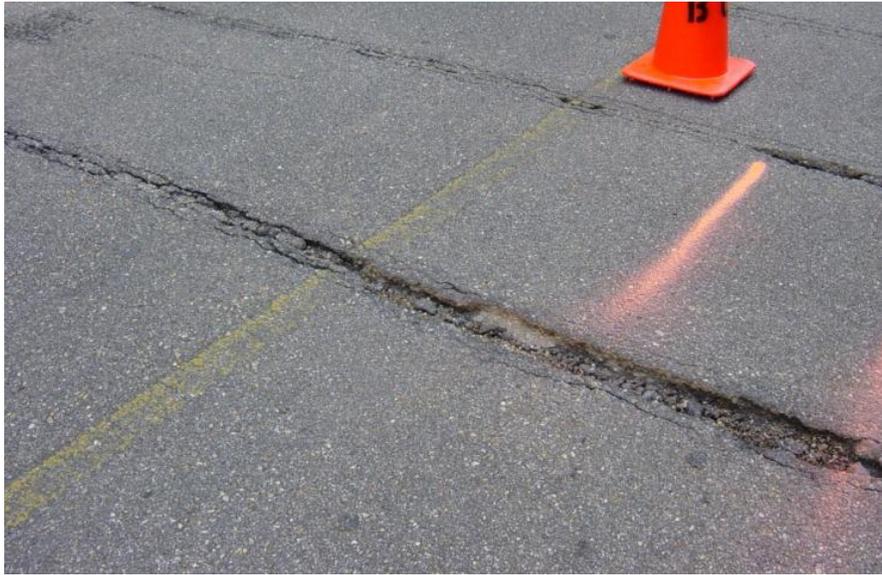
Figure 2.1. Wearing surface deterioration resulting from cupped deck panels

The cupping of the deck panels is believed to be a result of insufficient panel-to-girder connections combined with significant moisture content gradients between the top and bottom surfaces of the deck panel. Although bridges with flat, uncupped deck panels had wearing surface deterioration that was less severe than those with cupped panels, in most cases, the deterioration was significant nonetheless. Lastly, of the bridges tested, those with the best-performing asphalt wearing surfaces were also found to have lower global midspan girder deflections as shown in Table 2.2.

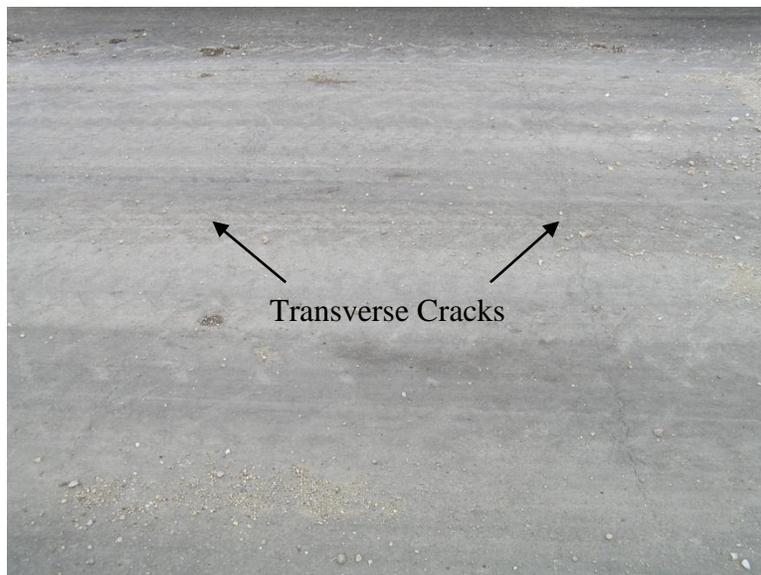
Inspection of the wearing surface one month following construction of the bridge noted transverse cracking at the deck panel joints on Span 2, as illustrated in Figure 5.1, and less noticeable cracks on Span 1 over the deck panel joints. However, cracking over the plywood joints was also observed in Span 1.

Figure 5.1. Transverse cracking evident one month post construction on Span 2

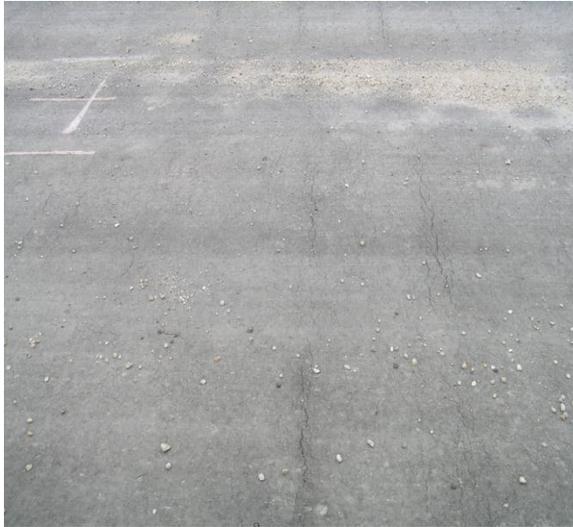
a. Span 1

One month after the initial inspection and testing, a follow-up inspection was completed. The substructure and superstructure were, again, in excellent condition and unchanged. The wearing surface condition was unchanged as well, with the exception of one observation. On Span 1, additional minor cracking in the wearing surface was noted at the deck panel joints, in addition to the cracking at the transverse plywood joints noted a month earlier, as shown in Figure 5.2.

Figure 5.2. Transverse cracking two months post construction

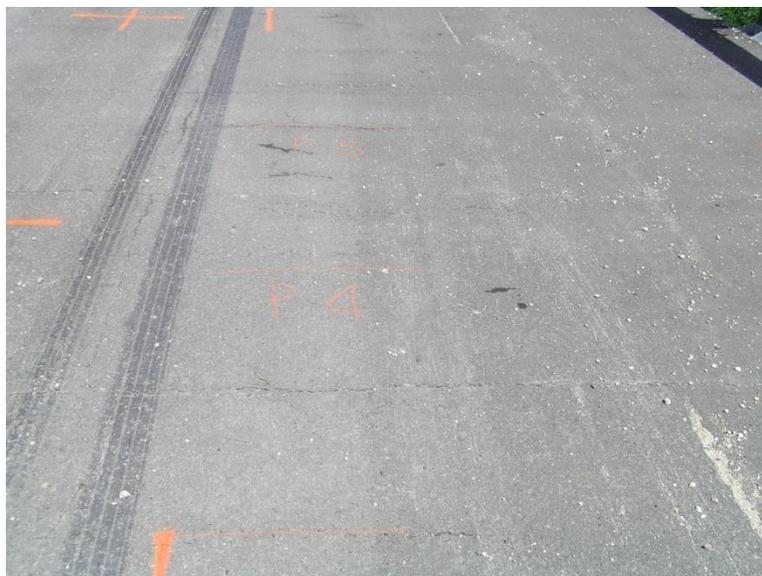
Approximately one year after construction of the demonstration bridge, the research team conducted a second visual inspection and load test on the structure. Visual inspection of the substructure and superstructure components again indicated that these components were in excellent condition. Inspection of the asphalt wearing surface revealed cracking of the wearing surface at the deck panel joints on Span 2 (no plywood); on Span 1 (with plywood), visible cracking was evident at the transverse plywood joints as well as at the panel joints (see Figure 5.3).

Figure 5.3. Transverse cracking, Span 1, one year post construction
