# Evaluation of Hand Held Infrared Cameras for Bridge Deck Inspection

Final Report

September 2013

SP&R Project # RB15-012

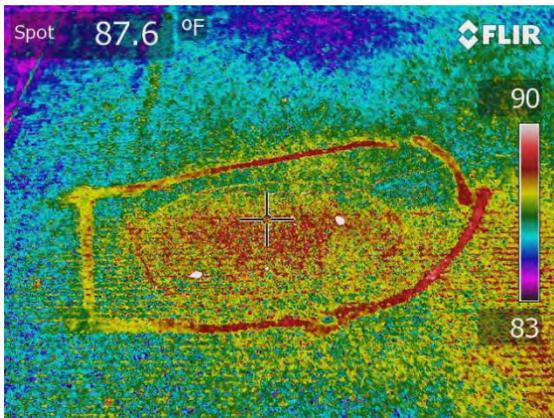
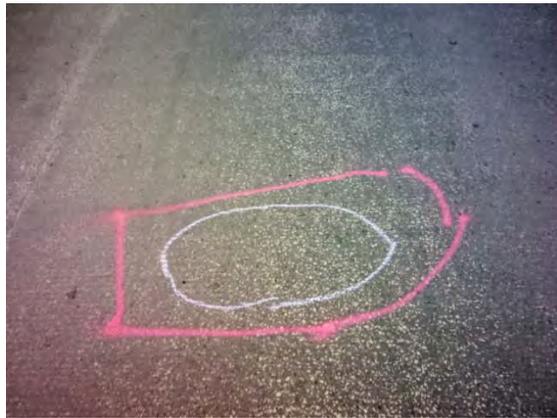
During the initial inspection time, the camera did not identify temperature discrepancies at the locations identified as hollow by manual sounding. As the deck temperature increased, temperature variations were identified at the hollow areas and there was some correlation between the two methods. However, the infrared image variation between the wheel path and the rest of the deck obscured the temperature variation at hollow areas. The following photographs show the infrared image and corresponding visual image of hollow locations. The paint outline identifies the extent of hollow areas as determined by manual sounding. The chalk outline identifies the hollow areas identified with the

infrared camera. Hollow locations in the shadow of the barrier rail were not identified with the infrared camera.

Figure 2 delamination IR image

Figure 2a delamination visual image

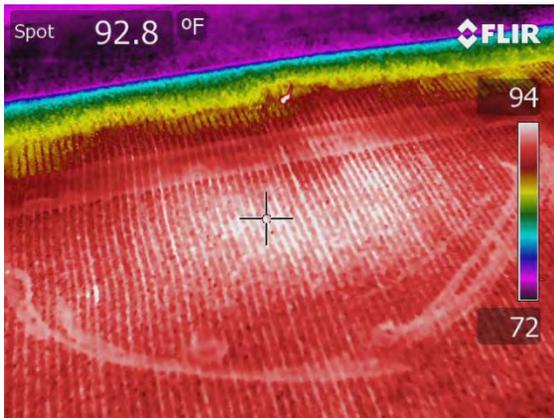
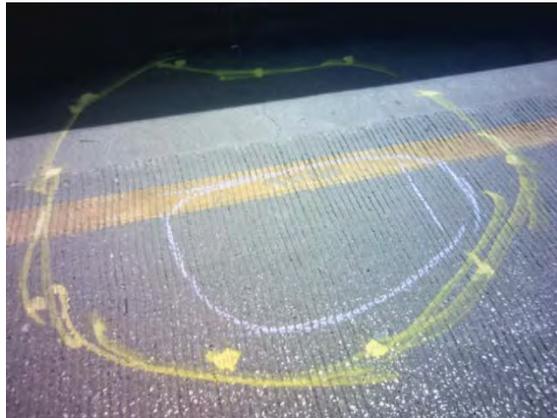
Figure 3 delamination IR image

Figure 3a delamination visual image

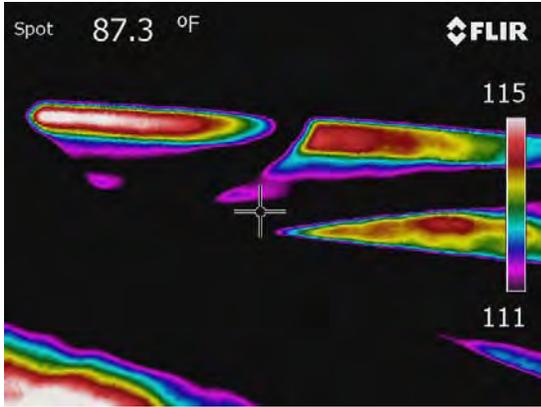
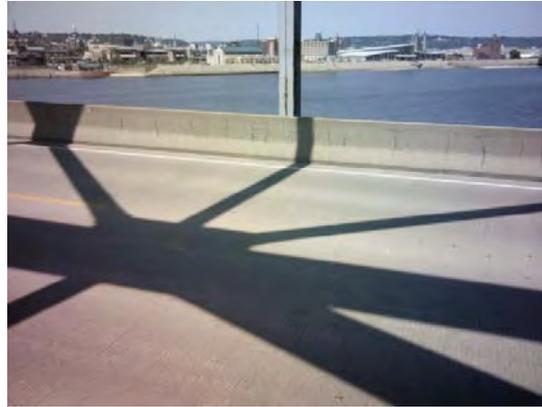
The bridge was surveyed July 7, 2012. This bridge is a tied arch truss. The superstructure shadows prevented evaluation of the deck. This is shown in figures 4 and 4a. Portions of the substructure were also reviewed with the infrared camera. Delaminations were clearly identified in the IR image although confirmation by hand sounding was not performed due to access limitations. Examples of the substructure findings are shown in figures 5, 5a, 6 and 6a.

Figure 4 deck IR image

Figure 4a deck visual image

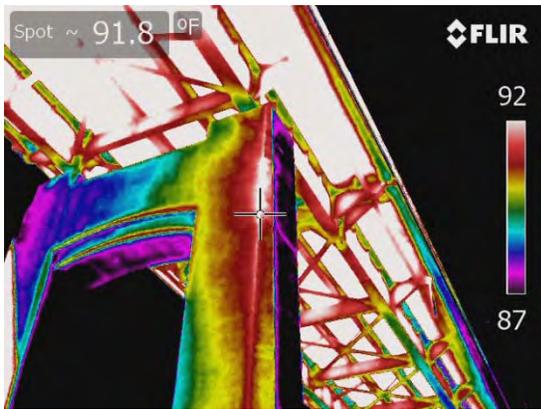
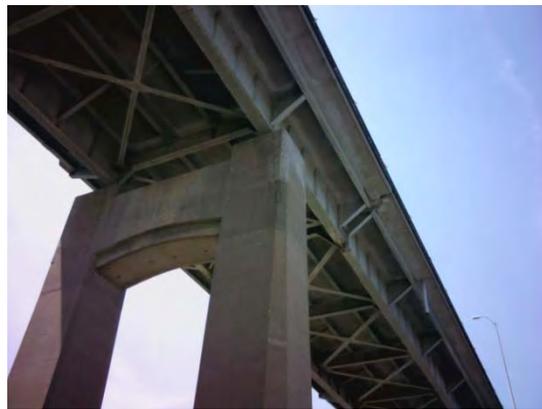
Figure 5 substructure IR image

Figure 5a substructure visual image

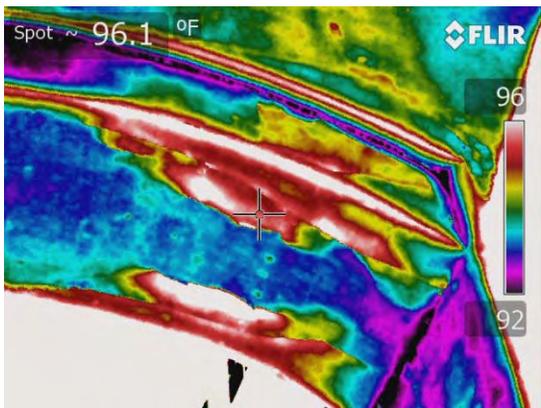
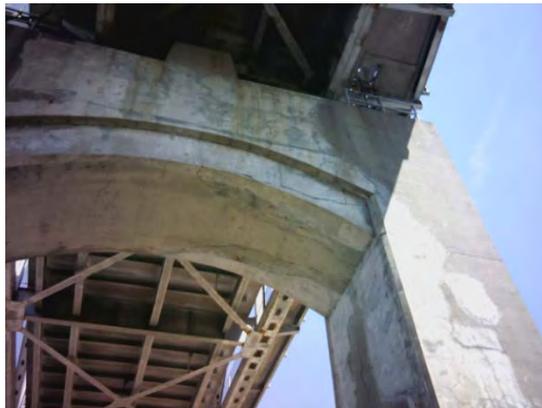
Figure 6 substructure IR image

Figure 6a substructure visual image

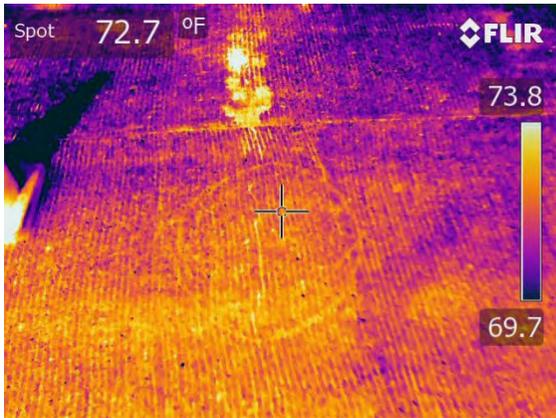
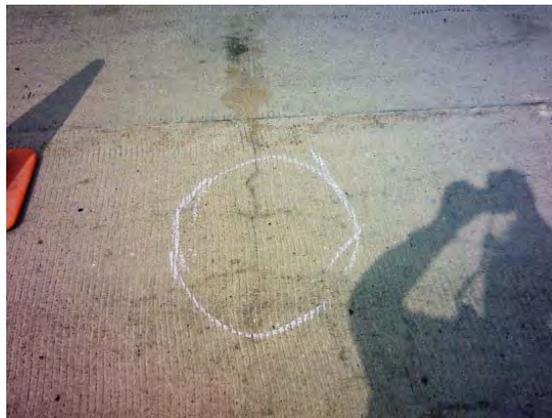
This bridge was surveyed on September 21 and September 26, 2012. Numerous delaminations were identified using hand sounding techniques. Most of the delaminations could not be identified with the infrared cameras. Of those that could, it is doubtful that they would have been located without the prior hand sounding. Figures 7 and 7a show a typical delamination.

Figure 7 deck IR image

Figure 7a deck visual image

Cores were taken at selected locations. The delaminations were found to be over two inches deep and were beyond the capabilities of the thermal imaging camera to detect.
