## ASSESSMENT OF WEATHERING STEEL BRIDGE PERFORMANCE IN IOWA AND DEVELOPMENT OF INSPECTION AND MAINTENANCE TECHNIQUES

**Final Report**  
**SPR 90-00-RB17-012**  
February 21, 2013  
WJE No. 2011.1671

*Sponsored by:*  
**Iowa Department of Transportation**  
**Office of Bridges and Structures**  
**800 Lincoln Way**  
**Ames, IA 50010**

*Prepared by:*  
**Wiss, Janney, Elstner Associates, Inc.**  
330 Pflingsten Road  
Northbrook, Illinois 60062  
847.272.7400 tel | 847.291.4813 fax

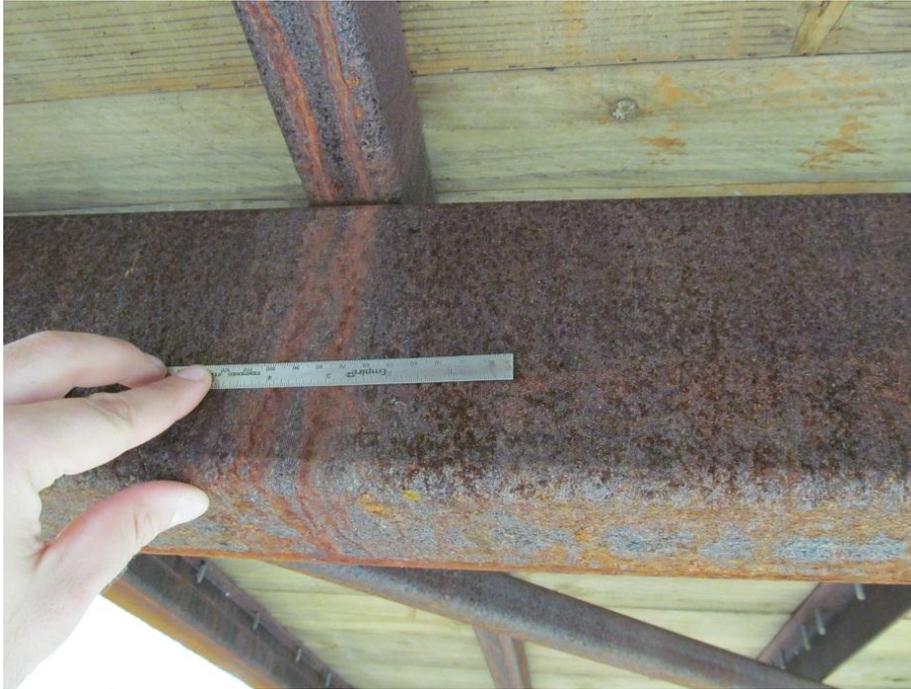
*Figure 4. Apparent nonprotective patina on the floor beams and bottom chords of this 10 month old wood-decked pedestrian bridge.*

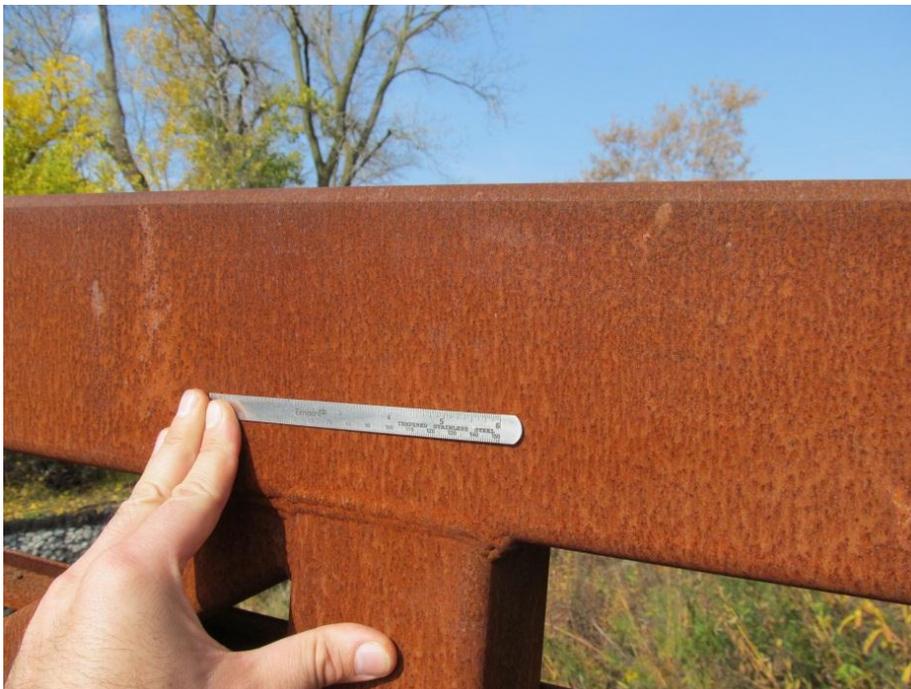
*Figure 5. Developing patina on pedestrian bridge in a suburban Illinois park. Note the adherent, small size of the patina rust particles, and the reddish coloration.*

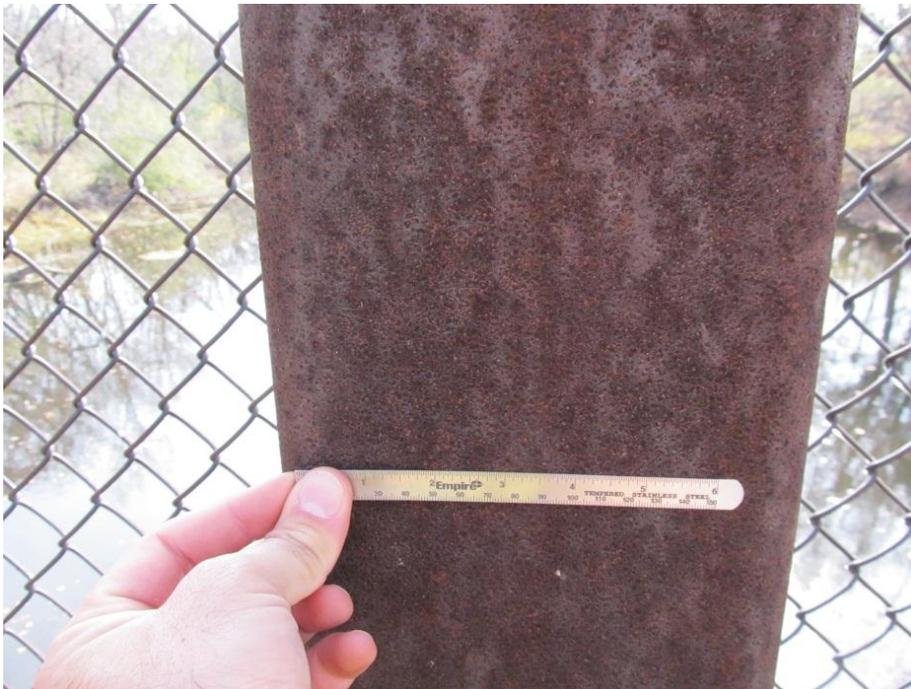
*Figure 7. Close-up photo of patina performance on the Des Plaines River pedestrian bridge; patina is dense and adherent, with small constituent rust particles.*

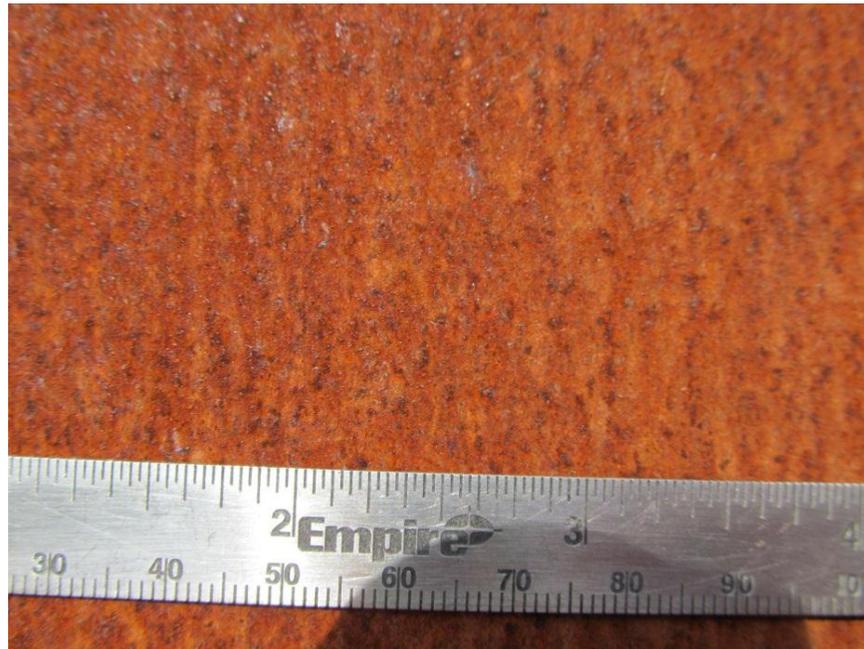
*Figure 16. Close-up photo of Category 5 patina taken from Illinois pedestrian bridge truss. Only isolated regions of Category 5 patina, likely due to mill scale, were observed on Iowa bridges.*

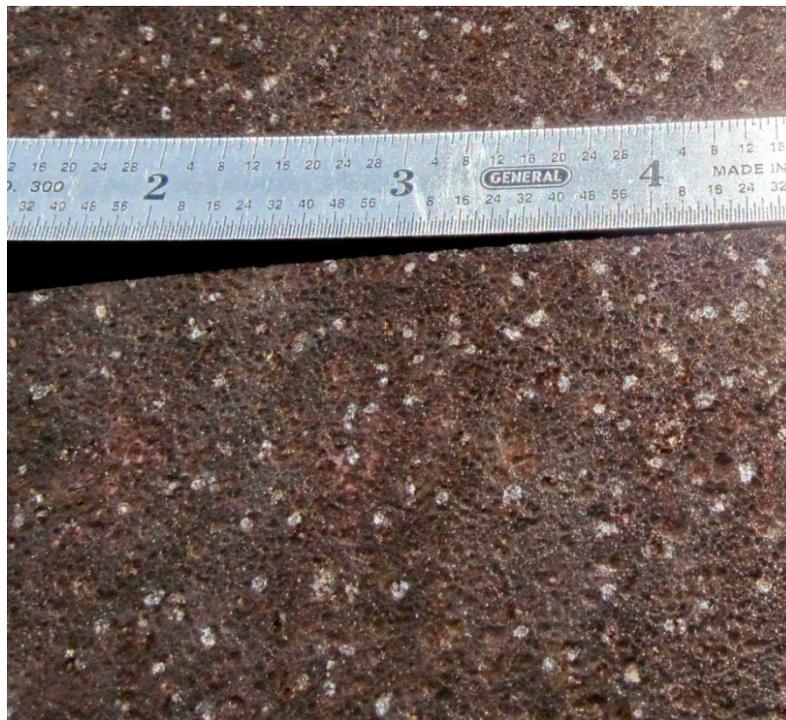
*Figure 17. Close-up photo of Category 4 patina commonly observed on exterior web of fascia girder. Surface is textured but tightly adherent, and rust formations are small. No loose flakes are present.*

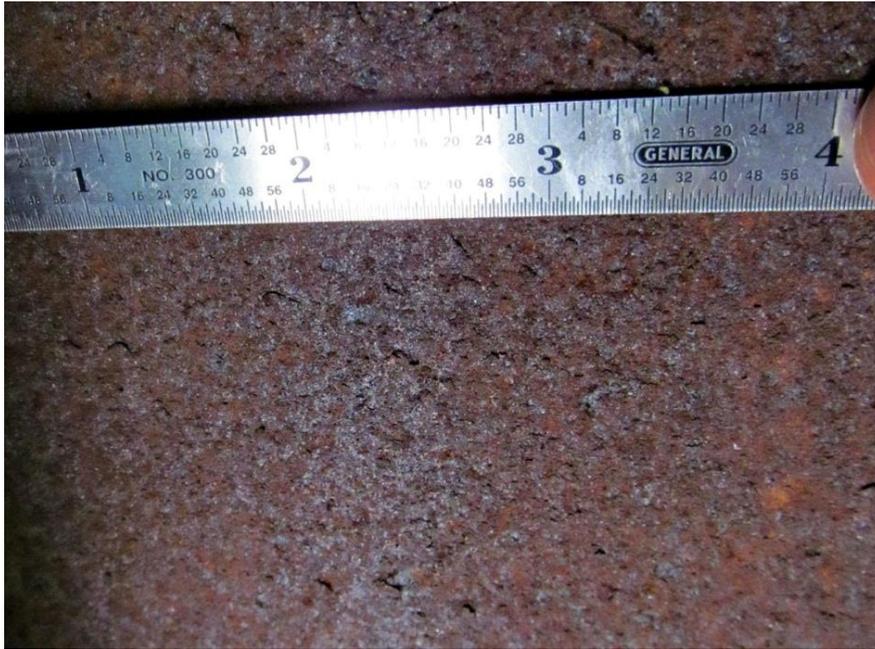
*Figure 18. Close-up photo of Category 3 patina on bottom of interior girder web. Texture is less uniform but still generally adherent, with some small loose flakes.*

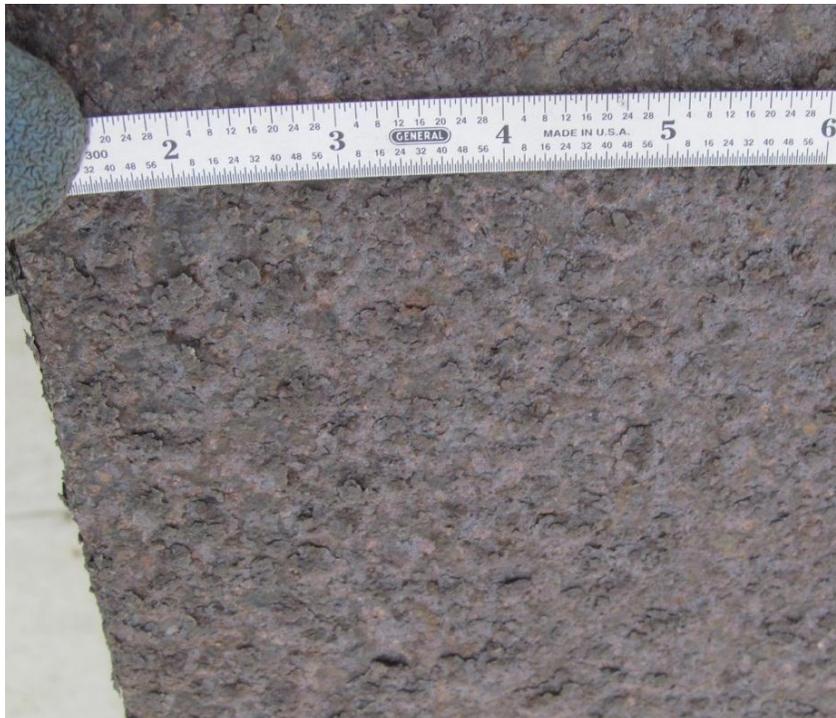
*Figure 19. Close-up photo of typical Category 2 patina on the underside of an interior girder bottom flange. Medium size flakes are easily peeled away with a fingernail.*

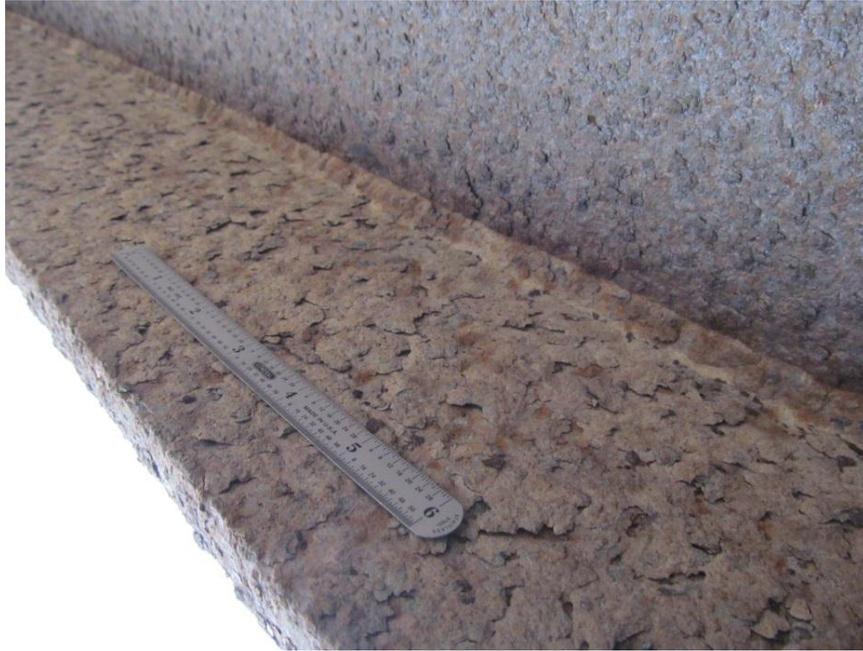
*Figure 20. Category 1 patina on top of an interior girder bottom flange; note the large, loose, thick flakes that cover virtually the entire surface. Section loss is not yet apparent in this case.*

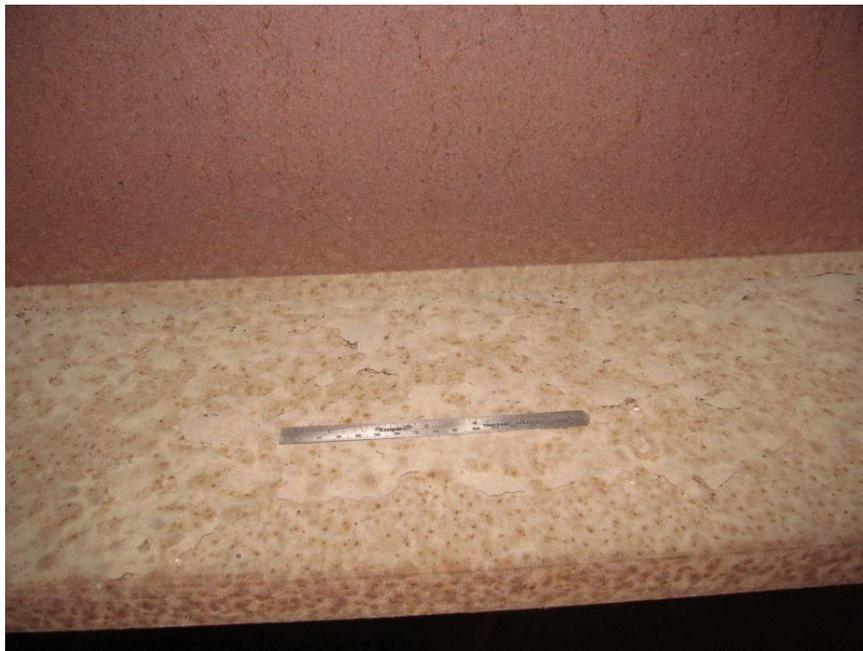
*Figure 21. Poulitice corrosion on an interior girder flange in downtown Des Moines. This is typical of conditions observed on the tops of many interior horizontal elements. Close examination and testing confirms this chalky film is primarily a mixture of dirt and salts.*

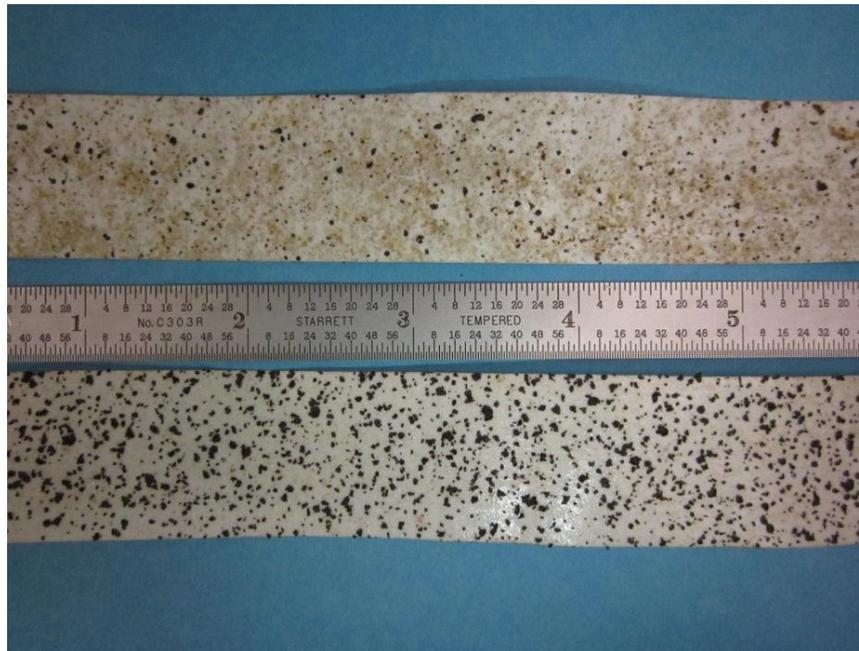
*Figure 22. Tape test comparison of heavily chalked interior (top sample) and exterior (bottom sample) fascia girder bottom flange; note lighter coloration of salt and dirt deposits compared to rust flakes in poultice corrosion sample (top sample). Patina index rating for both of these specimens is 3.5.*

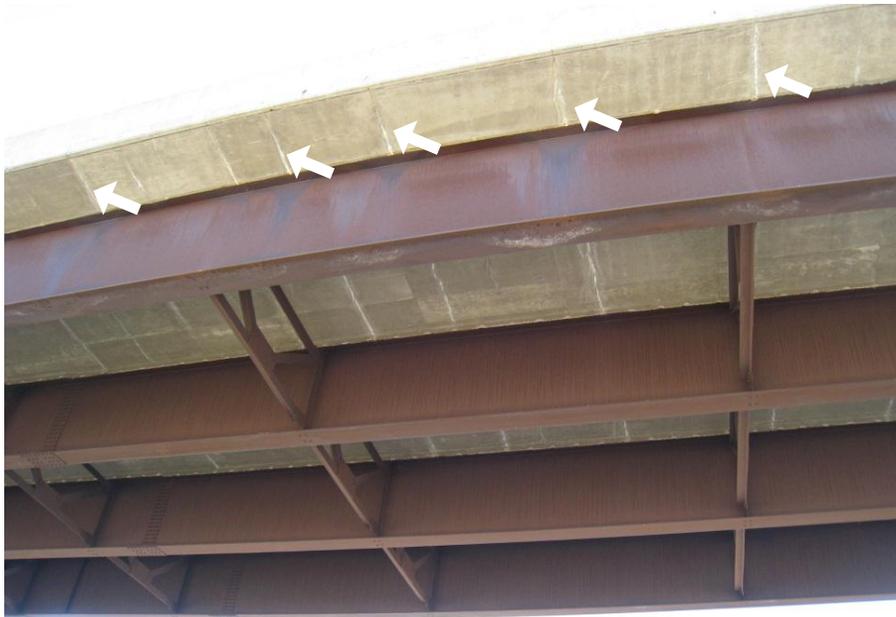
*Figure 35. Cracking with efflorescence noted in the concrete deck (arrows) at Structure 9799.5L075, Field Selection 10. Note areas of non-uniform, black weathering steel patina and salt staining on the bottom flange below each crack in the deck.*

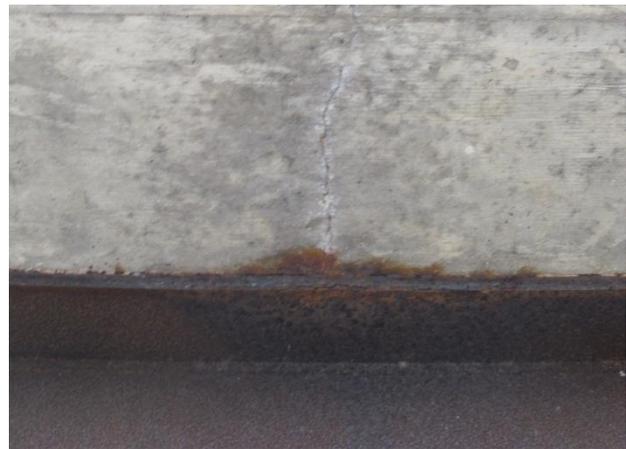
*Figure 2. Top flange deterioration beneath concrete deck crack; possibly index rating of 1 on hidden top.*

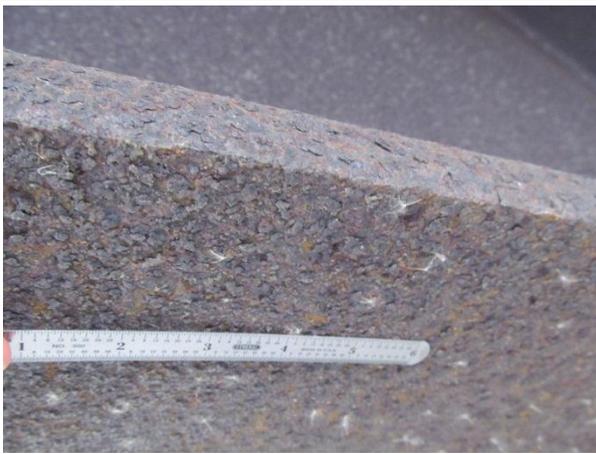
*Figure 3. Flakiness on interior bottom flange near south abutment (Index = 2.5). Worse than over traffic on north half of bridge.*

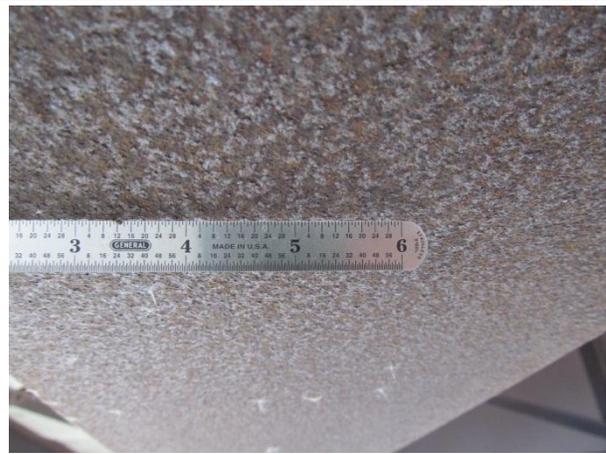
*Figure 4. Interior bottom flange condition near north abutment; index here is 3.5. Contrast with Figure 3 from identical location at south end.*

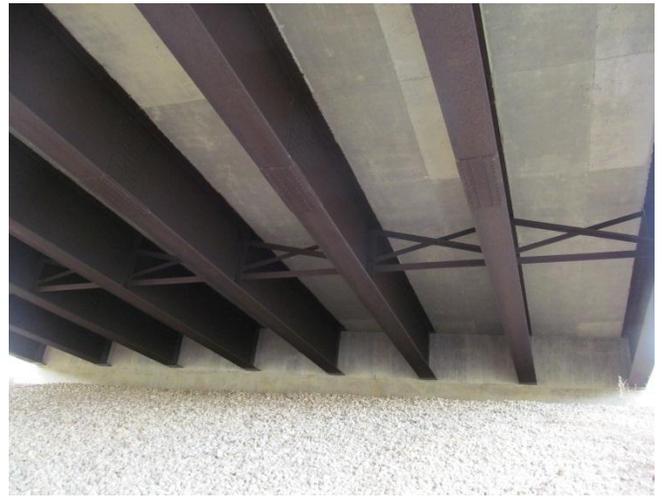
*Figure 2. Typical conditions underneath interior of both bridges. Index = 3.5 to 3 on bottom flanges. Sound deck prevents water infiltration from above.*

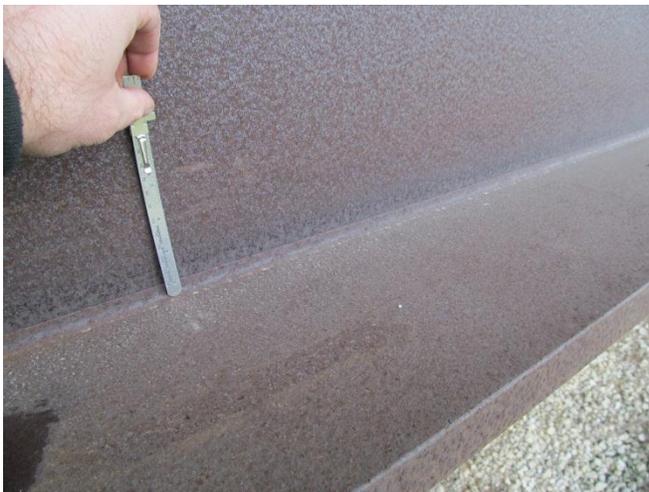
*Figure 3. Index 4 and 3 patina on web and top of bottom flange, respectively, near fascia girder tape and chloride tests on 608020.*

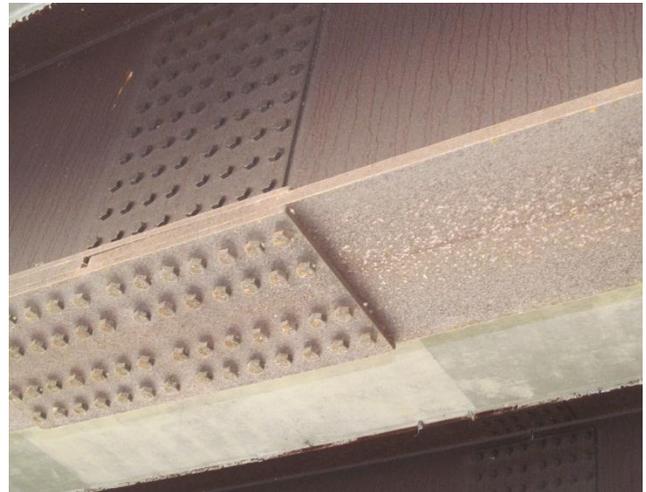
*Figure 4. Mild salty staining and flakiness visible on bottom flange near girder splices over shoulder. Patina Index = 3.*

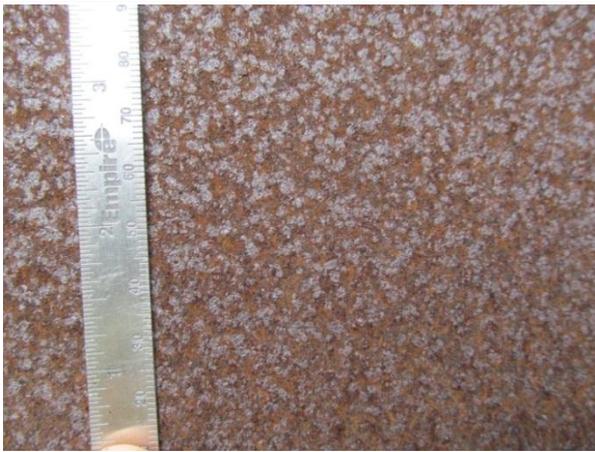
Figure 3. Typical close-up of Index 4 patina on fascia web.

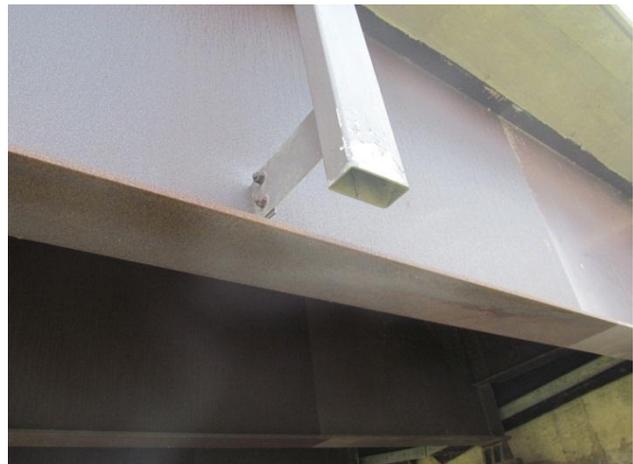
Figure 6. View of downspout; bottom flange corrosion extends away from spout, primarily in direction of girder slope.

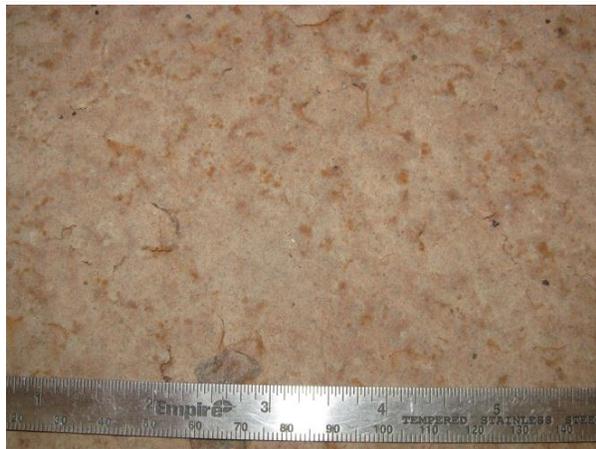
Figure 1. Top of bottom flange poutlice prior to washing; Index = 2, chlorides measured = 20 ppm.

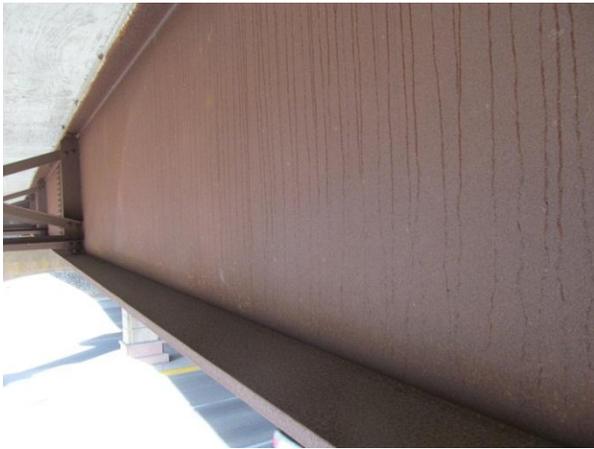
*Figure 1. Typical interior girder conditions; good patina performance on web and flange, despite flange poutlice.*

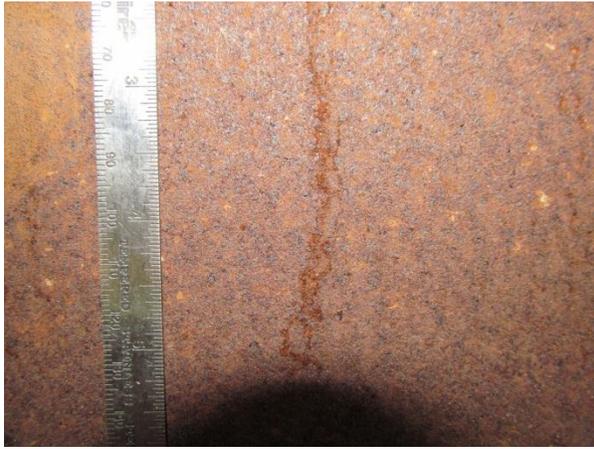
*Figure 3. Web patina performing well (Index = 3.5).*

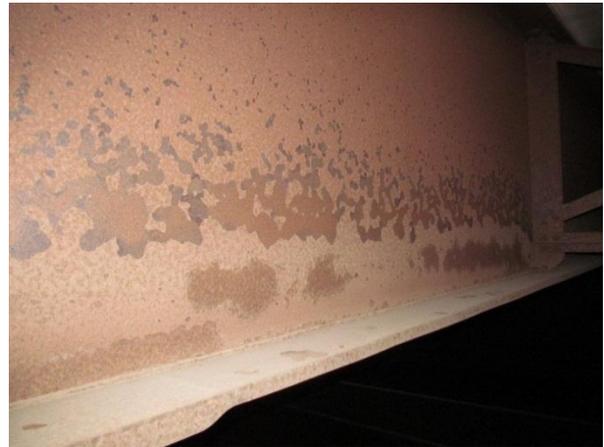
*Figure 2. Typical widespread delamination on web above traffic. Lower delaminations appear older, beginning to deteriorate again.*

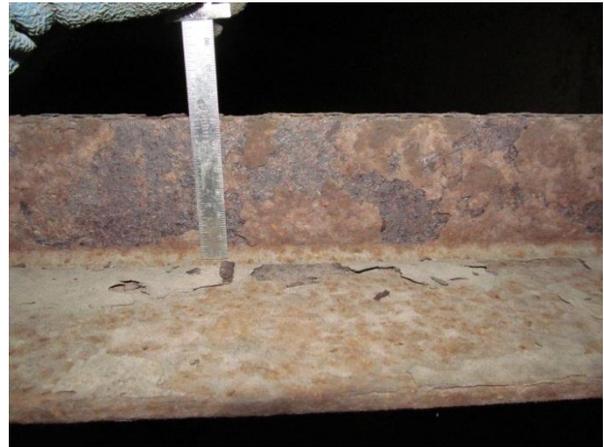
*Figure 4. Heavy deterioration typical of cross-frame members over traffic lanes.*

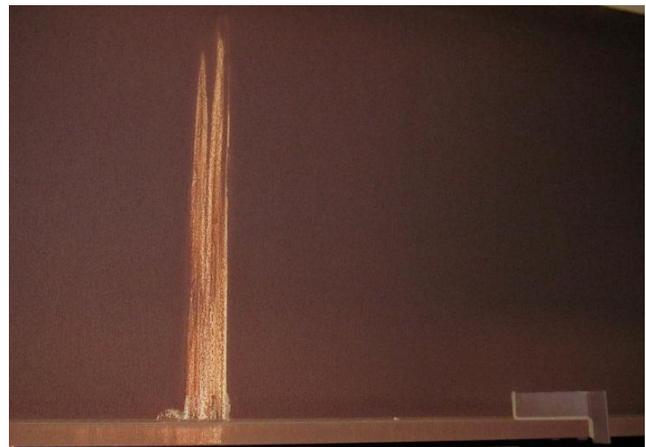
*Figure 6. Example of staining on fascia girder. Patina locally under-developed underneath.*

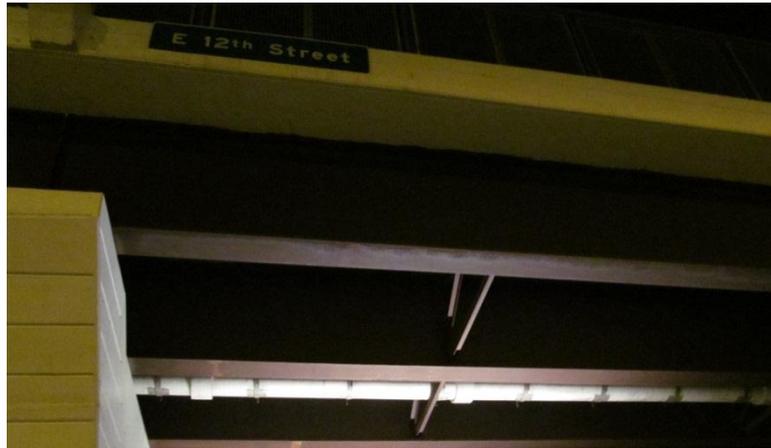
*Figure 1. White, salty staining on west fascia girder (toward oncoming traffic) bottom flange south of pier.*

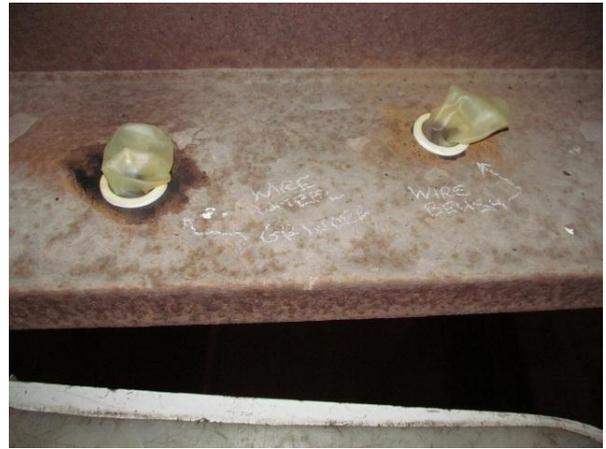
Figure 2. Chloride tests with some leaking on chalky poultrice of bottom flange before washing.

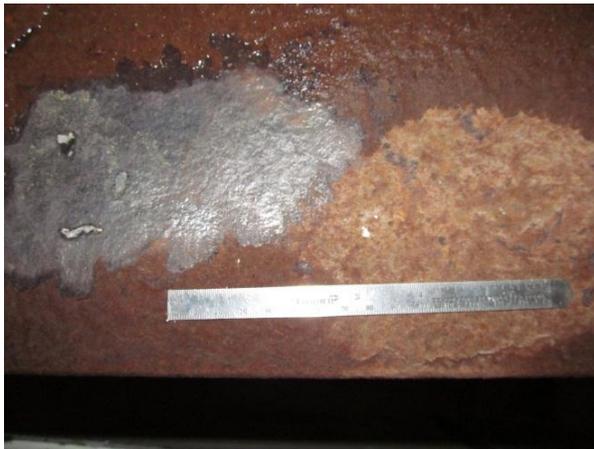
Figure 3. Close-up of wire wheel ground area and adjacent as-is poultrice after washing and drying.

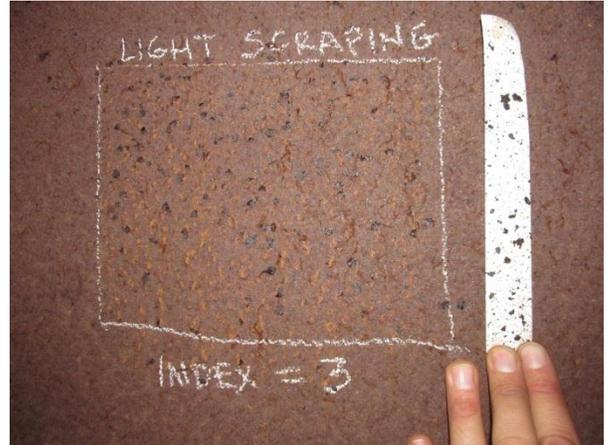
Figure 2. Interior middle of web tape test and hand scraping of loose flake (dark spots). Index later determined to be 2 based on tape flake size.

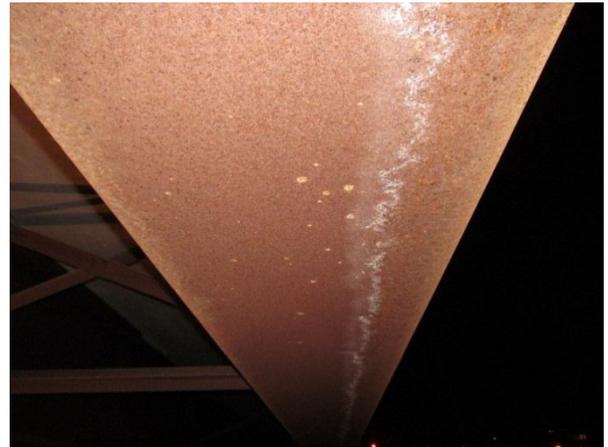
Figure 4. White staining on bottom flange of west fascia on eastbound lanes (side toward traffic).

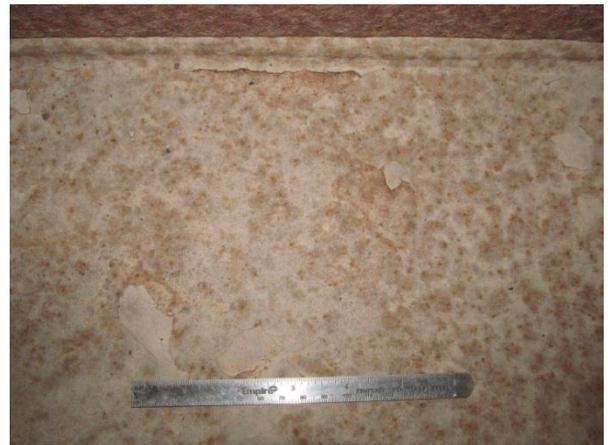
Figure 6. Delaminated, heavy pultice corrosion on interior bottom flange.

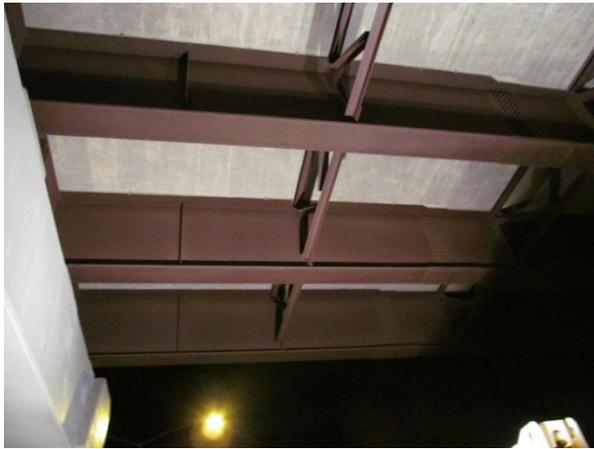
*Figure 1. East half of bridge girders near pier; generally good patina condition viewed from below.*

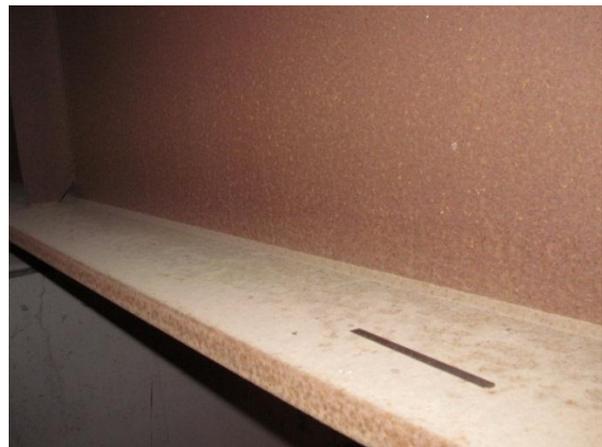
*Figure 6. Interior girder bottom flange with heavy poultrice corrosion viewed from arm's length.*

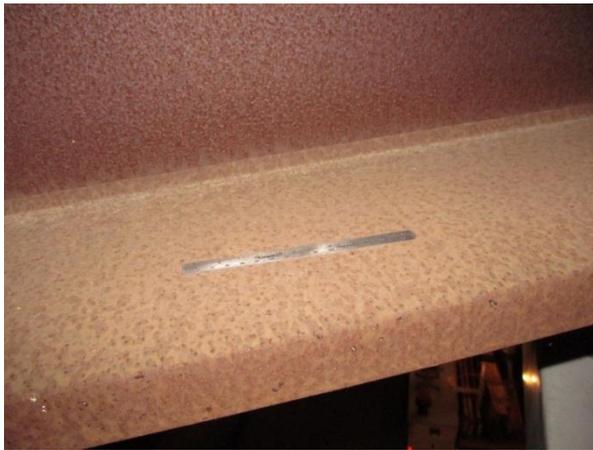
*Figure 3. Light poulitice corrosion without flaking or deterioration on fascia girder flange.*

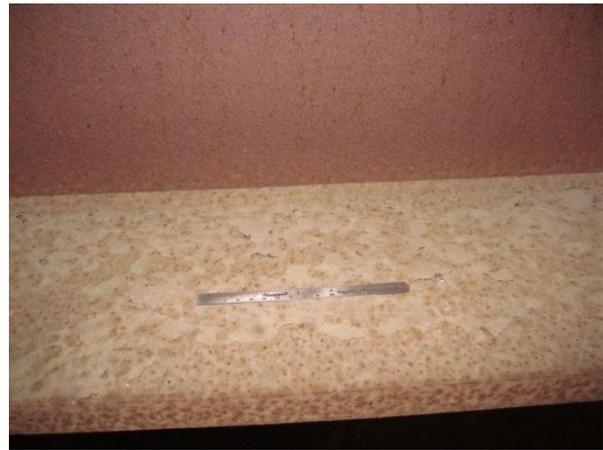
*Figure 4. Heavy poulitice corrosion with delaminated flaking on interior bottom flange.*

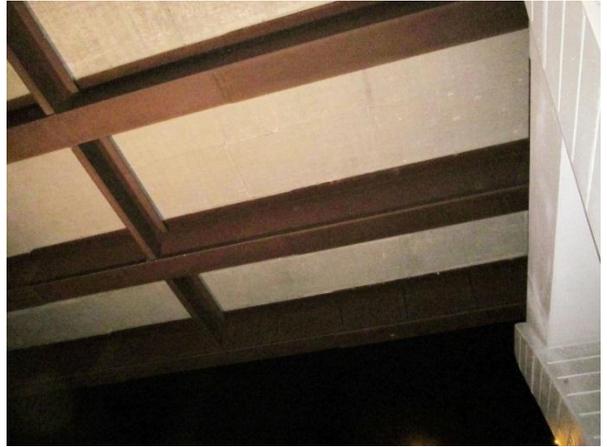
Figure 2. Girders and diaphragms near south pier; appear in good condition from below.

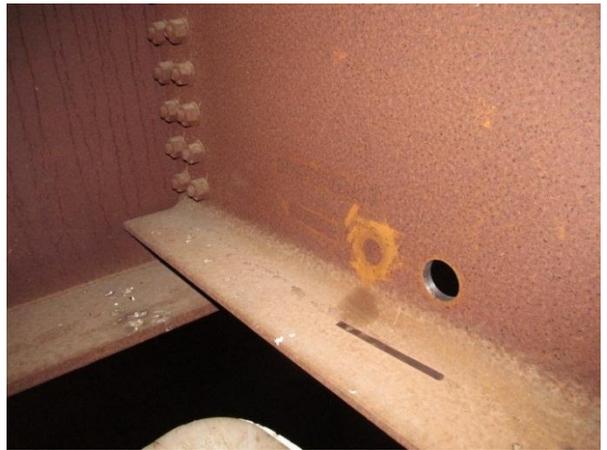
Figure 4. Heavy poutlice corrosion on diaphragm and girder flange at core location.

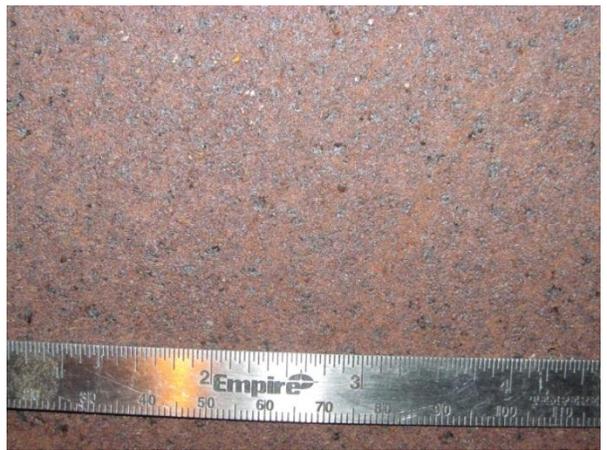
Figure 6. Detail of patina condition on diaphragm web adjacent to core. Index=3.5.

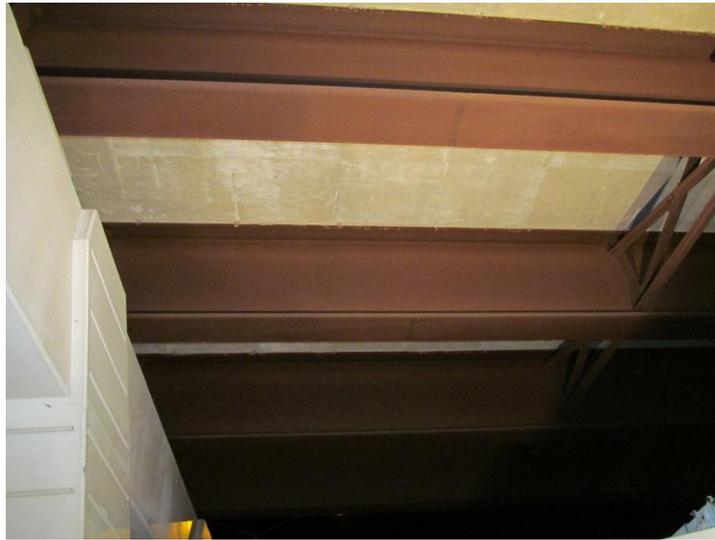
*Figure 1. Girders near the intermediate pier; no signs of significant deterioration visible.*

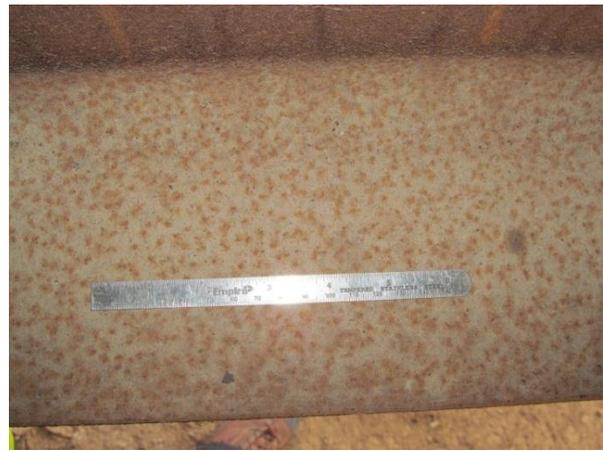
*Figure 4. Interior top of bottom fascia flange with light poutlice corrosion, but minimal flakiness.*

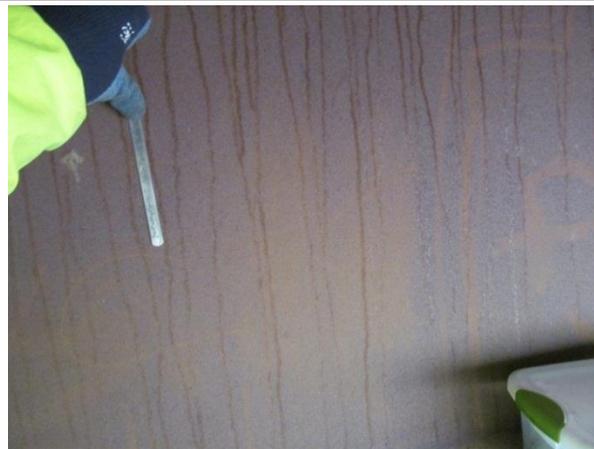
*Figure 5. Interior web performing well.*

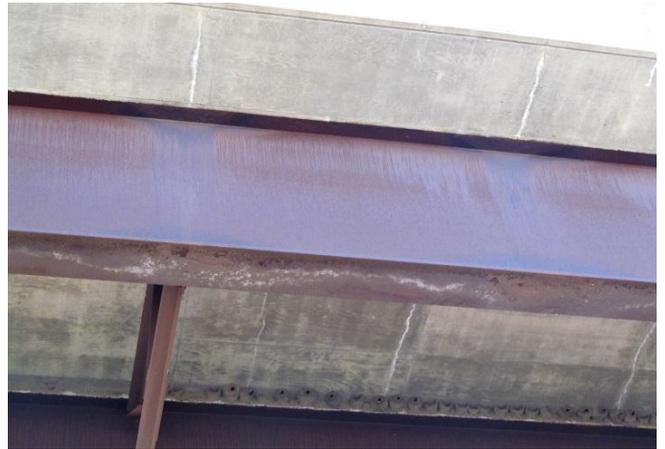
Figure 2. Exterior of west fascia girder on southbound bridge showing localized patina deterioration on all surfaces beneath cracks.

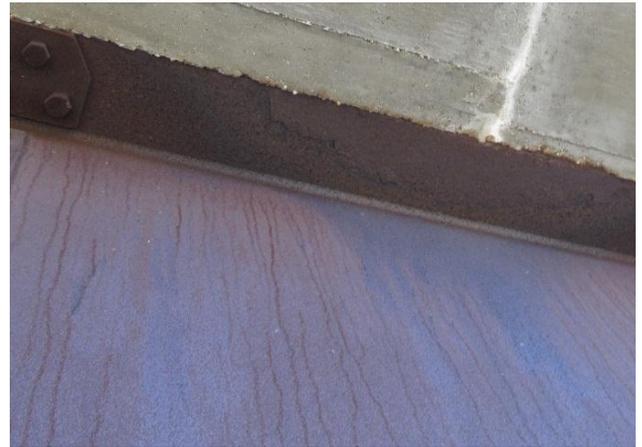
Figure 4. Heavy deterioration/delamination of west fascia girder top flange at crack, possibly Index = 1.

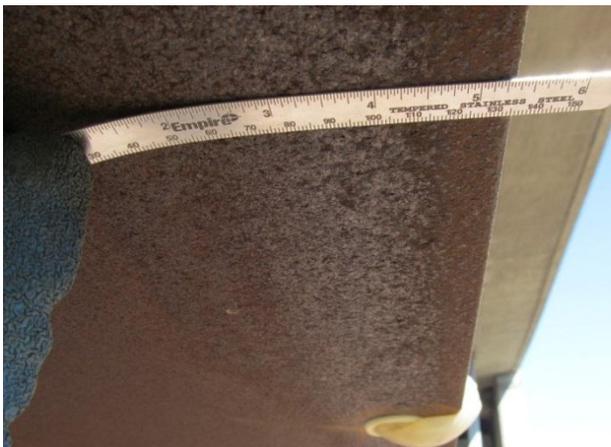
Figure 5. Condition of bottom of flange of east fascia near north abutment considerably better than west fascia (Index = 3).

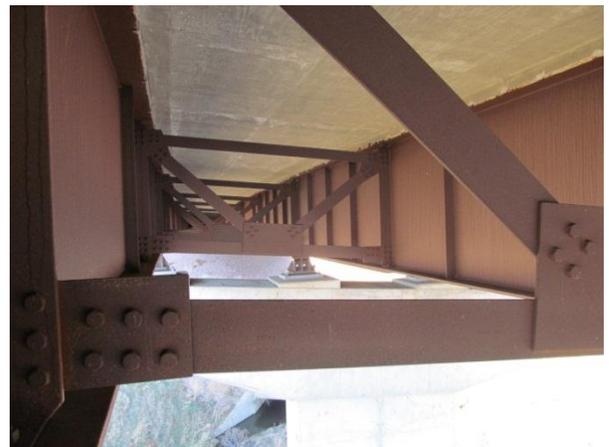
Figure 6. Typical condition of other interior surfaces away from deck cracks typically Index = 3 to 4, with little to no surface chlorides measured.

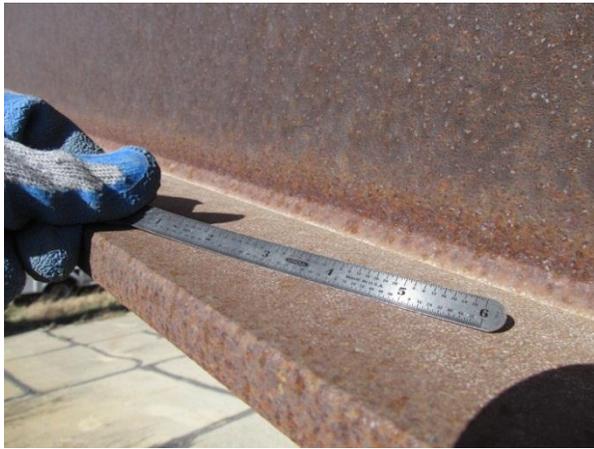
*Figure 1. Exterior surfaces over traffic in good condition after more than 40 years.*

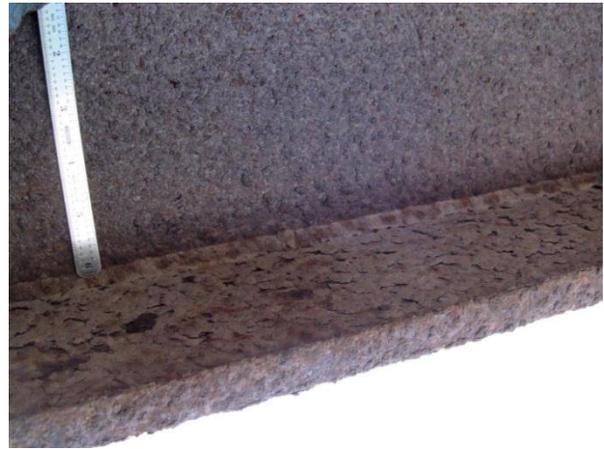
*Figure 2. Interior surfaces over traffic showing signs of long-term deterioration.*

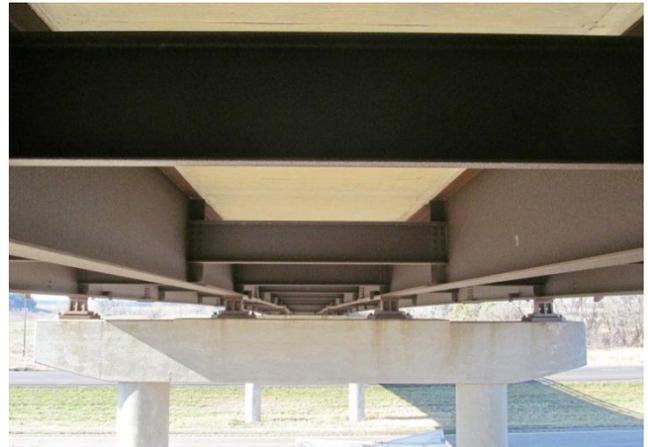
*Figure 4. East pier viewed from east abutment. Drainage deflectors separating spans effectively.*

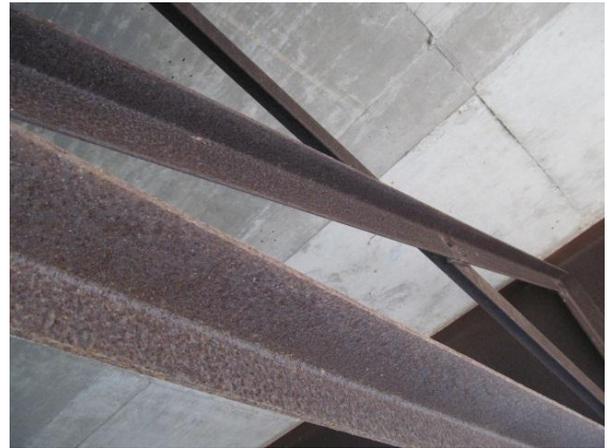
Figure 4. Typical cross frame condition near south abutment. Index = 3.

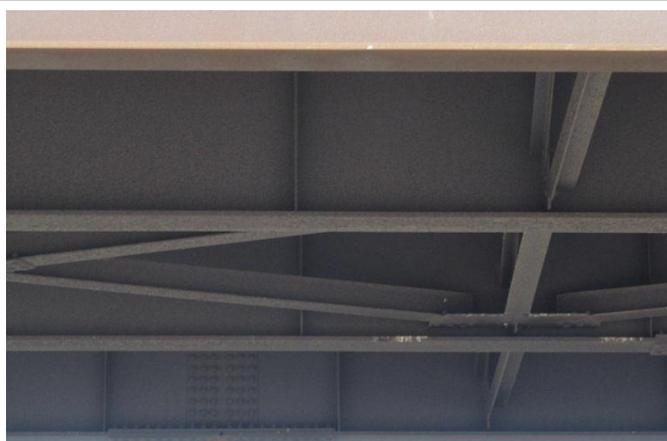
Figure 5. Heavy flaking visible from the ground on interior flanges and webs over traffic lanes; Index = 2.
