Western Iowa Missouri River Flooding— Geo-Infrastructure Damage Assessment, Repair, and Mitigation Strategies

SEPTEMBER 2013

Final Report

Federal Highway Administration
Iowa Highway Research Board
(IHRB Project TR-638)
Iowa Department of Transportation
(InTrans Project 11-419)

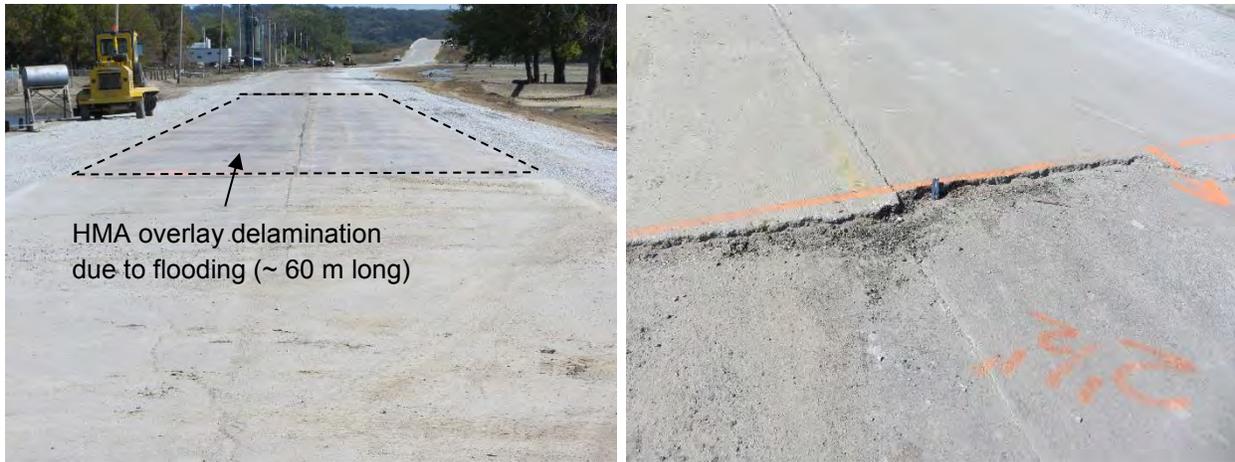
Figure 40. Delaminated HMA overlay over PCC pavement and eroded shoulders refilled with crushed limestone – Old Mormon Road (looking east), Pottawatamie County (Photos taken on 9/21/11)

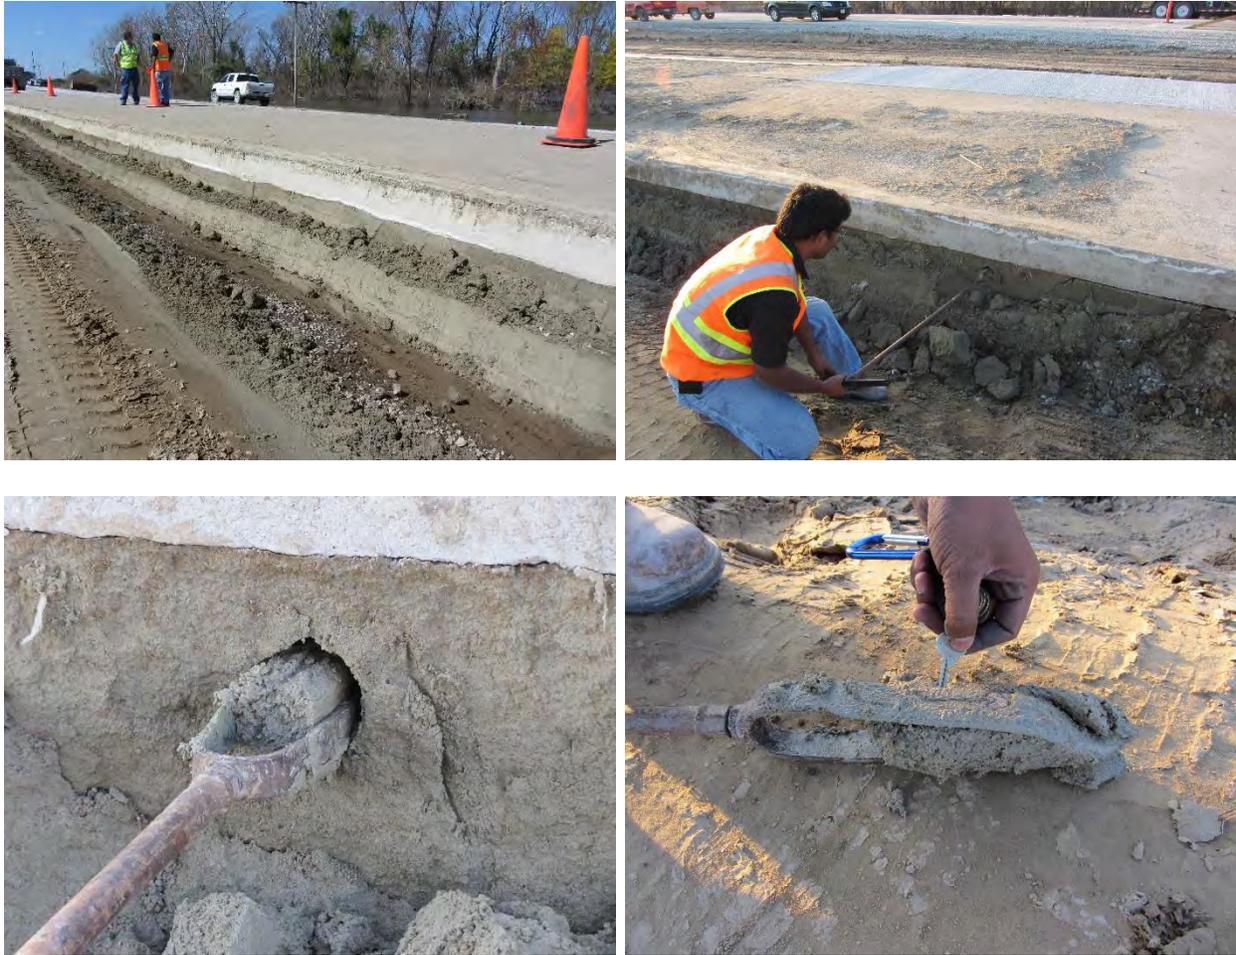
Figure 63. Eroded base material and voids under PCC pavement filled with cement grout – TS2 [Note: Cement grout was placed two days prior to taking these photos] (Photos taken on 9/21/11) – Pottawattamie County

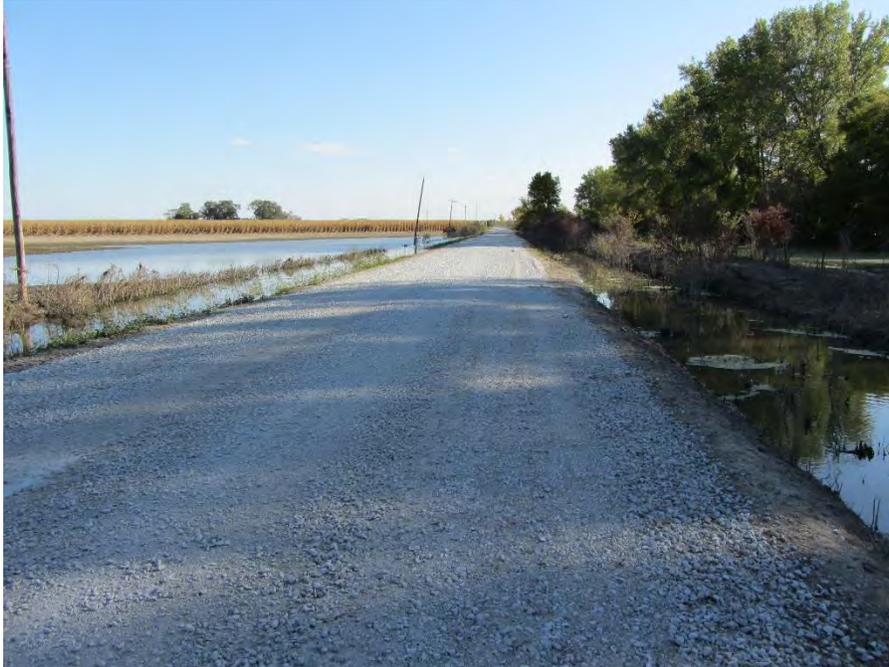
Figure 72. New gravel placed at the middle of the segment following flooding on TS3 (Photo taken on 9/21/2011) – Pottawattamie County

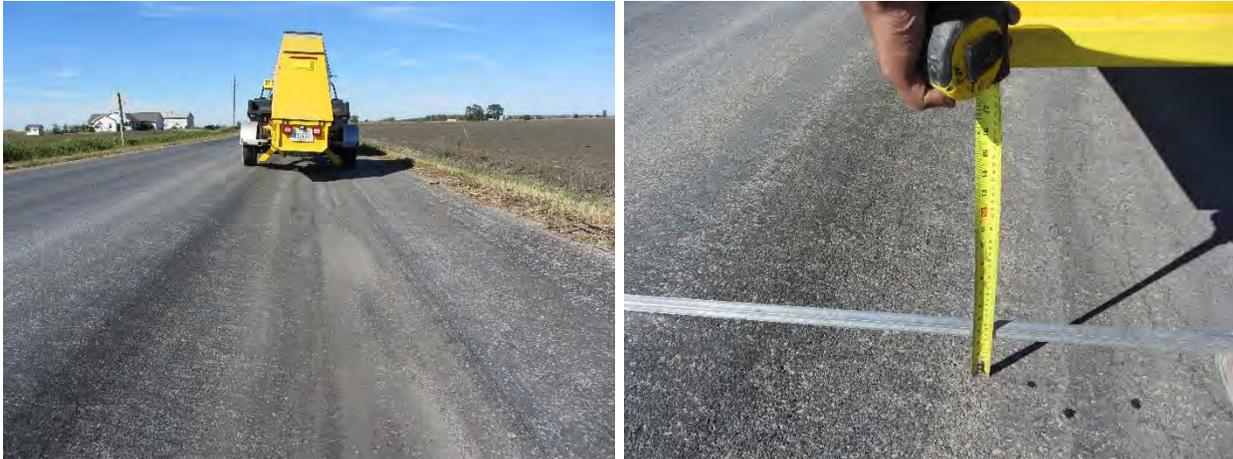
Figure 82. Rutting observed near the east end of the test segment (near test location D-38) (photo taken on 9/23/11) on TS4 – Pottawattamie County

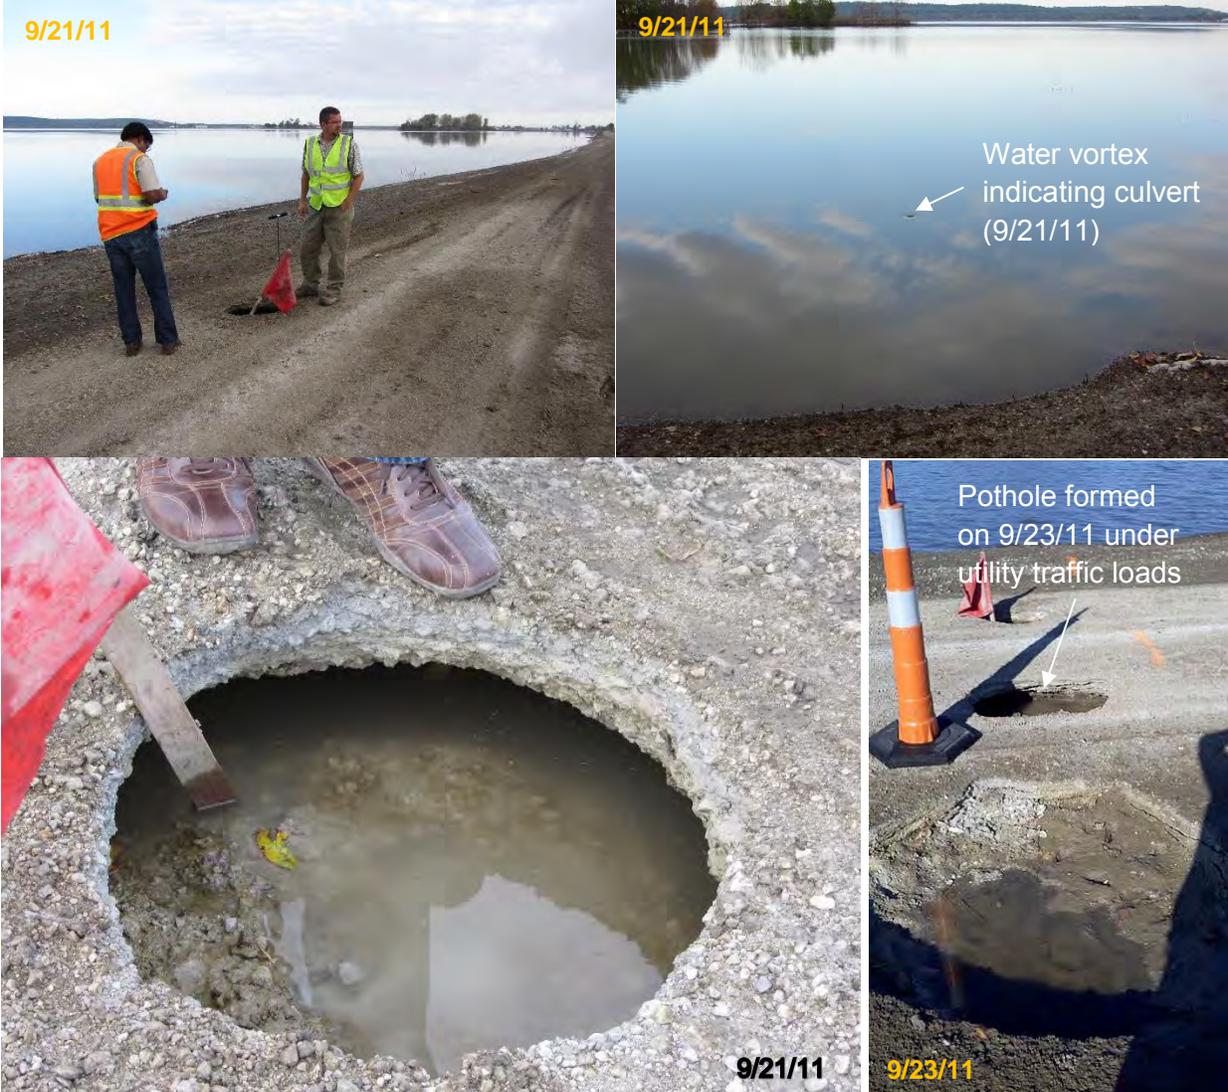
Figure 89. Potholes (with about 0.5 m (1.5 ft) diameter) under gravel road due to erosion of backfill material around a culvert located beneath the road TS 5 (Photos taken on 9/21/11 and 9/23/11) – Pottawatamie County

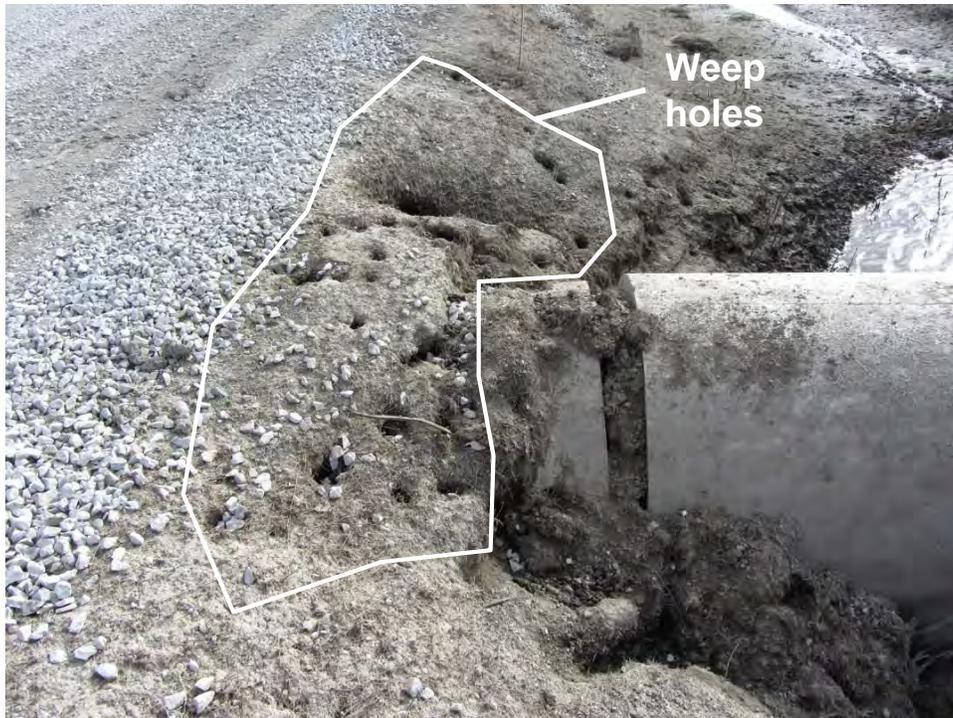
Figure 91. Weep holes (20+) around the culvert observed after flood waters receded on TS5 (Photo taken on 10/25/11) – Pottawattamie County

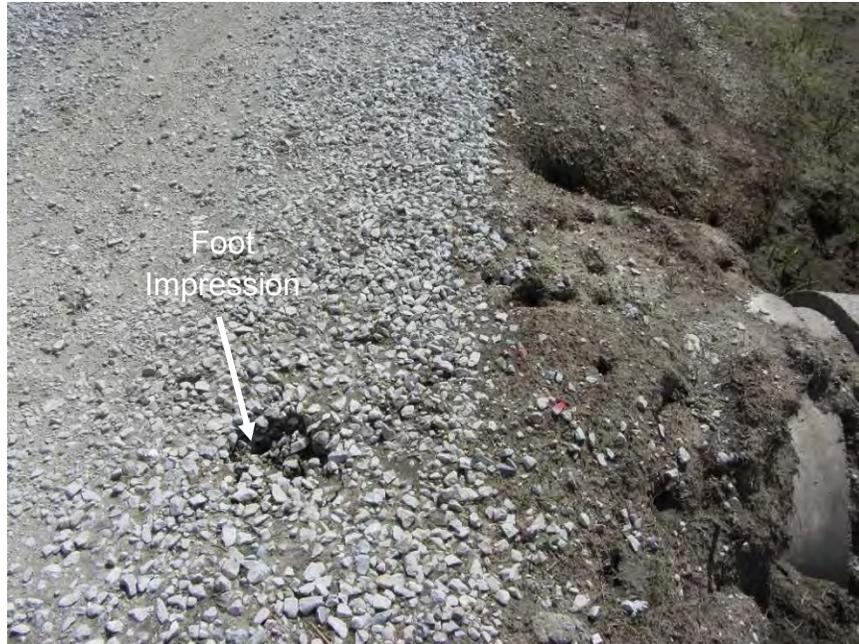
Figure 92. Loose backfill material around culvert replaced after flood waters receded on TS5 (Photo taken on 4/5/12) – Pottawattamie County

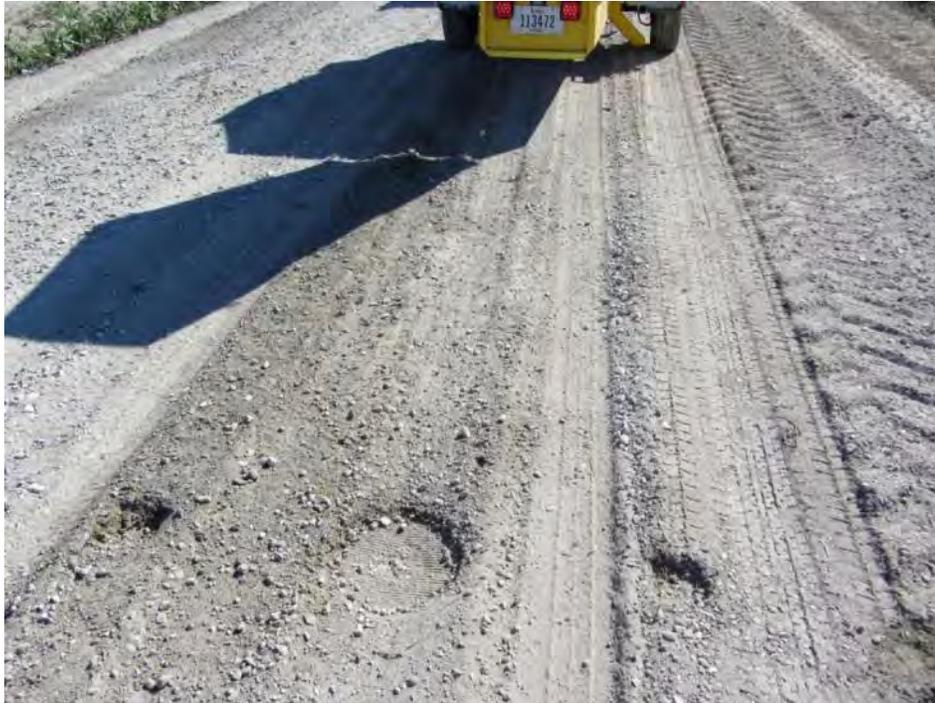
Figure 110. FWD plate depression and rutting under truck wheels near culvert (Picture taken on 9/23/2011) – Pottawattamie County

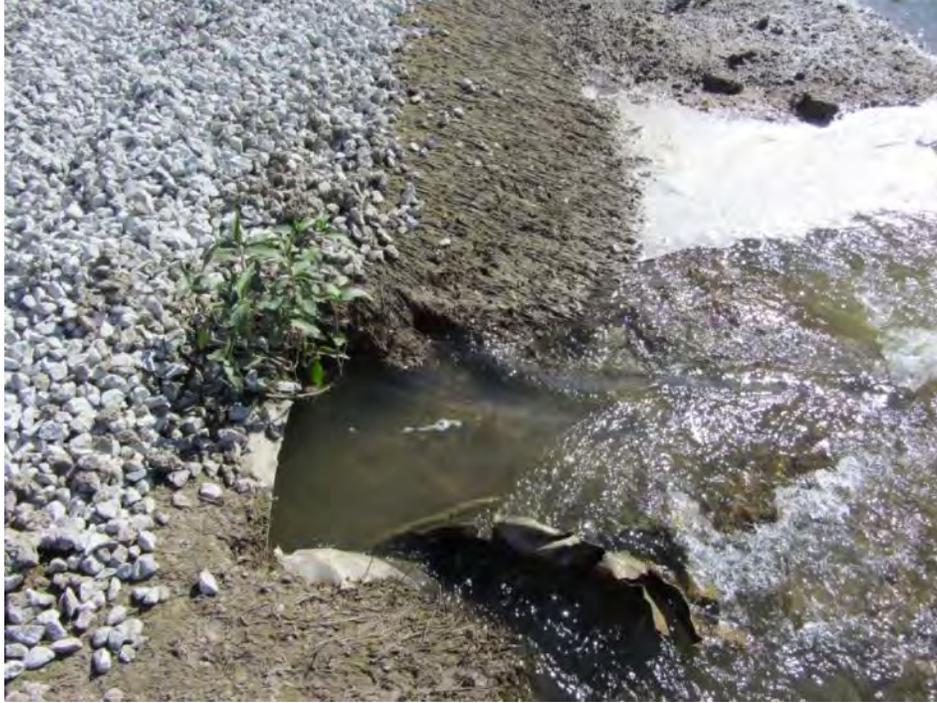
Figure 112. Replacement gravel cover over culvert (Picture taken on 9/23/2011) – Pottawattamie County

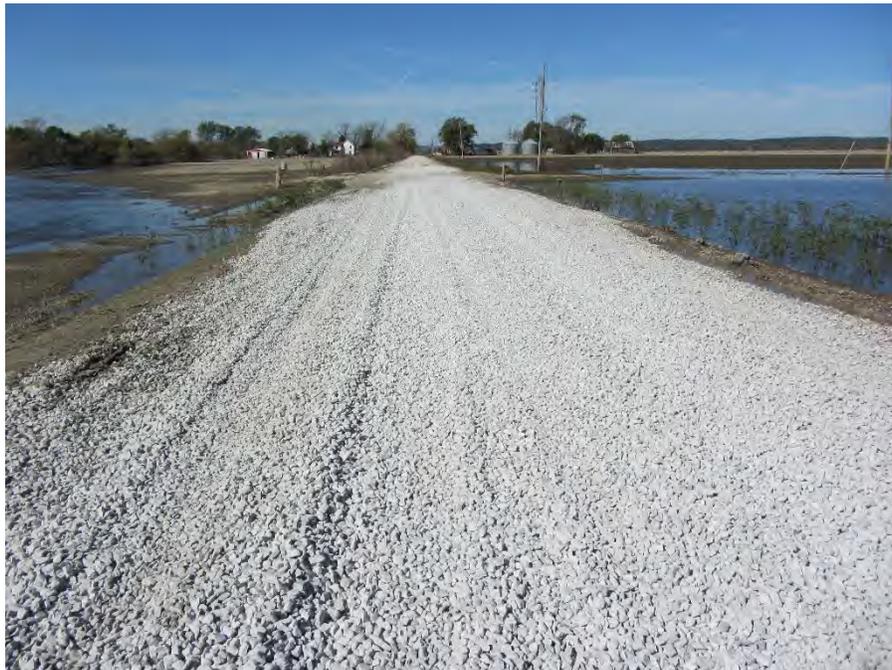
Figure 113. Location of newly placed gravel on TS6 over a metal pipe culvert (Picture taken on 9/23/11) – Pottawattamie County

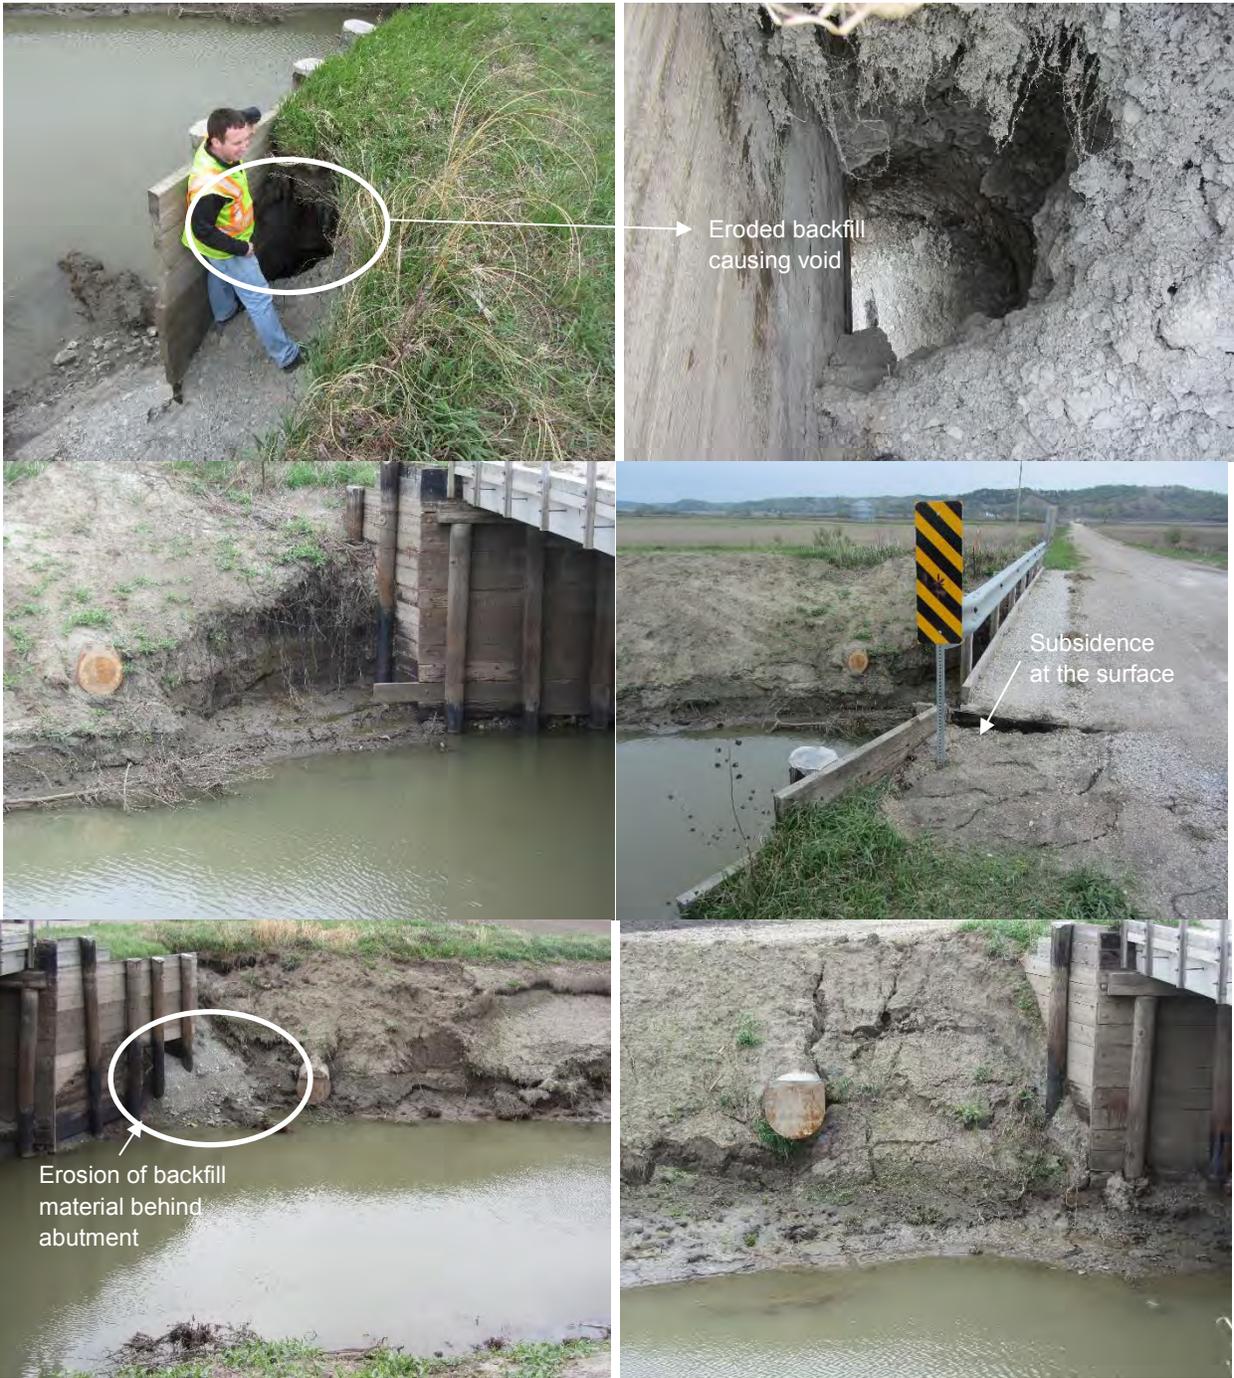
Figure 134. Bridge conditions on TS1 on 4/4/12 – Fremont County

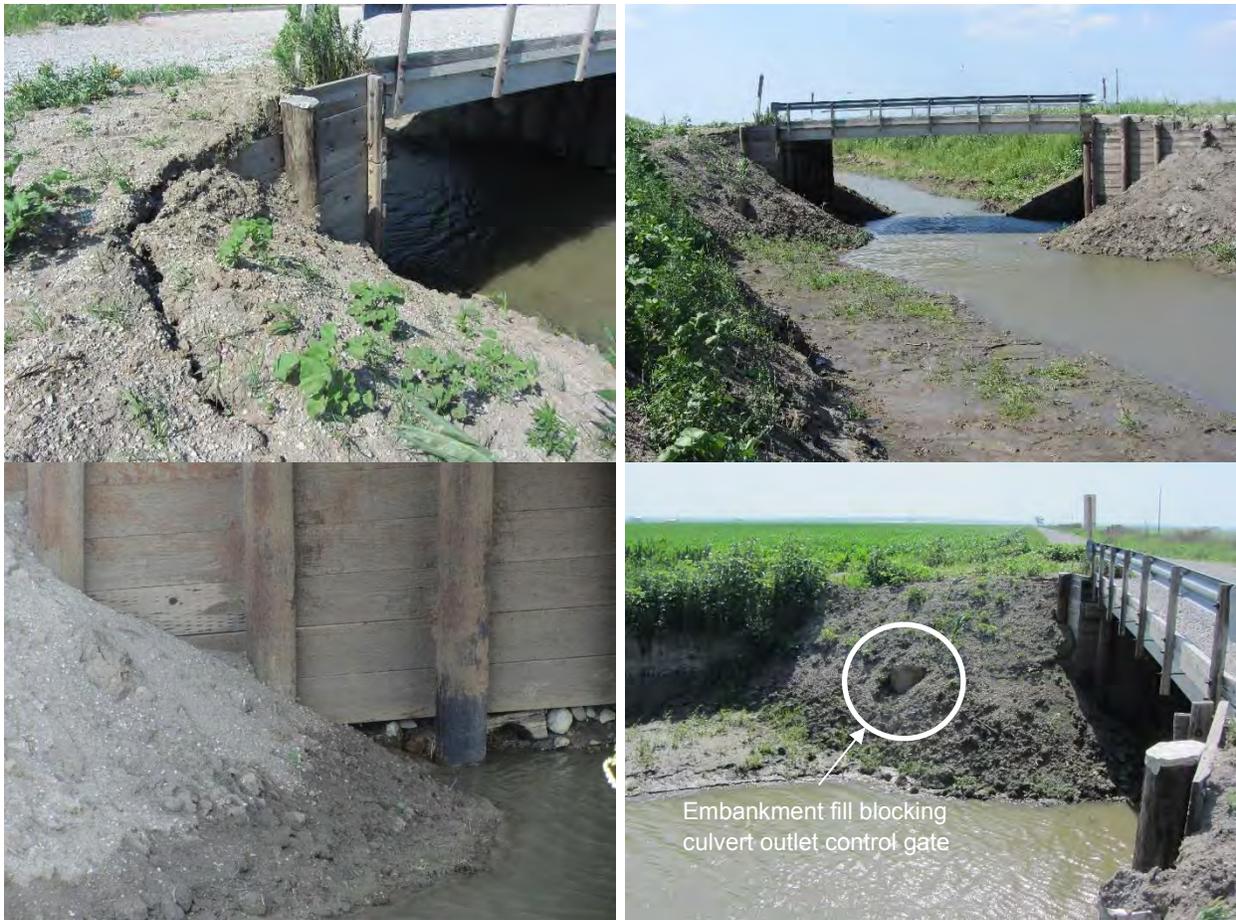
Figure 135. Bridge conditions on TS1 on 6/9/12 – Fremont County

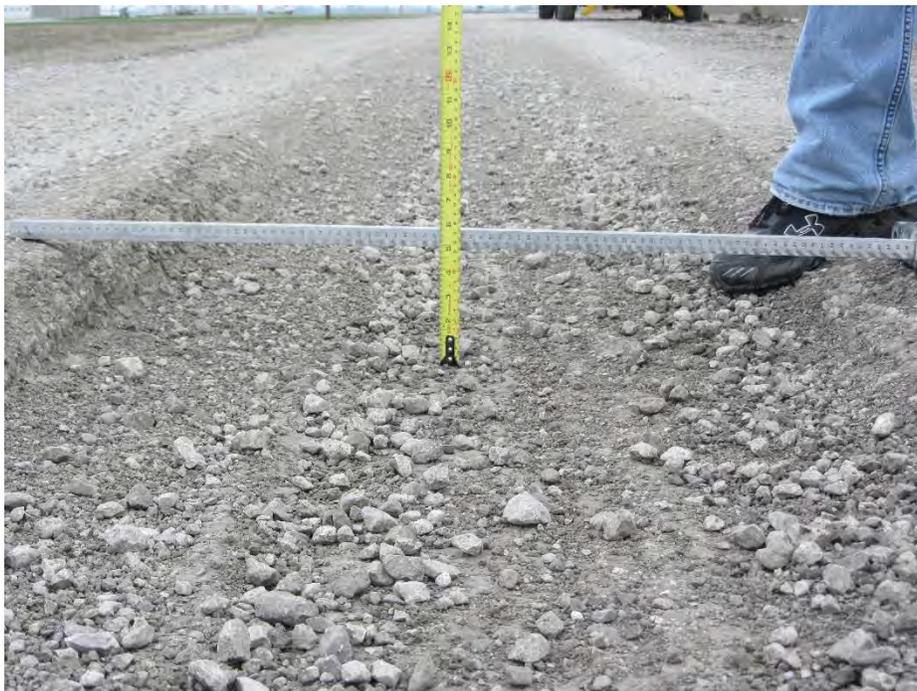
Figure 156. Rutting observed near 3000 m station on TS2 (Picture taken 4/4/12)

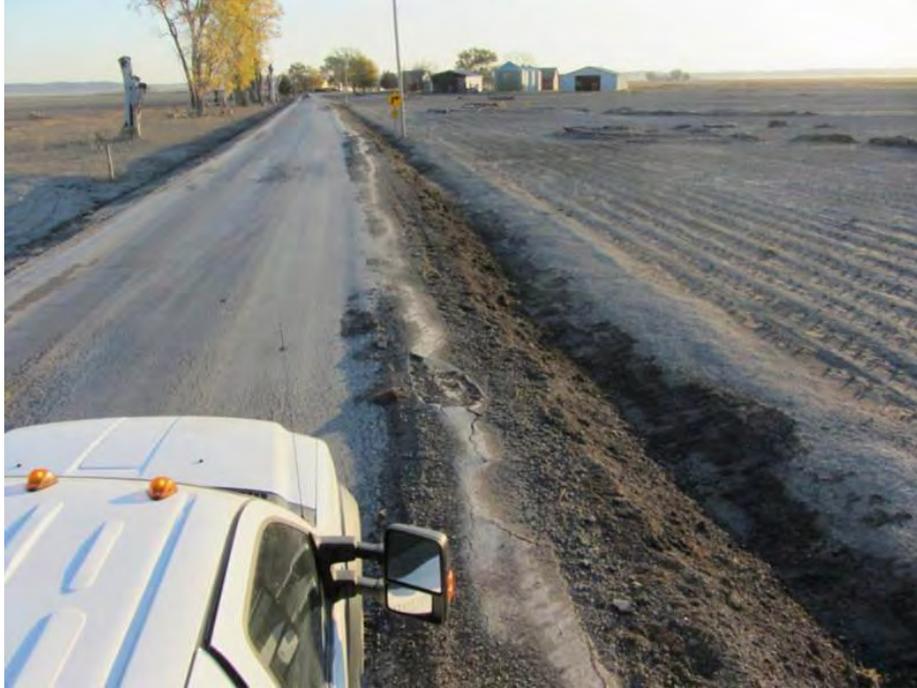
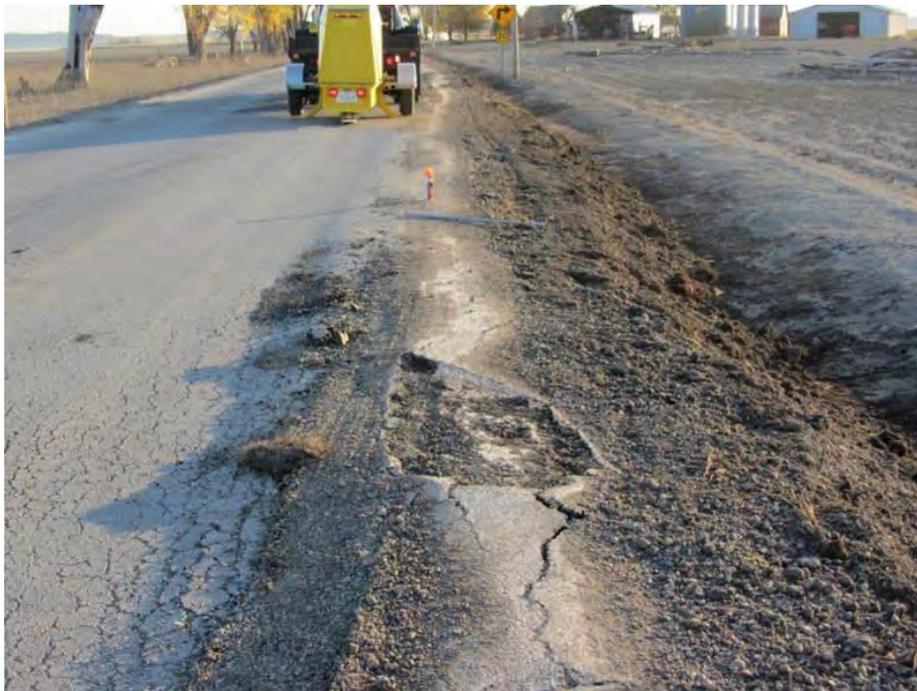
Figure 162. Rutting observed on the surface and washed out shoulders during flooding on TS4 – Fremont County (Picture taken 10/28/11)

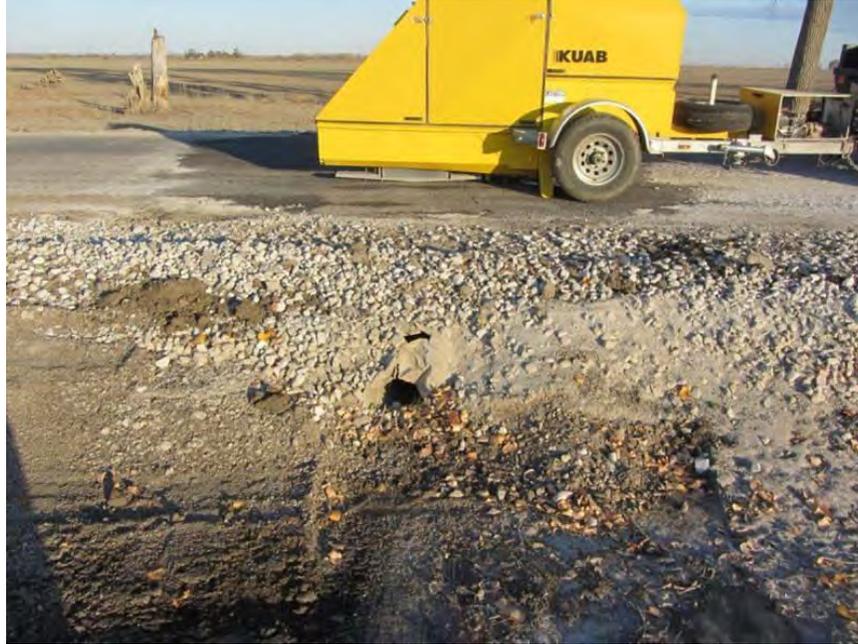
Figure 163. Surface patch repair over a culvert on TS4 – Fremont County (Picture taken 10/28/11)
