Laboratory and Field Testing of an Accelerated Bridge Construction Demonstration Bridge: US Highway 6 Bridge over Keg Creek

Final Report
April 2013

Sponsored by
Federal Highway Administration
Iowa Department of Transportation
(InTrans Project 11-411)

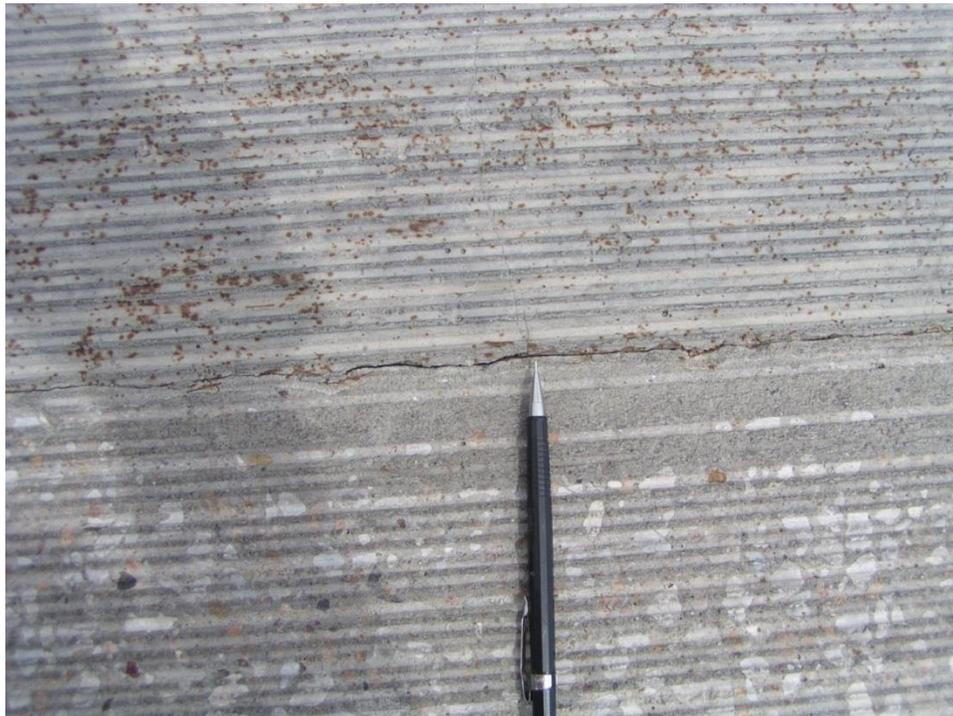
Visual inspection, as well as evaluation of the collected data, showed a breakdown of the bond between the interface of the HPC and UHPC at the joints. The breakdown of this bond resulted in cracking of the deck allowing an ingress of road salts, which is verified by the presence of efflorescence on the underside of the bridge deck at joint interfaces.

Figure 4.14. Observed cracking of longitudinal joint between modules 2 and 3
