FIELD INSTRUMENTATION AND TESTING OF HIGH-MAST LIGHTING TOWERS IN THE STATE OF IOWA

DRAFT FINAL REPORT

January 2006

Iowa Department of Transportation
Office of Bridges and Structures
800 Lincoln Way
Ames, IA 50010

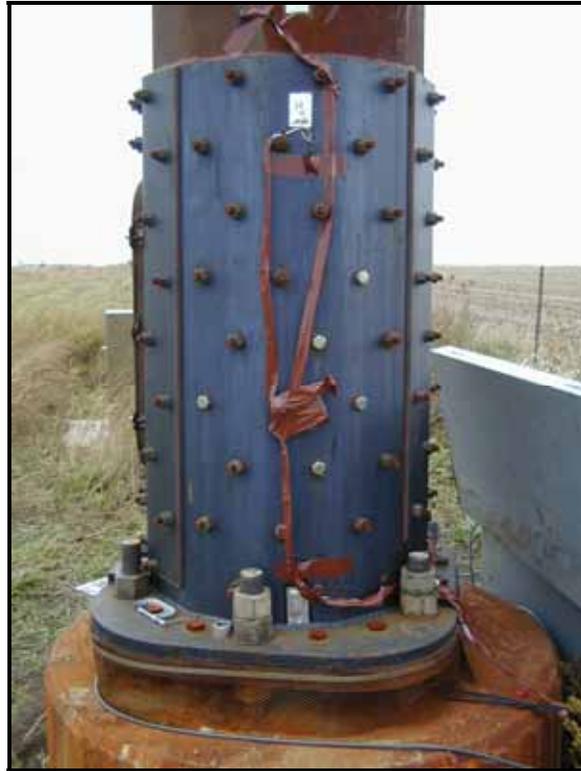
The second tower had been retrofitted with a steel splice jacket at the base as seen in Figure 1.1. The retrofit was designed by Wiss, Janney, Elstner, and Associates. Strain gages were installed on both the splice jacket and on the original tower just above the jacket. This tower is termed the “*Retrofit tower.*”

Figure 1.1 – Jacket retrofit designed by Wiss, Janney, Elstner, and Associates and installed in Clear Lake, Iowa

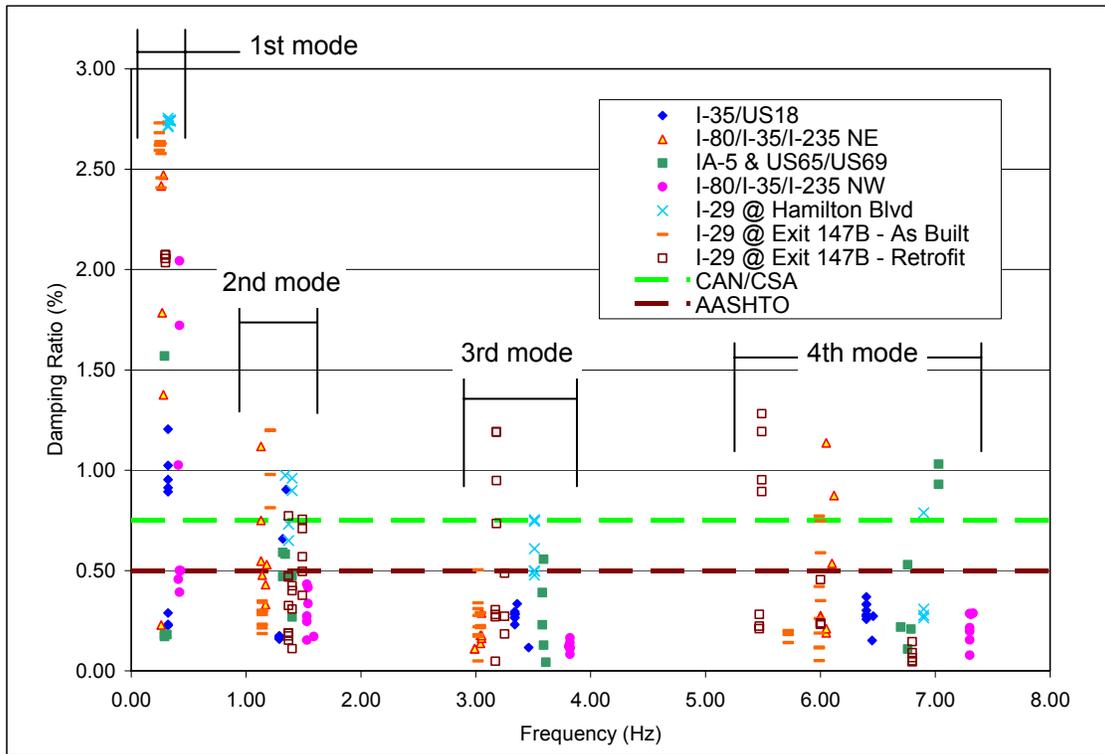
Plots of frequency versus the damping ratio of all the towers are shown in Figure 3.3. Also included in the plot are the specified damping ratios from the AASHTO and the CAN/CSA specifications. AASHTO recommends using a ratio of 0.5% when the actual damping ratio of the structure is unknown [2], and the Canadian Bridge Code (CAN/CSA) specifies a damping ratio of 0.75% when experimentally determined values are unavailable [3][4]. These plots show that the damping ratios in all four modes are in many instances considerably lower than the assumed values in the two different codes. Furthermore, the AASHTO and CAN/CSA specifications do not address the possibility of different damping ratios in the higher modes of vibration. These recommended damping ratios are not conservative estimations for the higher modes based on this research.

Figure 3.3 – Damping Ratio vs. Frequency

Structures with high damping ratios require fewer cycles for the vibration to attenuate. The high-mast towers have very low damping ratios and as a result experience a high number of cycles that can cause damage. These cycles can be accumulated during vortex shedding or following natural wind gusts. When a tower with low damping ratios is stressed beyond the constant amplitude fatigue limit (CAFL), a significant number of damaging cycles are accumulated before the stress range falls below the CAFL. The pole-to-base connection of these structures is assumed to be an E' fatigue detail per the code (but may be even worse), with a CAFL of 2.6 ksi, which means that low stress ranges can exceed the CAFL. Therefore, the low CAFL in combination with a low damping ratio can produce many damaging cycles on the high-mast light structures and consequently reduce the fatigue life. However, it should be noted that the designation of E' for the base plate connection is based on a very limited number of tests. It is likely that the actual fatigue performance of these connections is even worse than E' due to the thin baseplates and tube walls found on many high-mast towers.

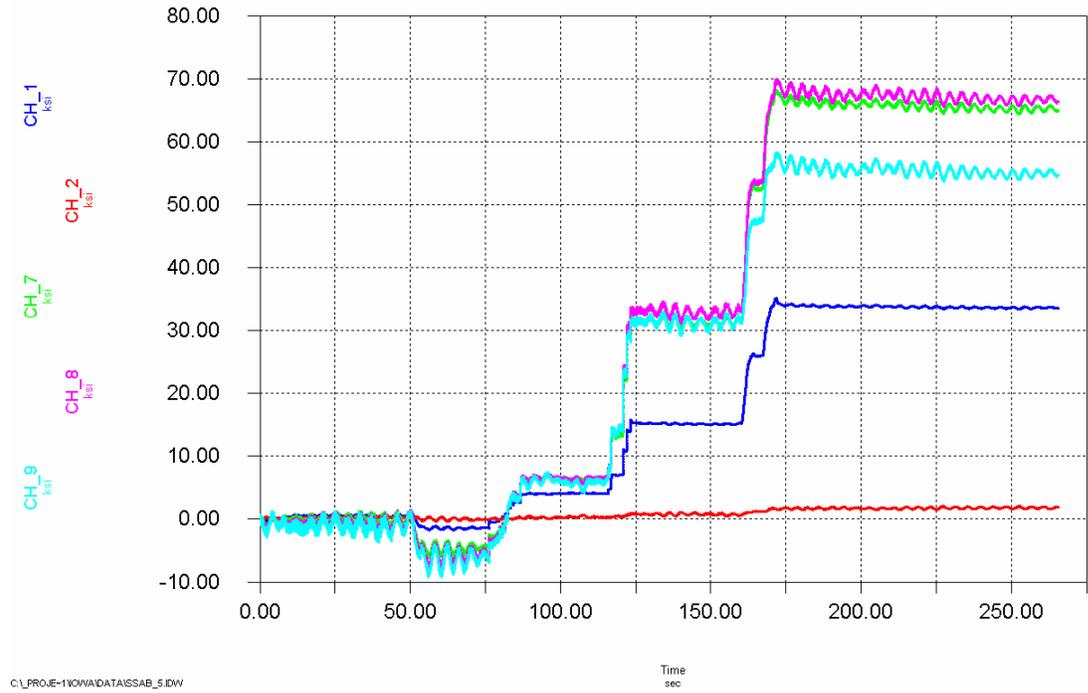
To evaluate the effect of leveling nuts that are not properly leveled prior to final tightening, one leveling nut (adjacent to strain gage CH_1) was purposely lowered approximately 1/8 inch. Data from all strain gages were recorded while the top nut was tightened down. The data from strain gages CH_1, CH_2, CH_7, CH_8, and CH_9 recorded during this operation are presented in Figure 3.6. Each of the plateaus on the strain history represents a break between successive tightening operations. Strain gage CH_1 is located on the tube wall 3 inches above the column-to-base weld toe near the improperly tightened anchor bolt. Strain gage CH_2 is on the opposite face from CH_1. Notice that the stresses on the opposite side of the tower (CH_2) are not affected by the loose anchor bolts.

Strain gages CH_7, CH_8, and CH_9 are located at the weld toe below CH_1 (see Figure 2.9.) It can be seen that at the weld toe, very high stresses (70 ksi) are induced into the tube wall by tightening down the anchor nut. It is likely that the material locally yielded.

Figure 3.6 – Localized stress changes due to poor installation techniques

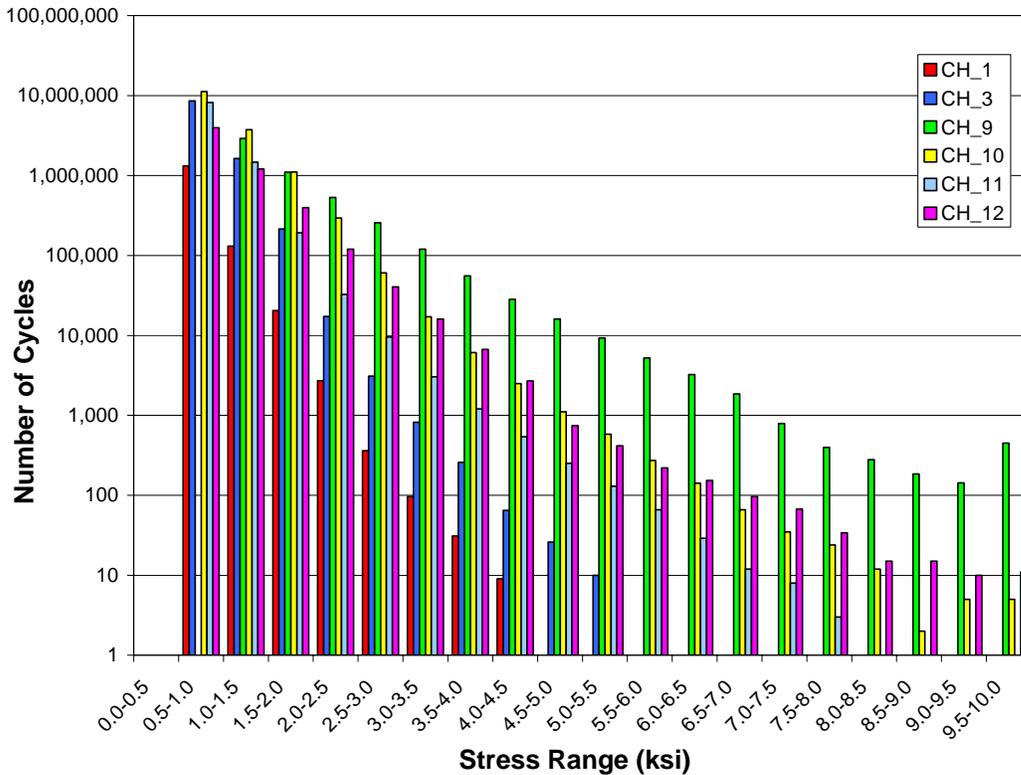
Furthermore, the CAFL of all details (which may be conservative) was exceeded with a frequency of more than 1 in 10,000 at all gages. The stresses caused by vortex shedding were of a much lower magnitude.

Figure 4.1 – Stress-range histograms for strain gages located on the As-built tower

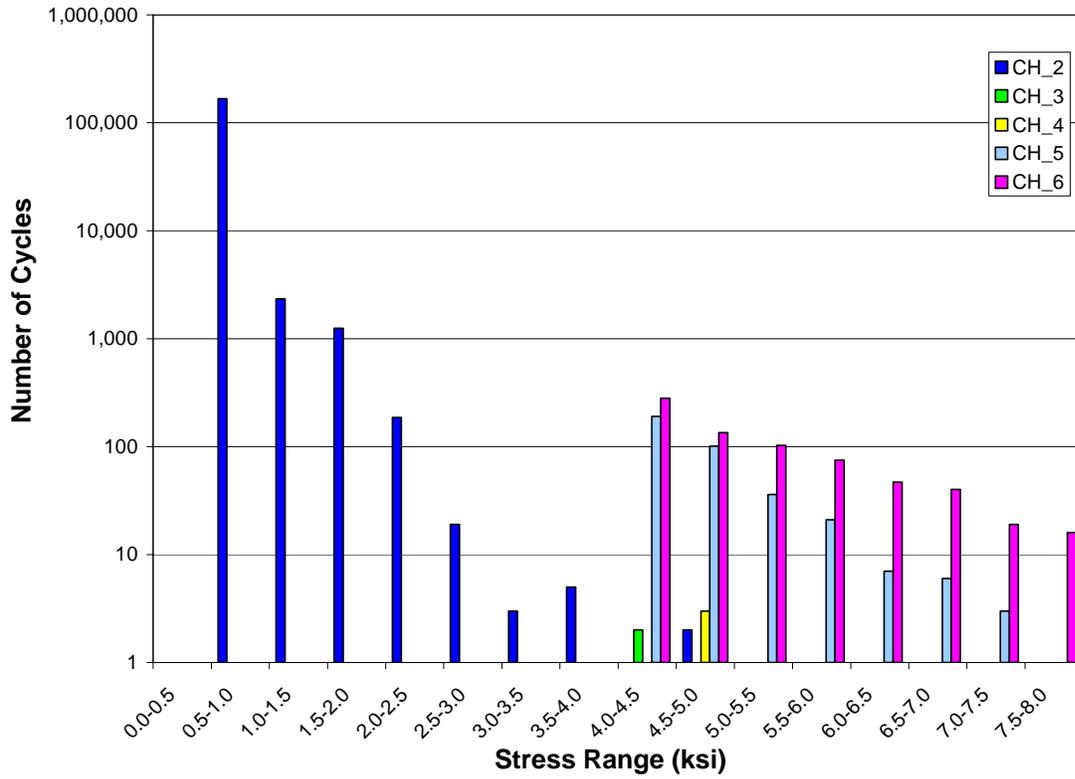
The full penetration weld at the base of the tower (strain gage CH_2) is considered at category E' per AASHTO [2], with a CAFL of 2.6 ksi. (It is noted CH_2 is located on the jacket and not on the original tower wall.) All stress cycles less than 0.5 ksi were removed from the histogram. The maximum measured stress range in CH_2 was 6.5 ksi. The CAFL was exceeded at a frequency of 0.02% which is greater than 0.01% (1/10,000), therefore, finite fatigue life can be expected. However, for this strain gage, the minimum calculated fatigue life is greater than 100 years, or effectively infinite life.

Strain gages CH_3, CH_4, CH_5, and CH_6 are installed at locations considered to be fatigue category B for a slip-critical bolted connection, with a CAFL of 10 ksi. As a result, all stress cycles less than 2.5 ksi were removed from the spectrum. It can be seen from Table 4.4 that the CAFL was never exceeded and therefore infinite fatigue life can be expected on the jacket itself.

Figure 4.5 – Stress-range histograms for strain gages located on the Retrofit tower

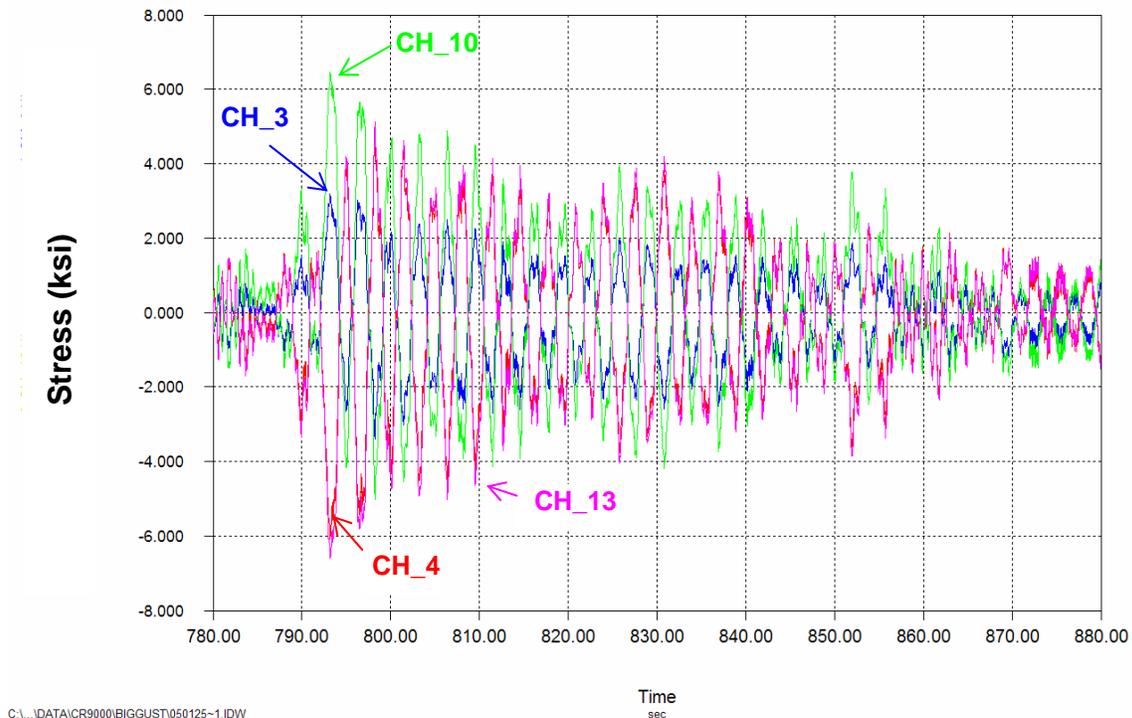
Shown in Figure 4.11 is a stress time history for the rapid gust event discussed above. Strain gages CH_3 and CH_4 are on the west and east sides of the pole, respectively, 3 inches above the base. Strain gages CH_10 and CH_13 are on the west and east sides of the pole, respectively, 5 feet 9 inches above the base. The response at all strain gages was relatively low (less than 2 ksi) until the large gust occurred at time equal to 792 seconds, at which point the stresses in all gages rose dramatically (maximum of 6.2 ksi at CH_10). Primarily the response was in the first vibration mode, as the time between successive peaks was approximately 3.3 seconds. It can also be seen that the vibration of the pole continued for a number of cycles after the original event. These additional stress cycles contribute to the cumulative fatigue damage at the base of the tower.

Figure 4.11 – Stress time-history for four gages on the east and west sides of the tower for a large wind event at the As-built tower on January 22, 2005 and 5:20AM

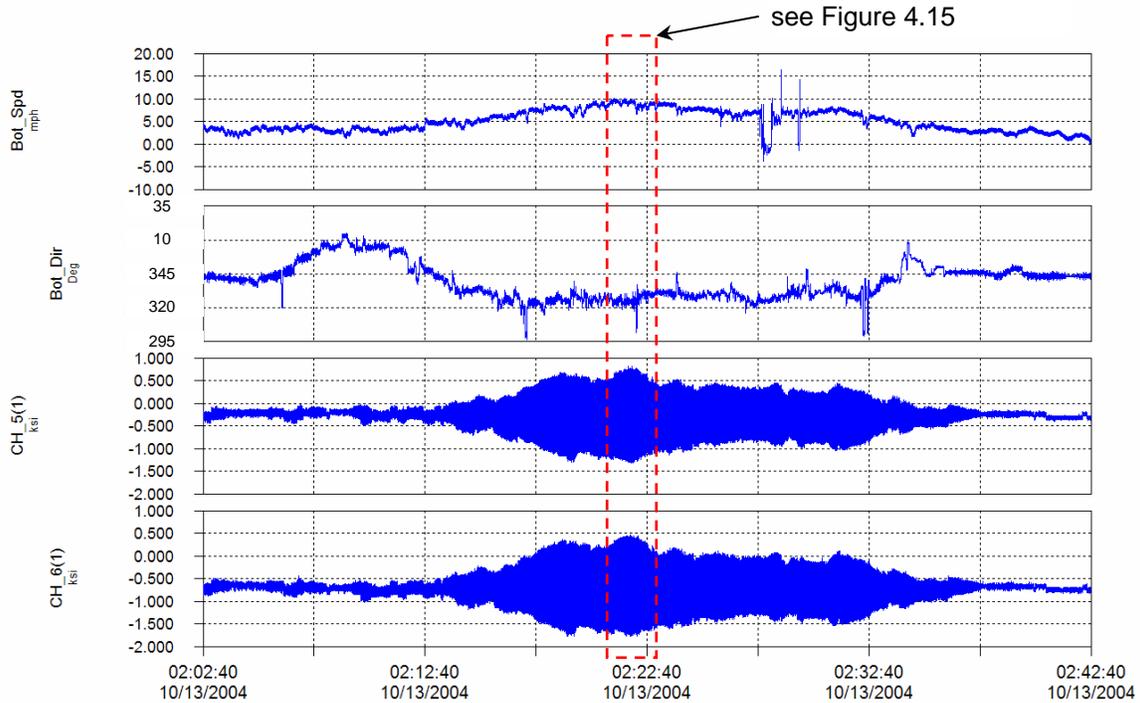
In this section the wind phenomena of vortex shedding will be examined. Good examples of vortex shedding were recorded at the Retrofit tower. Such an example is presented in Figure 4.14. Shown in the Figure is a segment of time equal to 30 minutes recorded on October 13, 2004. Four data traces are shown in the Figure, namely wind speed at the 33 foot elevation, wind direction (corrected to represent compass directions), strain gage CH_5, and strain gage CH_6. These strain gages are located on opposite sides of the tower on the tower just above the retrofit jacket. A zoomed-in segment of data indicated by the dashed box, is shown in Figure 4.15.

Figure 4.14 – Example of vortex shedding occurring in the second vibration mode (frequency = 1.32 Hz) showing response of strain gages CH_5 and CH_6

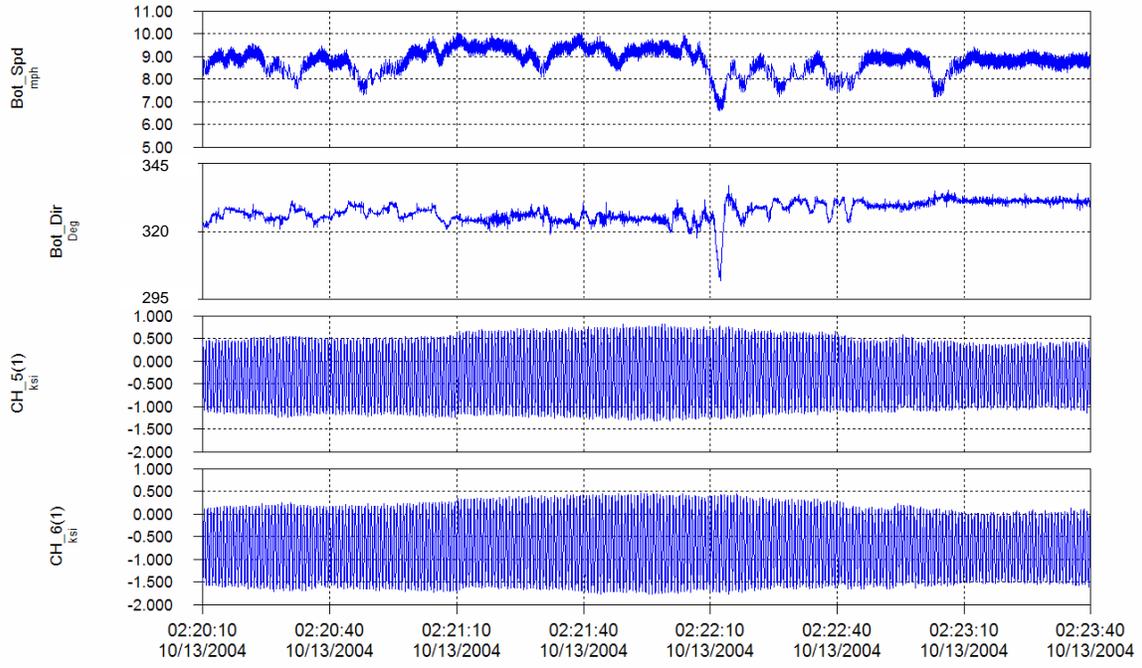
Though this stress is not excessively high, there are approximately 1300 stress cycles caused by this single event. It has been found that the 2nd mode vortex shedding is most common at these towers, but that the measured stress range is low. However, due to the fact that the socket connection at the base has poor fatigue resistance (the CAFL

may be less than 2.3 ksi for E'), vortex shedding has the potential to cause a large number of damage-causing cycles.

Figure 4.15 – Detail plot of vortex shedding occurring in the second vibration mode (frequency = 1.32 Hz) showing response of strain gages CH_5 and CH_6
