Sample NSTM Locations and Condition for Trusses

County: Adair FHWA No.: 012345 County ID: Prescott 13 Insp. Date: 7/18/2013

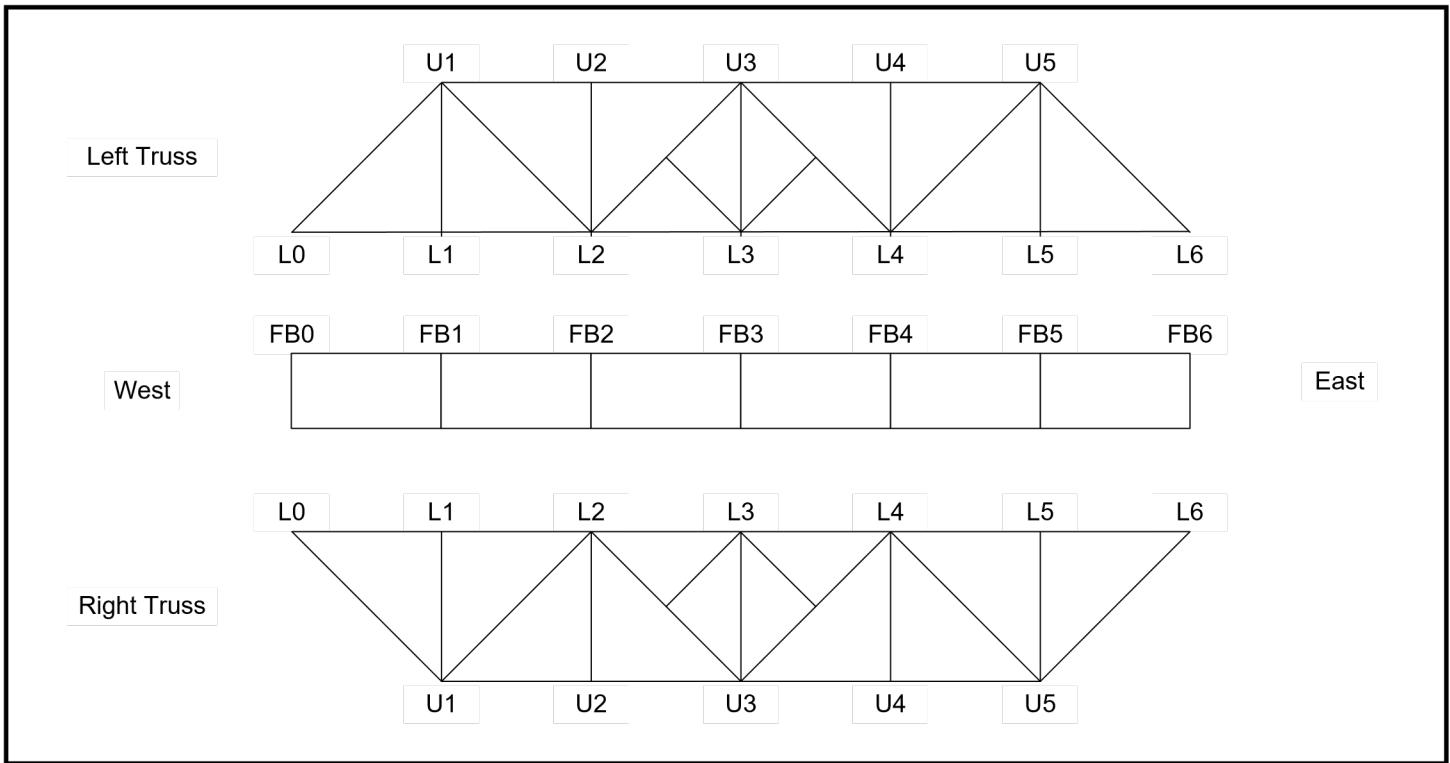
Span	Member Location	NSTM Member?	Comment #'s Left Truss	Comment #'s Right Truss	Inspection Procedure Required	Inspection Procedure Used
1	L0-U1		2	2		
1	L0-L1	Y	1	1	Hands-on	Hands-on
1	U1-L1	Y	1, 8	1, 8, 5	Hands-on	Hands-on
1	U1-U2		2	2		
1	U1-L2	Y	1, 4	1, 4	Hands-on	Hands-on
1	L1-L2	Y	2	6	Hands-on	Mag-Partical
1	U2-L2	Y	2, 8	2, 8	Hands-on	Hands-on
1	U2-U3		2, 7	2, 7		
1	L2-U3		1	1, 4		
1	Brace at L2-U3		2	2		
1	L2-L3	Y	1, 5	1, 9	Hands-on	Dye Penetrant
1	U3-L3	Y	2, 8	2, 8	Hands-on	Hands-on
1	U3-U4		2, 7	1		
1	U3-L4		1, 4	1, 4		
1	Brace at U3-L4		2	2		
1	L3-L4	Y	2, 5	1, 9	Hands-on	Ultrasonic
1	U4-L4	Y	2, 3, 6	2, 8	Hands-on	Hands-on
1	U4-U5		2	2		
1	L4-U5	Y	1, 4	1	Hands-on	Hands-on
1	L4-L5	Y	2	2	Hands-on	Hands-on
1	U5-L5	Y	1, 3	2, 8	Hands-on	Hands-on
1	U5-L6		2	2		
1	L5-L6	Y	1	2	Hands-on	Hands-on

Code	Comment
1	No notable deficiencies.
2	Light damage.
3	Moderate damage.
4	Gusset Plates damaged when torch was used to cut rivets when truss was moved.
5	Splice plates on top & bottom flanges not bolted to L3.
6	Weld between the vertical & railing spacer bar cracked.
7	Channels damaged when torch was used to cut rivets when truss was moved.
8	Spacer blocks welded to vertical, welds across direction of the stress.
9	Interior splice plate top channel flange missing at L3.
