Flame Hardened Snow Plow Blades

Final Report

RB13-012

April 2013

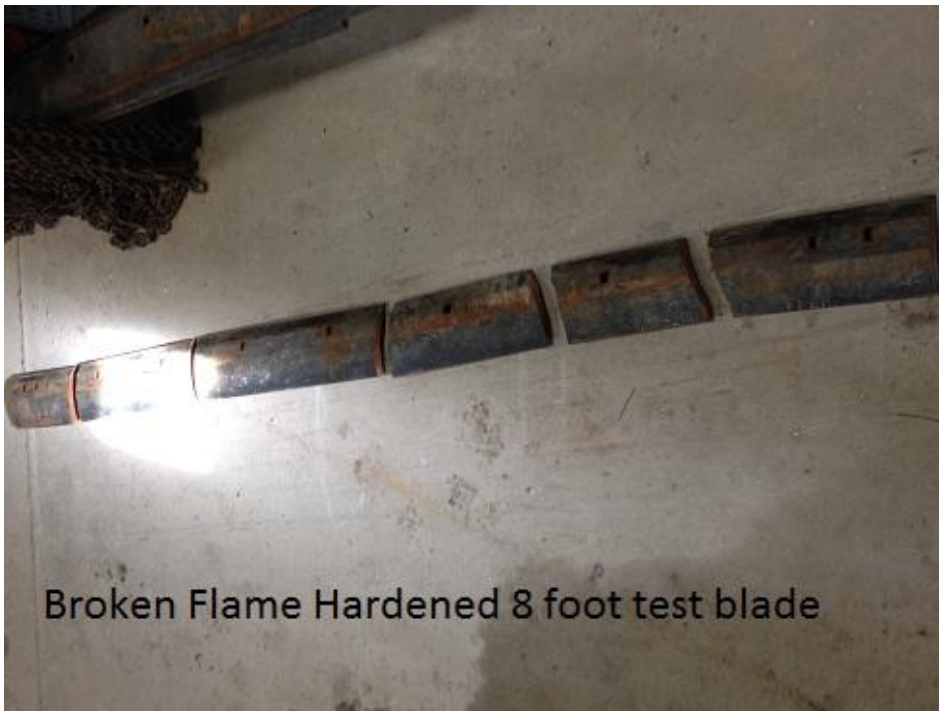
Seventy-five percent of the flame hardened blades were found to have vertically broken into two or more pieces causing one garage to remove the blade with usable life remaining due to safety concerns. The testing garages indicated that this is not typical with our current blades.

Of the garages that reported the type of road surface the blades were used on, an equal amount reported plowing on Portland cement and Asphaltic concrete, with the remaining reporting they plowed on Portland cement that has been resurfaced with Asphaltic Cement concrete. Cracked or broken flame-hardened blades were reported on all three surfaces.

It is not recommended that the DOT pursue the purchase of these blades at this time due to the increased cost without seeing significantly increased lifespan and the safety concerns associated with broken blades.
