IDENTIFICATION OF THE BEST PRACTICES FOR DESIGN, CONSTRUCTION, AND REPAIR OF BRIDGE APPROACHES

Iowa DOT Project TR-481 CTRE Project 02-118

Final Report

January 2005

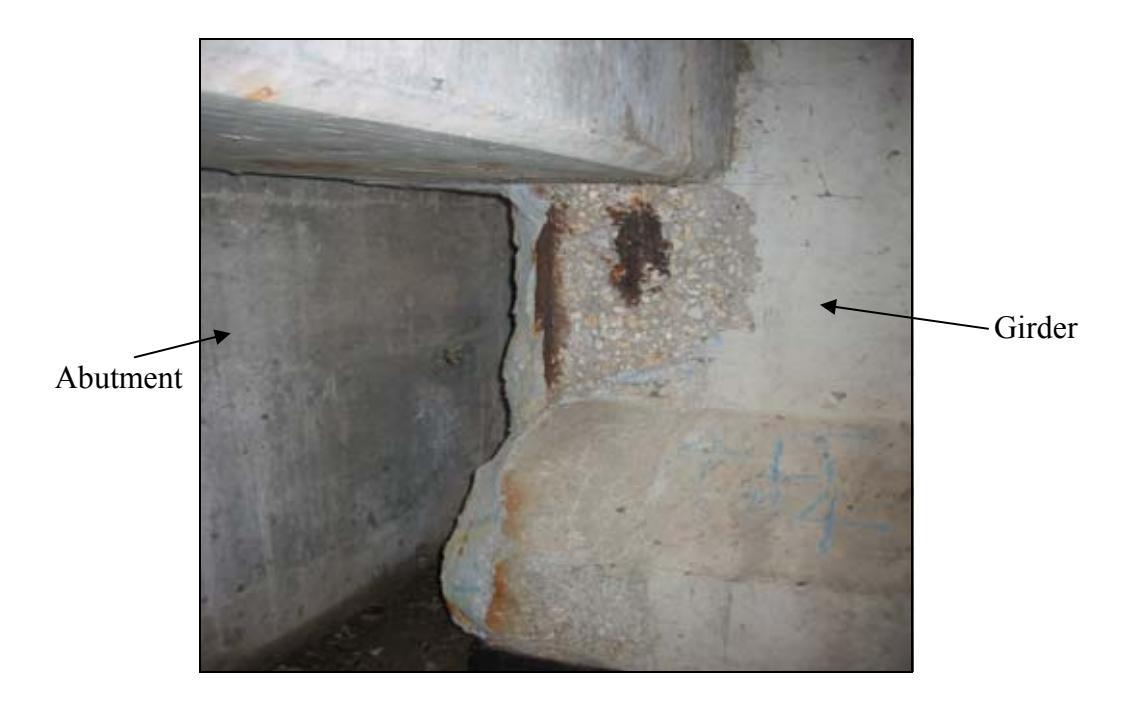
Figure 18. Deterioration of concrete with visible steel of the girders (South end NBL)

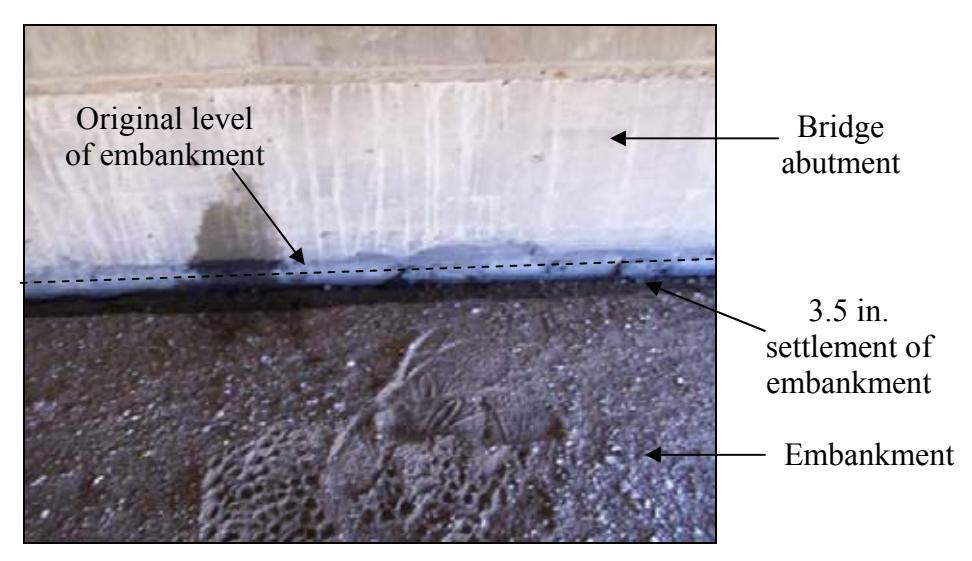
Figure 52. Settlement of the embankment under the bridge and a gap between the abutment and the embankment (East end WBL)

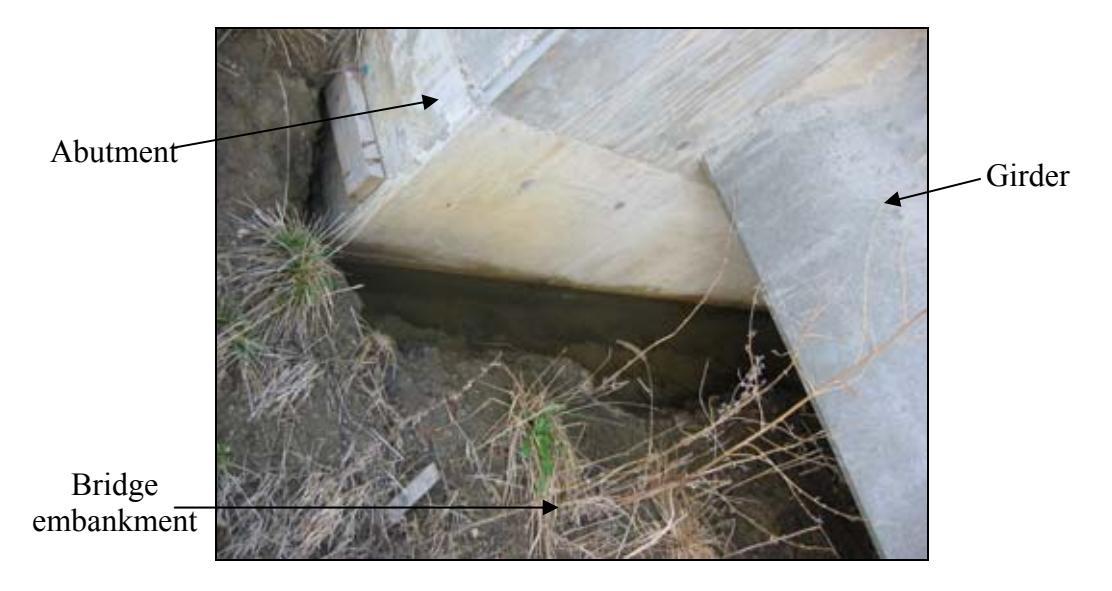
This bridge has integral abutments and prestressed concrete girders. A two-inch void was observed under the bridge approach slab. In addition, erosion of the embankments under the bridge was observed. Figure 65 shows water ponding between the embankment and the abutment.

Figure 65. Ponding water at the abutment under the bridge

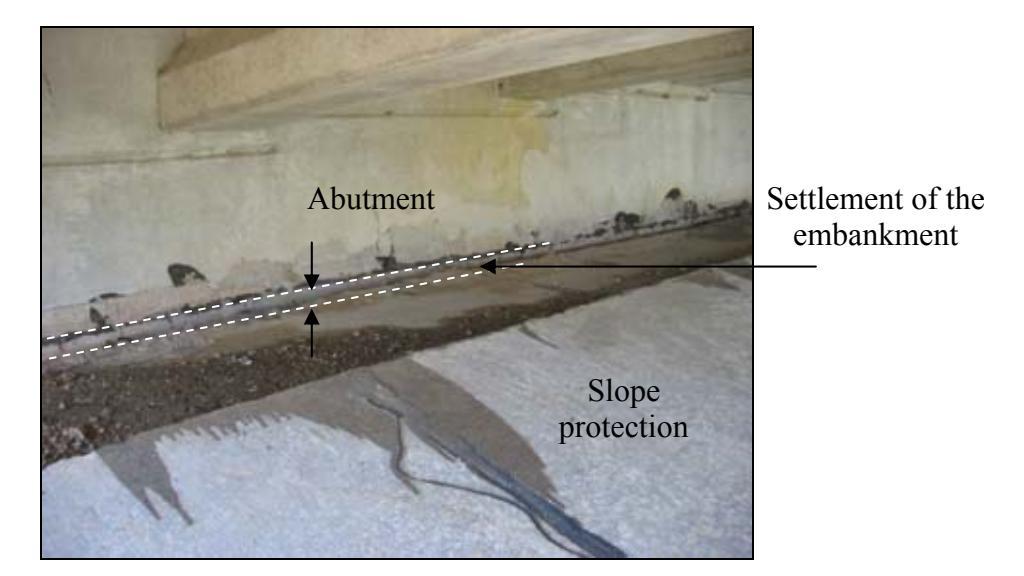
Figure 78. Settlement of the embankment under the bridge and a gap between the embankment and the abutment

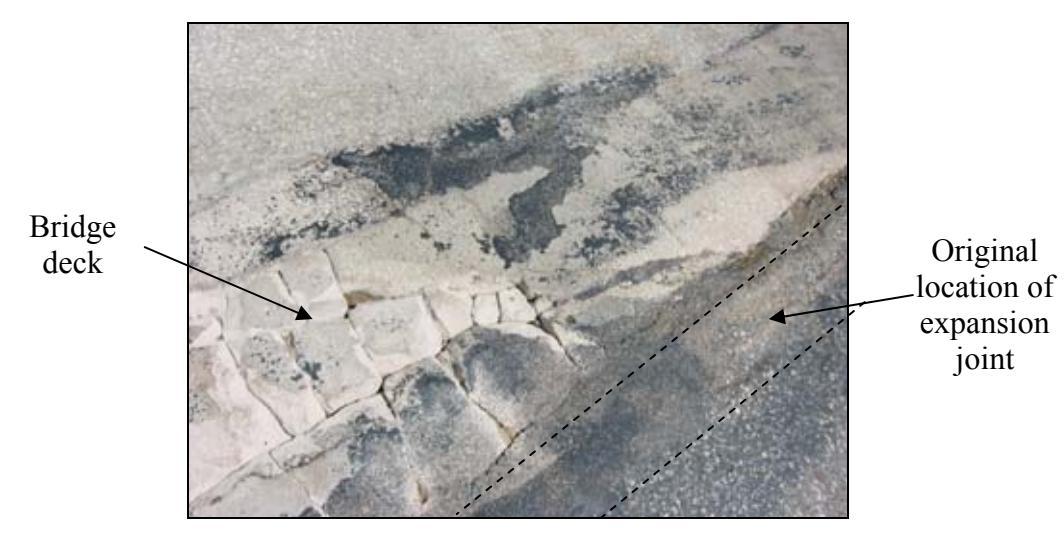
Figure 79. Breakage of bridge deck concrete

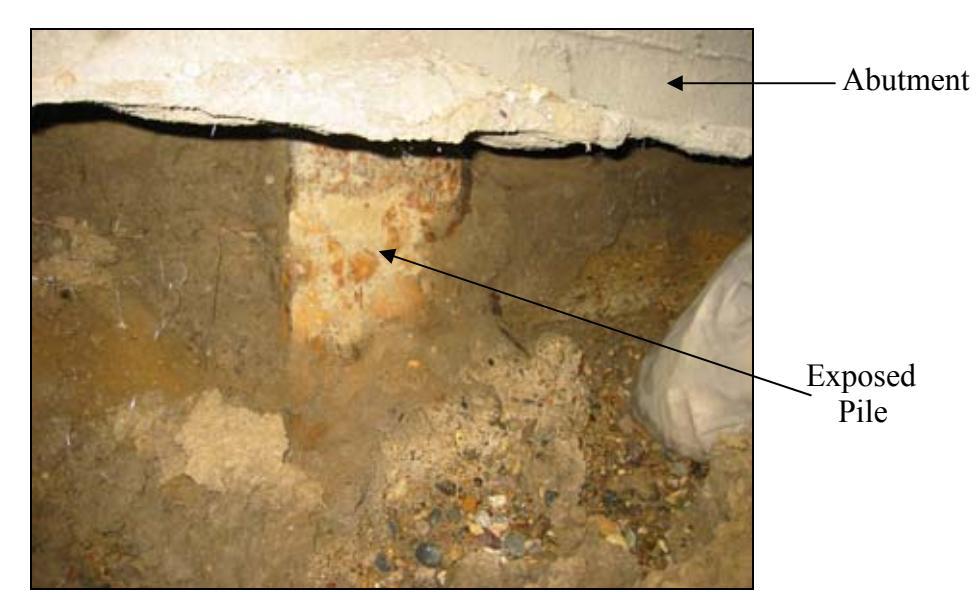
This is a three-span steel bridge with non-integral abutments. Differential settlement of about 4 inches was observed between the approach slab and wingwall. In addition, damage to the expansion joints was noted. Furthermore, soil erosion under the abutment was observed, which led to the exposure of H-piles supporting the abutment (Figure 105). No slope protection was used for the embankment under the bridge. In addition, it was observed that the approach slab panels were shaking under the impact of traffic loads, indicating a void under the approach slab.

Figure 105. Exposed H-pile caused by soil erosion under the abutment

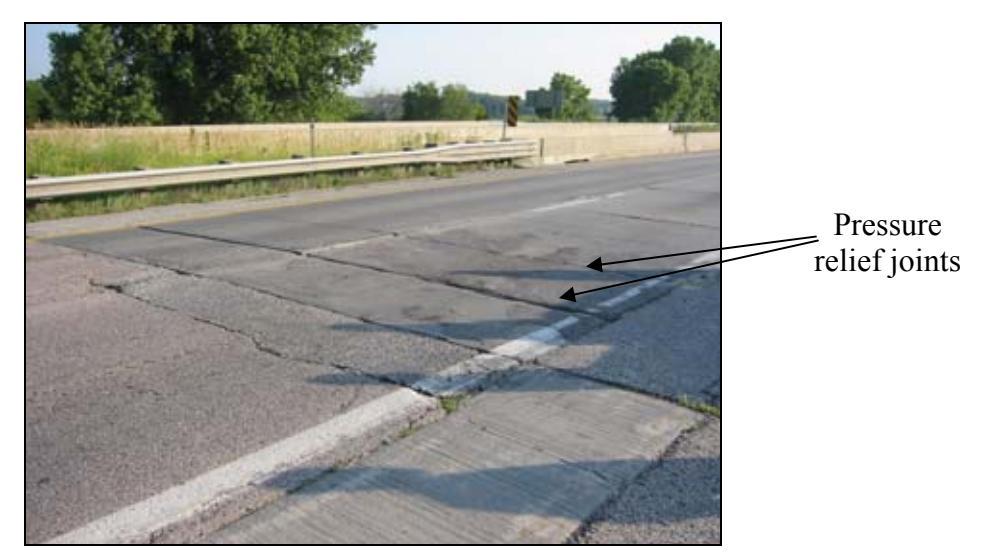
Figure 106. Pressure relief joint made by cutting the approach slab

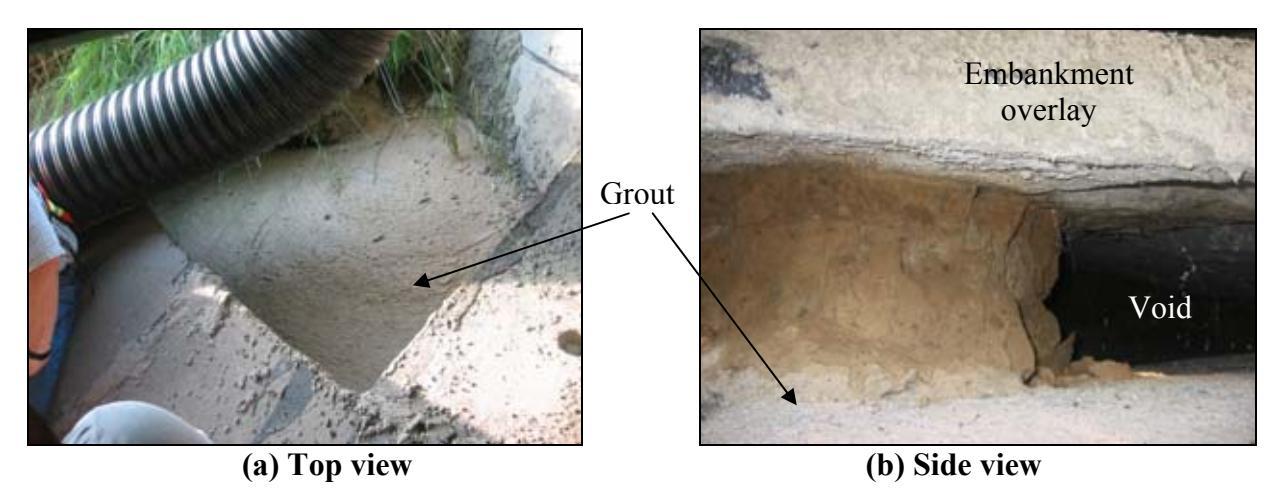
Figure 107. Grout pumped under the slope protection cover to fill the void caused by erosion

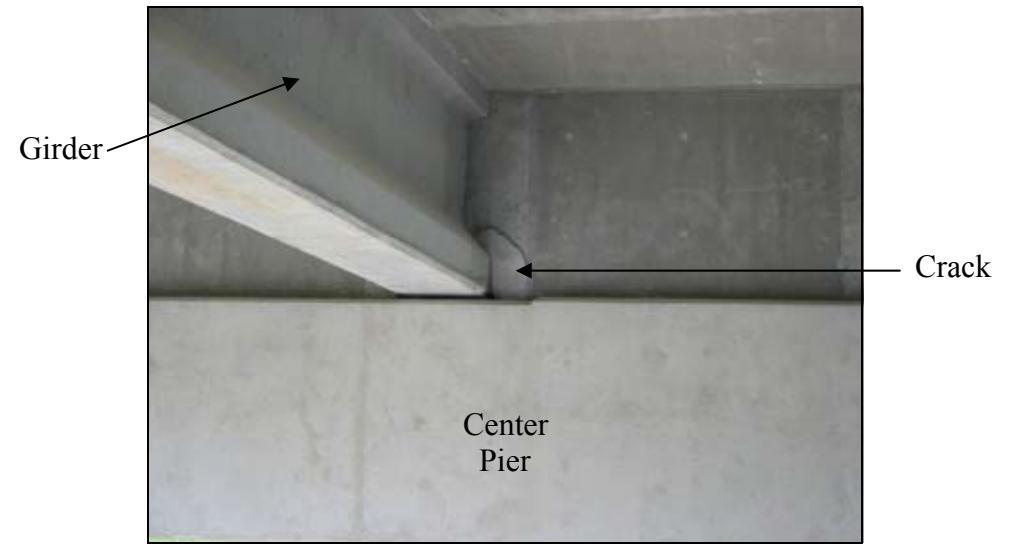
Figure 117. Cracked girder at the center pier

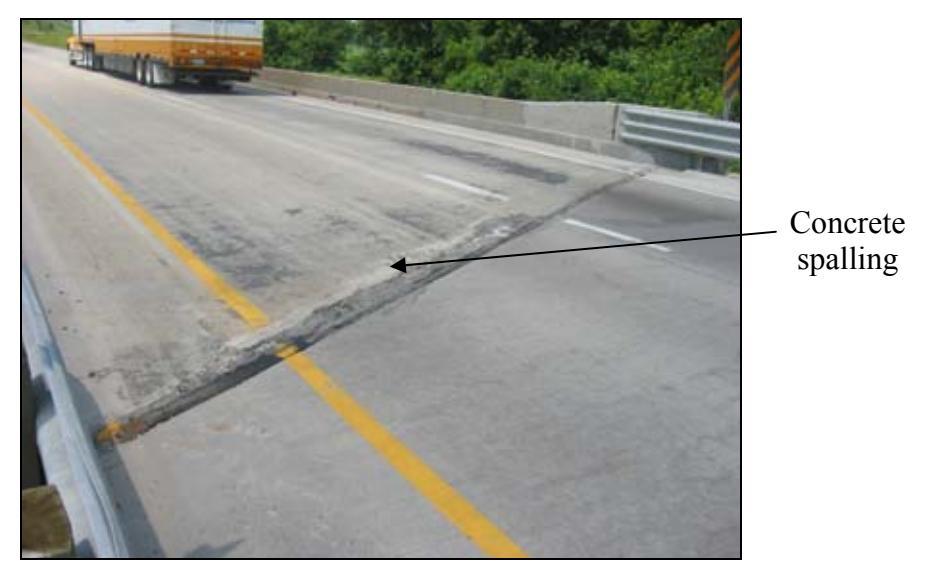
Figure 128. Concrete spalling at the expansion joint

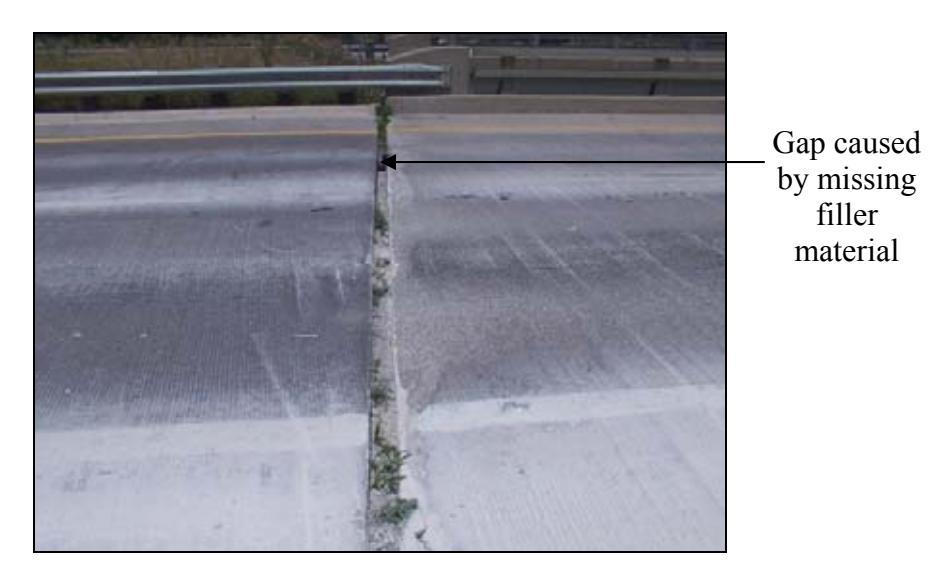
This bridge has four spans with non-integral abutments. The expansion joint was not properly sealed and cracks around the joint were observed at both the east and westbound lanes (Figure 134). Faulting of the approach slab was noticed at the west end of the eastbound lane, as shown in Figure 135, and replaced in summer 2003 (Figure 136). The embankments of the bridge had an aggregate slope protection cover.

Figure 134. Expansion joint poorly sealed and filled with fines (West end of EBL)

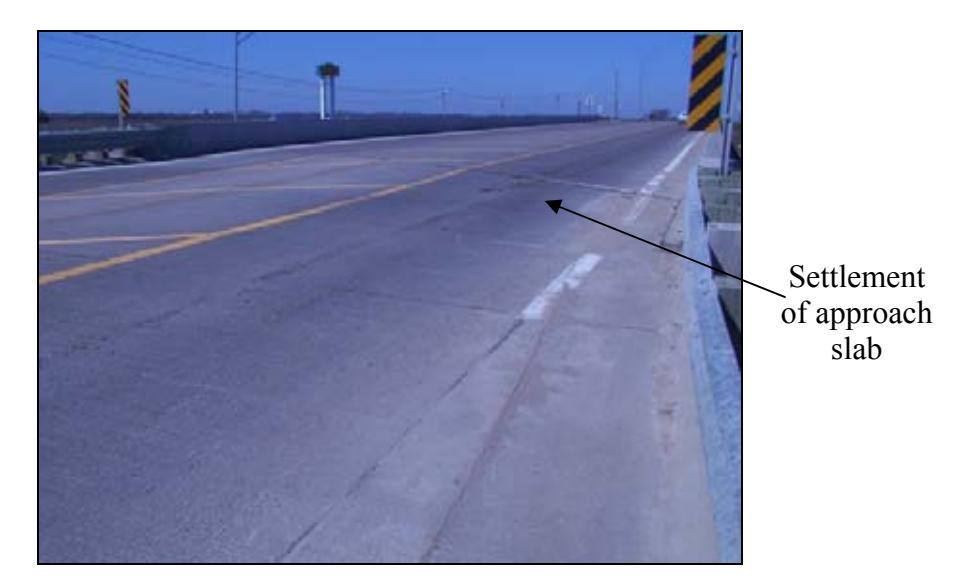
At the east end, differential settlement of about 1 inch between the approach slab and the bridge deck was measured (Figure 141). The expansion joint width was 5 inches. The sealer used to keep the joint filler in place deteriorated shortly after construction, and the forks used to hold the joint material in place were not found. As a result, the joint filler was missing leaving a large gap (Figure 142) allowing water to erode the backfill material under the approach slab. The void developed under the approach slab was about 4 inches deep (Figure 143). Another indication of poor water management was the observed erosion at the sides of the abutment (See Figure 144). Furthermore, concrete spalling was observed at the expansion joint.

Figure 141. Differential settlement at the bridge approach (East end)

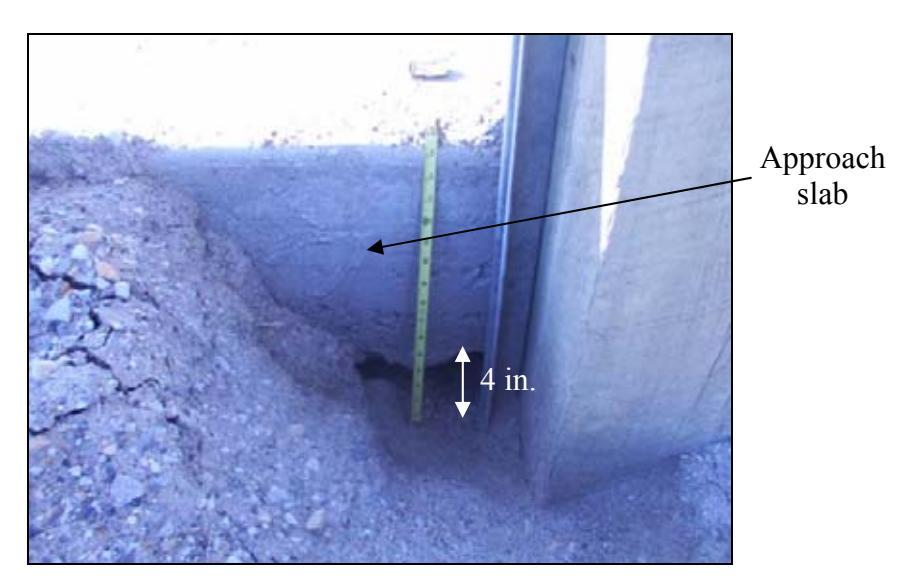
Figure 143. Void developed under the approach slab (East end)

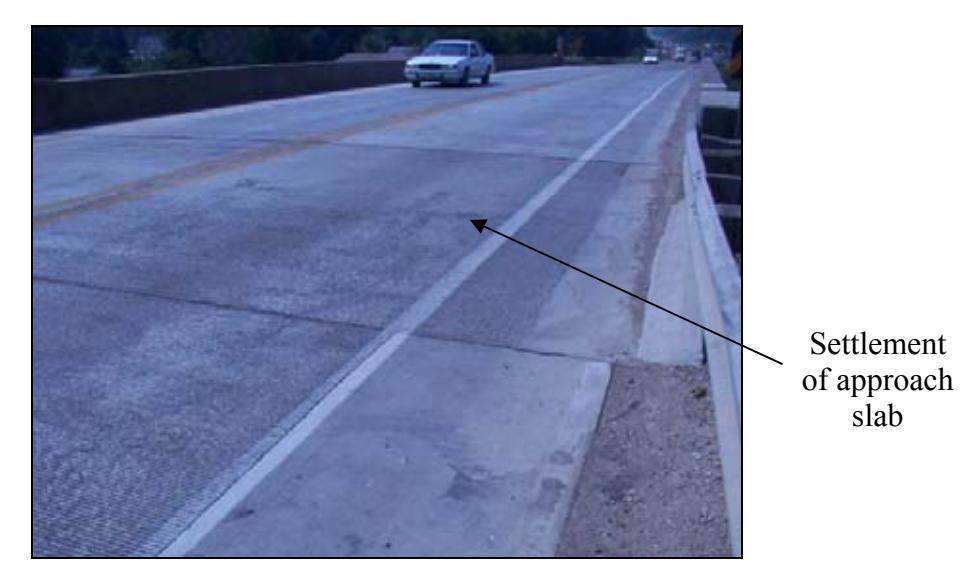
This is a three-span bridge with integral abutments. The approaches were replaced in May 2004 due to the failure of the paving notch. After replacing the approaches, the new expansion joints were 2.5 inches wide. Differential settlement between the bridge deck and the approach slab was observed (Figure 145). At the south end of the bridge, a gap 1 inch wide was observed between the abutment and slope cover (Figure 146), while the embankment settled 3 inches. At the north end of the bridge, concrete slope protection panels were removed for replacement due to uneven settlement, cracking, and failure. The soil used at the embankment under the bridge was silty clay. Aggregate were used at the sides of the abutment to minimize erosion. Similar to other bridges inspected in District 5, this bridge reportedly does not have a subdrain around the abutment.

Figure 145. Differential settlement at recently replaced bridge approach

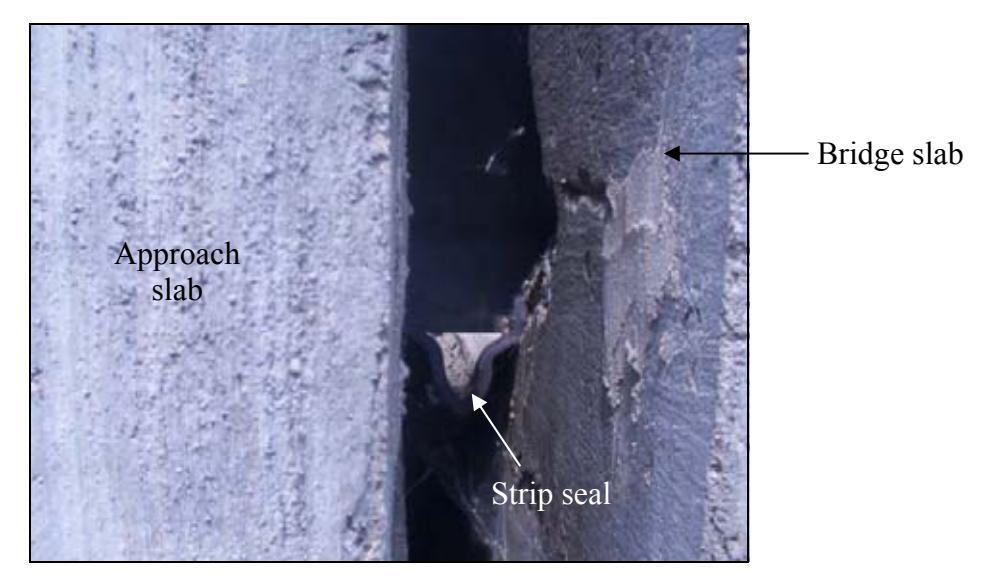
Figure 148. Side view of the strip seal which was cut short (South end of SBL)

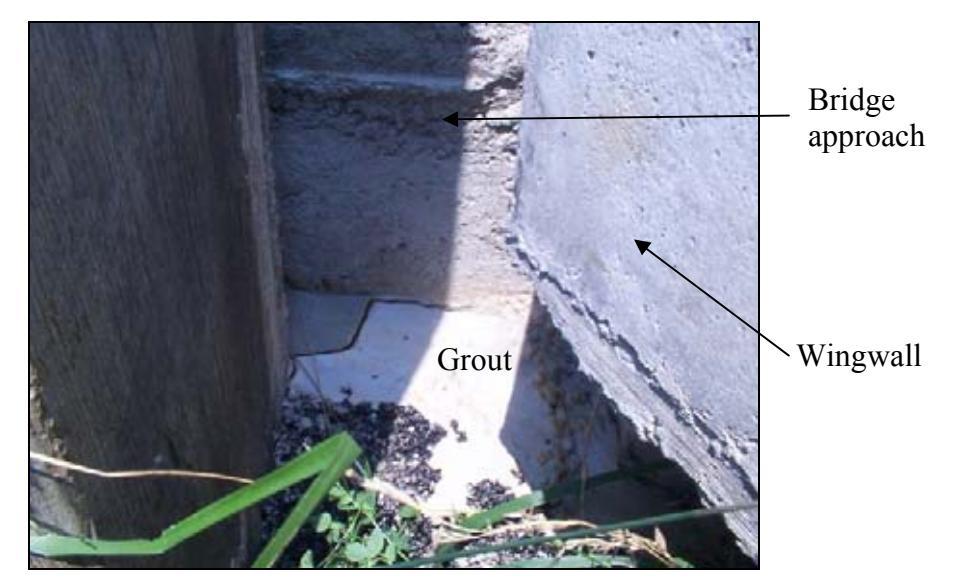
Figure 152. Grouting under the approach slab (South end of NBL)

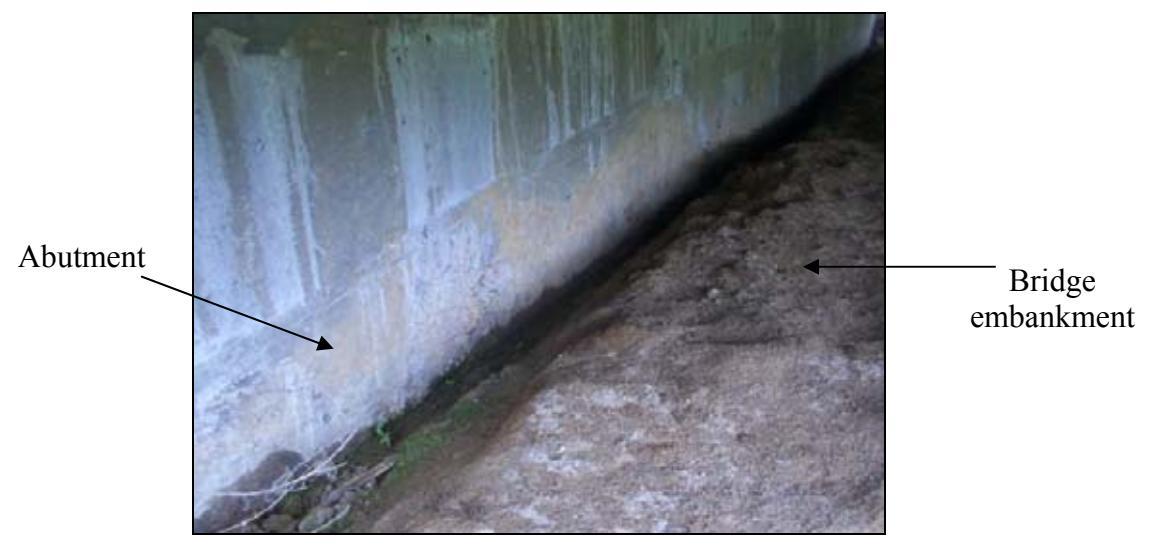
Figure 155. Erosion of the embankment soil (West end of WBL)

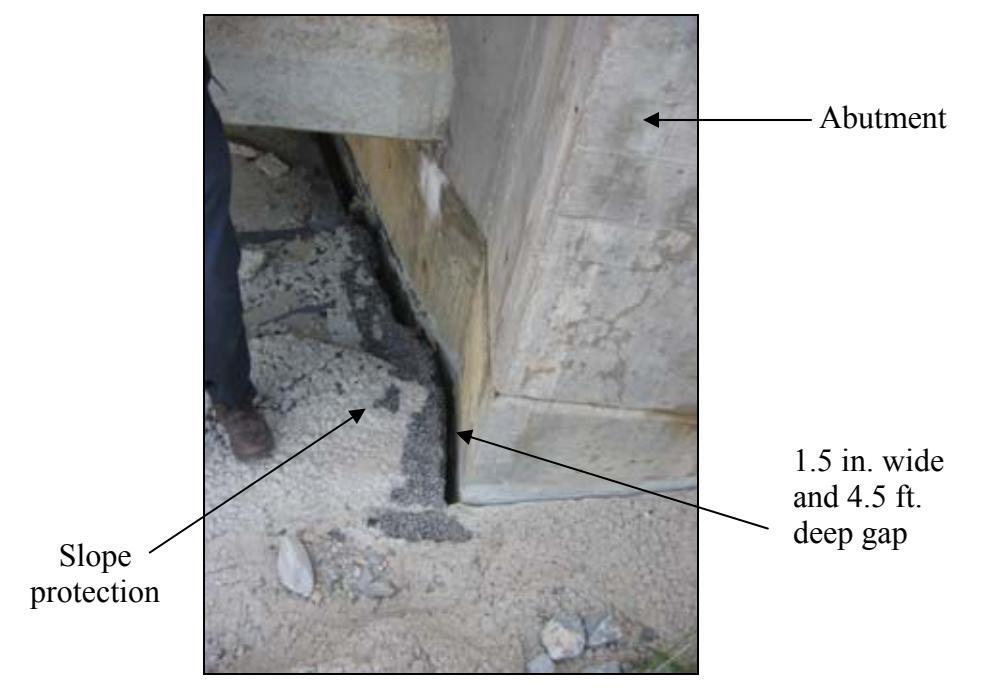
Figure 170. Gap between abutment and embankment

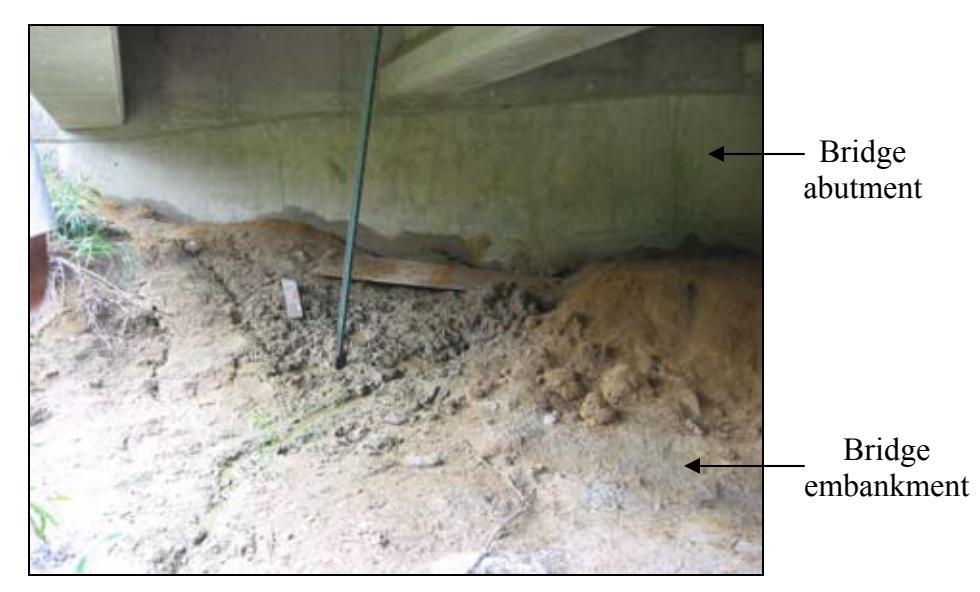
Figure 172. Soil erosion of the embankment under the bridge

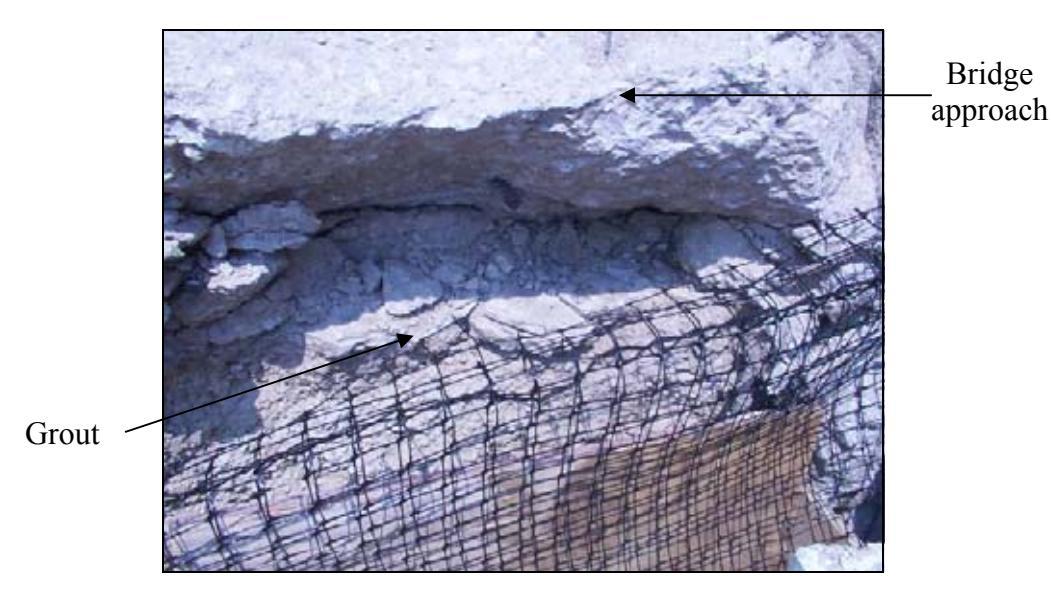
This bridge has three spans with steel girders and non-integral abutments. The bridge approach was grouted to fill a void (see Figure 236). During the field inspection, replacement of both approach slabs and the paving notch of the northbound lanes were in progress. The approach slabs were replaced due to excessive settlement and cracking, which is believed to be a result of severe erosion and subsequent void development. At the south end of the bridge, new granular backfill was placed and compacted in 8-inch-loose lifts using a vibratory base plate. The width of the newly constructed paving notch was 12 inches, with an expansion joint width of 2.5 inches (Figure 237). The bridge did not have subdrains and none were installed. The bridge embankment soil is mostly silty clay with no slope protection. At the north end of the bridge, reconstruction of the abutment was still in progress (Figure 238).

Figure 236. Grout pumped under existing approach (South end of SBL)

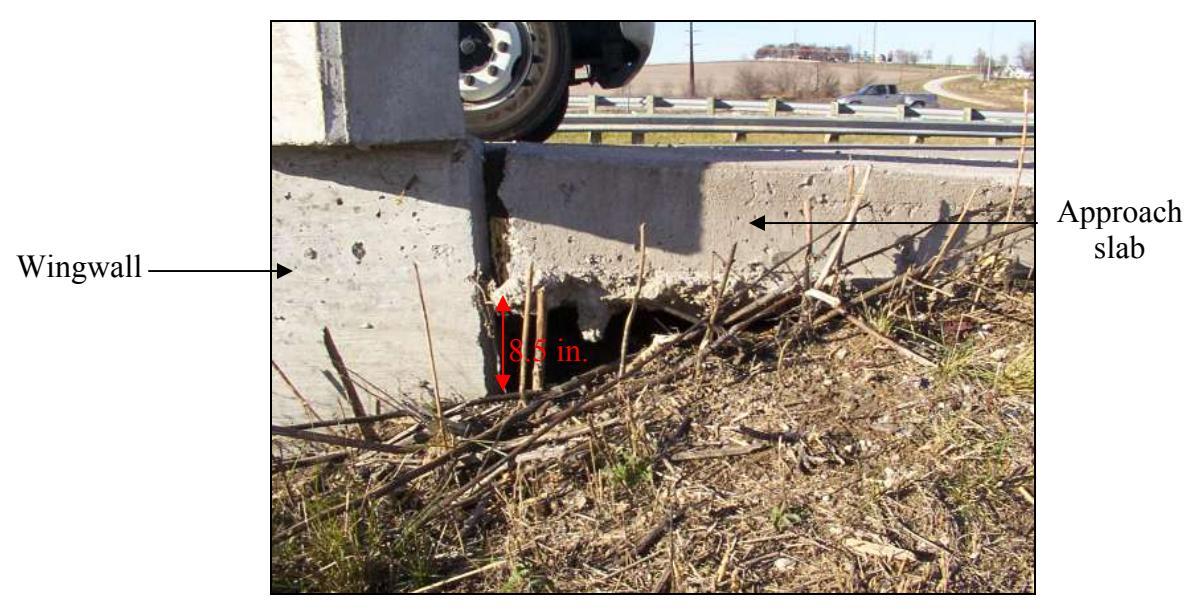
Figure 239. Void under approach slab (North end of SBL)

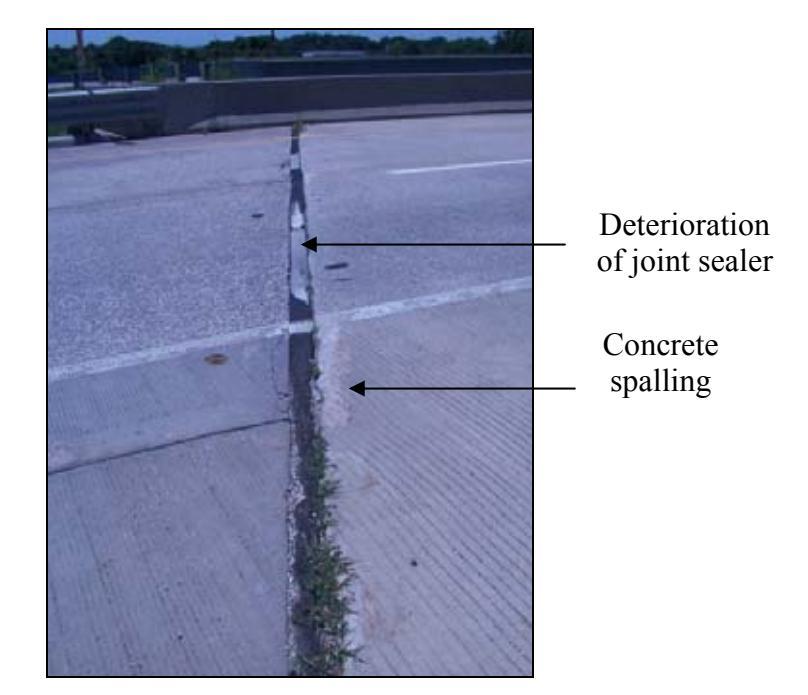
Figure 266. Deteriorated flexible foam used as joint filler (South end of NBL)

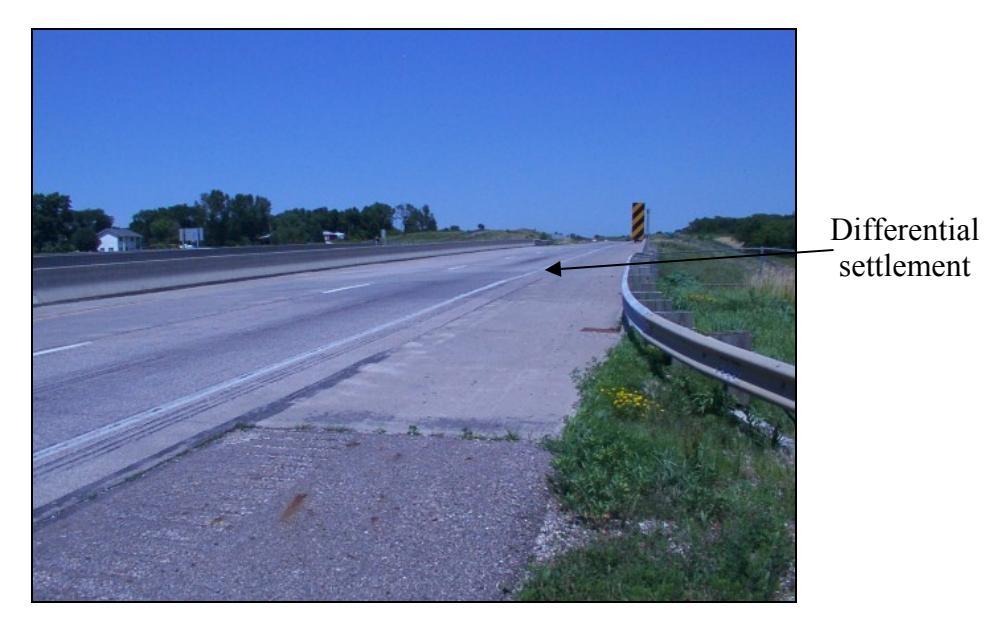
Figure 281. Differential settlement of the approach slab (North end of SBL)

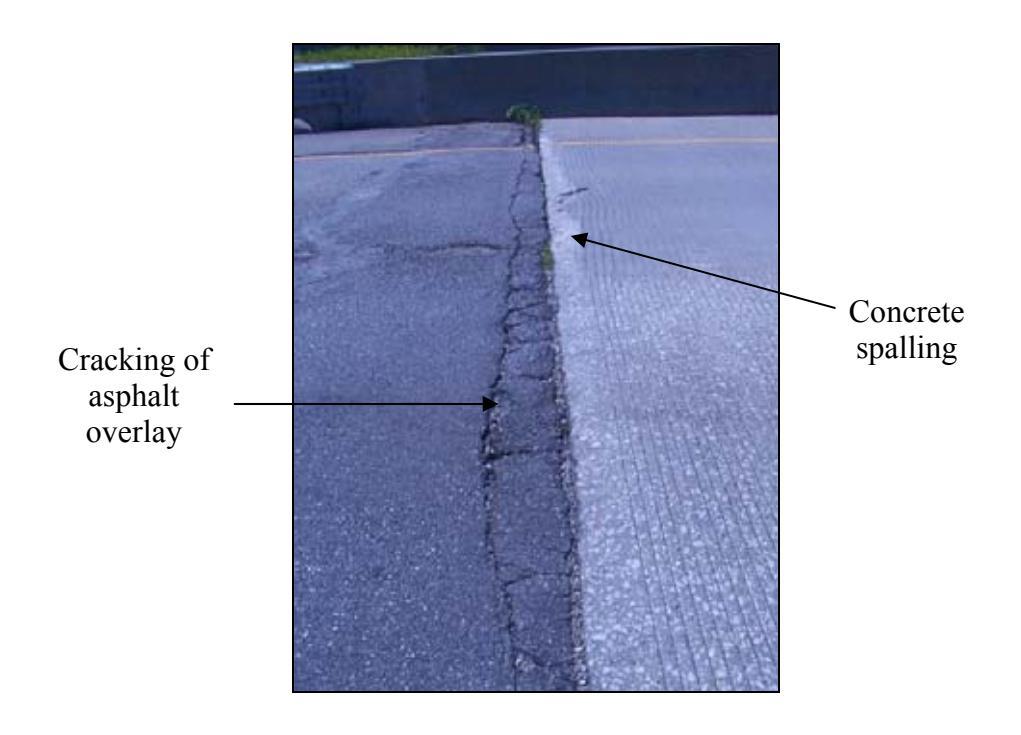
Figure 299. Concrete spalling and cracking of asphalt overlay at the expansion joint (South end of NBL)

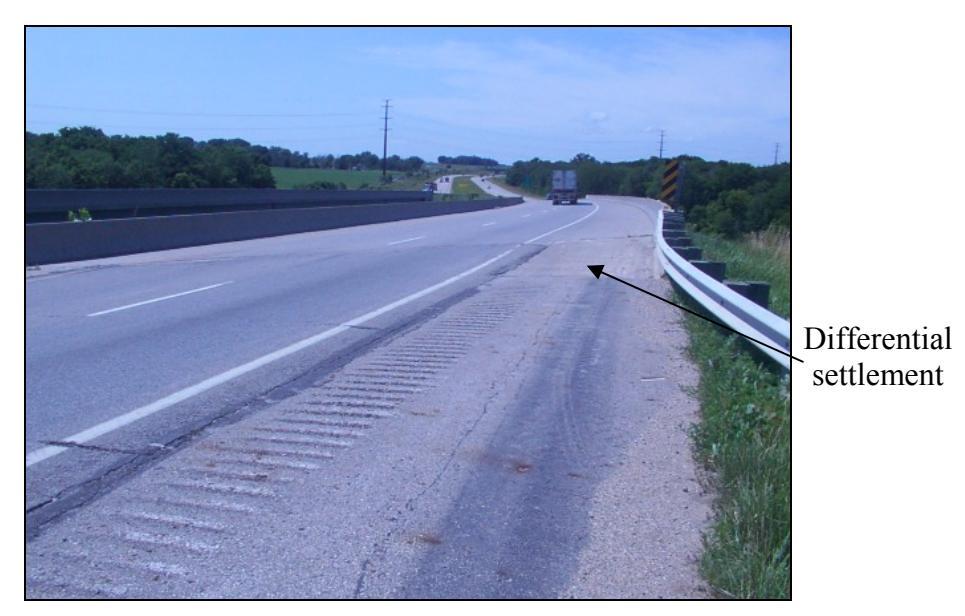
Figure 311. Settlement of bridge approach (South end of NBL)

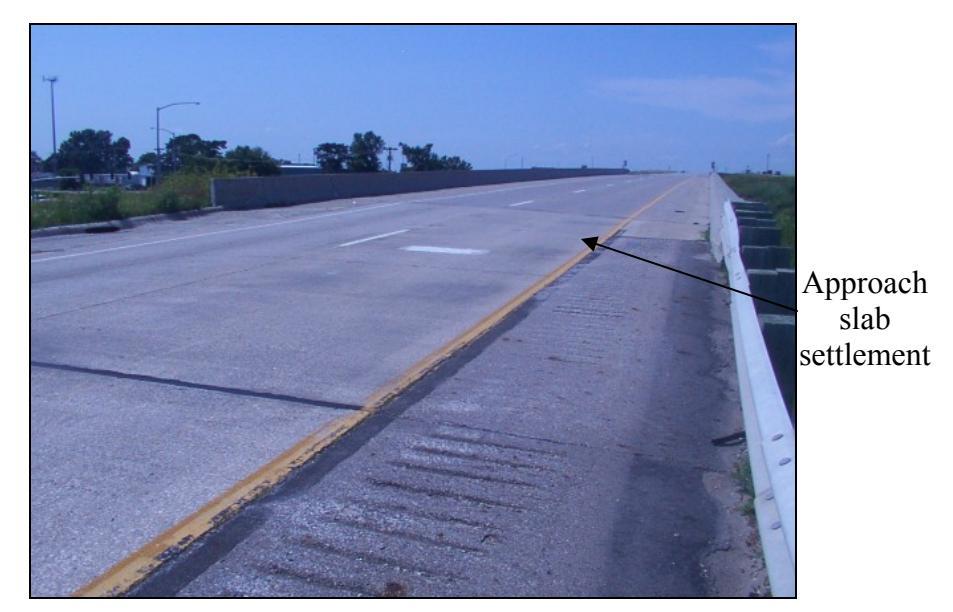
Figure 320. Bridge approach settlement (South end of SBL)

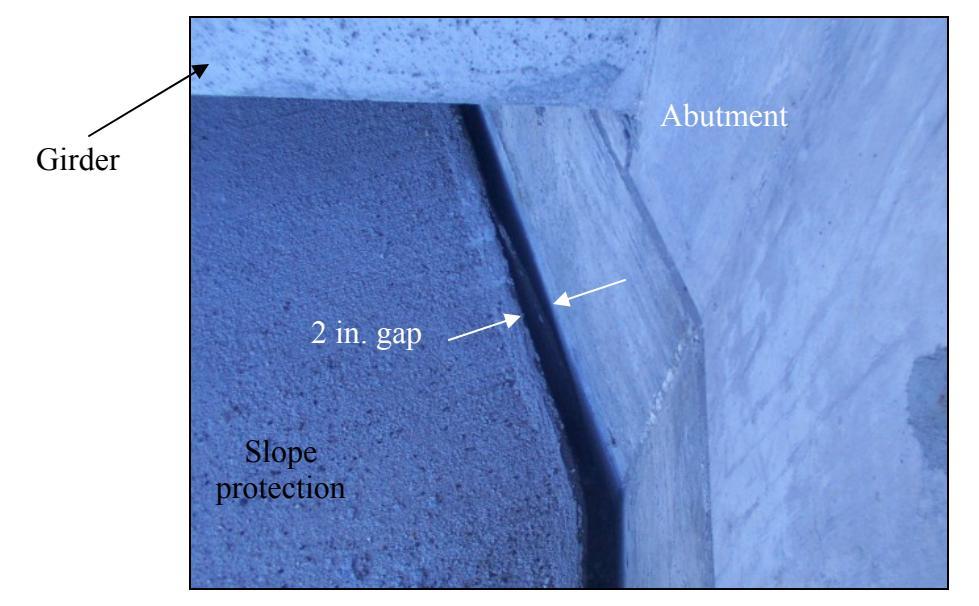
Figure 325. Lateral movement of the abutment away from the bridge embankment caused by expansion of the bridge structure (North end of NBL)

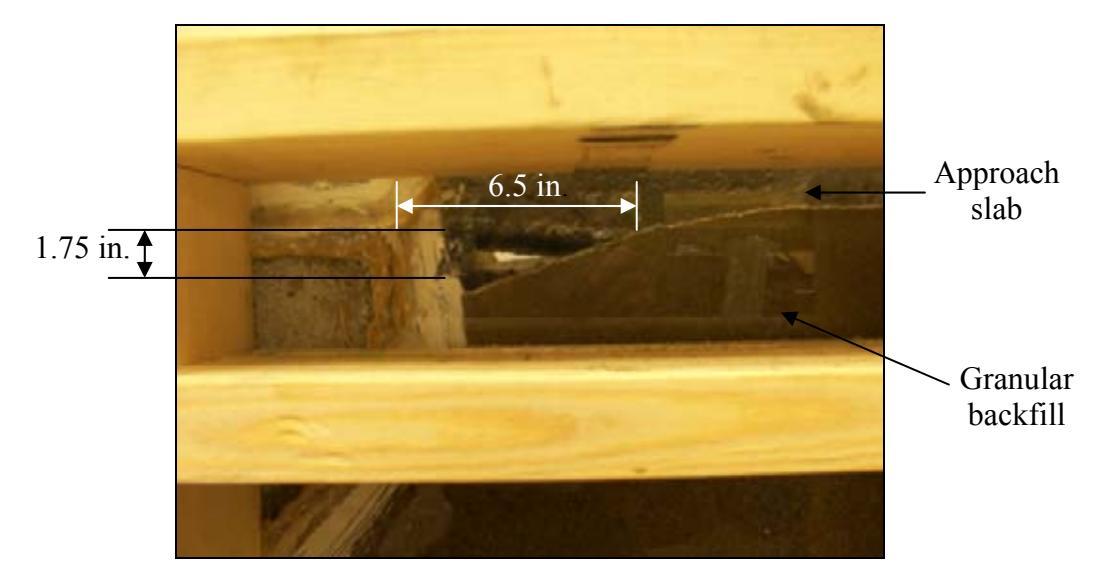
Figure 377. A void that is 1.75 in. deep and 6.5 in. long developed under the approach slab

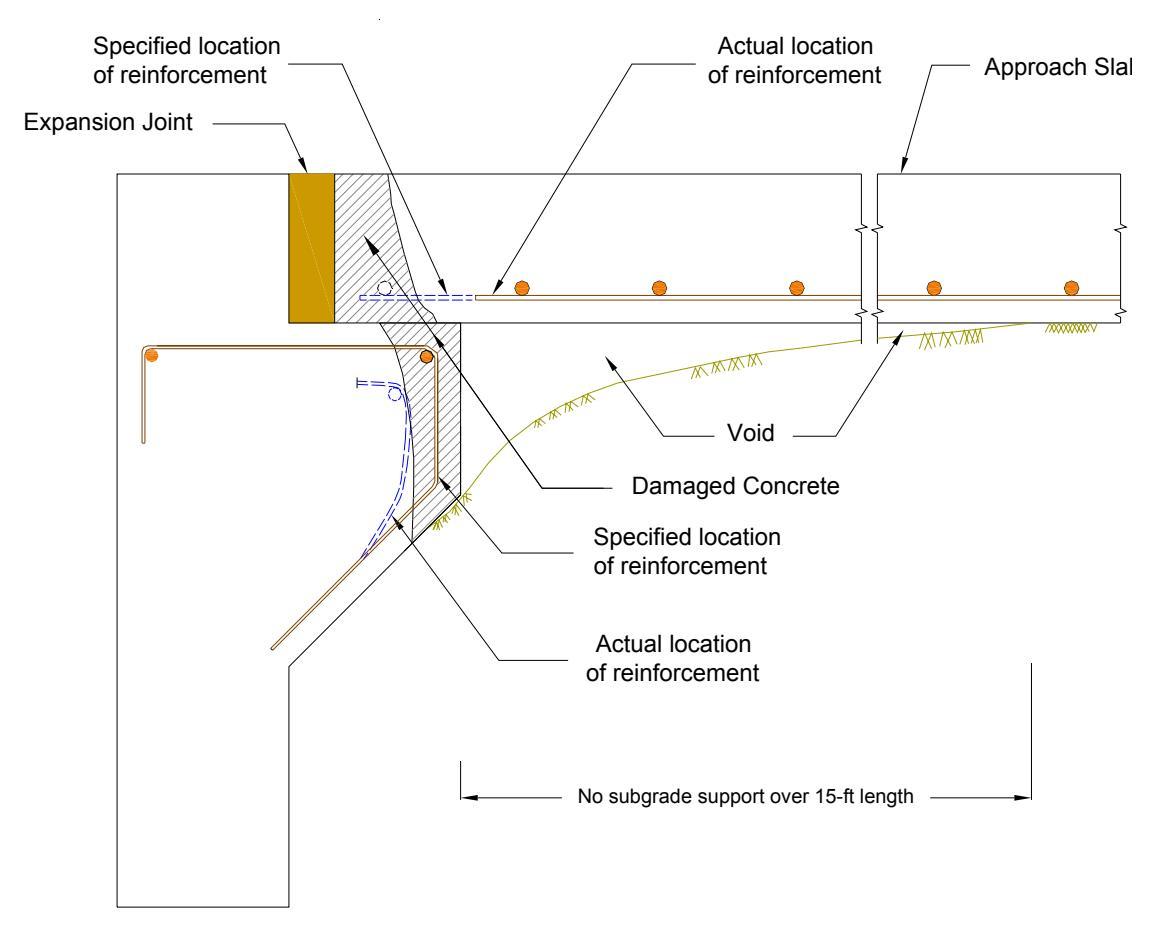
Figure 413. Inaccurate placement of reinforcing steel in the paving notch and the approach slab (Brakke 2003)
