Laboratory Testing and Evaluation Report

24th Street Bridge over I80/I29, Council Bluffs, Iowa

February 28, 2008

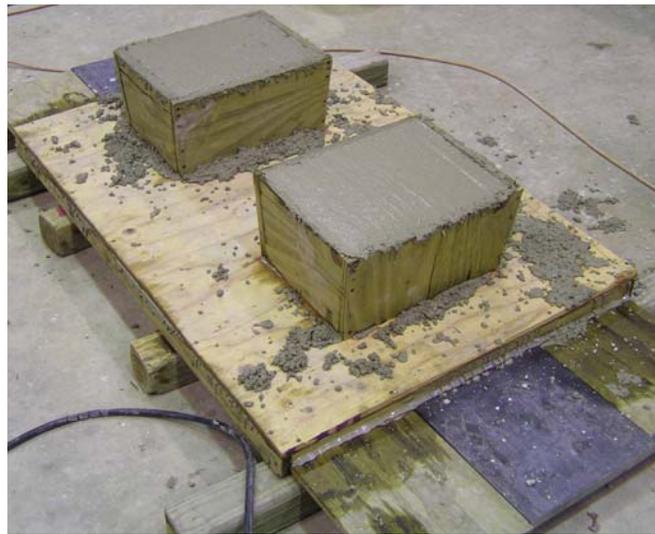
Figure 3.3. Stud pocket and haunch mock-up prior to form removal.

Once installation and the ability to test the studs were deemed sufficient, testing continued with the investigation of the flow of concrete through the stud pockets into the girder haunch. For testing, a 5 ft³ batch of concrete was made consisting of 122.2 lbs of cement, 30.6 lbs of slag, 53.7 lbs of water, 254.2 lbs fine aggregate, 249 lbs coarse aggregate (3/8" washed limestone), and 170 mL of high range water reducer (ADVA 190, High Range Water Reducing Admixture). After mixing, a slump of 9.5in. was measured. This exceeded the allowable slump, so the drum was allowed to run for another 15-20 min. at which point an acceptable slump of 7.5in. was measured. The concrete was then placed into the two stud pockets in the mock-up and agitated with an electric vibrator. Figures 3.3, 3.4 and 3.5 show the mock-up filled with concrete before and after removal of the forms, respectively.

Figures 3 through 5 clearly indicate that concrete can sufficiently flow through the stud pockets and into the haunch area in the specified dimensions. Small voids did exist on the top of the haunch as a result of trapped air in the forms, however, the concrete still reached full depth in all areas.

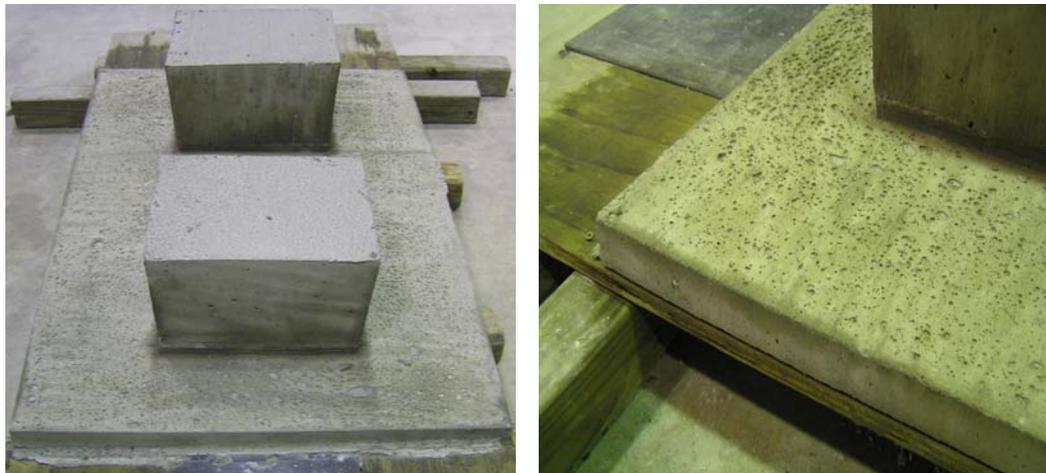
Figure 3.4. Stud pocket and haunch mock-up after form removal.

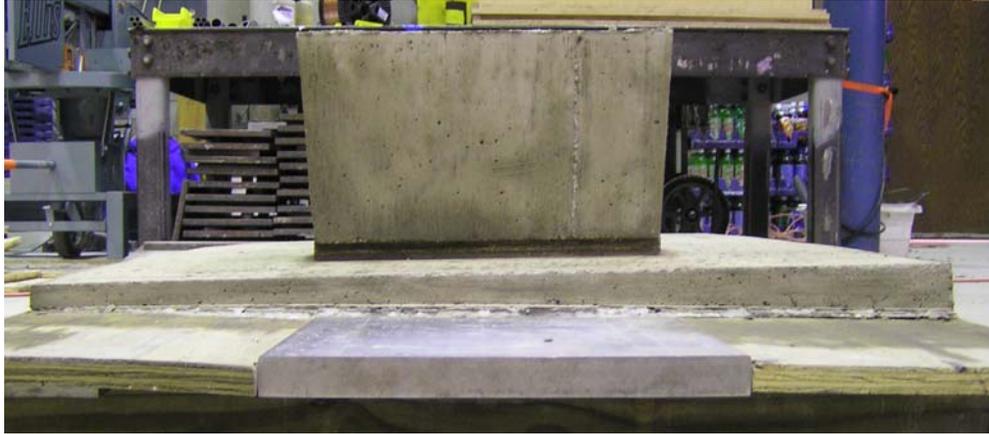
Figure 3.5. Haunch cross-section after form removal.

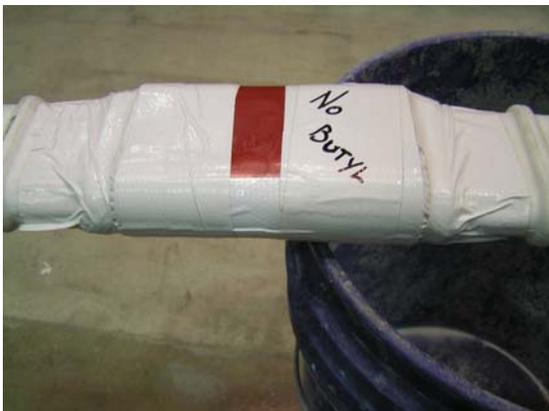
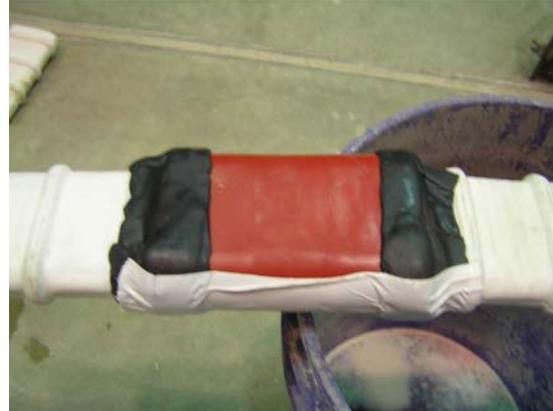
a. Waterproof duct tape

b. Butyl rubber and duct tape

Figure 3.6. Mockup splice connections for 1"x3" P-T duct.

The 1in. x 3in. duct splice connection detail was evaluated to determine if grout or moisture would seep into the duct at the connection locations and thusly causing future problems when post tensioning the strands and grouting the ducts. To evaluate the performance of the duct splices, two mockup duct splices were constructed and placed in grout. One duct splice was constructed of Polyken waterproof duct tape. This splice was constructed with one duct tape strip placed along the longitudinal seam of the coupler, then three 12in. strips of tape were wrapped around both joint interfaces of the duct and coupler, as shown in Fig. 3.6a. The second splice mockup was constructed with 12in. long x 1/16in. thick x 1 1/2in. wide butyl rubber strips wrapped around the joint interfaces of the duct and coupler. The longitudinal joint of the coupler was sealed with a strip of Polyken duct tape, as shown in Fig. 3.6b.

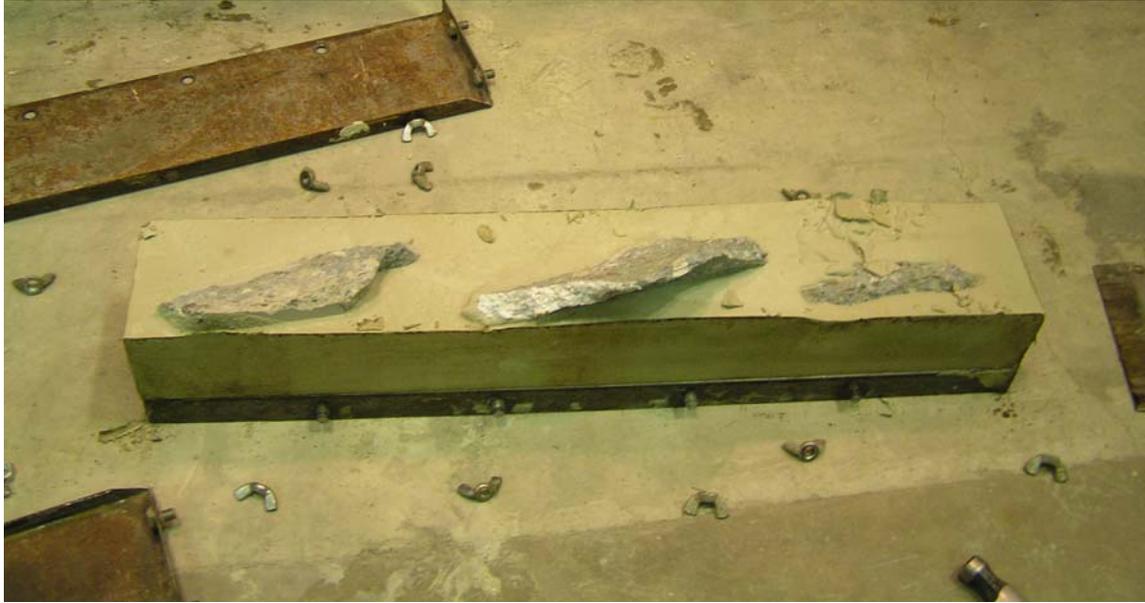
Figure 3.7. Mockup duct embedded in grout beam.

After constructing the connections, the ends of the ducts were sealed with butyl rubber and duct tape to assure that no grout would seep in from the ends. The ducts were then placed in a small beam form and a flowable grout mixture was placed around the duct. Approximately 3in. of grout was placed above the top of the duct. Scrap concrete pieces were used as ballast to prevent the duct from floating out of the grout mixture. The cured beam and ballast can be seen in Fig. 3.7.

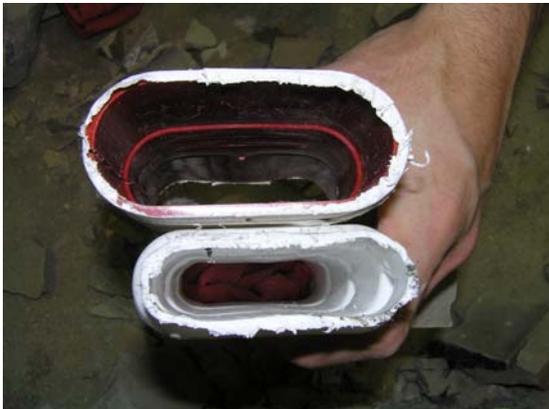
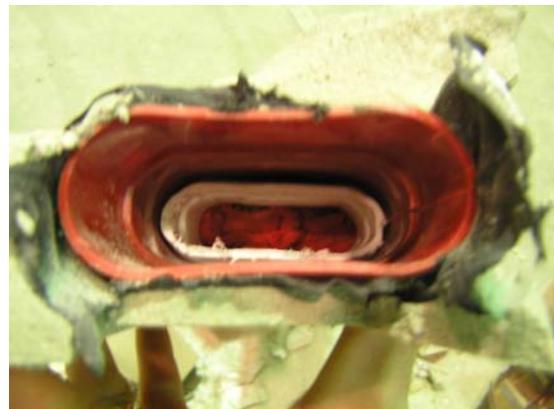
a. Waterproof duct tape

b. Butyl rubber and duct tape

Figure 3.8. Interior of duct splices after embedded in grout.

After allowing the grout to cure for 5 hours, the beam was broken apart with a sledge hammer to examine the embedded ducts and couplers. The splice connections were cut apart and the interior of the ducts were visually examined for any traces of grout or moisture. Both connection types were found to have no grout or moisture in the interior of the duct. The interior of the ducts can be seen in Fig. 3.8. The waterproof duct tape and the butyl rubber methods of grout proofing the splices were both found to be acceptable.

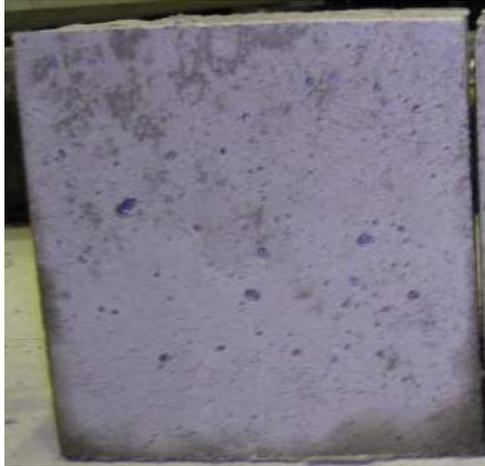
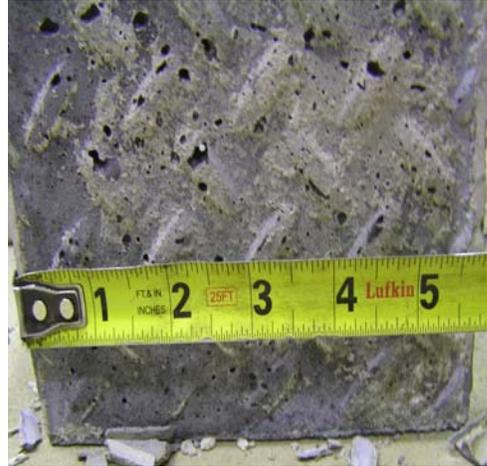
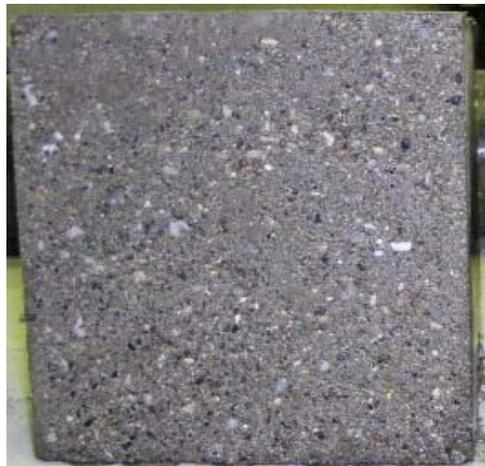
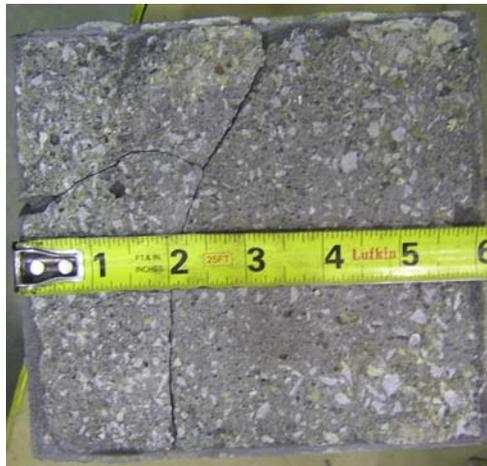
Control

Diamond Plate Form

Chemical Etching

Sandblasting

Figure 3.12. Shear interfaces after testing for each alternative.

From Table 3.1, a progression in higher shear bond strength is evident as one moves downward in the table. Visual inspection of all four alternative grout surfaces prior to grout application could have nearly anticipated these results. The Control specimens grout interfaces were relatively smooth with only a few voids from air pockets. These voids from air pockets are likely what provided most of the shear resistance for this alternative as little to no concrete was removed with the grout. This suggests little to no bond between the concrete and grout. The overall interface left by the Diamond Plate was smooth as well. However, the indentions left by the ‘diamond’ treads in the concrete provided numerous small shear keys for the grout to adhere to and increase the resistance to load compared to the Control. In terms of appearance, the Chemical Etching and Sandblasting appeared to have similar levels of “roughening”; however, they differed significantly in terms of performance for resistance to shear. Based on the results presented in Table 3.1, Sandblasting appears to be the most effective surface treatment for resistance to pure shear. See Fig. 3.12 for photos illustrating the shear interface of each alternative after testing was completed.
