ESTABLISHING LOAD TRANSFER IN EXISTING  
JOINTED CONCRETE PAVEMENTS

Georgia Department of Transportation  
Office of Materials and Research  
Pavement & Physical Research Branch

Prepared for Presentation at the  
1985 Annual Meeting of the  
Transportation Research Board  
Washington, D.C.

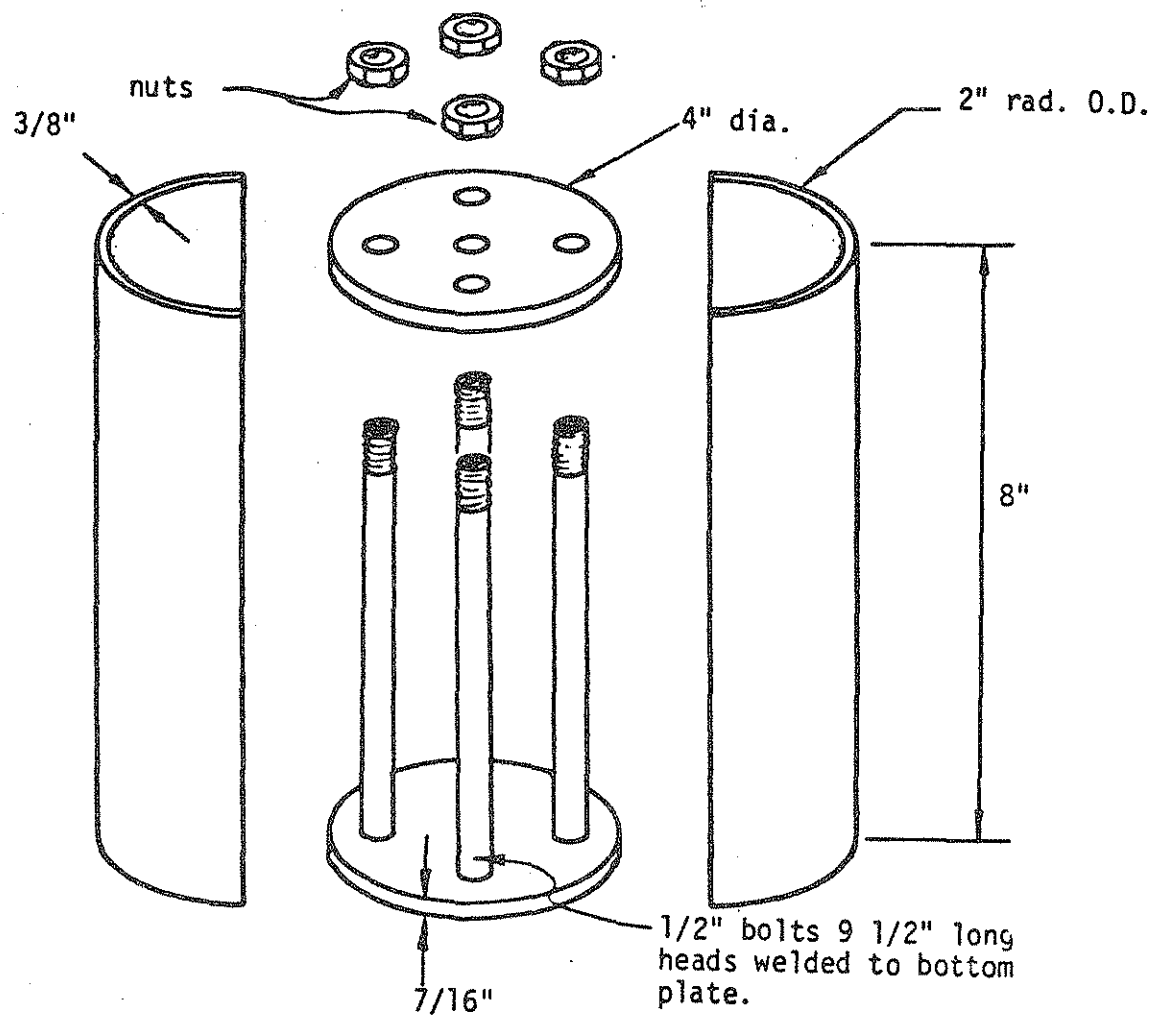
Figure 1 Georgia Split Pipe Device

Georgia Split Pipe Device - This device was developed by the Georgia DOT Office of Materials and Research personnel and is shown in Figure 1. To install these devices the two sides of the "split pipe" are epoxied to either

side of the 4 inch diameter core hole and the epoxy allowed to set. The top and bottom plates rest on the top and bottom edges of the two split pipe pieces. The four bolts are tightened and the load transfer between the slabs is carried by the four bolts and the epoxy bond between the split pipe pieces and the concrete core hole surfaces. Thermal expansion movement is accommodated by the slippage of the top and bottom plates on the end of the split pipe pieces.

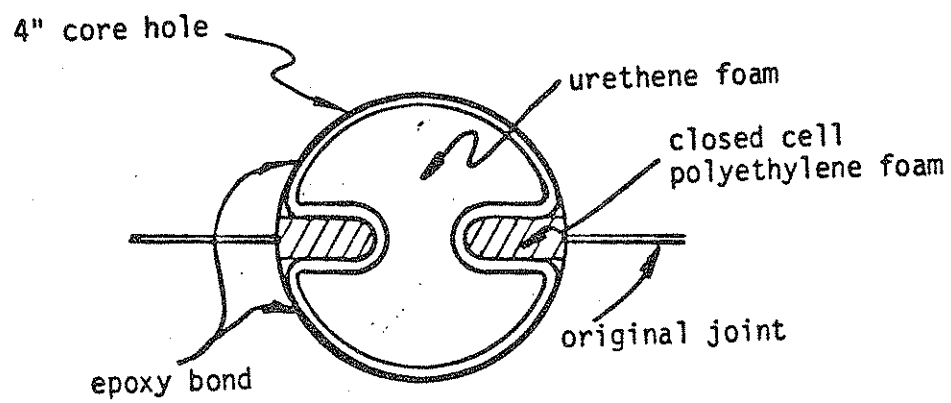
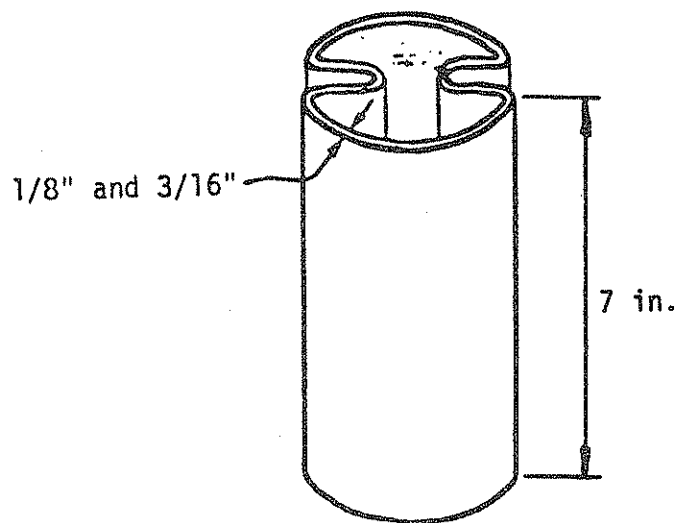
Figure 2 Figure Eight Device

Figure Eight Device - This device is a single piece cylindrical metal shell formed in the shape of the numeral eight as shown in Figure 2. The device is installed in a 4 inch diameter core hole and epoxy is used to bond the device to the walls of the core hole. The center of the device and the indentations on the side are filled with foam to keep out debris. The device has previously been used experimentally in France (4).

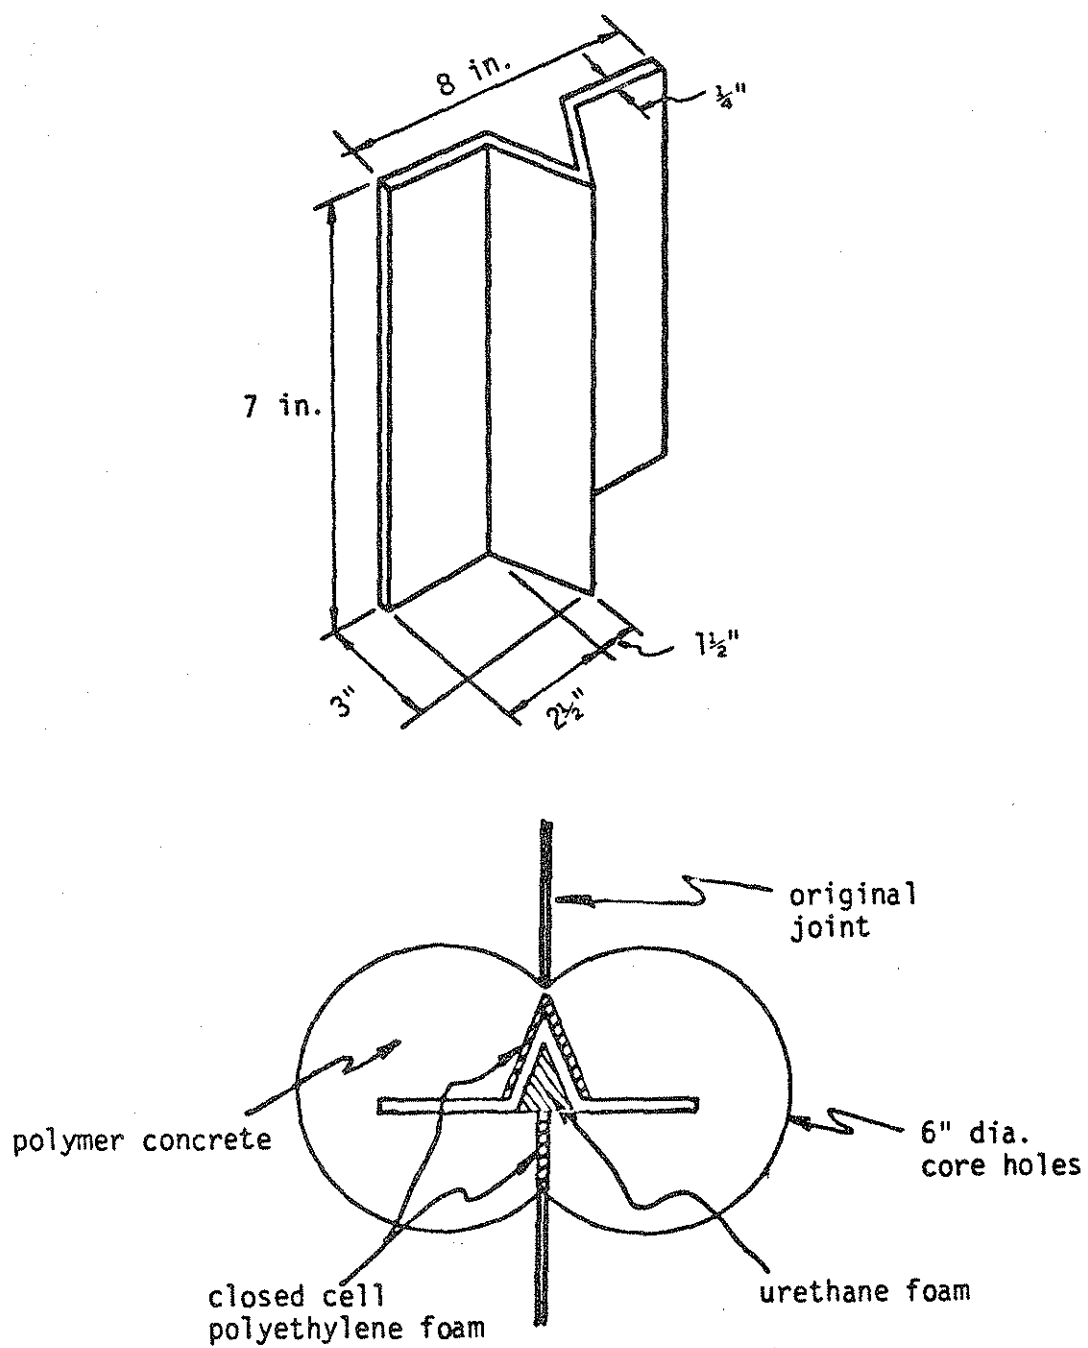
Figure 3 Vee Device

Vee Load Transfer Device - This type load transfer device was first proposed in a report published by FHWA in 1977 (3) along with the "Figure Eight" device. The device consists of a 1/4 inch thick steel plate bent into the shape of a V as shown in Figure 3. The device is not commercially available and was specially fabricated for this research project.

In order to be able to install the Vee device, two 6 inch diameter core holes have to be drilled which are filled with a patching material after the installation. The V portion was filled with a urethane foam and a thin layer of polyethelyne foam was placed around the outside of the V to allow for expansion and contraction of the slab. An additional piece of foam was used to reestablish the joint.

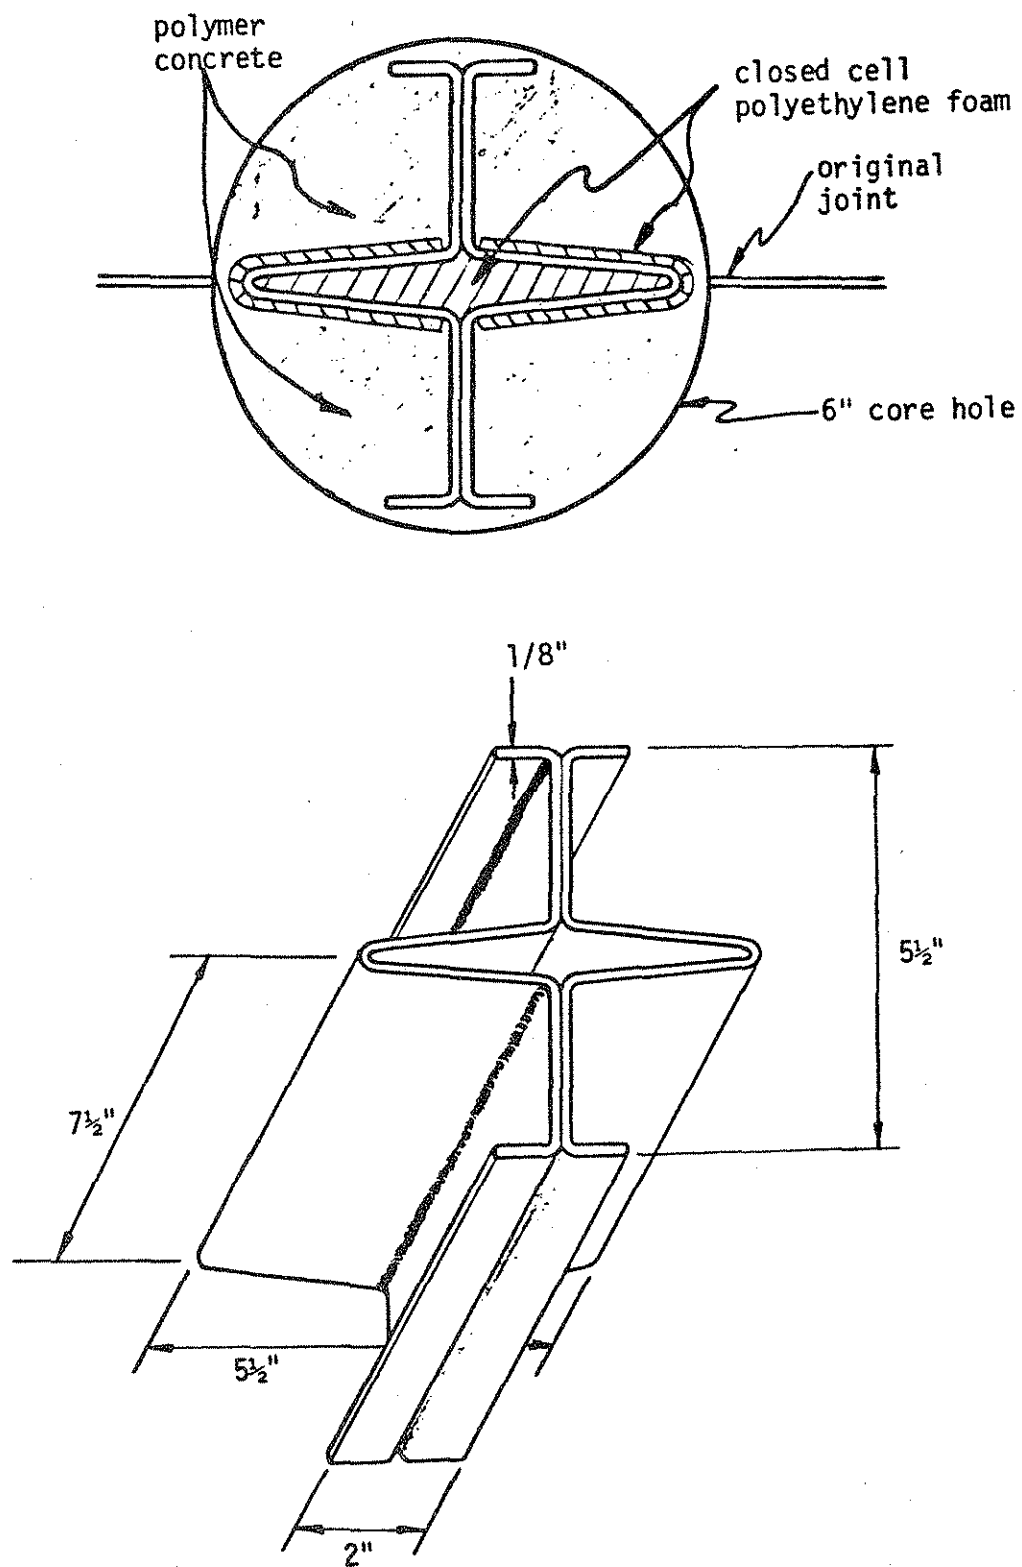
Figure 4 Double Vee Device

Double Vee Load Transfer Device - This device essentially is two Vee devices placed back-to-back and down-sized to accommodate installation in a

6 inch core hole. The device was designed and initially tested at the University of Illinois (5) and is now commercially available under the trade name of LTD Plus. Some minor additional design changes to the device shown in Figure 4 have taken place since its use in this research project. The center section of the device is filled with foam to keep out debris and a thin foam pad is placed around the outside of the V portion to allow for expansion and contraction movement. The devices used in this project are epoxy coated to prevent rusting and current devices are manufactured from stainless steel.

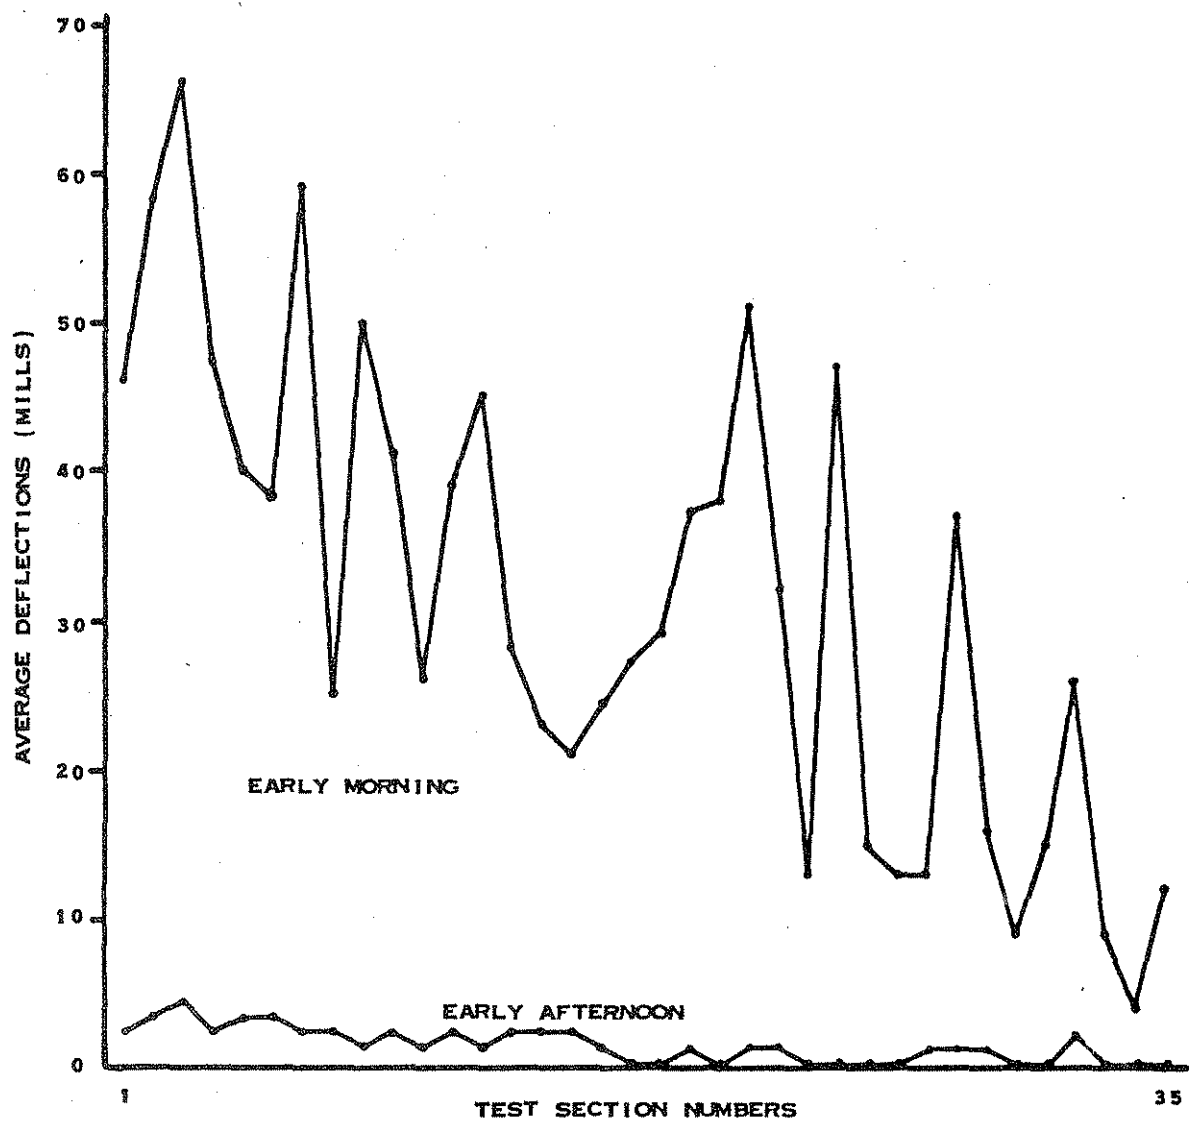
FIGURE 5 DEFLECTION LEVELS OF LEAVE SLAB CORNERS  
SEPTEMBER 1982

The effects of seasonal changes on the load transfer conditions was evident from the three series of tests which were conducted at different times of the year and clearly showed that the higher deflections were obtained in September 1982 and always occurred in the early morning test series for all three evaluation periods. The deflections obtained with the load on the leave side of the joint also were generally larger than the deflection obtained on the approach side when loaded. The deflection data also shows that the vertical movement measured in the early afternoon is generally negligible regardless of the magnitude of the movement measured in the early morning (Figure 5). Performance comparisons between the various load transfer systems were therefore based on deflections measured during the early morning hours when significant slab movements are likely to take place.

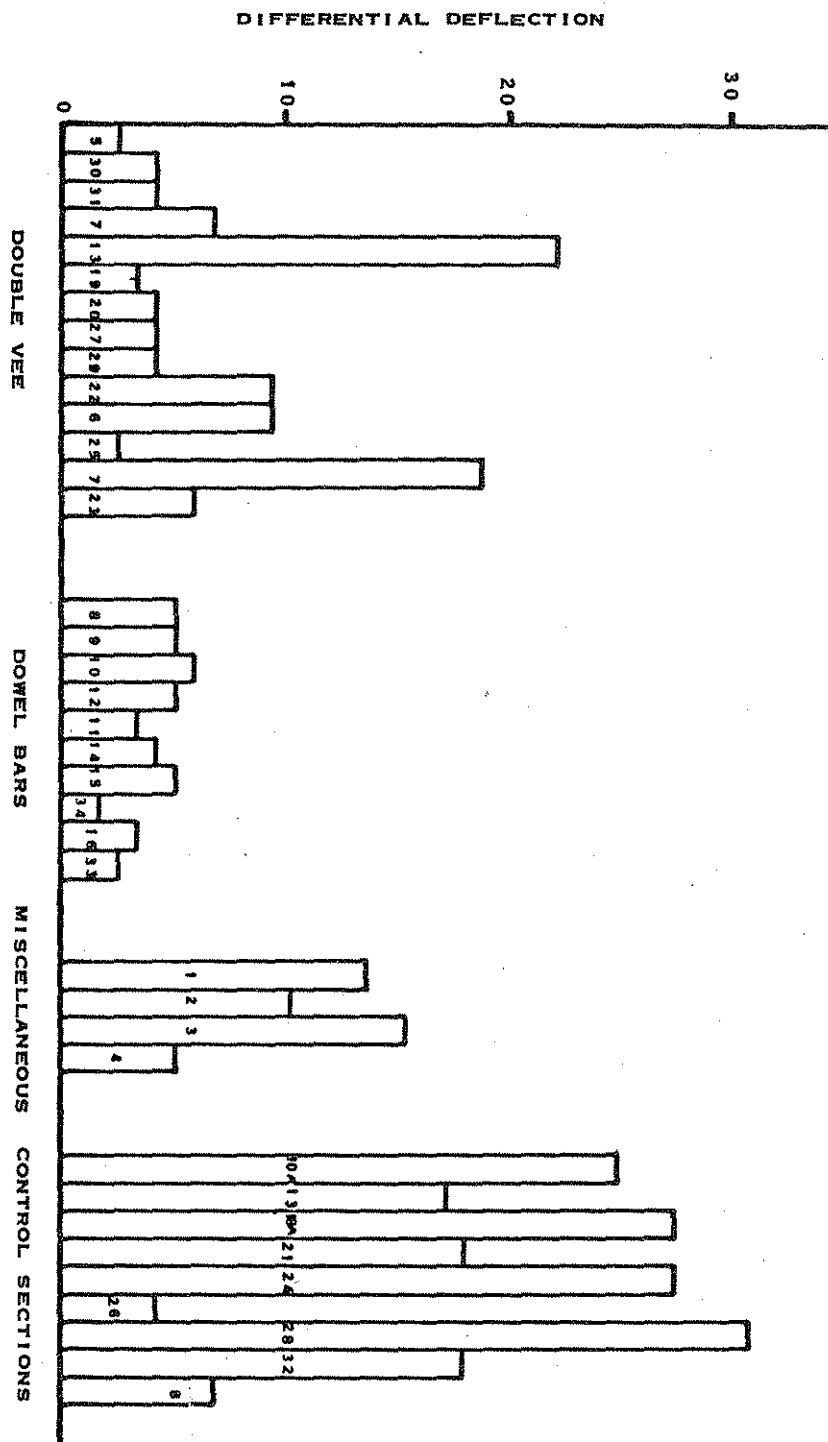
FIGURE 6 DIFFERENTIAL DEFLECTION VALUES - MARCH 1983  
EARLY MORNING LOAD ON LEAVE SLAB

The critical time period for analysis is the deflections obtained during the early morning testing with the load placed on the leave side of the joint. The average differential deflection values for each test section is shown in Figure 6 for the March 1983 test period with the load placed on the leave slab. The bar charts in Figure 6 clearly show that all the sections with the dowel bars were performing well along with ten of the fourteen sections containing Double Vee devices. Section four containing the Vee device shows good performance on the bar chart, however, the data is suspect for this section for March 1983 since the deflection difference obtained in September 1982 was 35 mills. The March 1983 readings were generally much less than those obtained in September 1982 for sections showing poor performance. For the sections with good performance there generally was not much difference between the September 1982 and March 1983 differential deflection values. This fact is an indication of the seasonal influence on sections with little or no mechanical interlock. When adequate mechanical interlock is present, the seasonal influences are minimized in a manner similar to that noted previously for the daily temperature cycle changes.
