# INVESTIGATION of HIGHWAY LIGHTING

IOWA HIGHWAY RESEARCH BOARD

PROJECT HR-154  
Final Report

HIGHWAY DIVISION  
November 1976

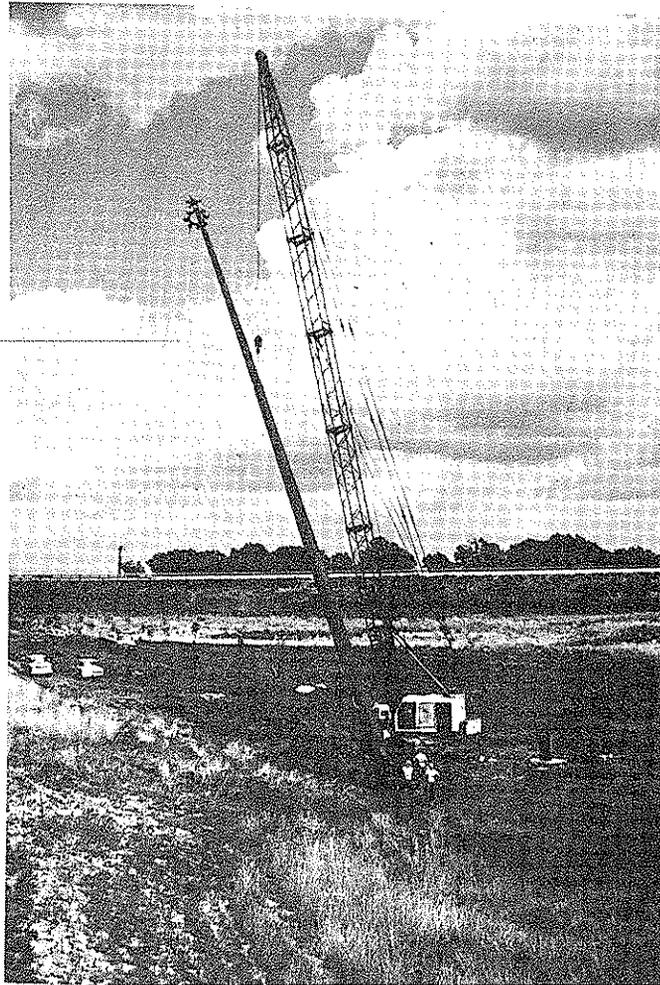
Figure 2. Erection of the largest tower  
in the installation

Special equipment for the tower construction operations included pile driving machinery for footing construction, and a crane to erect the towers. The largest tower in this installation, shown in Figure 2, is 180 feet long and weighs approximately 12 tons. Some towers were located well outside the hazardous zone near the traffic lanes, and the construction operations could all take place outside this zone. Where towers were located at the minimum lateral clearance of 50 feet to the roadway, many operations were performed from the shoulder area, with need for traffic control.

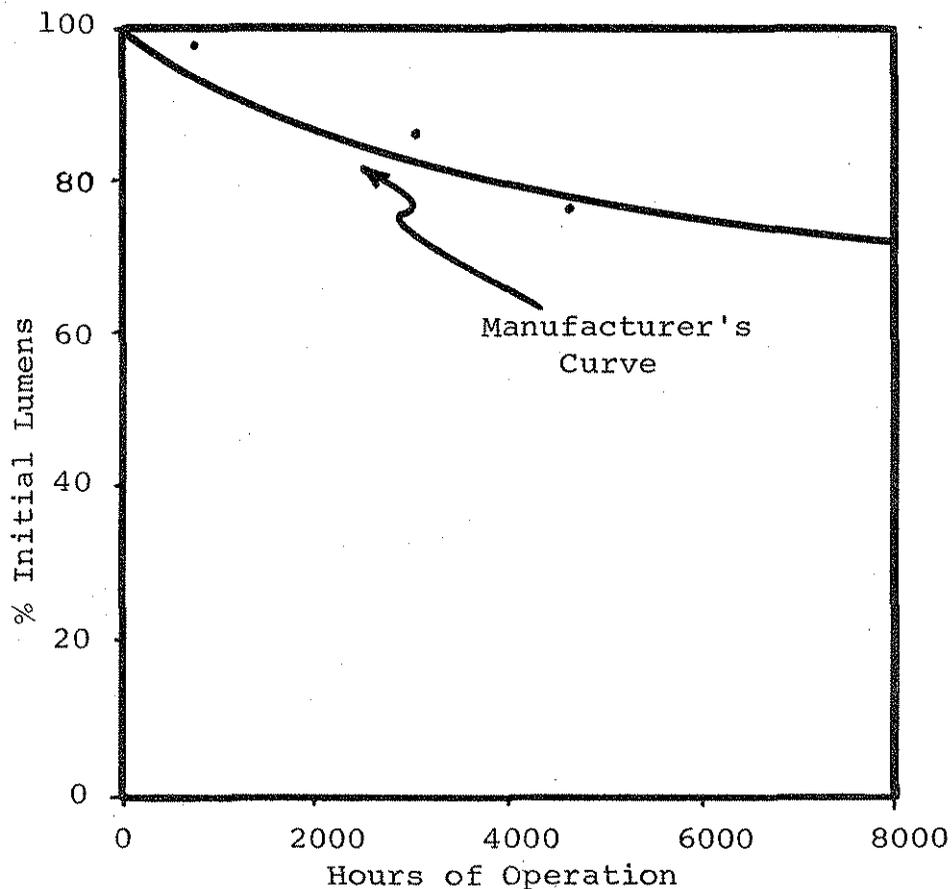
Figure 3. Manufacturer's maintenance curve vs. measured field data

reduction with respect to hours of operation. Also illustrated on the curve are results from the maintenance factor investigation, showing the reduction in average HFC for corresponding time intervals. The manufacturer's curve was verified for the period of time involved. This further shows that the reduction in light output was due to lamp output depreciation, and not to the effects of dirt or contamination on the luminaire optics.

September and were not completed until December. Therefore, a wide variation in burning time existed between towers. Tower No. 11 was totally out of service from September through December, 1974 due to a jamming of the lowering device. Further readings were considered to have little meaning since Tower No. 11 was centrally placed in the interchange and therefore affects most locations. The manufacturer's lamp output maintenance curve in Figure 3 shows the percentage of output

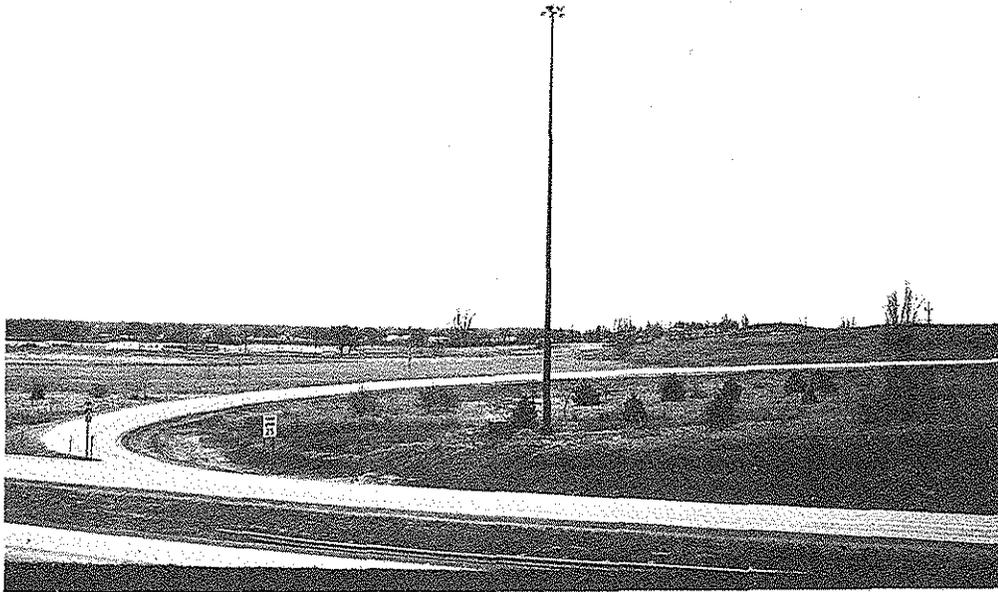
Figure 4. Typical tower installation

The uncluttered daytime appearance of the tower lighting installation was preferred over that of the conventional lighting installation. Figure 4 shows that one tower is used to light the entire loop of an interchange.

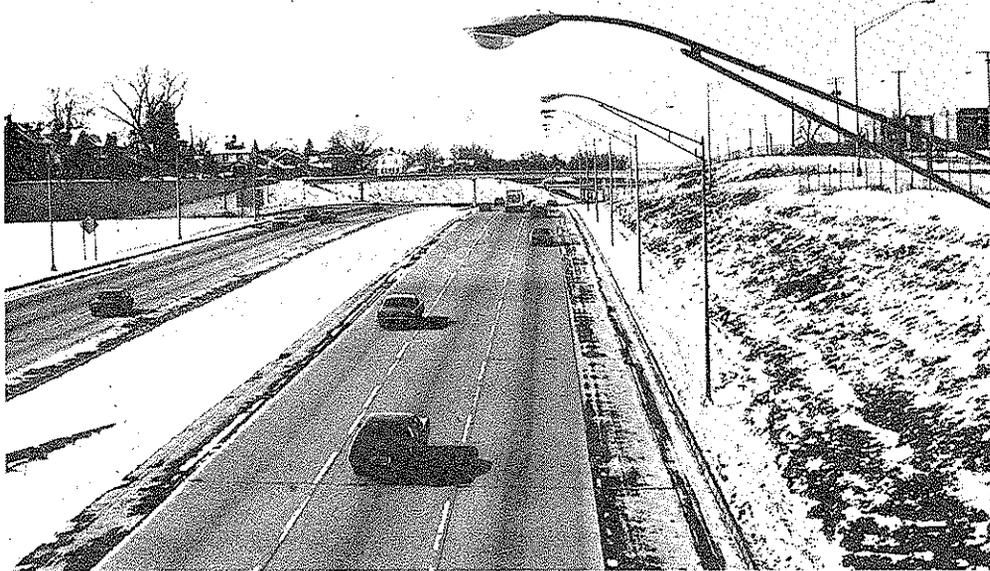
Figure 5. Typical Conventional Lighting

The number of poles required for a conventional lighting system is shown in Figure 5. Aesthetically, this is less pleasing. Further, the poles are a safety hazard because they are close to the traffic lane.
