Final Report

Research Project HR-155

Research project HR-155 was initiated to study soil erosion problems along the secondary road system in Iowa and to find a substitute for straw for the control of soil erosion during the period of seed establishment. Accordingly, six field research sites were established to test the ability of commercial soil conditioners to control soil erosion. The six field research sites were selected (Figure 1) on the basis of terrain and type of soil material exposed on the cut-slope areas. The sites are described in Table 1 according to the regions delineated in Figure 1.

ROADSIDE EROSION RESEARCH IN SELECTED IOWA COUNTIES<sup>1/</sup>

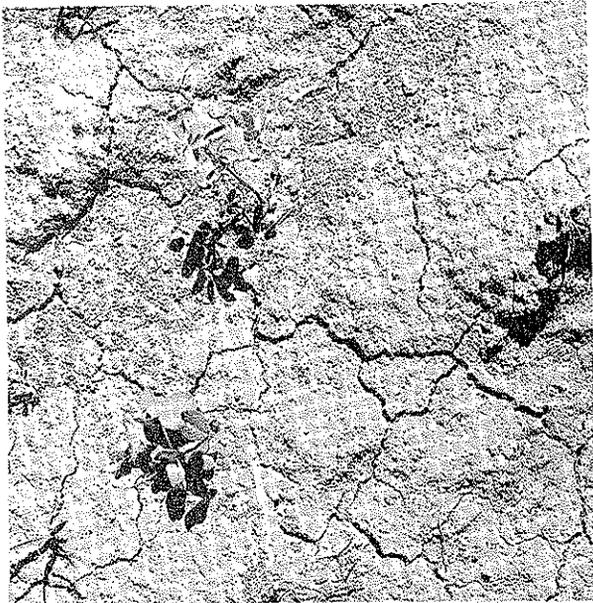
Plate 2. Roadbank in Poweshiek  
County, Iowa. Untreated.
