Final Report

HR-171

Evaluation of Crushed Limestone
Rock as a Mulch Material

The Effectiveness of a Limestone Aggregate Covering on Highway Back Slopes in
Controlling Erosion and in Establishing Plant Cover

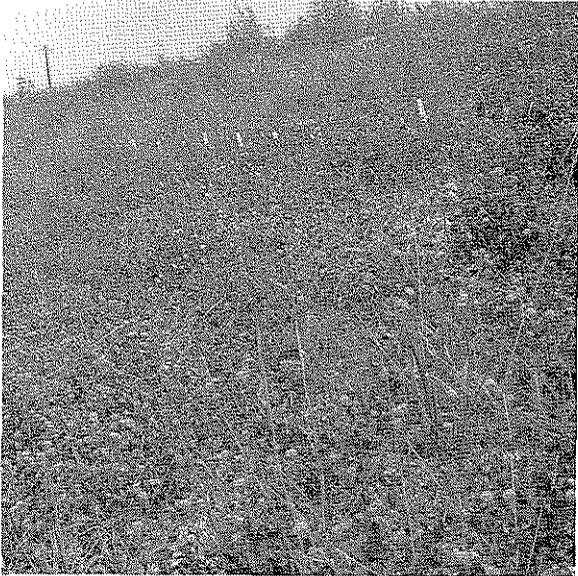
1. Good growth of alsike clover and complete erosion control under a limestone rock mulch at Webster City, August 1, 1975

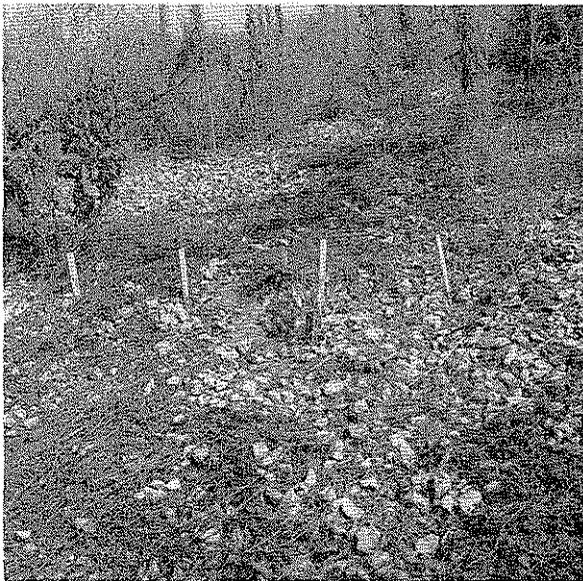
3. Failure of rock mulch at Grimes site because of run-on of water from higher area. August 1, 1975

Some water appeared to run on the Grimes plots from higher ground. Under these conditions the rock mulch could not control soil movement. Essentially all erosion on the rock treated plots at Webster City occurred in one such run-on area.

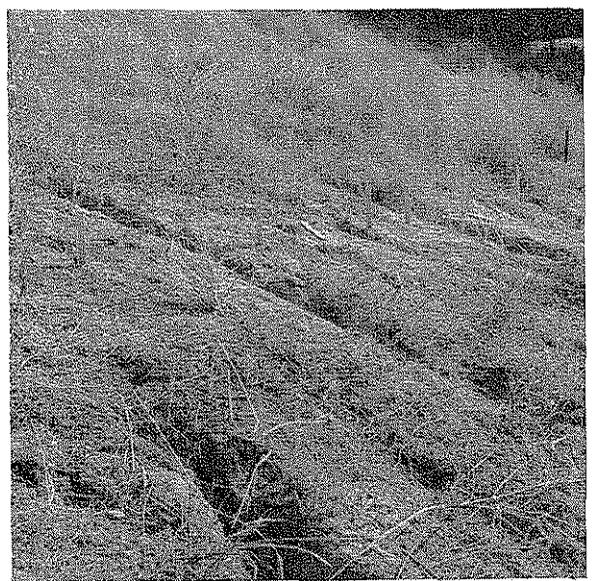
4. Severely eroded slope at Grimes site and poor plant stand on unmulched plot. August 1, 1975

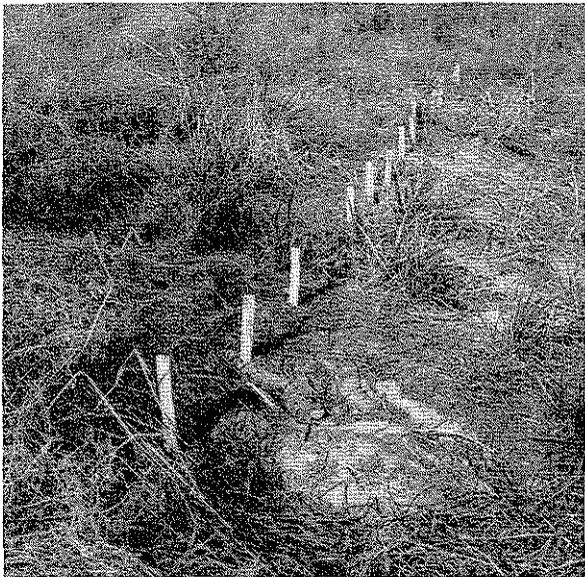
5. Average erosion (250 ton/A) on an unmulched plot at Grimes, August 1, 1975

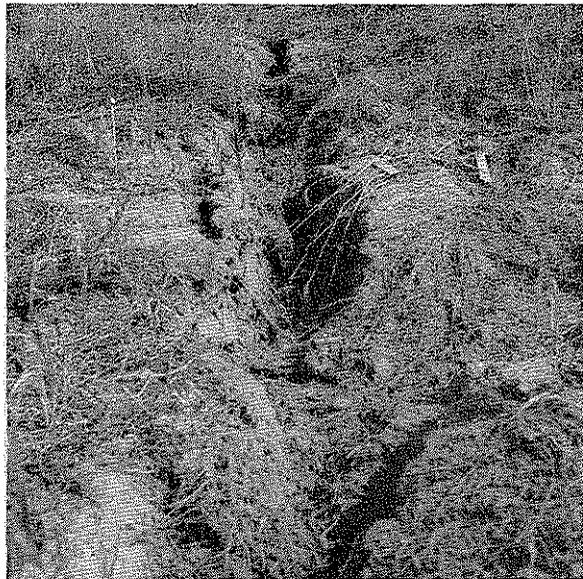
6. Close-up of rill erosion at Grimes site

The stake method of measuring erosion was not adequate for evaluating rill erosion, because most rills formed between the stakes. Width and depth measurements of rills were taken across the stake lines in July 1975. These measurements were converted into average surface deflation estimates and are reported in tables 4 and 5. Rill erosion was reduced by the rock mulch treatment at both sites. Rill erosion was more severe on both treated and untreated plots at Grimes as compared to Webster City. At Grimes rill erosion was reduced from 81 tons per acre to 22 tons per acre by the use of a rock mulch. At Webster City the untreated plots lost 27 tons per acre of soil and the treated plots 8 tons per acre.
