Performance of a Nongrouted Thin Bonded PCC Overlay

Highway Research Advisory Board
Project HR - 291

Final Report

Iowa Department
of Transportation

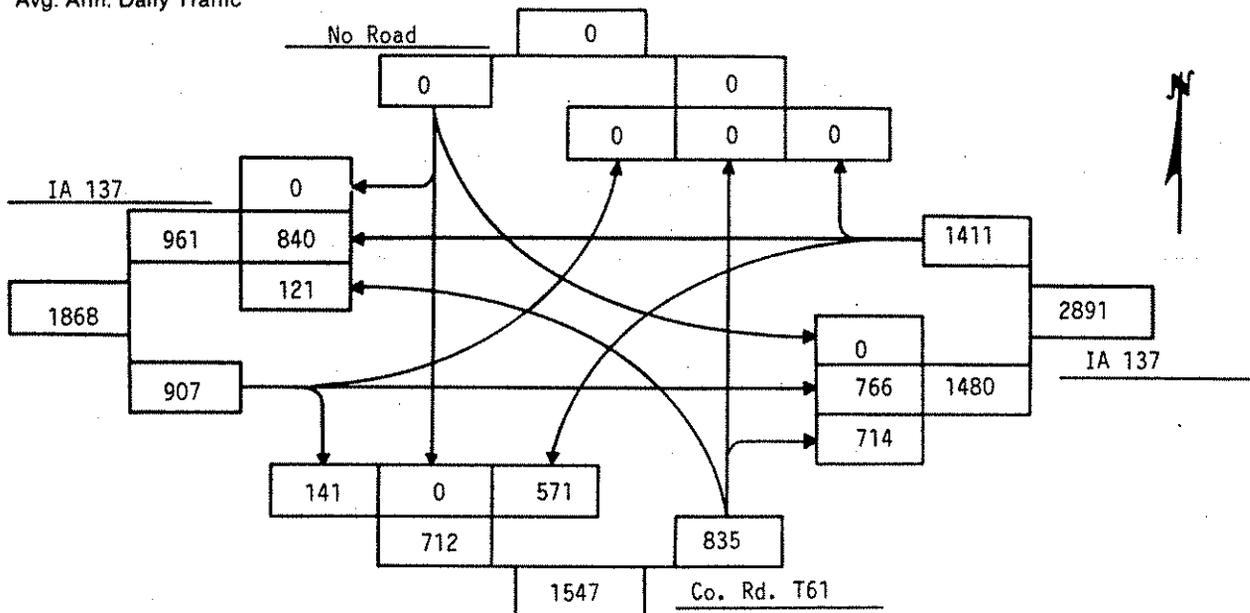
Figure 1

Traffic data complete with vehicle classification counts were conducted in 1986 and 1990 to be converted into a number of equivalent 18-kip (80 kN) single axle loads (ESAL) that indicate the magnitude of loads applied to the pavement research sections south of the Cargill plant.

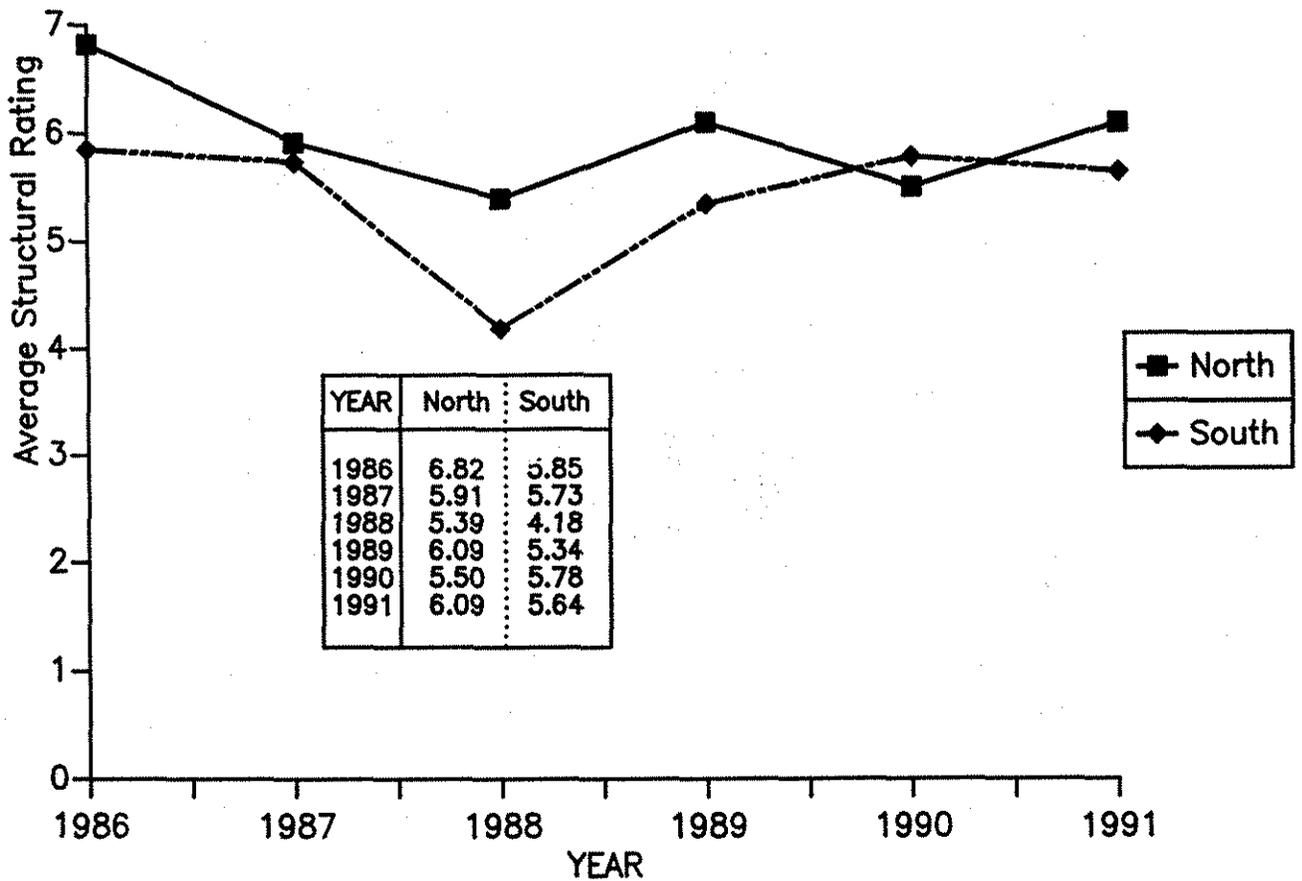
Road Rater testing has been conducted annually on the entire project. The Road Rater is a dynamic deflection measuring device used to determine the structural adequacy of pavements. It can be seen from Figure 3 that the annual structural ratings for the northbound lane are higher than those for the southbound lane, except for an anomalous value in 1990. Figure 4 bears a similar relationship for structural ratings over joint locations with an anomalous rating for 1991. The contrasting difference in values between the north and south lanes over the entire project can be attributed essentially to a variation in traffic loadings. A majority of the trucks entering the Cargill corn sweetener refinement plant turn south off of Highway 137 onto T61 and then unload their grain. It follows that the southbound lane has experienced a greater share of 18-kip (80 kN) ESAL loadings, and thus has consistently lower structural ratings than the northbound lane.

Annual Road Rater Results HR-291

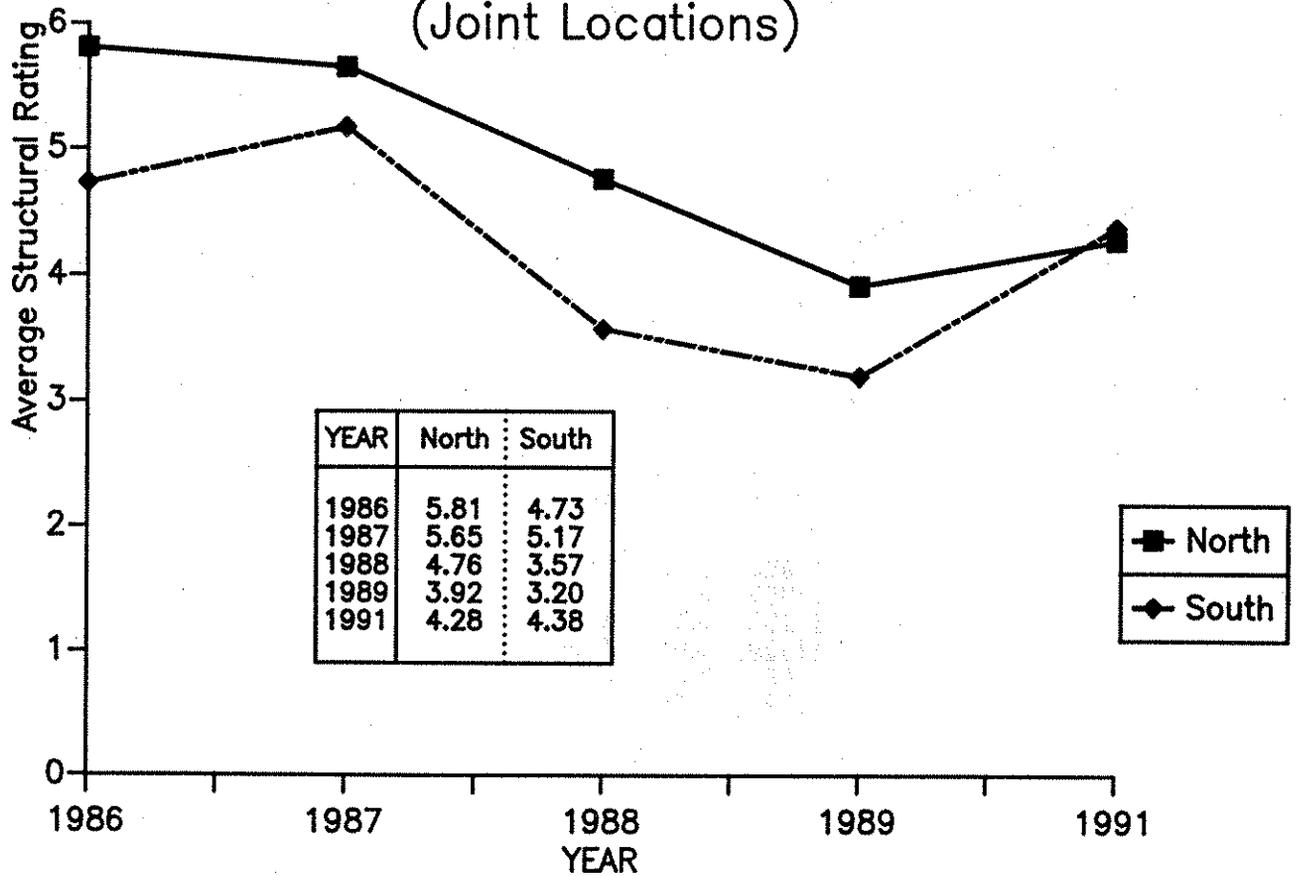
Figure 4

Annual Road Rater Results HR-291 (Joint Locations)

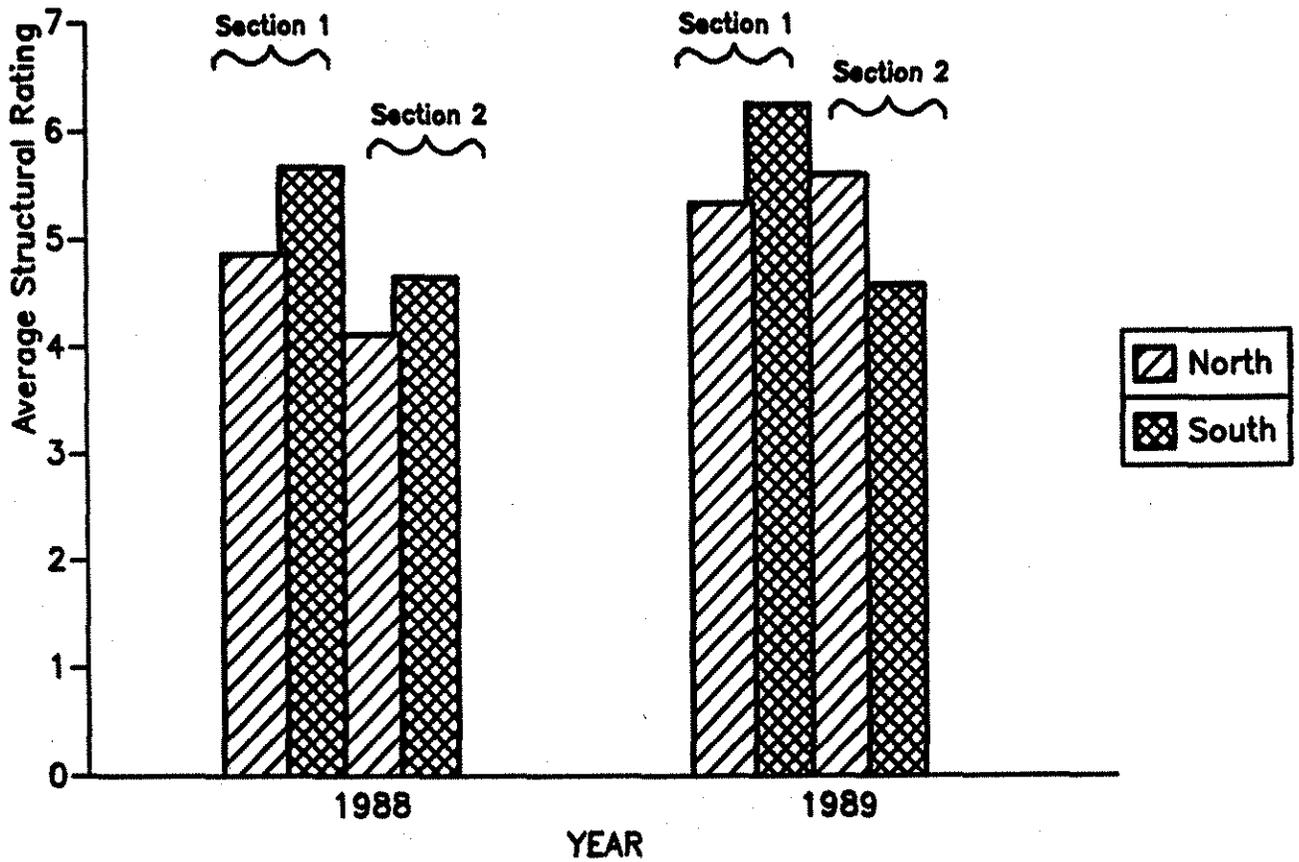
Figure 5

It is interesting to note a converse relationship in structural ratings among the ungrouted test sections 1 and 2 with that aforementioned (Figure 5). These sections lie south of the Cargill plant on which the loaded grain traffic must travel north to unload. Thus, the northbound lane has experienced the larger degree of 18 kip (80 kN) ESAL loadings, and consequently has a lower structural rating than the southbound lane. Again, there is an anomaly in the results for Section 2 in 1989. This may be explained by the fact that annual test-

Annual Road Rater Results HR-291 (Ungroued Sections)

ing is performed in the outside wheeltrack during the months of April and May when the roadway exhibits the greatest instability, and depending upon the amount of moisture in the soil at the time of freezing, the structural rating can vary from one year to the next.

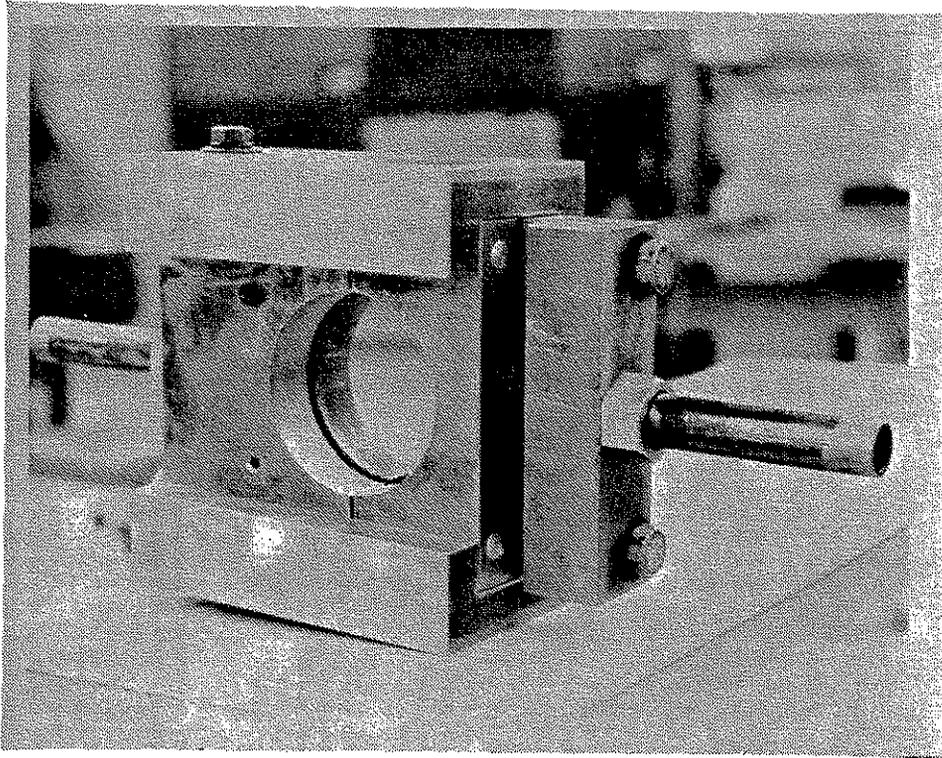
1. Testing jig to accommodate a 4" diameter specimen. The jig is designed to provide a direct shearing force at the bonded interface.
2. Hydraulic testing machine capable of applying a smooth and uniform tensile load. The accuracy of the reading shall be with \pm 1.0% of the indicated load.

Figure 1 Testing Jig

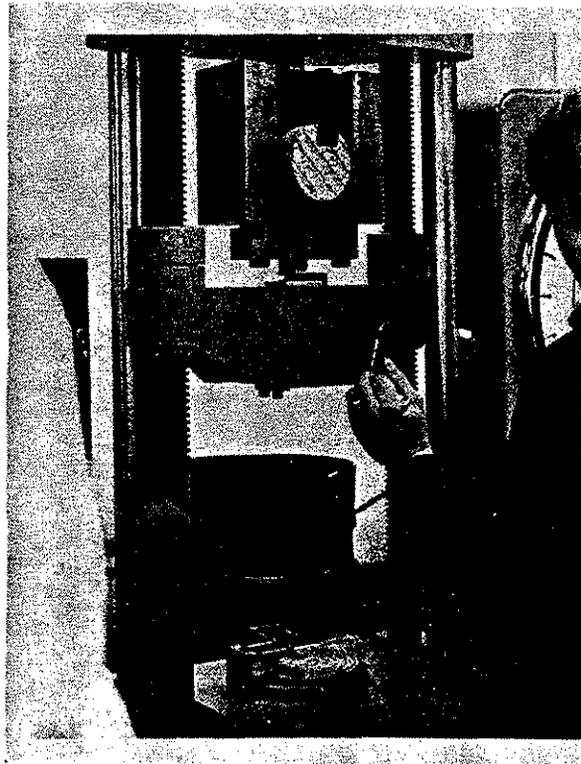
- (a) Place the specimen in the testing jig in such a manner that the bonded interface is placed in the space between the main halves of the jig.
- (b) In the event that the interface is irregular and cannot entirely be placed within the specified space, the interface will be placed as close as practical and a special notation made.

- (c) Carefully align the testing jig in the testing machine with the central axis of the jig in the center of the testing machine.

Figure 2 Hydraulic Testing Machine,
Testing Jig and Specimen
