Field Measurements of Plow Loads During Ice Removal Operations

Iowa Department of Transportation Project HR 334

Final Report

IIHR Report No. 365

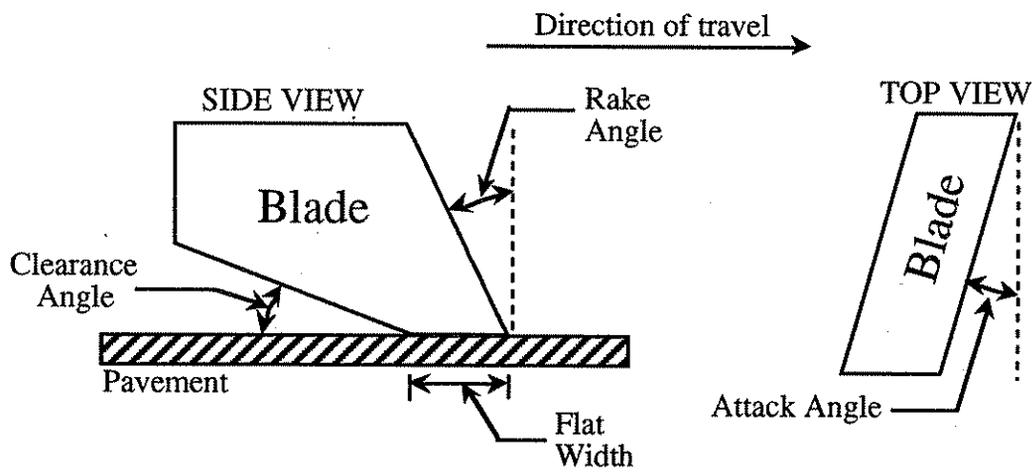
Figure 1. Definition of terms used in SHRP study.

Recent studies have shown that the shape of the blade used on a plow blade is very important in determining the loads acting on the plow. These studies, which were part of the Strategic Highway Research Program (SHRP), examined the effect of a number of parameters on the forces required to remove ice from a sample of pavement in the laboratory (Nixon 1993; Nixon et al., 1993). Some of the parameters studied included clearance angle, attack angle, rake angle, and blade flat width, are shown in figure 1. It was found that if a blade had a non zero clearance angle (specifically, in this series of experiments, if the clearance angle was 2° or greater) then the forces on the blade were reduced by a factor of twenty when compared to a blade with a zero degree clearance angle. It was also found that the scraping forces increased when the blade flat width was more than 3/8 of an inch.

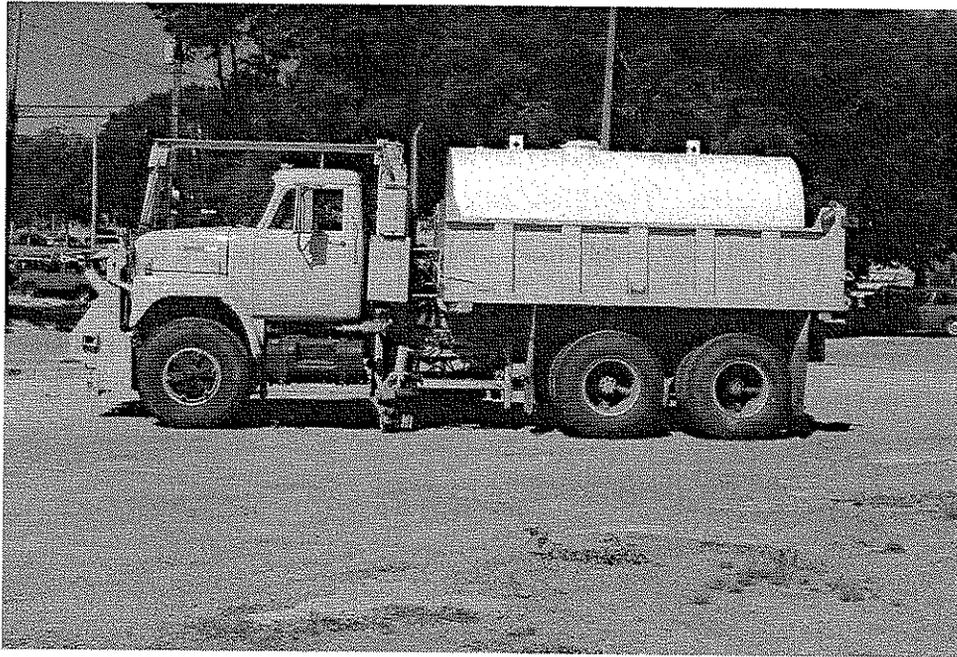
Figure 2. IDoT truck used for the test series.

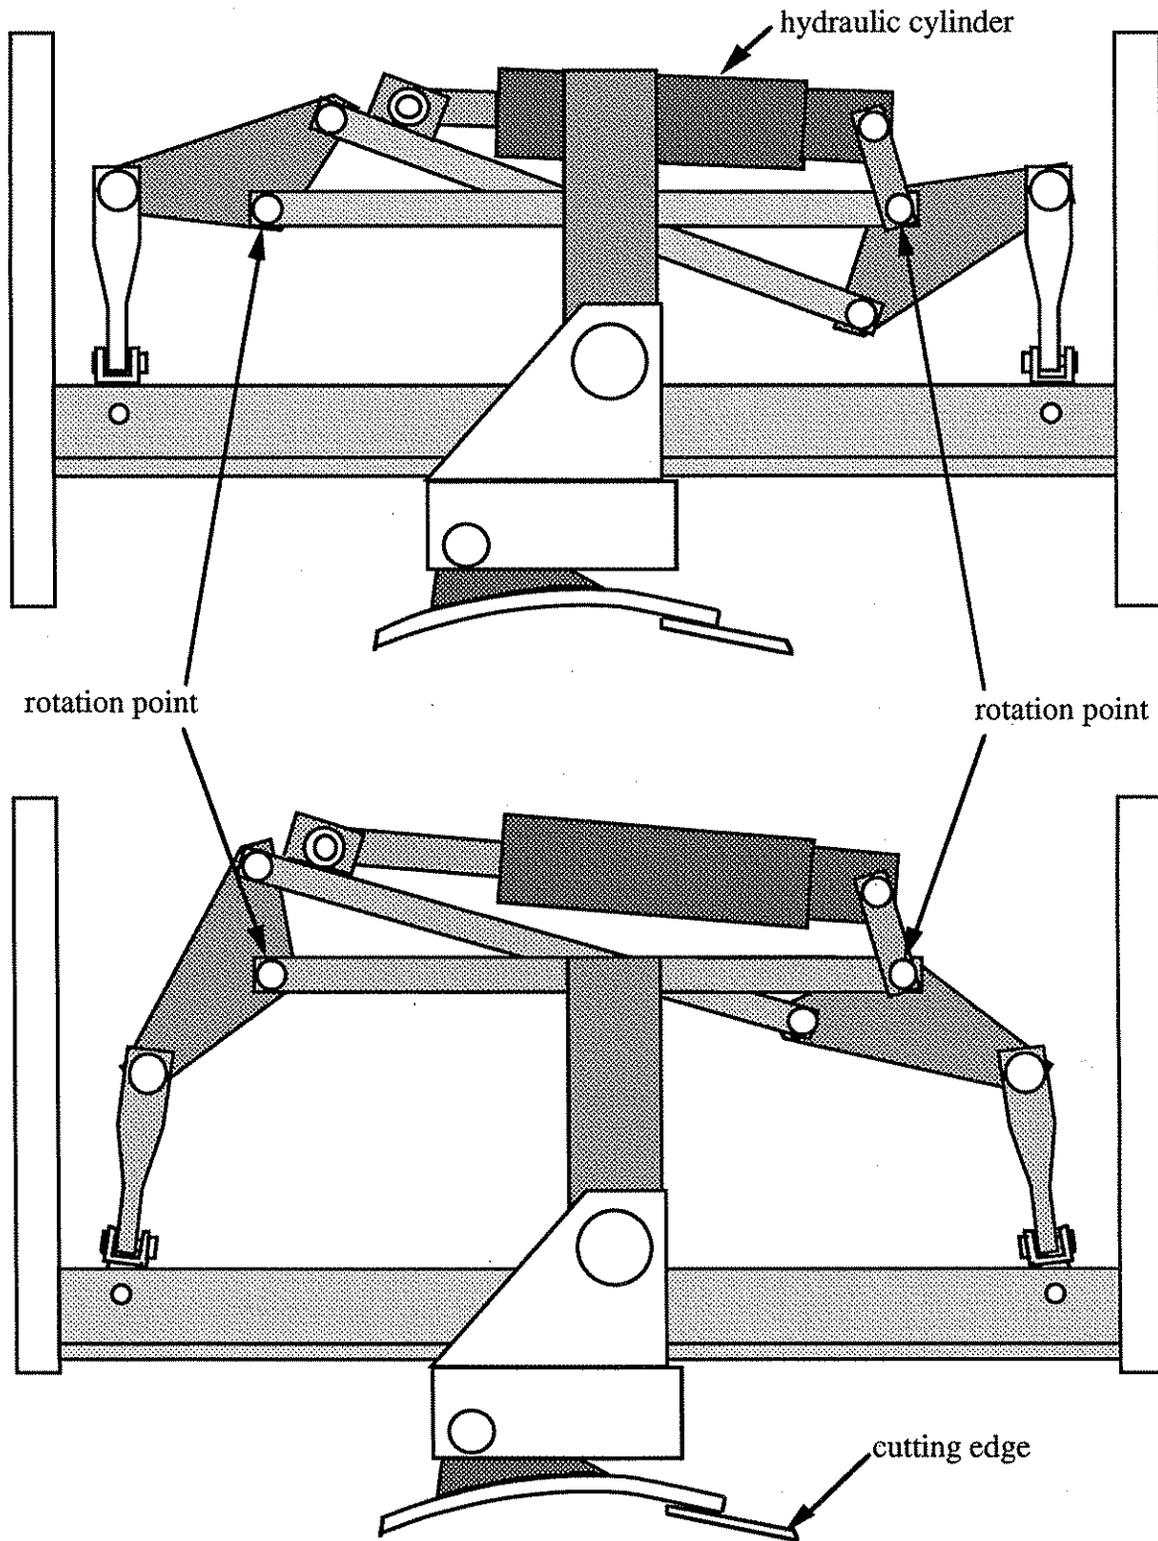
Figure 3. Side view of underbody plow's vertical motion.

1. Range of motion. The blade could be moved vertically approximately 8 inches by the extension of two hydraulic cylinders and a linkage system. Figure 3 shows the left side cylinder and linkage system. Extension of the hydraulic cylinder causes the triangular shaped links to rotate and in turn lower the blade. The two cylinders allow the operator to control the vertical position or download to the left or right side of the blade independently. The vertical range allows for the download pressure on the blade to be varied. Download was accomplished by transferring the weight of the truck from the tires to the blade by lowering the blade with the two hydraulic cylinders. The more the blade was forced down the more weight was taken away from the tires and placed on the blade.

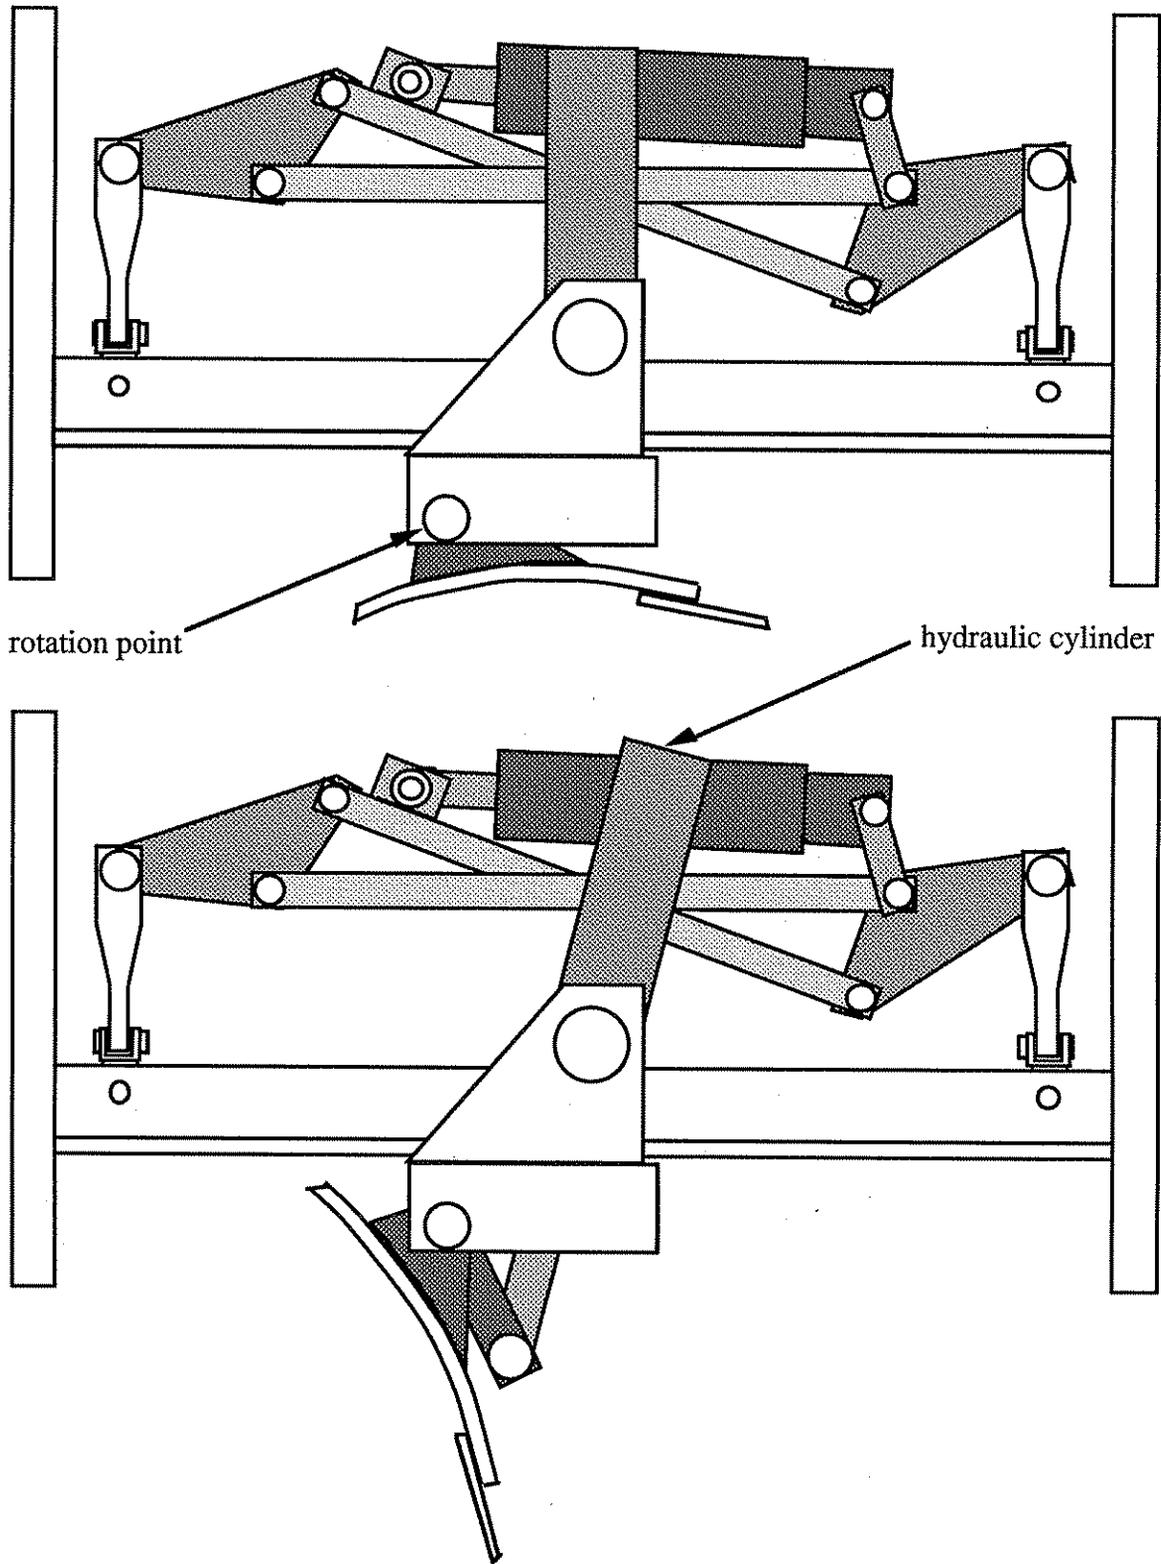
Figure 5. Side view of underbody plow's blade angle motion.

In addition to the variable download abilities, the blade angle could be adjusted over an 80 degree range. The blade angle was defined as the angle the blade made with the perpendicular of the road surface as shown in figure 4. This range of motion allowed the blade to be positioned anywhere between a point nearly perpendicular to the road surface to a point that placed the blade nearly parallel to the road surface. Blade angle was set by

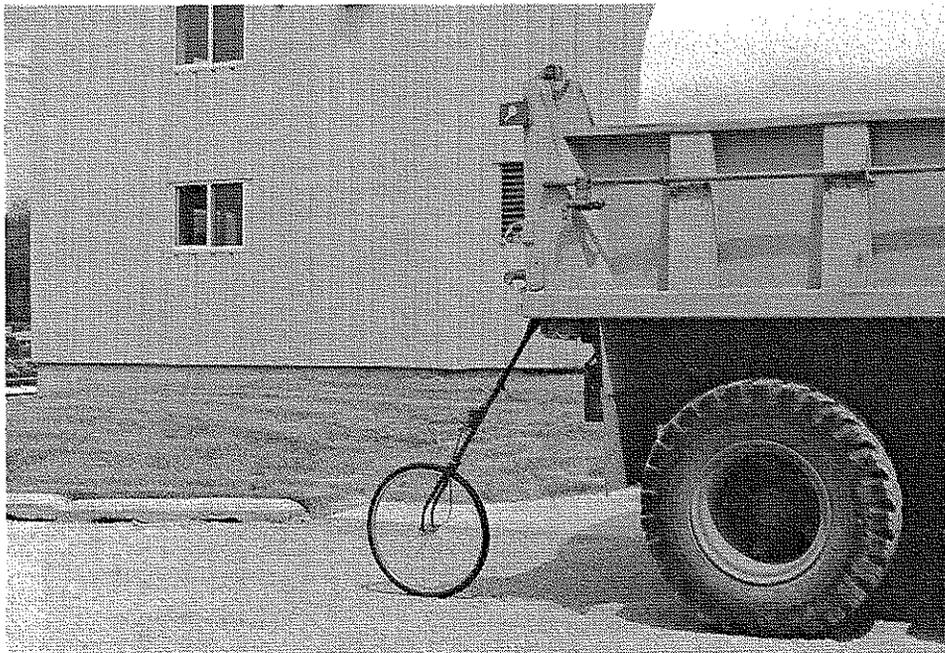
Figure 9. Fifth wheel used to record truck's speed during tests.

The angle that the blade had with the pavement was measured with an inclinometer. A Schaevitz Angle Star Protractor System was used for this task. The inclinometer was located on the left side of the blade in a protective box shown in figure 8. The velocity of the truck was determined by a fifth wheel located at the rear of the truck and shown in figure 9. This fifth wheel used a DC tachometer generator that provided a linear relationship of the speed to voltage. This allowed the speed to be determined with an accuracy of 0.1 mph.

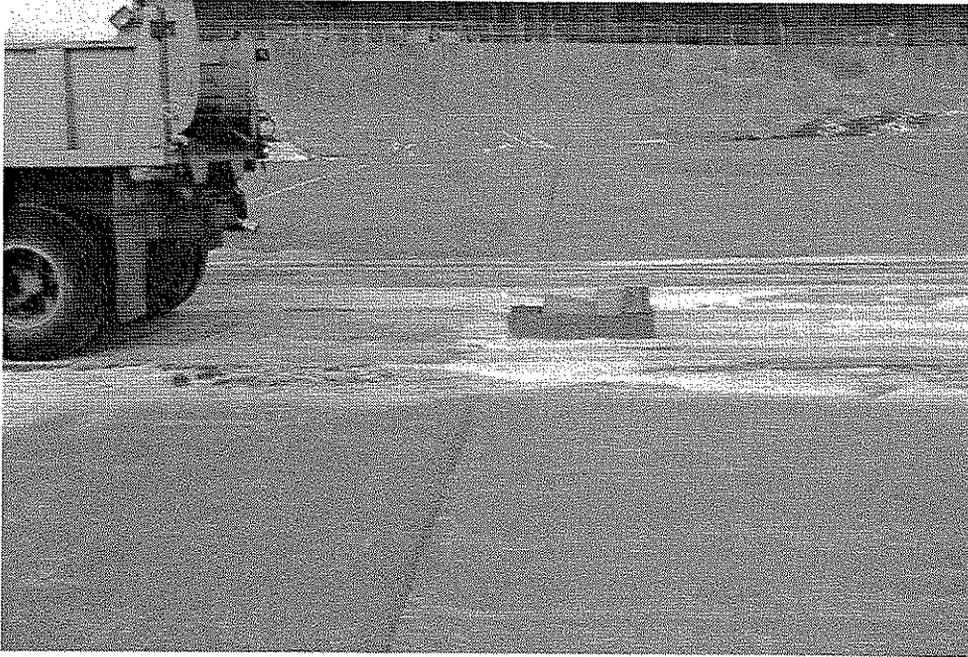
Figure 10. Friction sled pulled behind truck to measure change of road conditions.

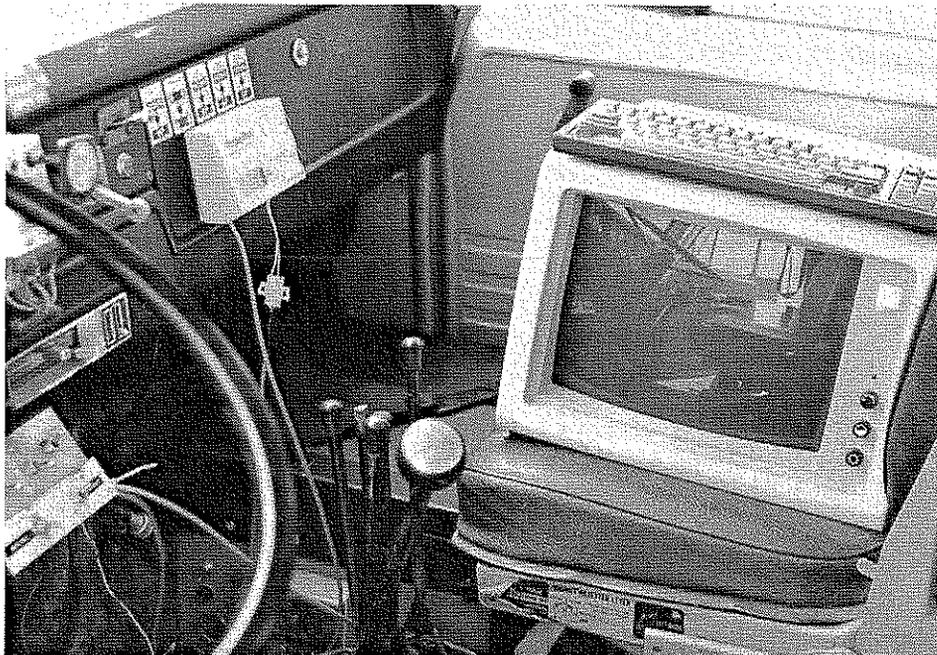
Figure 11. Computer system in testing configuration.

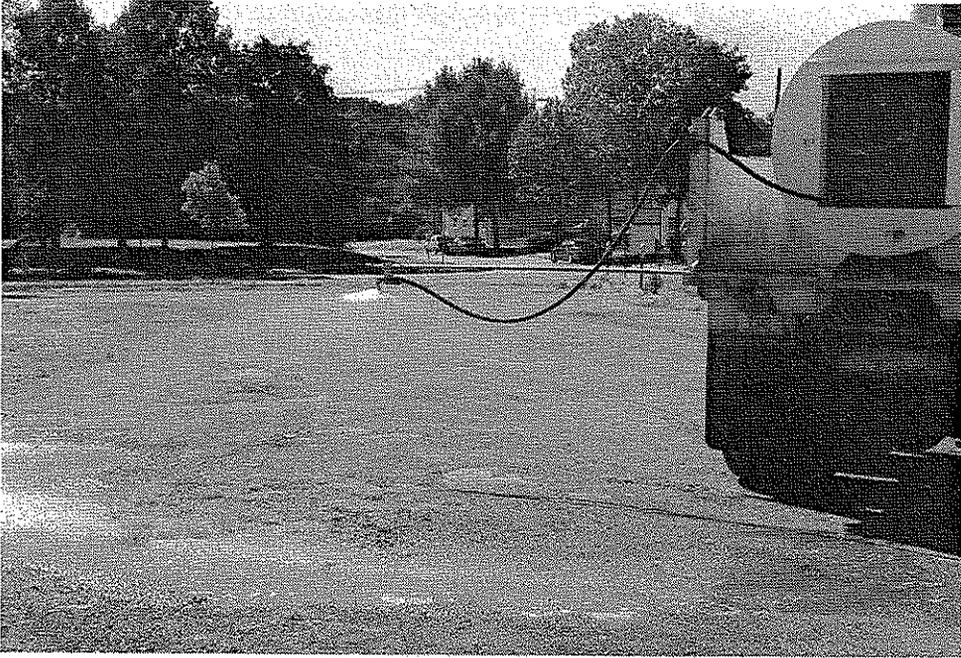
Figure 12. Spray system used to make ice sheet for tests.

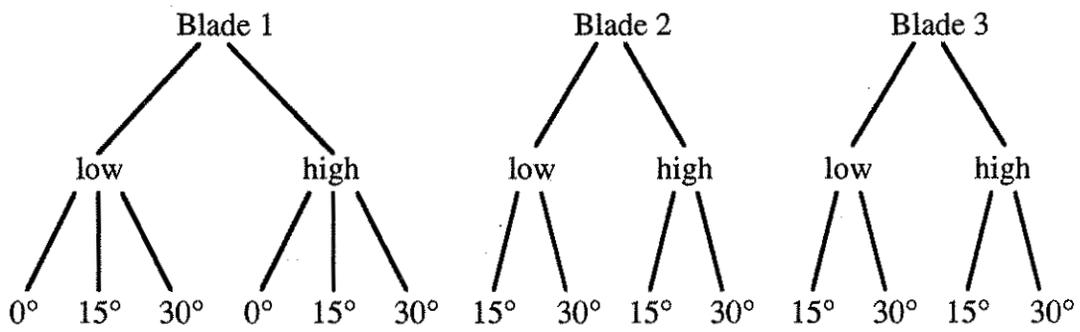
Figure 13. Schematic representation of the test matrix.

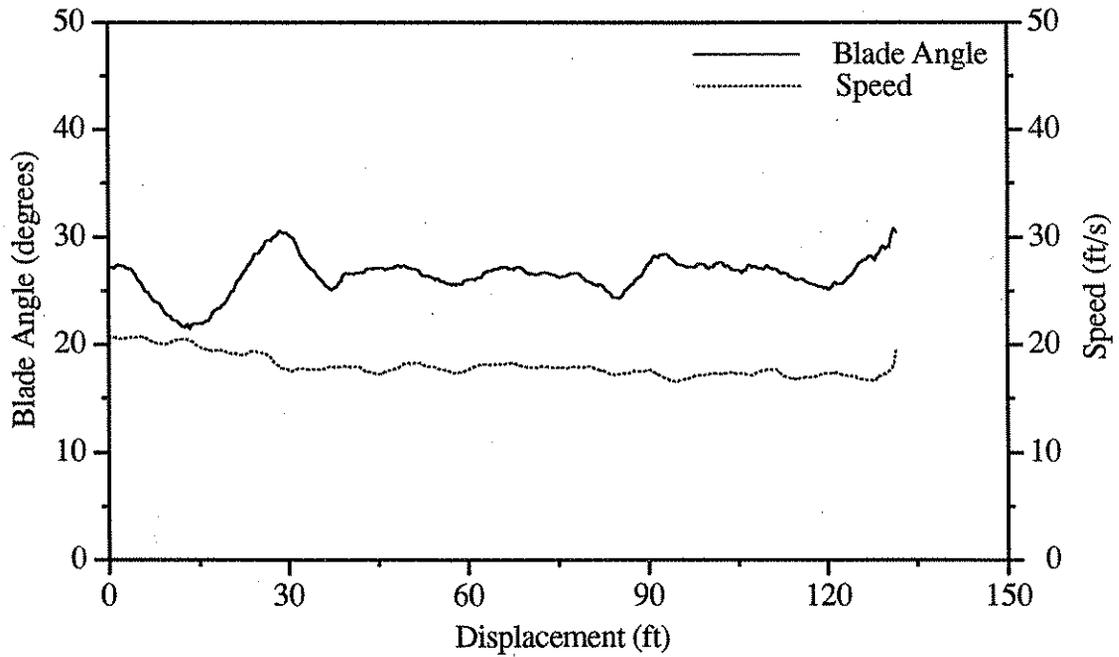
Figure 17. Blade angle and speed of truck for test number 28.

The raw data can then be transformed to show the loads, blade angle and speed of the truck as shown in figures 16 and 17. The vertical force is the sum of channels 1 and 2 and the horizontal force is the difference of channel 3's recorded force less the force due to the vertical loading as determined from the calibration of the system. It should be noted that all values are plotted against the distance traveled from the beginning of the test. The starting point was taken as the point where the raw data of channel 1 and channel 2 leveled off indicating that the download pressure was no longer being increased. A summary of the data values for all the tests is given in appendix A. The results from all the tests in graphical form are presented in appendix B.

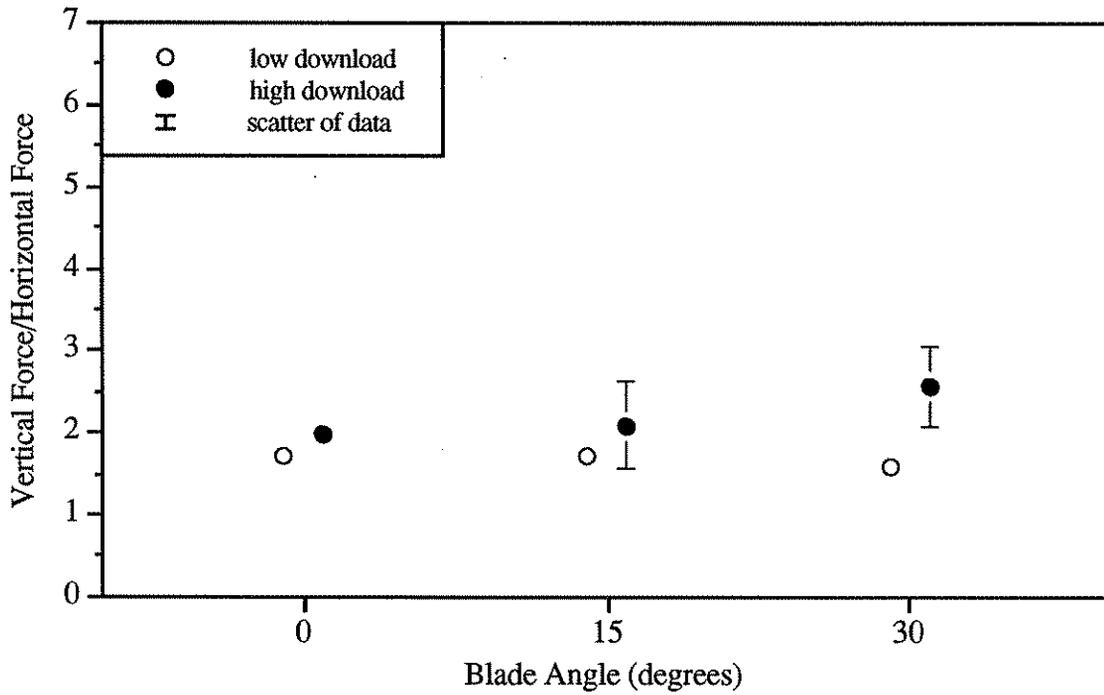
Figure 18. Average force ratio values for test series performed on blade 1.

C. Efficiency Results. Using the efficiency ratio allows a comparison to be made between the three blades. The results of the tests for all the blades are shown in figure 18 through figure 20. As previously mentioned there were no tests performed at 0° for blade 2 and blade 3 because of the limits of the underbody plow and due to the shape of the blades. It should be noted that the data has been offset about the tested blade angles to provide for clearer presentation of results. The average value of all the tests and the standard deviations are plotted for each blade. It was found that there was in some cases significant scatter in the data. This will be discussed further in the next chapter. The results obtained for blade 3 have been separated into two groups. This was due to a high amount of wear that the blade experienced from removing snow and ice deposited on the test site during a storm. This point will be discussed further in the next chapter.

B. Comparison of Efficiency Results for Different Blades. As shown in figure 18 the value of the force ratio (ratio of vertical to horizontal force), remained nearly the same for all tests for blade 1. For both the low and high download conditions over the range of blade angle the force ratio did not change by any significant amount. In order to determine how significant any variations between testing conditions might be, t-tests were performed between the results for each testing condition. The results of the t-tests for blade 1 are shown in Table 1, in which the p values for each pair of test conditions are given. Values of 0.01 or less indicate that differences exist between the results for the two test conditions at the 99% level of probability. This means that it is very likely (a 99% chance) that the two conditions cause differing behavior and thus that the parameter changed between the conditions does have an effect on scraping load. Values less than 0.05 indicate significance at the 95% level. This suggests that the parameter changed between the two conditions may have an effect on the scraping load. Any values greater than 0.05 indicate that the changed parameter between the two tests does not have any significant effect on scraping load.

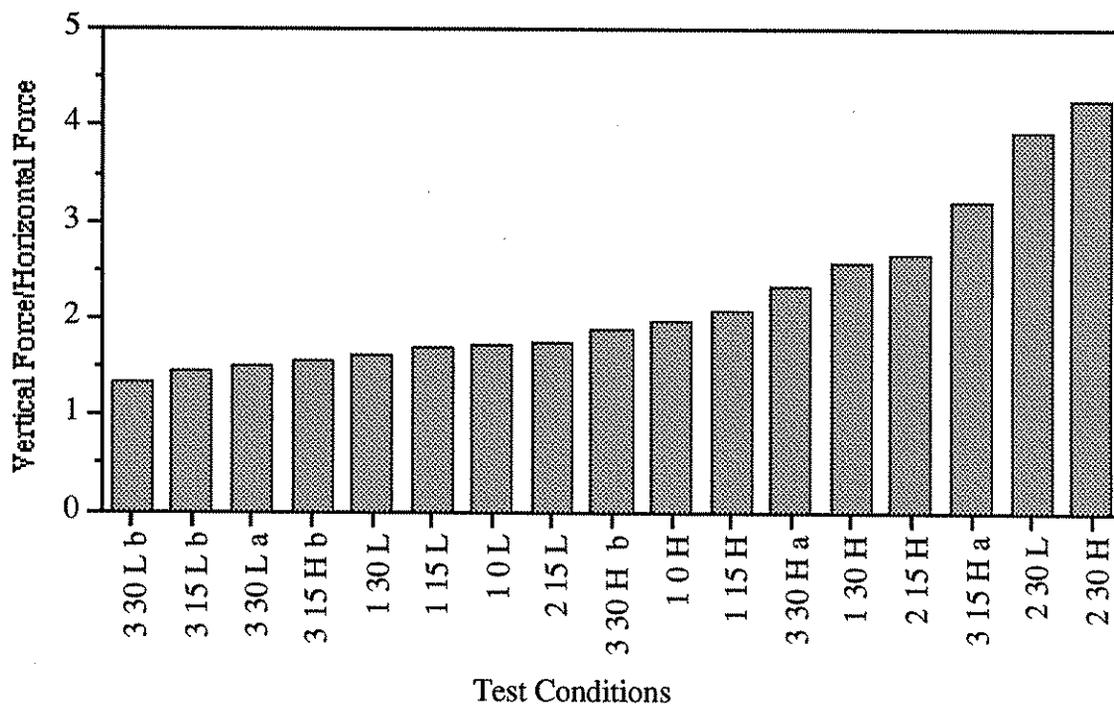
Figure 21. Average ordered force ratio values for all testing configurations.

By plotting the average values of the force ratio for all the test conditions in ascending order, a comparison of the three blades can be made (see figure 21). The notation used for the categories along the x-axis in figure 21 is as follows, blade number, blade angle, low or high download, and for blade 3 tests before wear occurred (b) or after wear occurred (a). Blade 3 had the lowest force ratio for the first four cases followed closely by blade 1 and then blade 2.

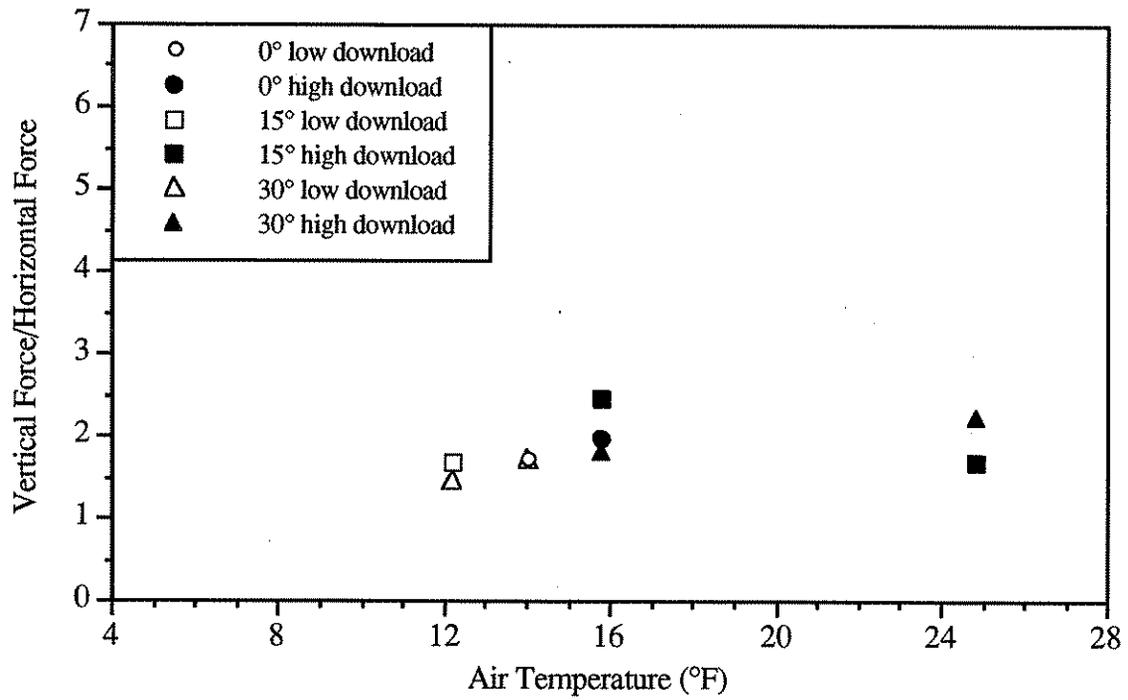
Figure 22. Air temperature effects of force ratio for all blade 1 tests.

1. Air temperature effects on efficiency. One of the variables beyond the control of the tests was the temperature. It was observed that for tests performed on warmer days (> 23 °F) more ice was removed than on very cold test days. By plotting the force ratio against the air temperature it was hoped to show any relationship to the amount of ice removed as a function of the air temperature. Plots of the force ratio versus the air temperature for each blade and test conditions are shown in figure 22 through figure 25.

1. Air temperature effects on efficiency. Figure 22 indicates the effects air temperature has on the force ratio for blade 1. It seems that there is no direct relation between the air temperature and the results of the tests. Similar trends (figures 23 - 25) indicate air temperature does not affect force ratio for blades 2 and 3. However, it was observed during testing that more ice was removed from the pavement on warmer days. This underscores the difference between good efficiency and good ice removal. A low ratio of vertical to horizontal force indicates that ice is being removed efficiently (i.e. with a relatively low download). However, this gives no indication of how much ice was removed. Thus it is possible to remove ice very efficiently (low ratio), but not very

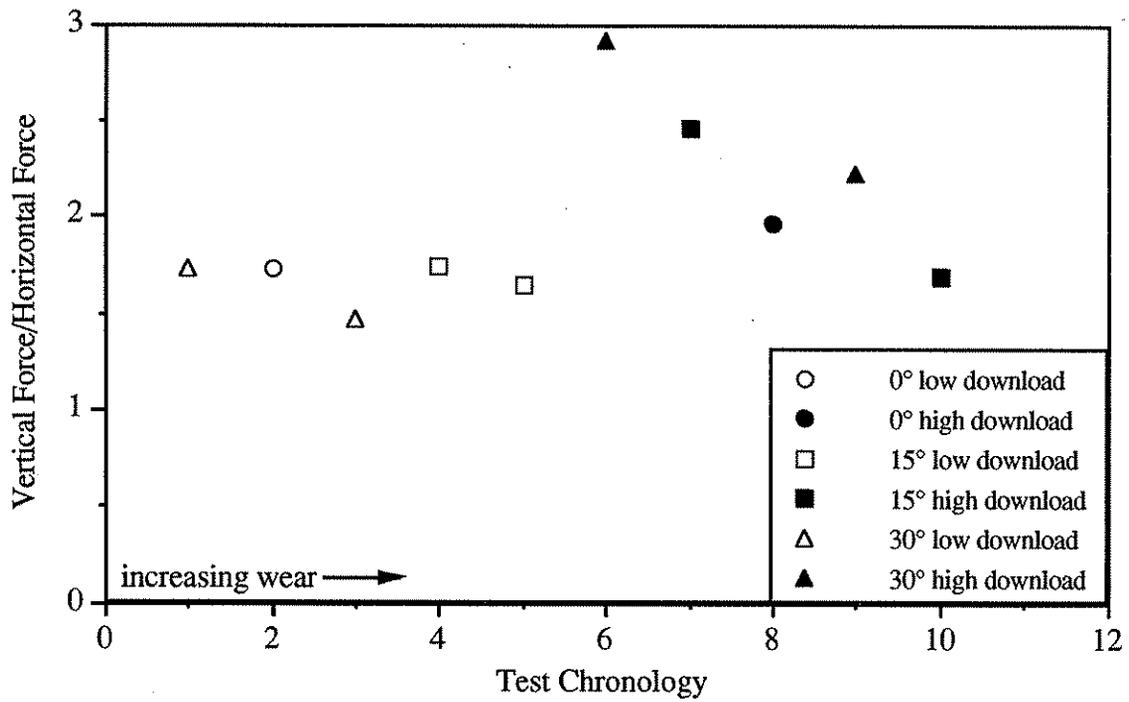
Figure 26. Effects of wear on the force ratio for blade 1 tests.

2. Effects of wear on efficiency. Another factor of the tests was the wear the blade experiences through repeated testing. The force ratio vs. the test chronology was plotted for each blade in attempts to indicate the effect the wear of the blade had on the tests. These results are presented in figure 26 through 28.

2. Effects of wear on efficiency. Another factor to consider was the wear of the blade as the test series proceeded. This was examined by plotting the test average force ratio against the test number for the blade. Figure 26 shows the results obtained for blade 1 and indicates the different test configurations. There does not appear to be any direct correlation between the wear and the force ratio for this blade.

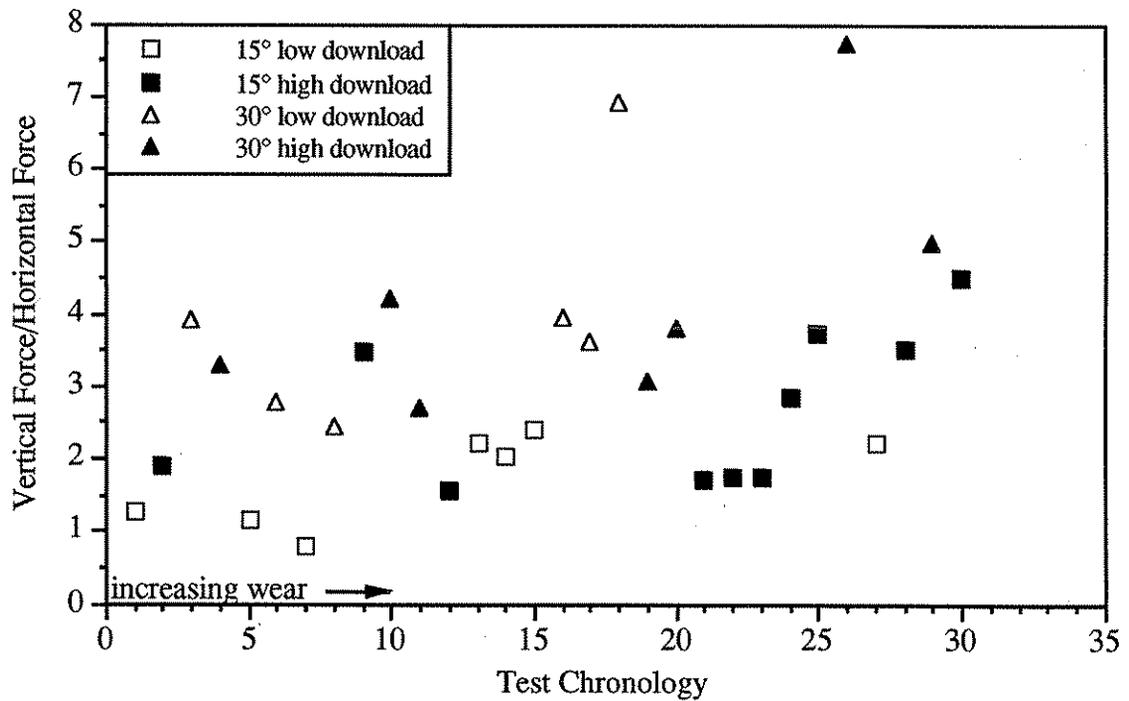
Figure 27. Effects of wear on the force ratio for blade 2 tests.

Figure 27 shows the results for blade 2. As can be seen the results are scattered in a random manner which also suggests no correlation. Results from blade 3, shown in figure 28 show at first a rising trend as the test were performed and then a scattering after the point in time when the blade experienced a large amount of wear as indicated by the dashed line. After the blade received the wear the results are very similar to blade 2 which has the flat portion on the leading edge as can be seen in figure 7. Blade 3 also had a flat width similar to blade 2 due to the wear from removing the snow and ice.

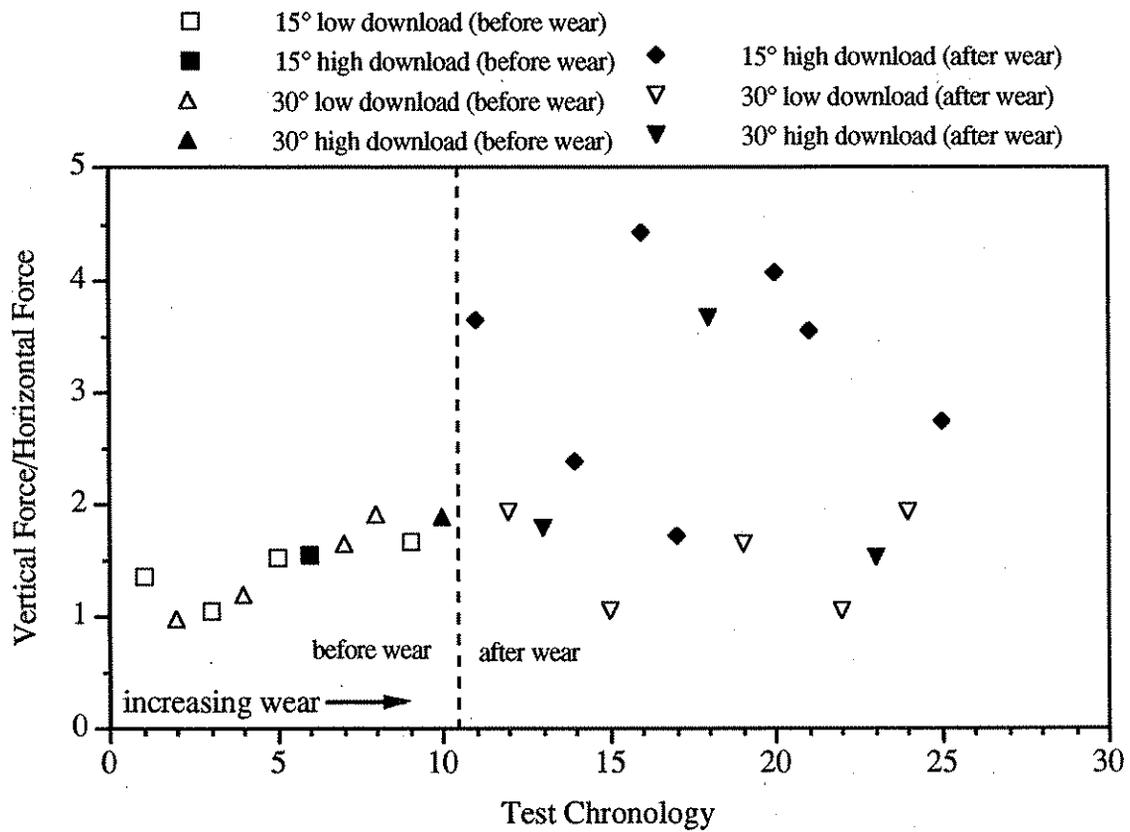
Figure 28. Effects of wear on the force ratio for blade 3 tests.

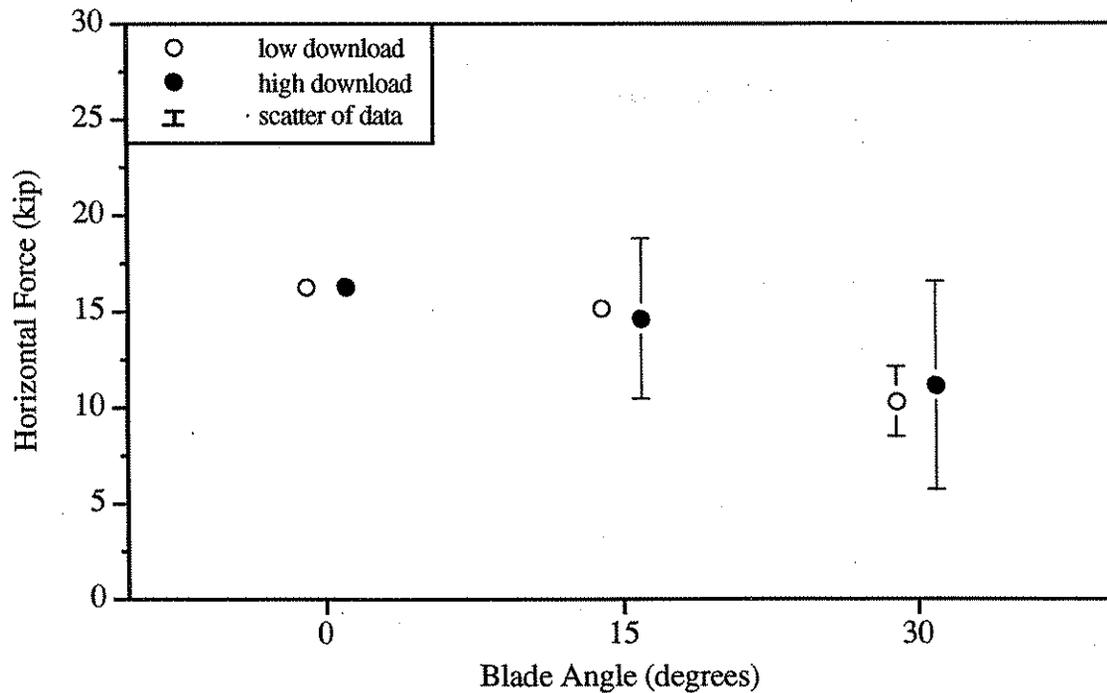
Figure 29. Average horizontal force values for test series performed on blade 1.

C. Comparison of Effectiveness Results for Different Blades. As shown in figure 29 the horizontal force decreased with increasing blade angle for both the low and high download conditions for blade 1. T-tests of the results are given in table 4 which indicate a significant difference between 0° and 30° . Results with 15° compared to other angles is mixed which could be attributed to the small sample size. No significant difference in results are evident between the effectiveness of low and high download tests. Further tests with blade 1 are necessary to better establish the effectiveness of the blade. (Note that effectiveness is defined in Section III.B).

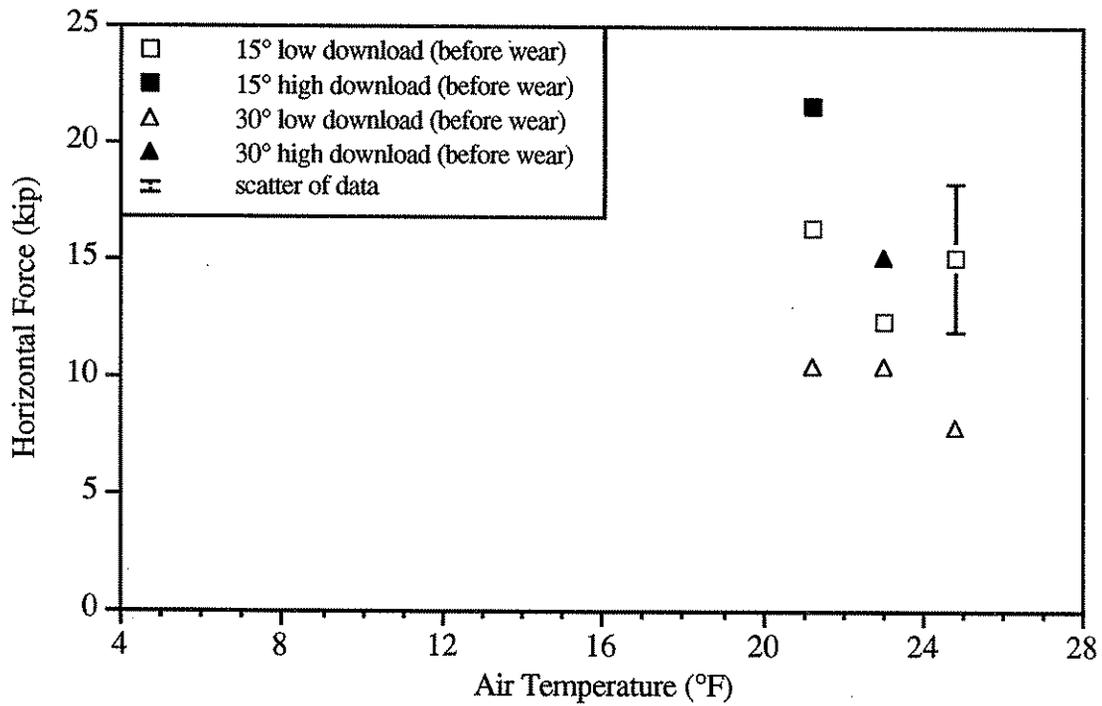
Figure 36. Air temperature effects of horizontal force for blade 3 tests before wear.

1. Air temperature effects on effectiveness. Figures 33 through 37 indicate how the effectiveness of the test changes with air temperature. As before with the force ratio versus air temperature, there does not appear to be any relation between the measured effectiveness and the air temperature for any of the blades. However, this could be due to the method of gathering the air temperature data and not the pavement temperature.

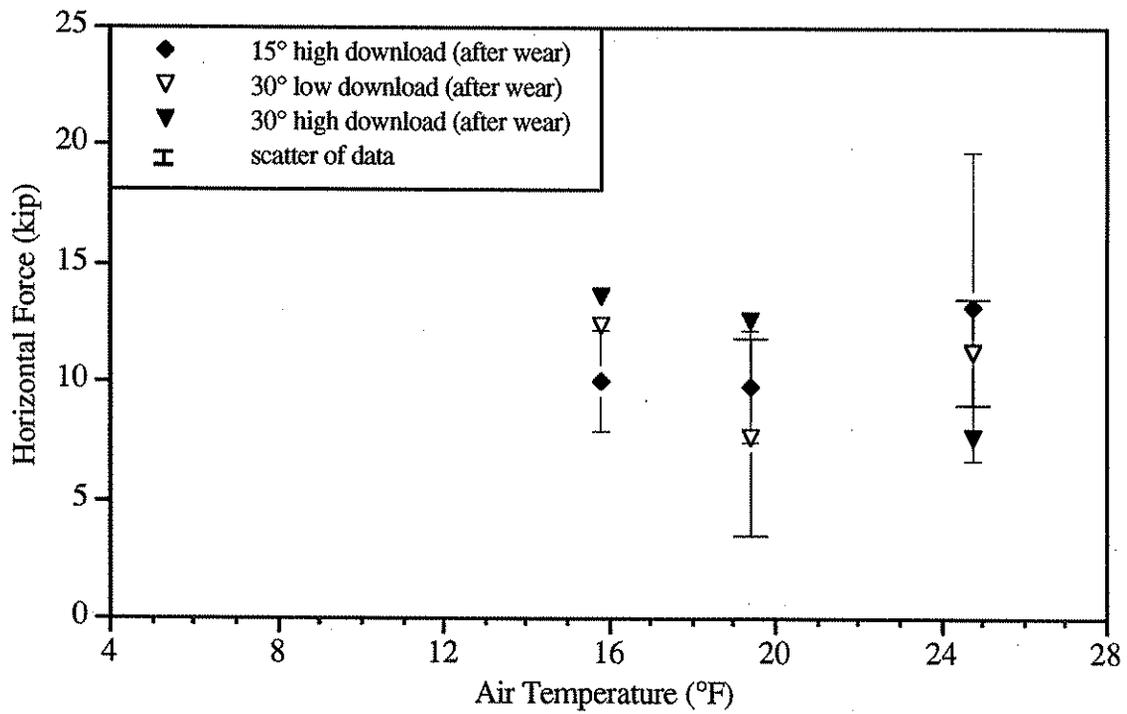
Figure 37. Air temperature effects of horizontal force for blade 3 tests after wear.

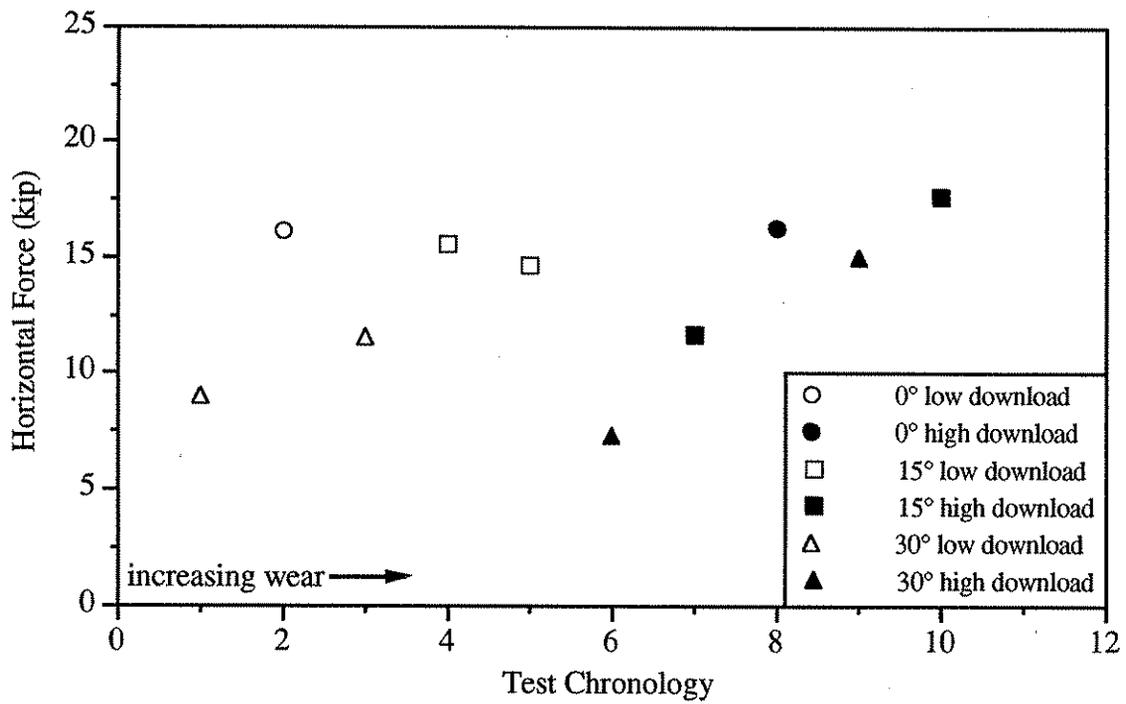
Figure 38. Effects of wear on the horizontal force for blade 1 tests.

2. Effects of wear on effectiveness. The horizontal force was plotted against the test chronology for each blade in attempts to indicate the effect the wear of the blade had on the tests. These results are presented in figures 38 through 40.

2. **Effects of wear on effectiveness.** Figures 38 through 40 show the test chronologies for blade 1, 2, and 3 respectively. From these figures the effect of wear to the blade surface does not seem to have any apparent effect on the effectiveness of the blade to remove ice.

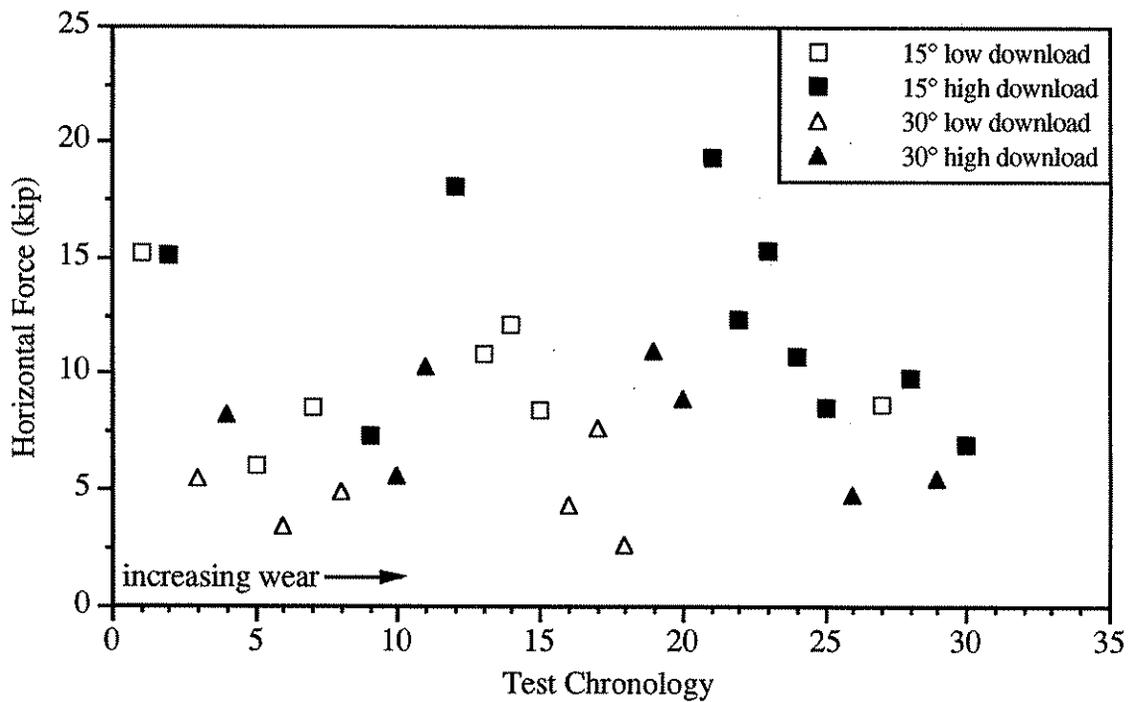
Figure 39. Effects of wear on the horizontal force for blade 2 tests.

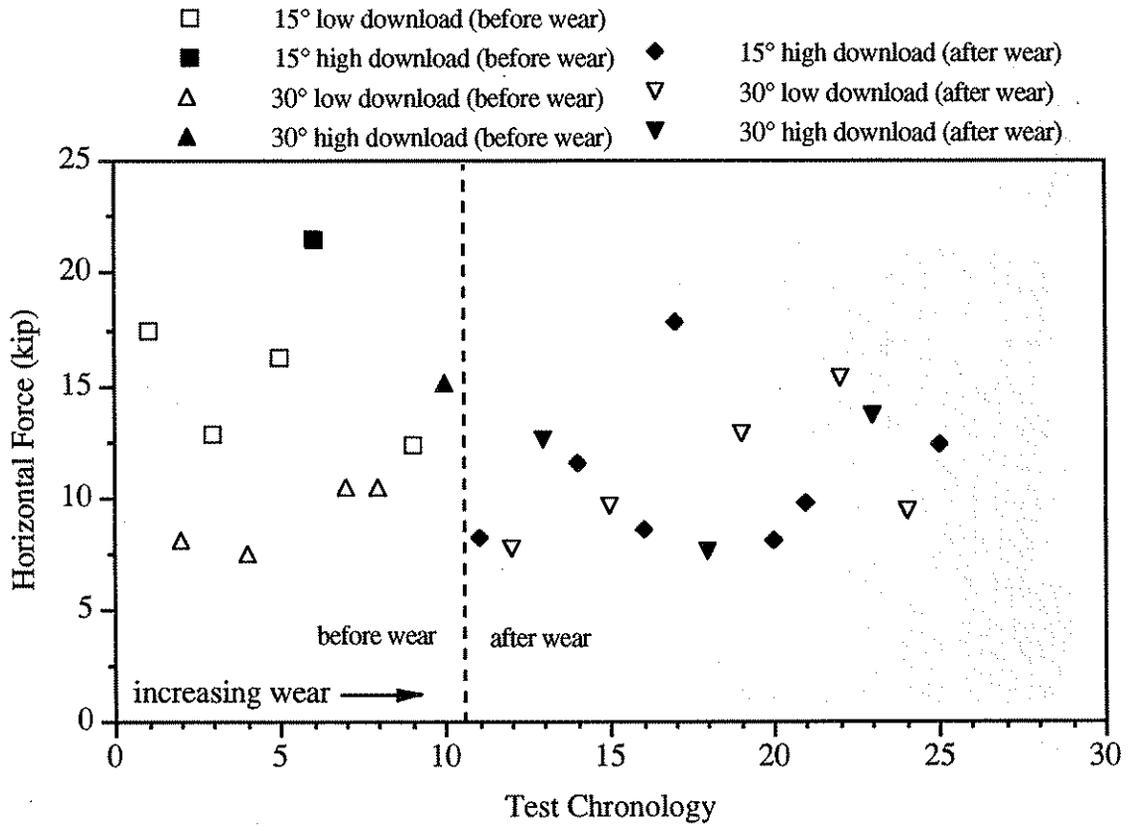
Figure 40. Effects of wear on the horizontal force for blade 3 tests.

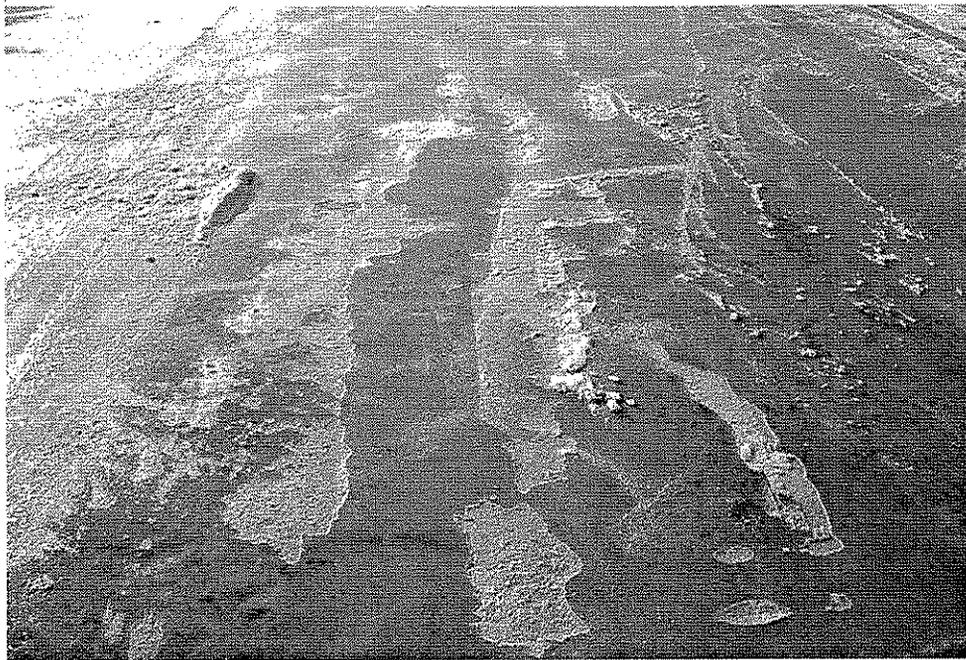
Figure 41. Ice sheet after test number 2 with blade 1, low download, 0° blade angle.

E. Visual Results. The differences in each blades ability to remove ice from the pavement can be seen visually. Figure 41 - 42 show the ice sheet after a test using blade 1. Figures 43 and 44 show the results with blade 2 and likewise figures 45 and 46 show the results of blade 3. Figure 47 shows the amount of ice removed using blade 3 at 15° with a high download.

D. Visual Results. From figures 41 - 42 the results of scraping the ice with blade 1 can be seen for the 15° low download case. The test shows that the blade will removed some of the ice, but never removed ice across the entire width of the blade. At times ice was removed clear down to the pavement and at other times only half the thickness of the ice was removed. It is not understood why the blade behaves in this manner, but all the tests performed on blade 1 displayed this behavior. It was also observed that during tests with blade 1 that although ice was not removed across the entire width of the blade, sparks were seen coming from the blade during the tests indicating that the blade was in contact with the pavement.
