Field Measurements of Plow Loads During Ice Removal Operations

Iowa Department of Transportation Project HR 334

Final Report

IIHR Report No. 365

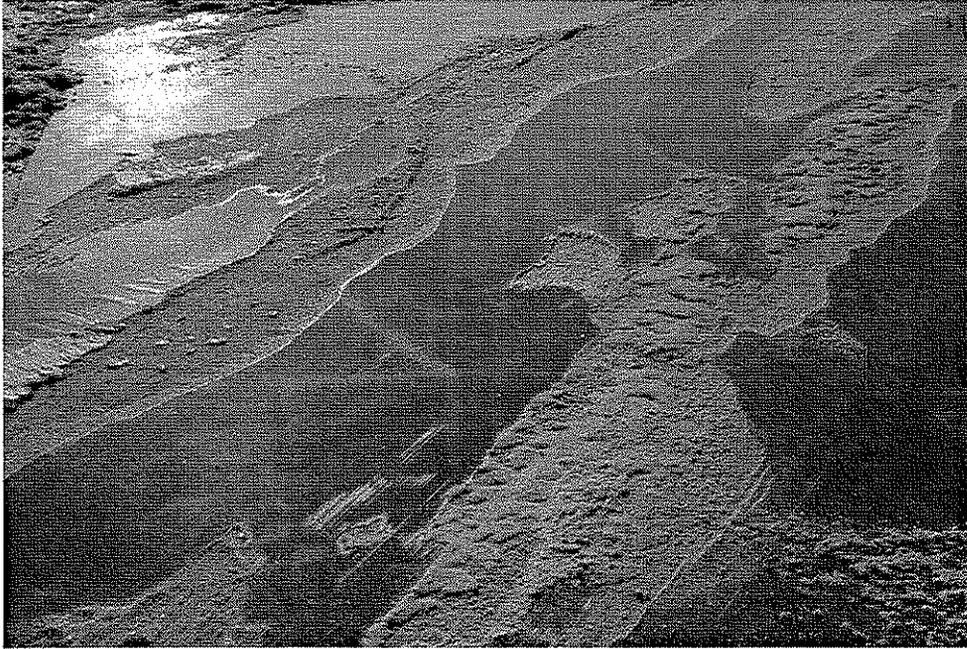
Figure 42. Ice sheet after test number 2 with blade 1, low download, 0° blade angle.

E. Visual Results. The differences in each blades ability to remove ice from the pavement can be seen visually. Figure 41 - 42 show the ice sheet after a test using blade 1. Figures 43 and 44 show the results with blade 2 and likewise figures 45 and 46 show the results of blade 3. Figure 47 shows the amount of ice removed using blade 3 at 15° with a high download.

D. Visual Results. From figures 41 - 42 the results of scraping the ice with blade 1 can be seen for the 15° low download case. The test shows that the blade will removed some of the ice, but never removed ice across the entire width of the blade. At times ice was removed clear down to the pavement and at other times only half the thickness of the ice was removed. It is not understood why the blade behaves in this manner, but all the tests performed on blade 1 displayed this behavior. It was also observed that during tests with blade 1 that although ice was not removed across the entire width of the blade, sparks were seen coming from the blade during the tests indicating that the blade was in contact with the pavement.

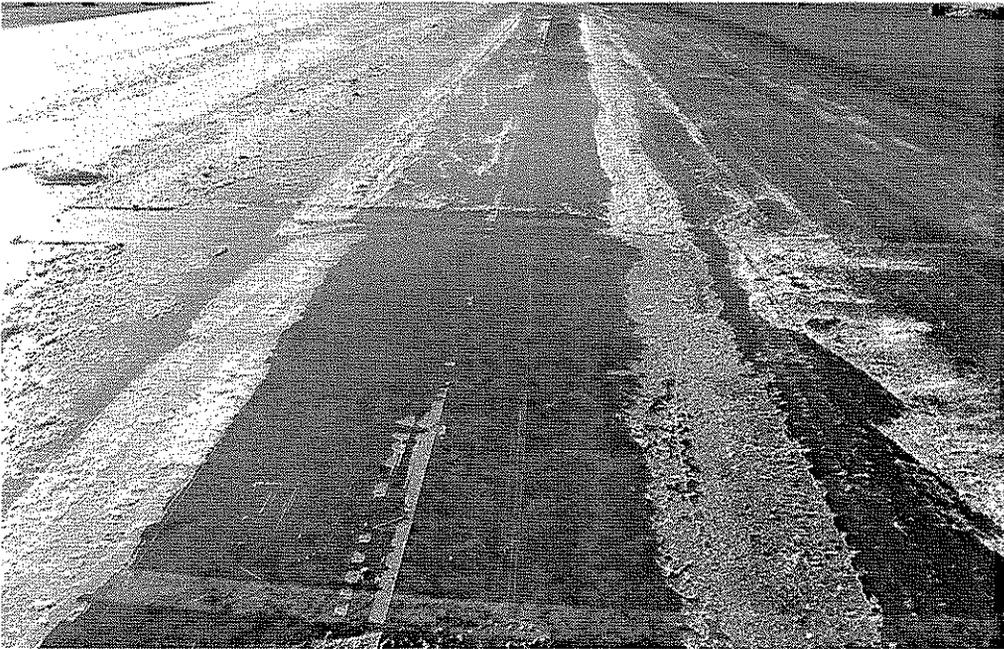
Figure 43. Ice sheet after test number 14 with blade 2, high download, 30° blade angle.

Figures 43 - 44 show the results of scraping with blade 2 at 15° low download. For this test the blade was not mounted straight with the pavement surface. This was due to the distortion of the blade mount caused by the use it had received in its lifetime, and for further testing repairs will have to be made to the mounting to remove this possible source of error. From this test it can be seen that the blade removed between half and all of the ice on the outer edge of the test strip. When the blade was adjusted to fit to the surface of the pavement better, however, similar results to blade 1 were obtained. Generally all tests at 30° with blade 2 and 3 showed this sort of behavior with ice only being removed from the outer edges of the testing run. This was due to the distortion of the blade mount and could not be corrected.

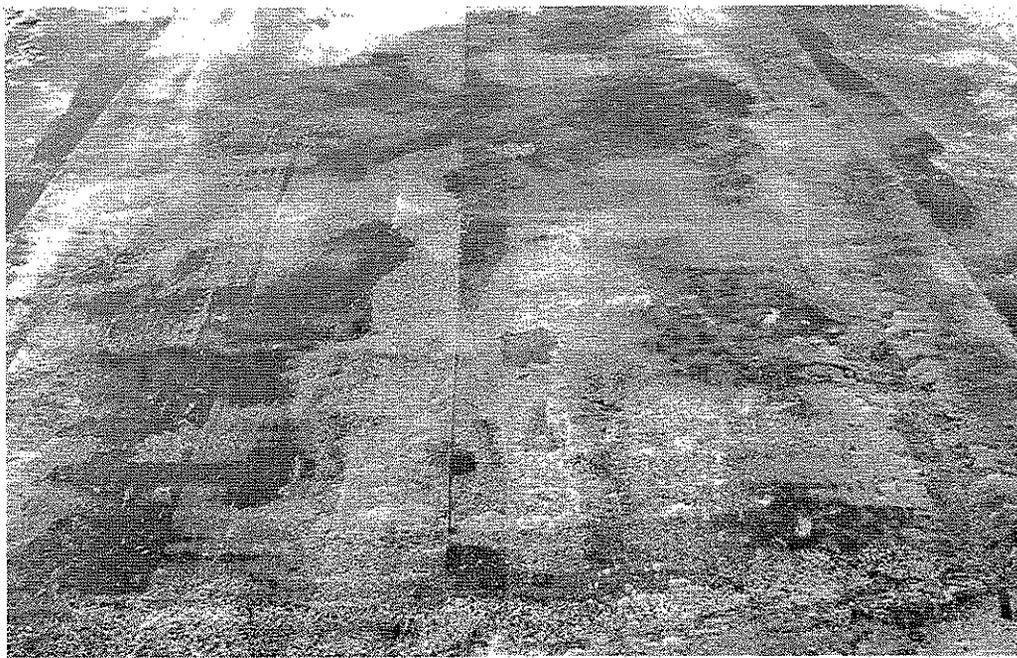
Figure 45. Ice sheet after test number 22 with blade 3, low download, 30° blade angle.

The results for blade 3 are shown in figures 45 - 46. It can be seen that the blade removed nearly half of the ice thickness across the entire width of the blade for a 15° low download test. Figure 47 shows a close up of the edge of a test performed at 15° high download. The figure indicates that nearly the total thickness of the ice was removed. Upon further examination it was also apparent that in spots the blade had removed some of the pavement surface as well. Also for this test the truck did not have sufficient power to maintain the speed during the test and was brought to a stop from 15 mph. However, as the speed decreased nearly all of the ice was removed throughout the test. This test is number 26 in appendix B.

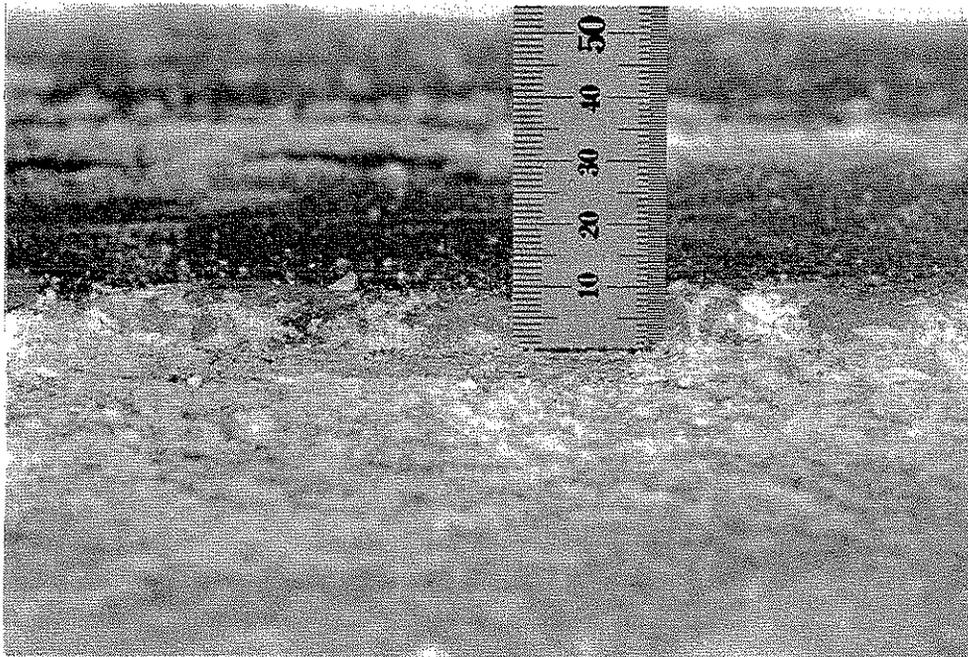
Figure 47. Depth of ice removed for test number 26 with blade 3, high download, 15° blade angle.

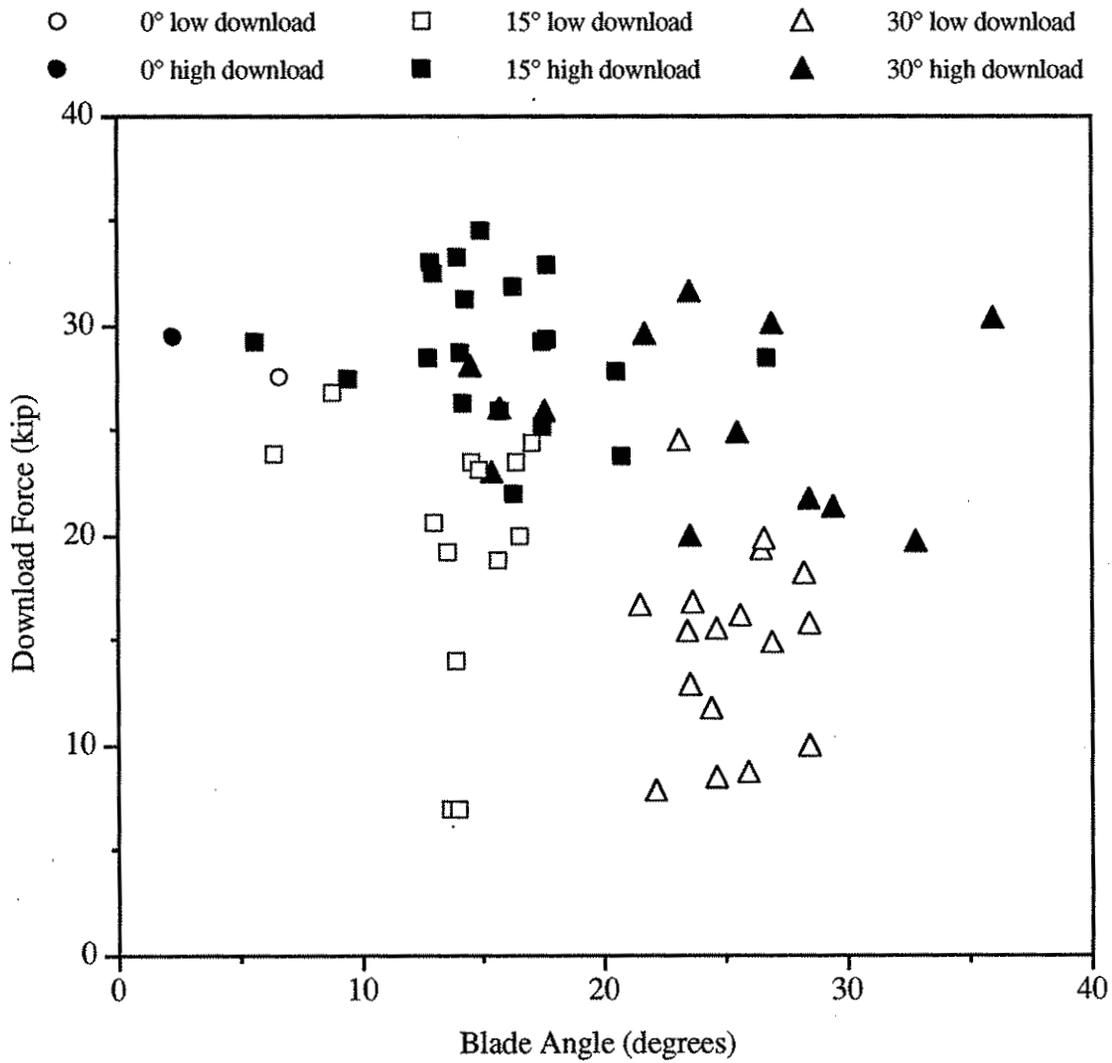
Figure 48. Comparison of testing conditions for all tests.

A. Variability of the Test Conditions. Examination of the results for each test (see appendix B) indicates that there can be a large amount of variation from test to test, even for nominally identical testing conditions. This was attributed to the fact that the equipment used for the tests was not designed to be a precision test machine, but a practical machine used to remove snow and ice from roadways. It was noticed that the blade support of the underbody plow had been completely worn through the bolt holes used to attach the blade and that a new piece of steel had been welded to the remaining support. This caused some unevenness in the blade when it was mounted to the blade support. Also the blade mount itself was not of true shape, most likely caused by the years of service the plow had seen.

The amount of download could not be consistently repeated from test to test because the only indication of download was by the amount of pressure in the hydraulic system as observed on the computer screen. Given the amount of truck bounce experienced, and the difficulty of reading from a computer screen while driving the truck, it was not possible to apply the correct pressure repeatedly from test to test. For further experiments, a digital display will be used to give a more easily read measure of the down pressure applied. In these tests, however, there was a range of download that was achieved for both low and high download tests. Similarly the blade angle also varied from test to test (i.e. in 15° tests, the blade angle might in reality vary between 20° and 10°). Figure 48 indicates the average download and average blade angle for all the tests. It can be seen that most tests that were set for low download fall in a range from 5 kip to 20 kip and that the high download tests are in a range from 20 kip to 35 kip. The blade angle had a range of 10° to 20° for tests at 15° and varied from 20° to 30° for the tests performed at 30°.

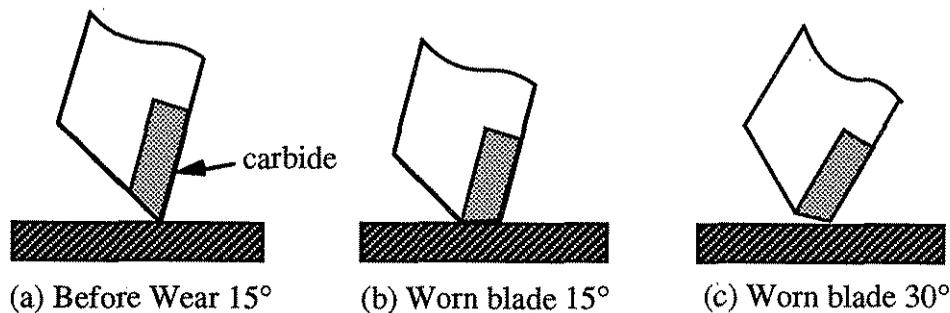
Figure 49. Wear characteristics of blade 3.

Results for blade 3 have been separated into two parts due to a large amount of wear the blade received in removing snow and ice from the test area deposited as result of bad weather that occurred between January 10-13. After the storm the blade experienced a great deal of use in clearing the access road to the test site and the testing area. As a result the blade flat width was increased from nearly 0" to about 3/8" when the blade was in the 15° position. The effect of this wear is apparent in figure 20. At the 15° position there was a significant increase in the force ratio between the no wear and worn blade tests. The t-test results shown in Table 3 support this conclusion. Tests before the wear took place are indicated by the (b) and tests after the wear took place by the (a). The change in force ratio is not as apparent for the 30° blade angle. This could be partly due to the fact that at 30° the blade flat width was much smaller than at 15° as shown in figure 49. Figure 49 (a) shows blade 3 at 15° before it received any wear. Figure 49 (b) shows the blade after the wear and figure 49 (c) shows the worn blade at 30°. Even with the wear at 30° the blade has a pointed surface to work with and not a flattened portion as in the 15° position as shown in figure 49 (b). This new unworn point could still provide good ice removal at 30°, as indicated by the low force ratio results obtained for this condition with blade 3.

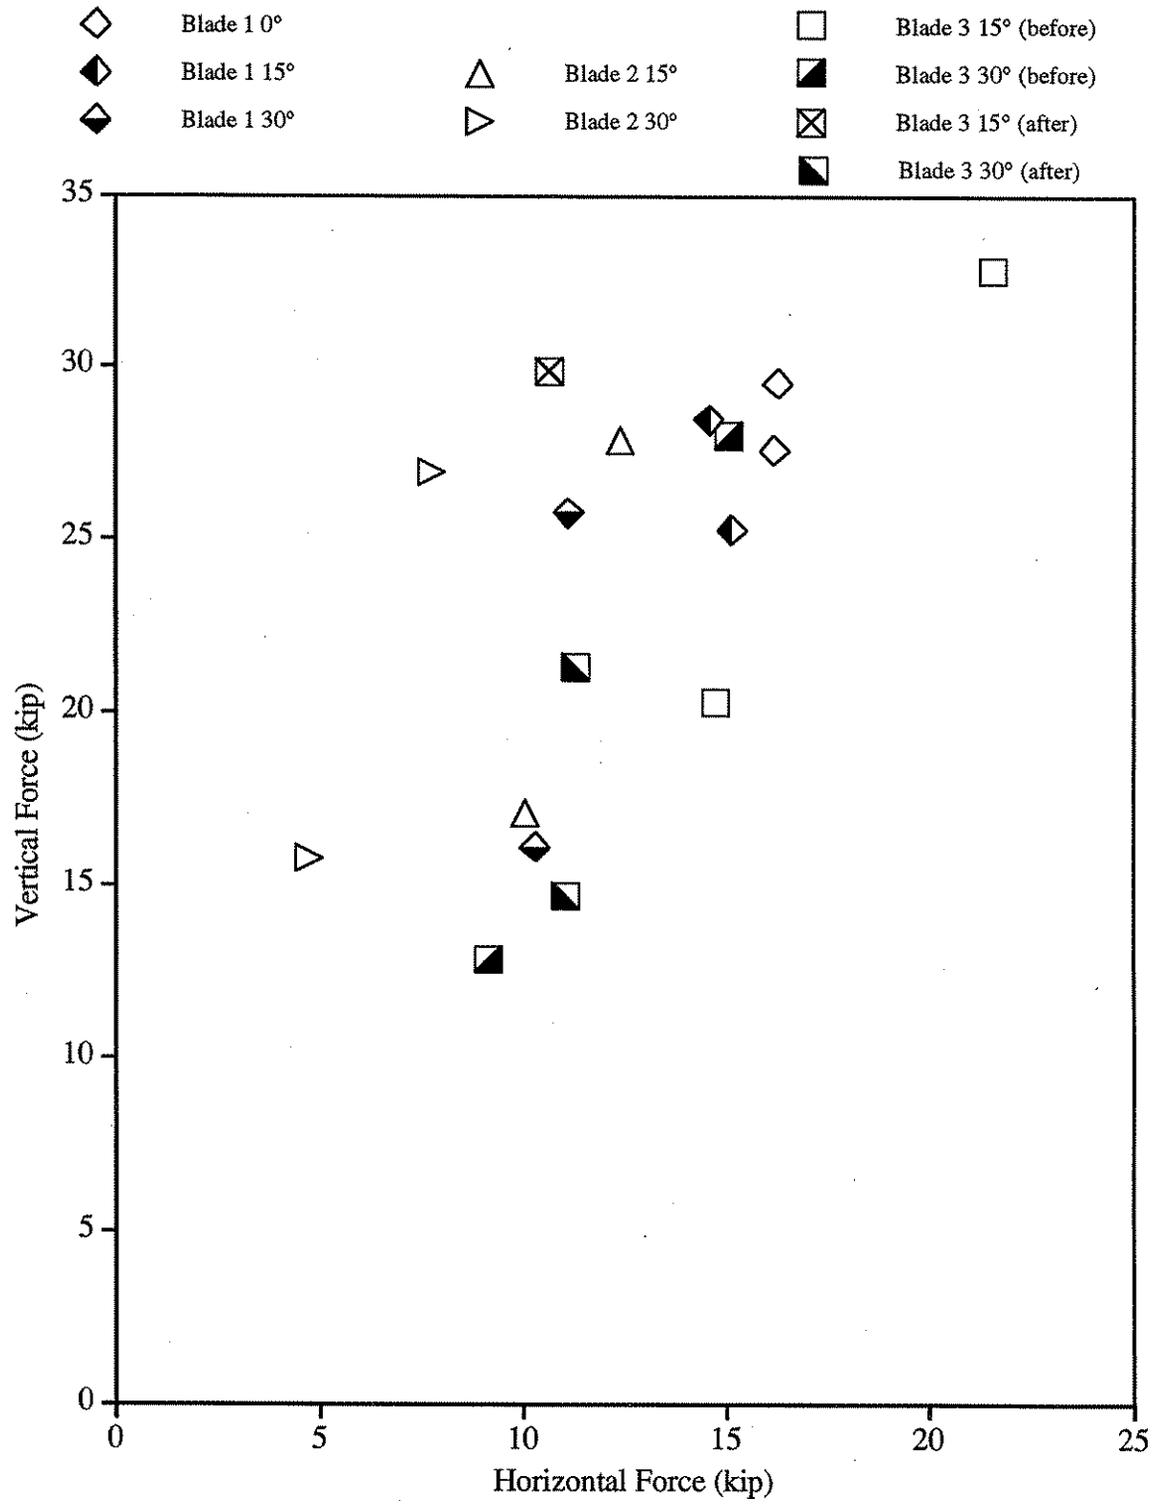
Figure 50. Effectiveness of all blades and testing conditions.

The results of the vertical force versus the horizontal force, or effectiveness, for all blades and all testing configurations is shown in figure 50. From this figure it becomes apparent what the overall trends were between the testing conditions. For nearly all cases the horizontal force was larger at higher downloads. This was not the case for blade 3 at 15° blade angle for the before and after wear conditions, but was true for the other conditions of blade 3. The only other exception was blade 1 at 15° blade angle. However for this condition the low and high download were nearly the same. This was also true for blade 1 at 0°. These tests were performed at the beginning of the research project and the testing procedures, as well as familiarity of the equipment, had not yet been refined. So comparison between these conditions does not provide any valuable information. Another point that is evident from figure 50 is that for all of the tests the effectiveness was better at smaller blade angles. The only exception being for the wear effect of blade 3 at 15° blade angle, high download.

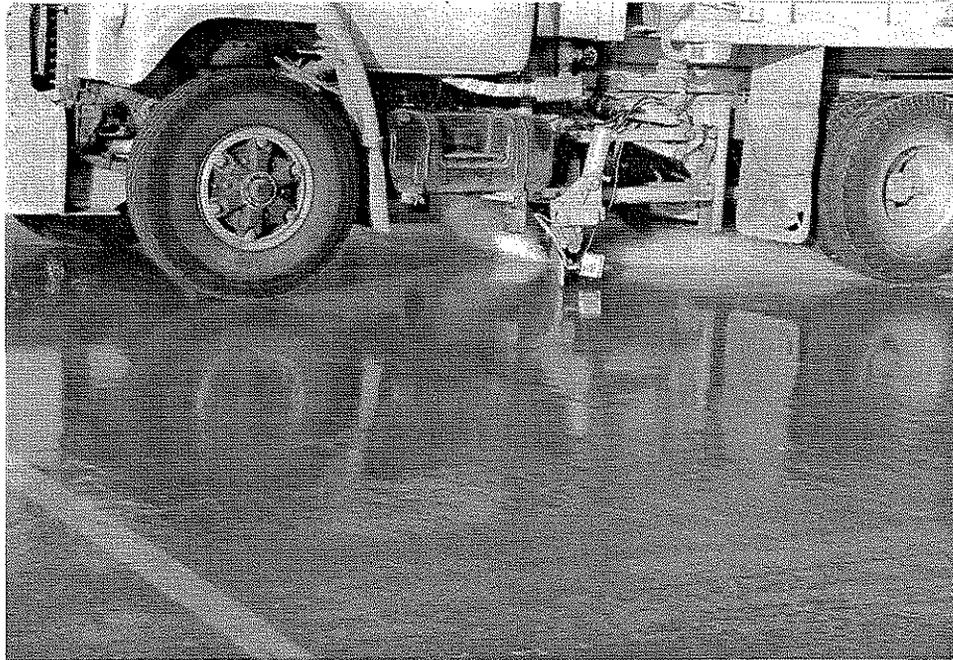
Figure 51. The truck scraping ice with blade 1.

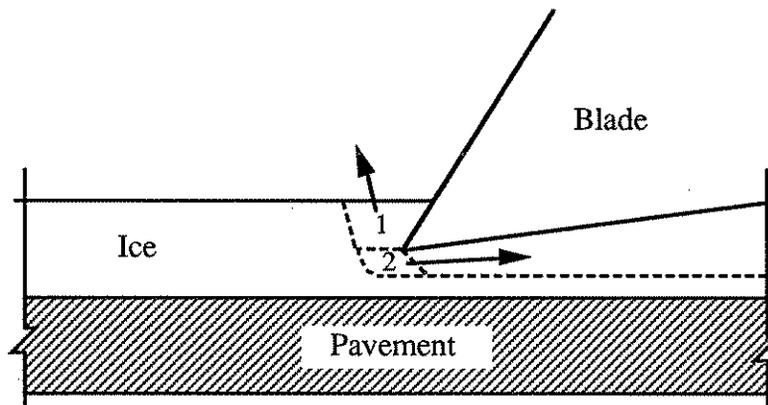
Figure 52. Tentative model of ice failure under the blade.

possible to develop a tentative model for the failure of ice under the blade. The tests show that the ice is fractured into very small particles (having the consistency of powder) during scraping. It appears that the ice is crushed by compressive forces generated ahead of and beneath the blade. Figure 51 shows the truck scraping ice with blade 1. This particular test was a preliminary test to ensure that the data acquisition system was functioning properly (therefore it does not appear with the results in appendix B) and was performed on November 7, 1991. This picture shows that ice fragments are ejected both before and behind the blade, which suggests that there are two zones of failure as indicated in figure 52.

Ice in zone 1 is ejected upwards, before the blade. Because the ice is so finely fractured, there is relatively little friction between the blade and ice and thus cast angle has a minimal effect on the force. The ice in zone 2 is also fractured, but in order to clear, it must pass underneath the blade. Upon fracturing, the ice takes up more volume than in its unfractured state, and thus requires some clearance in order to pass beneath the blade. If this clearance is not available the broken ice fragments must be recompressed by the blade, resulting in a high downforce. This is a preliminary model and requires further examination, both by way of testing and also by some finite element modeling.
