Field/Laboratory Testing of Damaged Prestressed Concrete Girder Bridges

Sponsored by the
Iowa Department of Transportation
Project Development Division and the
Iowa Highway Research Board

Iowa DOT Project HR-397

REPORT

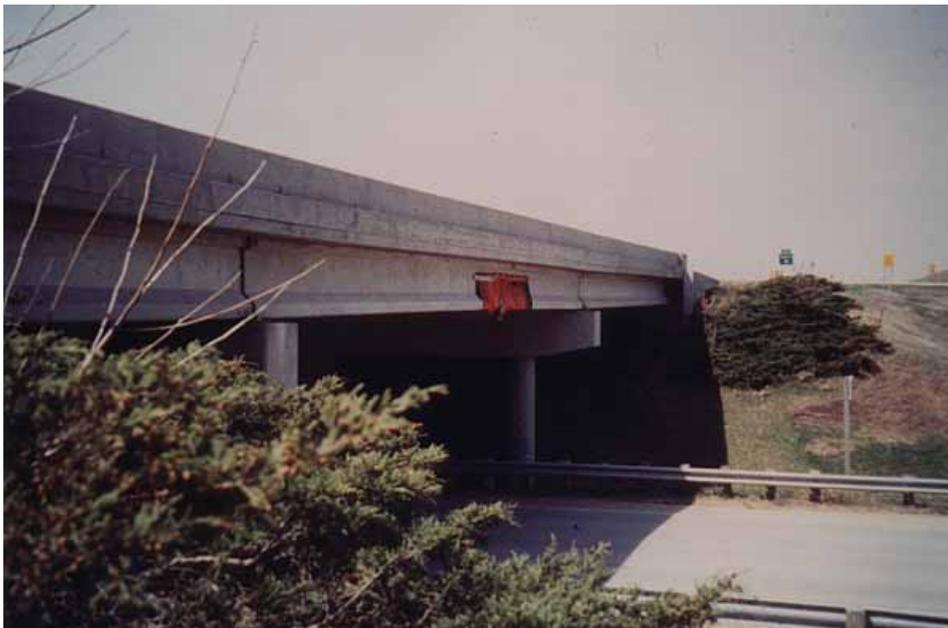
Figure 3.2. Elevation View of WB Bridge, Looking West (Damaged Beam 1W in Center Span).

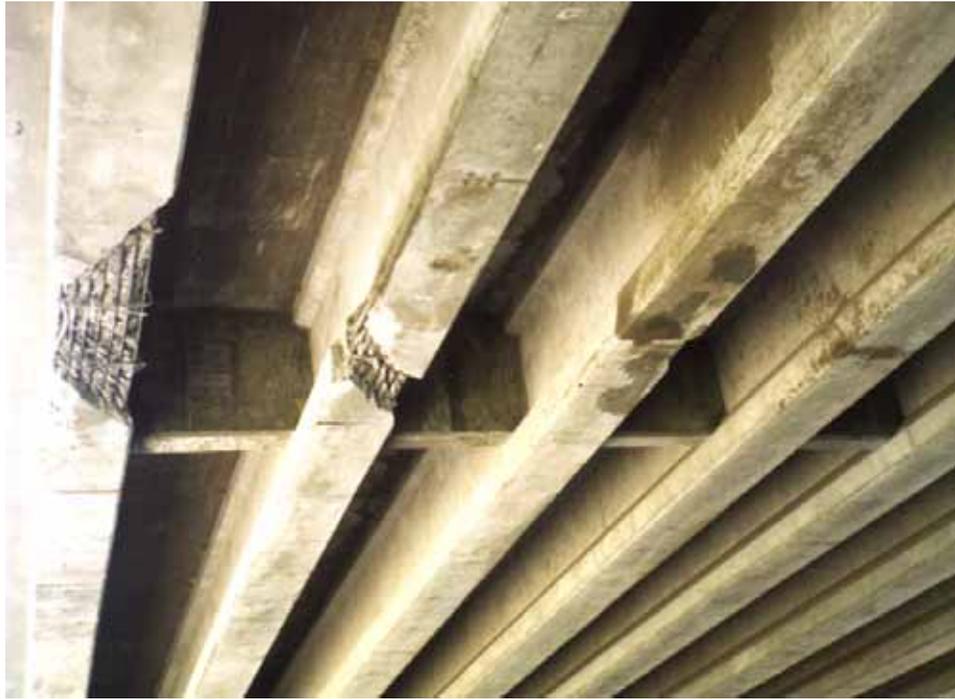
Figure 3.4. Underside of Damaged WB Bridge, Beam 1W at Left.

The clearance under the north beams of the WB bridge was measured to be ± 13 ft-9 in.; the bridge is now posted for a clearance of 13 ft-7 in. Substandard vertical clearance is the main cause of bridge damage in Iowa. An internal study by the Iowa DOT in 1995 found that of all hit bridges, the most common cause of damage was impact from construction equipment (Phillips et al, 1995). The study also concluded that adequate clearance was not a safeguard against collision. Examining all bridges damaged by impact in the time period of 1990 to 1995, the study revealed that fifteen structures had clearance in excess of 15 ft and seven in excess of 16 ft. In many collisions, the offender is unknown and the Iowa DOT bears the financial responsibility of repairing the bridge.

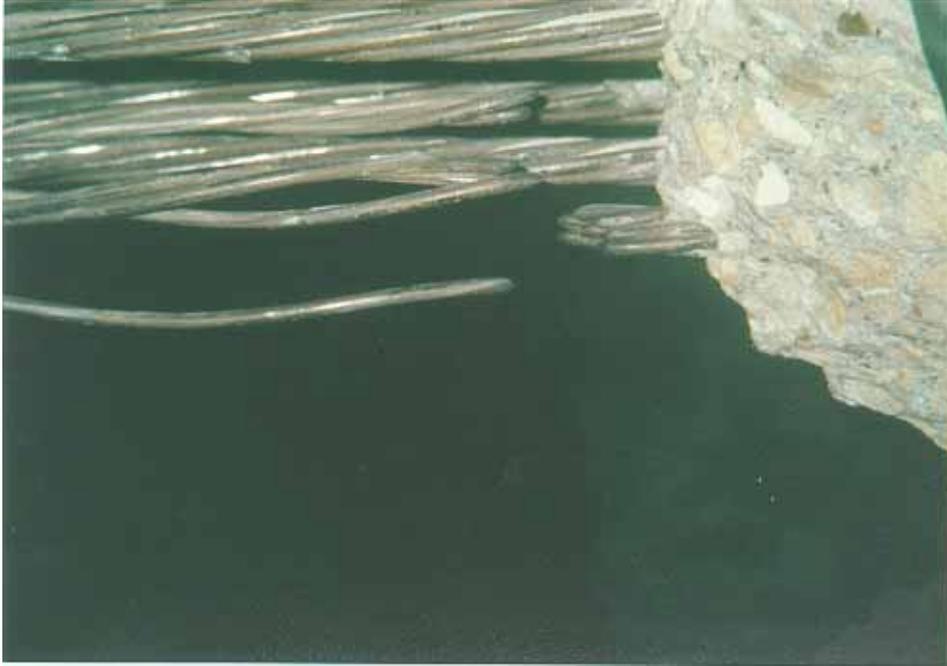
Figure 4.10. Severed Prestressing Strand Exhibiting Necking Down Behavior.

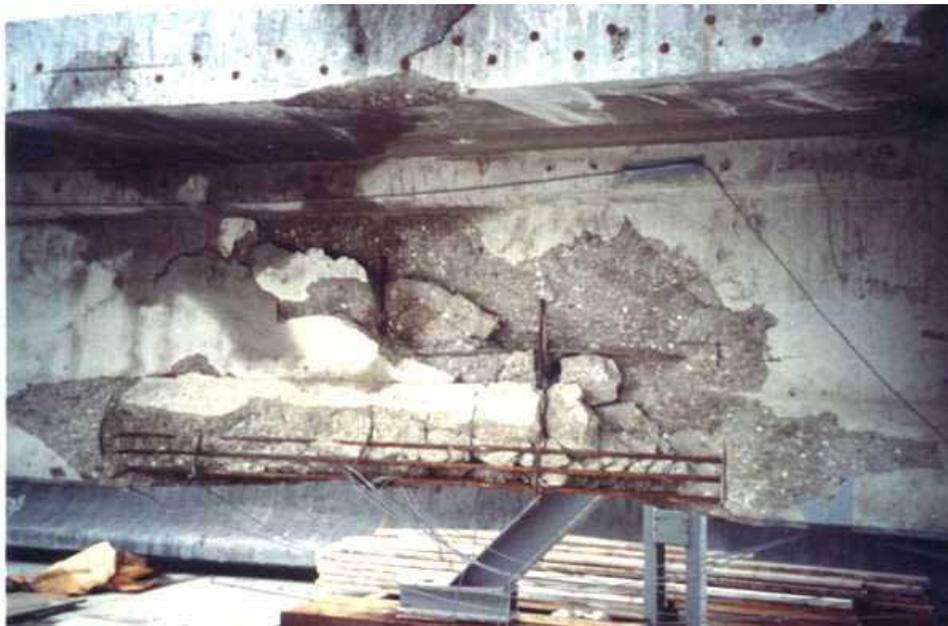
Figure 5.4. Close Up View of Damaged South Face of Beam 1W Prior to Testing.

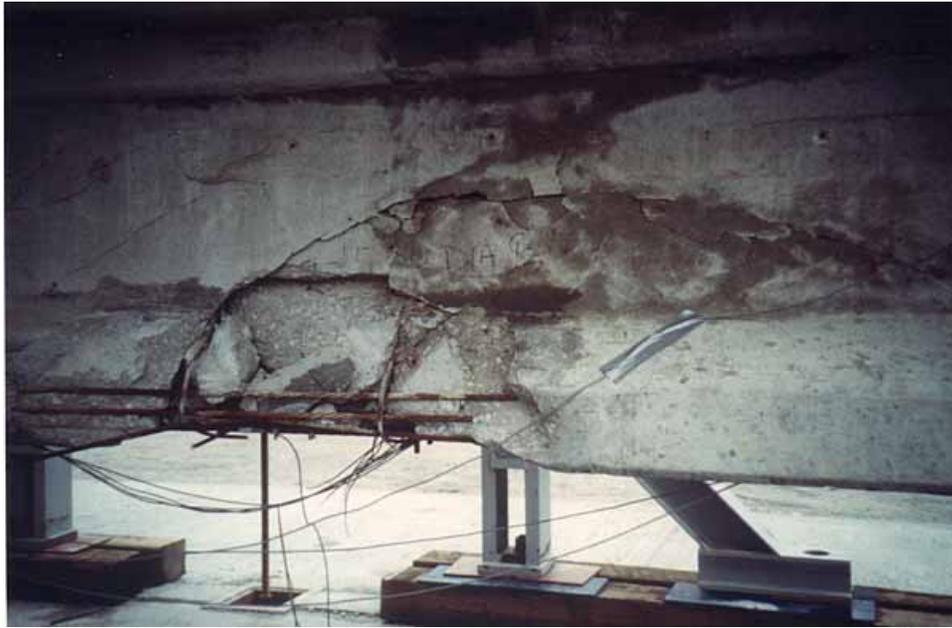
Figure 5.5. Close Up View of Damaged North Face of Beam 1W Prior to Testing.

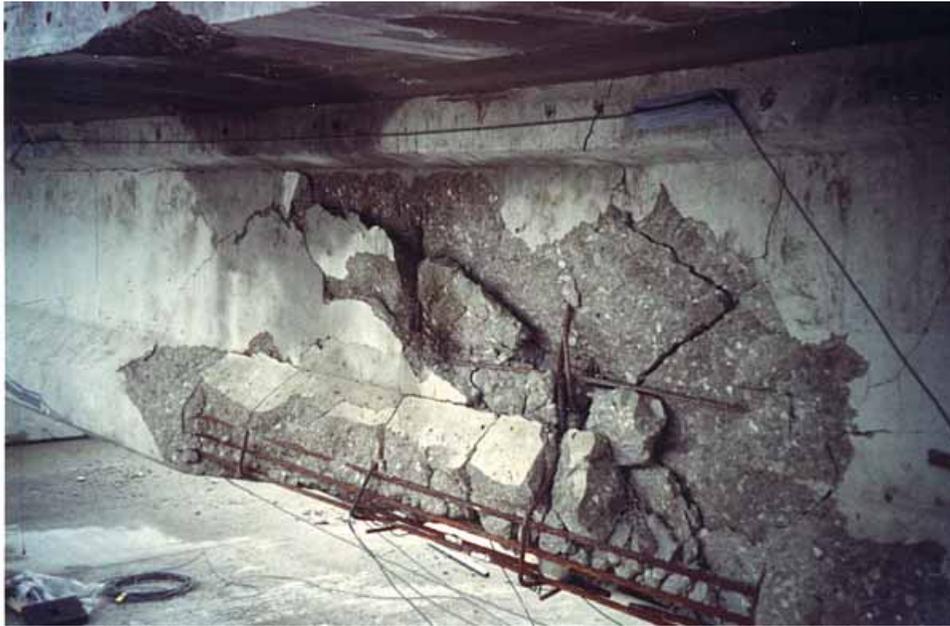
Figure 5.12. South Face of Beam 1W West of Midspan Following the Ultimate Load Test.

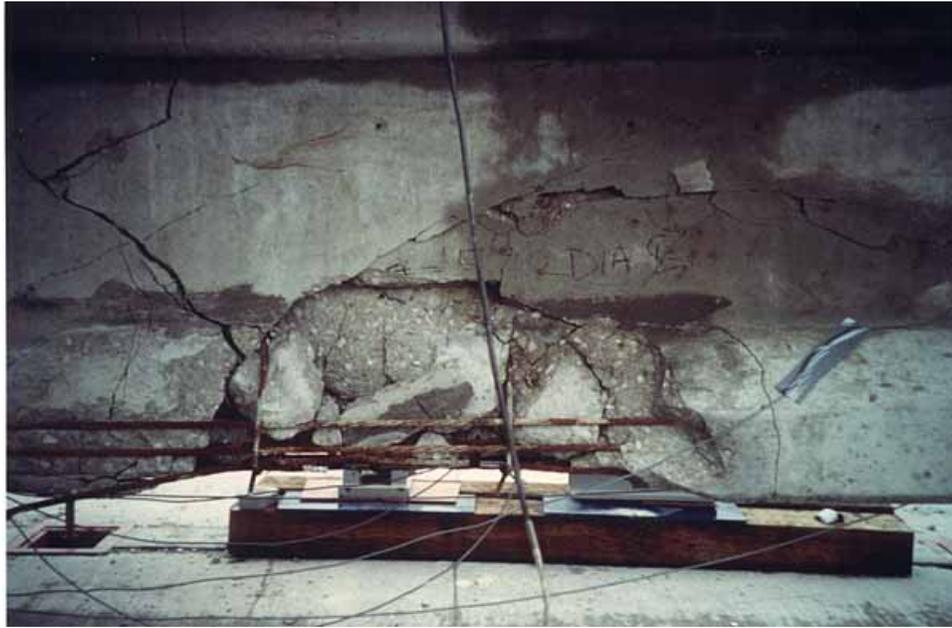
Figure 5.14. North Face Damage in Beam 1W Following Ultimate Load Test.

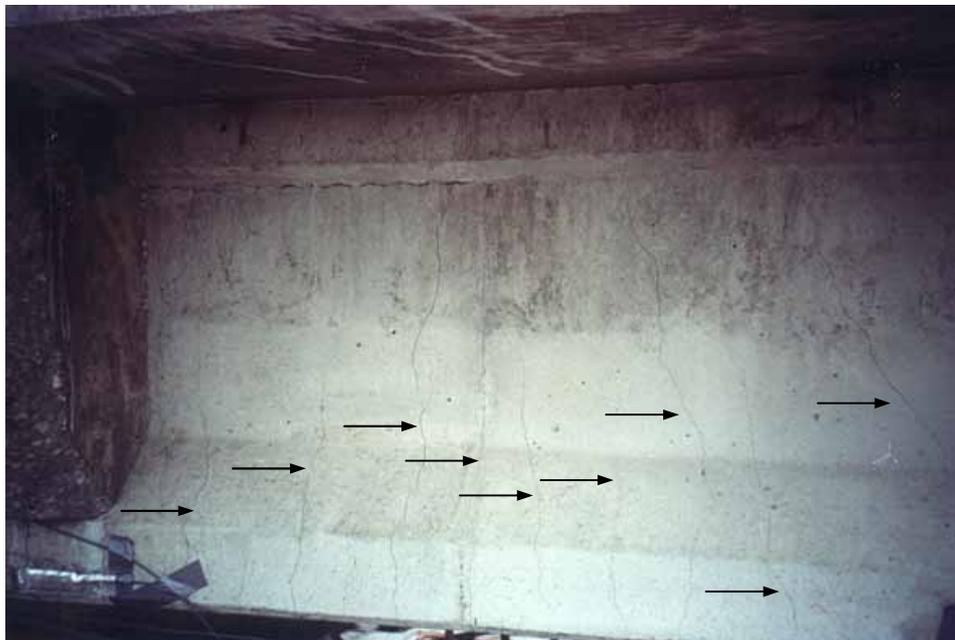
Figure 5.15. Cracks on South Face of Beam 1W East of Midspan Following Ultimate Load Test.

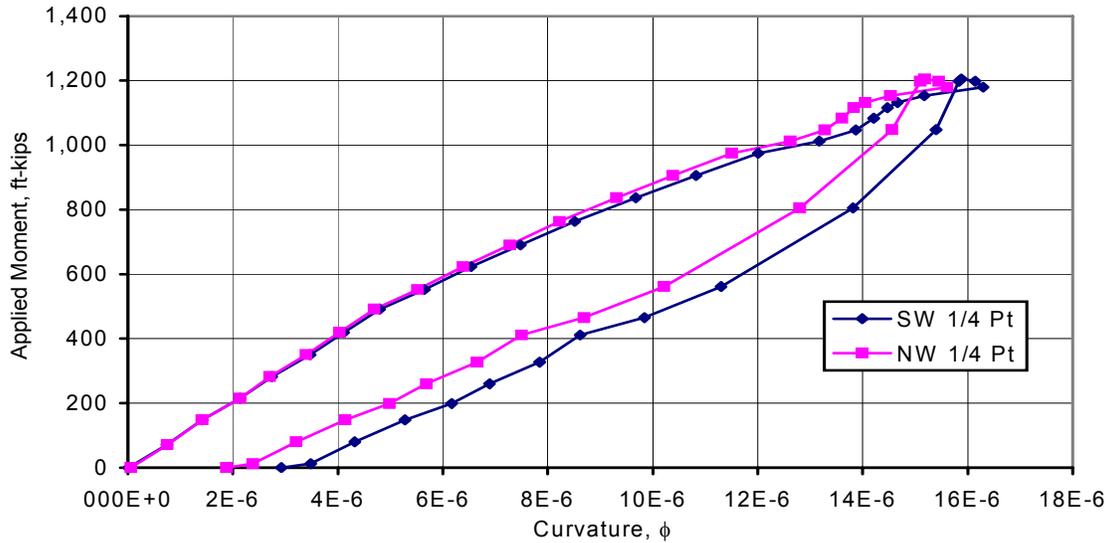
Figure 5.17 Ultimate Load Test of Beam 1W: Applied Moment vs. Curvature at W Quarter Point.

Figure 5.17 presents the moment, M , versus curvature, ϕ , response for the west quarter point where $\phi = M/EI$. For a section whose stiffness does not change with applied load, the M vs. ϕ response should be linear. A decreasing slope indicates cracking. Figure 5.17 indicates that the M vs. ϕ response begins to flatten out at a quarter point live load moment in excess of 500 ft-kips.

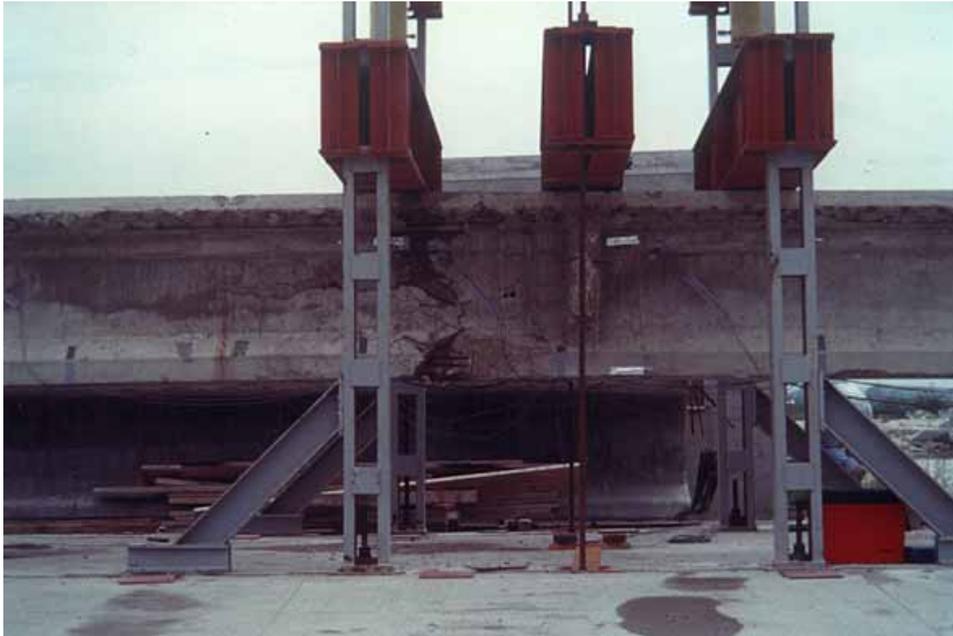
Figure 5.22. South Face of Damaged Beam 2W Prior to Repair.

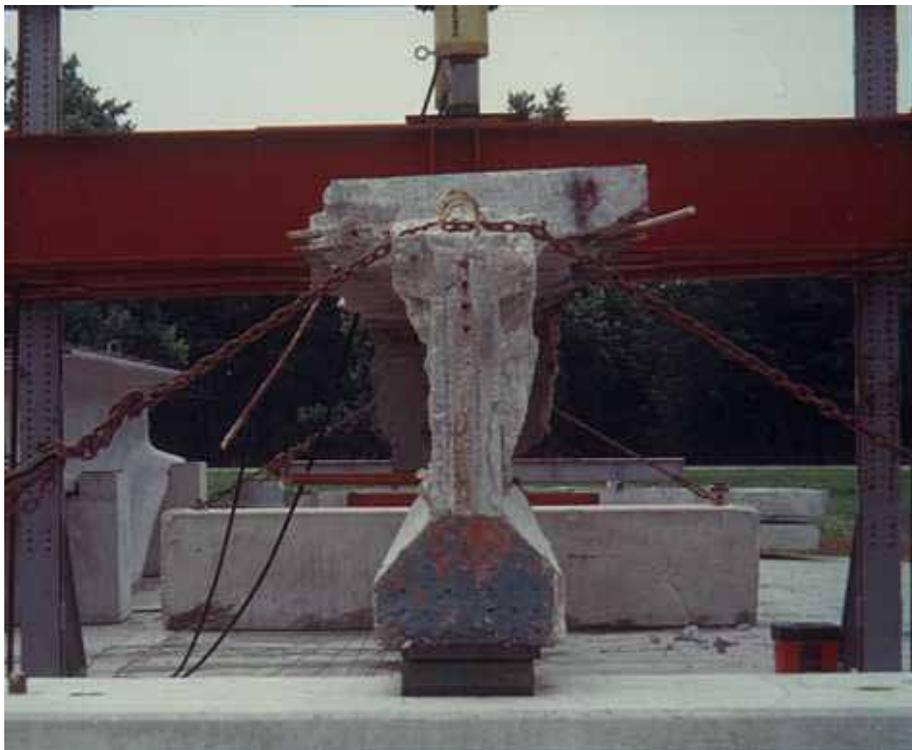
Figure 5.23. End Elevation of Beam 2W Prior to Repair (Looking East).

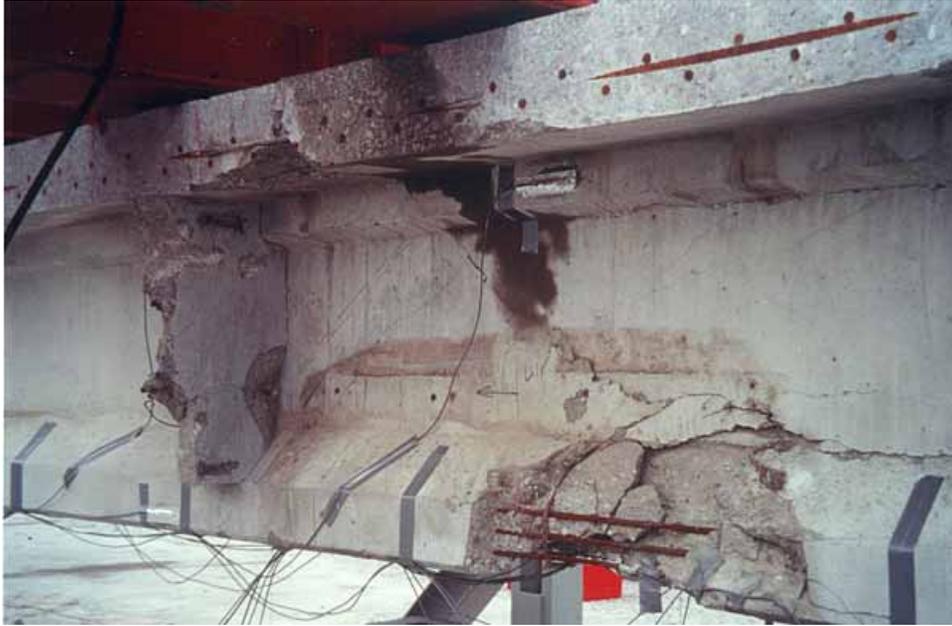
Figure 5.24. North Face Damage West of Midspan Diaphragm, Beam 2W.

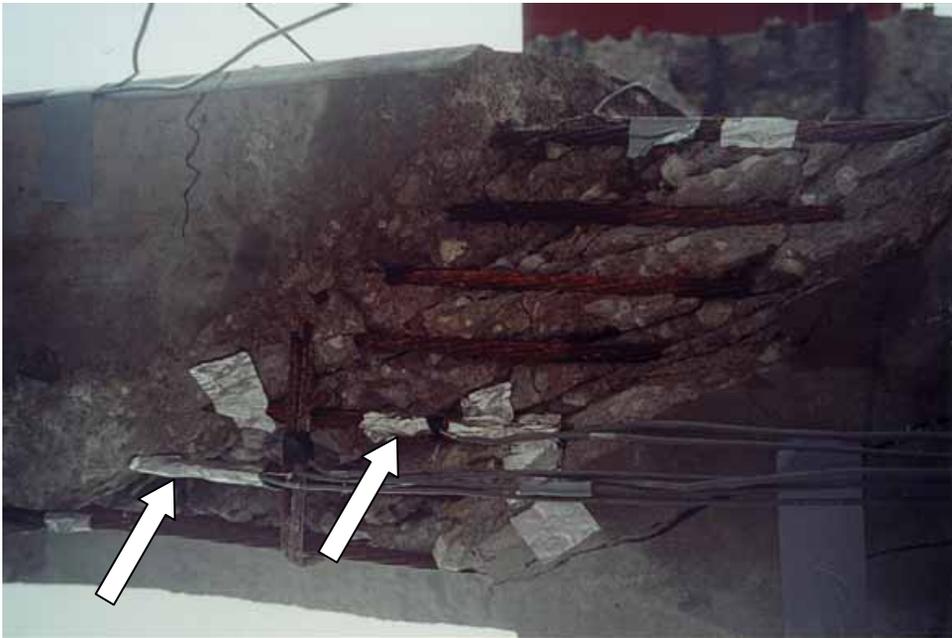
Figure 5.25. Underside of Damaged Flange, Beam 2W, Strain Gages on Strands 5 and 6.

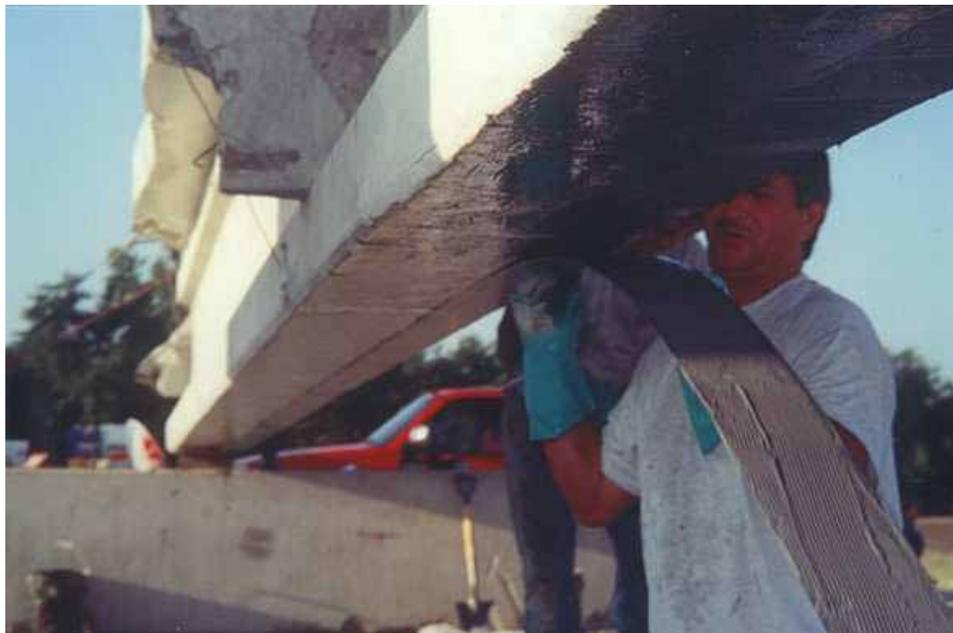
Figure 5.34. Installation of CFRP Reinforcing Plates to Repaired Bottom Flange of Beam 2W.

Following patching of the void that resulted from removal of the loose concrete from the bottom flange and web areas, strengthening began with the installation of longitudinal carbon fiber reinforced polymer (CFRP) plates on the bottom flange of Beam 2W as depicted in Figure 5.34. The longitudinal plates are pultruded CFRP that are easily applied in the field with only the tools depicted in Figure 5.33. Prior to installation of the plates, both the substrate, in this case the bottom flange of the beam, and the plate, are coated with a thin layer of epoxy. The plate is then aligned on the bottom of the substrate and the two epoxy layers pressed together with a hard rubber or wooden roller. It is important that adequate pressure be applied so that air bubbles are removed and only a thin glue line remains. A total of three plates were applied to the bottom flange over the full length of the beam. Strain gages were applied to the plates at both quarter points and at midspan.

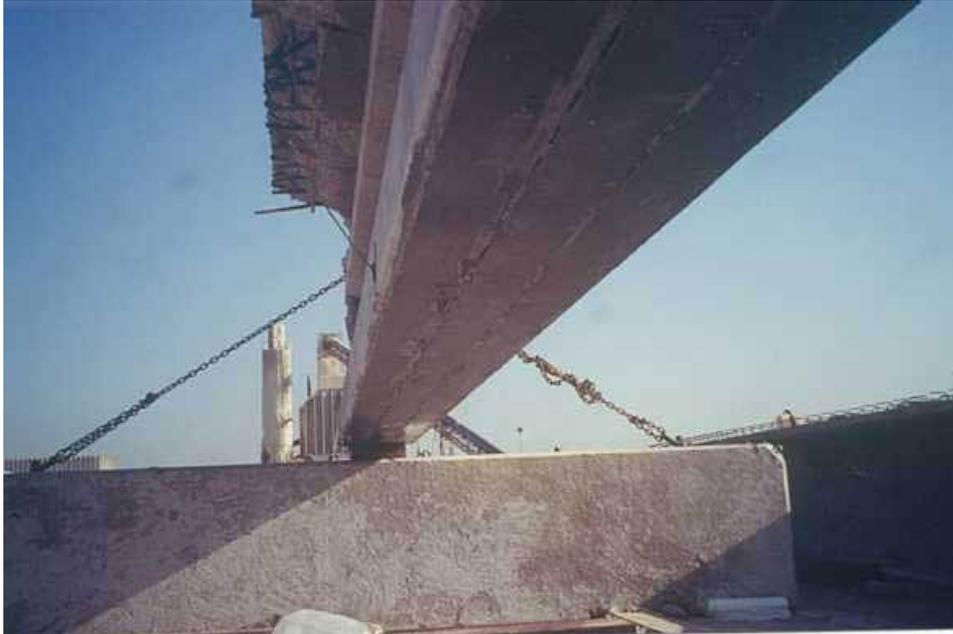
Figure 5.35. Completed Installation of CFRP Reinforcing Plates on Beam 2W.

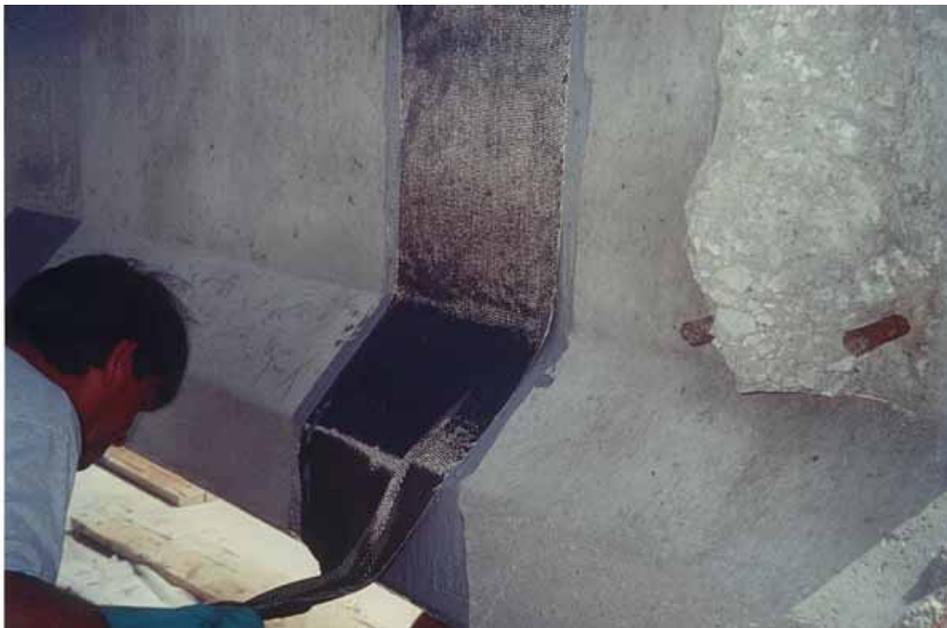
Figure 5.36. Placement of CFRP Fabric External Stirrups on Beam 2W.

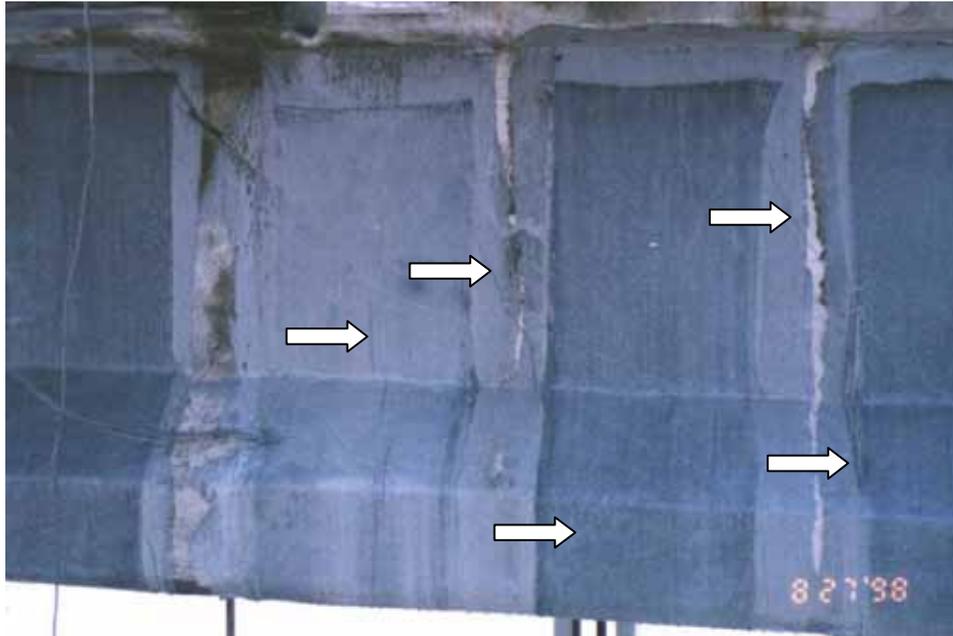
Figure 5.39. Vertical/Inclined Cracks in FRP Stirrups in Previously Damaged Region of Beam 2W.

Figure 5.39 illustrates the vertical and inclined cracks that developed in the concrete and propagated through the unidirectional CFRP stirrup. A picture of the debonded overlay immediately preceding the collapse of the beam is presented in Figure 5.40. A photograph of the collapse at a point approximately 4 ft from midspan, directly under the west actuator is presented in Figure 5.41. Finally, Figure 5.42 illustrates the fracture of the CFRP stirrups and corresponding debonding of the longitudinal plates following collapse of the beam.

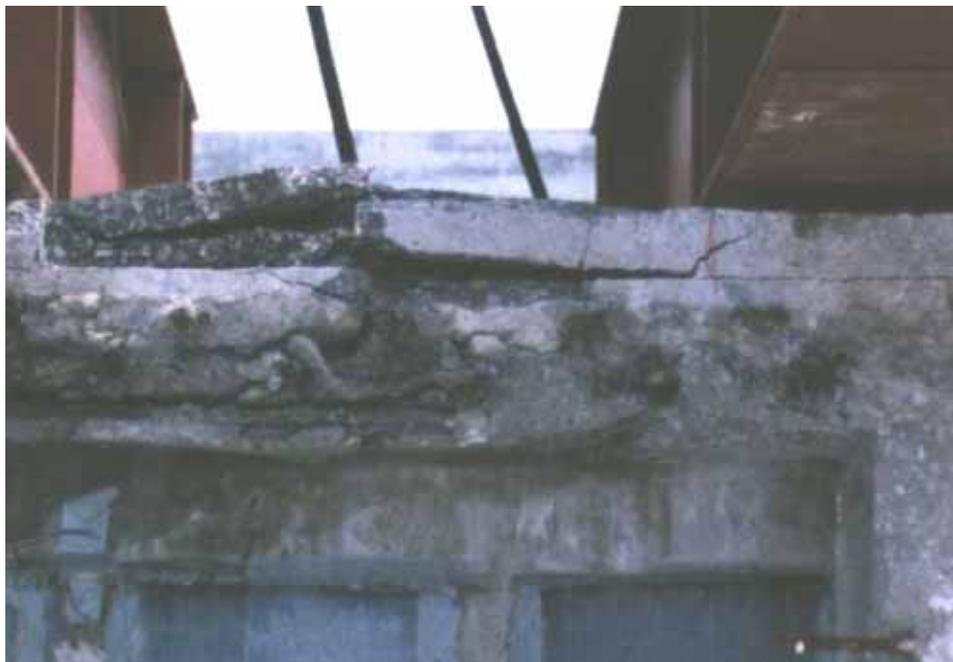
Figure 5.40. Debonded Overlay in Constant Moment Region of Beam 2W Near Ultimate Load.

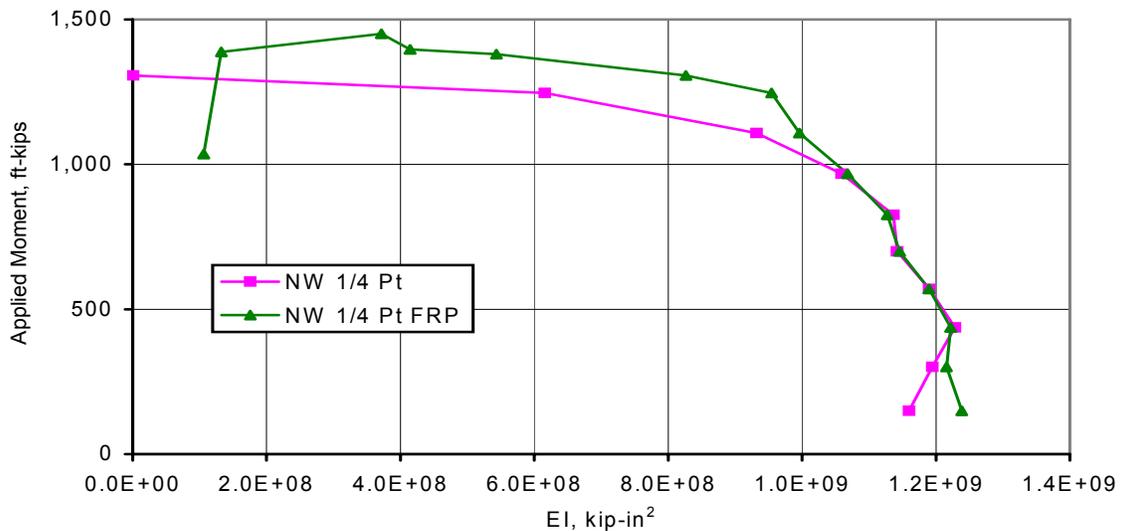
Figure 5.46. Ultimate Load Test of Repaired Beam 2W: Change in EI, West Quarter Point.

The change in EI for the west quarter point is presented in Figure 5.46. The low load stiffness of this cross-section as well as the damaged region is enhanced by the presence of the CFRP plates as previously discussed. Similar to Beam 1W (see Figure 5.18 for details), there is a dramatic drop in stiffness at the onset of significant structural cracking.

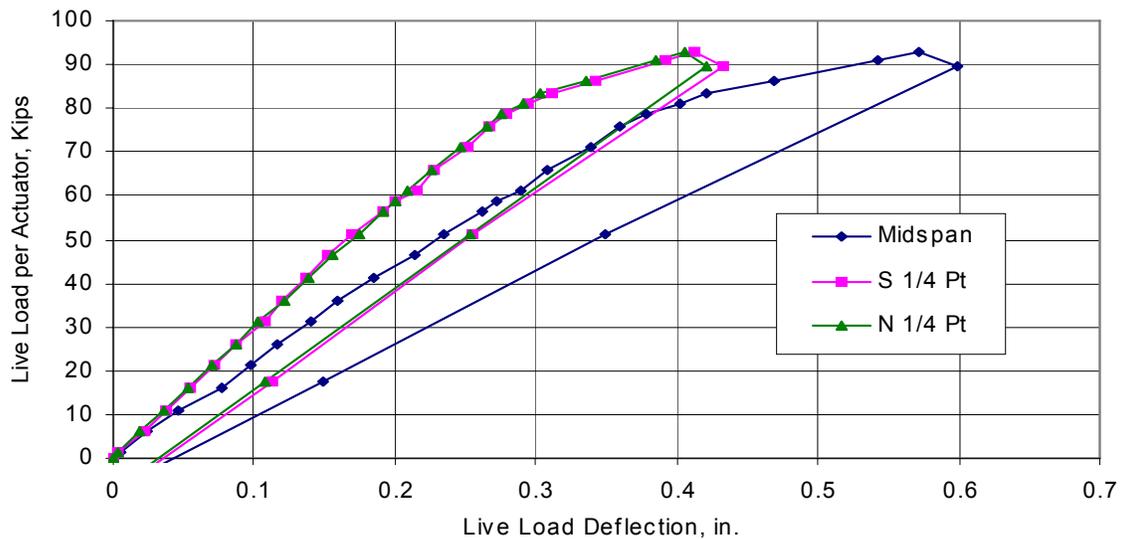
Figure 5.51. Beam 1 Cracking Test: Load per Actuator vs. Live Load Displacement.

The live load vs. displacement plot for the cracking test is presented in Figure 5.51. The nonlinear behavior above a load of 80 kips is indicative of the onset of cracking. Because of the way the load frame hangs from the beam itself, Beam 1 has a dead load of approximately 6,300 lbs. at each actuator location prior to application of any actuator load. This load and its corresponding displacement are not reflected in the plots that follow. Load, displacement and strain values are only due to live loads. A photo of Beam 1 following the cracking test is presented in Figure 5.52.

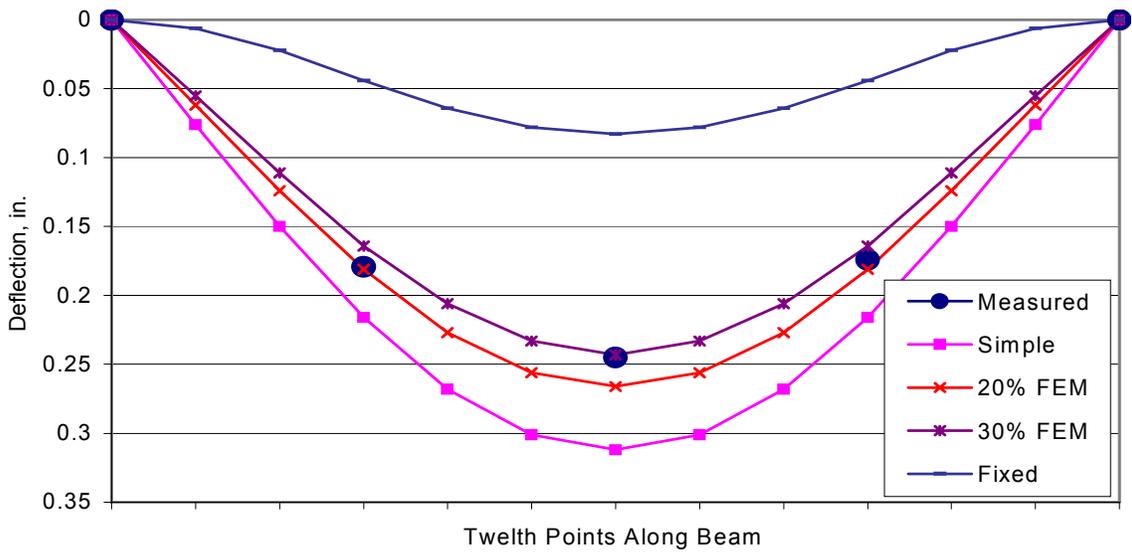
Figure 5.54. Measured vs. Predicted Deflections Along Beam 1 Using Experimental EI Value.

Predicted deflections for various degrees of end restraint using the measured EI value of 560×10^6 kip-in² are presented in Figure 5.54. Using the experimentally determined EI value as an improved estimate, the recorded deflections of the beams agree with a lower assumed end restraint provided by the abutment, somewhere between 20% and 30%. This is reasonable since the restraint should be lower than when the beams were interconnected by the slab, determined by Paradis (1998) to be approximately 50%.

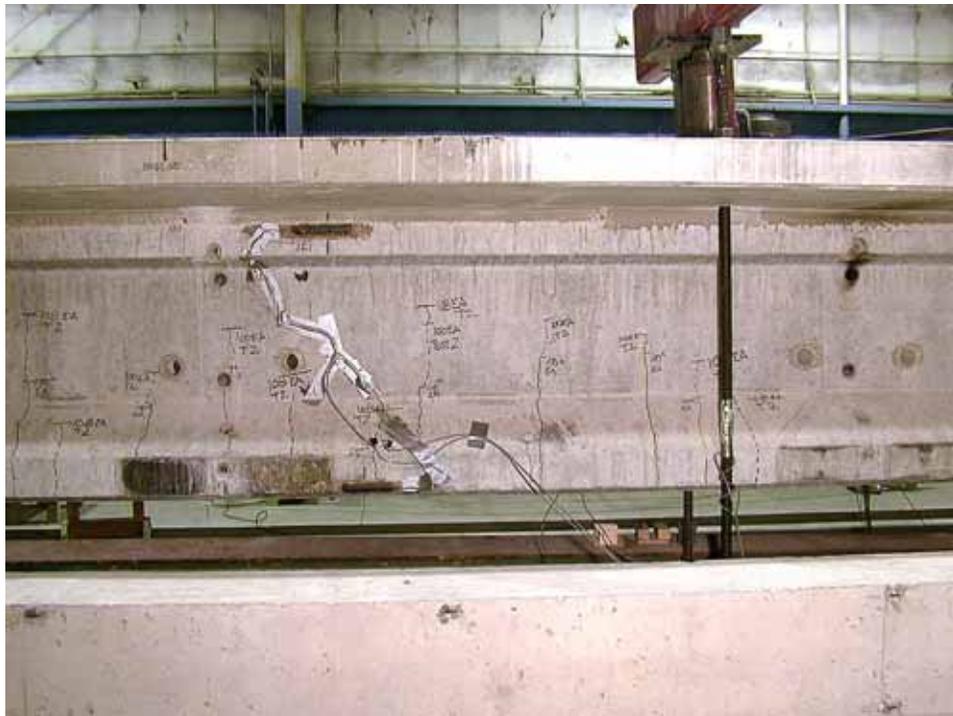
Figure 5.56. Beam 1 Crack Patterns Following the Unsuccessful Ultimate Load Test.

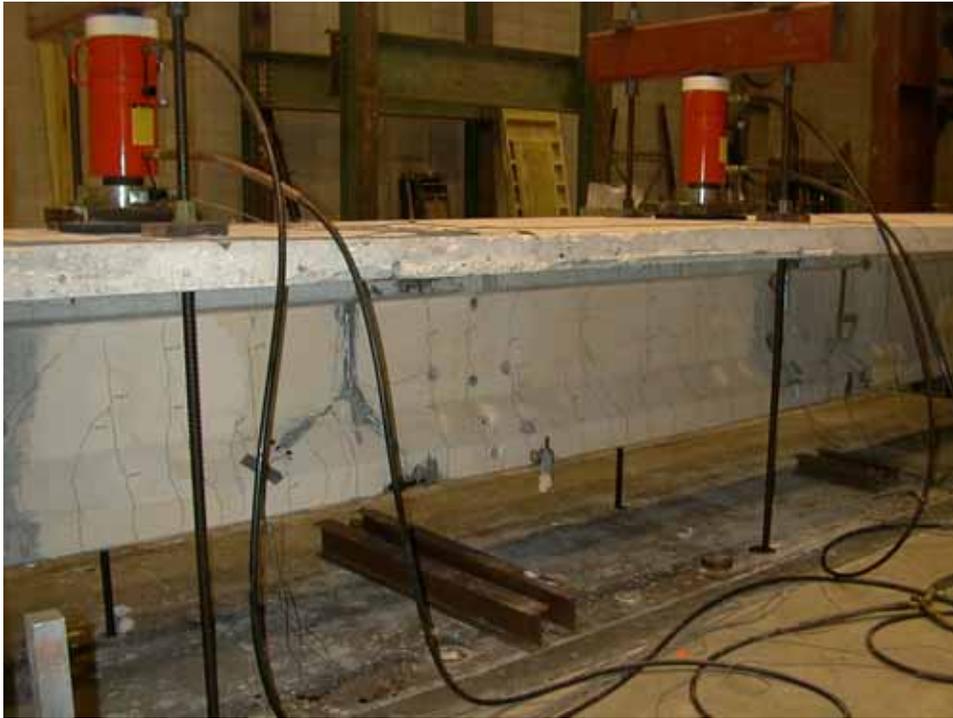
Figure 5.70. Overview of Beam 1 Crack Patterns Following the Ultimate Load Test.

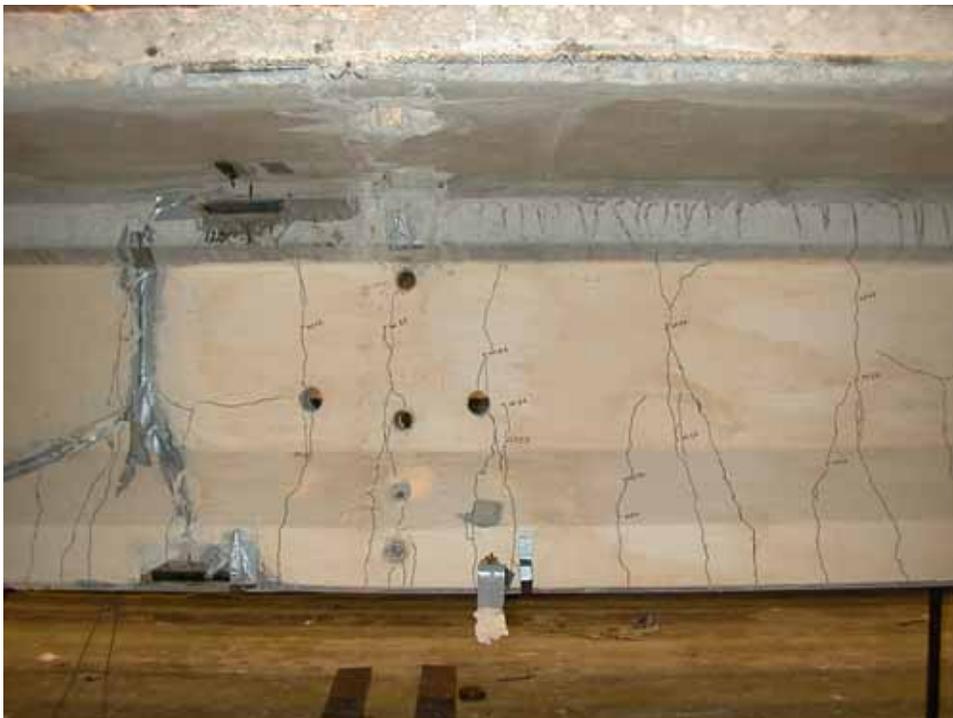
Figure 5.71. Extensive Vertical Cracking in the Constant Moment Region of Beam 1.

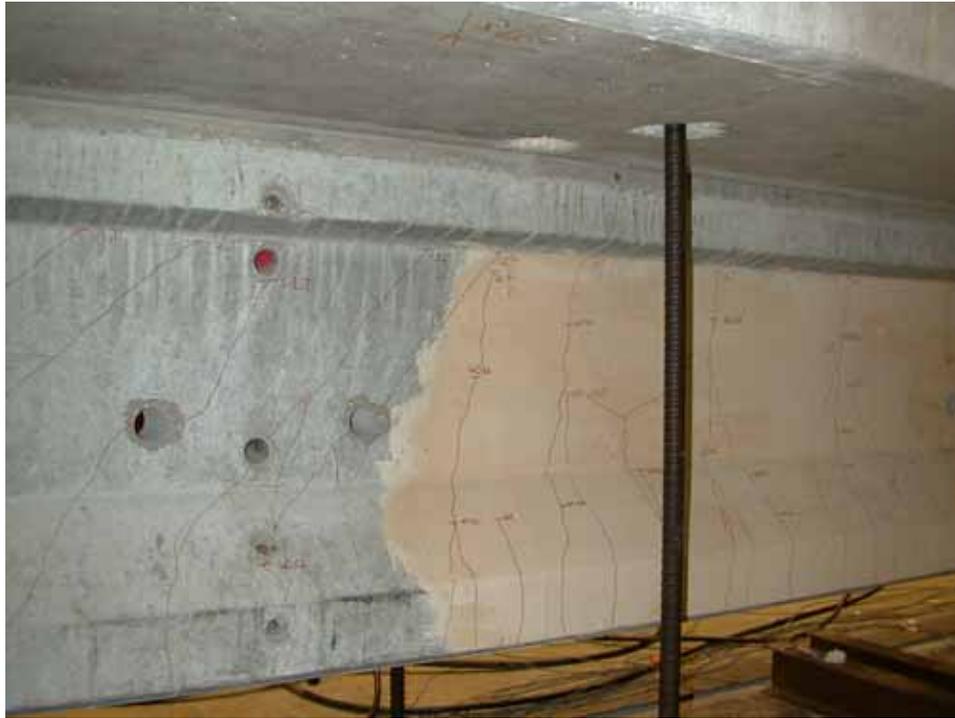
Figure 5.72. Diagonal Tension Cracks in High Moment/Shear Region of Beam 1.

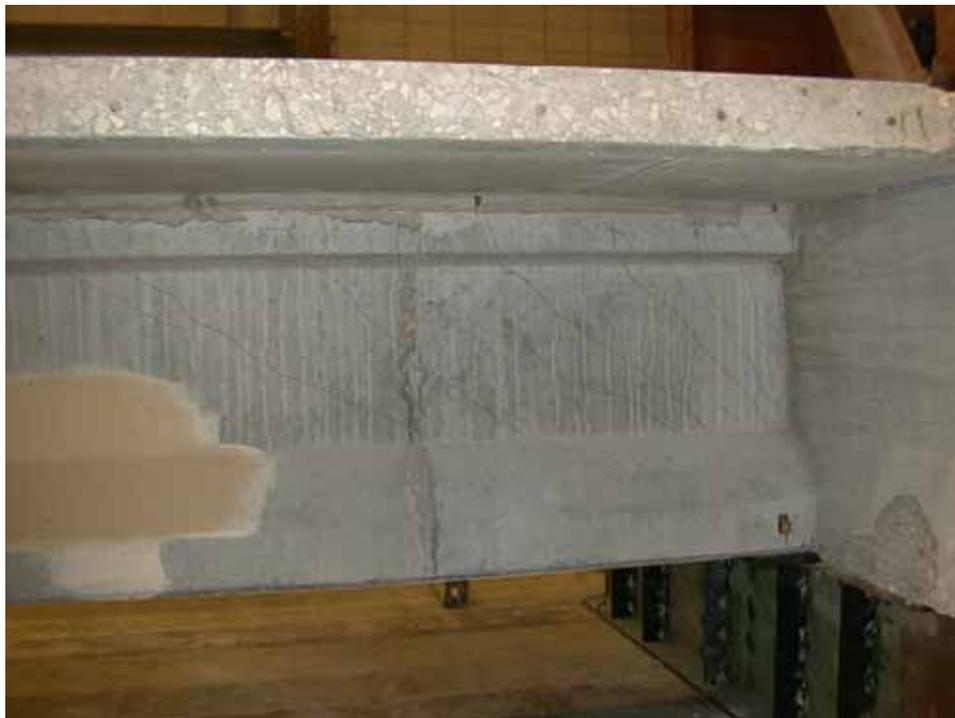
Figure 5.73. Web Shear Cracks in Beam 1 Adjacent to the Support.

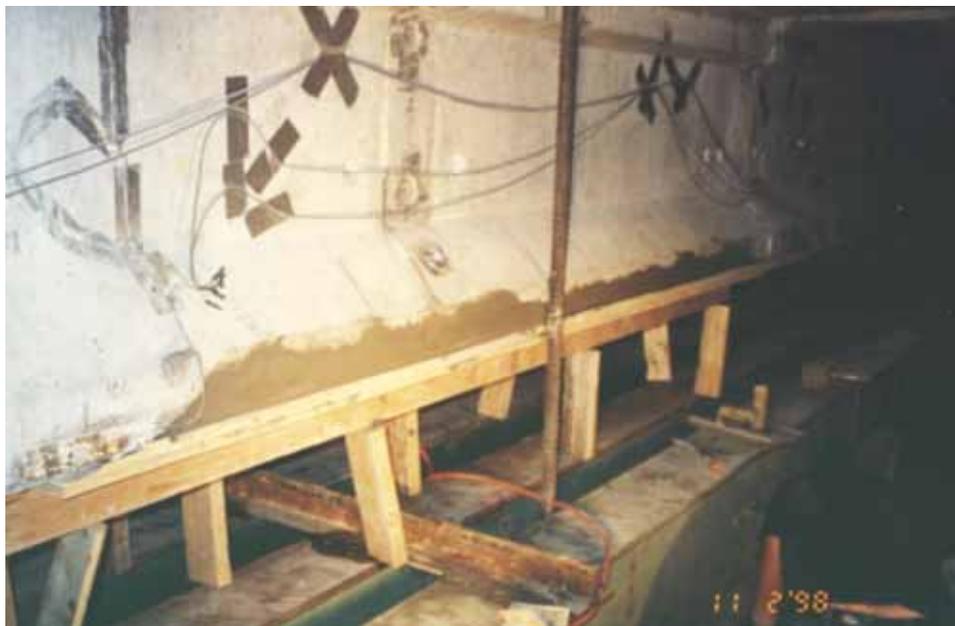
Figure 5.75. Completed Concrete Repair on Beam 2.

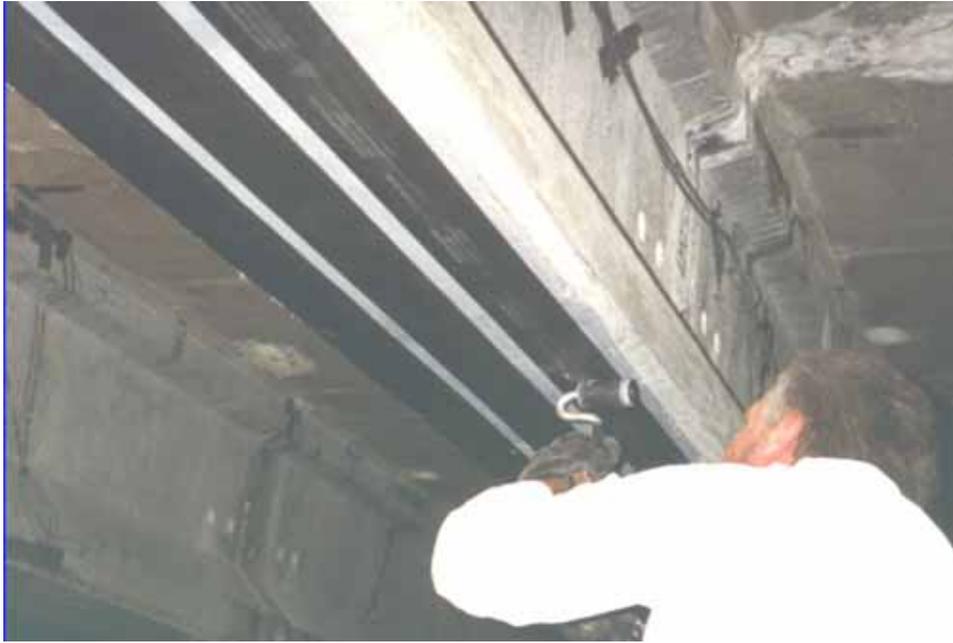
Figure 5.76. Installation of S1012 Reinforcing Plates on Beam 2 Bottom Flange.

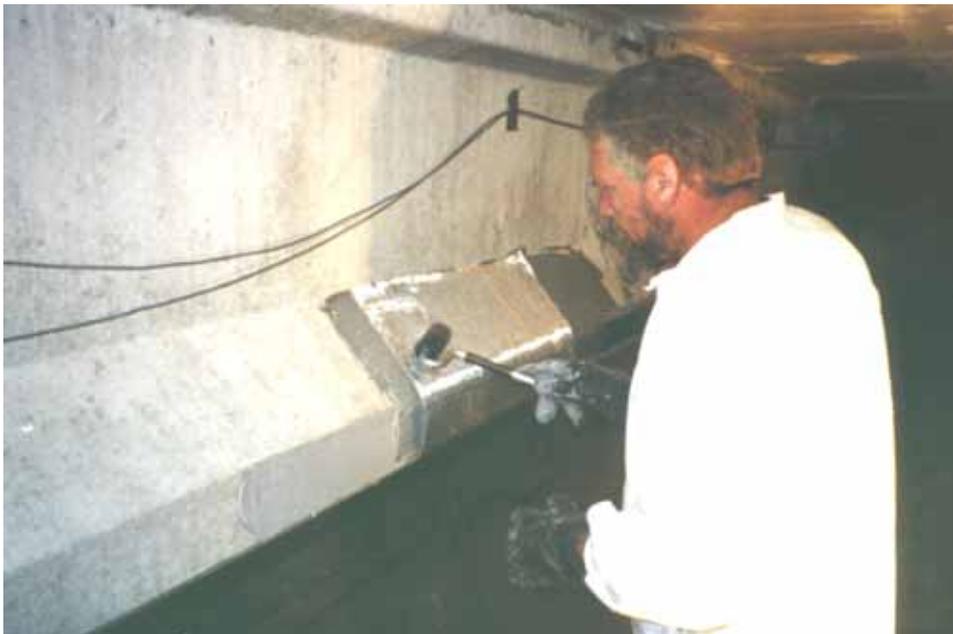
Figure 5.77. Installation of GFRP Wrap on Bottom and Sides of the Bottom Flange of Beam 2.
