DEMONSTRATION PROJECT NO. 72  
AUTOMATED PAVEMENT DATA  
COLLECTION EQUIPMENT  
Roughness and Profile Measurement

Iowa DOT Evaluation of the  
PASCO Road Survey System

K. Jeyapalan  
J. K. Cable, P.E.  
R. Welper  
Civil Engineering Department  
Iowa State University  
Ames, Iowa

March 1987

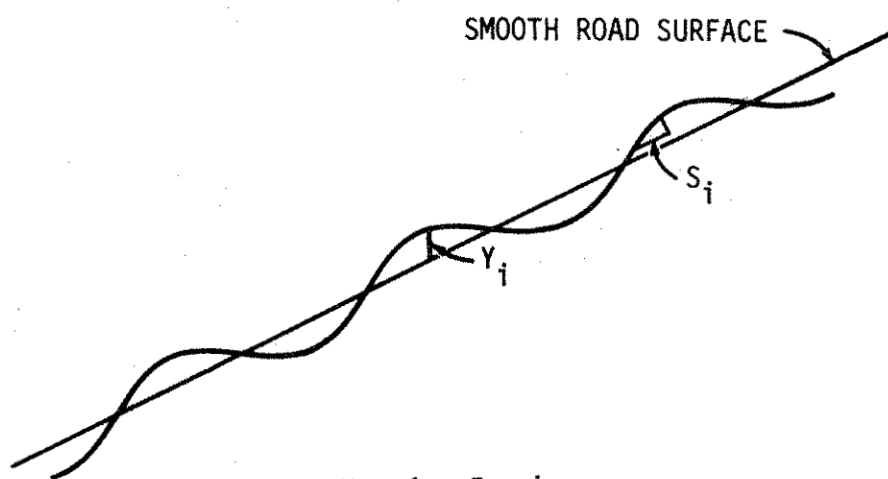
Fig. 1. Roughness.

$S_i$  = slope at a point  $i$  (see Fig. 1).

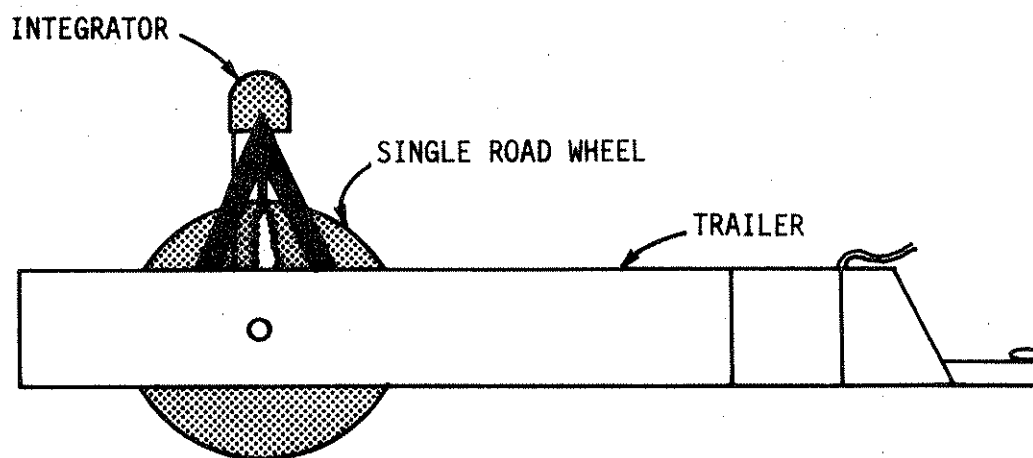
Fig. 2. BPR method.

The Iowa DOT uses the Bureau of Public Roads (BPR) roughometer to obtain the roughness in terms of inches of roughness per mile. The BPR consists of a single road wheel attached to an accumulating counter by a one-way clutch (see Fig. 2). As the wheel moves up and down while being towed, all movements in one direction are summed. Another counter records the number of revolutions of the tire so that distance traveled can be calculated (see the Appendix A).

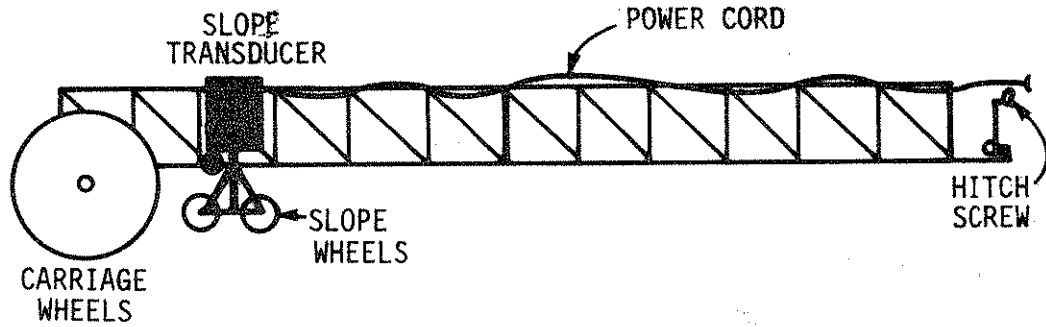
Fig. 3. CHLOE profilometer.

The BPR readings are calibrated against a standard roughometer, CHLOE, to give the LPVs. The CHLOE consists of two units: a trailer unit, which carries the transducing mechanism, and the electronic computer, which gets the information from the transducer, does the necessary computation, and displays the results. Figure 3 shows the CHLOE, Fig. 4 shows the transducer, and Fig. 5 shows the computer. The slope transducer is equipped with two eight-inch road wheels attached to the pivot arm. The transducer provides a continual measure of the angle between the bar connecting the slope wheels and the arbitrary reference of the trailer unit. The values obtained by the CHLOE are not affected by possible change in the towing vehicle's suspension. Because the CHLOE is very sensitive, slopes are obtained at five mph, which is time consuming. With the slope value,  $S$ , the slope variance  $SV$  (which is the variance of the slope) is computed from

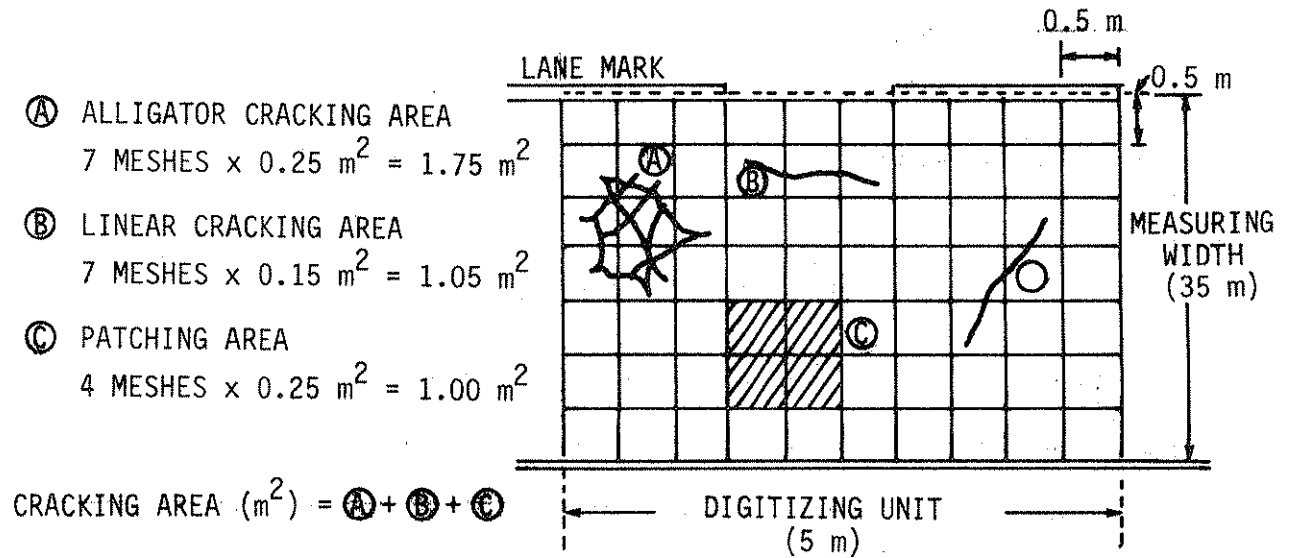
Fig. 6. Crack-digitizing method.

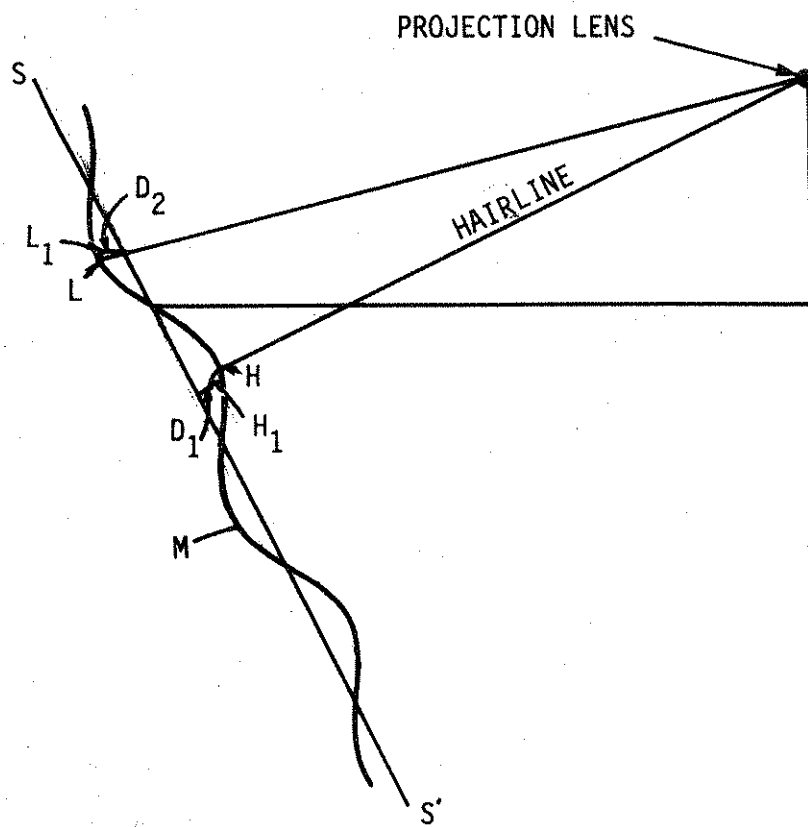
Fig. 7. Cross section of rutting wave pattern.

Figure 7 shows the projection of a hairline on the cross section of a road. If there is no rutting wave pattern, the hairline will be projected as a straight line SS'. However, if there is a rutting pattern LHM present, then the hairline at the high point H will be projected as  $H_1$  and at the low point L will be projected as  $L_1$ . The distance  $D_1$  of  $H_1$  from SS' is proportional to the height of rutting  $HH_1$  and distance  $D_2$  of  $L_1$  from SS' is proportional to the depth of the rutting. Now if the projected line is photographed by a vertical camera (see Fig. 8) directly above the line SS', then the hairline at H will be imaged at h and the hairline at L will be imaged at l. If p is the principal point of the camera, then  $ph = d_1$  and  $pl = d_2$  can be measured accurately using a comparator (photogrametric instrument used to measure x-y coordinates on a photograph to an accuracy of one micron). Then, the distance

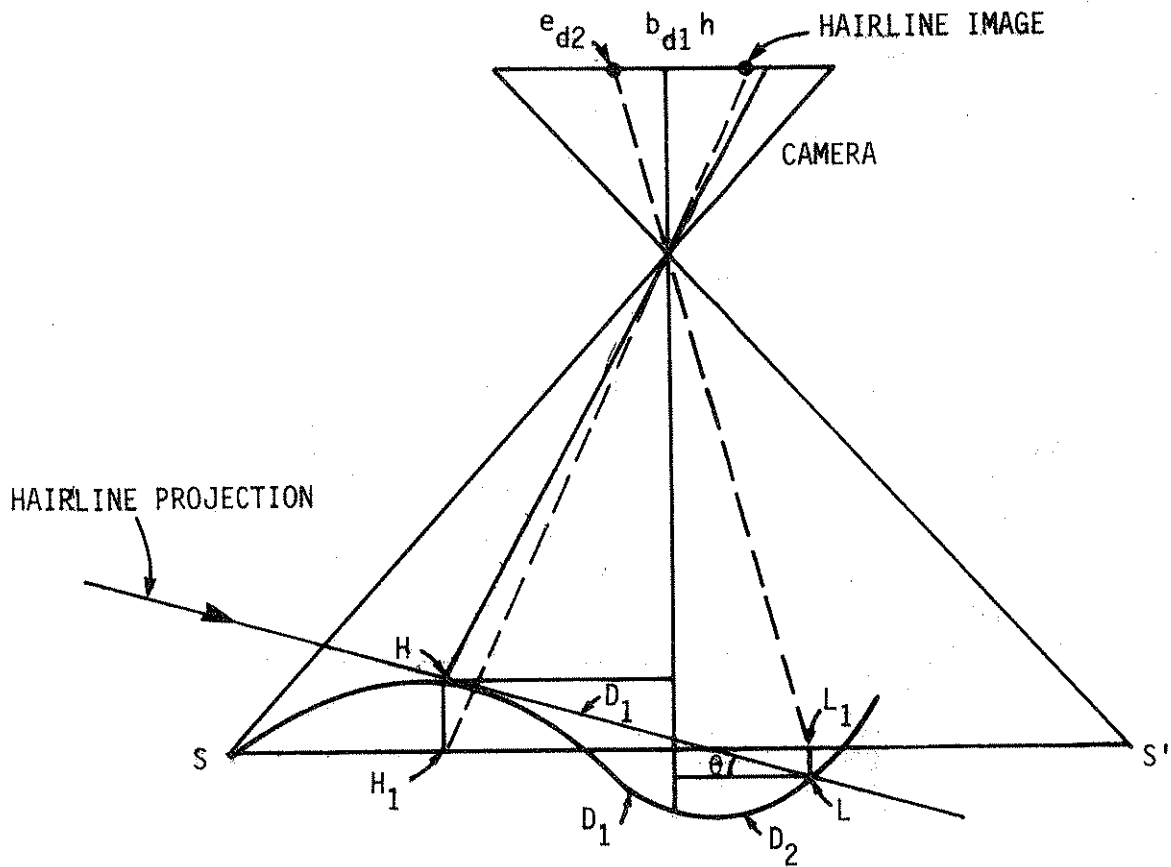
Fig. 8. ROADRECON-75.

In the ROADRECON-75 system the strobe light is mounted on the bumper of the survey vehicle and projects the hairline at an angle  $\theta = 26^\circ 33 \text{ min.}$ , such that  $\tan \theta = 1/2$ . The camera, mounted on a boom on top of the vehicle, photographs the lane in which the vehicle is driving (see Fig. 9). The camera is aimed straight down so any rutting is represented by a wave pattern in the hairline. The focal length of the camera,  $f = 0.6 \text{ in. (15 mm)}$ , and the height of the camera above the ground,  $H = 120 \text{ in. (3000 mm)}$ , result in a scale for the photograph of  $S = 200$ . Thus, the total rut depth =  $200(d_1 + d_2)/2$ , and if  $d_1$  and  $d_2$  are measured to an accuracy of  $\pm 0.0002 \text{ in. } (\pm 0.005 \text{ mm})$  by a comparator (or to an accuracy  $\pm 0.008 \text{ in. } (\pm 0.02 \text{ mm})$  on a digitizing tablet and

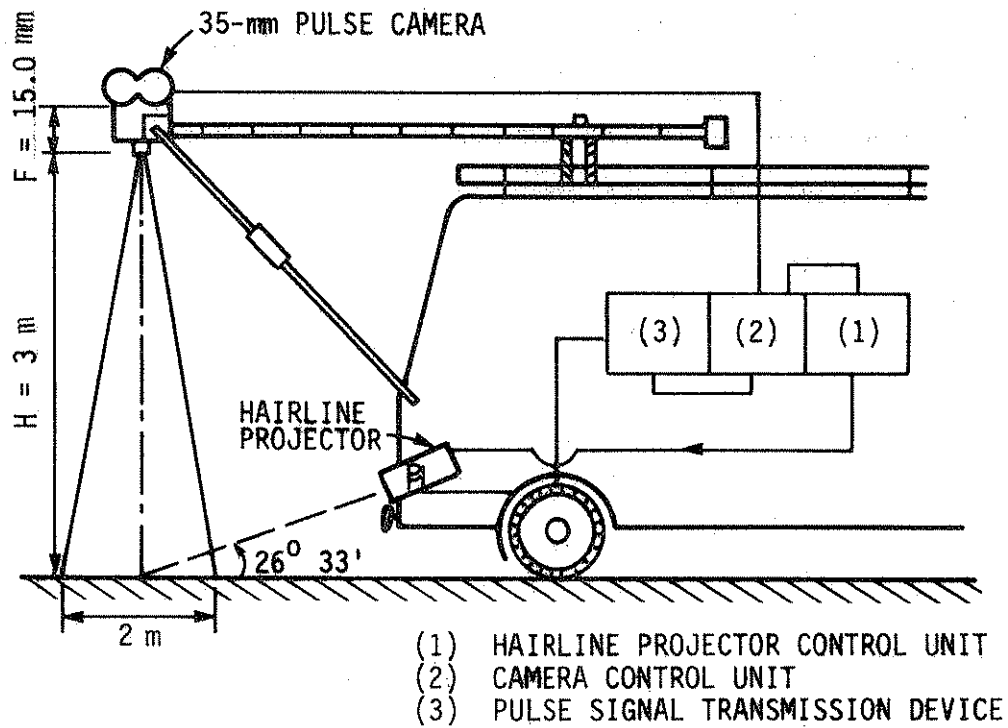
Fig. 9. ROADRECON-75 for rutting survey.

ten times enlargement imagery), the rut depth RD can be determined to an accuracy of  $\pm 0.04$  in. ( $\pm 1$  mm).

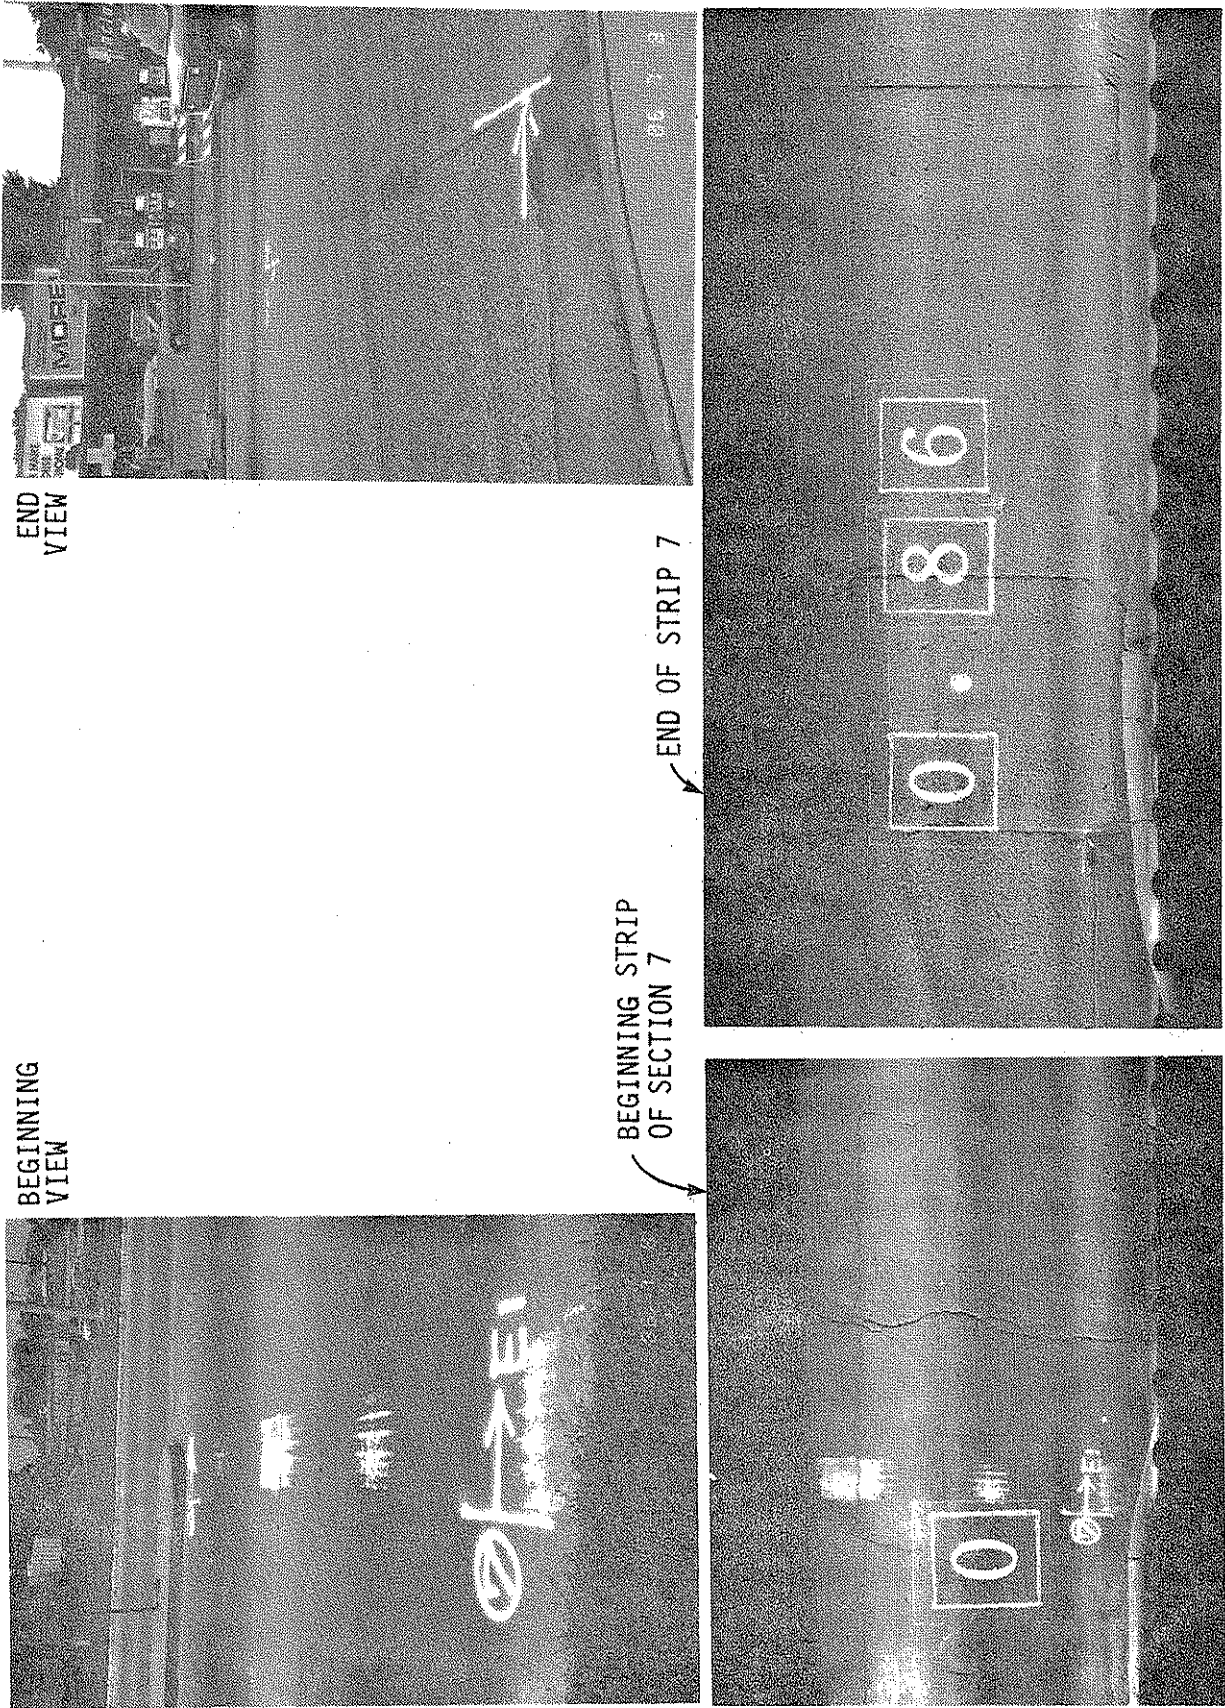
Fig. 12. Continuous strip photograph.

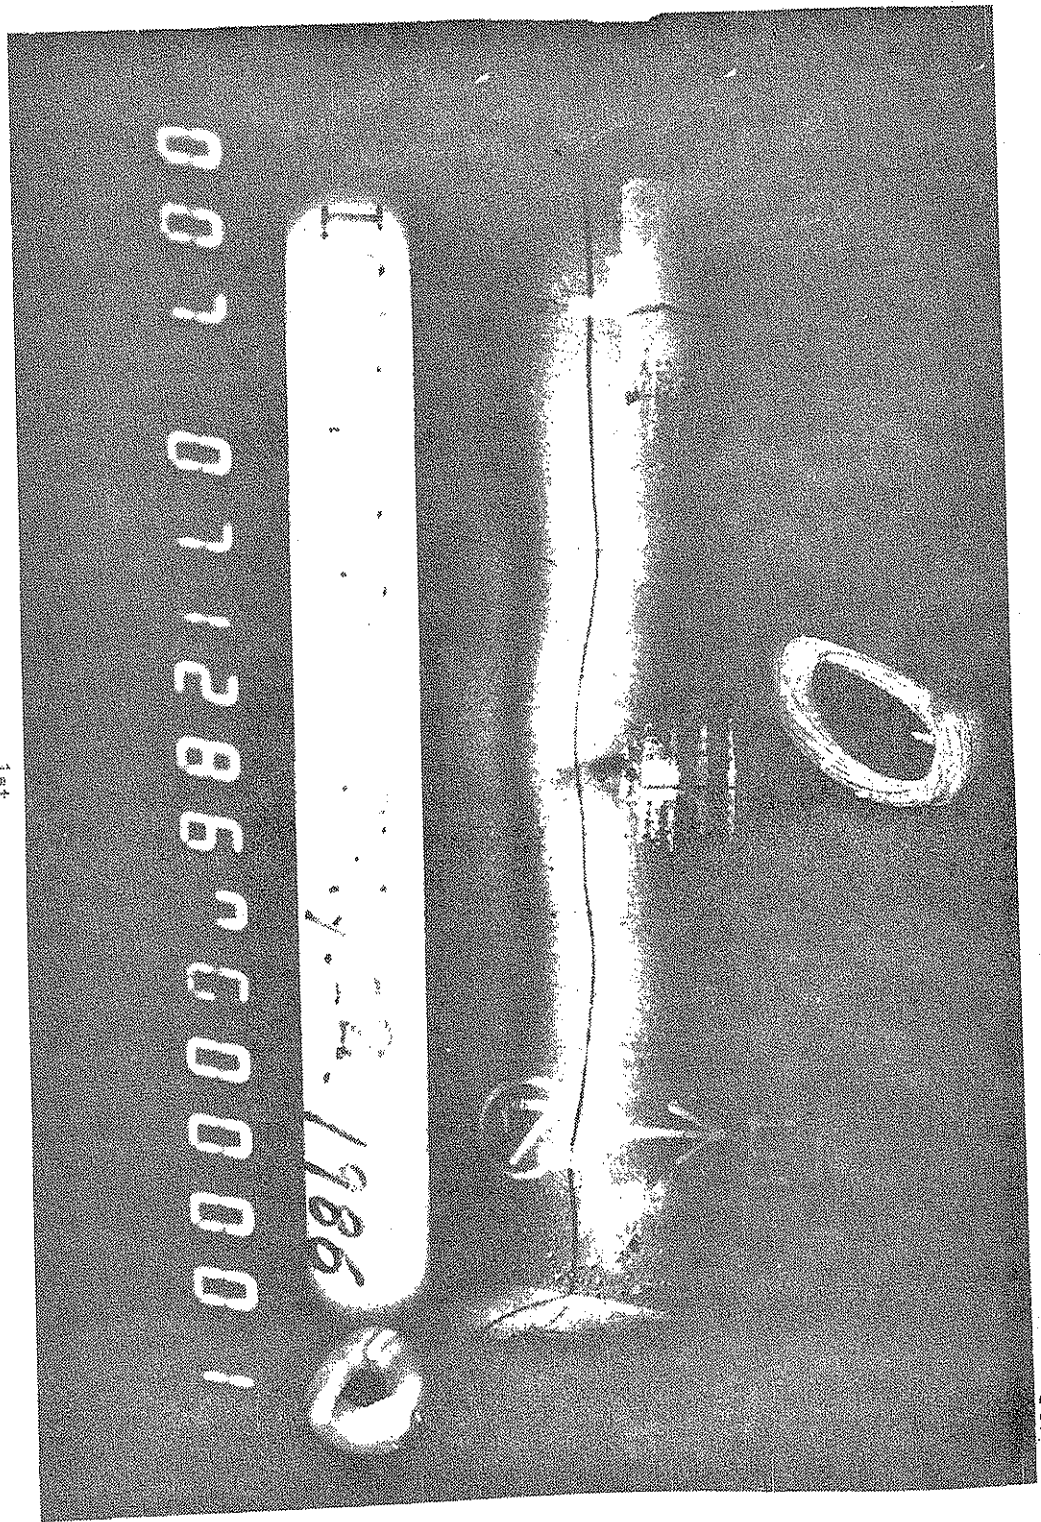
Fig. 13. Pulse photograph.

It takes two persons about 30 minutes to set up ROADRECON-75 (the pulse camera). The slit camera is replaced with the pulse camera, the hairline projector is mounted, and the camera boom is extended, adjusted, and secured. The first pulse photo is taken manually to include pavement markings at the beginnings of the sections. The rest of the photos are taken automatically at given intervals of pavement travel. Two or three photographs are taken at the end of each section. The film is then sent for developing, printing, and plotting of the cross profile. Figure 13 shows a typical pulse camera photograph and Fig. 14 shows a typical cross profile of the pavement from which rut measurements are made.

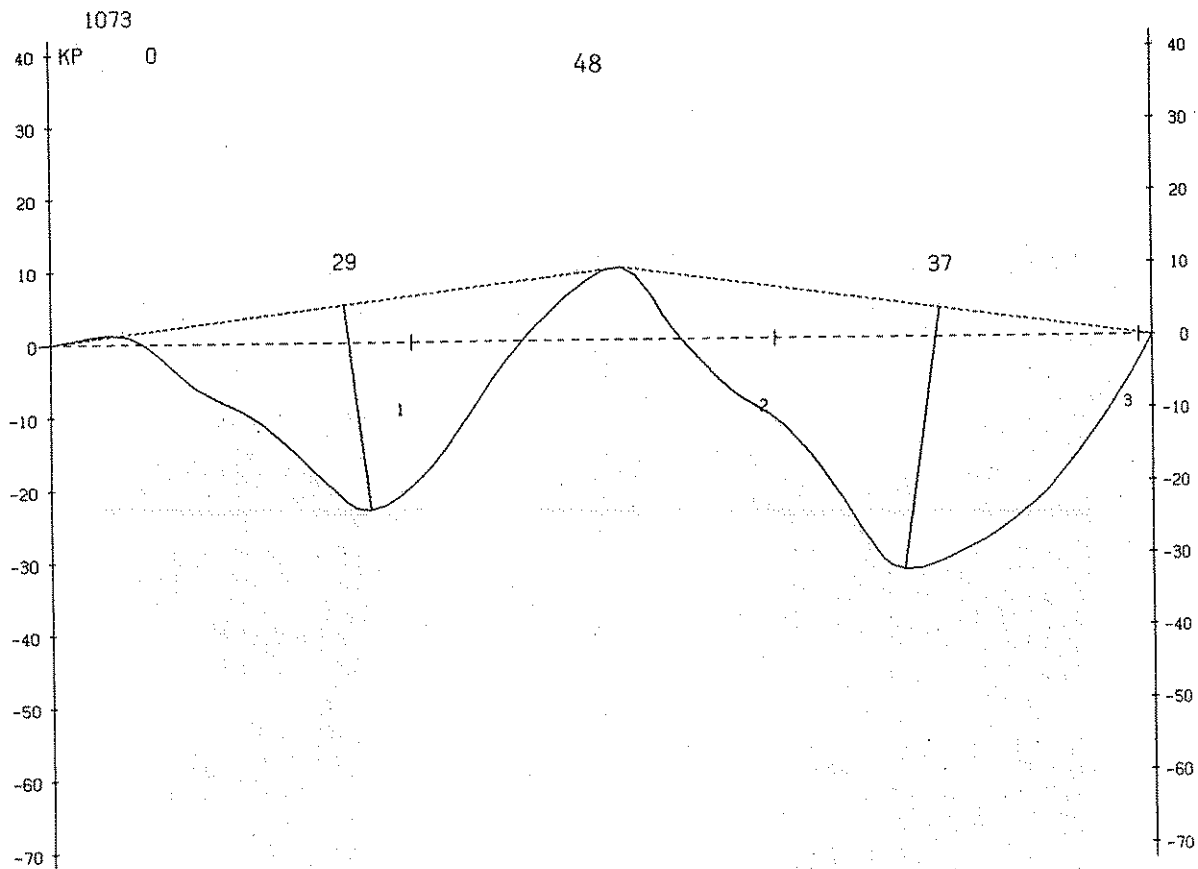
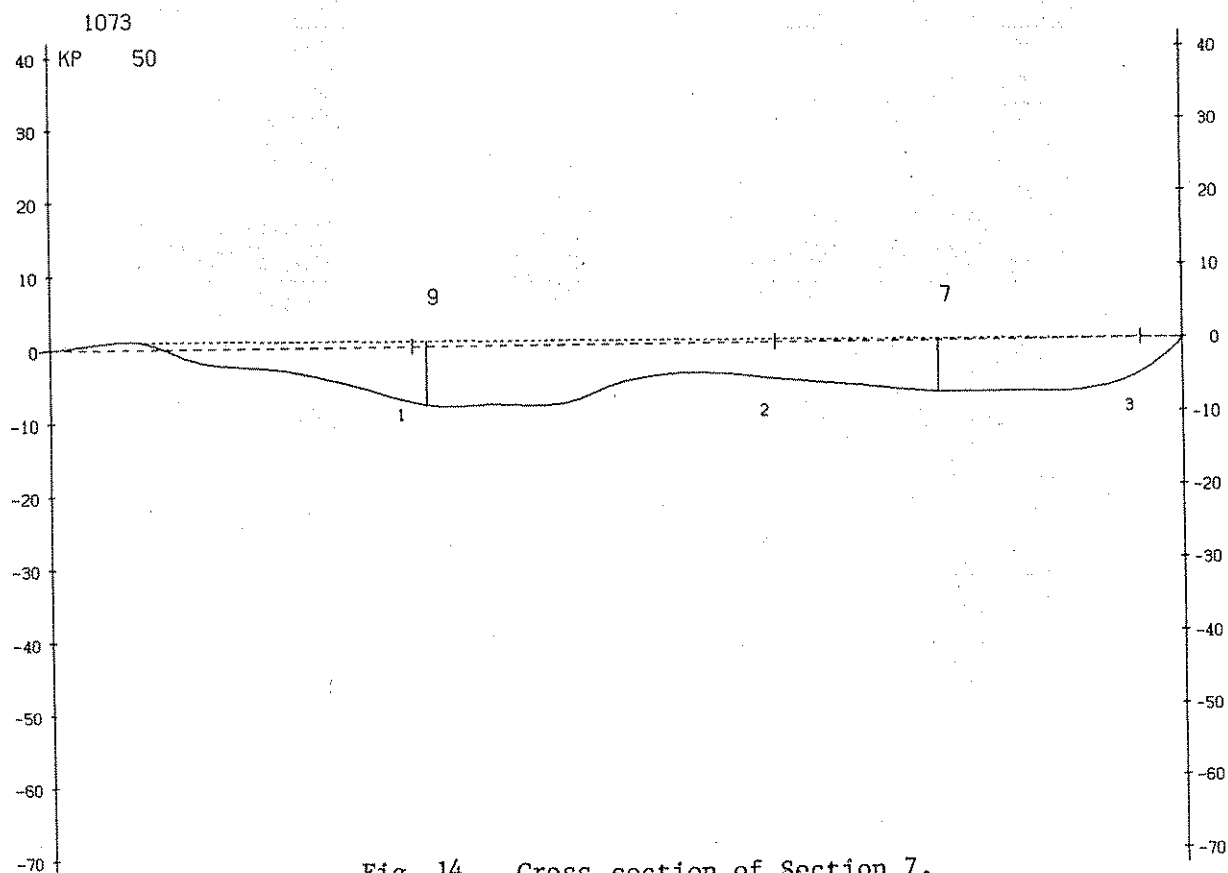
Fig. 14. Cross section of Section 7.

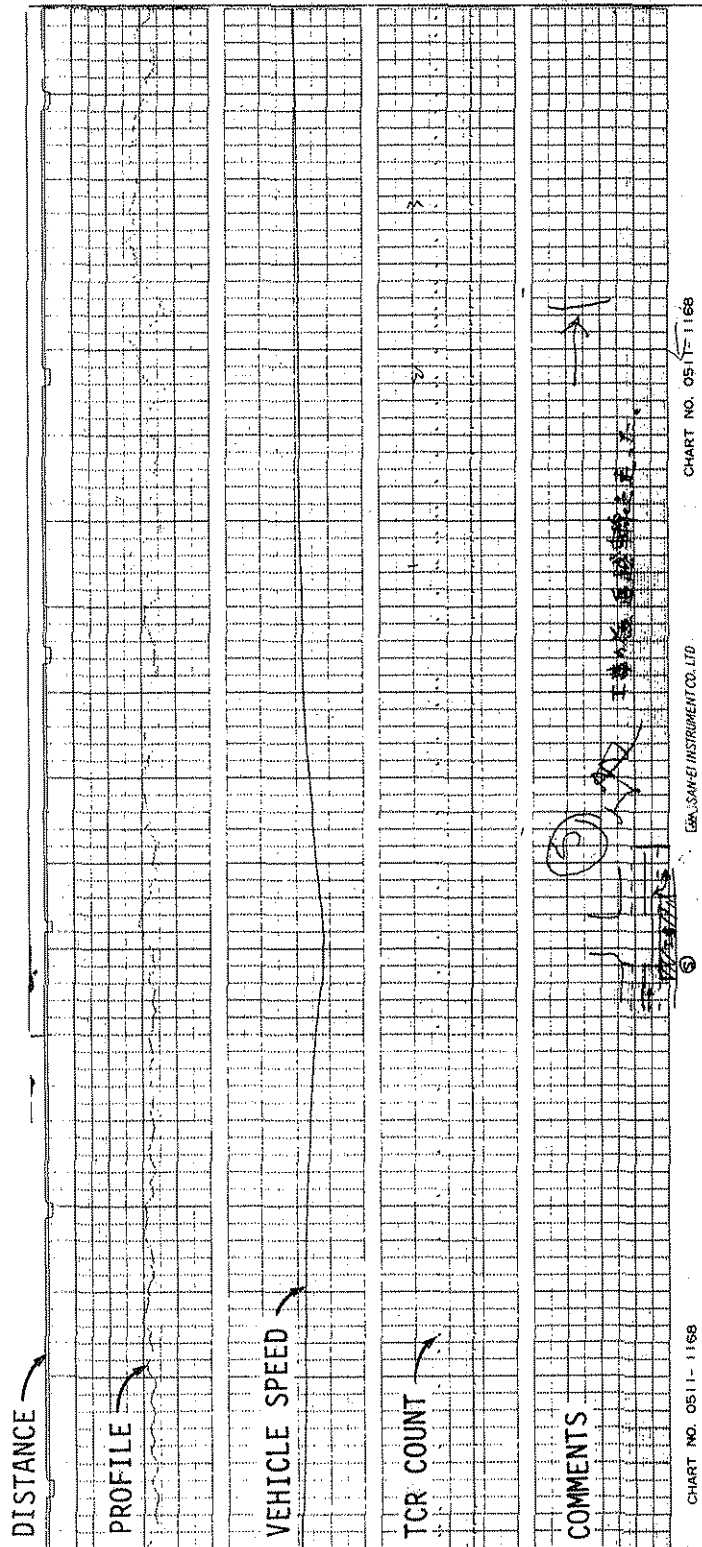
Fig. 15. Paper chart (longitudinal profile) by tracking wheel.

the paper chart is made manually at the beginning and end of the section. The cassette and the paper chart are sent for computations of the roughness. Figure 15 shows the paper chart of a typical run. The strip chart is broken into four separate tracing areas longitudinally. The upper trace is used to identify the distance traveled along the top of the trace area with 0.08 in. (2 cm) along the paper being equal to 8.9 ft (2 m) of travel. The second line of data within the same trace is the longitudinal profile of the section surveyed. The vertical scale on the graph is 2.0 in. of roughness per 0.4 in. (10 mm). The second trace area contains a plot of the speed of the survey vehicle. Its scale is 6.25 mph (10 km/h) for each 0.4 in. (10 mm) on the vertical scale. The third trace contains vertical tick marks near the center that represent the TCR count with each one equal to 0.4 in. (1 cm) of additional roughness. The additional information shown in this section was not used in this test and pertains only to the manufacturer's needs. The final trace area is used to make notes relative to particular problems noted in the survey such as the location of intersections or other special features along the route.

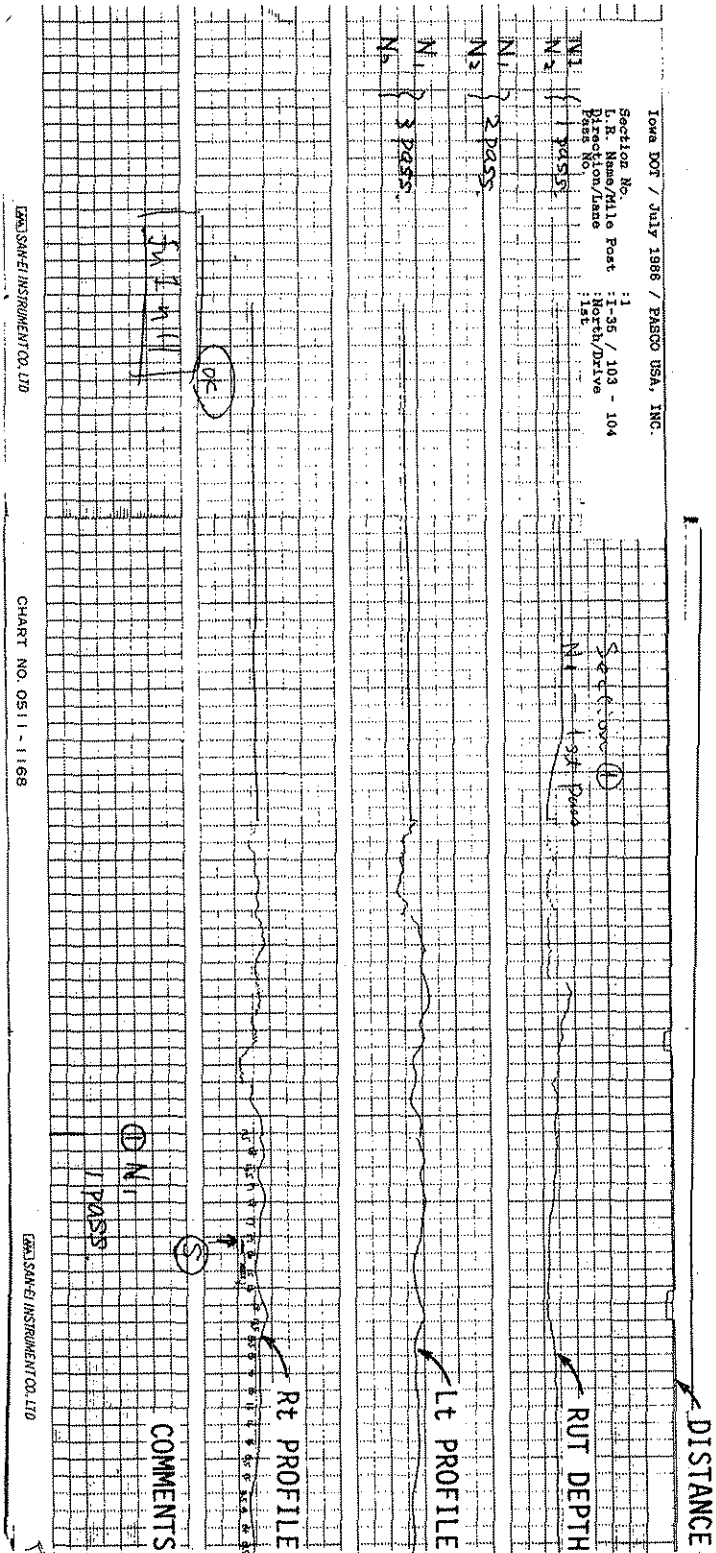
Fig. 16. Longitudinal profile by laser.

For ROADRECON-85B the mounting of the lasers takes about 10 to 15 min. Checking of proper connections and paper feeds takes another 5 min. Model 85 utilizes premounted laser units that require no setup time, but this model was unavailable for the test evaluation. The system is started well before the operation, and marks are made on the paper chart manually at the beginning and end of each section. The charts and the cassette tape are sent for computations of the roughness. Figure 16 shows the paper chart of a portion of a section. This chart is laid

out in a manner similar to that used in the ROADRECON-77 example. Distance is measured in the same manner along the top of the chart. The second line of data on the top trace is the rut depth in this instance and utilizes a scale of 2.0 in. for each 0.4 in. (10 mm) of graph vertically. The second trace area uses the same vertical scale to describe the profile at the left edge of the test vehicle, and a similar condition exists in the third trace to identify the right edge of the test vehicle laser trace of roughness. The fourth trace area is again used for notes on the route features.

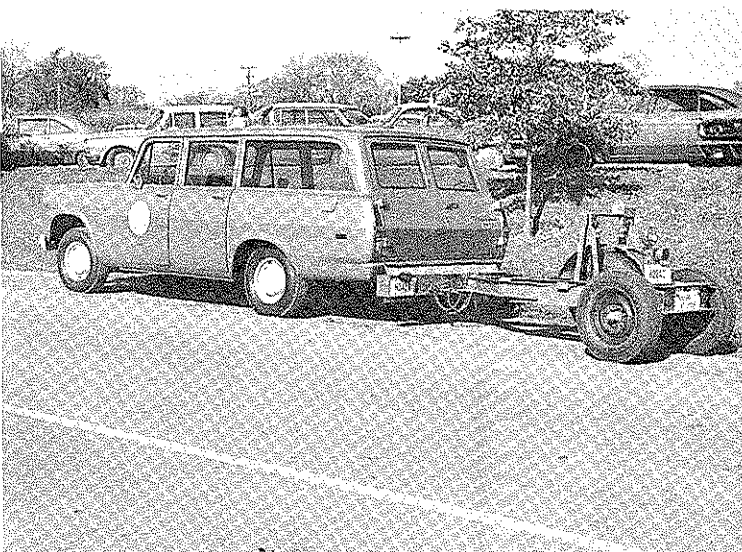
Fig. 1  
Roughometer in Towing Position

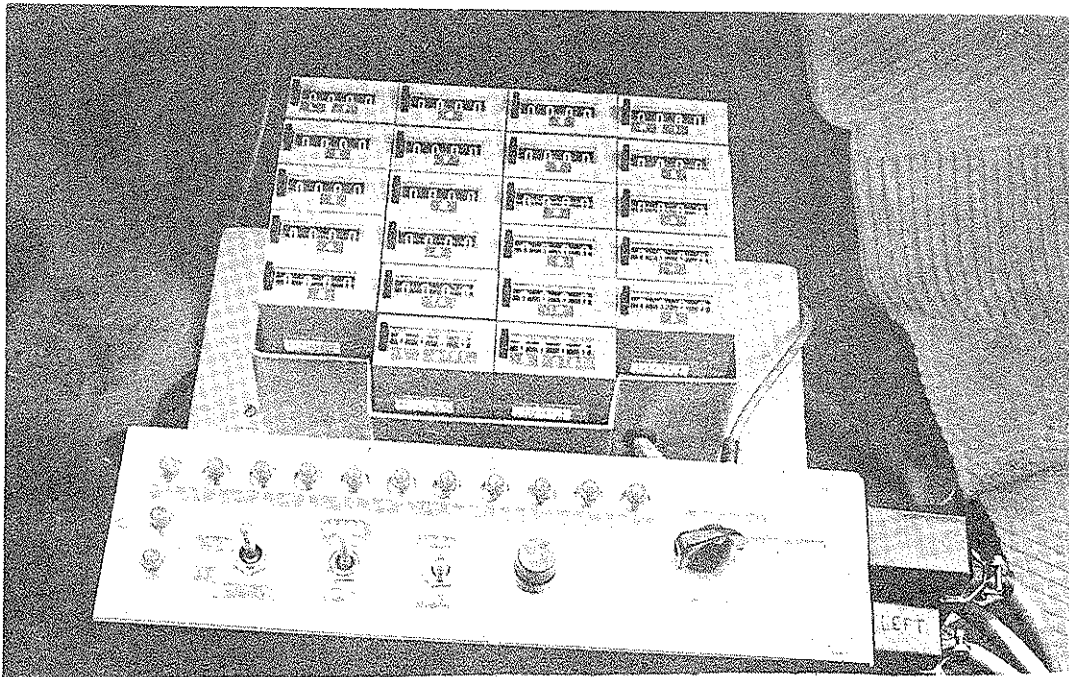
Fig. 2

The IJK Ride Indicator Control Console, showing Visual Indicators, Switches and Electrical Counters on the floor of the automobile.

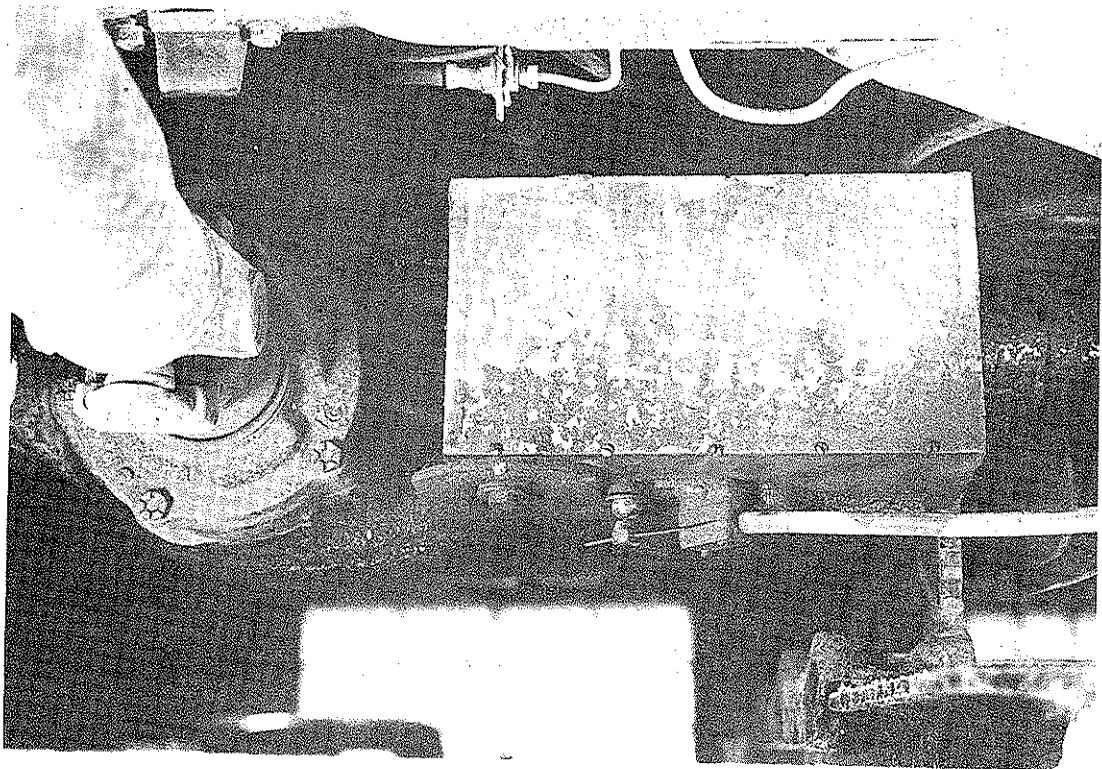
Fig. 4

The IJK Ride Indicator Sensing Unit with Cover as  
Mounted on the Rear Differential Housing of the  
Vehicle

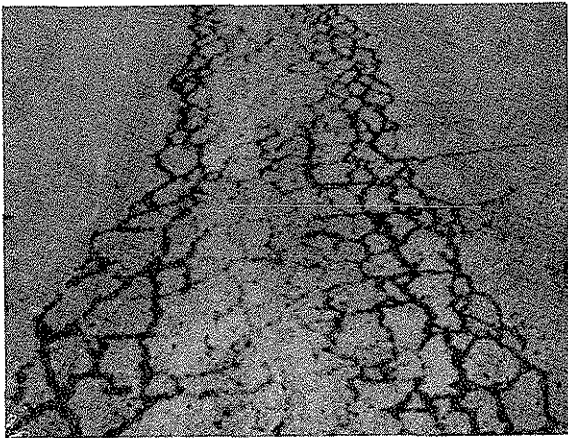
Figure 1.

Alligator cracking

Cracking, C, is defined as the square feet per 1000 square feet of pavement surface exhibiting alligator or fatigue cracking. This type of cracking is defined as load related cracking which has progressed to the state where cracks have connected together to form a grid like pattern resembling chicken wire or the skin of an alligator. This type of distress can

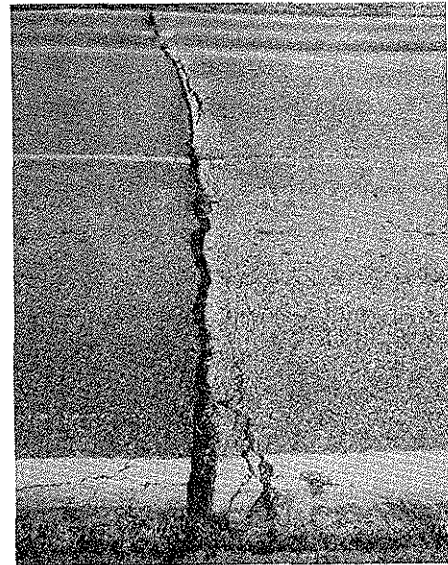
Figure 3.

Transverse Cracks and Faulting

Cracking, T, is defined as the number of transverse (right angles to traffic direction) cracks that are open to a width of 1/4" over half their length or have been sealed. Random or diagonal cracks are ignored.

Faulting, F, is defined as the mean vertical displacement, in inches, measured with a 4-ft. straightedge.

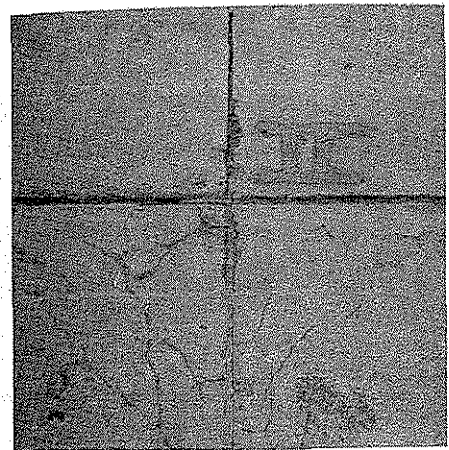
Figure 4.

D-cracking - Initial stages

D-cracking, D, refers to a characteristic pattern than can develop in portland cement concrete. Initially, the occurrence of D-cracking may be preceded and accompanied by staining of the pavement surface near joints and cracks. However, not all stained joints and cracks develop D-cracking. D-cracked concrete will first exhibit fine parallel cracks adjacent to the transverse and longitudinal joints at the interior corners. The D-cracks will bend around the corner in a concave or hourglass pattern. As the D-cracking progresses, the entire length of the transverse, longitudinal and random cracks will be affected. The cracked pieces may become loose and dislodged under the action of traffic. The occurrence of D-cracking in the check sections will be rated on a point scale as described in the Test Procedure section.

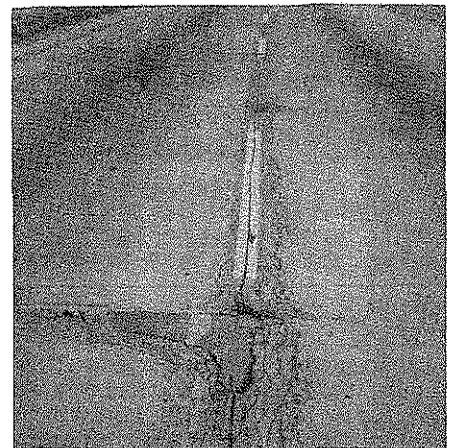
Figure 5.

D-cracking - All joints affected

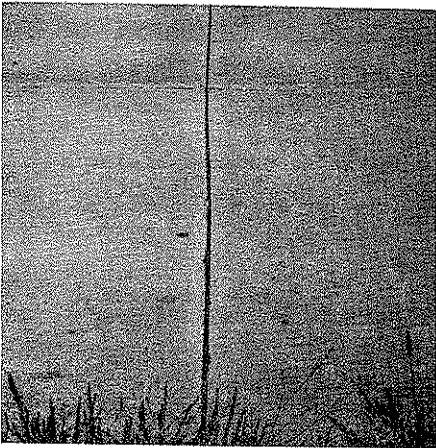
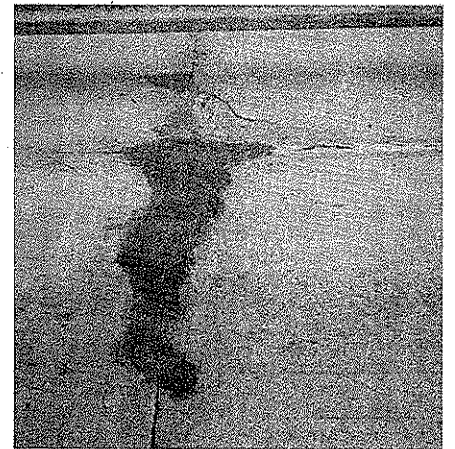
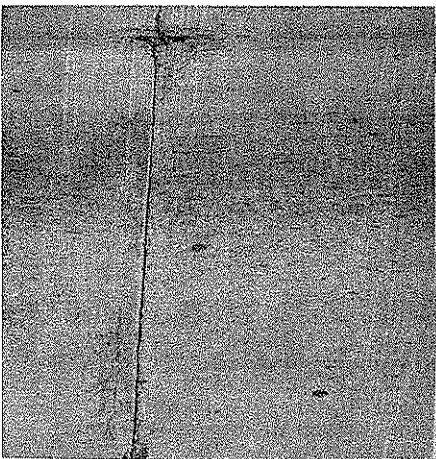
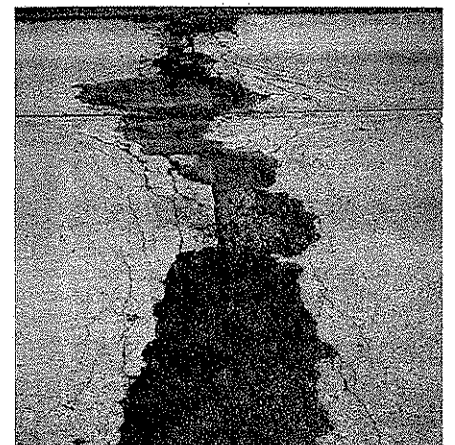
Figure 6. Examples of D-crack Occurrence Factors

- 4 = D-cracking very evident as in 3 above. Spalling and removal by traffic has progressed to point that regular maintenance patching is required. Effect on riding quality of pavement is now noticeable.

- 5 = D-cracking has continued to progress at sites identified in 3 above and requires regular maintenance patching. Full depth patches may be necessary. Ride quality has deteriorated to point where reduced driving speed is necessary for comfort and safety.

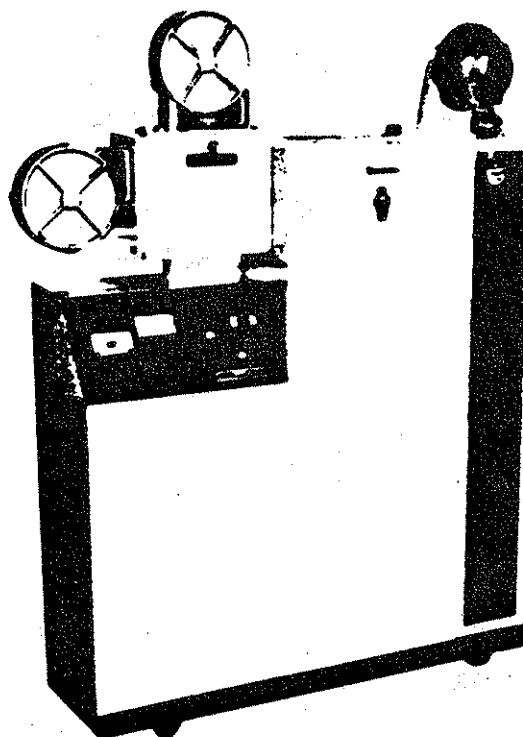
Processing speed:	0 - 30 feet/min.
Developing temperature:	15° - 40°C
Fixing temperature:	fixed at 28°C
Drying temperature:	40° - 70°C
Water consumption:	4 liters/min. (at 4° - 30°C)
Film magazine:	1,000 feet

Fig. B.4. Automatic film processor.

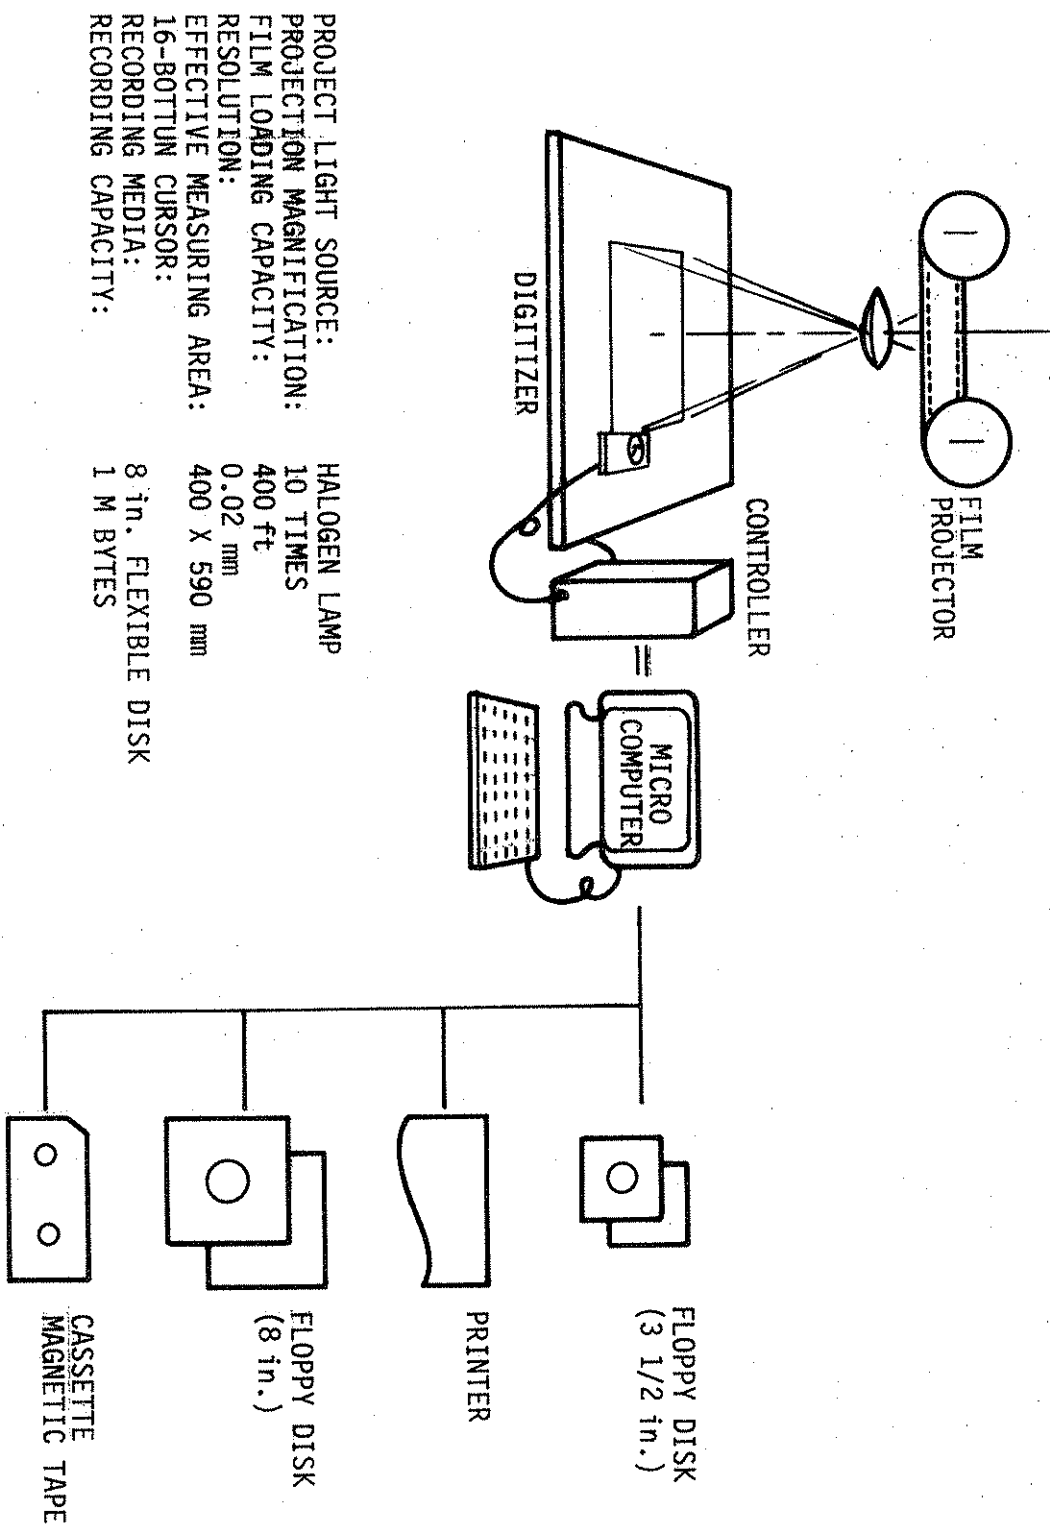
Fig. B.5. ROADRECON film digitizer.

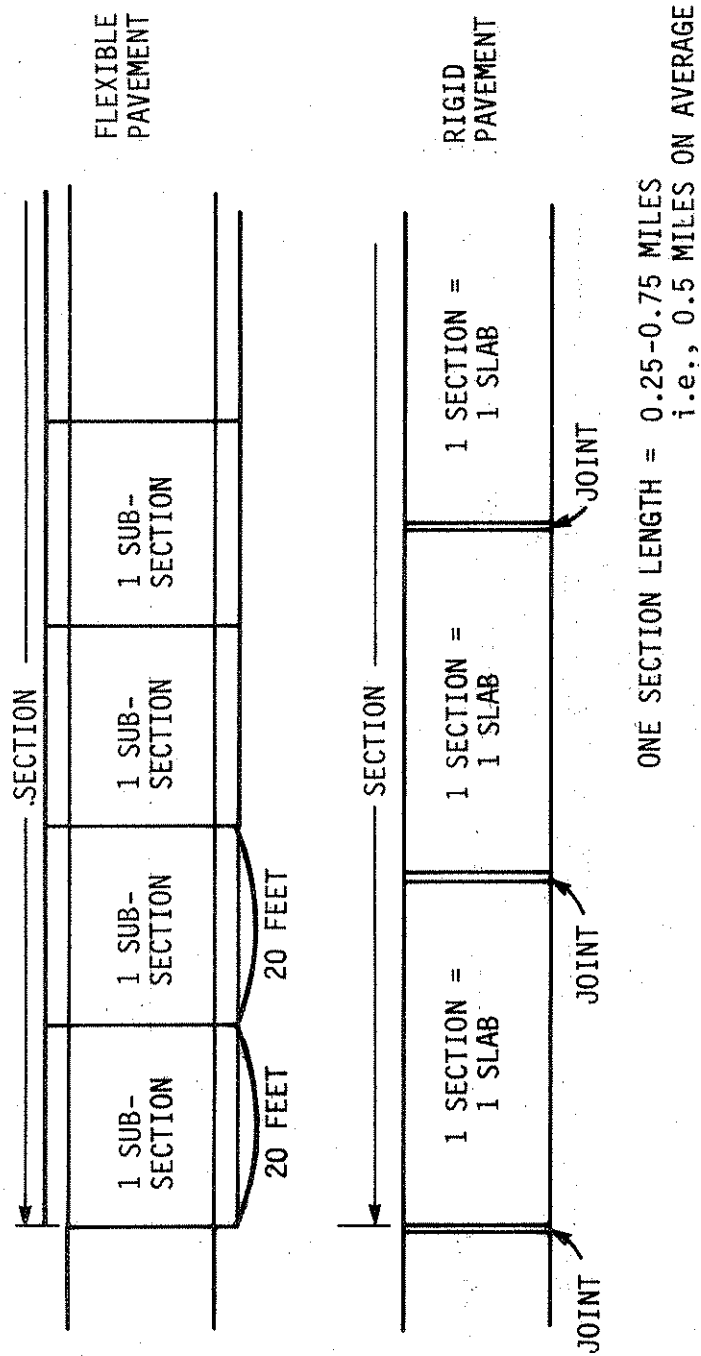
Fig. B.6. Definition of subsection.

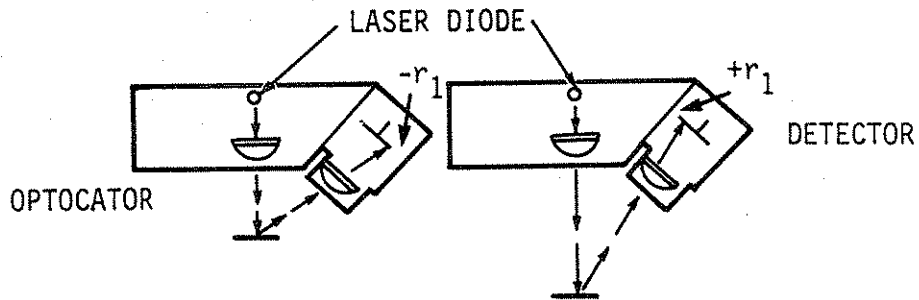
Fig. B.10. Laser reflection.

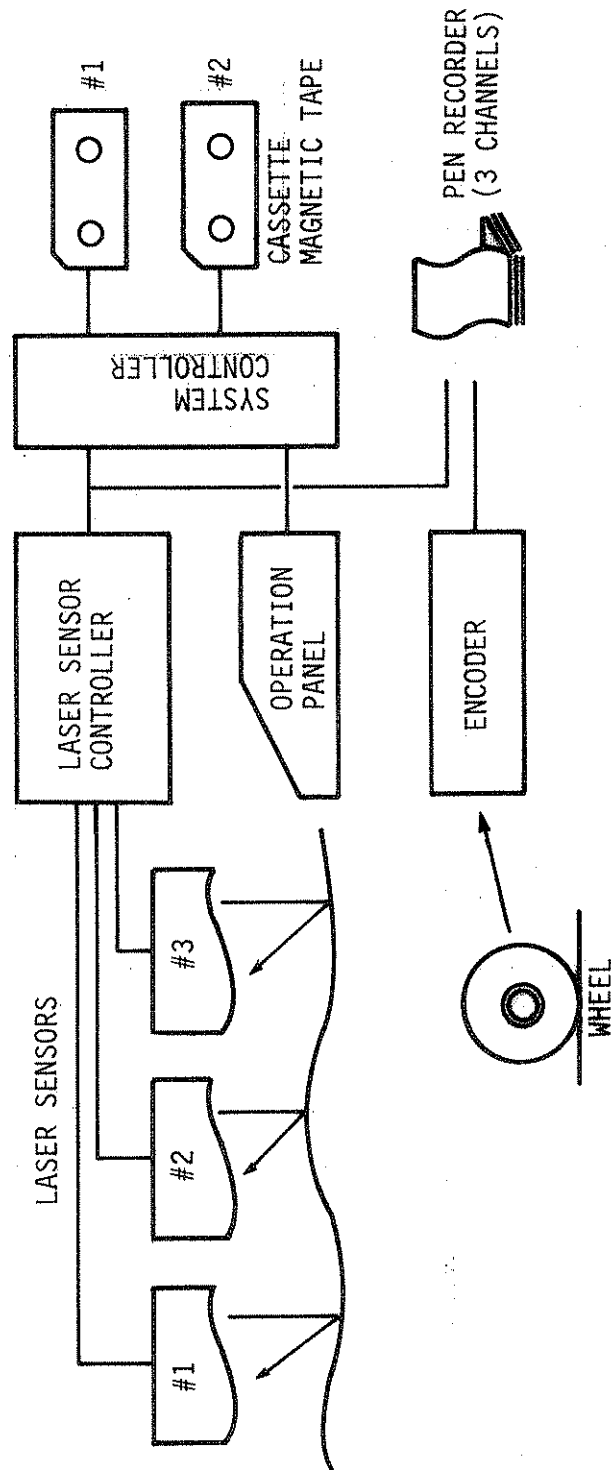
Fig. B. 11. Diagram of laser system composition. (ROADRECON-85B).
