DEMONSTRATION PROJECT NO. 72  
AUTOMATED PAVEMENT DATA  
COLLECTION EQUIPMENT  
Roughness and Profile Measurement

Iowa DOT Evaluation of the  
PASCO Road Survey System

K. Jeyapalan  
J. K. Cable, P.E.  
R. Welper  
Civil Engineering Department  
Iowa State University  
Ames, Iowa

March 1987

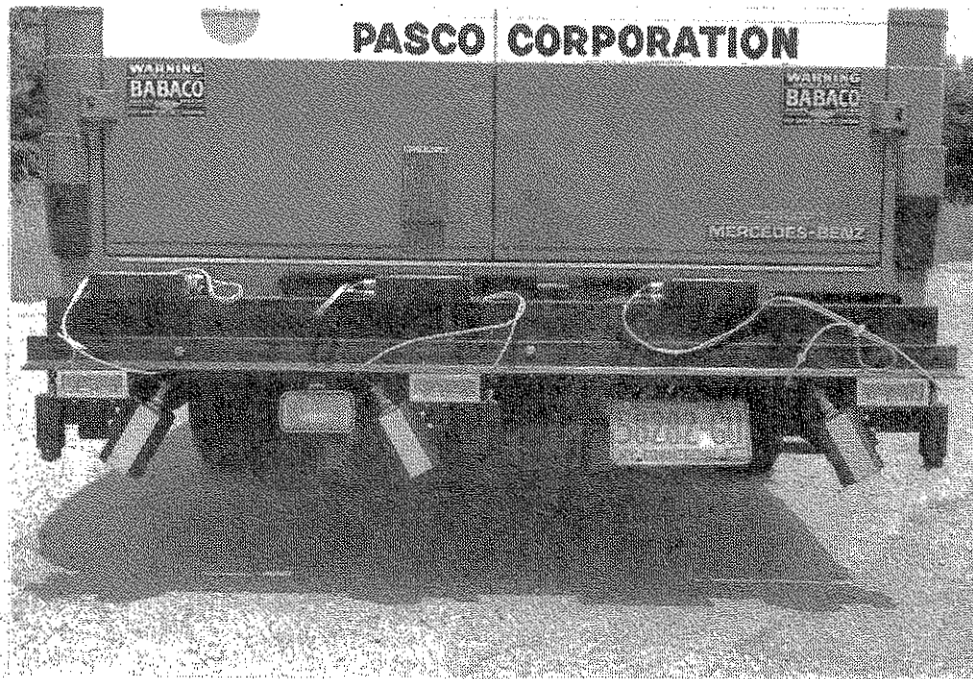
Fig. B.14. Laser mounting on PASCO vehicle.

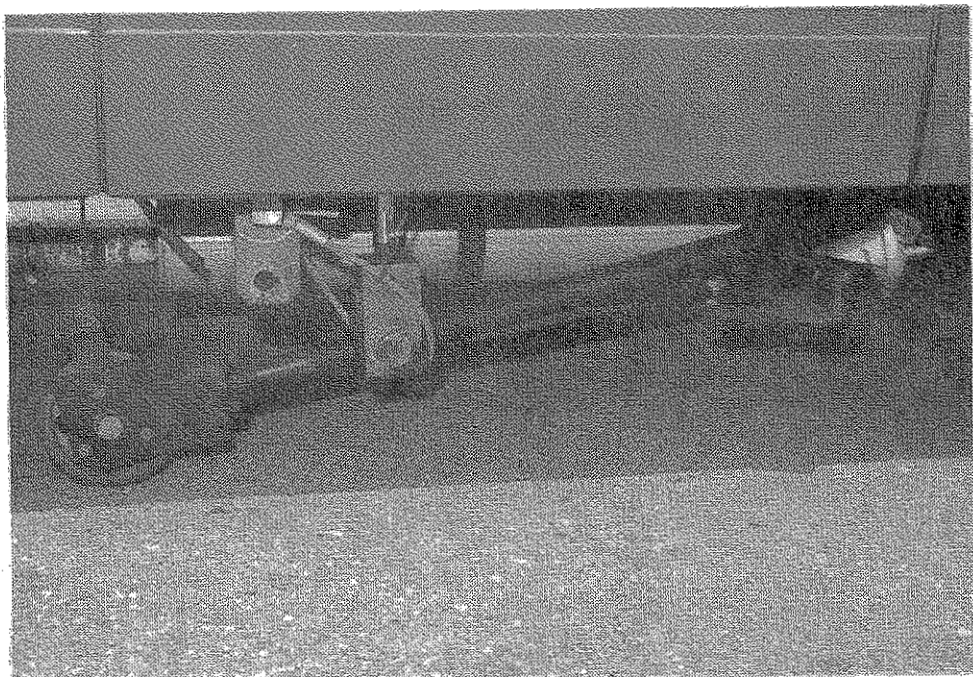
Fig. B.15. Tracking wheel mounting on PASCO vehicle.

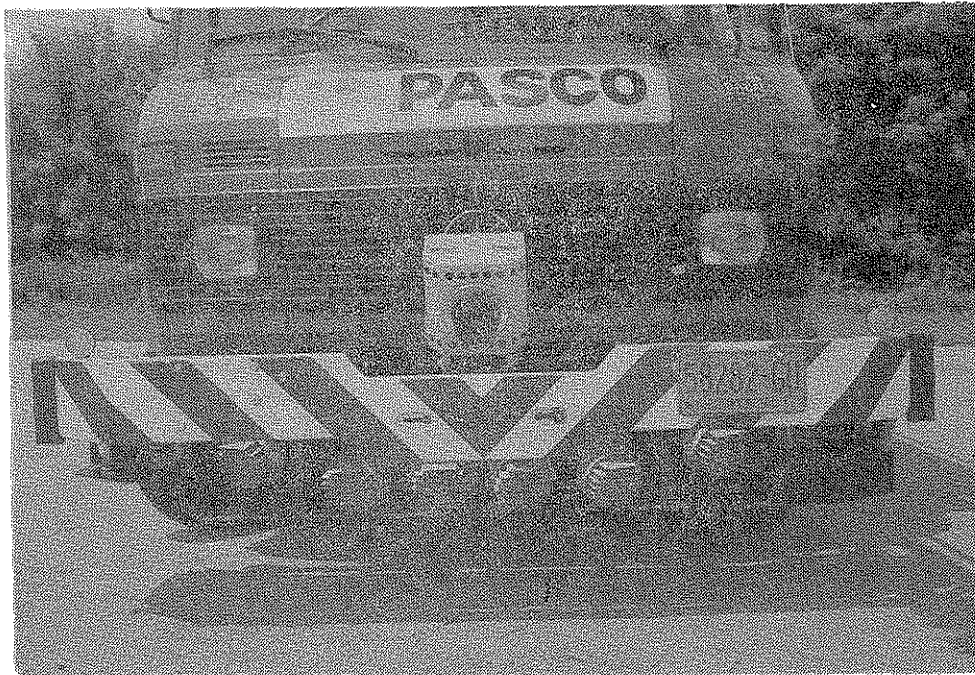
Fig. B.17. Hairline projection mounting on PASCO vehicle.

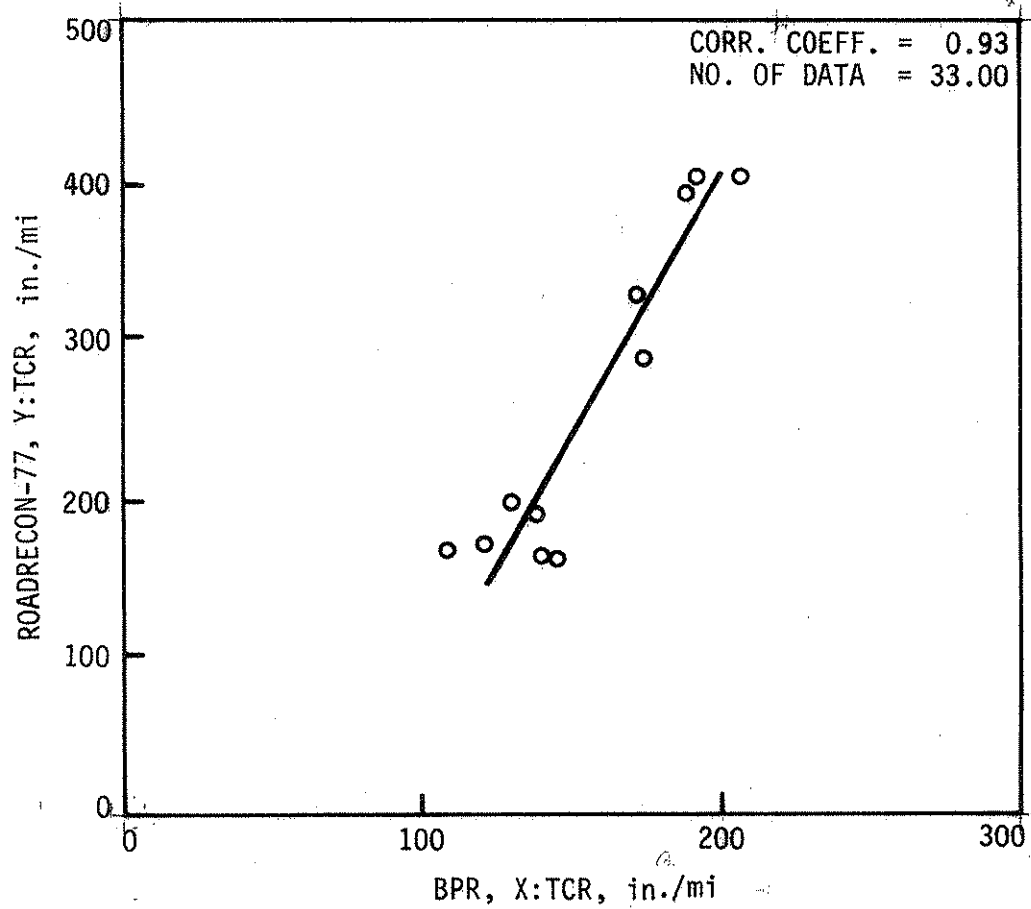
Fig. C.1. BPR vs ROADRECON-77 (TCR).

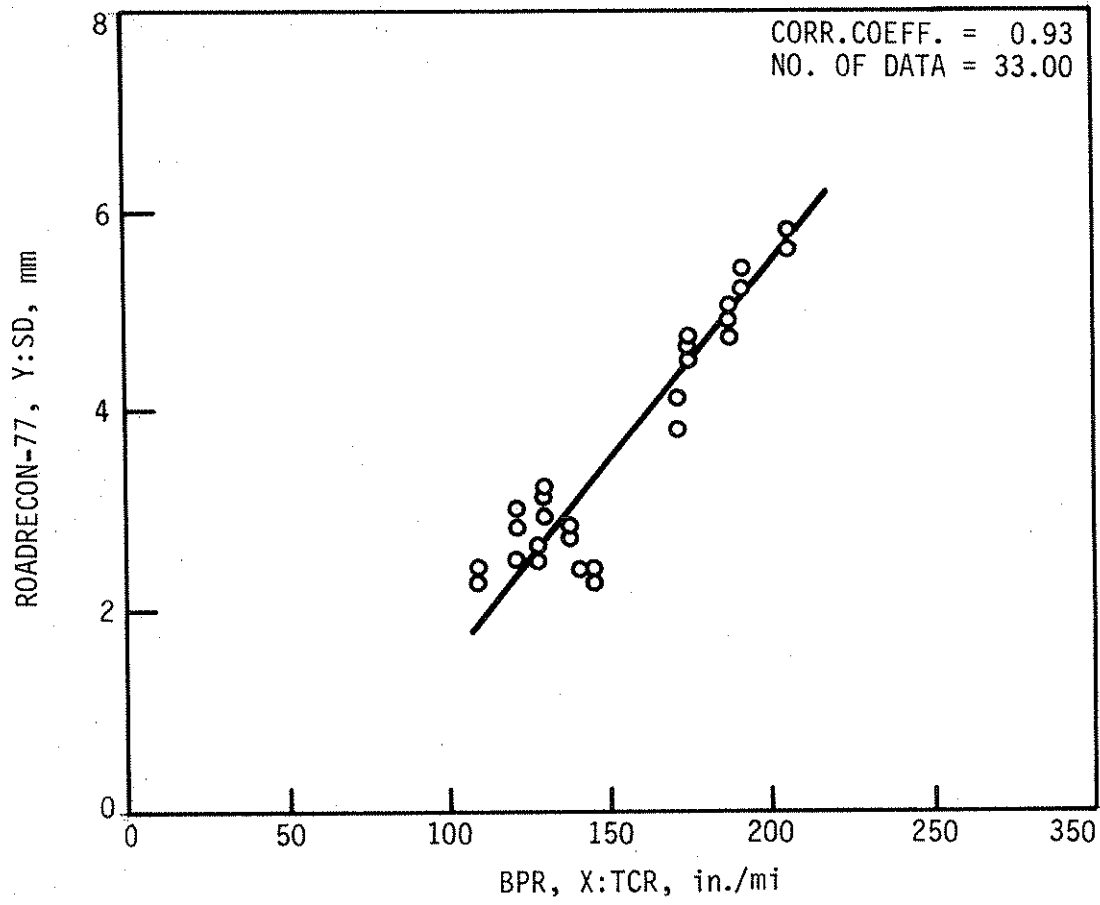
Fig. C.2. BPR vs ROADRECON-77 (SD).

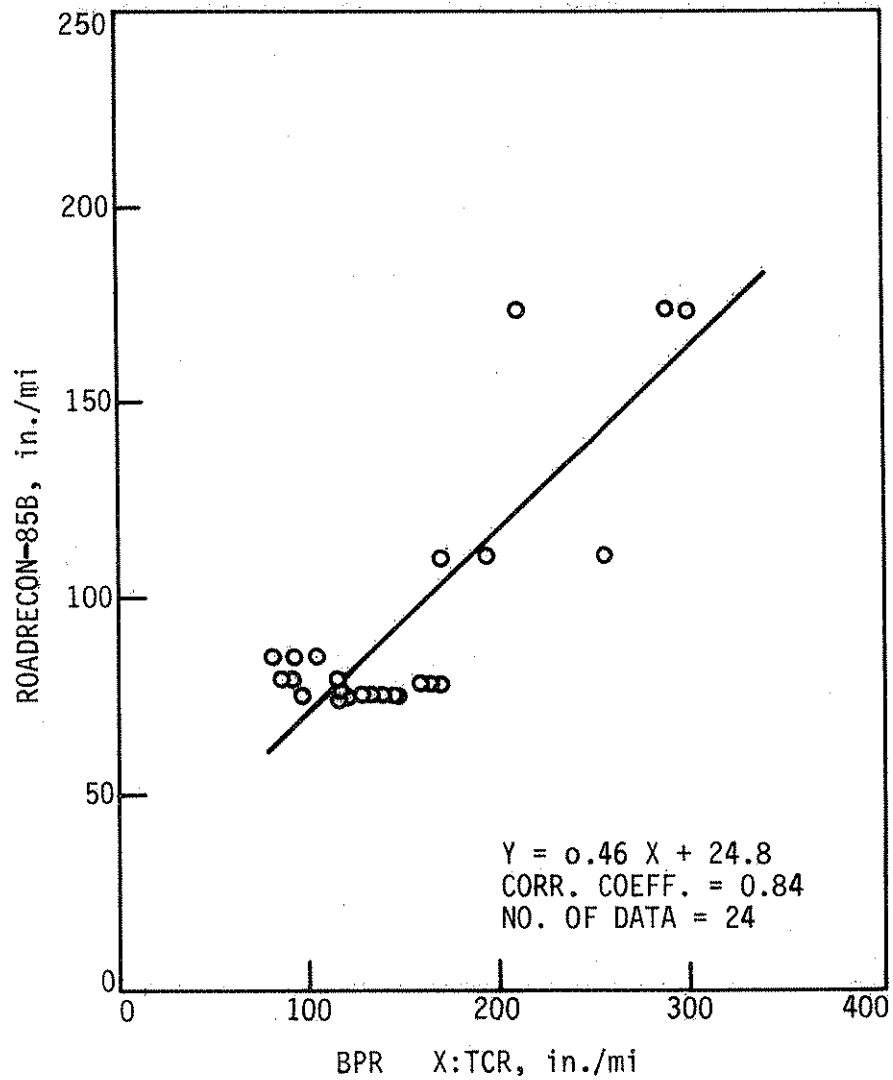
Fig. C.3. BPR vs ROADRECON-85 (TCR).

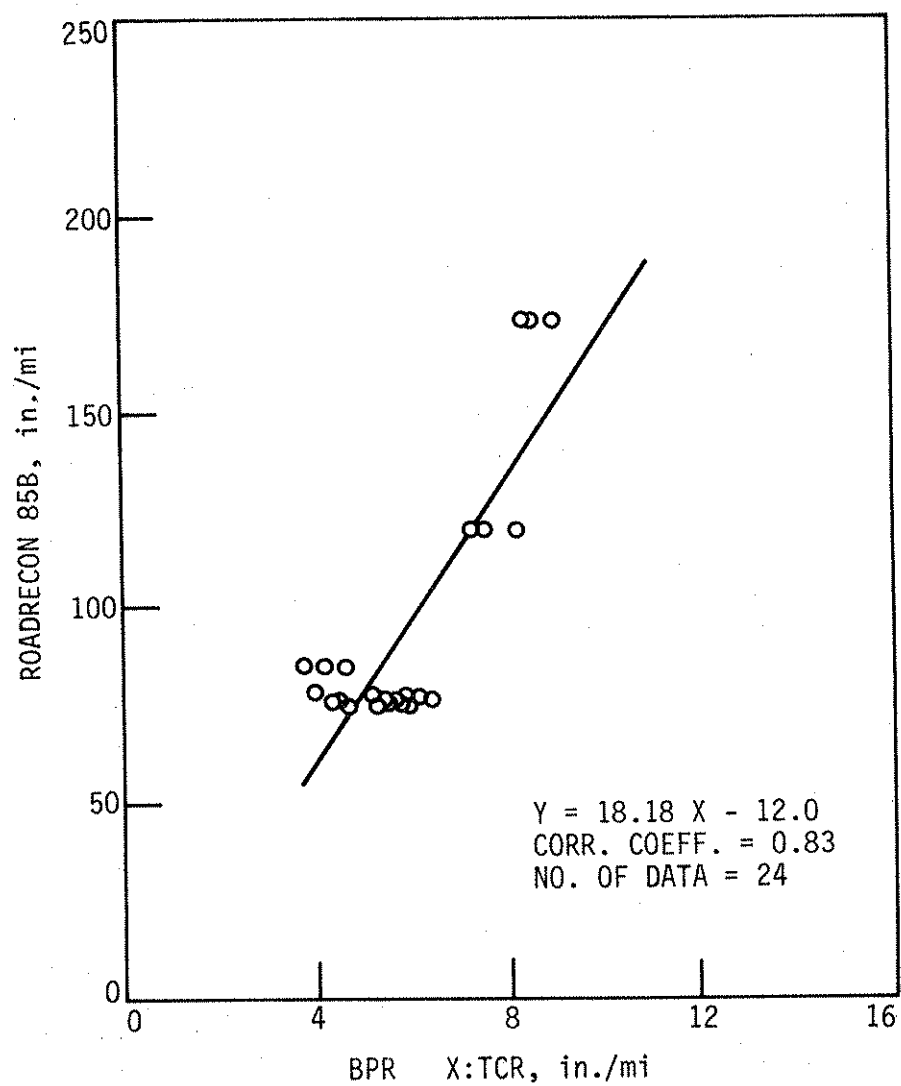
Fig. C.4. BPR vs ROADRECON-85 (SD).

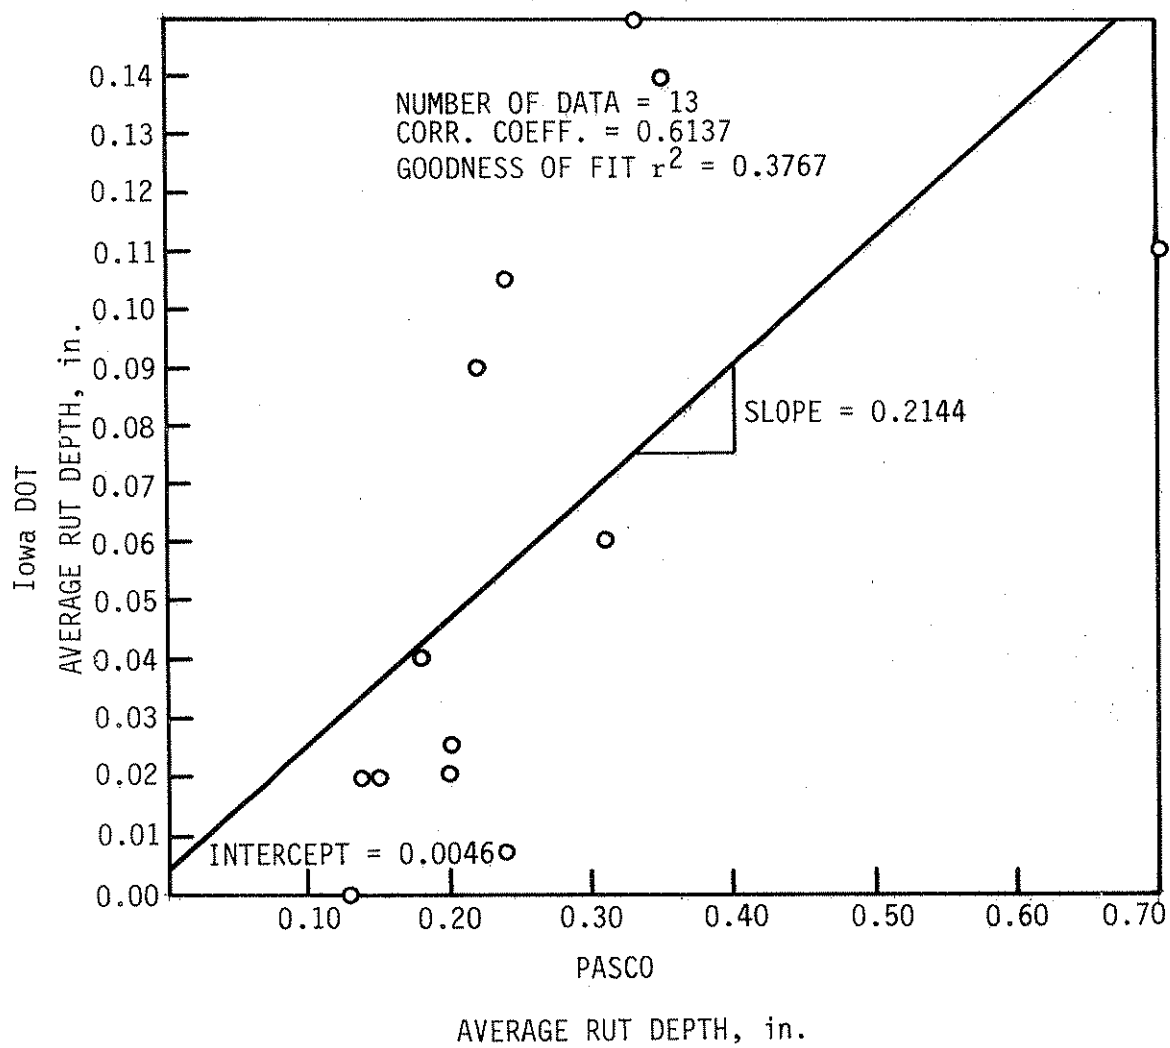
Fig. C.5. Rut depth (PASCO vs Iowa DOT).

Rut-depth correlations of 0.61 and cracking of 0.32 (70% confidence level) are attributed to the ability of the PASCO equipment to measure the entire cross profile and to measure all cracks under constant light and vertical viewing conditions. The equipment can measure each crack

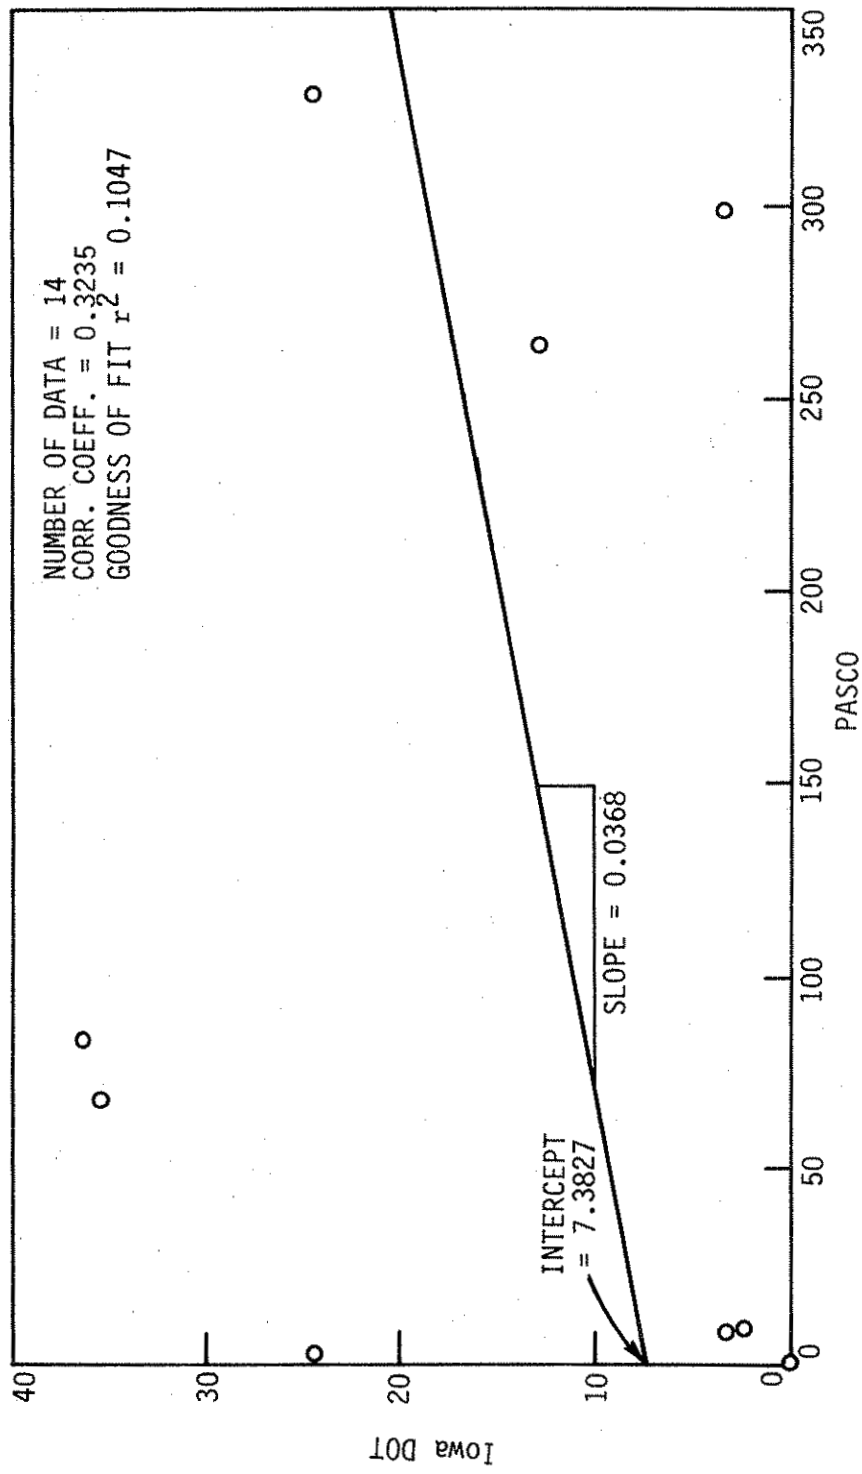
Fig. C.6. Cracks (PASCO vs Iowa DOT).

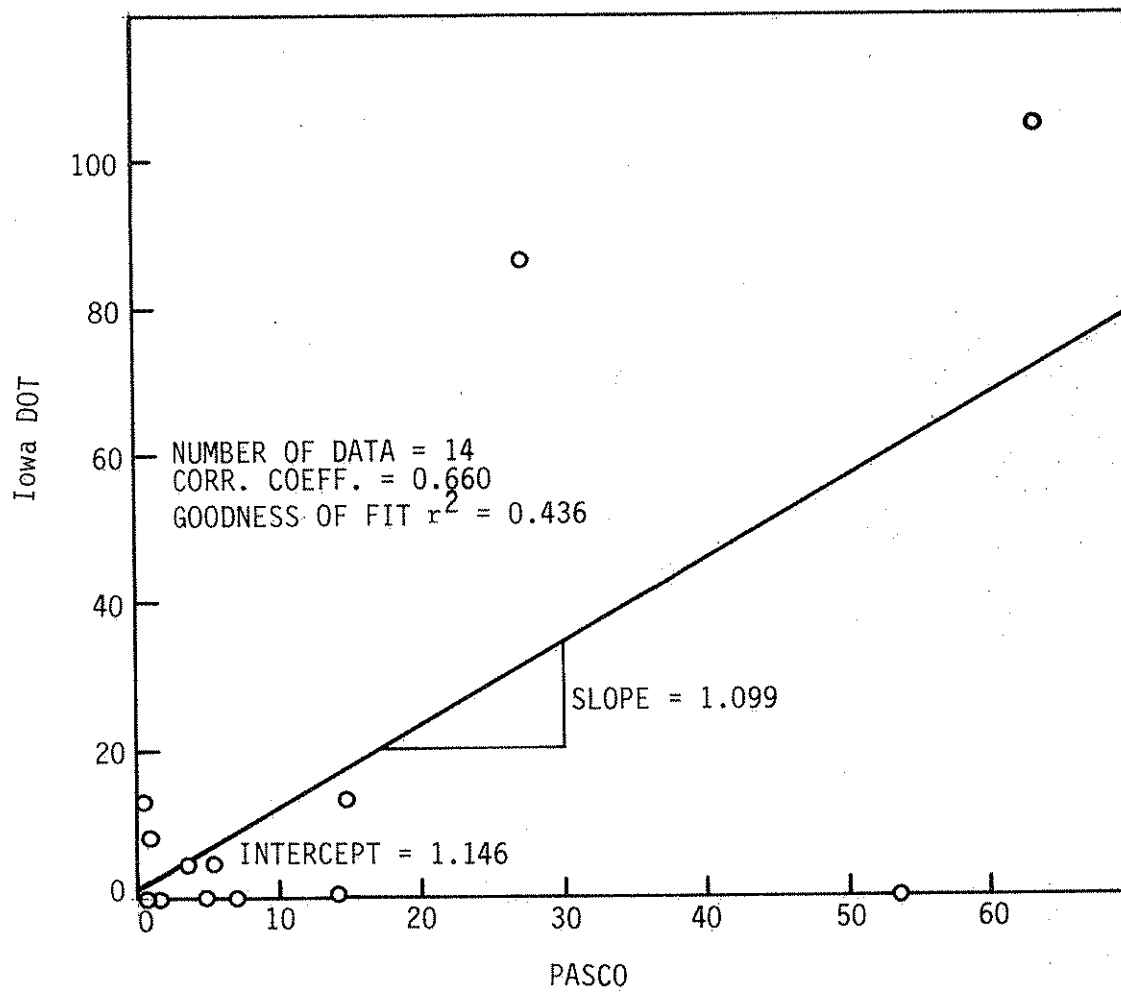
Fig. C.7. Patches (Iowa DOT vs PASCO).

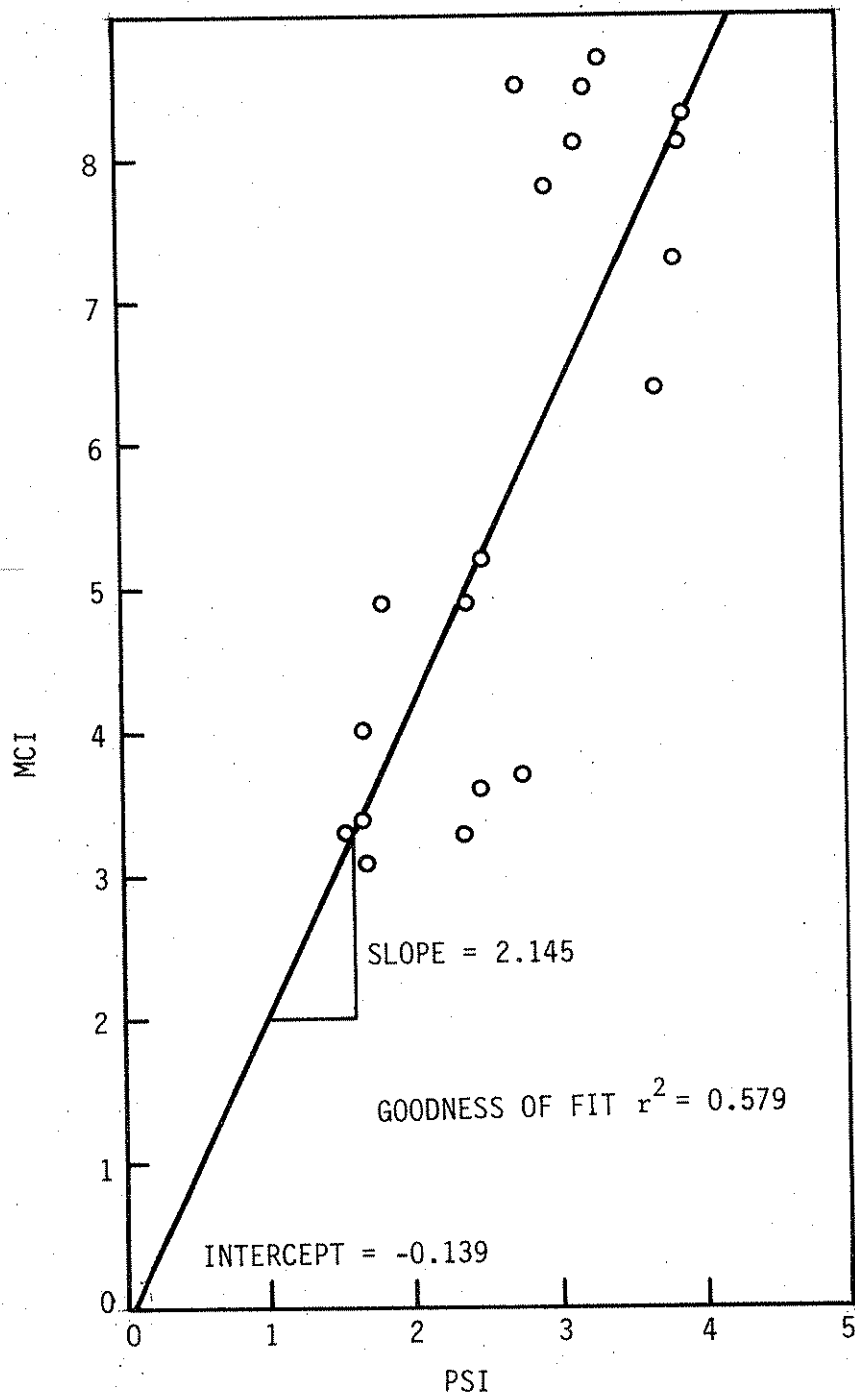
Fig. C.8. MCI vs PSI.

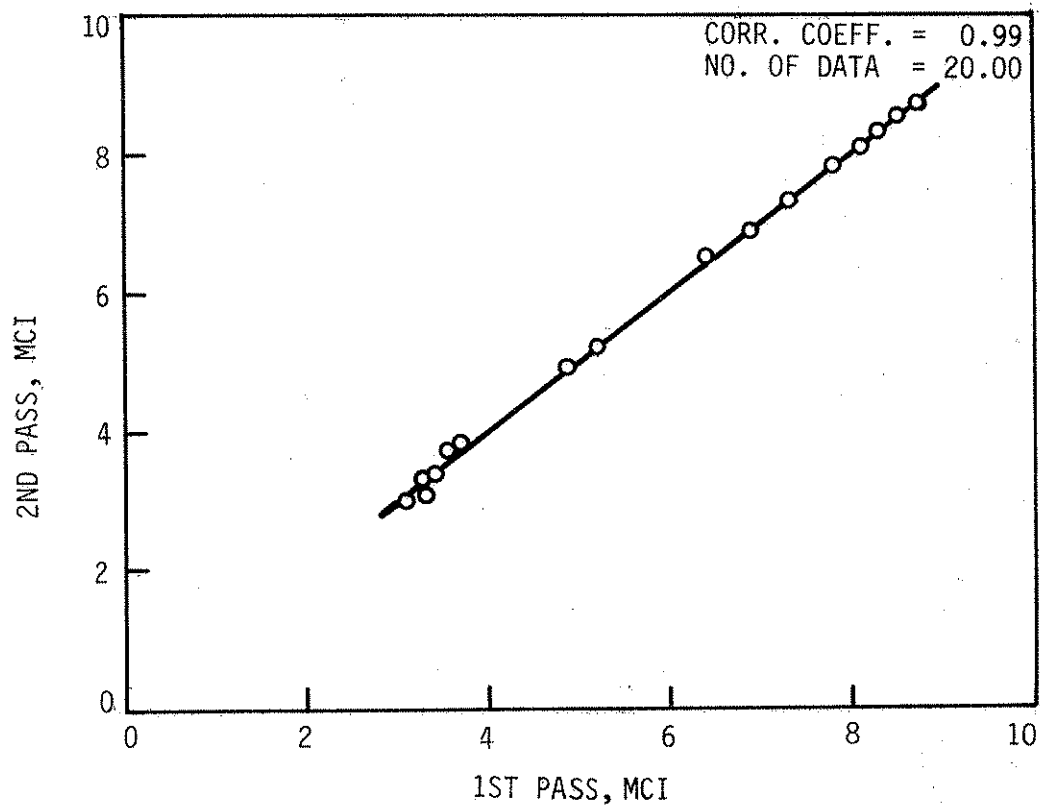
Fig. C.9. MCI (1st pass vs 2nd pass).

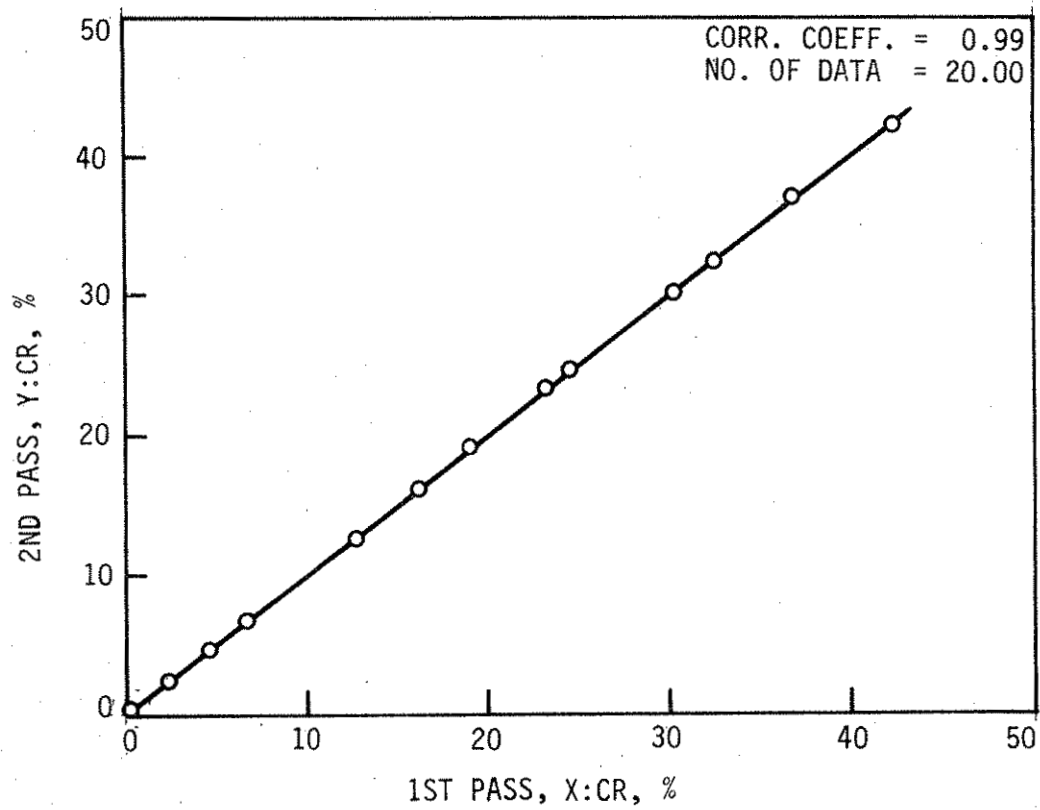
Fig. C.10. ROADRECON-70 (1st pass vs 2nd pass).

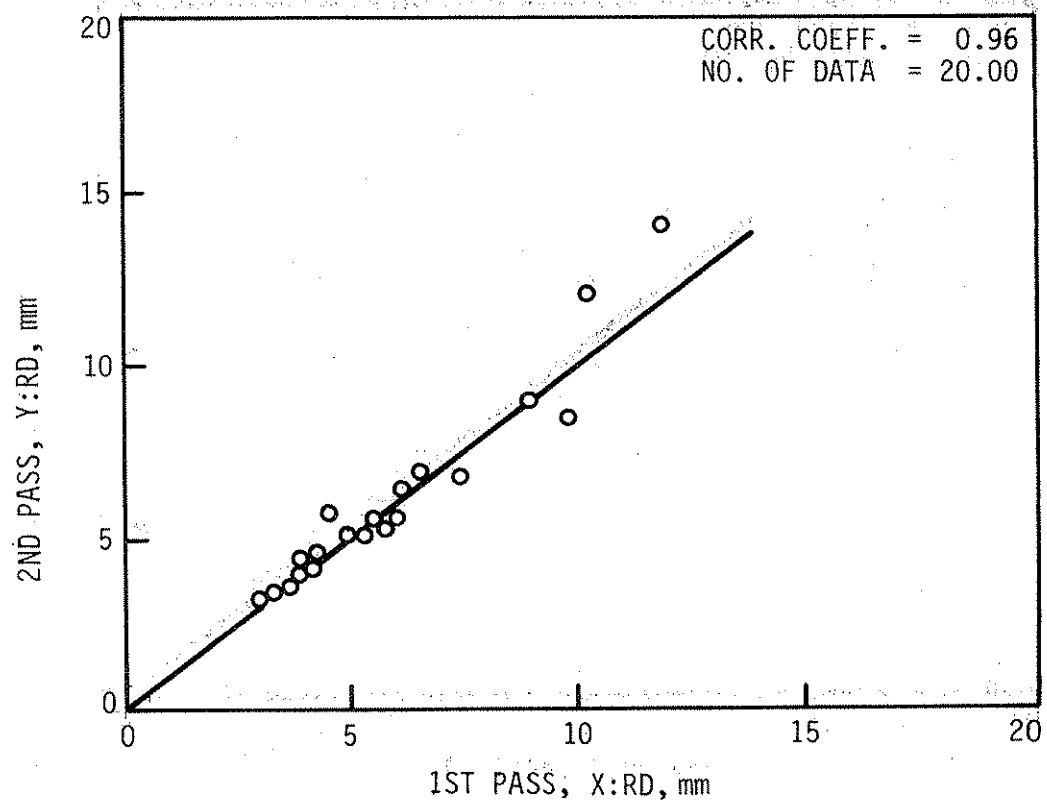
Fig. C.11. ROADRECON-75 (1st pass vs 2nd pass).

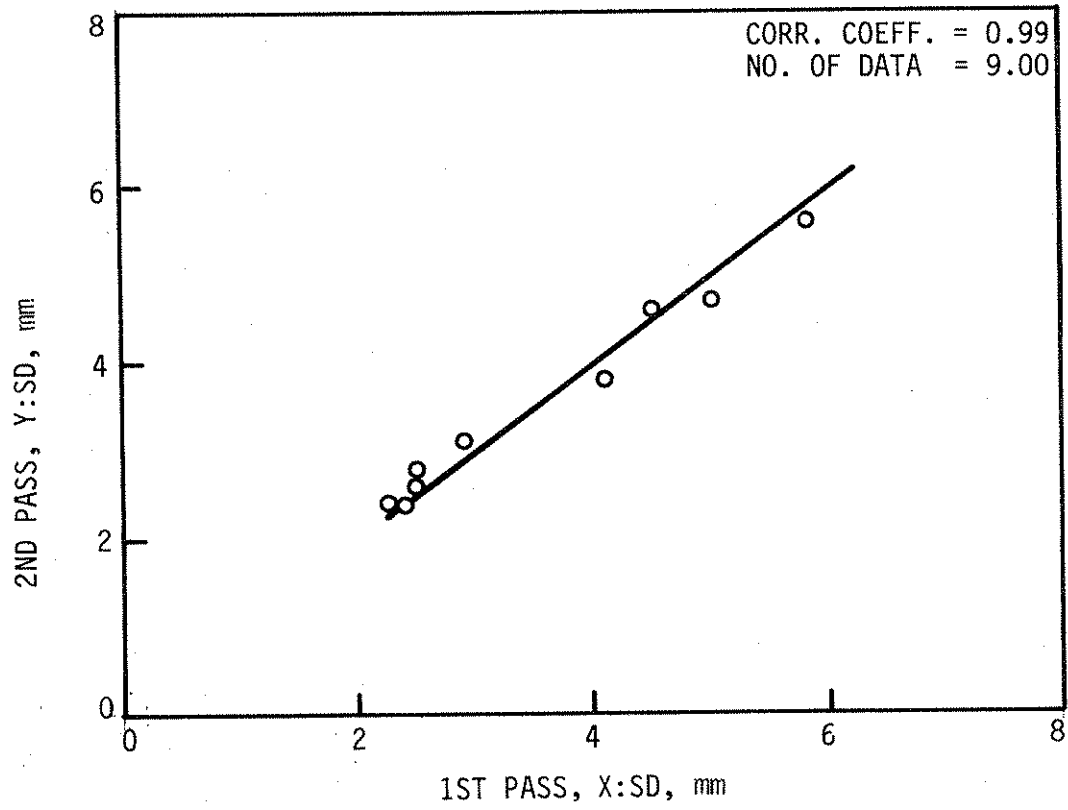
Fig. C.12. ROADRECON-77 (1st pass vs 2nd pass).

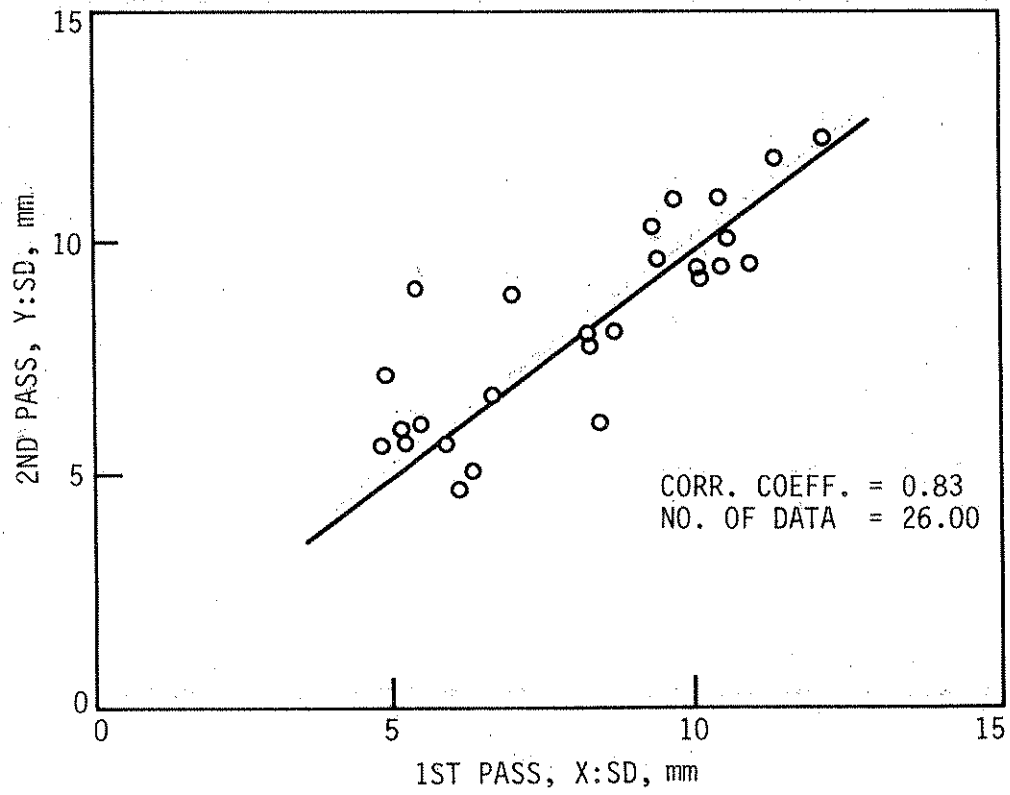
Fig. C.13. ROADRECON-85B (1st pass vs 2nd pass).
