# **RETAINING WALL - MODULAR UNIT REINFORCED EARTH TENSAR GEOGRID REINFORCEMENT**

**Final Report  
For  
HR-549**

**Iowa Department  
of Transportation**

BLAIRS FERRY ROAD/LINDALE DRIVE INTERSECTION  
RECONSTRUCTION PROJECT  
MARION, IOWA  
M-MG-0820(4)--8X-57

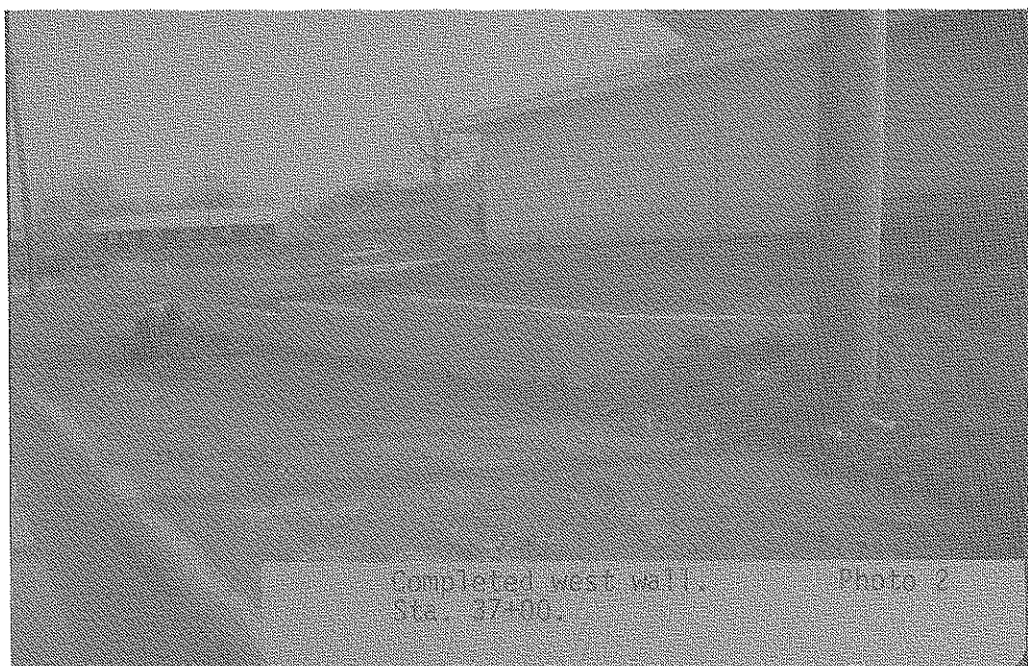
Photo 2

Completed west wall.  
Sta. 37+00.
