**IOWA STATE HIGHWAY COMMISSION**  
**MATERIALS DEPARTMENT**

**R-262**

***Bridge Deck***  
***Waterproofing***  
***Membrane Study***

**December, 1974**

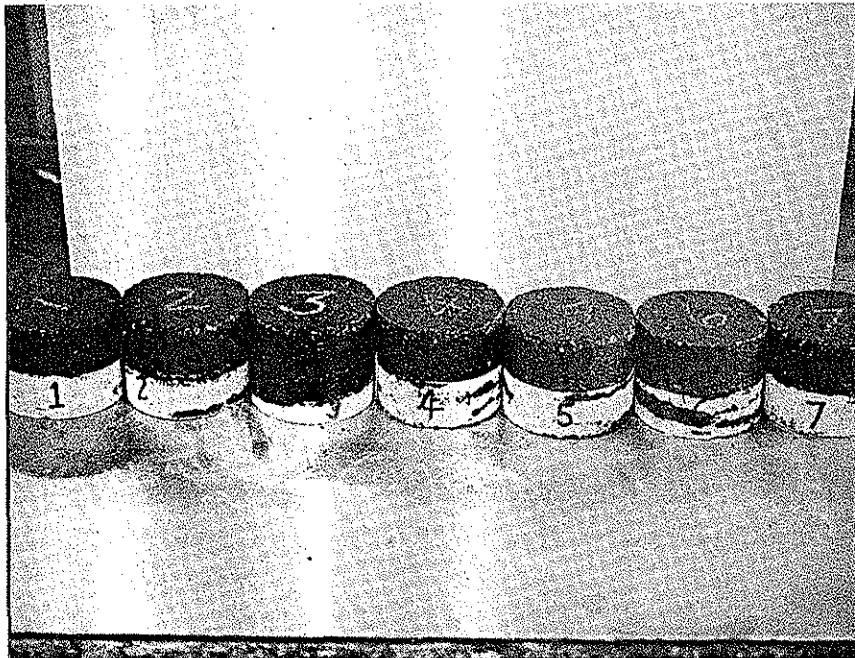
Figure 9

Shear test specimens with membrane system and asphaltic concrete applied
