# Innovative Solutions for Slope Stability Reinforcement and Characterization: Vol. II

## Final Report December 2005

the Iowa Highway Research Board  
(IHRB Project TR-489)

the Iowa Department of Transportation  
(CTRE Project 03-127)

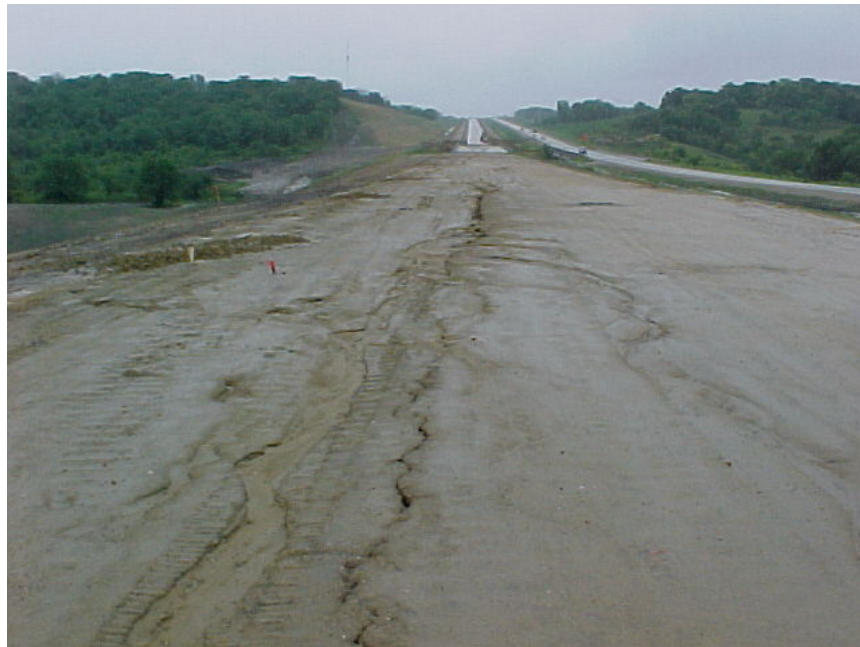
**Figure 1. Existing slope failure at Highway 330 in Jasper County, Iowa (White 2003)**

Soil slope instability continues to be a problem in Iowa in transportation routes or along highways and roadways. Failures occur in both cut slopes and earth embankment fill slopes. Chu (2001) reported that 48 counties in Iowa have experienced slope stability problems since 1993. A particular case is the Highway 330 slope failure in Jasper County, Iowa, which developed an approximate 35 m long head scarp (Figure 1). Field borings conducted after tension cracks developed showed that the fill soils were 8% to 10% above optimum moisture content, which indicated that the soil was nearly saturated and had developed low shear strength. Slope failures have posed concerns to the public safety, caused construction delays and resulted in costly repair work.

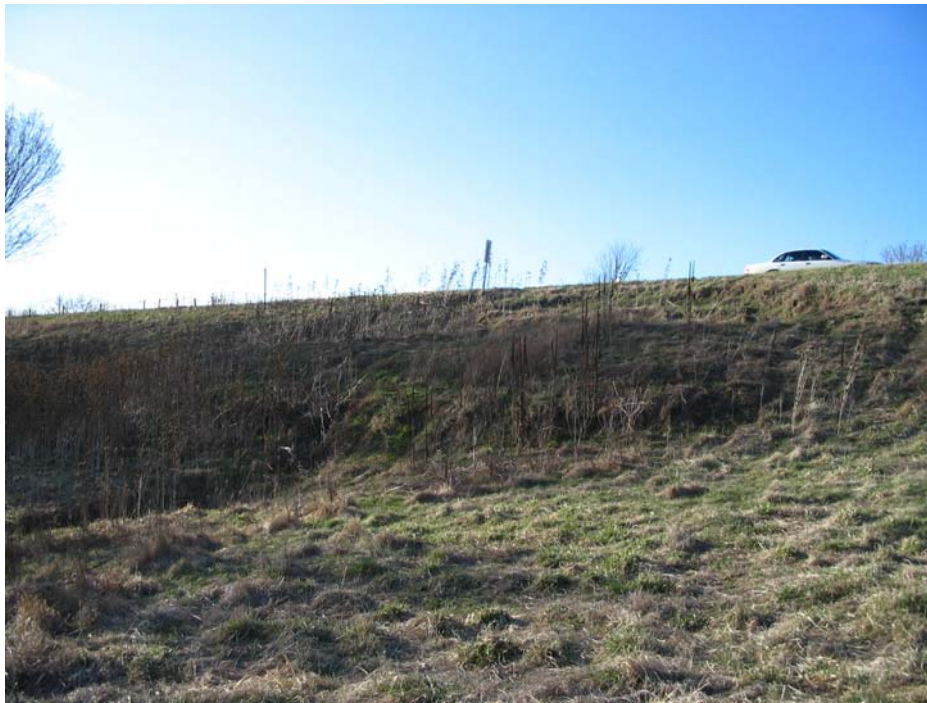
(b) Looking northwest, close view of the bulge and the scrap (photo taken by Yang, 04/01/05)

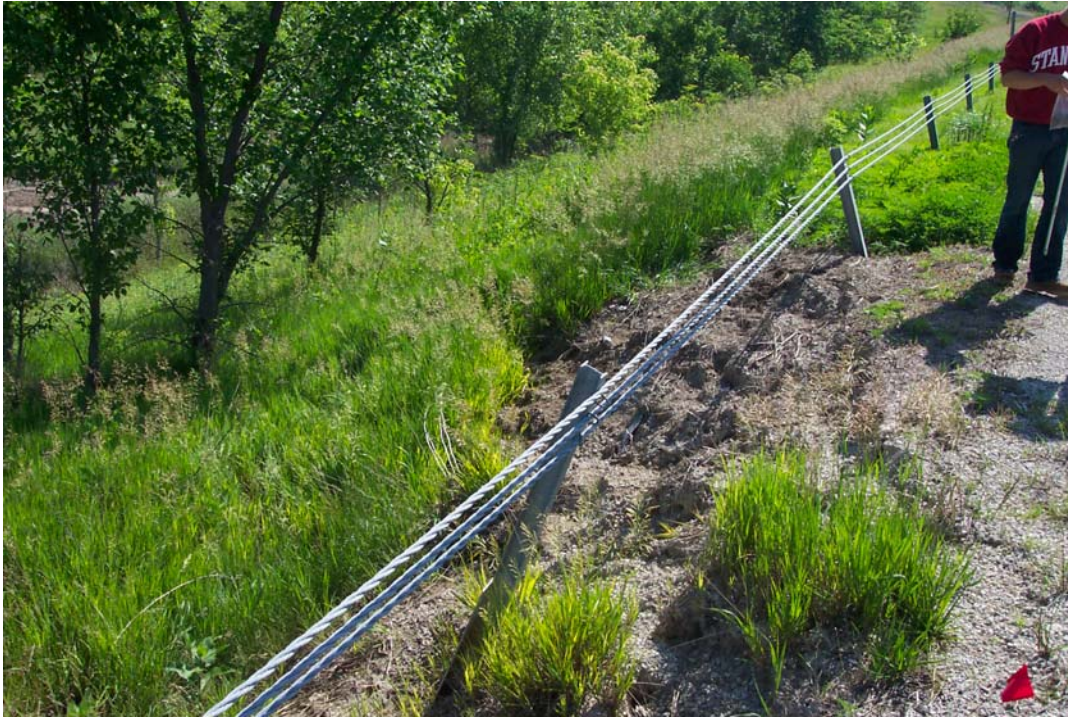
(a) Looking northeast, showing the slope failure at top (photo taken by Thompson, 06/04/04)

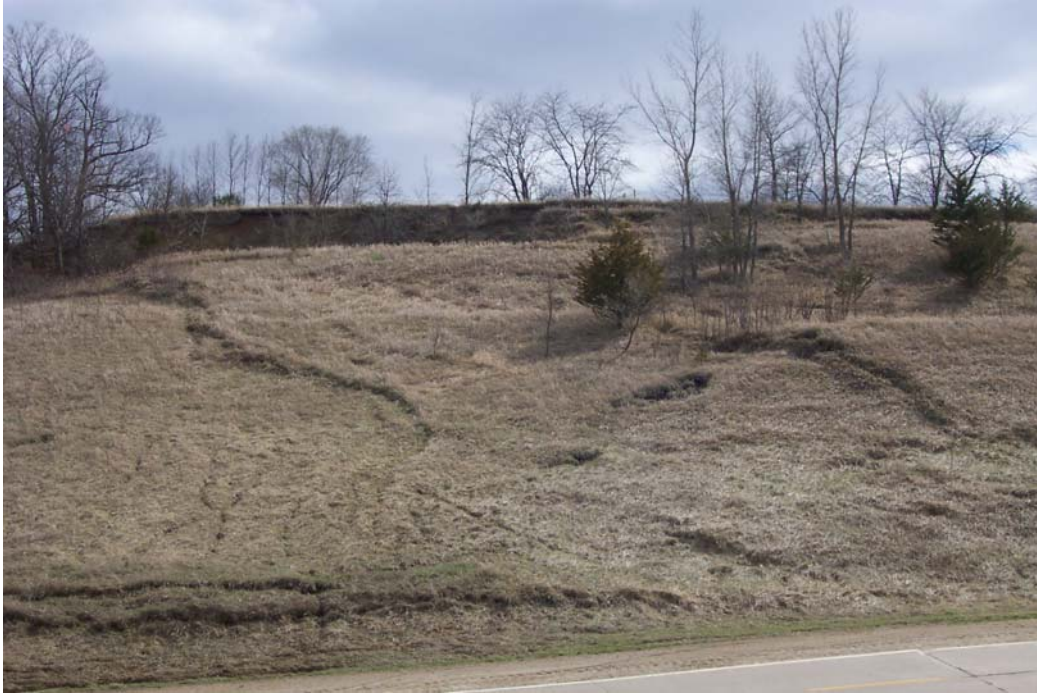
(d) Looking southwest, scarps of the slope 11 (photo taken by Thompson, 03/30/04)
