# Integral Bridge Abutment-to- Approach Slab Connection

**Final Report**  
**June 2008**

the Iowa Department of Transportation (Projects 05-197 & 05-219)

the Iowa Highway Research Board (Projects TR-530 & TR-539)

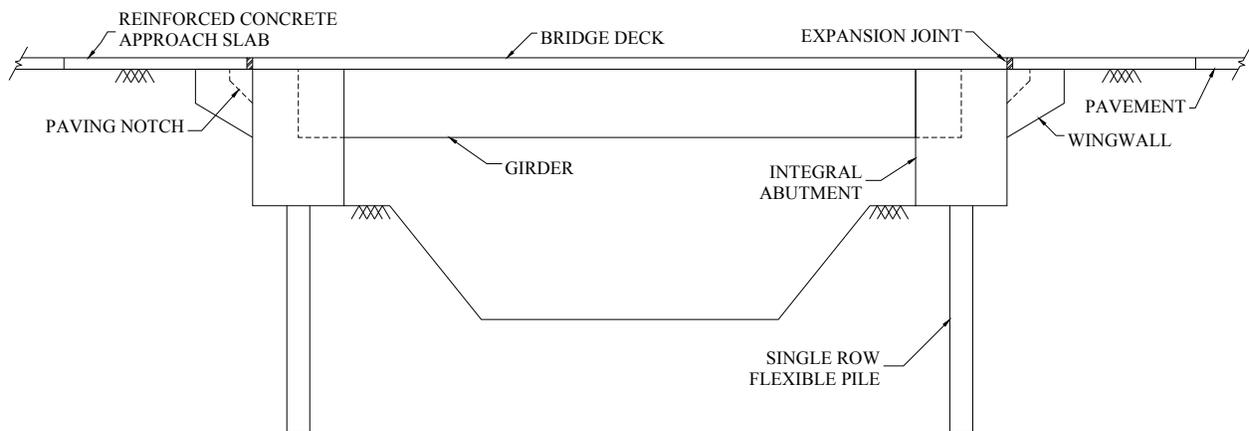
**Figure 2.1. Simplified elevation view of a typical integral abutment bridge**

I-A bridges, which are conceptually depicted in Figure 2.1, have become well known and widely used across the country. A study of current practices in the U.S. and Canada was performed by Kunin and Alampalli (2000). The authors reported the results of a 1996 survey of which 31 agencies responded to having experience with I-A bridges. Additionally, they found that by 1996 over 9,770 I-A bridges had been built. The popularity of I-A bridges stems from the many advantages they offer (Brena et. al. 2007; Burke 1993; Lawver et. al. 2000; Kunin and Alampalli 2000). Cost, both initial construction and long-term maintenance, is the biggest benefit derived from I-A designs due to the elimination of expansion joints and bearings. Generally I-A bridges experience less deterioration from de-icing chemicals and snowplows, decreased impact loads, improved ride quality, are simpler to construct, and have improved structural resistance to seismic events. Burke (1993) concludes that I-A bridges should be used whenever applicable because of the many advantages over the few disadvantages. One problem facing bridges nationwide is bump development at the end of the bridge. The bump problem appears to be a consistent problem with I-A bridges (Briaud et al. 1997).

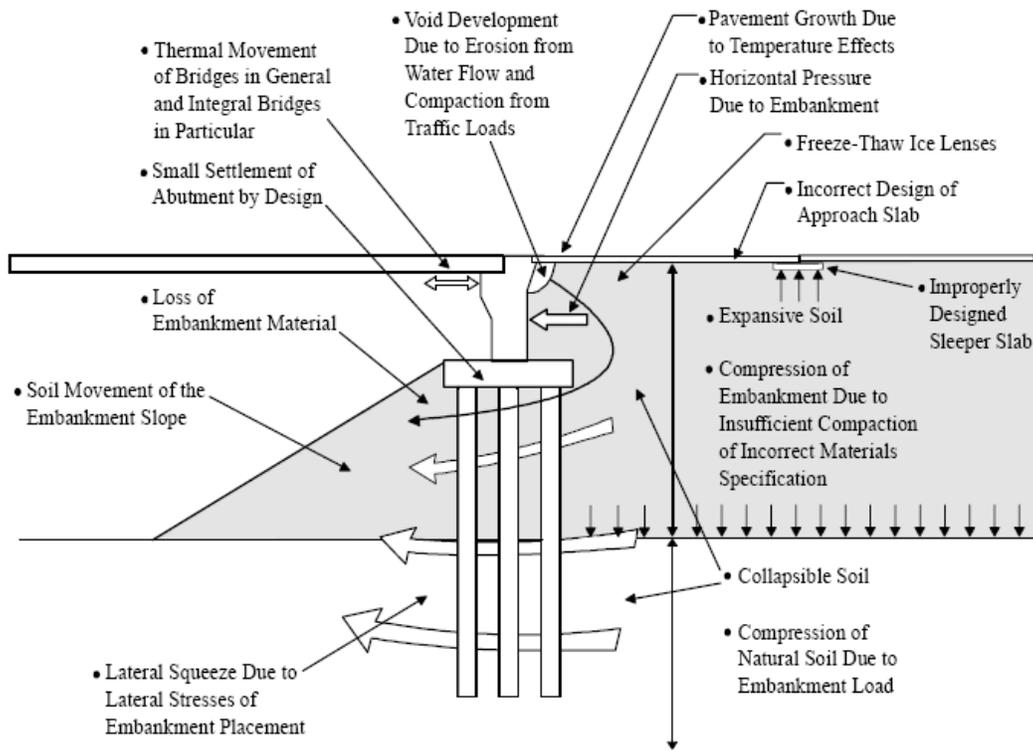
**Figure 2.2. Problems leading to the formation of the bump (Briaud et al. 1997)**

In a literature review and survey of various state DOTs, Briaud et al (1997) summarized causes of the bump and offered potential solutions. According to the report “the bump develops when there is a differential settlement or movements between the bridge abutment and the pavement of the approach embankment.” This problem was estimated to impact 25% of the bridges in the country. Typically the bump is not a significant safety problem: rather it is an expensive maintenance issue. Three main causes for the bump can be taken from Briaud’s report. Figure 2.2 conceptually shows the causes which are summarized below:

While the above items seem to suggest that the problem is geotechnical and construction in nature, there is actually a structural issue present. Integral abutment bridges are called out as a distinct issue, with “many engineers responding to the survey believing the bump worsens with integral abutment bridges” (Briaud et al. 1997 pp. 25). Thermal cycles are a key behavior with I-A bridges since they do not have expansion joints and expand/contract with the thermal cycles. When I-A bridges expand, the fill material is compacted, creating a void that increases when the bridge contracts.

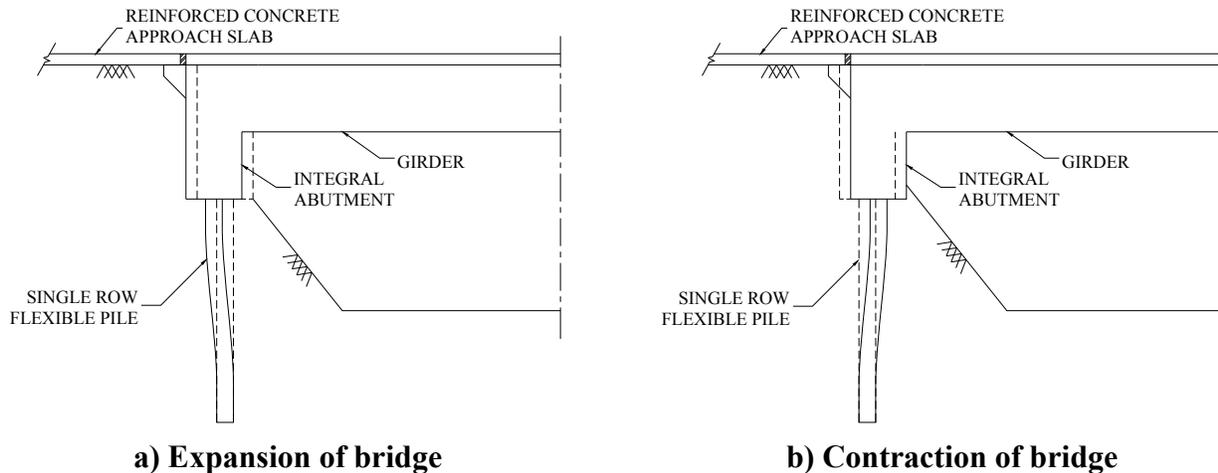
**Figure 2.3. Temperature induced movement of an integral abutment bridge**

Schaefer and Koch (1992) also reported on the longitudinal movement of I-A bridges and the cyclic loading they impose on the backfill and foundation. As the temperature increases the superstructure and abutment move outward, toward the soil causing lateral earth pressures, and compacting the soil. As the temperature decreases, the bridge abutments move away from the compressed soil and a void forms (Figure 2.3). The creation of this void may lead to soil erosion that further increases the size of the void (White et al. 2005).

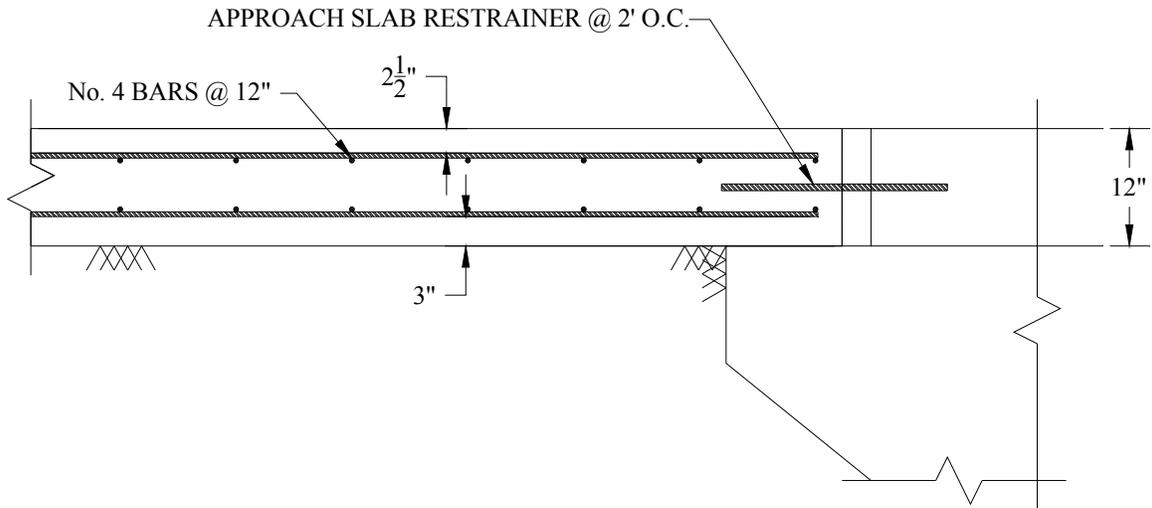
**Figure 2.4. Deck steel extension connection (standard Nevada detail)**

Kunin and Alampalli (2000) found that there are two main approach slab to bridge connections. The first technique is to connect the slab reinforcement to the bridge through extension of the deck steel (see Figure 2.4). The second technique uses reinforcing steel to connect the slab to the corbel or abutment (see Figure 2.5). Another option to the two cited by Kunin and Alampalli is to have the approach slab rest on the paving notch of the abutment (see Figure 2.6). Hoppe (1999) reports that 71% of the state DOT's using I-A bridges use a mechanical connection between the approach slab and bridge.

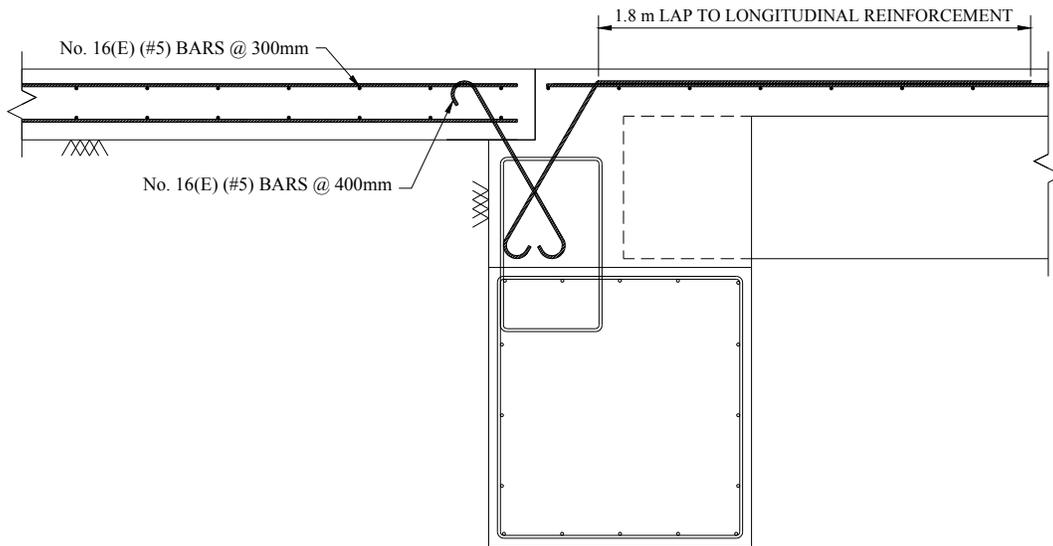
**Figure 2.7. Typical New York detail**

The report by Yannotti, Alampalli, and White (2005) discussed the New York DOT experience with I-A bridges and presented specific practices. Of particular interest was the modification made to the approach slab to abutment connection after a 1996 study (similar to Figure 2.4). The older detail involved the extension of bridge deck steel horizontally into the approach slab. This detail was found to be unsatisfactory because the approach slab was unable to accommodate any settlement. This settlement typically caused transverse cracking in the bridge deck and transverse and longitudinal cracking of the approach slab. A new detail, shown in Figure 2.7, was developed using reinforcing bars at 45° into the bridge deck and the approach slab. This connection allows rotation of the slab by minimizing the moment capacity if the fill settles.

Harry White of the New York State DOT (NYSDOT) was contacted for further information. He added that the horizontal bar detail mentioned above provided negative moment capacity so that when the fill and slab settled, rotation was restrained leading to the cracking discussed above. He also indicated that the new detail (see Figure 2.7) is performing adequately and no notable problems have arisen. A requirement of NYSDOT and other states is the use of a polyethylene sheet under the full width of the slab to reduce sliding friction.

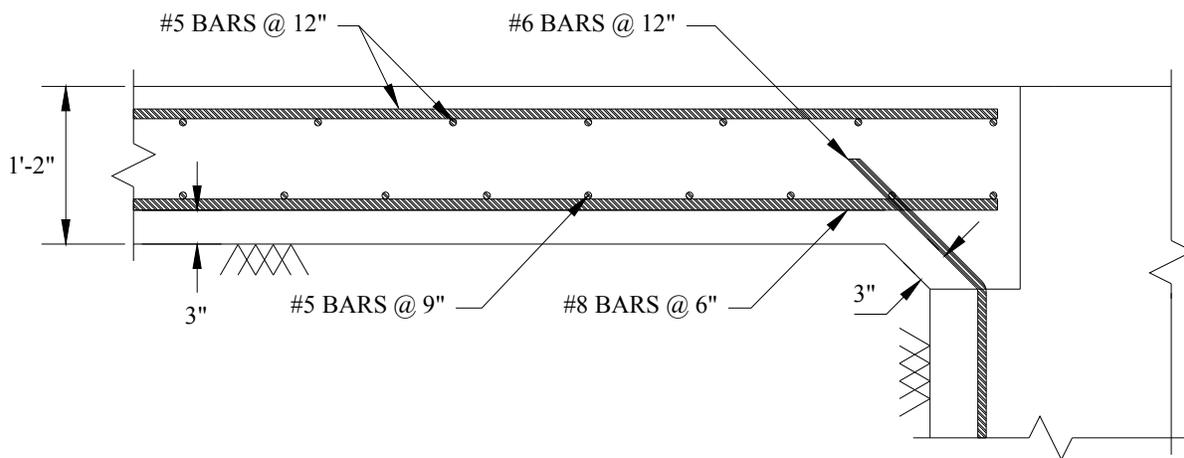
**Figure 2.12. Typical Nebraska detail**

the approach slab as an approach section, which rests on a grade beam supported by piles at the end opposite the bridge. From the grade beam to the pavement, another transition section, called the pavement section is used. According to Mr. Milliken, the reason for the connection was to eliminate, or at the least, move the bump from the end of the bridge to a location that is more easily maintained. This methodology also eliminated water from infiltrating the bearing of the bridge. A problem arising from the approach slabs was settlement of the sleeper slabs in the original design, leading to the use of grade beams as described above. Recently, hairline cracks, perpendicular to the grade beams on bridges with severe skews, were discovered. A top mat of steel was added in the approach slab, but no feedback was yet available. Overall, management is pleased with the performance thus far. No research has been performed on the approach slabs and connection. There is nothing done to reduce the friction between the slab and the ground. Fill behind the abutment is considered only necessary until the concrete in the approach section reaches strength, at which time it acts like a bridge between the abutment and grade beam. Granular backfill is used, with drainage provided by drainage fabric. The material is installed in lifts and compacted with smaller equipment to avoid damaging the wing-walls.

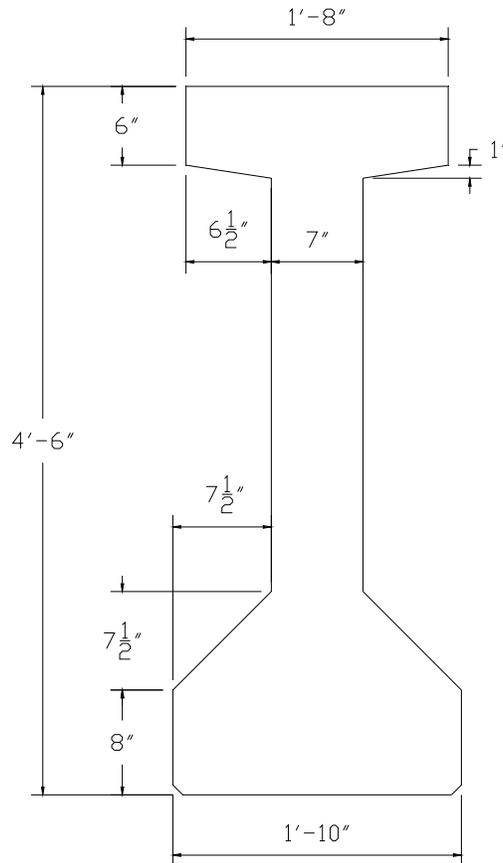
**Figure 3.3. Typical LXD beam cross section**

10 in. wide bottom flanges and 1 ft - 8 in. wide top flanges (see Figure 3.3). Spacing of the girders is 6 ft - 2in. center to center. The girders are integrally cast at the abutments and piers. Span-to-span live load continuity at the piers is achieved by cast-in-place diaphragms.

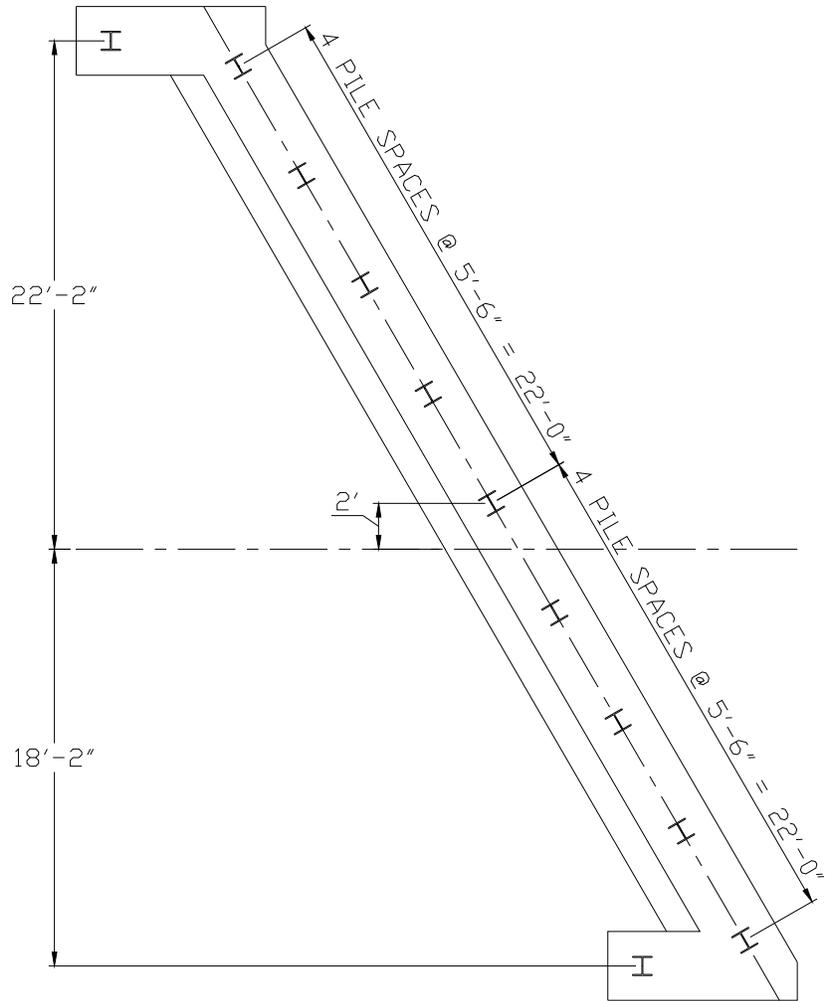
**Figure 3.4. Plan view of a typical abutment**

The bridge abutments are founded on a single row of nine nominal 70 ft long HP10x57 piles with an additional HP10x57 pile under each wing wall for a total of eleven piles (see Figure 3.4 and Figure 3.5). The piles are aligned with the web parallel to the face of the abutment and wing walls. The piles were driven the entire 70 ft length, with the top 15 ft predrilled. Design bearing of the piles is 50 tons. The piers consist of rectangular reinforced concrete (RC) pile caps 3 ft - 4in. x 3 ft - 4 in. at the lowest step, founded atop a line of 17 - 75 ft HP10x57 piles (see Figure 3.6). The exterior piles are battered transversely at a ratio of 1:12 horizontal to vertical. The upper 15 ft of all piles are encased in a 20 in. diameter reinforced concrete shell.

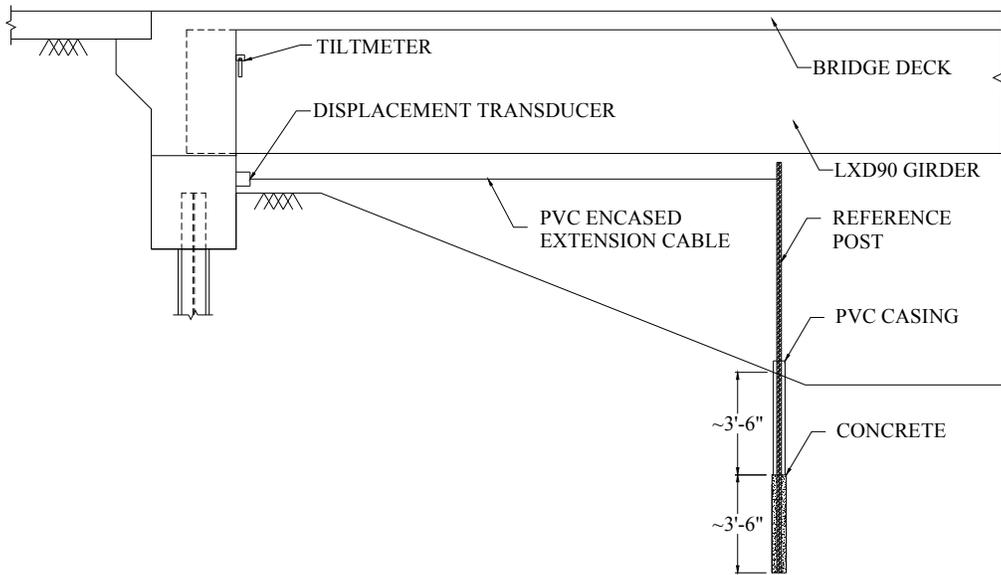
**Figure 3.15. Typical displacement meter installation**

The reference posts, 3 in. diameter steel pipes, were initially installed near the toe of the embankment under the bridge. Four foot deep holes were drilled, the pipes were placed, and the hole and pipe were filled with concrete. Several months into the project, the initial longitudinal displacement reference posts were replaced with 2 in. diameter steel pipes because post movement was suspected. These new posts were installed 7 to 8 ft into the ground (see Figure 3.15). The bottom 3 to 4 ft of the holes were filled with concrete. In the top 3 to 4 ft of the holes a 6 in. diameter PVC pipe was used as casing to isolate the reference post from the soil. The cable running from the displacement meter to the reference post was enclosed in a PVC pipe to protect it from build up of snow, ice, and animals. Figure 3.16 shows a photograph of the installed displacement gauge.

In addition to the displacement meters, Geokon Vibrating Wire Tiltmeters were attached to the front abutment face as shown in Figure 3.15 to measure longitudinal rotation. As the bridge abutment rotates the effect of gravity on the mass inside the tiltmeter changes the force on an internal elastic hinge, changing the frequency of the vibrating wire in the elastic hinge. One tiltmeter was attached to each corner of the south abutment of each bridge (see Figure 3.14). Figure 3.16 is a photograph of an installed displacement gauge and tiltmeter and Figure 3.17 is a close up photograph of an installed tiltmeter.

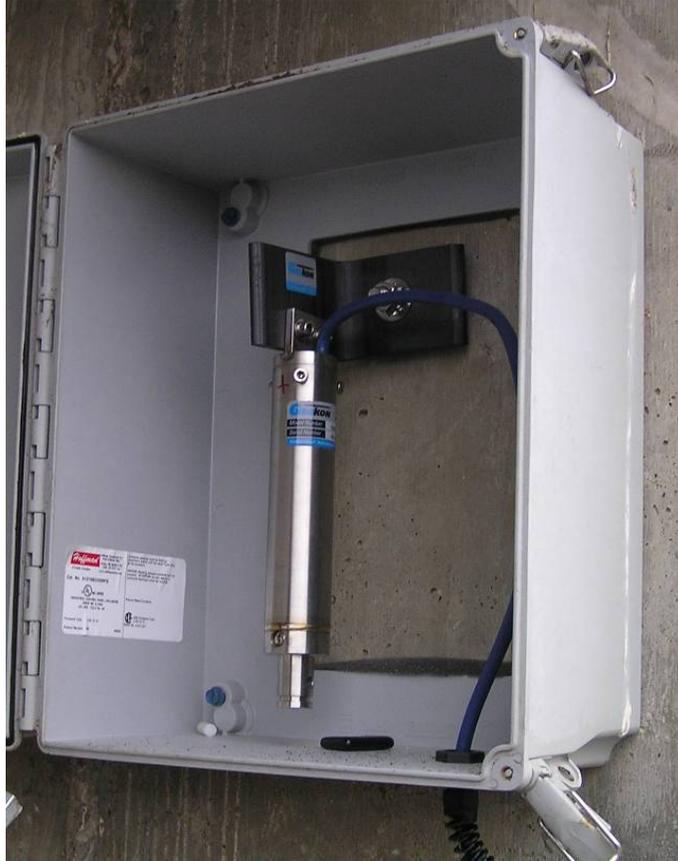
**Figure 3.17. Photograph of a tiltmeter**

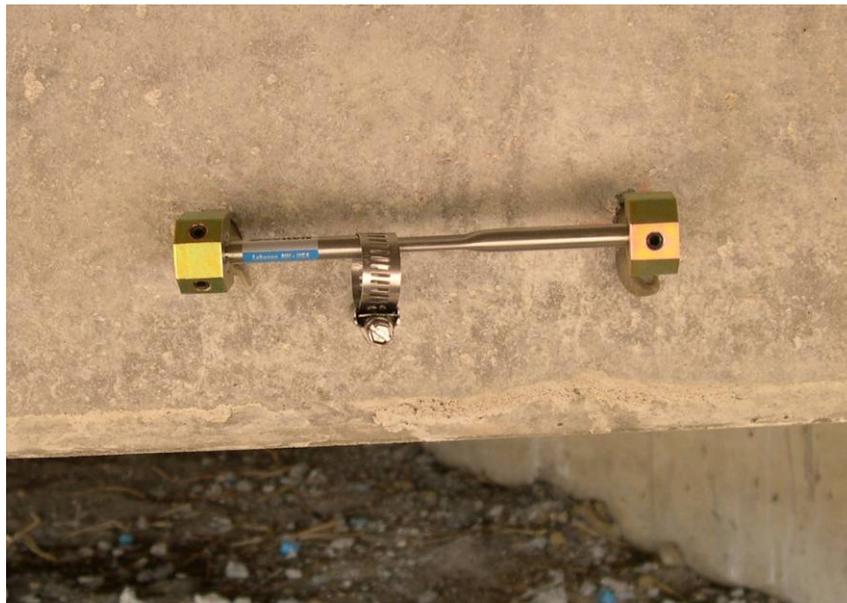
**Figure 3.19. Photograph of installed girder gauge**

Geokon Model 4000 Vibrating Wire Strain Gauges were installed on the south span of each bridge along girders two, four, and six (see Figure 3.14). Gauges were placed on the top and bottom flanges as shown in Figure 3.18 at locations 5 ft from the abutment, mid-span, and 5 ft from the pier. Figure 3.19 is a photograph of an installed girder strain gauge.

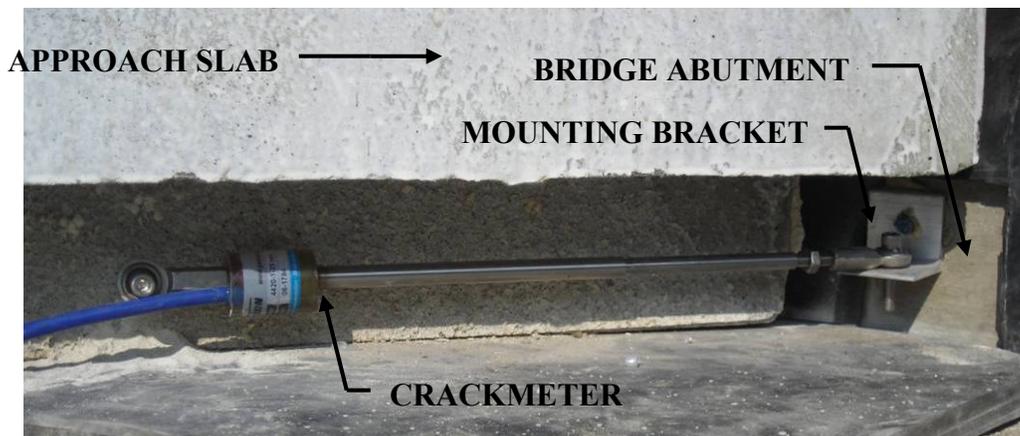
**Figure 3.22. A crackmeter installed across the bridge-to-approach slab joint**

Across the transverse approach slab precast panel joints, the expansion joints, and the bridge to approach slab joints, Geokon Model 4420 Vibrating Wire Crackmeters were installed (see Figure 3.14). Special block-outs were cast into the approach slabs at the joint to accommodate the sensors. An installed crackmeter is shown in the photograph in Figure 3.22. As the joint opens and closes, the relative movement of the crackmeter ends is recorded.

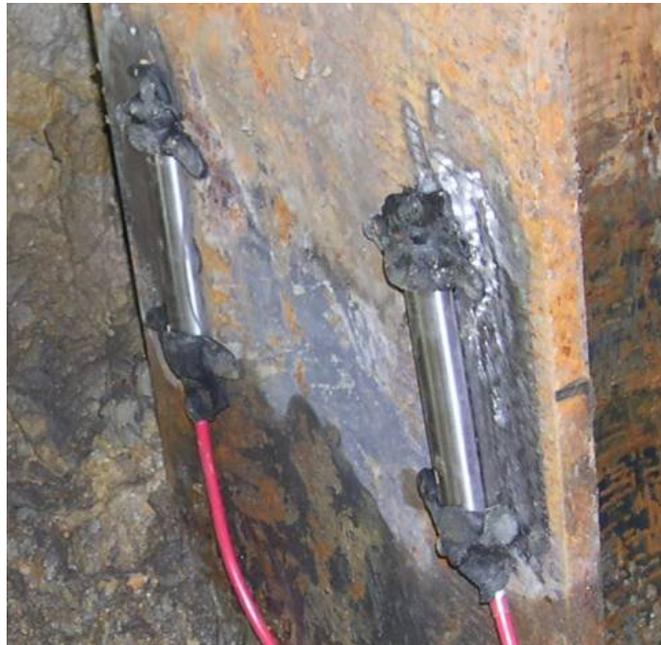
**Figure 3.25. Photograph of an instrumented pile**

Geokon Model 4150 Spot-Weldable Vibrating Wire Strain Gauges were epoxied to the flanges of piles two, five, and eight beneath the south bridge abutments on both bridges (see Figure 3.23). Four sensors were installed per pile, 1 in. from the flange tips (see Figure 3.24) and 1 ft below the bottom of the abutment. Figure 3.25 is a photograph showing an instrumented pile.

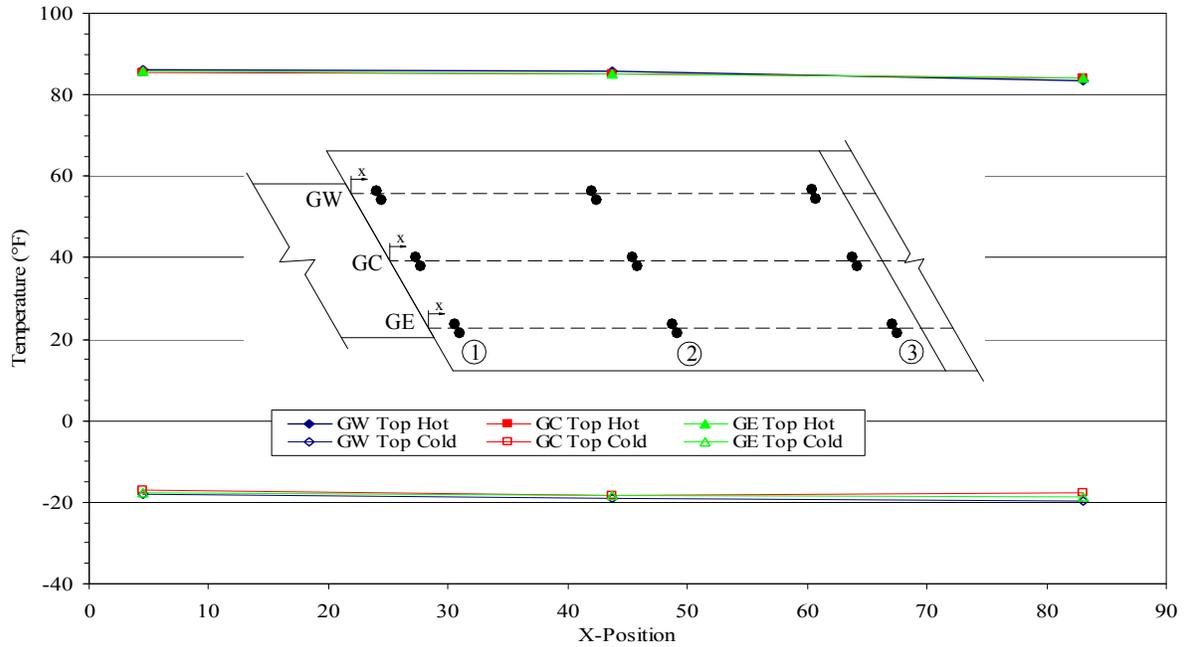
**Figure 4.3. Temperature variation at the top of the northbound bridge girders**

The temperatures recorded by the girder strain gauges are shown in Figure 4.3 and Figure 4.4 for the top and bottom girder flanges, respectively, for the hot and cold days identified in Section 4.1.1. Variation across the bridge is shown by the different series for each girder. Unlike the approach slab when only a single gauge was used, temperature variation between the top and the bottom of the girder can be observed. As can be seen, the temperature remains almost constant both across the bridge and along the girders for both the top and bottom girder gauges.

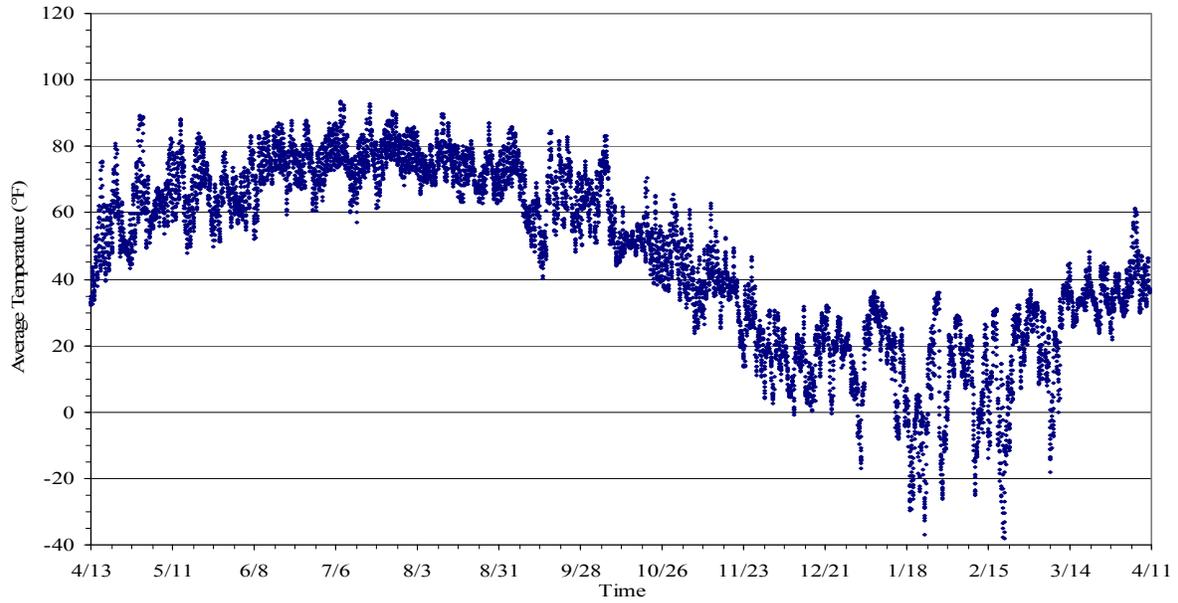
**Figure 4.6. Average northbound bridge temperature over time**

The average bridge temperature in Figure 4.6 was compared to the observed Sheldon, IA ambient air temperature (referred to herein as the "air temperature") daily highs and lows gathered from the Weather Channel website for Sheldon, IA. The resulting comparison is shown in Figure 4.7. Weather Channel data were not gathered in July and are unavailable at this time. While the air temperatures do not exactly match the bridge temperatures, the two correlate well, with the exception of the extreme cold temperatures. The correlation between bridge and air temperature can be seen in Figure 4.8 where the daily high and low air temperatures are plotted against the daily high and low average bridge temperatures. A linear regression analysis was performed and indicates that a correlation with an  $R^2$  greater than 0.95 existed for both the high and low values. The average high bridge temperature is about 3.86°F below the high air temperature. The average low bridge temperature was above the low air temperature on hot days, both of which tended to occur just before sunrise. On these days, the thermal mass of the bridge was retaining the heat of the previous day during the night while the air cooled more. On cold days (December to March), the average low bridge temperature was lower than the air temperature, which could not be explained.

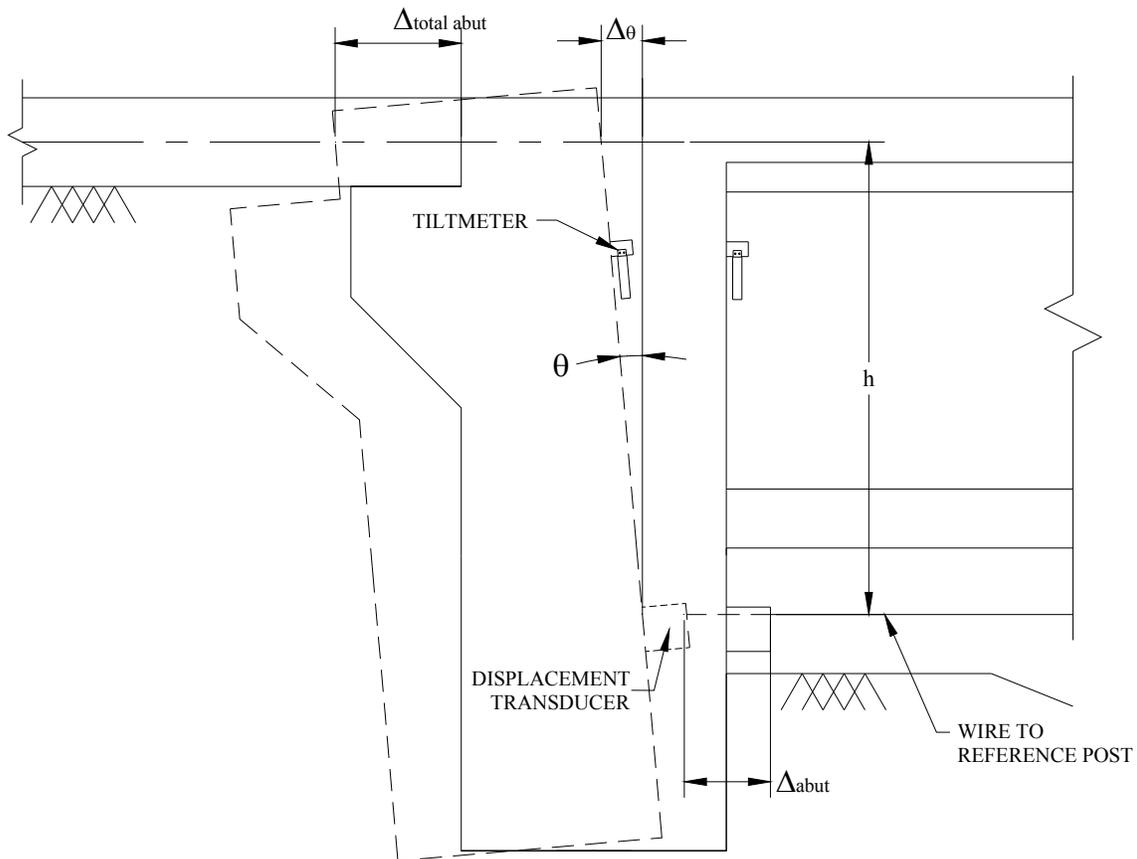
**Figure 4.9. Drawing showing displacement and rotation of a typical abutment**

As previously discussed, the south abutments of the bridges were instrumented to measure displacement (i.e., longitudinal and transverse translation and rotation of the abutment in the longitudinal direction (see Figure 3.15 and Figure 4.9)). The displacement transducer measures the longitudinal displacement, referred to as  $\Delta_{abut}$ , of the abutment near the base. Displacement caused by rotation of the abutment is referred to as  $\Delta_{\theta}$ . Positive displacement due to both sources is illustrated in Figure 4.9.

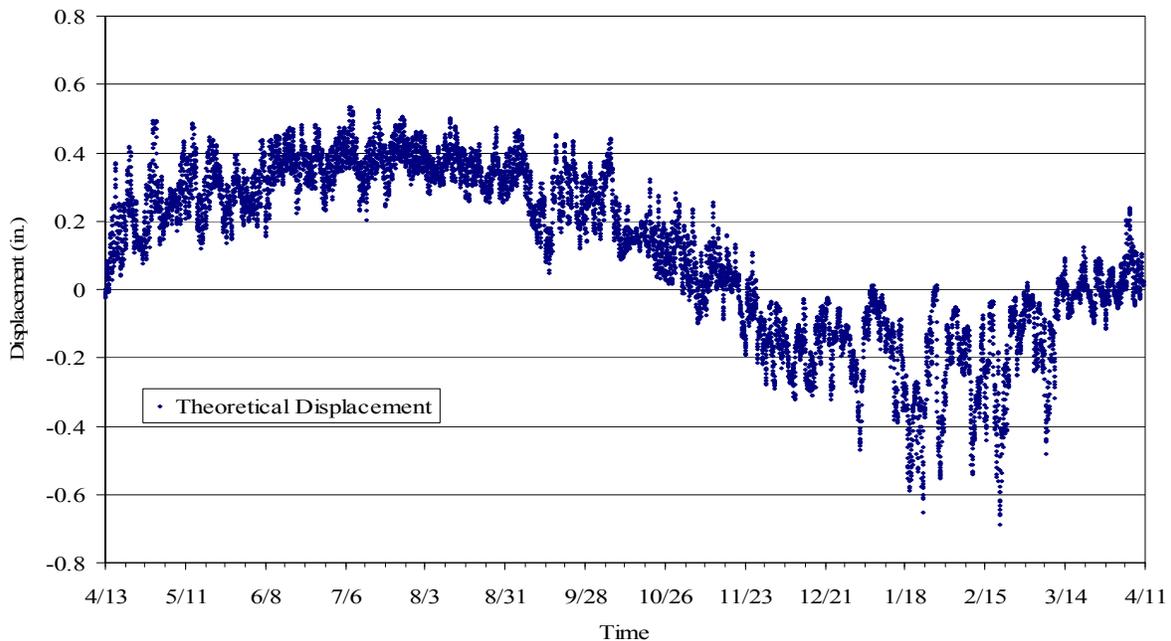
**Figure 4.16. Theoretical abutment displacement**

The coefficient of thermal expansion for concrete was calculated by the method presented by Abendroth and Greimann (Abendroth and Greimann 2005), which is based on the site specific concrete mix ingredients and proportions. Using the mix proportions furnished by Andrews Prestressed Concrete, the coefficient of thermal expansion ( $\alpha$ ) for the bridge girders was found to be on the order of 4.6 to 5.3x10<sup>-6</sup>in./in./°F. In this work an  $\alpha$  equal to 5.0x10<sup>-6</sup>in./in./°F was used. The theoretical abutment displacement over time using the average bridge temperatures shown in Figure 4.6 can be seen in Figure 4.16. The range of theoretical displacement is near 1.0 in. which is greater than the observed 0.8 in. displacement of the abutment.

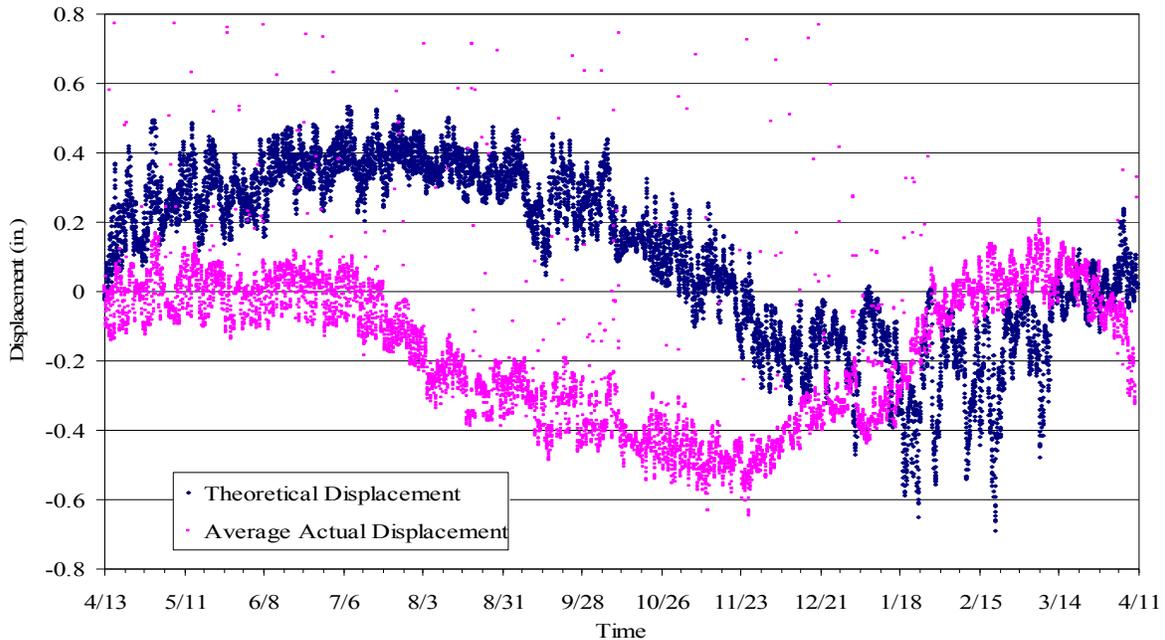
**Figure 4.17. Theoretical and average actual abutment displacement of the northbound bridge over time (combined Figure 4.15 and Figure 4.16)**

A comparison of the theoretical and average measured abutment displacement can be seen in Figure 4.17. From July to the beginning of December the theoretical and actual displacement follow the same trend (i.e., the abutment displaces to the north as the temperature cools). Beginning in December the abutment displaces to the south while the theoretical displacement predicts continued displacement to the north corresponding to reduced temperatures. Others (Hassiotis,2005) have observed somewhat similar behavior during the winter months and concluded that the behavior might be caused by (1) the bridge pushing against frozen soil as it warms in the spring and (2) soil filling the gap behind the abutment as the bridge contracts during the winter. Hassiotis also observed “strain-ratcheting” of the soil behind the abutment. In the current case with a long approach slab that is attached directly to the abutment a phenomena that produces a similar ratcheting behavior is observed. As the bridge expands, it pushes against the approach slab. Initially, the friction beneath the approach slab and forces at the approach slab/pavement expansion joint resist this motion. If the bridge expansion is sufficiently large, eventually the friction forces will be overcome and the slab will slide. As the bridge cools, the bridge will eventually slide the slab in the opposite direction. Appendix A presents a simple analytical model that helps to understand this phenomenon.

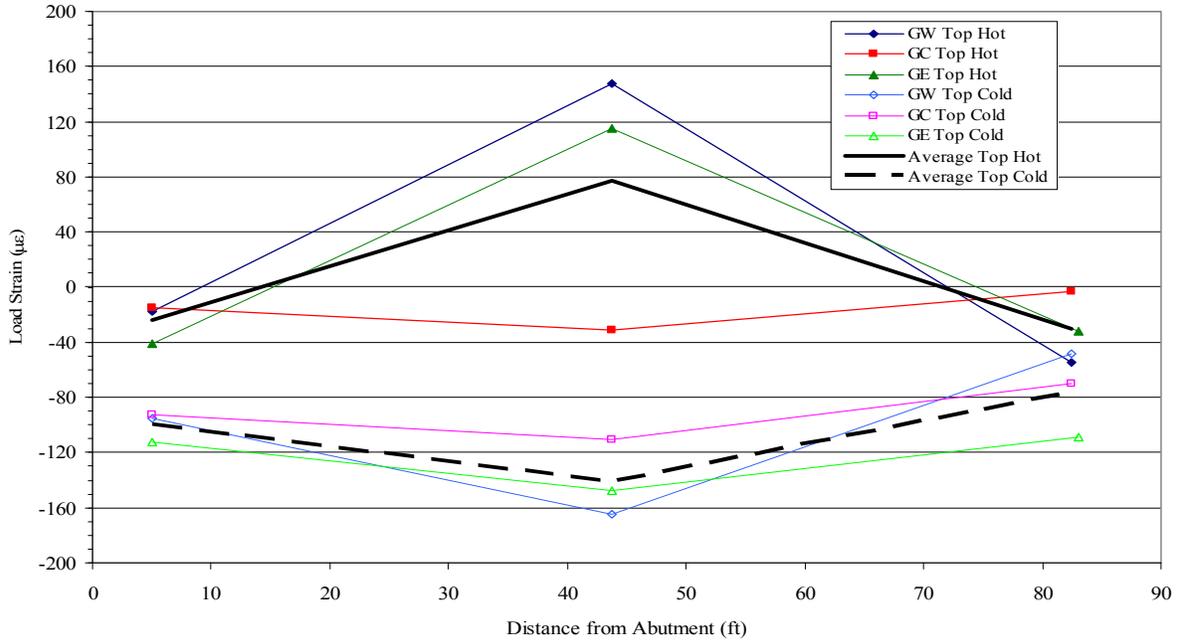
**Figure 4.23. Load strain variation at the top of the northbound bridge girders with respect to position**

The recorded girder load strains are shown in Figure 4.23 and Figure 4.24, top and bottom respectively, plotted against gauge position along the girder for the hot and cold days identified in Section 4.1.1. Variation across the bridge is shown by the different series for each girder. Similar strains might be expected for each girder for each case (top, bottom, hot, cold), but this is not always the case. On the cold day the load strains of each girder compared fairly well at all 3 positions. However, but on the hot day the mid-span load strains of the center girder, GC, and west girder, GW, did not compare as well. To study the overall, general behavior of the bridge, the load strains for the top and bottom of the bridge were averaged and are shown in Figure 4.23 and Figure 4.24, respectively.

Knowing the load strains in the top and bottom flanges of a section, the distance to the gauge location ( $y_1$  and  $y_2$ ), section properties (area,  $A$ , and moment-of-inertia,  $I$ ), and assuming a modulus of elasticity,  $E$ , the moment and axial load on the composite section (shown in Figure 4.25) can be found. Note that in this discussion axial force that cause tension is positive and moment that causes tension in the bottom fiber is positive.
