# Precast Concrete Elements for Accelerated Bridge Construction

## Volume 3. Laboratory Testing, Field Testing, and Evaluation of a Precast Concrete Bridge: Black Hawk County

**Final Report**  
**January 2009**

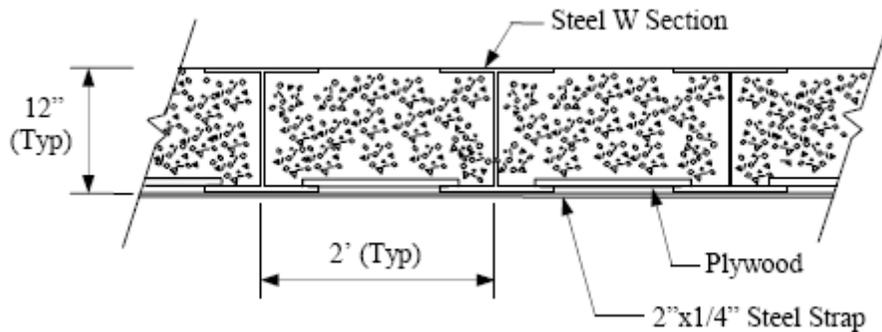
The Beam-in-Slab Bridge (BISB), has proven, through both in-service use and laboratory and field testing, to be an effective replacement alternative for spans of up to 50 ft. The original BISB system consists of longitudinal W12 sections spaced on 2 ft centers that serve as the main structural elements. The girders are restrained during the construction phase by steel straps welded to the bottom flanges of the beams. A plywood stay-in-place formwork 'floor' rests on the bottom flanges. A 3 in. gap is left between the plywood and the web to allow for contact of the concrete with the bottom flange. To complete the structure, unreinforced concrete is placed between the steel sections and struck off even with the top flanges. A cross section of the original BISB design is presented in Figure 1.1 (Klaiber, et al., 1997).

**Figure 1.1. BISB cross section**

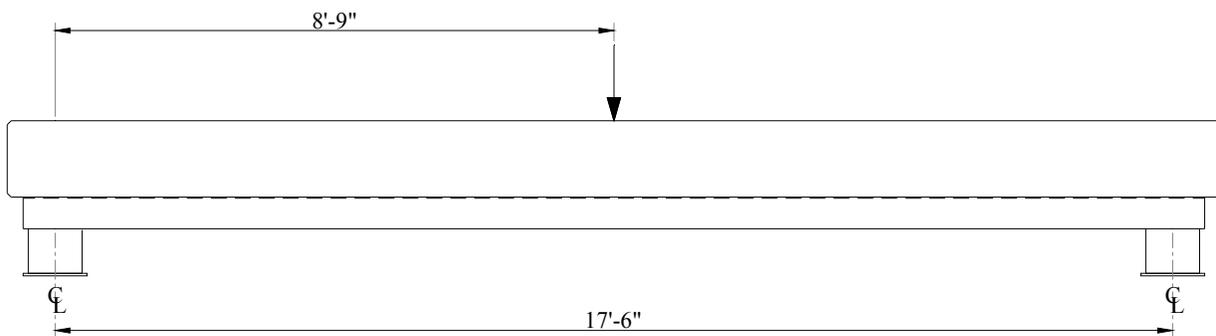
Due to a higher than anticipated capacity, the load frame for the positive ultimate strength test was not sufficient for failing the abutment cap. Thus, the negative ultimate bending strength was also investigated for Cap 1. The cap was placed within the load frame as shown in Figure 2.6. The actuator was placed on the floor, and pushed on the bottom of the cap, creating negative bending.

a) Positive strength test dimensions

**Figure 2.5. Positive ultimate strength bending test set-up**

b) Photograph of test

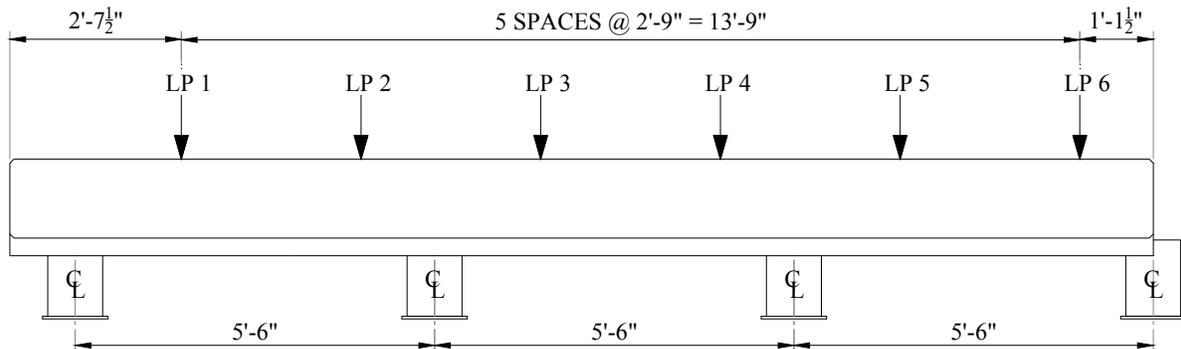
The service level test set-up for Cap 2 is shown in Figure 2.8. Four piles were spaced at 5'-6" and the first load point was located 2' - 7½" from the edge of the cap, with the remaining load points evenly spaced on 2' - 9" centers. Service level loading followed the same procedure used for Cap 1.

**Figure 2.8. Cap 2 service test set-up**

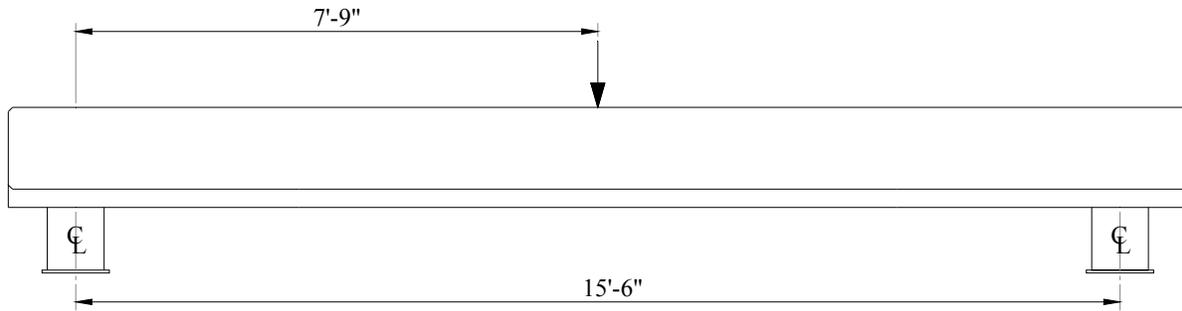
Cap 2 was tested for positive bending strength in the same manner as Cap 1. Two piles were used for supports, spaced at 15'-6". A single point load was applied at the midspan of the abutment cap to produce positive bending as shown in Figure 2.9. A negative strength bending test was not performed on Cap 2 as the abutment cap was failed during the positive strength bending test.

a) Strength test dimensions

b) Photograph of test

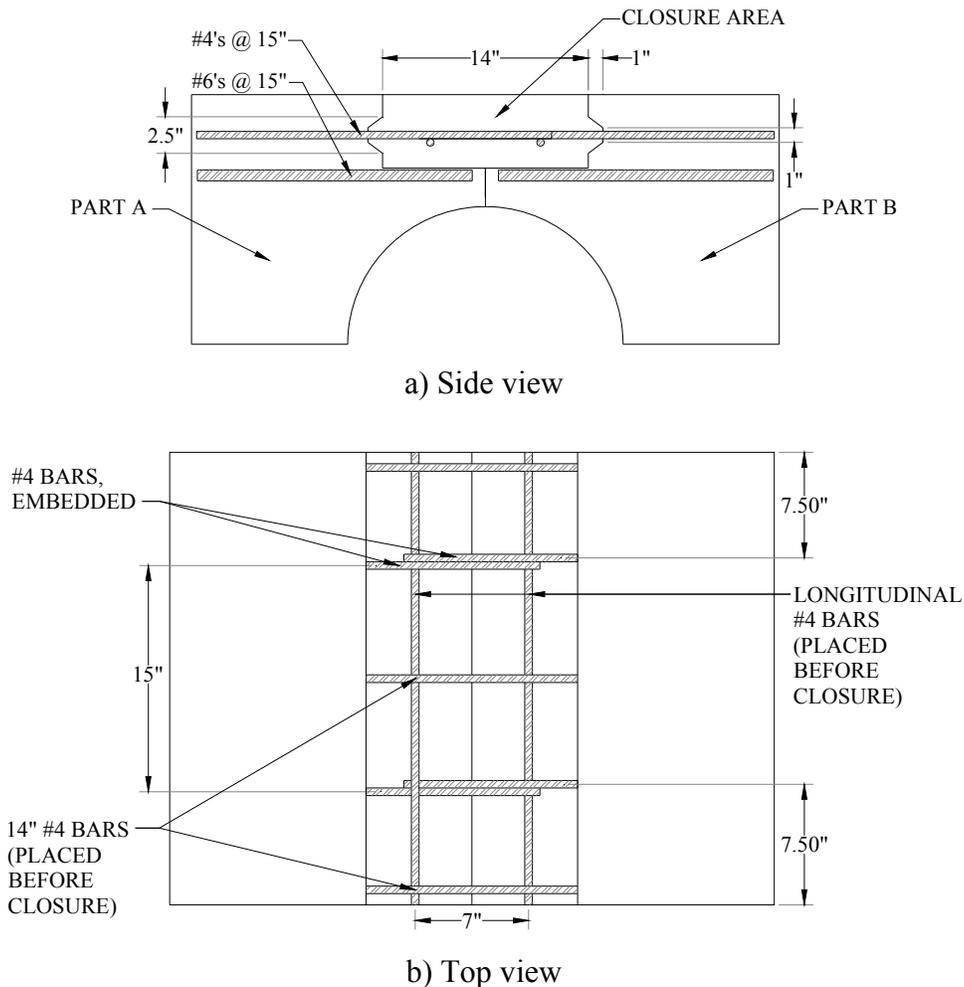
Black Hawk County designed the Type 1 Connection shown in Figure 2.12. This connection is characterized by the #4 reinforcing bars protruding out through the shear key of each precast panel on 15 in. centers into the closure area (see Figure 2.12). Before leaving the casting yard, #4 longitudinal bars that run the entire length of the closure are tied to the protruding #4 bars. After the deck panels are placed in the field, 14 in. long #4 bars are centered between the protruding #4 bars before the concrete is placed.

**Figure 2.12. Type 1 Connection**

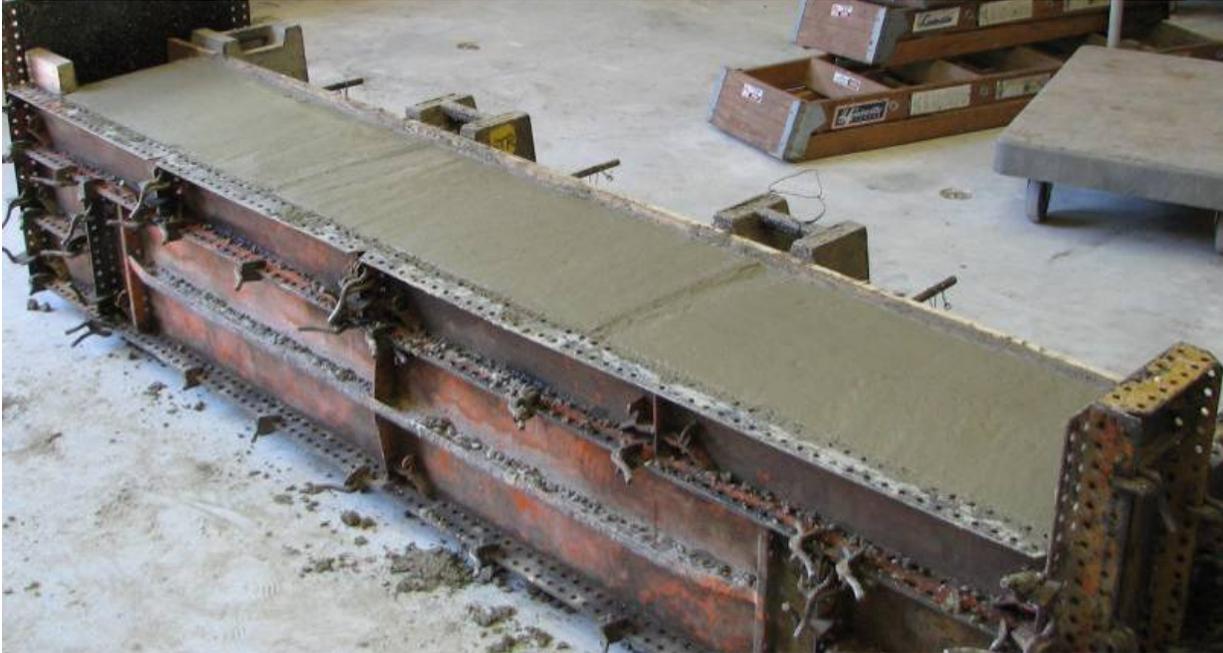
**Figure 2.15. Finished concrete surface of Type 1 Connection**

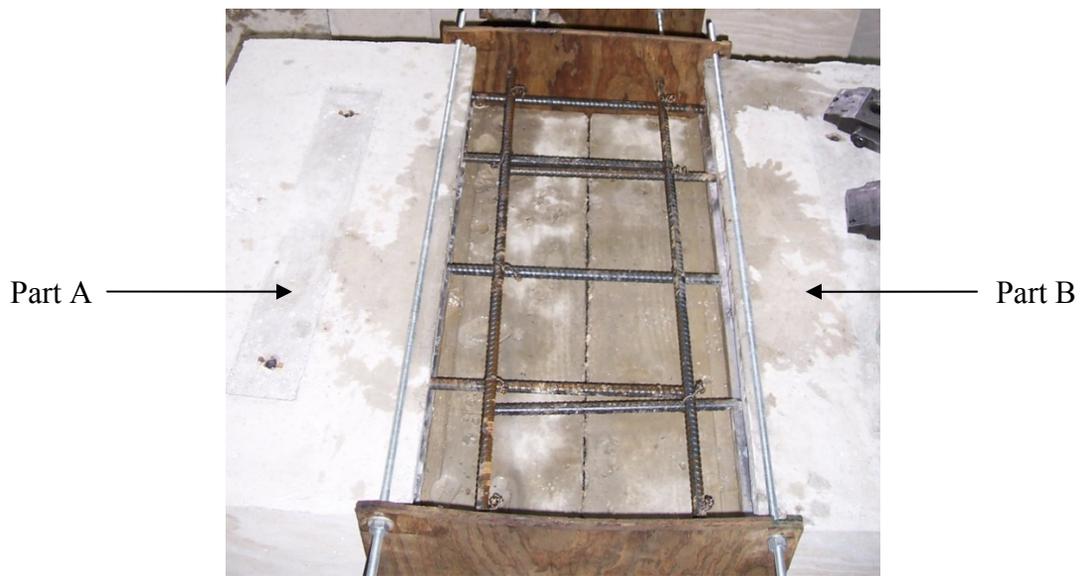
**Figure 2.16. Position of reinforcing bar before closure**

For the closure pour, the specimens (Parts A & B) were arranged as shown in Figure 2.12. Pieces of plywood, held in place with threaded rods, were used to cap the ends of each closure area. Six 30 in. long #4 bars (two for each specimen) and nine 14 in. long #4 bars (three for each specimen) were placed in the closure area. The 30 in. bars were placed longitudinally in the joint, one on each side, 3.25 in. from the center of the joint. The three 14 in. bars for each specimen were placed transversely across the joint. One bar was centered between the protruding bars and two bars were placed near the end of the closure area; this reinforcing is shown in Figure 2.16.

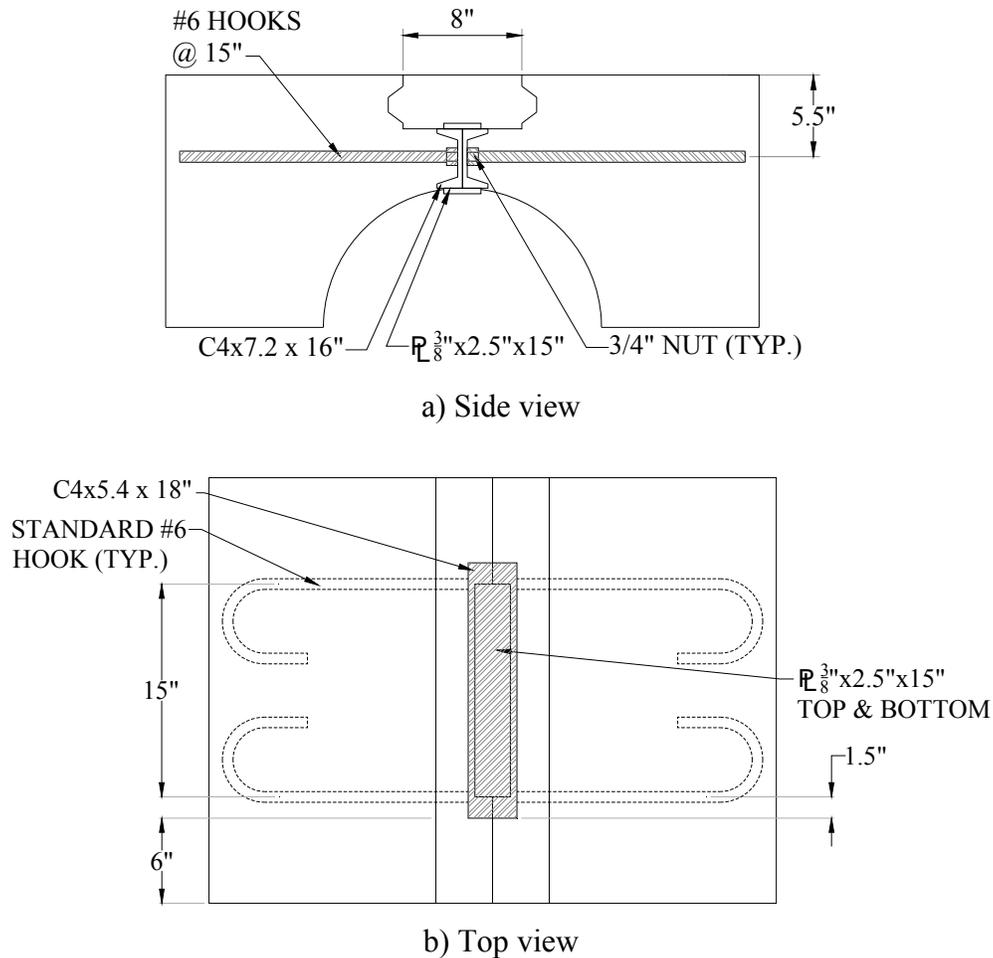
Type 2 Connection, presented in Figure 2.17, uses no reinforcing bar in the closure area, thus allowing a smaller closure area to be used. Instead of reinforcing bar, two steel plates are welded to the top and bottom of steel C-channels at the bottom of the joint to connect the panels. Before casting the panels, the C-channel is welded onto the #6 reinforcing bars that run transversely across the panels. In the field, the plates are welded to the top and bottom of the channel, after which concrete is placed in the closure area.

**Figure 2.17. Type 2 Connection**

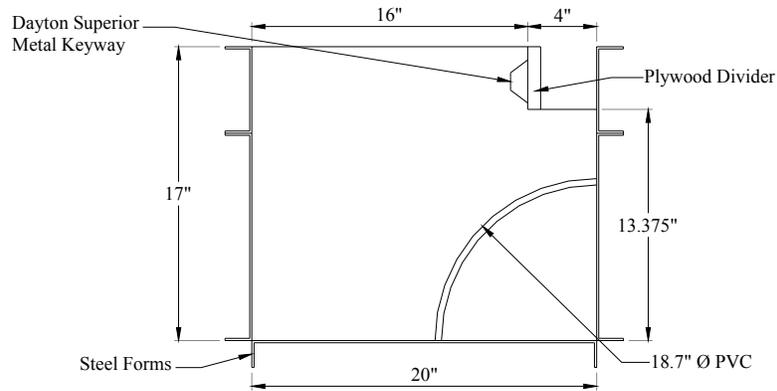
external ties positioned over the plywood dividers were used for each set of forms to maintain the width of the forms. The layout of the formwork for the Type 2 Connection is presented in Figure 2.18.

**Figure 2.18. Type 2 Connection form details**

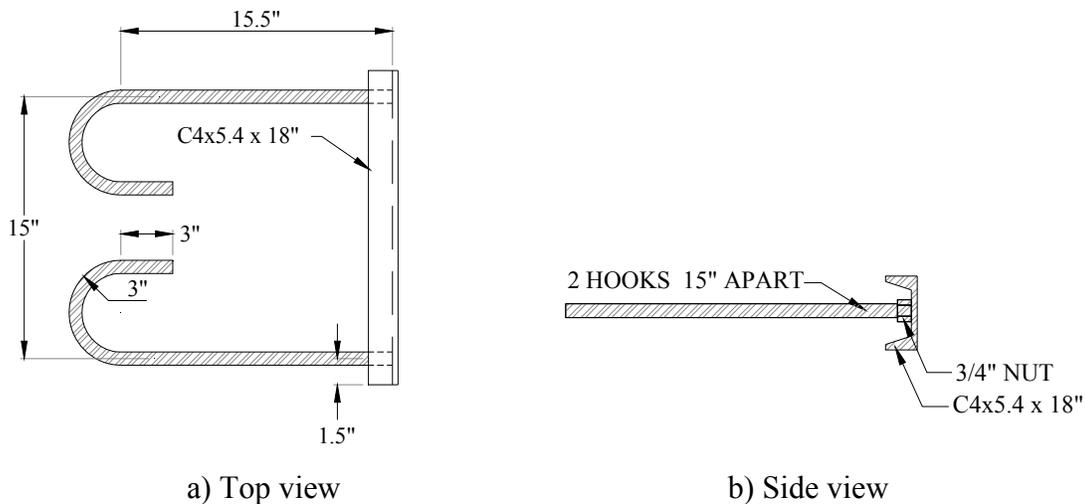
Welding the two #6 reinforcing bars to the C-channels provides the connection between the channels and the panels. The reinforcing bars were cut to 28 in. and were bent into 180 degree hooks with a minimum radius and tail length of 3 in. Preparation for the welding of the #6 bars to the C-channels included grinding off rust on the reinforcing bar, and the welding of a  $\frac{7}{8}$  in. nut to the end of the rebar for the purpose of increasing the weld area between the reinforcing bars and the channels (C4x5.4 18 in. long). The center of the #6 bars were positioned at a distance of 1.5 in. from the end of the C-channel, and welded in place. Chairs were cut to a vertical height of 11 in. to provide support for the #6 bars at the desired location 5.5 in. from the top of the connection. Details of the reinforcement for the Type 2 Connection are shown in Figure 2.19.

**Figure 2.19. Type 2 Connection reinforcing detail**

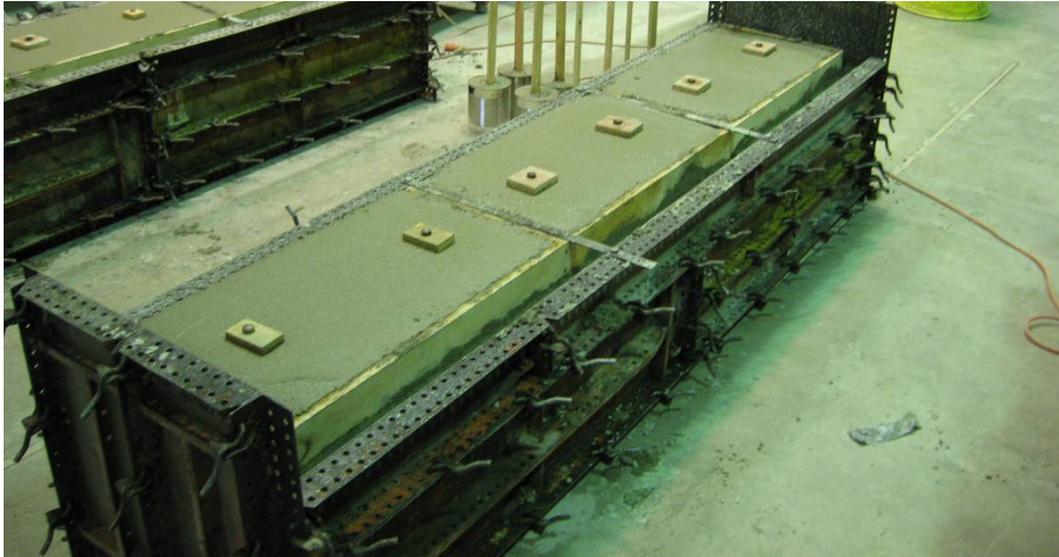
**Figure 2.20. Finished concrete and positioned anchors for Type 2 Connection**

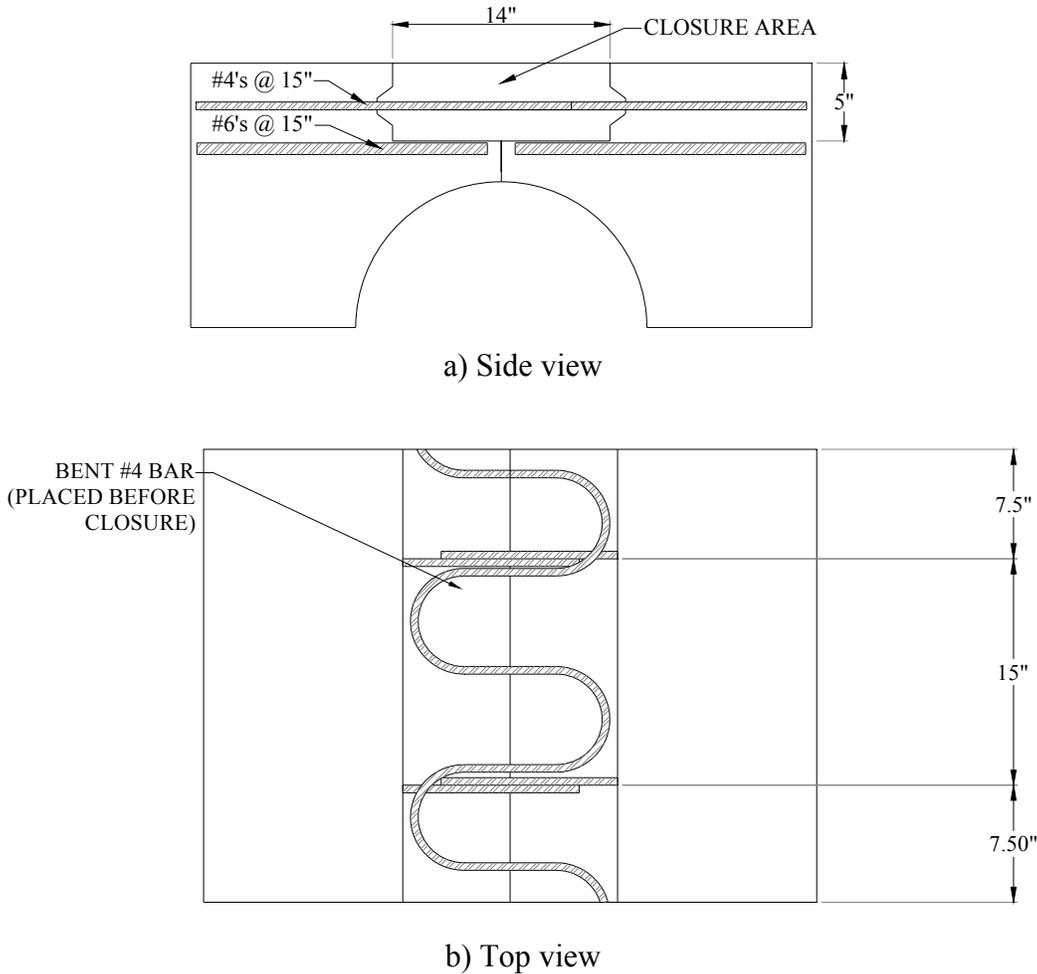
Formwork for the Type 3 Connection was assembled into a single form, 96 in. long x 40 in. wide. The forms were uniformly 17 in. tall. The steel forms were oiled to allow cured concrete to easily separate from the concrete. Plywood was again used to separate the forms into sections. Notches were cut into the plywood to allow 1 in. thick x 5 in. tall x 8 ft. long boards to be added to the formwork for the purpose of forming the vertical portion of the closure area. Metal keyways were prepared in the same manner as the keyways for the Type 1 Connections, and were attached to the boards to form the shear key. PVC pipe 18.75 in. in diameter was cut into three 30 in. long pieces, cut in half longitudinally, and centered in the form. Boards (1 in. thick x  $2\frac{5}{8}$  in. tall x 30 in.) were placed on top of the PVC to separate each section. A single exterior tie was used to maintain the 40 in. distance between the sides of the forms.

**Figure 2.22. Type 3 Connection**

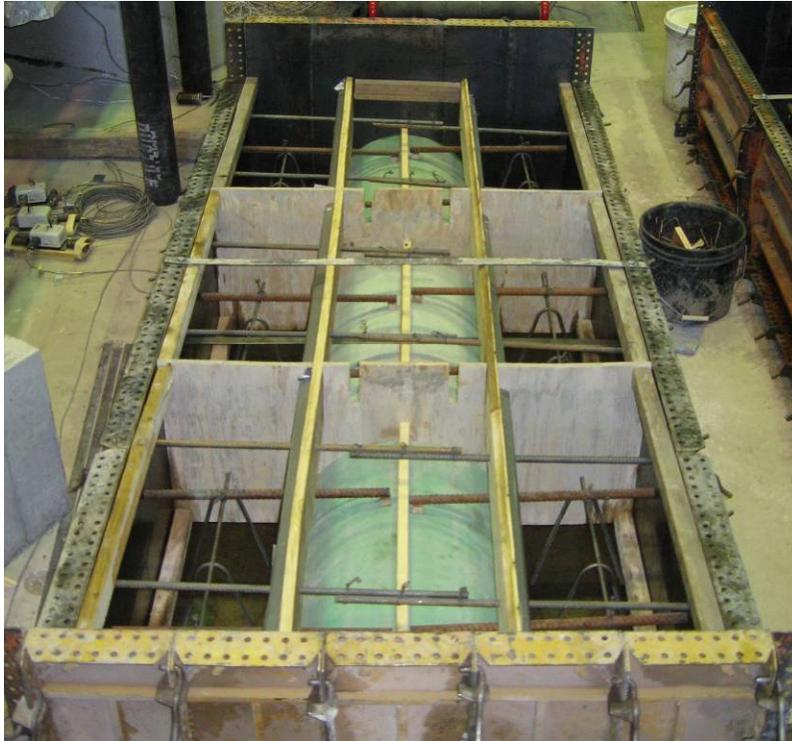
**Figure 2.23. Completed formwork for Type 3 Connection**

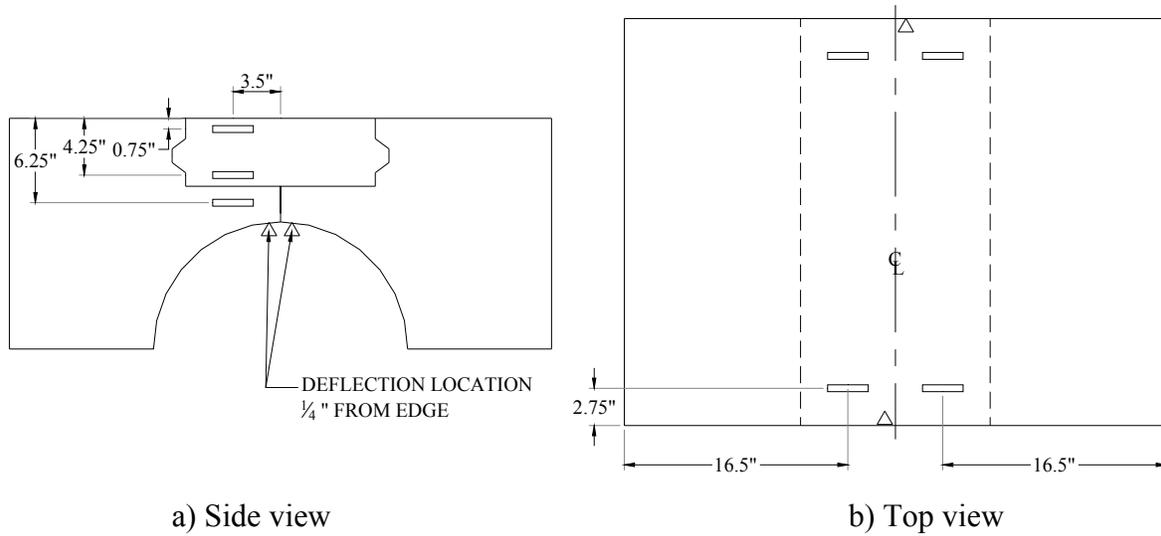
**Figure 2.28. Strain gage locations in all three connections**

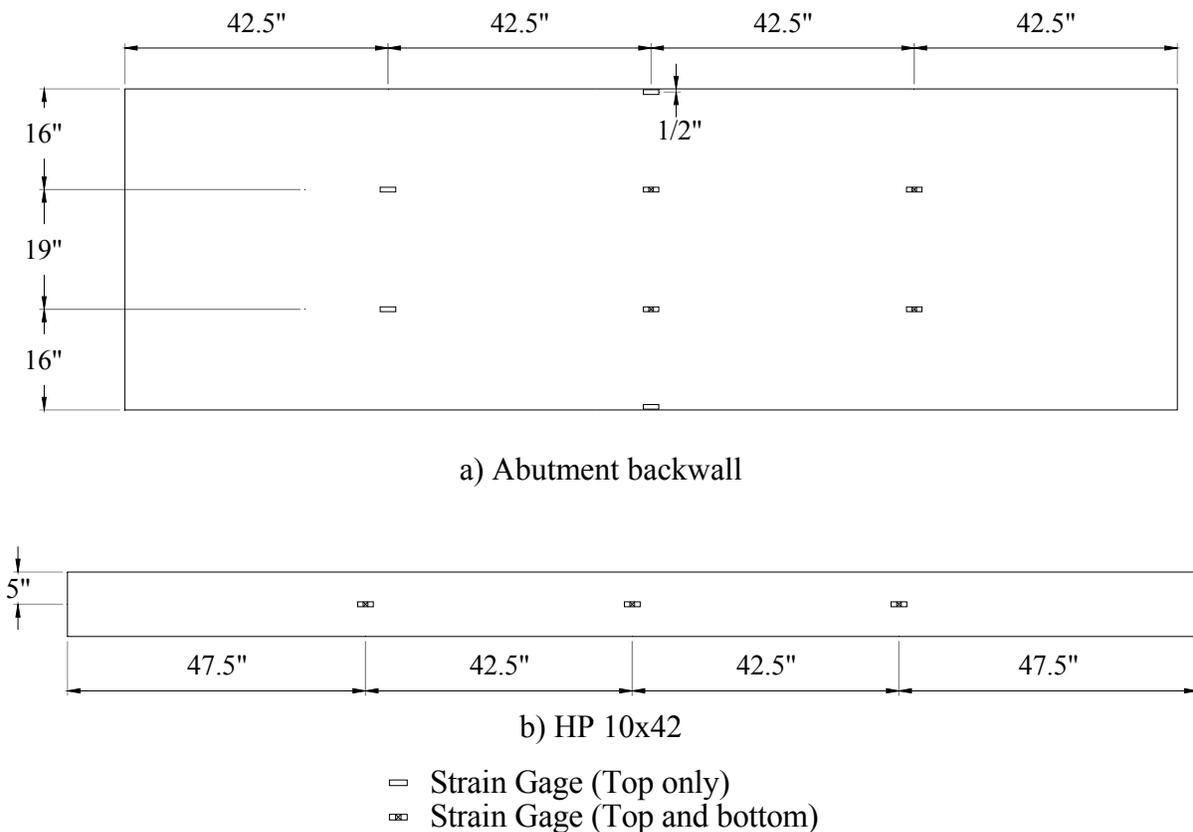
**Figure 2.35. Strain gage instrumentation for backwall service test**

This section presents the results of the abutment backwall testing described in Chapter 2.3. Labeling for all of the instrumentation used (see Figure 2.35 for locations) is presented in Figure 3.18. As previously stated, testing started on the backwall alone, that is, the backwall was not supported by the H-piles. After applying various combinations of load at the three load points, the H-piles were moved into position on the long sides of the backwall. Load-deflection curves at DC2 while subjected to load at Load Point 2 are shown in Figure 3.19 (refer to Figure 2.38 for the load positions). Table 3.9 presents the deflection data for a 1 kip, 3 kip, and 5 kip simulated triangular load, both without and with the H-piles. Stiffness of the wall was dramatically increased by the addition of the H-piles; deflections decreased by about 80%. The reduction in deflection occurs because the addition of the H-piles increases the longitudinal stiffness of the wall.

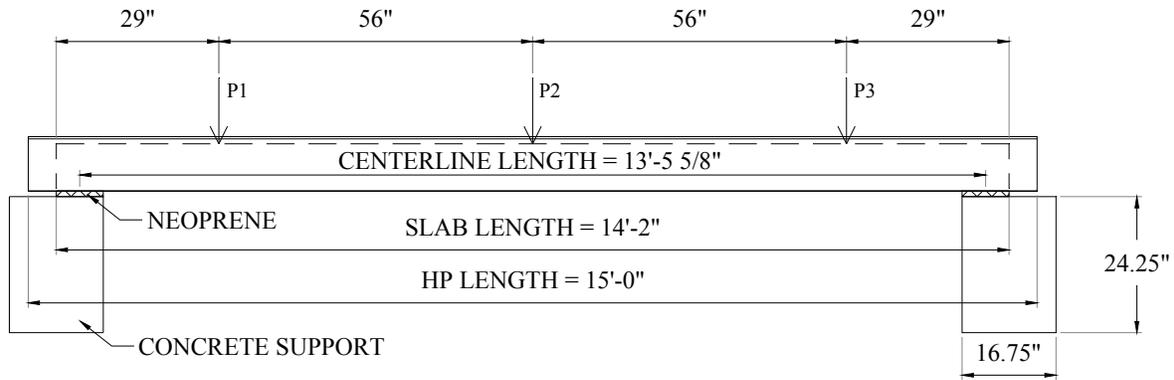
Service testing was performed, both without and with the HP 10x42's, by applying load at three points on the top of the backwall, shown in Figure 2.38. Starting without the HP10x42's, the load points were first loaded individually, and then all loaded at different magnitudes of load, to create a triangular load distribution; the ratio of P1 to P2 to P3 was 1 to 3 to 5. After this testing, the HP 10x42's were installed and positioned so that the backwall was resting on the flanges of the two steel sections as shown in Figure 2.37. Again, the load points were loaded individually and then loaded simultaneously using the same P1/P2/P3 ratio. Neoprene pads were placed under each end of the backwall to maintain the centerline span distance of 13' - 5" for testing both without and with the HP 10x42's (see Figure 2.38).

**Figure 2.38. Position of loads used in backwall service load tests**

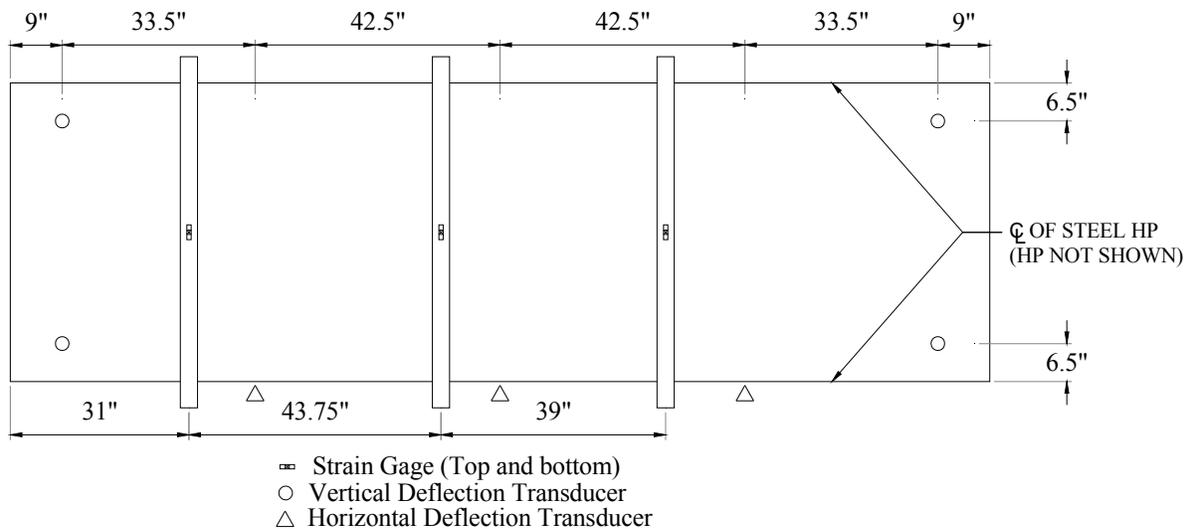
Possible rotation of the piles about their longitudinal axis under the high loads expected during the ultimate load capacity test caused concern about the stability of the system which resulted in slight modifications to the test set-up. To minimize this rotation, steel strap (3 in. x  $\frac{3}{8}$  in. x 5 ft. long) were bolted to the top and bottom flanges of the HP 10x42's (see Figure 2.39). Strain gages were mounted on the straps to determine strains in these elements during testing. Additionally, three LVDT's were attached to the bottom of the flanges and measured any horizontal movement between the steel sections, and four LVDT's were attached to the bottom face of the backwall at the corners near the concrete supports. The location of the additional instrumentation is shown in Figure 2.39.

**Figure 2.39. Additional instrumentation used in the ultimate strength test of the abutment backwall**

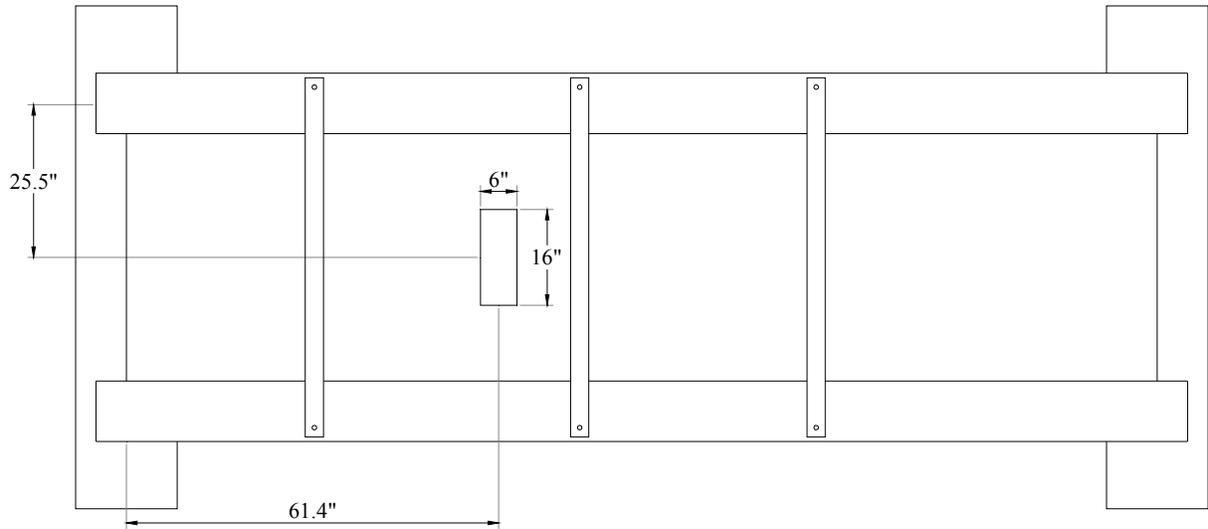
The position of the load in the ultimate strength test is 61.4 in. from the bottom of the wall, as shown in Figure 2.40. This location corresponds to the location of the resultant force due to worst case soil loading and five 5-ton axles spaced at 4.25' on the abutment. Load was applied at this location until the wall was unable to support the load.

a) Location of load for strength test

b) Photograph of test in progress

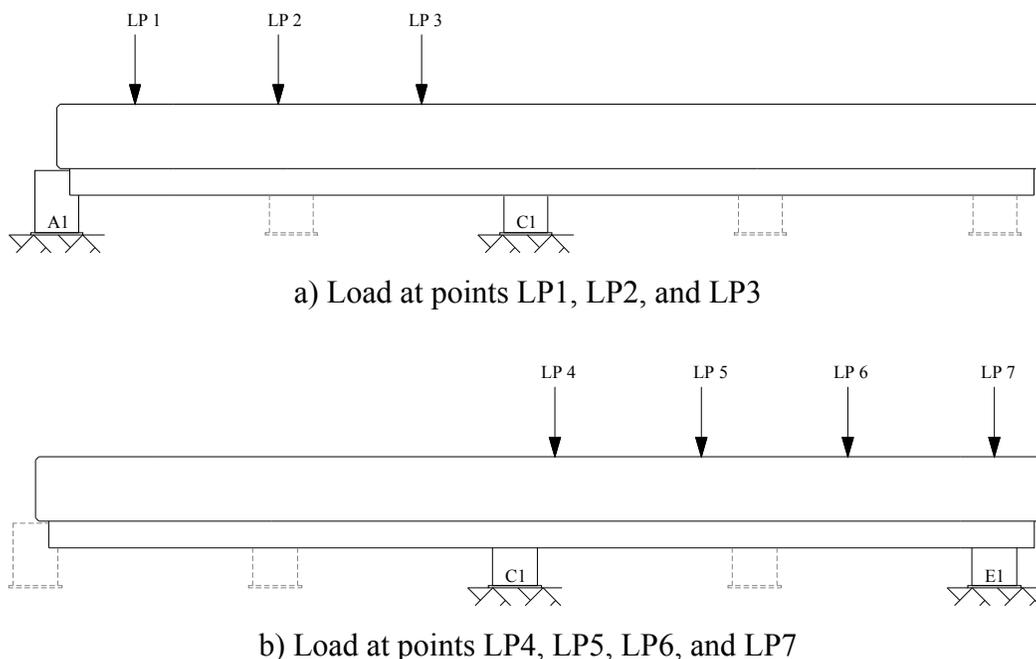
**Figure 3.3. Support conditions for Cap 1 for each load point.**

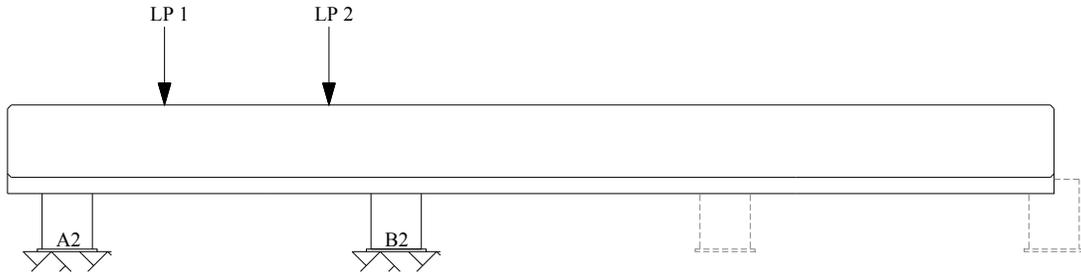
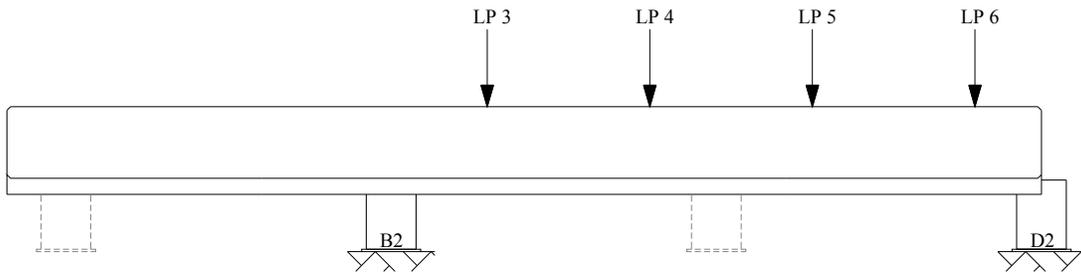
a) Load at LP1 and LP2

b) Load at LP3, LP4, LP5, and LP6

**Figure 3.4. Support conditions for Cap 2 for each load point**

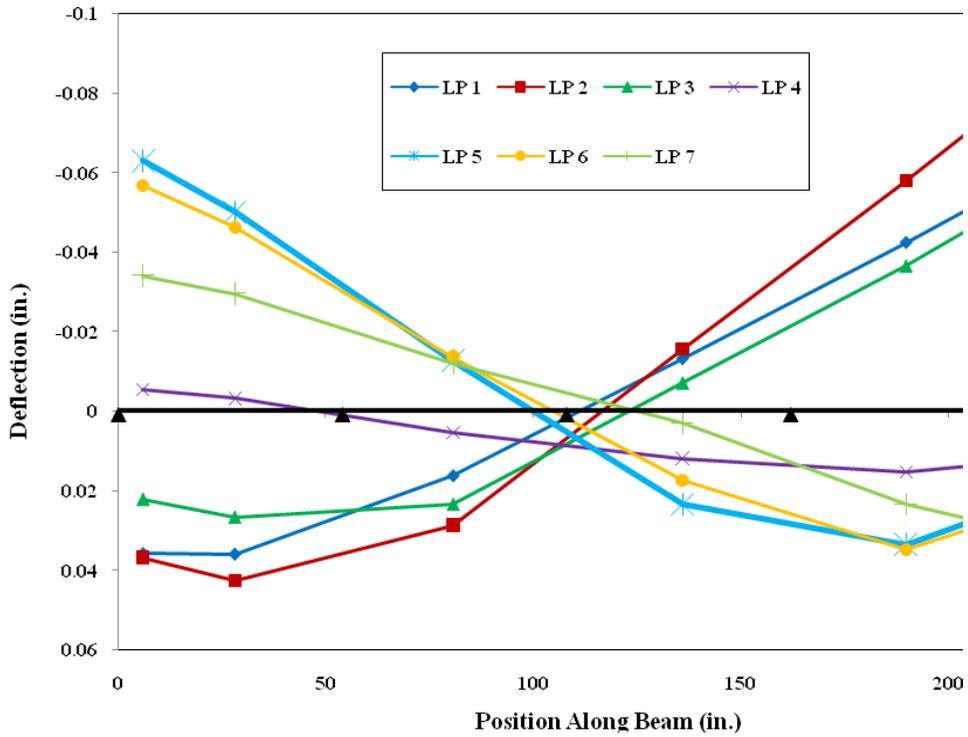
**Figure 3.5. Deflection profile for Cap 1 for the seven load points used**

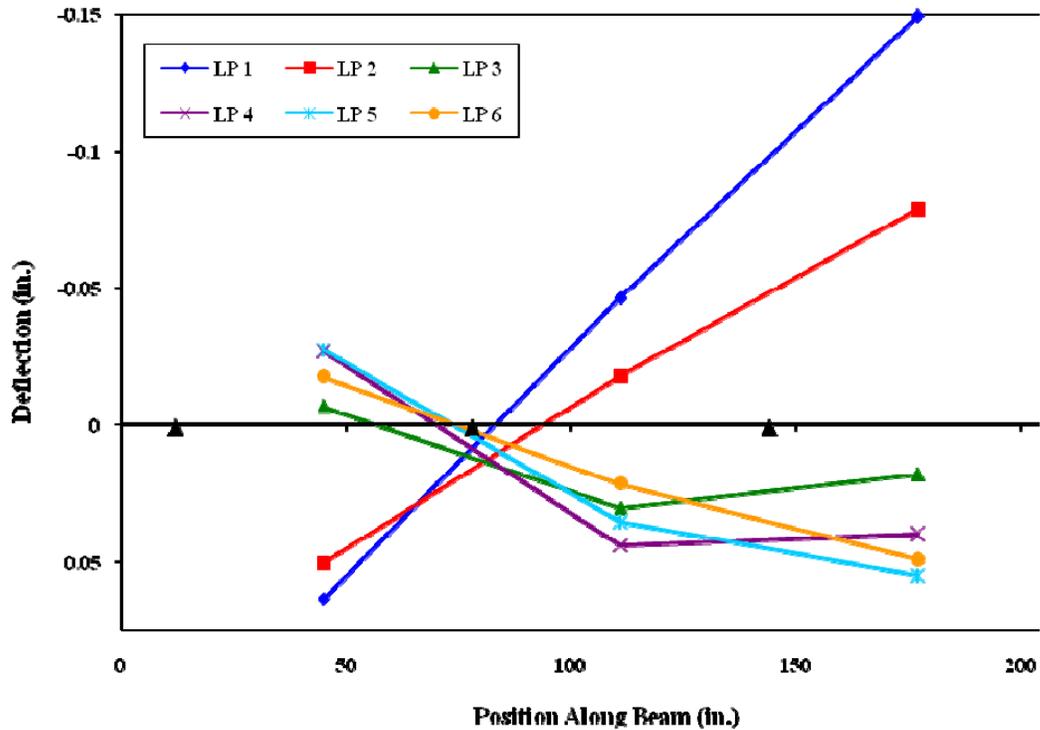
Figure 3.6. Deflection profile for Cap 2 for the six load points used

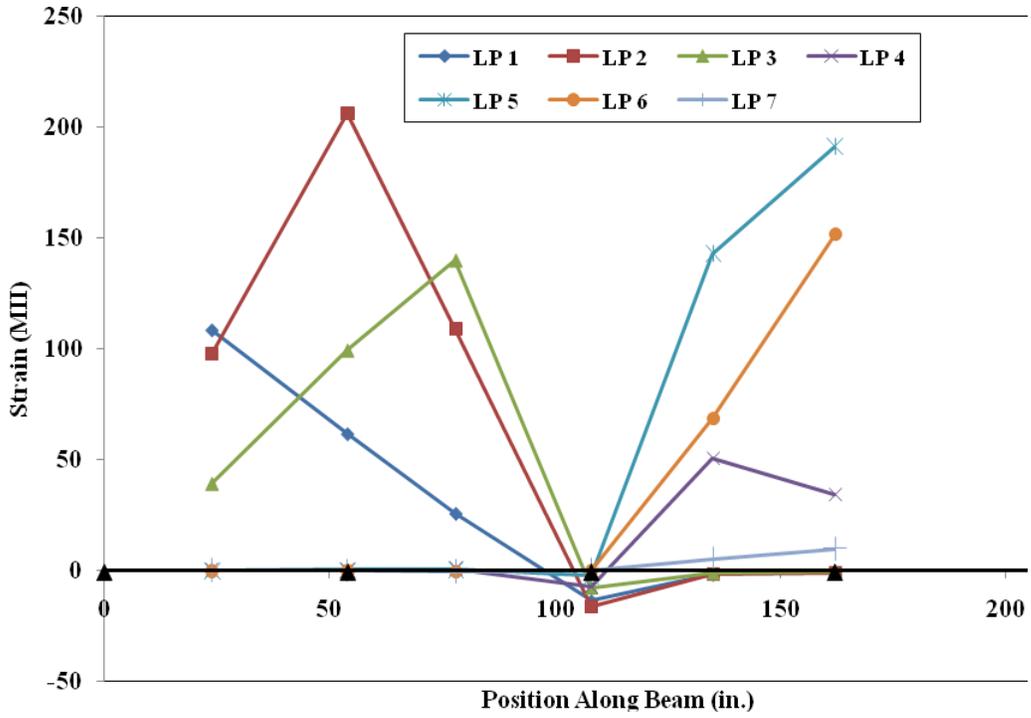
Figure 3.7. Steel strains for Cap 1 for the seven load points used

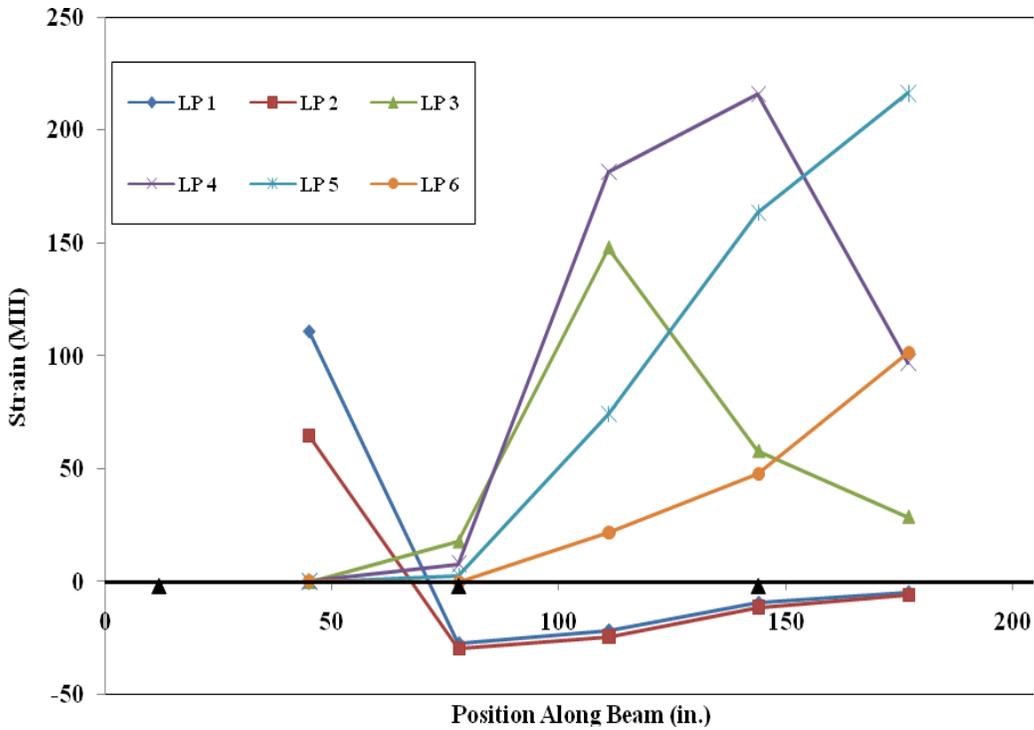
Figure 3.8. Steel strains for Cap 2 for the six load points used

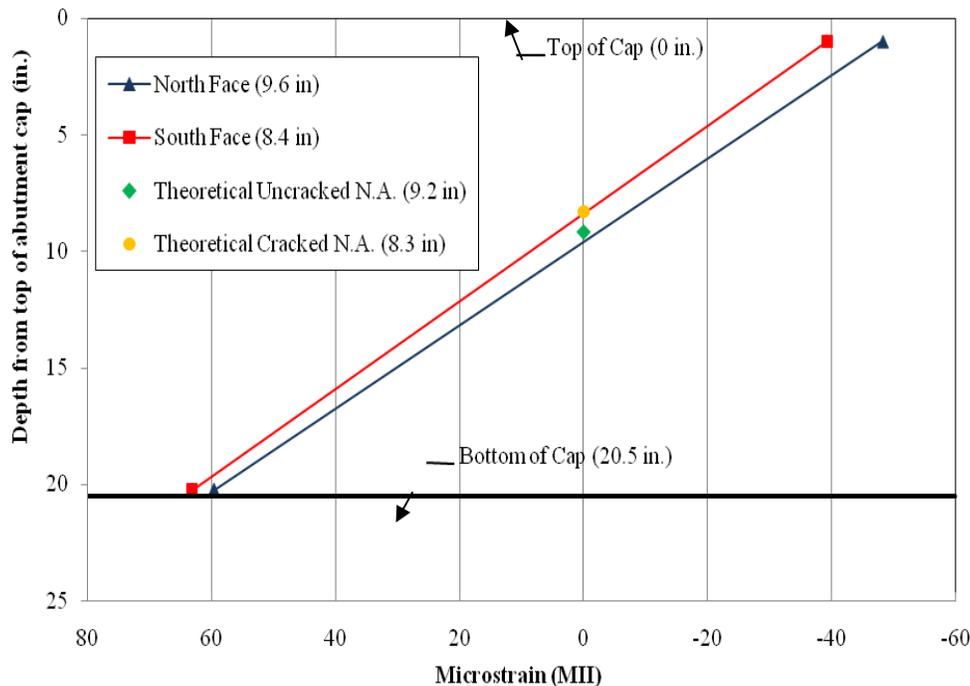
Using this equation, the theoretical uncracked neutral axes 9.2 in. from the top of Cap 1 and 7.95 in. from the top of Cap 2 were calculated. The theoretical cracked neutral axes were calculated to be at 8.3 in. and 6.0 in. for Cap 1 and Cap 2, respectively. The neutral axis at Section 2 for both the north and south faces of Cap 1 while the load was at the second load position is shown in Figure 3.9. Note that the top gages are 1 in. below the top of the cap. Both the theoretical cracked and uncracked neutral axis locations are also plotted on this graph. Taking experimental error into account, the laboratory results are in moderately good agreement with the theoretical data points. From Figure 3.9 and Figure 3.10, it appears that there is some eccentricity being developed in the system in that the north face neutral axis is approximately 1 in. lower than the south face neutral axis. A possible explanation for this discrepancy is the uneven bearing on the pile supports or the loading was applied off center.

**Figure 3.9. Cap 1 neutral axis at Section 2, Load Position 1, 40 kip load**

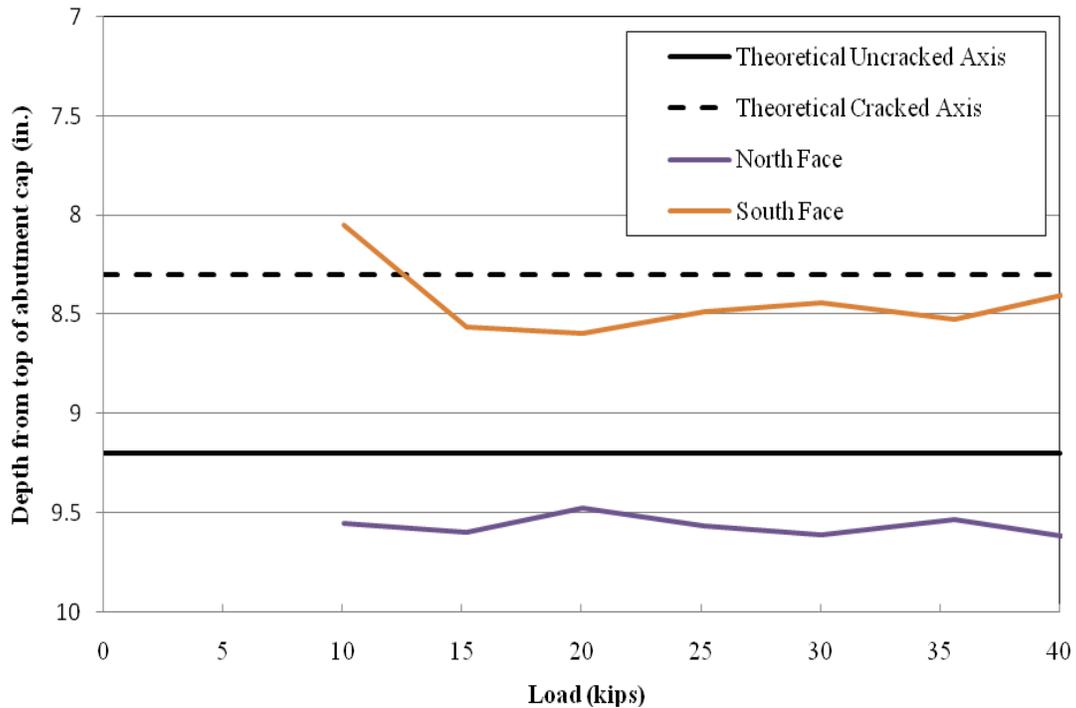
**Figure 3.10. Cap 1 neutral axis at Section 2 plotted against load**

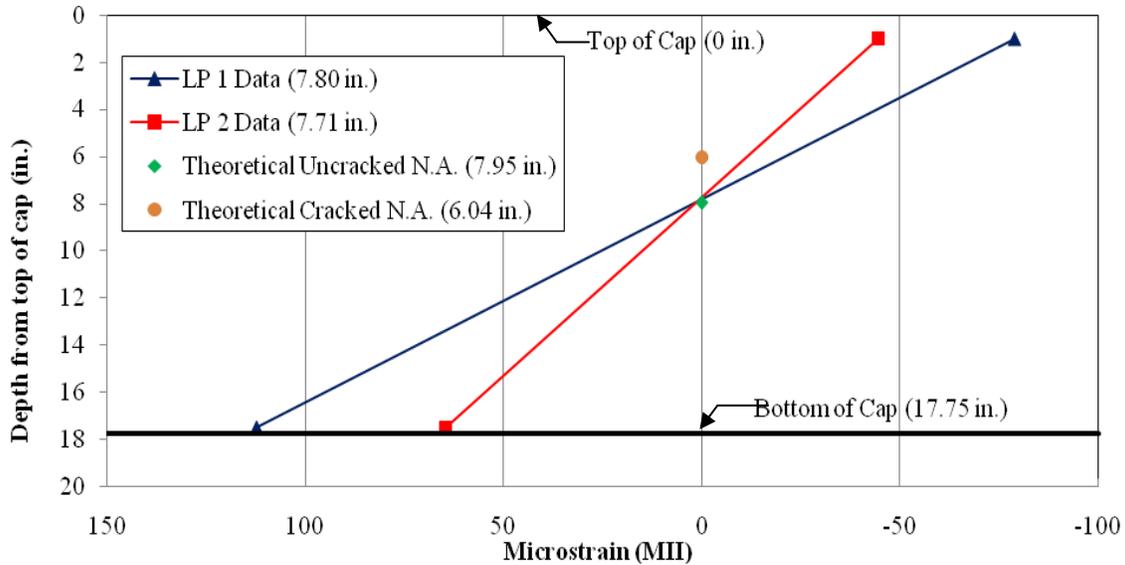
The neutral axis calculated from the service testing of Cap 2 and also the theoretical cracked and uncracked axes locations are presented in Figure 3.11. The lines were drawn using the data from the first and second load positions, using the top concrete strain gage and the steel gage at Section 1. Both the theoretical cracked and uncracked neutral axis locations are plotted on the graph (6.04 in. and 7.95 in. from the top of the cap, respectively), as can be seen the experimental axes are within experimental error of the uncracked axis.

**Figure 3.11. Cap 2 neutral axis at Section 1, Load Positions 1 and 2, at 40 kips**

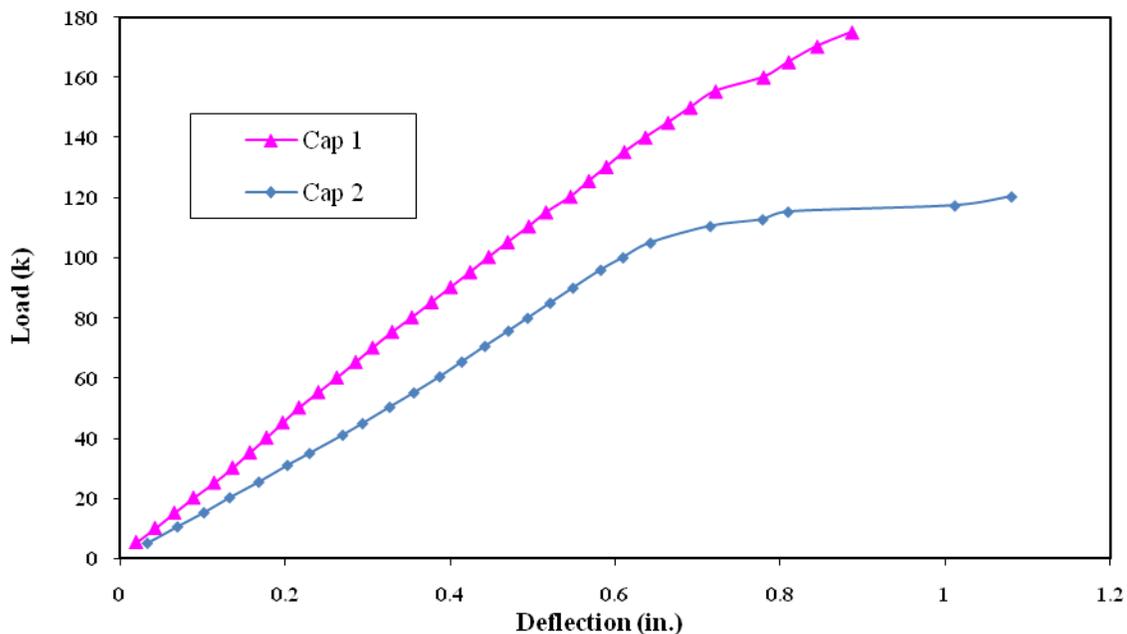
Both abutment caps were tested to determine their maximum positive moment capacity, and Cap 1 was also tested to determine maximum negative capacity. Cap 1 did not experience failure during the positive capacity test as the limit of the load frame was reached. The threshold for failure was considered to be the point at which load could no longer be sustained by the caps. Load-deflection curves for the positive moment capacity tests for Cap 1 and Cap 2 are presented in Figure 3.12. Notice that the curve for Cap 1 only starts to show non-linear behavior before the test ended (capacity of load system reached) and that the curve for test 2 shows a traditional ductile failure. Cap 1 supported 175 kip, which corresponds to a moment of 765 kip-ft, and

deflected 0.87 in. before the test was terminated, while Cap 2 failed when a load of 120 kip, corresponding to a moment of 465 kip-ft, was applied and a deflection of 1.08 in. occurred.

**Figure 3.12. Plot of load vs. deflection for positive capacity tests of caps**

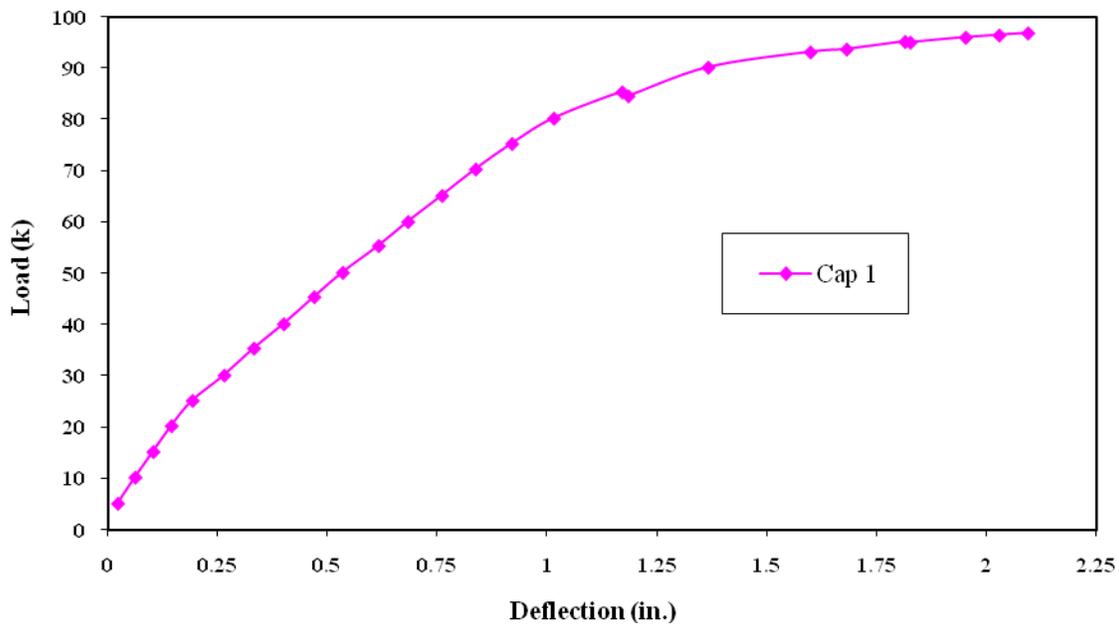
Cap 2 was not tested for negative moment capacity due to the damage sustained during the positive capacity test. The load-deflection curve for the negative moment capacity test for Cap 1 is shown in Figure 3.13. As is clearly seen, Cap 1 experienced a ductile failure at 97 kips, which induced a moment of 363 kip-ft in, deflecting 2.1 in. Factored experimental moment capacities for the caps, along with their factored theoretical capacities (determined from strain compatibility), are presented in Table 3.5. The design moment for the caps for both positive and negative bending is 156 kip-ft. Both caps exceed the positive capacity called for by the designer, while Cap 1 exceeded the capacity required for negative moment capacity. While not tested for negative moment capacity, Cap 2 should have more than enough capacity to meet the moment demand required of it. This can be deduced from the excellent performance of Cap 1 coupled with the fact that Cap 2 has more reinforcing steel than Cap 1 during negative bending. According to Black Hawk County, Cap 2 is much more cost effective than Cap 1, as Cap 2 saves approximately \$1000 per abutment cap in material cost. Due to adequate moment capacity and significant cost savings, Cap 2 should be used for future PMBISB projects.

**Figure 3.13. Plot of load vs. deflection for negative capacity test of Cap 1**
