# Precast Concrete Elements for Accelerated Bridge Construction

## Volume 3. Laboratory Testing, Field Testing, and Evaluation of a Precast Concrete Bridge: Black Hawk County

**Final Report**  
**January 2009**

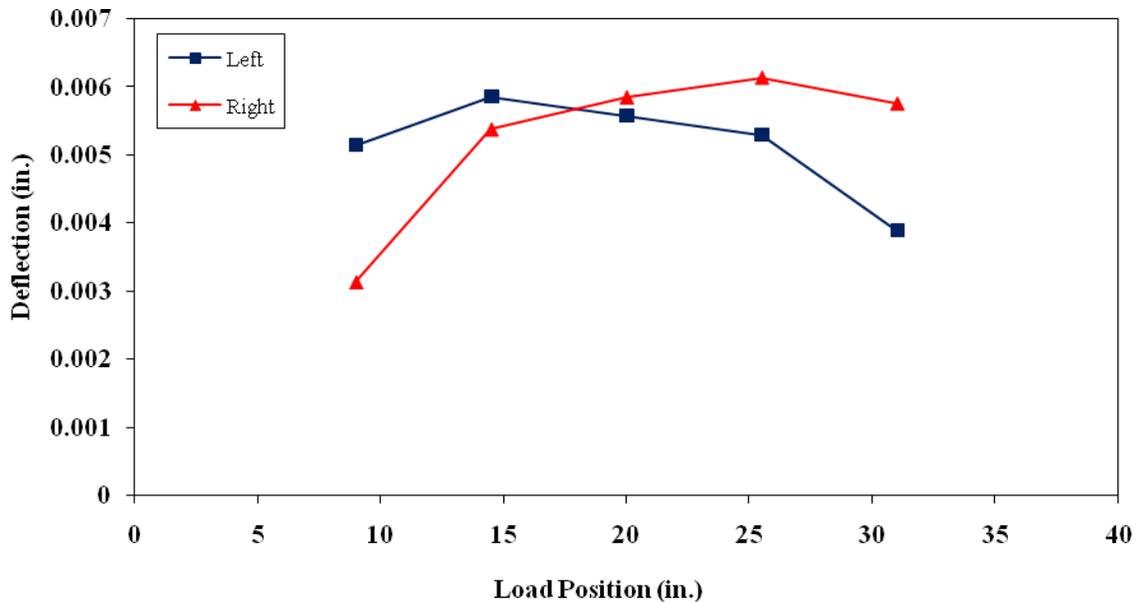
Connections, the side of the specimen that is carrying the load deflects more than the other side, as is expected since there is no positive connection between the instrumented areas (see Figure 2.28 for deflection instrumentation locations). The Type 2 Connection deflections show continuity between the two sides of the specimen. This was expected as the welded plates create a positive connection in the Type 2 Connection. The instrumentation labeling for the concrete gages on the top surface of the specimens is shown in Figure 3.17. Table 3.6 presents the highest compressive strains that occurred in these strain gages for all three connection types.

**Figure 3.14. Type 1 Connection service deflections**

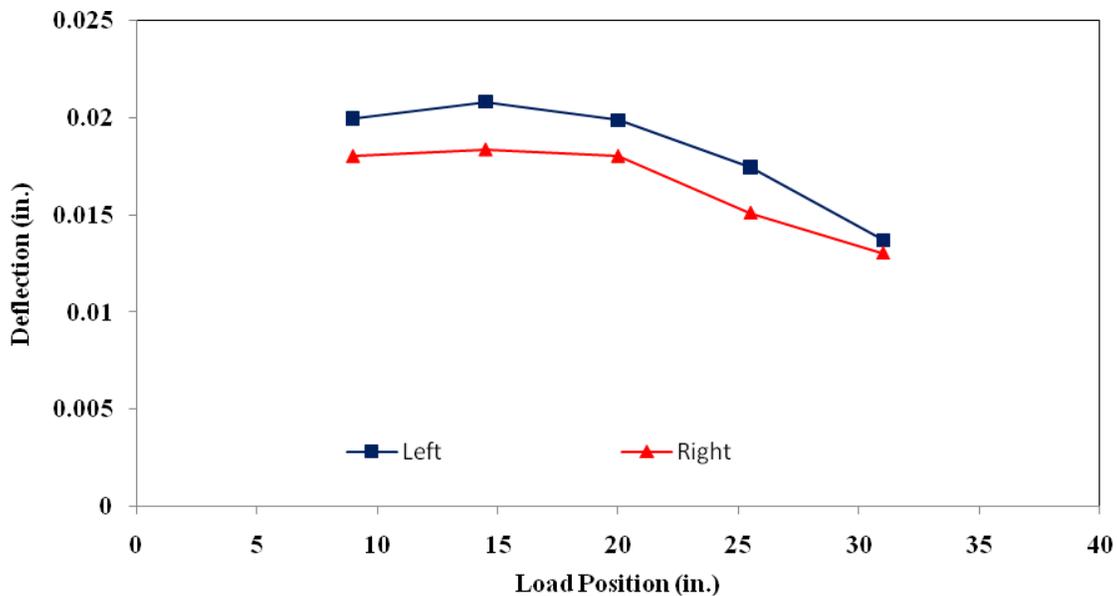
**Figure 3.15. Type 2 Connection service deflections**

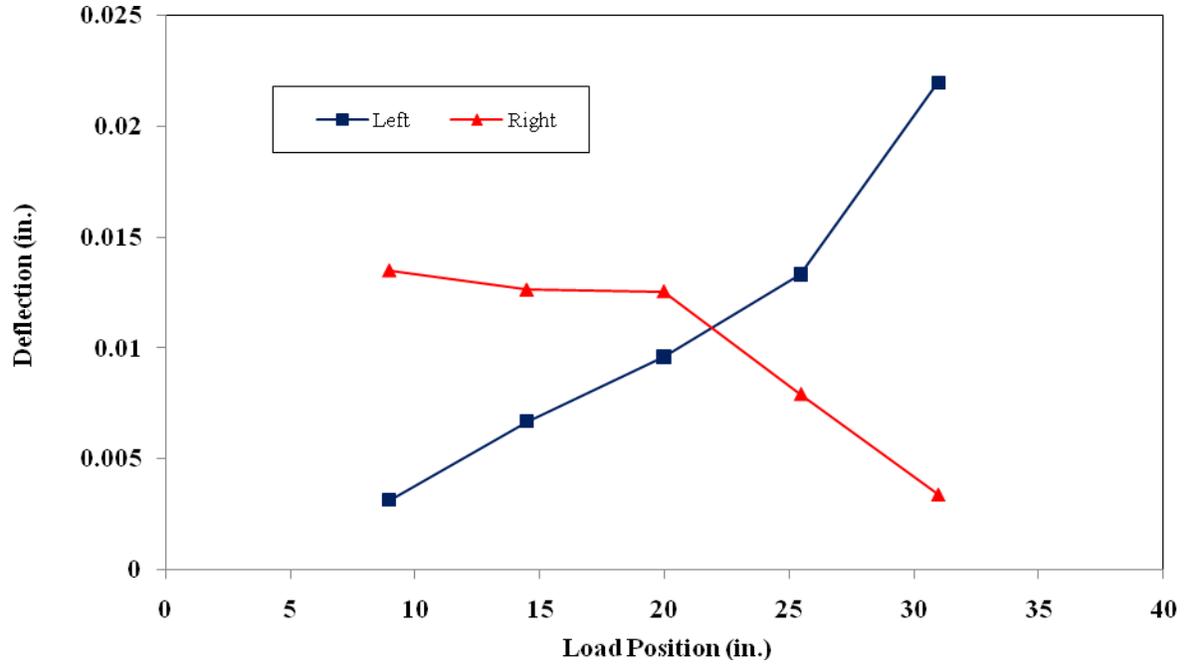
**Figure 3.16. Type 3 Connection service deflections**

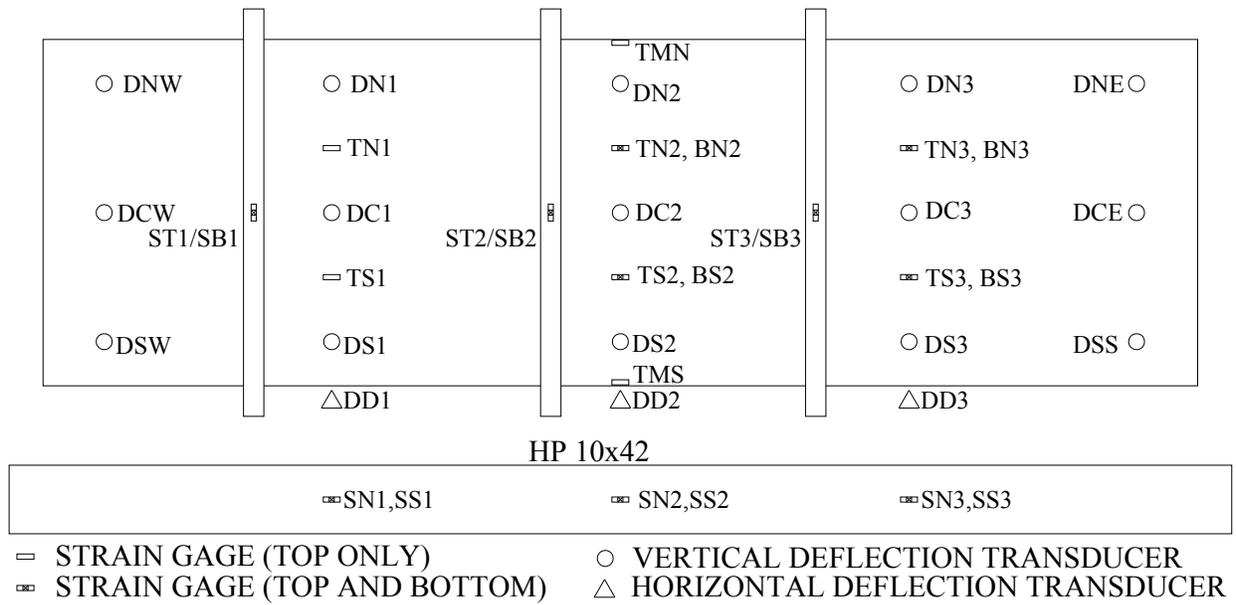
**Figure 3.18. Labels for the abutment backwall instrumentation**

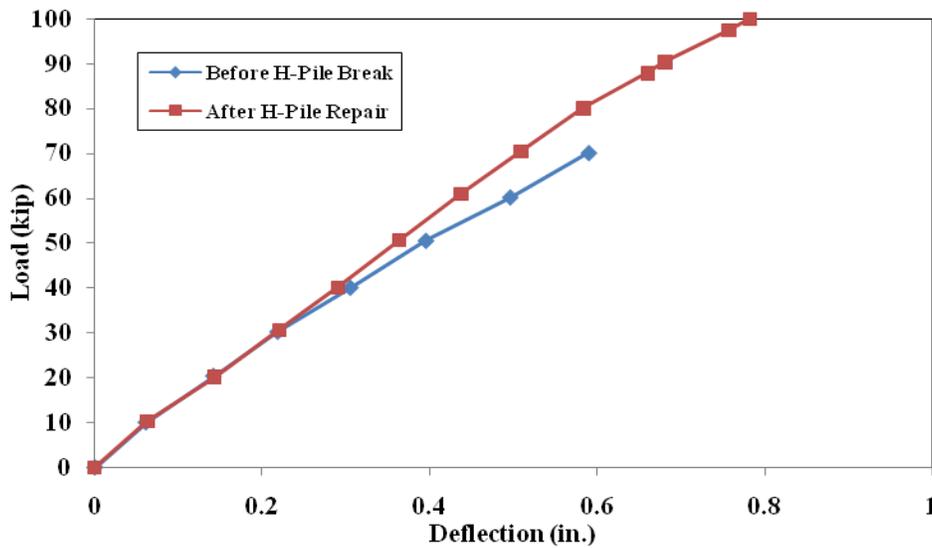
After the repair, the test was performed again, and the slab was still able to resist a point load of 100 kips. The load-deflection curves at DC2, both before and after the H-pile break, are shown in Figure 3.21. The failed backwall specimen is shown in Figure 3.22; the pattern of the cracking suggests that punching shear was the mode of failure. During the strength testing, the stress induced in the steel straps was less than 2.7 ksi for the top straps and less than 1.1 ksi for the bottom straps. The expected resultant load from both a 5-axle, 10 tons per axle truck over the abutment and the lateral earth pressure from an undrained clay under worst-case conditions is approximately 63 kips. Even in its weakened state, the backwall system provided a factor of safety of 1.6 against failure.

**Figure 3.21. Load-deflection curves for strength testing at DC2 before and after HP break**

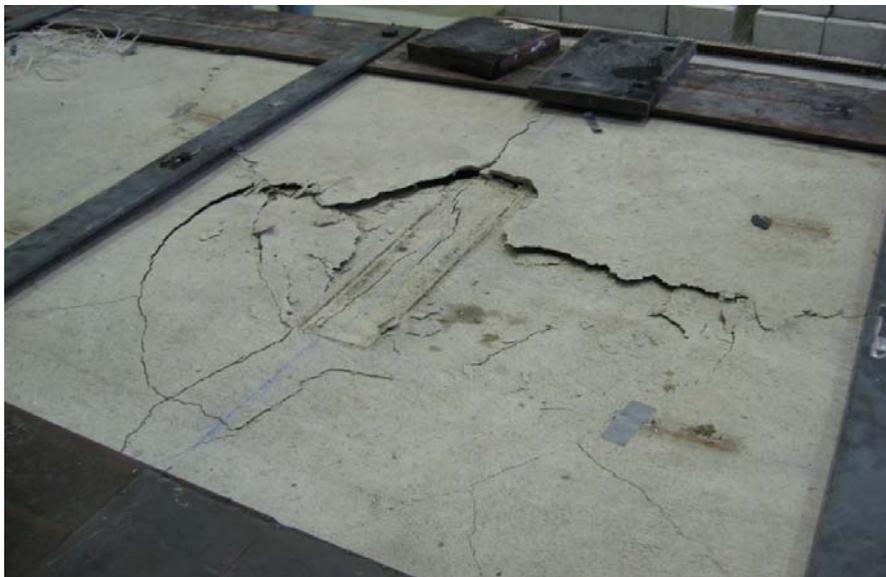
**Figure 3.22. Failed abutment backwall specimen**

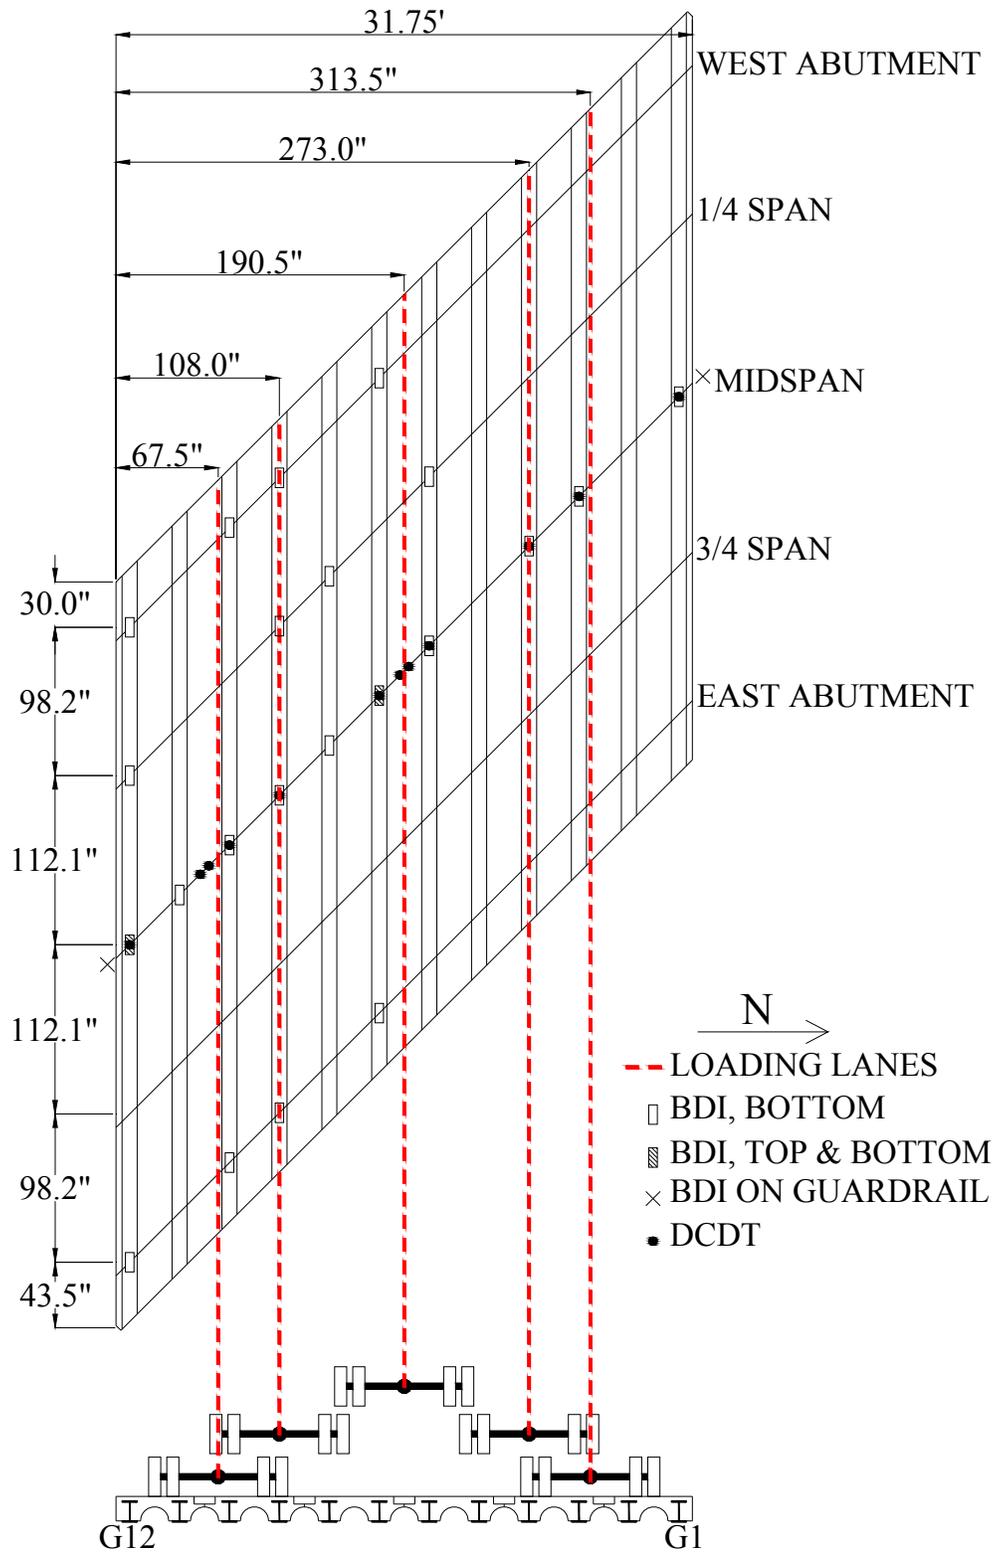
Figure 4.11. Instrumentation and loading lane layout for MVRB

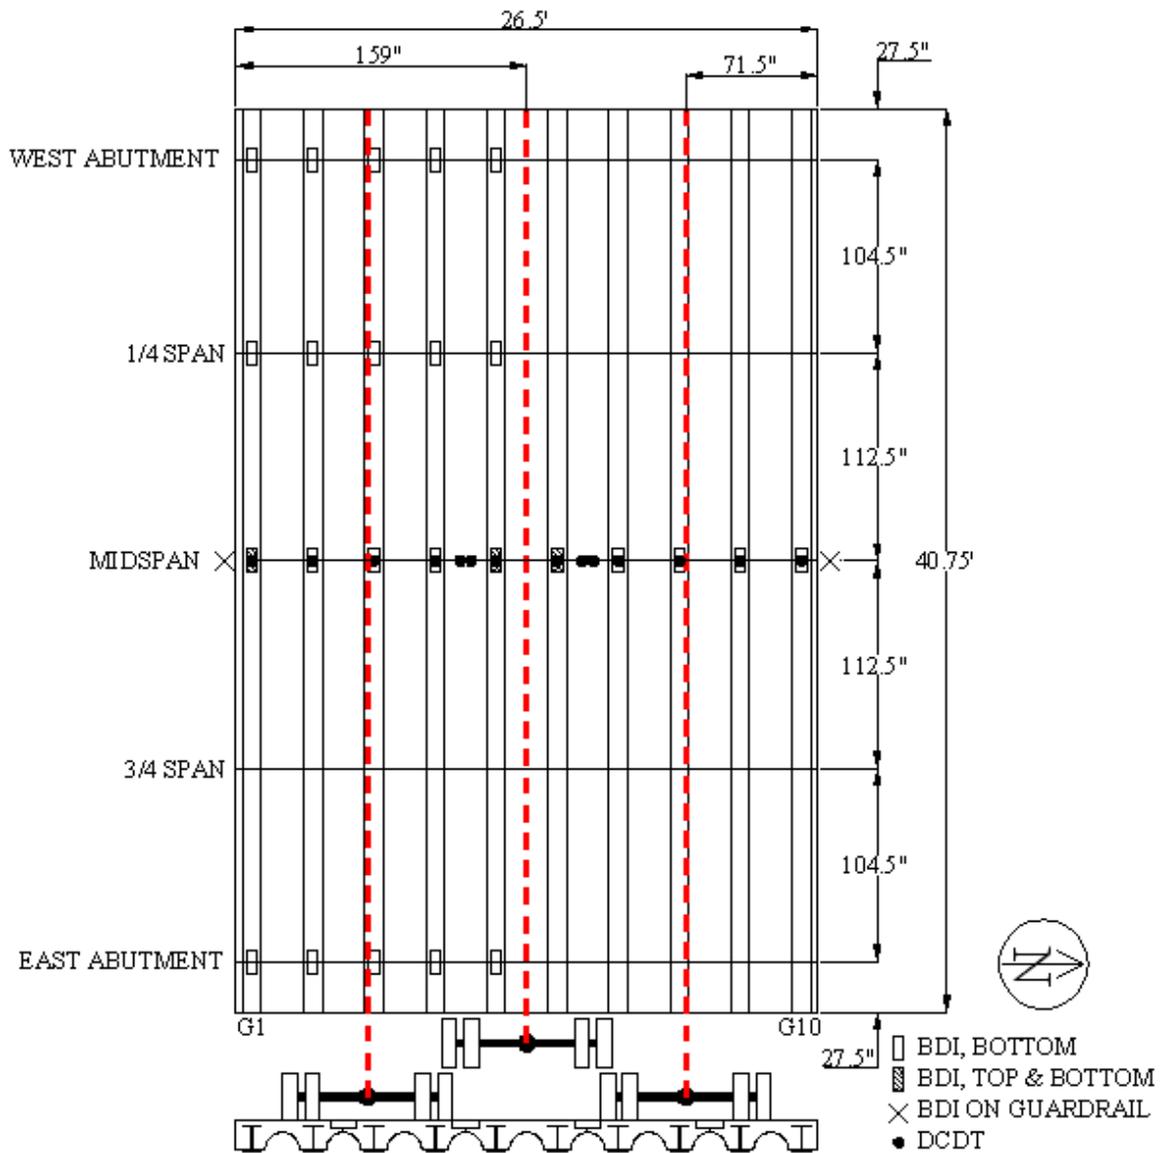
**Figure 4.18. Instrumentation and loading lane layout for MRB**

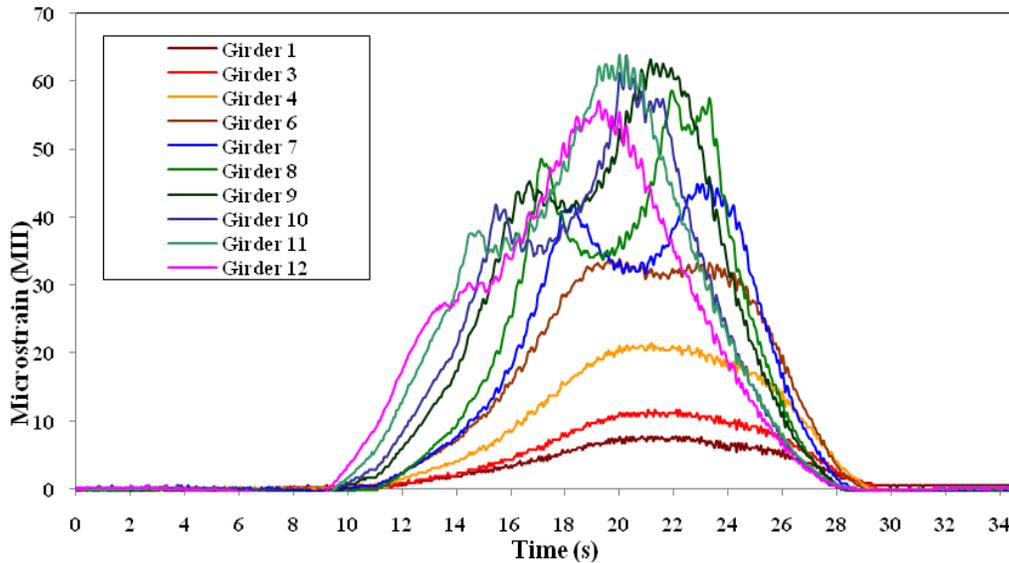
Figure 5.1. Midspan strain history for Test 4.1

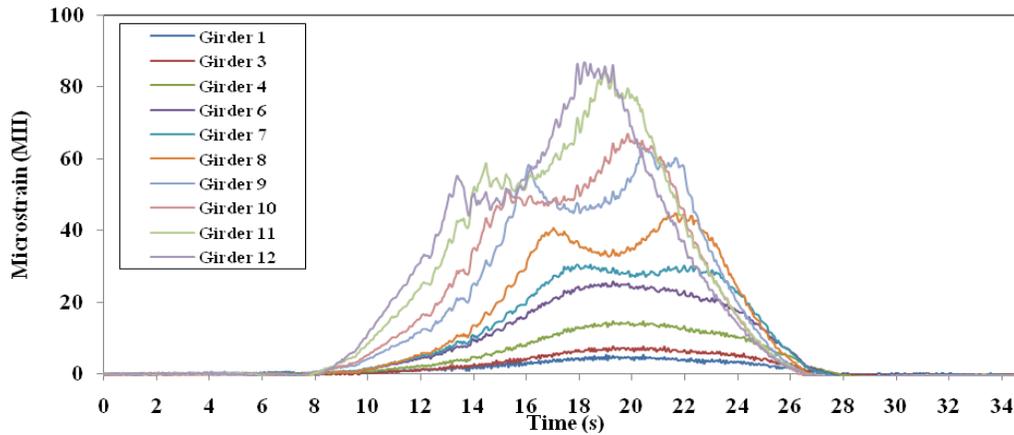
**Figure 5.2. Midspan strain history for Test 5.1**

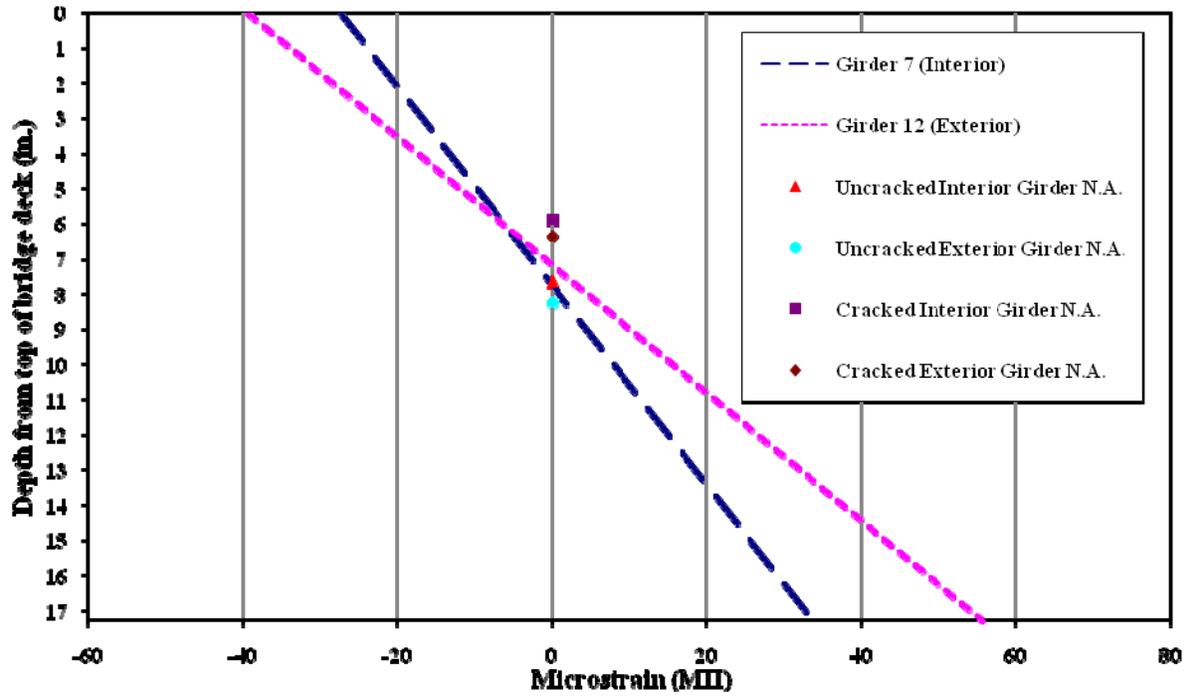
Figure 5.3. Test 4.1 neutral axes

The location of the bridge’s neutral axis was determined for each test by assuming a linear strain profile through the cross section between the compressive strain values on the deck surface and the tensile strain values on the beam’s bottom flange. The experimental neutral axes for Test 4.1 are presented graphically in Figure 5.3, resulting in a range of neutral axes values from 7.15 to 7.74 in. below the concrete deck. The experimental neutral axes for Test 5.1 are presented in Figure 5.4. Also, shown are the theoretical gross and cracked transformed neutral axes; gross neutral axes for the interior and exterior girders are 7.65 and 8.23 in., respectively, while cracked experimental values for interior and exterior girders are 5.9 and 6.35 in., respectively.

The theoretical neutral axes results, listed in Table 5.1, are distances from the top of the cross-section. The cracked and uncracked midspan neutral axes of the theoretical interior longitudinal beam bracket the experimental midspan neutral axes results (also shown in Table 5.1). Consequently, these results provide evidence that the bridge has an effective cross-section bounded by the fully cracked and gross section; the bridge behaves as if partially cracked. This behavior was observed for all five test lanes.

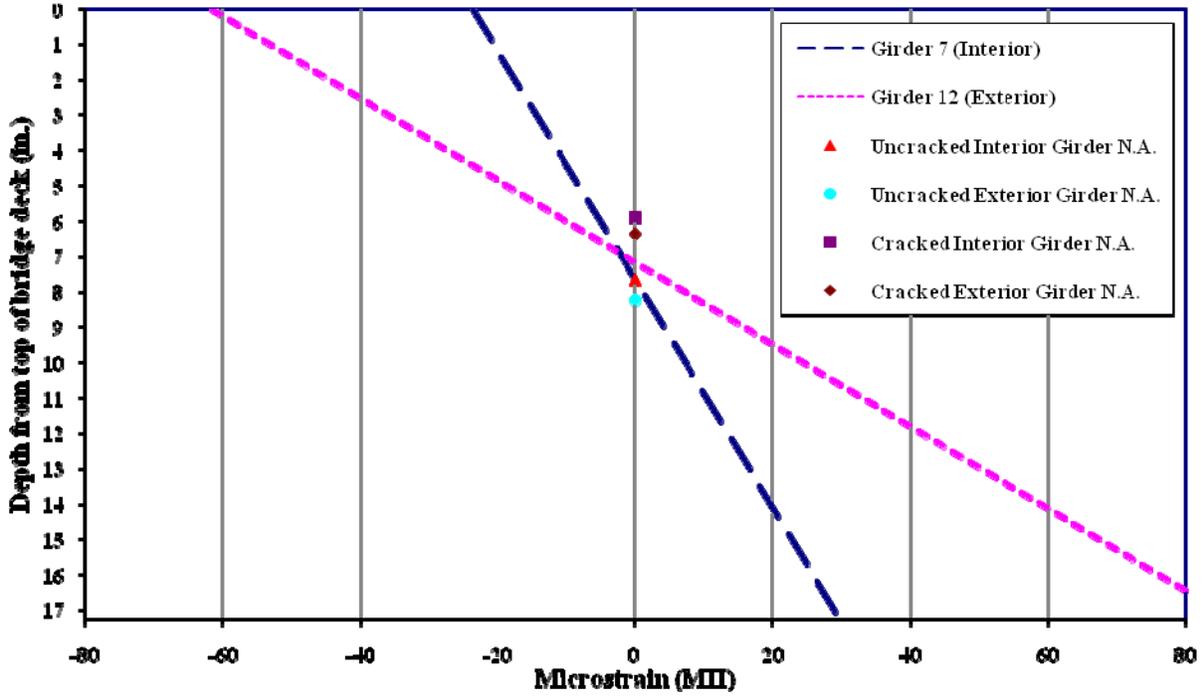
Figure 5.4. Test 5.1 neutral axes

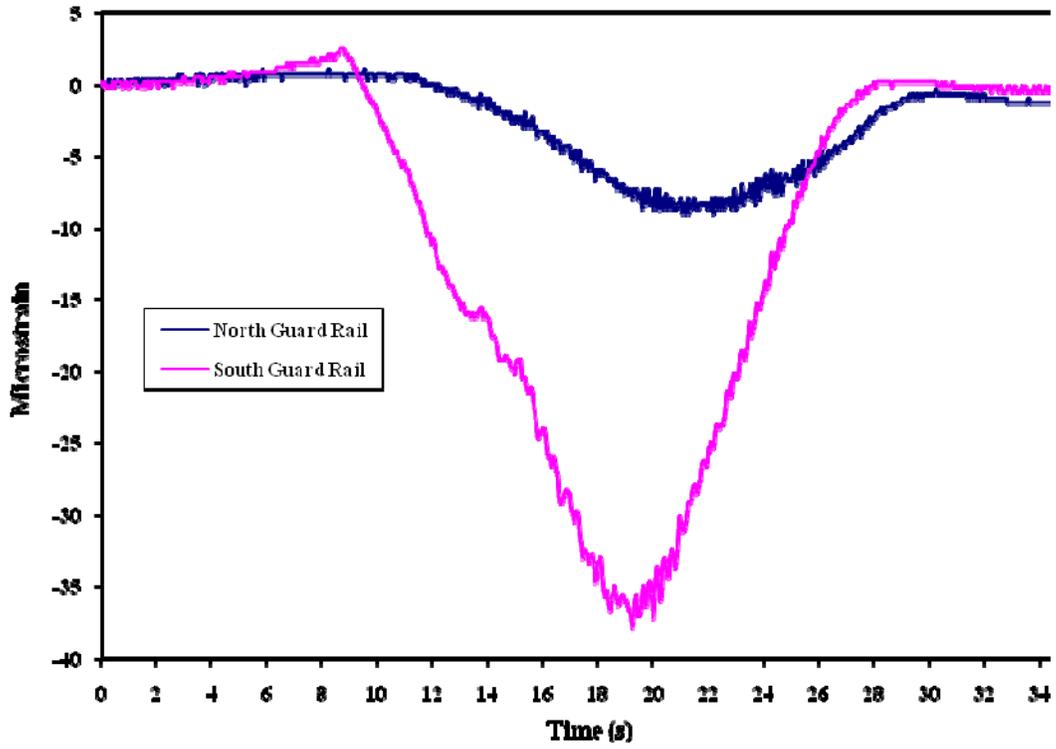
Figure 5.5. Guardrail strains for Test 4.1

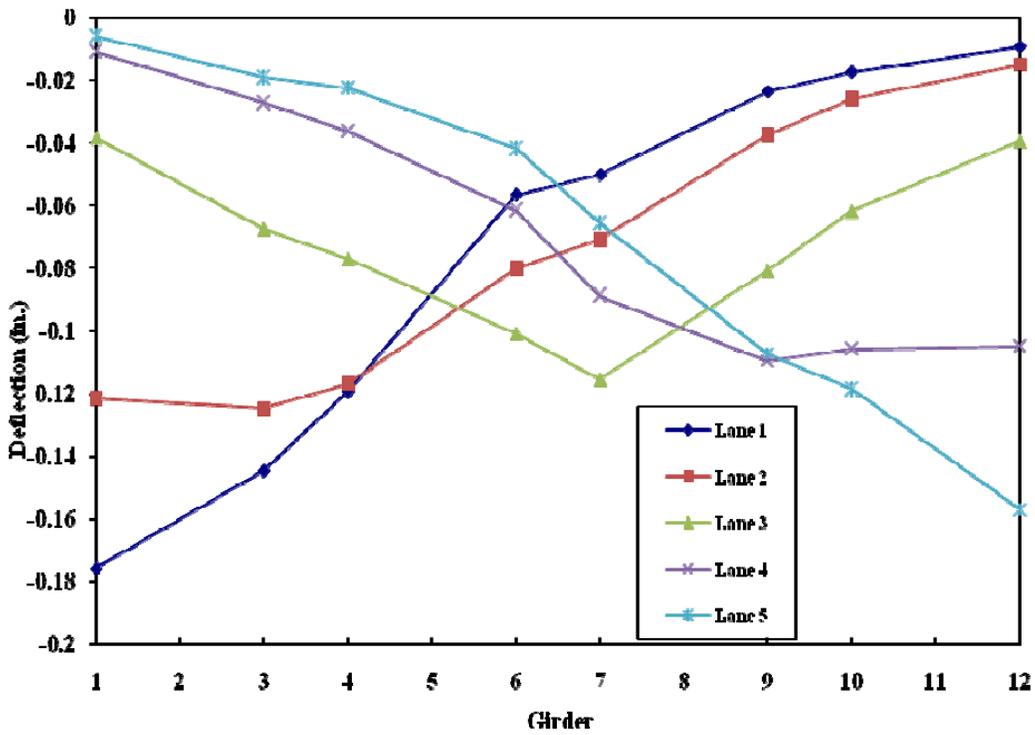
Figure 5.7. Midspan displacement profiles for all five test lanes

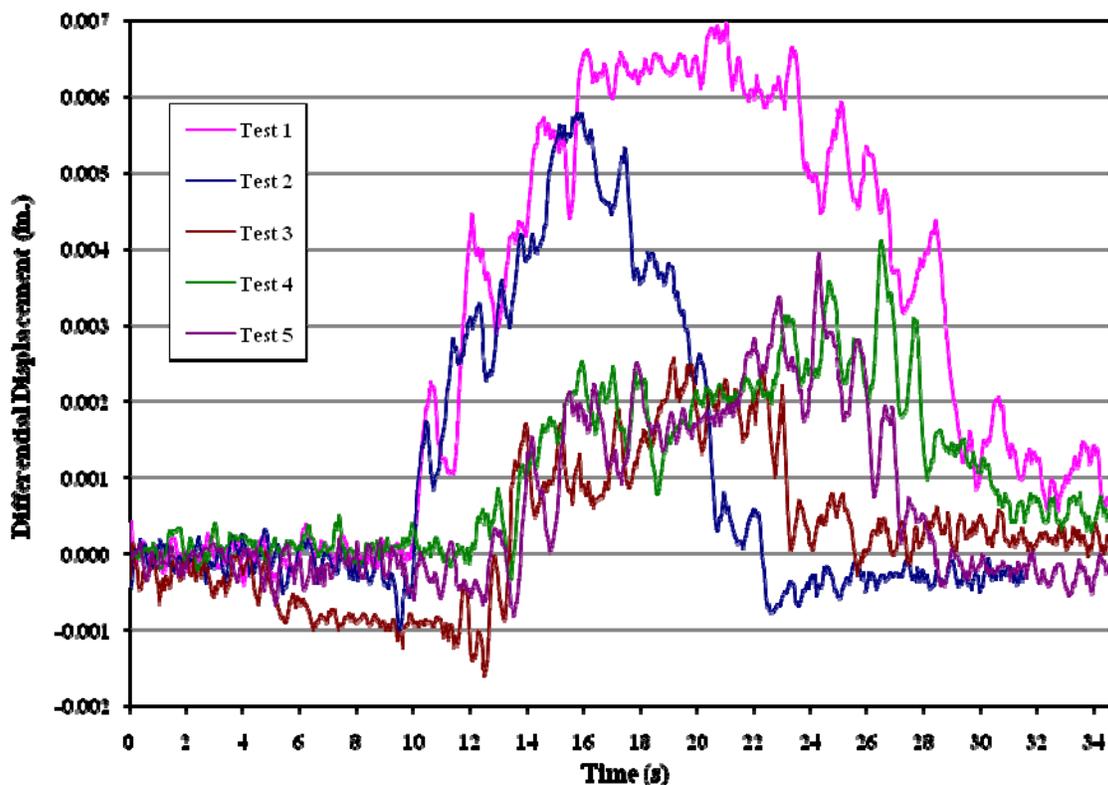
**Figure 5.8. Differential displacements along centerline joint**

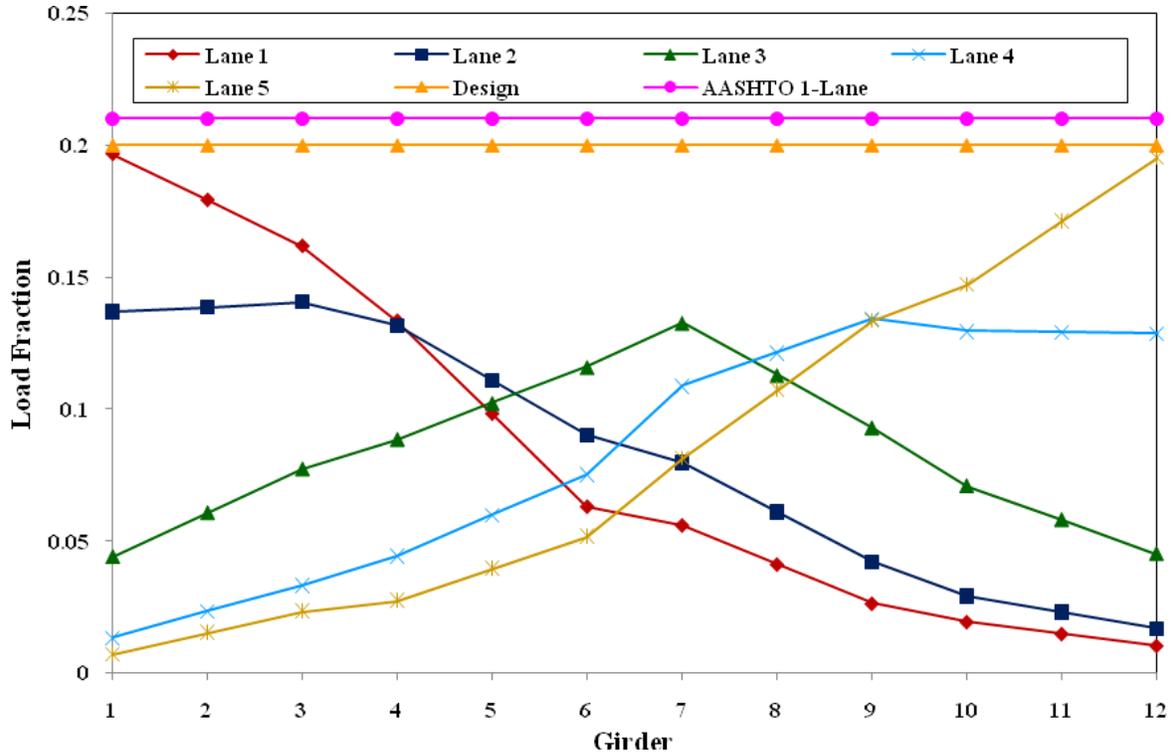
Figure 5.9. Single lane DF from deflections

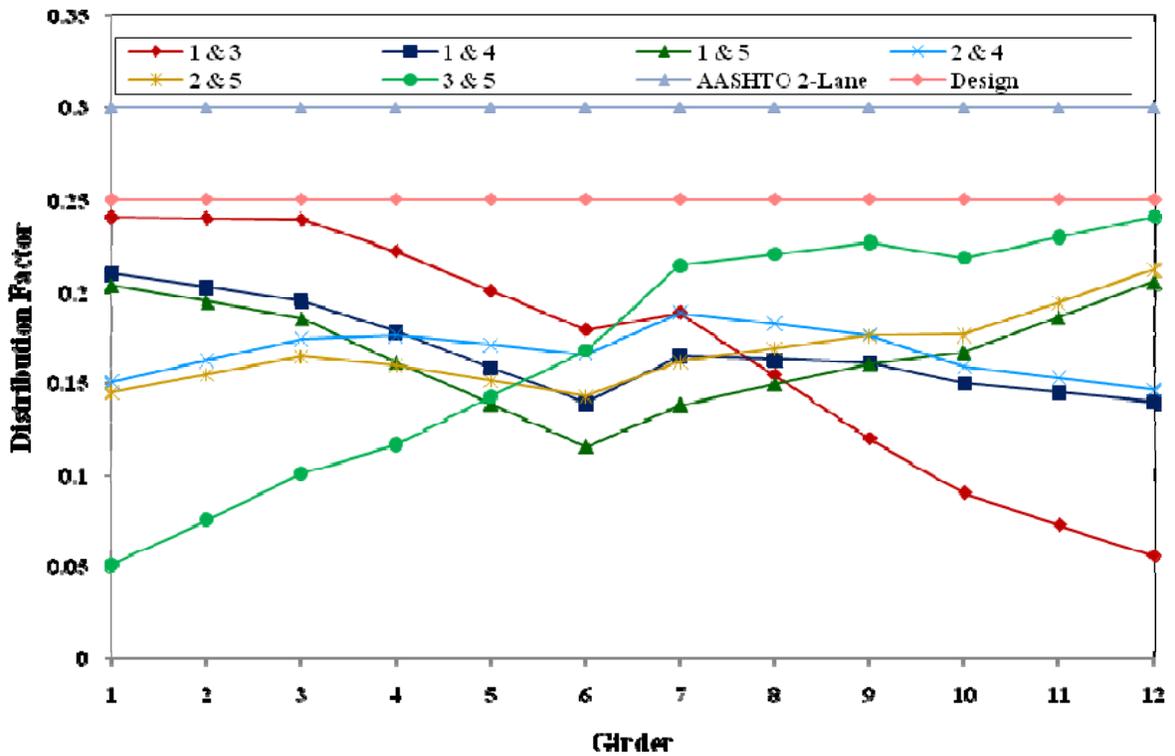
Figure 5.10. Two lane DF from deflections

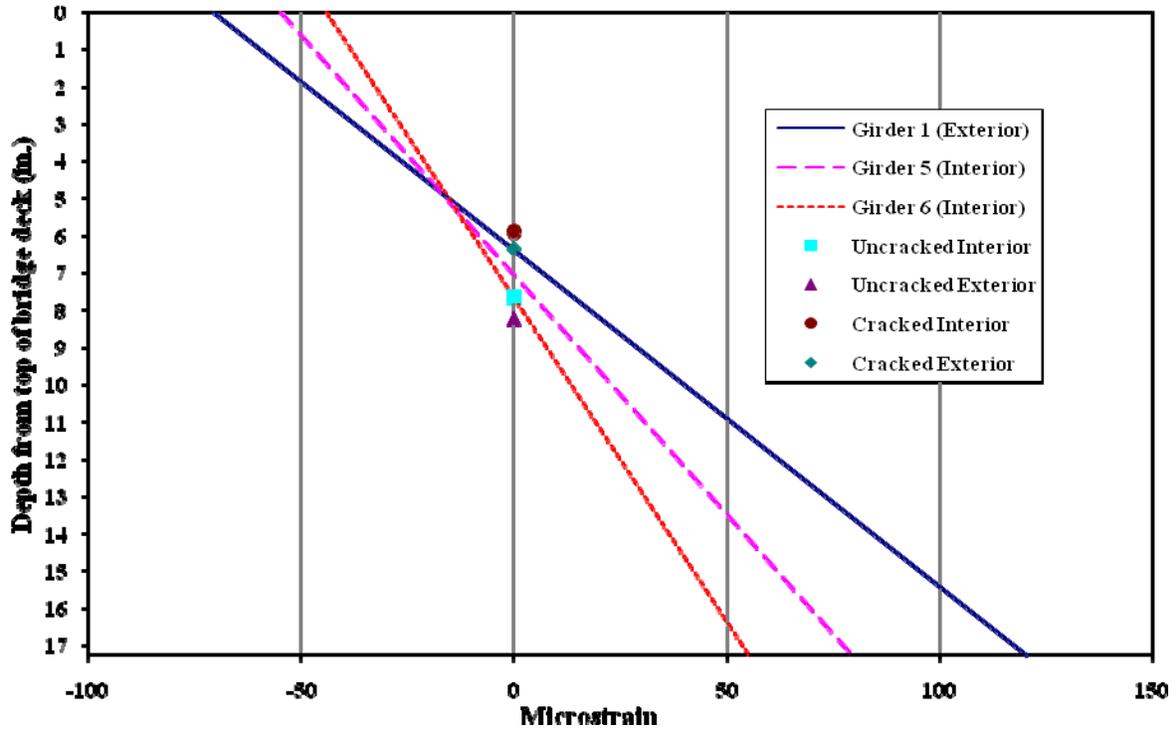
Figure 5.11. Test 3.1 neutral axes

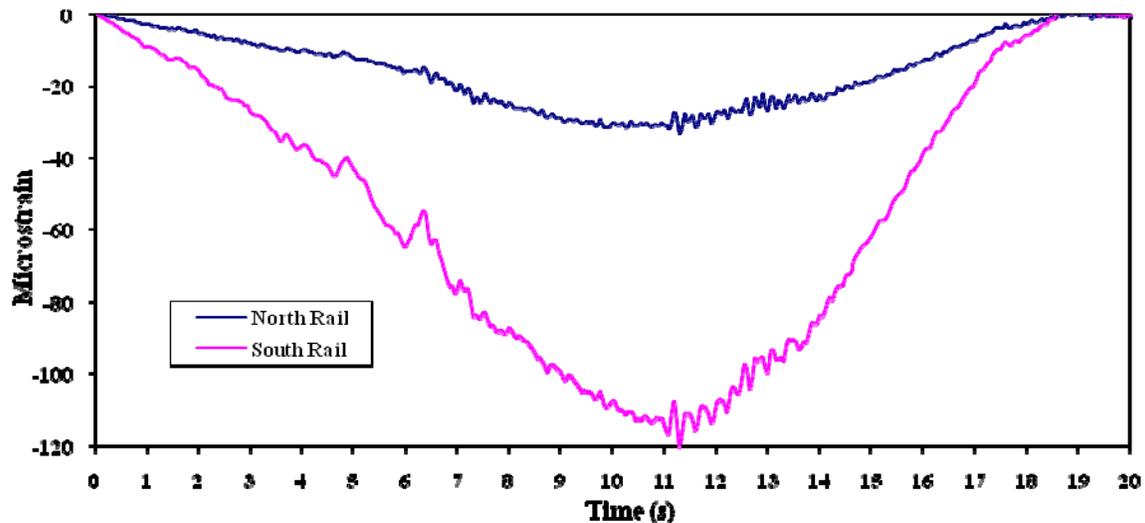
**Figure 5.12. Test 3.1 guardrail strains**

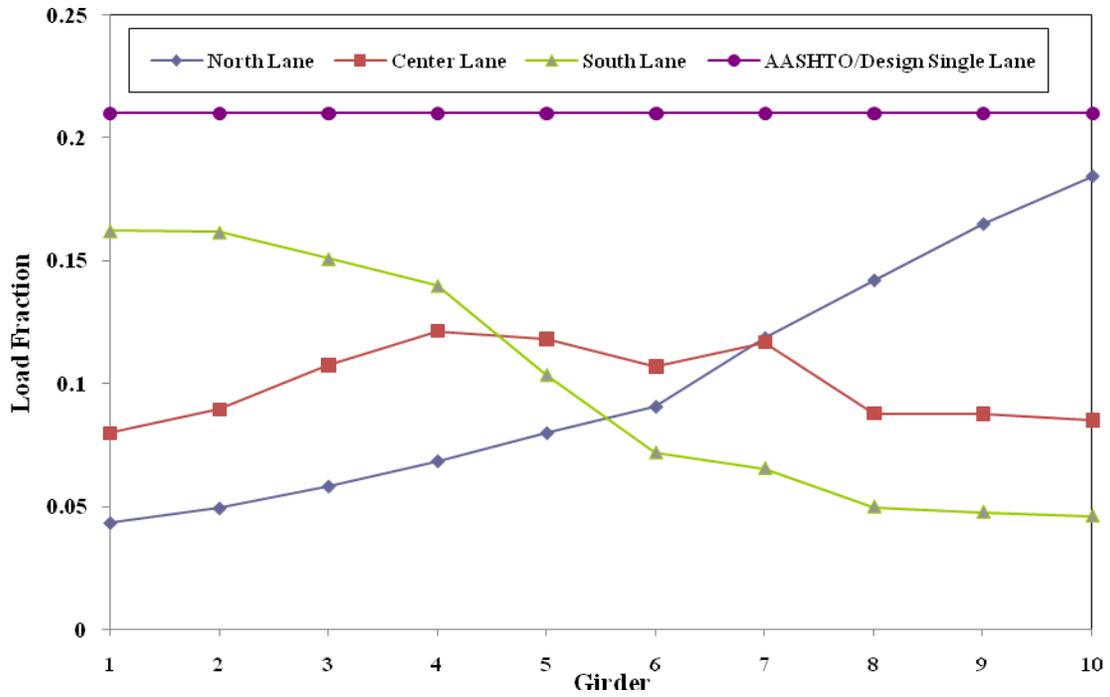
Figure 5.14. Single lane DF from strains

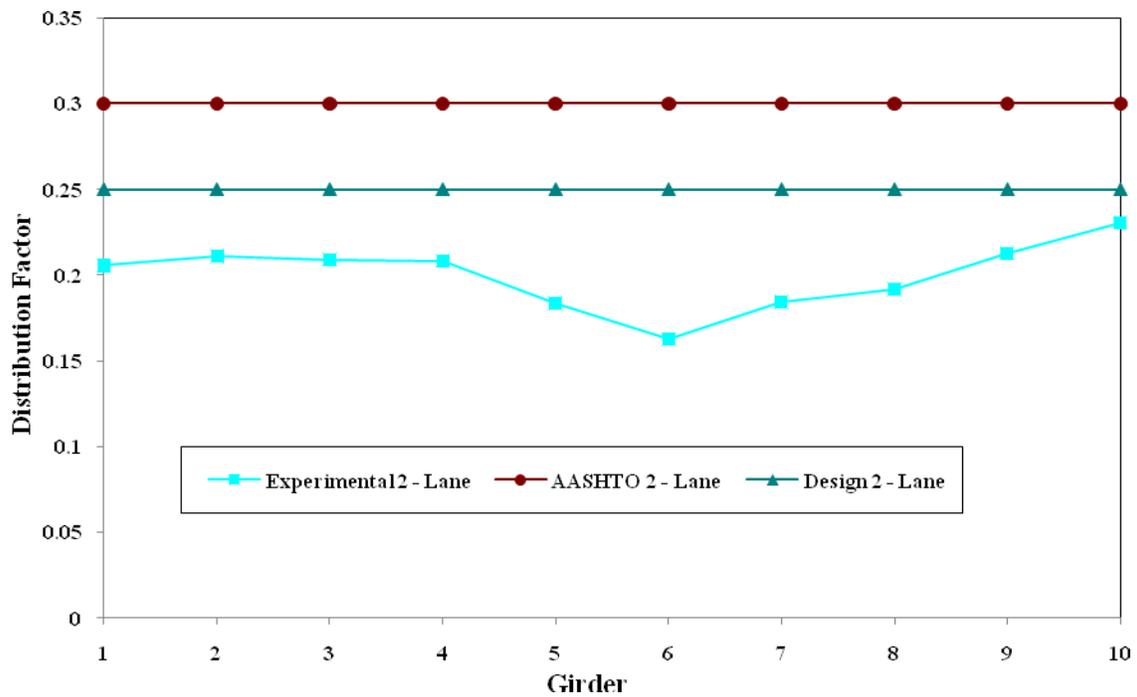
Figure 5.15. Two lane DF from strains
