Feasibility Study for Detection and Quantification of Corrosion in Bridge Barrier Rails

Final Report
April 2013

Sponsored by
Federal Highway Administration
Iowa Department of Transportation
(InTrans Project 11-413)

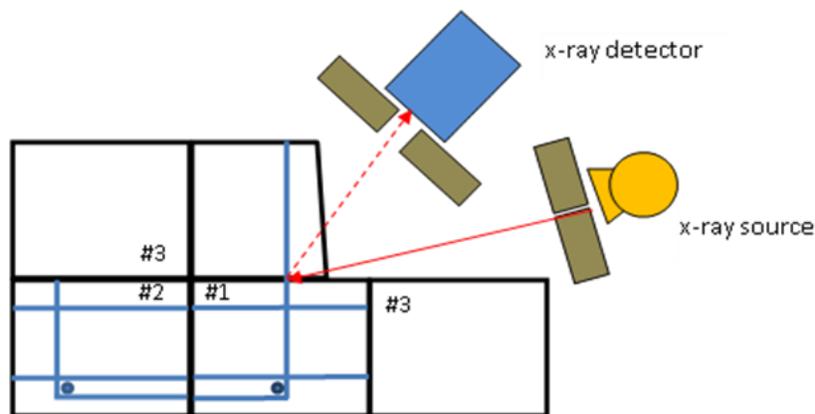
Figure 5. Configuration for back-scatter inspections

A single-sided x-ray inspection would greatly simplify the evaluation of bridge barrier rails. X-ray backscatter imaging, as shown in Figure 5, is an approach that can, in principle, achieve this.

Some very preliminary studies of x-ray backscatter were carried out using the configuration shown earlier in Figure 5. Comparison of the x-ray spectra observed for scattering from concrete and steel is shown in Figure 20.

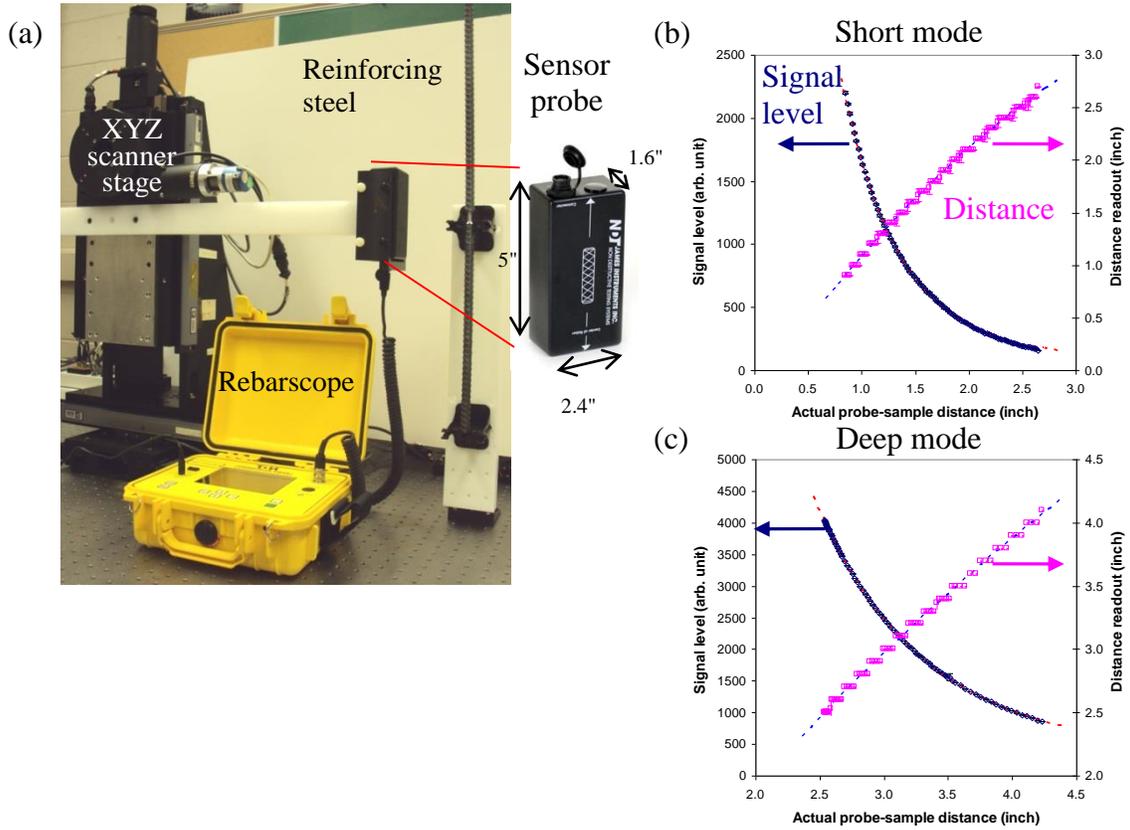
Figure 23. (a) Setup for EC scans on bare #4 reinforcing steel specimens and (b) and (c) signal level and distance readings versus actual probe distance

scanner stage (Figure 23a) that was under computer control for performing line or raster scans over the bare reinforcing steel or concrete test specimens.

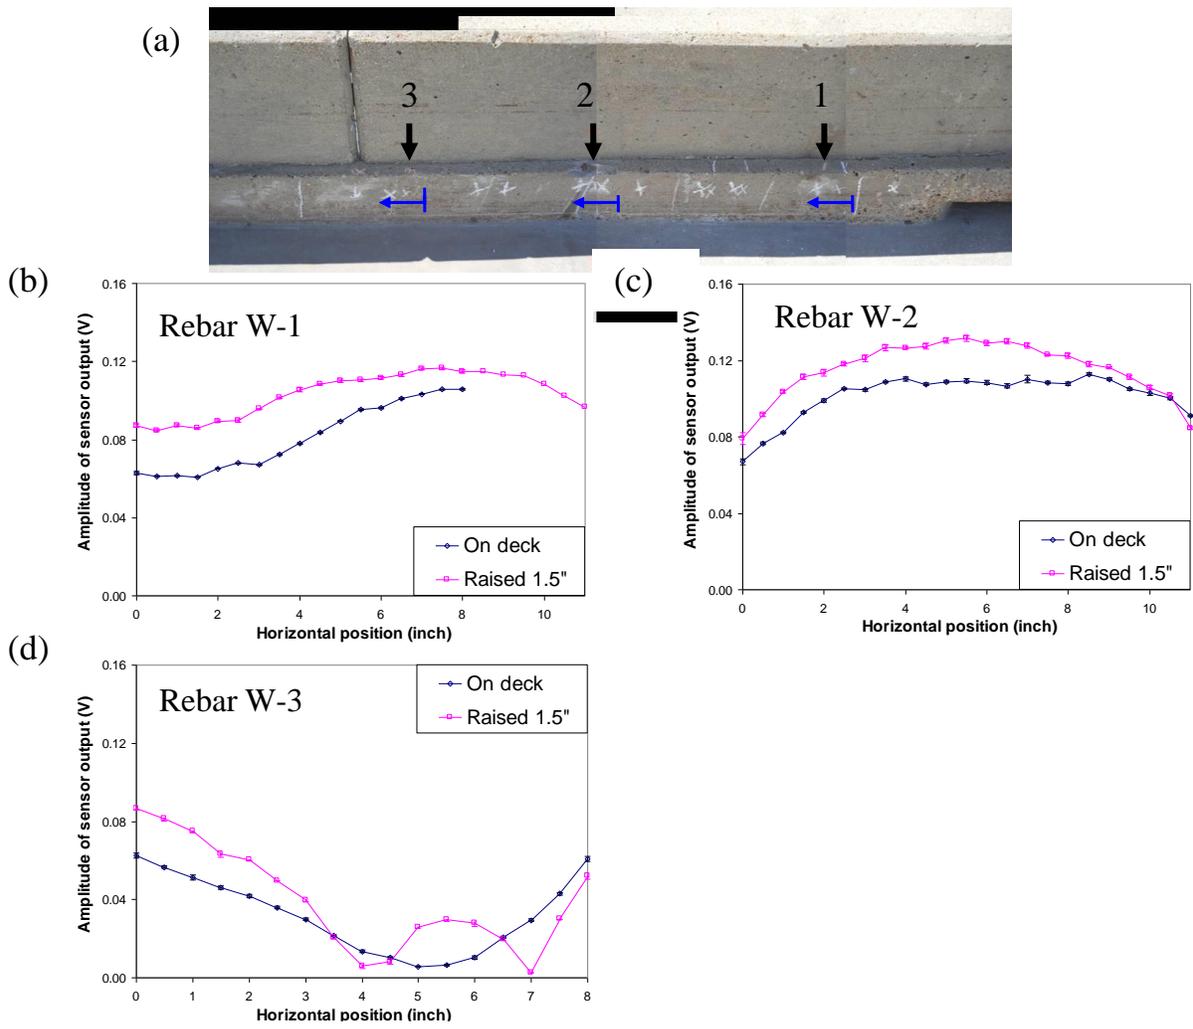
Figure 40. West-end section of barrier rail

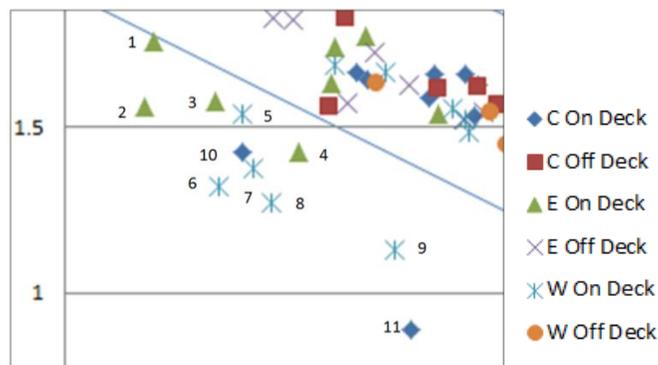
Figure 54. Identification of suspect reinforcing steel

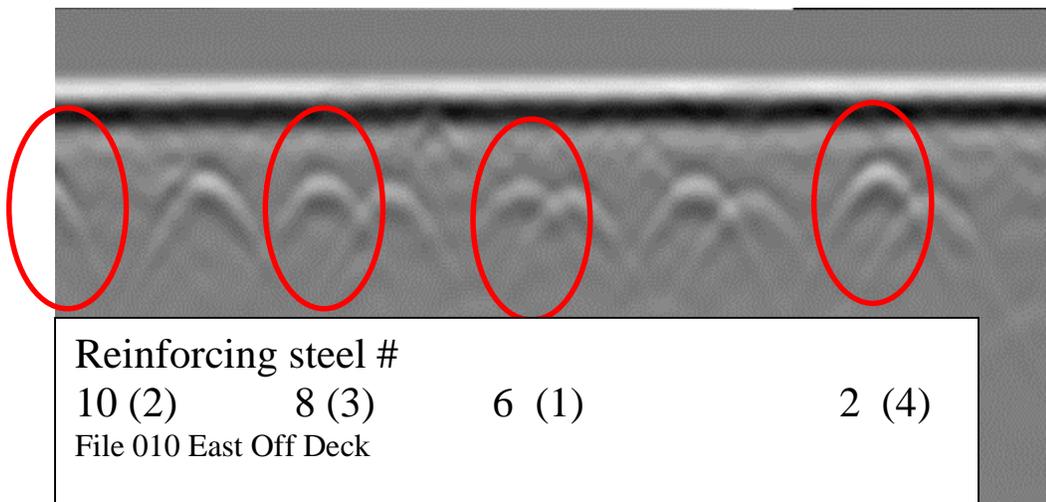
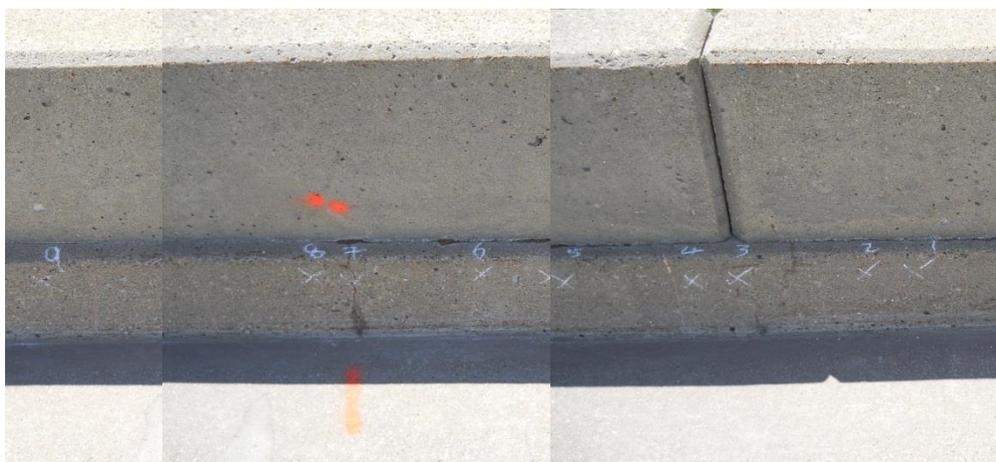
Figure 57. Suspect locations on the east end of the bridge

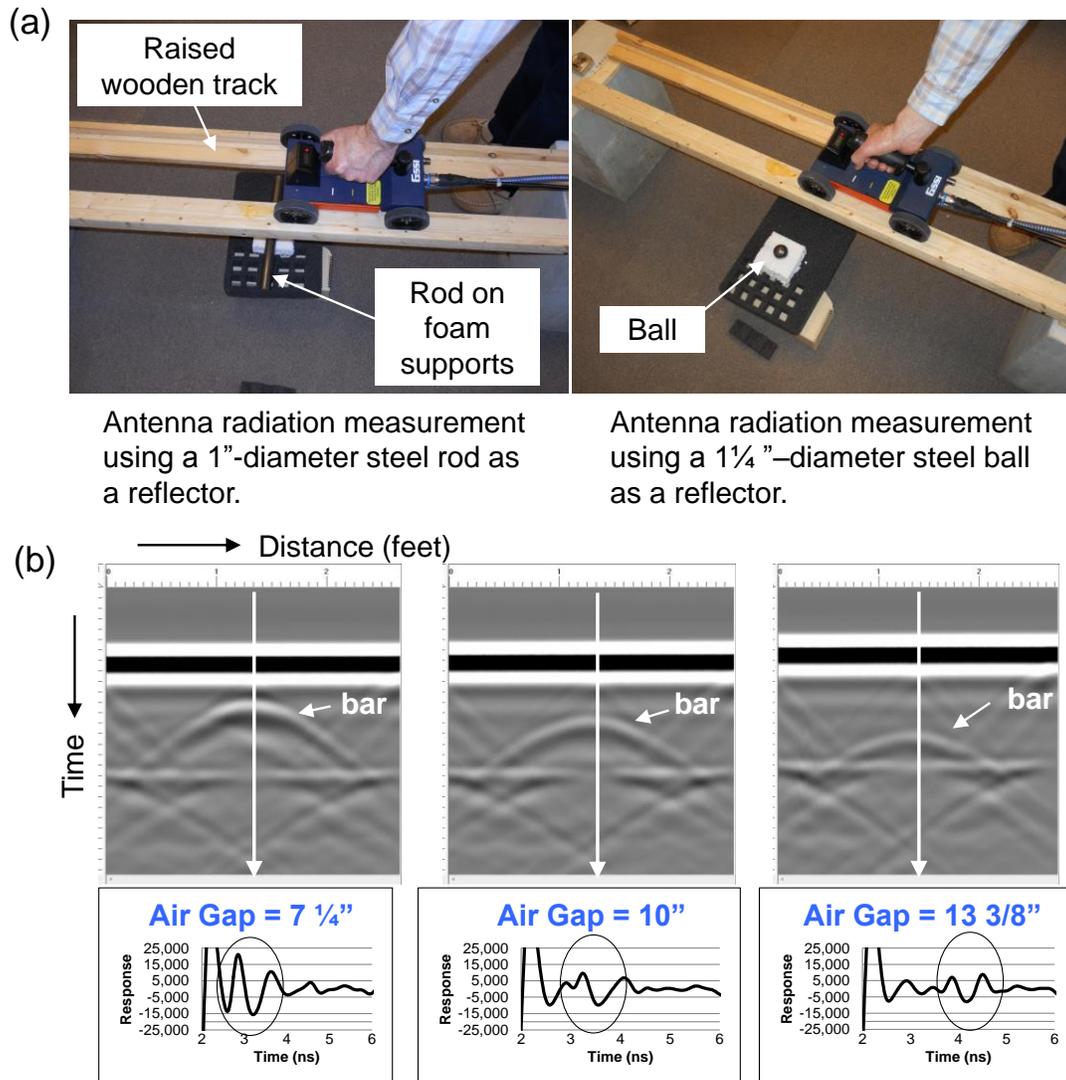
Figure 63. (a) Mapping the antenna radiation pattern using rod and ball targets and (b) B-scans for three choices of the air gap between the antenna and the rod target and corresponding A-scans for the peak response points
