Test and Evaluation Report

Drilled Shaft Load Testing I-235 over Union Pacific Railroad

January 5, 2006

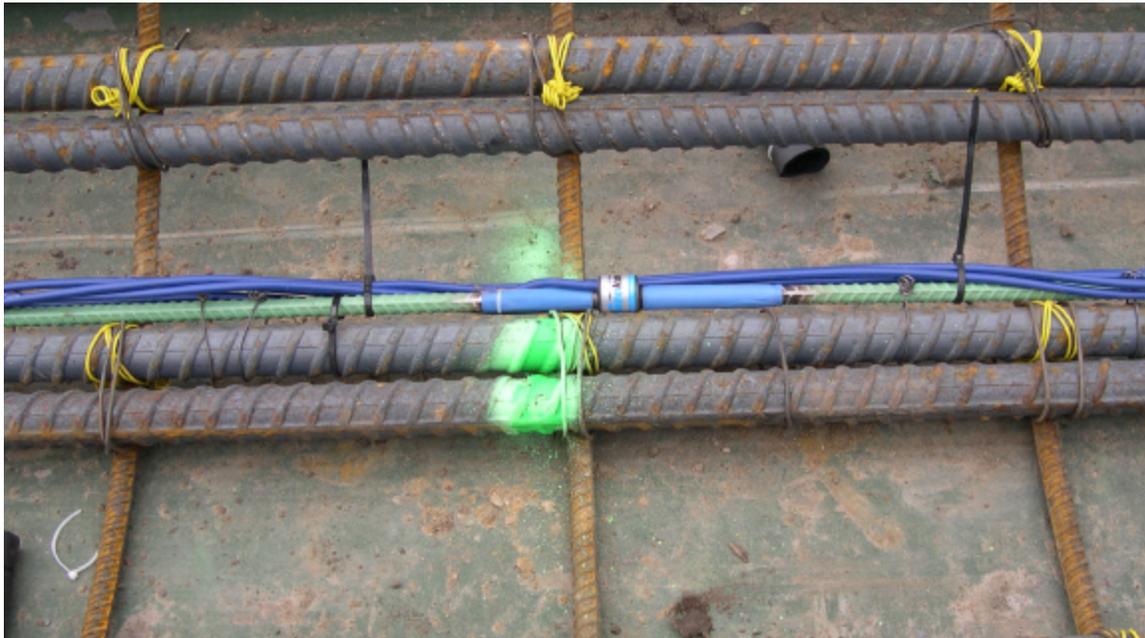
Figure 1. Strain sensor attached to reinforcing steel cage using sister bar

The drilled shaft foundation was instrumented with a total of 12 - Geokon 4911-4 vibrating wire rebar strainmeters and 16 - Geokon 3911 rebar resistance-type strain gauges. The strain sensors were attached to the reinforcing steel cage prior to concrete casting by means of a “sister bar” as shown in Figure 1.

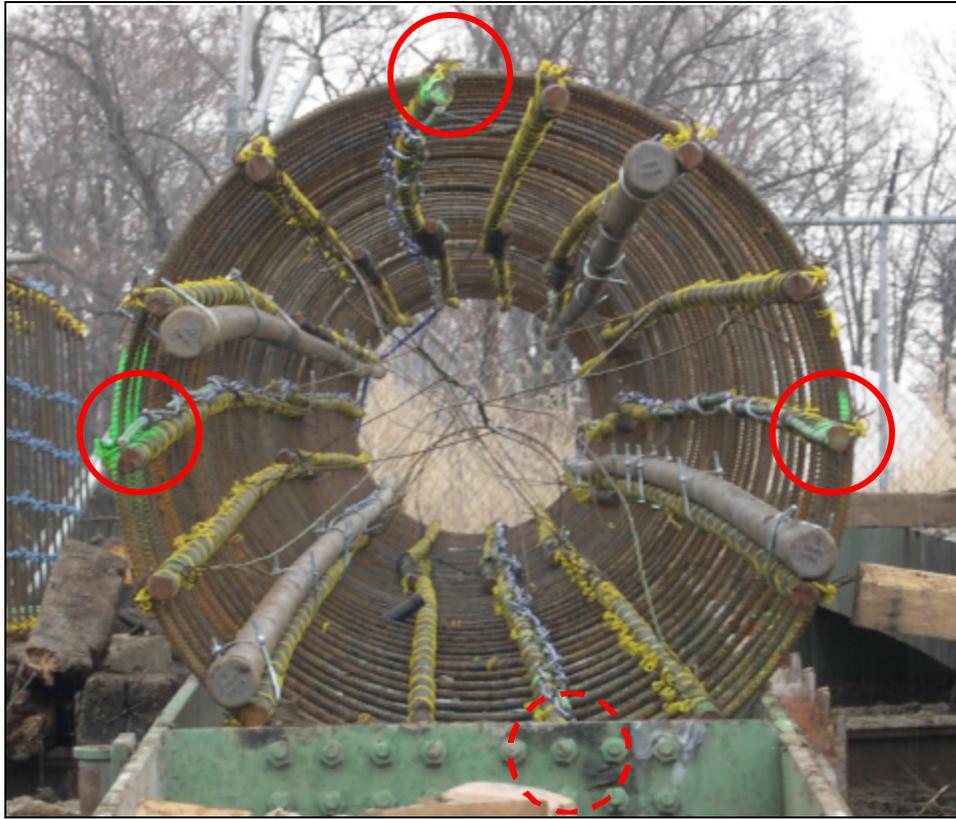
Figure 2. Strain gauges (circled) located at four equally-spaced points on reinforcing cage

The strain sensors were located at approximately the quarter points around the perimeter of the drilled shaft (see Figure 2) and at elevations corresponding to changes in the subsurface soil profile. At each elevation where a group of strain sensors was installed, two vibrating wire sensors and two resistance strain sensors were placed on opposite sides of the reinforcing cage. During construction, efforts were made to ensure that the pairs of resistance sensors were oriented parallel with future traffic to facilitate collection of strain data during future live traffic conditions.

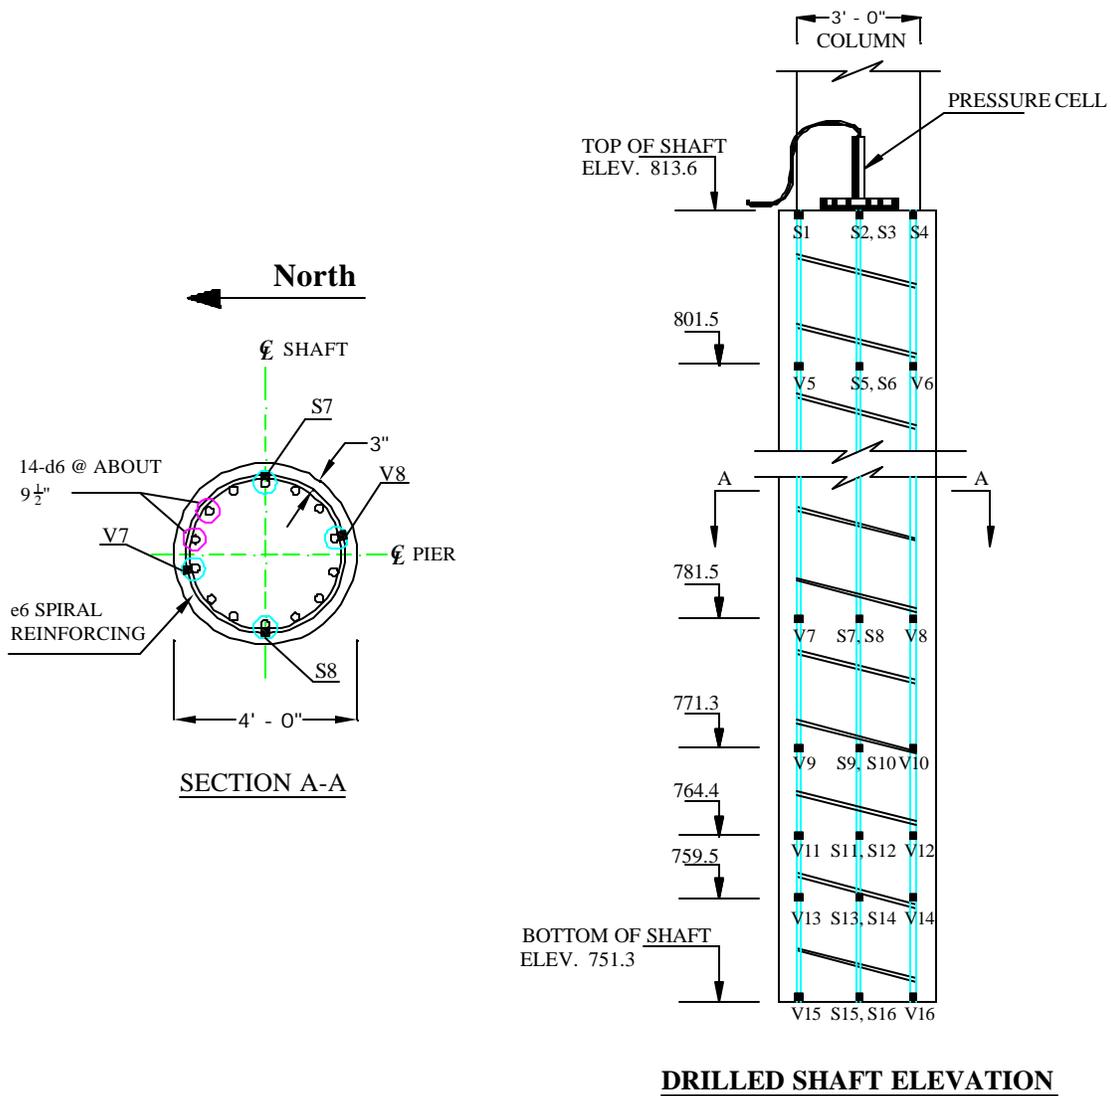
Figure 3. Schematic view of drilled shaft and installed instrumentation

In addition, the shaft was instrumented with a Geokon 4810 contact pressure cell, which was installed at the interface between the drilled shaft and the column concrete. A schematic view of the installed instrumentation is presented in Figure 3.

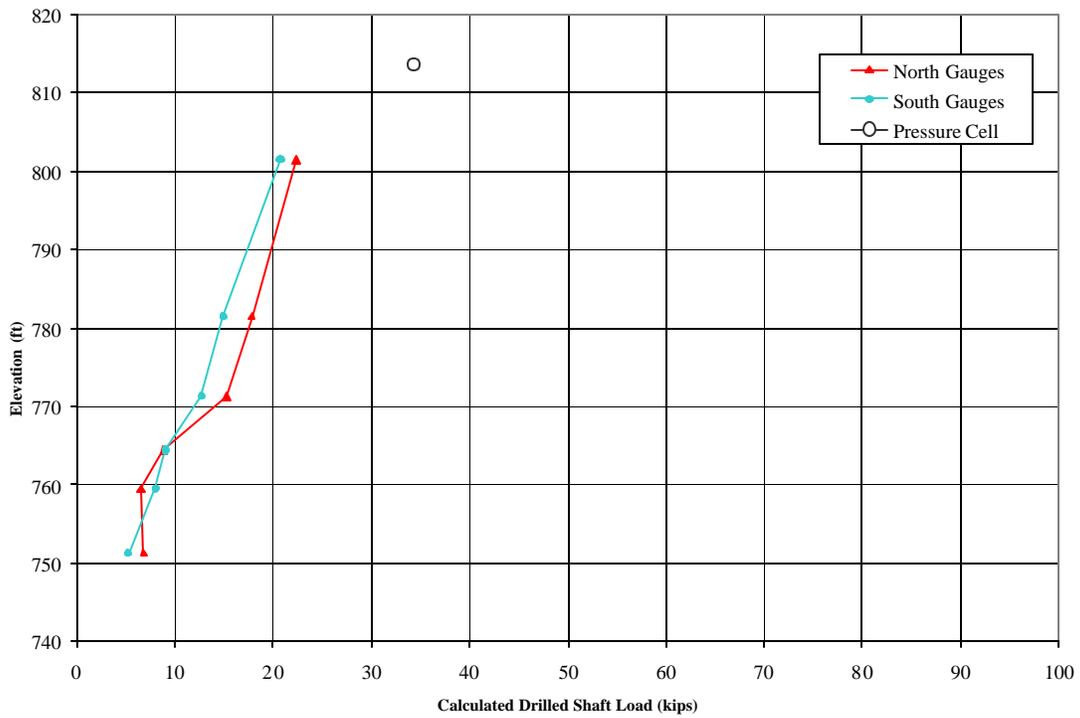
Figure 4. Drilled shaft load calculated from vibrating wire (N-S) strain sensors

The data collected from the north-south gauges indicate a maximum drilled shaft load of approximately 22 kips. It should be noted that the drilled shaft load was calculated using

an average strain over the shaft cross-section equal to the measured value from the sensor of interest. The reduction in strain from gauges near the top of the shaft to those located near the bottom occurs at a relatively linear rate. This decrease in strain (and thus drilled shaft load) provides evidence that applied truck loads are being transferred to the surrounding soil through surface friction. A plot of these results with respect to elevation is presented in Figure 4.

In addition, the north gauges indicate a slightly higher strain than those on the south side of the shaft, which may be evidence of some minimal flexural behavior in the transverse direction. It is very possible that the truck loads were applied with a slight eccentricity with respect to the column. This variation in strain appears much smaller at gauge locations near the bottom of the shaft. These locations are much nearer the point of transverse fixity in the foundation.

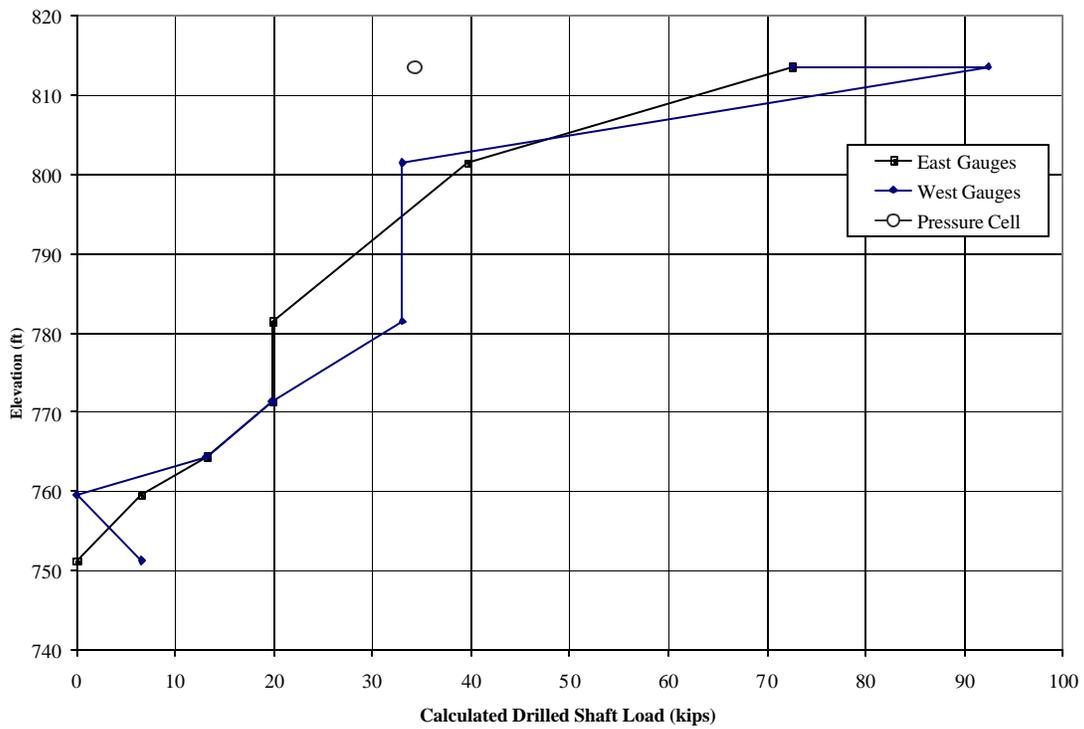
Figure 5. Drilled shaft load calculated from resistance-type (E-W) strain sensors

The data collected from the east-west gauges indicate a much larger maximum drilled shaft load of approximately 92 kips. The total weight of the live load vehicles was measured at 86.1 kips, so the actual shaft load must be considerably less than the measured value. However, two of the three functioning gauges at this same elevation indicate a more reasonable value of approximately 72 kips. These data are presented in Figure 5.

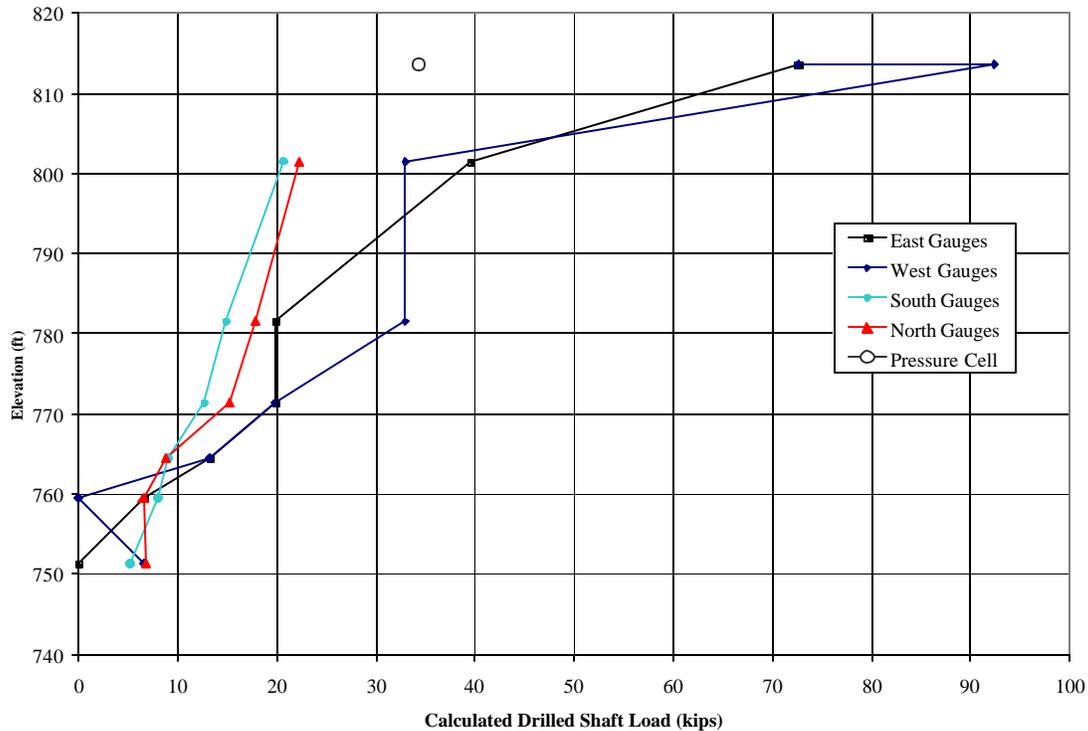
Figure 6. Drilled shaft load calculated from all strain sensors

The measured drilled shaft loads from all gauges are presented in Figure 6. A much more dramatic decrease in strain from top to bottom of the shaft was measured using the east-west gauges. These data indicate that approximately 67 percent of the drilled shaft load has been transferred to the surrounding soil within the uppermost 32 feet of the shaft length. However, the north-south gauges indicate that only 24 percent of the same load was transferred at that same elevation.
