HUMBOLDT MUNICIPAL AIRPORT
PAVEMENT MANAGEMENT REPORT

Prepared For:
Iowa Department of Transportation
Office of Aviation

Prepared By:
Applied Pavement Technology, Inc.

January 2010

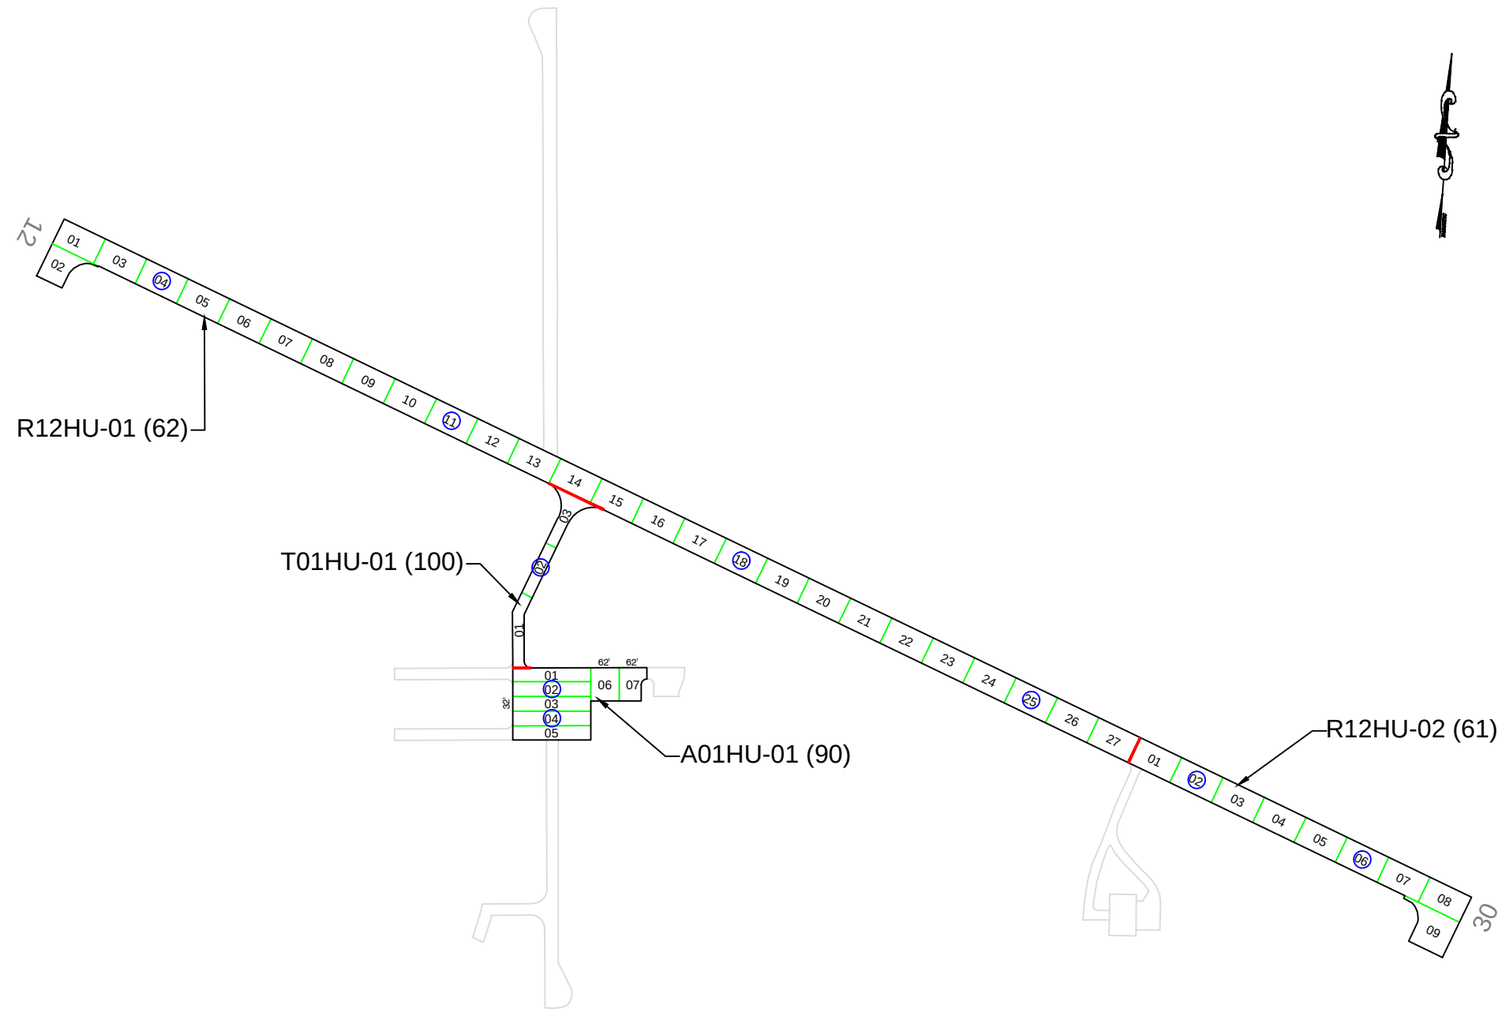
FIGURE 3. NETWORK DEFINITION MAP.

Runway 12-30 is defined by two sections. Section 01, the northern portion of the runway, and Section 02, the southern portion of the runway, are both in fair condition with significant amounts of low- and medium-severity longitudinal and transverse (L&T) cracking and small quantities of alligator cracking recorded. In addition, isolated areas of low-severity swelling were noted in Section 01. All of the low-severity cracking was unsealed and the medium-severity cracking was due to unsealed crack widths greater than ¼ inch.

Taxiway 01 was recently reconstructed and consists of one section in excellent condition with no distresses observed at the time of inspection.

The terminal apron area was recently reconstructed and consists of one section in good condition with small amounts of low- and medium-severity L&T cracking recorded. All of the low-severity cracking was unsealed and the medium-severity cracking was due to unsealed crack widths greater than ¼ inch.
